Re: Lead Based Paint Survey – Billet Building  
Sparrows Point Terminal - Area B  
Sparrows Point, Baltimore County  
ARM Project 150300M-12-4

**Table 1**  
Lead Based Paint Survey  
Sparrows Point - Billet Building

**ATTACHMENT 2**  
**Photo Log**

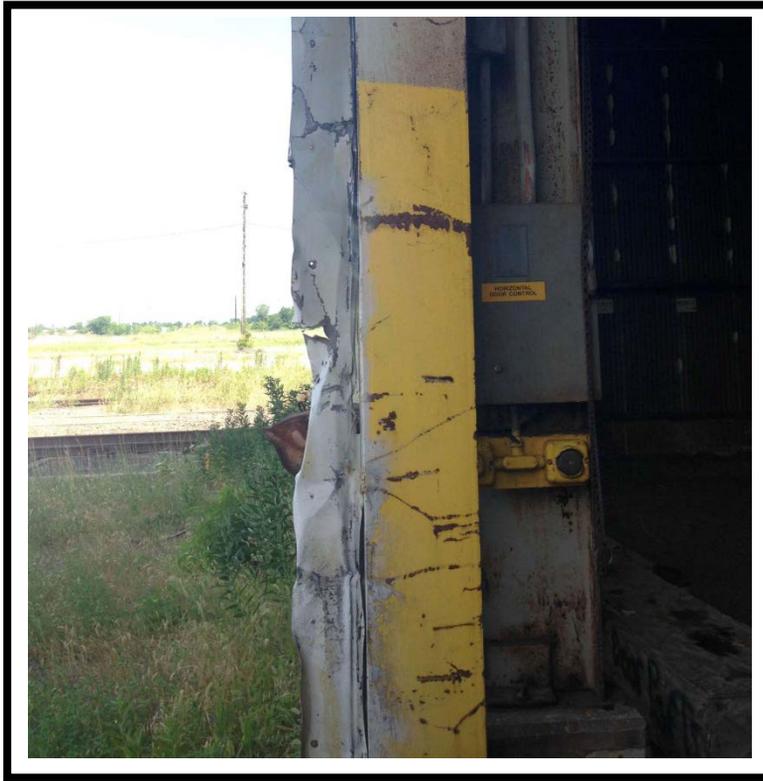
**Photo 11: View of west bay door frame, facing north**

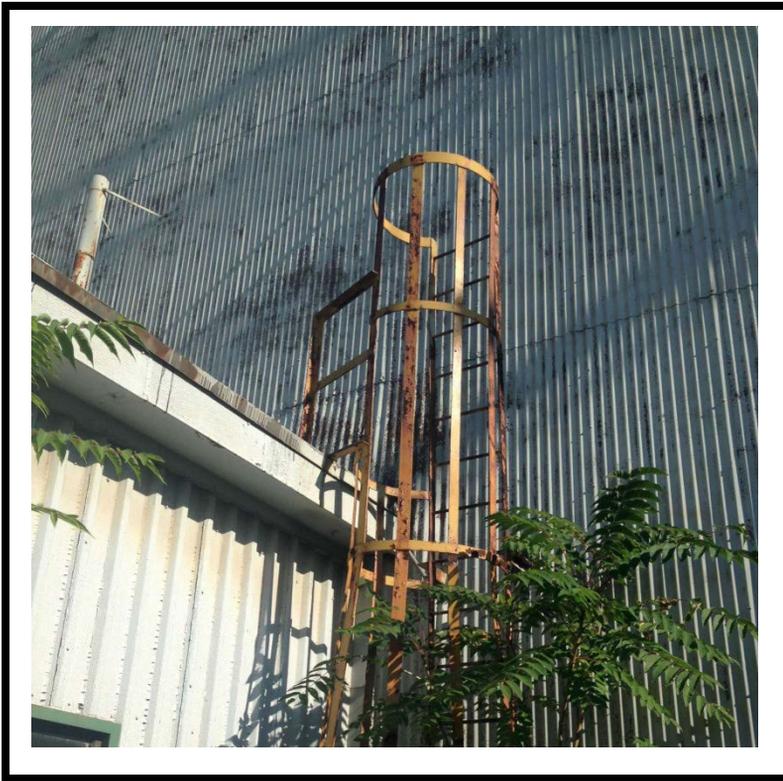
**Photo 13: View of wall ladder on south wall, facing northwest**

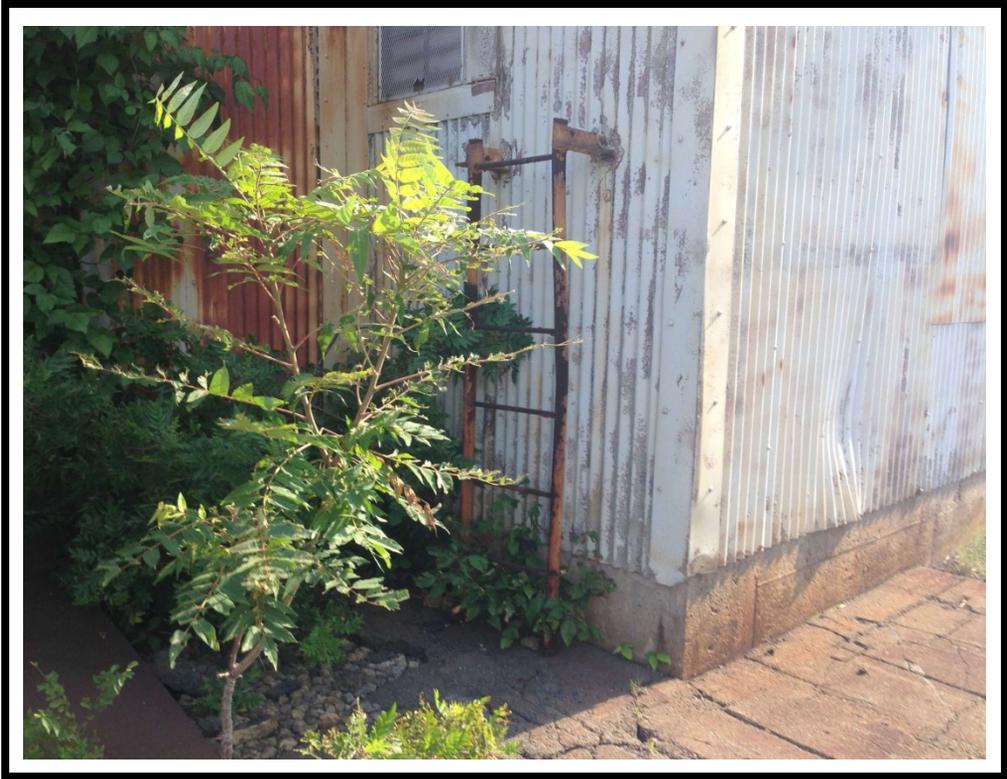
**Photo 17: View of OB #8 ladder, facing northeast**

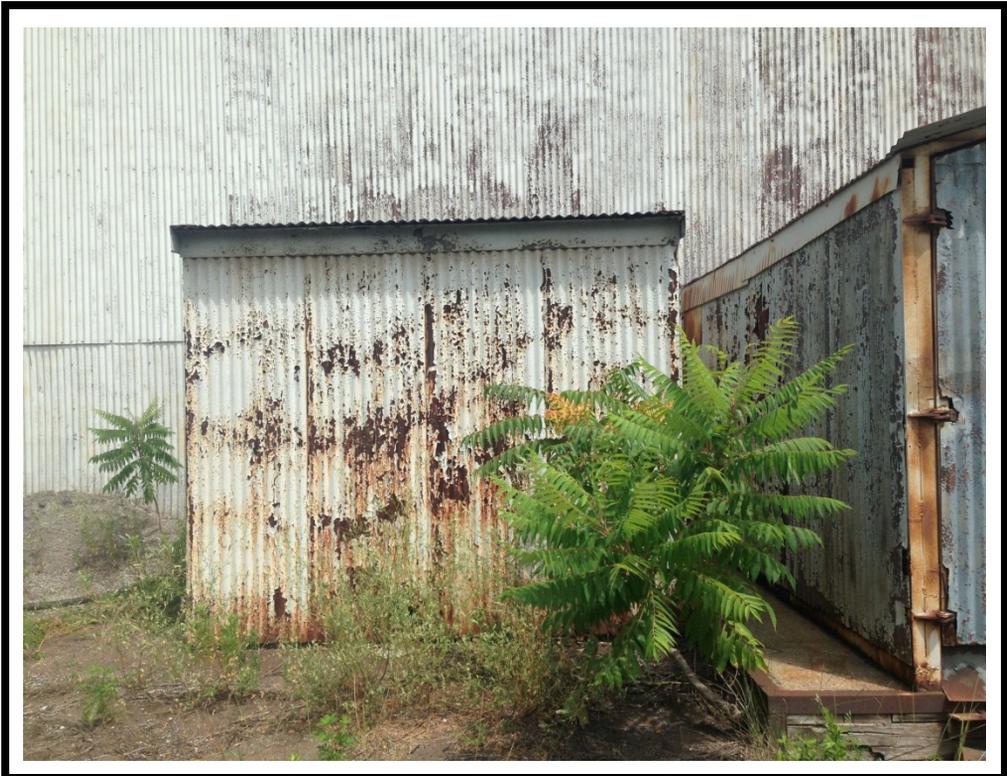
**Photo 18: View of OB #5 with peeling paint (inconclusive reading), facing north**

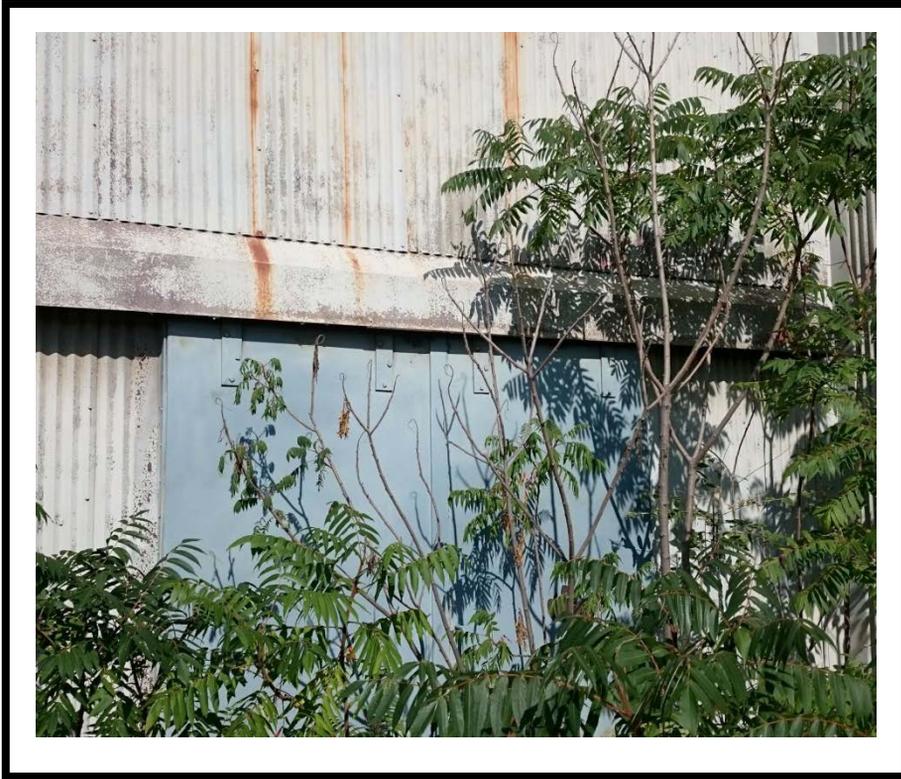
**Photo 19: View of OB #8 bay doors, facing west**

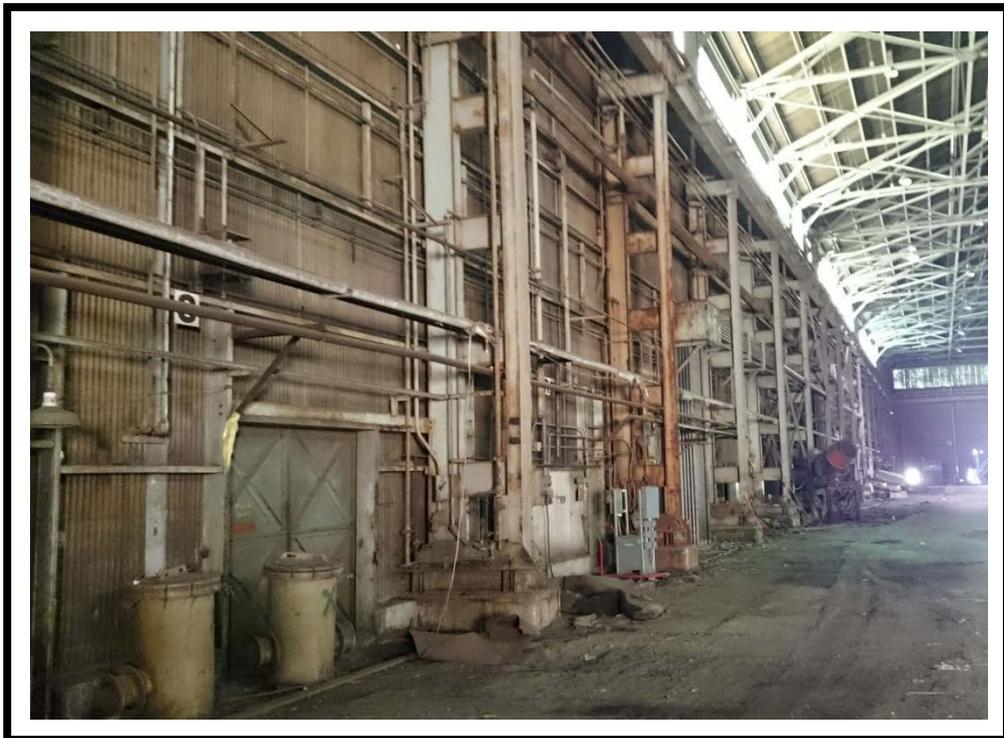
**Photo 20: View of support columns inside building on north wall, facing east**

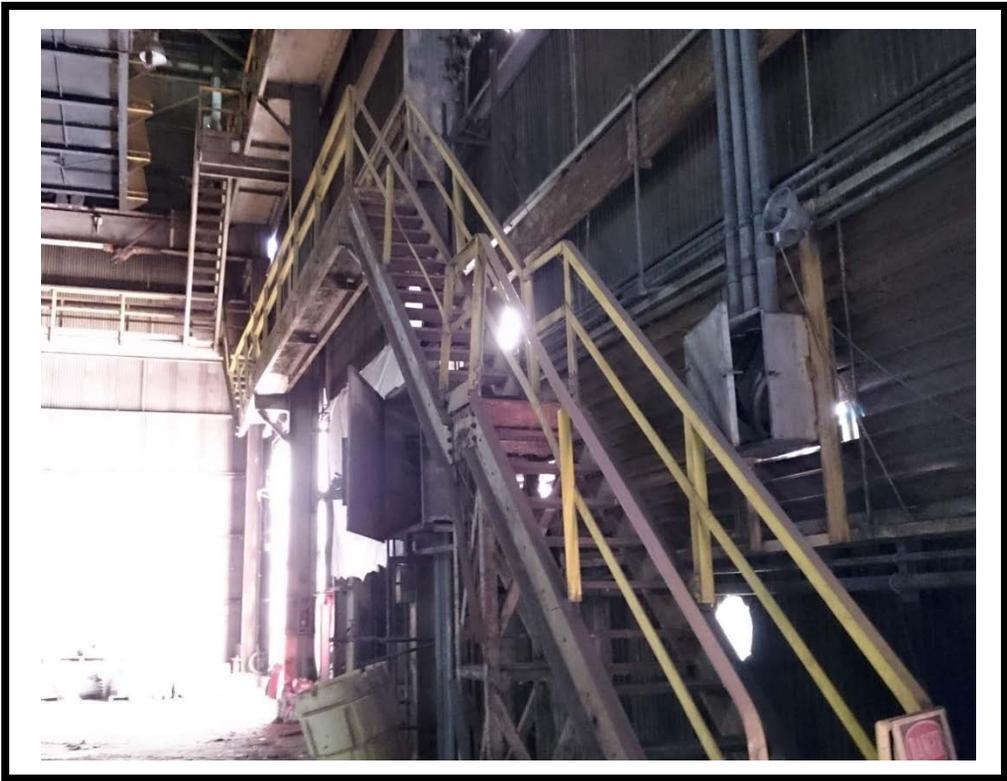
**Photo 21: View of railing to second level on east wall, facing north**

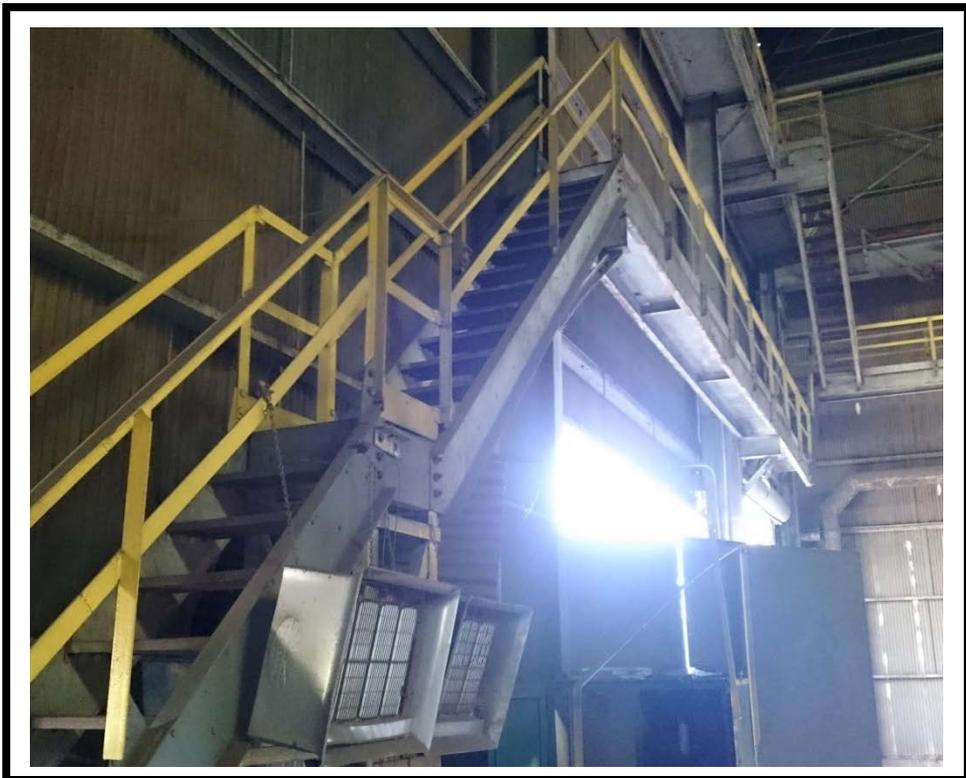
**Photo 22: View of railing to second level on west wall, facing north**

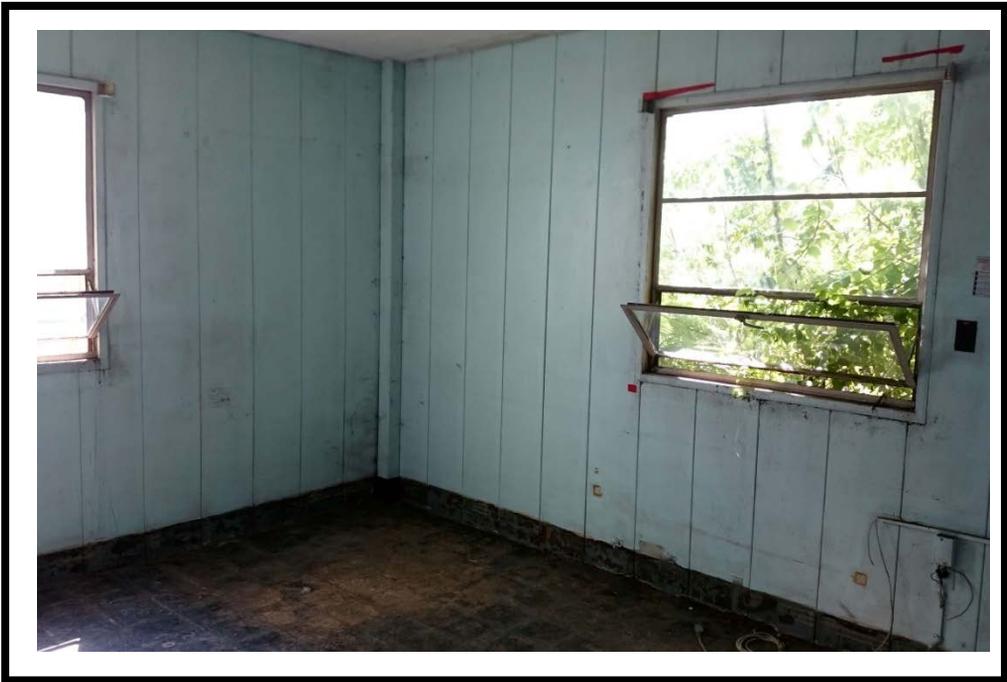
**Photo 25: View of west and south walls in OB #3, facing southwest**
