Dodging the Bullet: Lessons Learned From Recent Dam Emergencies

by
Hal Van Aller, P.E.
Maryland Dam Safety

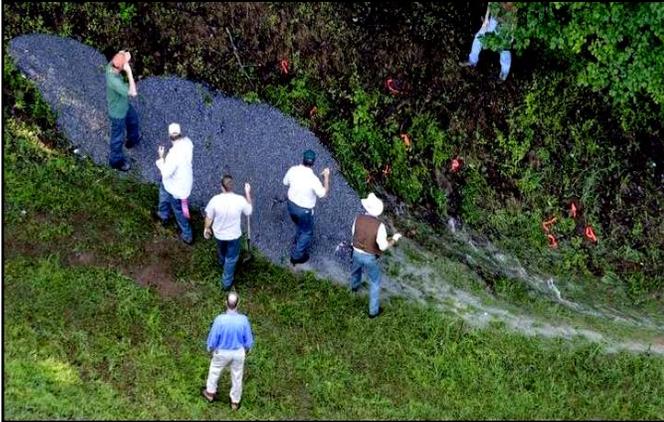
In an effort to prevent more flood damage to the Washington area, workers put gravel on a leak where water is sweeping through the dam.

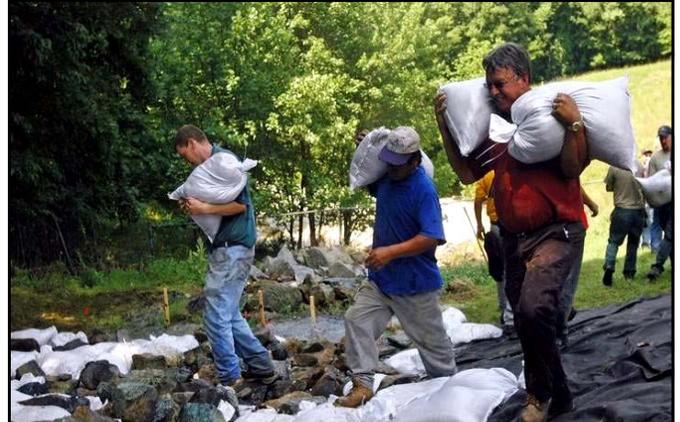
Area workers use sandbags as a temporary fix to stop the over flooding of the dam. Engineers and workers repair the damaged dam at Lake Needwood in Rock Creek Regional Park. The lake is 25 feet above normal and over 2,300 local residents were forced to evacuate.

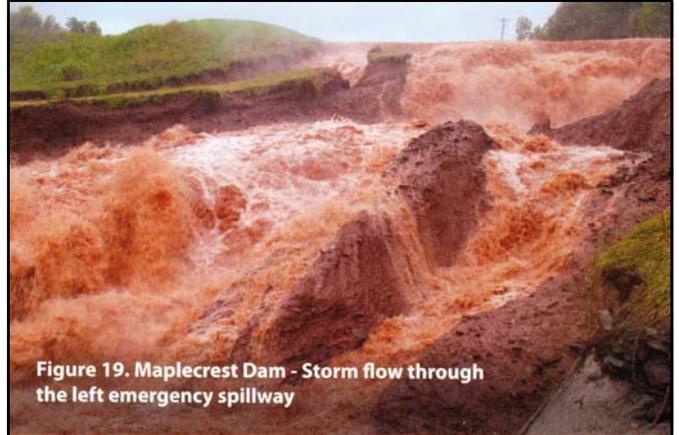
Figure 19. Maplecrest Dam - Storm flow through the left emergency spillway

Hurricane Irene, August, 2011 (New York)

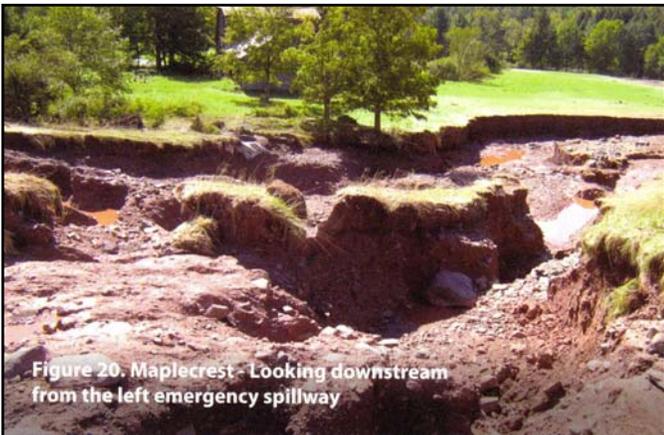
Figure 20. Maplecrest - Looking downstream from the left emergency spillway

Hurricane Irene, August, 2011 (New York)
