**WELLHEAD AREA SURVEY
ALPINE PANTRY
ACHD SITE NO. 86
Flintstone, Allegany County, Maryland**

ALWI Project No. AL7N001

NONCOMMUNITY WATER SUPPLY SANITARY SURVEY

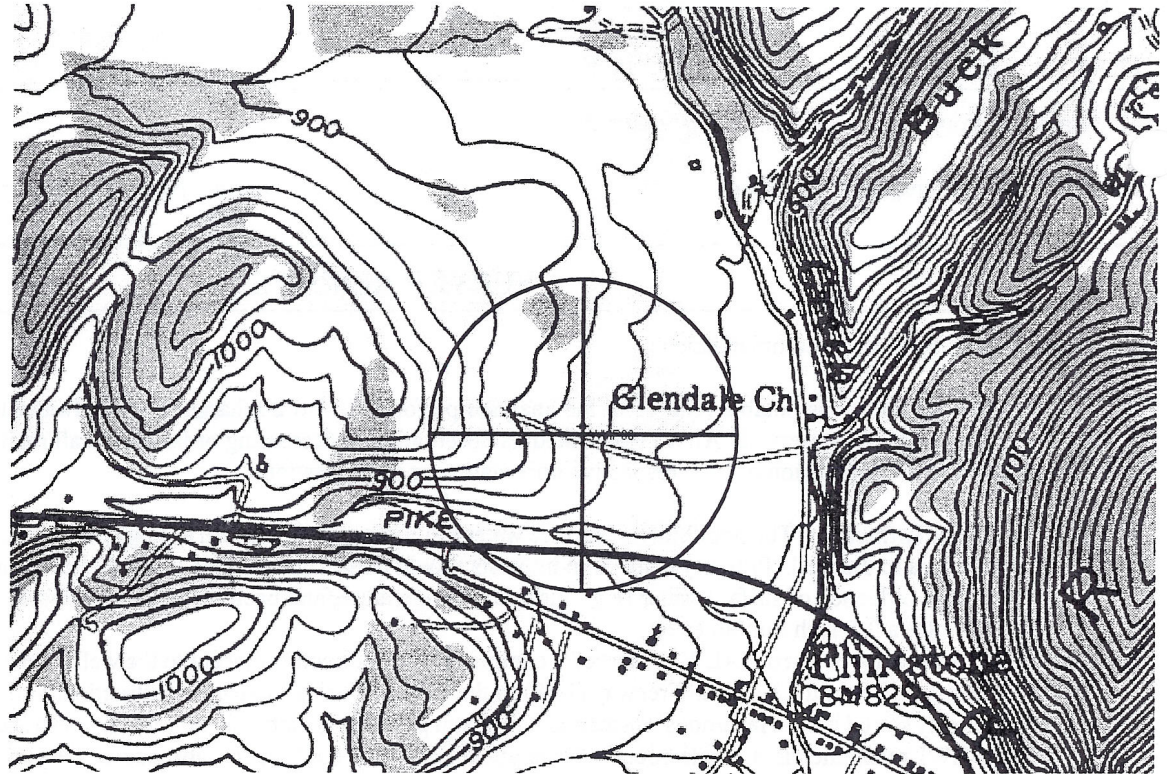
24. Well Location Diagram (1 in. = 1250 ft.) with Approximate Distances from Potential Contaminant Sources (i.e. septic, sewer lines, structures, petroleum storage, surface water bodies, etc.):

1. **Surface Water Influence** – The possibility of surface water infiltrating along the well casing is heightened by the proximity of a stormwater management area to the well. Property ownership interests should collect and analyze groundwater samples for indicators of groundwater under the direct influence of surface water (e.g., turbidity, temperature, and bacteria analyses performed daily for four consecutive days immediately after a 0.5-inch rainfall event).

2. **Adjacent Contractor's Yard** – ALWI observed a contractor's yard directly adjacent to the well. The yard reportedly traces its origins to the initial construction of the National Freeway (I-68) in the 1980s. During highway construction, various materials and large equipment were doubtlessly stored here. Hazardous wastes and petroleum products are intrinsic to highway construction work and may have been stored as well. ALWI recommends a single
