**WELLHEAD SURVEY AREA
BARRELVILLE OUTDOOR CLUB, INC.
ACHD SITE NO. 28
Mount Savage, Allegany County, Maryland**

ALWI Project No. AL7N001

NONCOMMUNITY WATER SUPPLY SANITARY SURVEY

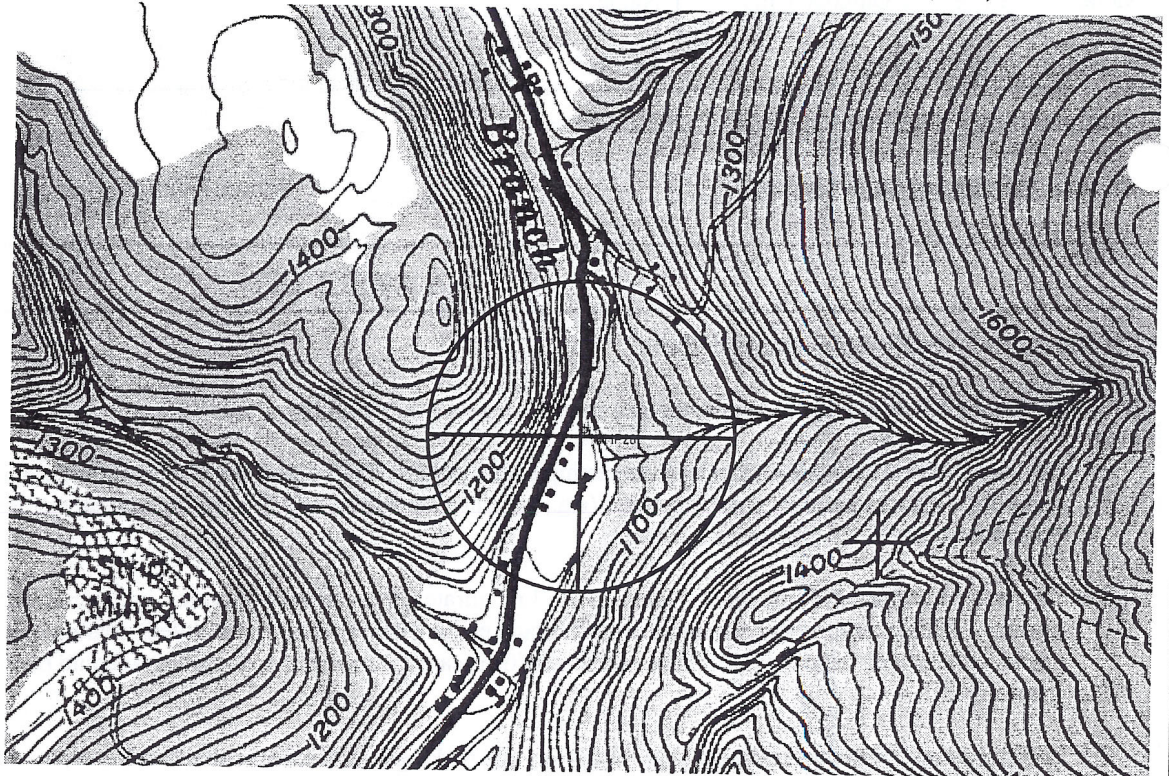
24. Well Location Diagram (1 in. = 1250 ft.) with Approximate Distances from Potential Contaminant Sources (i.e. septic, sewer lines, structures, petroleum storage, surface water bodies, etc.):

ALWI delineated a surveyed area surrounding this site's well using generalized criteria developed by MDE for non-community supplies, as modified by ALWI (with ACHD consent) based on the specific topographic setting of the site. The resultant delineation is shown on the "Water Plant Information" survey form (Appendix B). ALWI used a fixed radius of 1,000 feet around the well, which creates an area of approximately 72 acres. Within an assumed 600 gallons per day per acre (gpd/ac) of annualized groundwater recharge (Slaughter and Darling, 1962, Table 37), slightly more than 43,000 gallons per day exists within the aquifer beneath this surveyed area. In actuality, the modest demand of this well (approximately 500 gpd) is more than one full order of magnitude smaller than the total available in the surveyed area, lending a high degree of conservatism to this analysis.
