**WELLHEAD AREA SURVEY
CUMBERLAND VALLEY PACKING, INC.
ACHD SITE NO. 49
Cumberland, Allegany County, Maryland**

ALWI Project No. AL7N001

NONCOMMUNITY WATER SUPPLY SANITARY SURVEY

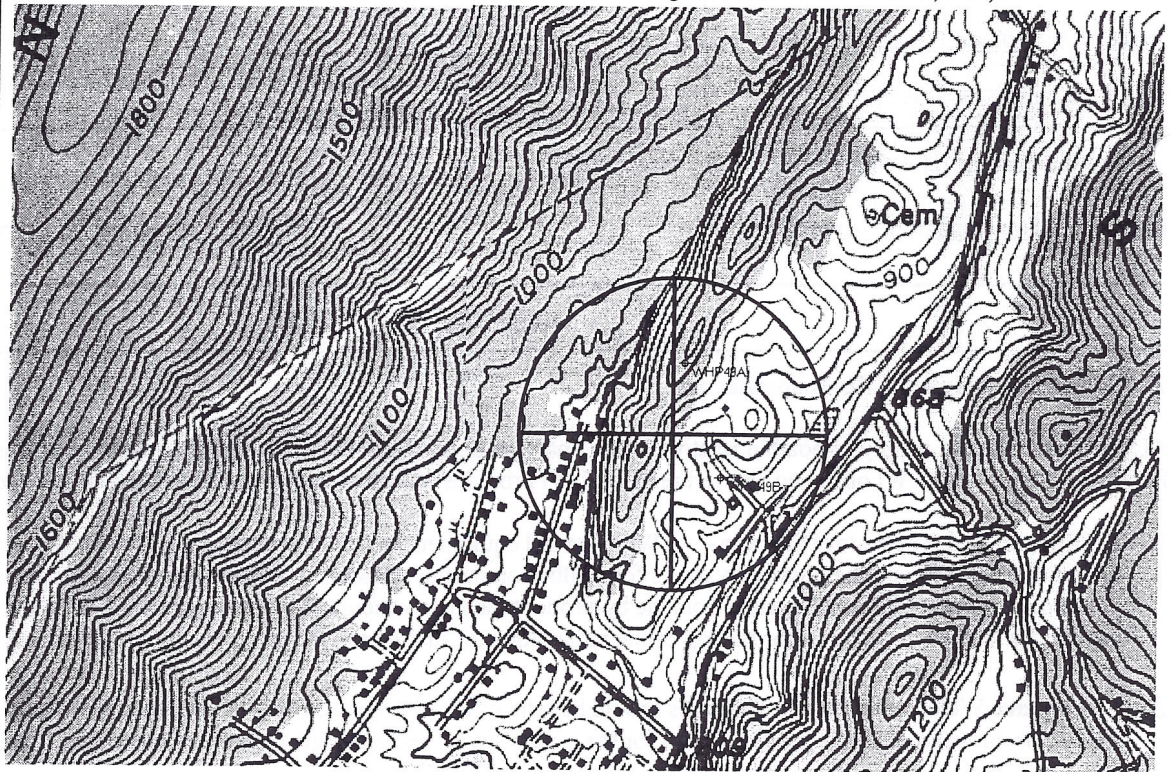
24. Well Location Diagram (1 in. = 1250 ft.) with Approximate Distances from Potential Contaminant Sources (i.e. septic, sewer lines, structures, petroleum storage, surface water bodies, etc.):

The resultant delineation is shown on the "Water Plant Information" survey form (Appendix B) and encompasses approximately 67% of the circle (originally 72 acres in size) or 48 acres. Within an assumed 600 gallons per day per acre (gpd/ac) of annualized groundwater recharge (Slaughter and Darling, 1962, Table 37), over 28,000 gallons per day exists within the aquifer beneath this surveyed area. In actuality, the modest demand on this well (doubtlessly less than 500 gpd) is nearly one full order of magnitude smaller than the surveyed area, lending a high degree of conservatism to this analysis.

No discharge to groundwater has been confirmed by any of the facilities or practices ALWI observed. ALWI identified the following potential sources of contamination within the surveyed area: equipment storage, the outdoor storage of deer processing by-products, downhill but within 100 feet of the well and at-grade pipes (as applied to a pitless connection). ALWI performed a site reconnaissance and conducted limited personal interviews to identify and describe these potential contaminant hazards.
