**WELLHEAD AREA SURVEY  
DALE'S PIT STOP  
ACHD SITE NO. 2  
McCoole, Allegany County, Maryland**

**ALWI Project No. AL7N001**

# NONCOMMUNITY WATER SUPPLY SANITARY SURVEY

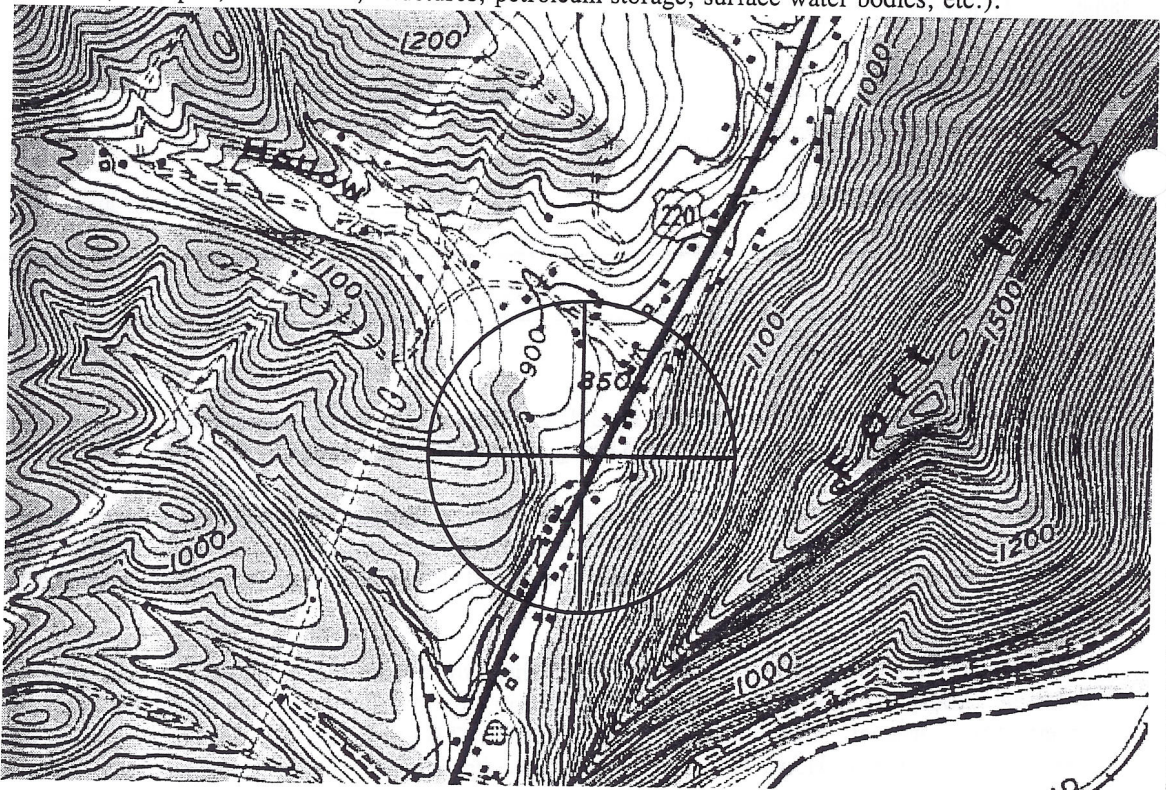
24. Well Location Diagram (1 in. = 1250 ft.) with Approximate Distances from Potential Contaminant Sources (i.e. septic, sewer lines, structures, petroleum storage, surface water bodies, etc.):

ALWI identified the following potential sources of contamination within the surveyed area: underground storage tanks (USTs), stormwater infiltration along the well's casing, salt from road deicing, and an adjacent agricultural area. ALWI performed a site reconnaissance and conducted limited personal interviews to identify and describe these potential contaminant hazards.
