**WELLHEAD AREA SURVEY
DOGWOOD FLAT HUNTING & FISHING CLUB, INC.
ACHD SITE NO. 4
Barton, Allegany County, Maryland**

ALWI Project No. AL7N001

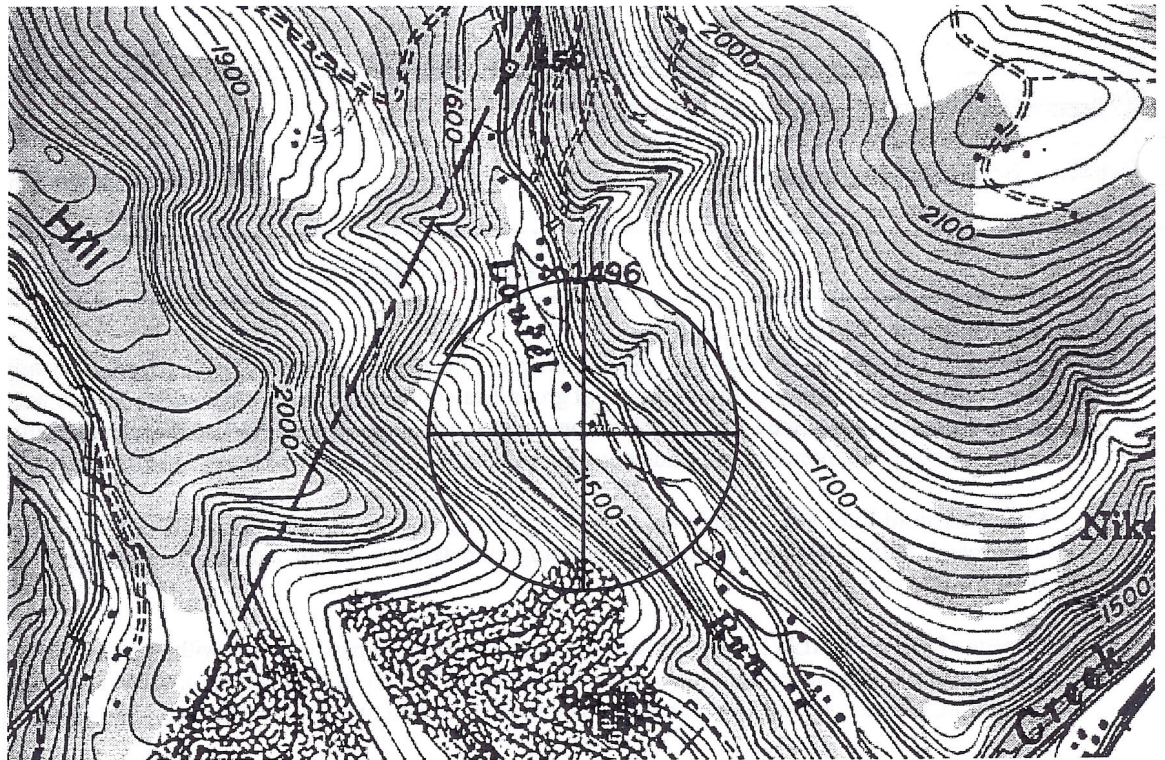
24. Well Location Diagram (1 in. = 1250 ft.) with Approximate Distances from Potential Contaminant Sources (i.e. septic, sewer lines, structures, petroleum storage, surface water bodies, etc.):

The close proximity of the well to Laurel Run places it at moderate to high risk for surface water influence as defined in the MDE guidance document. This risk would be better quantified with
