**WELLHEAD AREA SURVEY
THIRSTY'S BAR AND GRILL
ACHD SITE NO. 52
North Branch, Allegany County, Maryland**

ALWI Project No. AL7N001

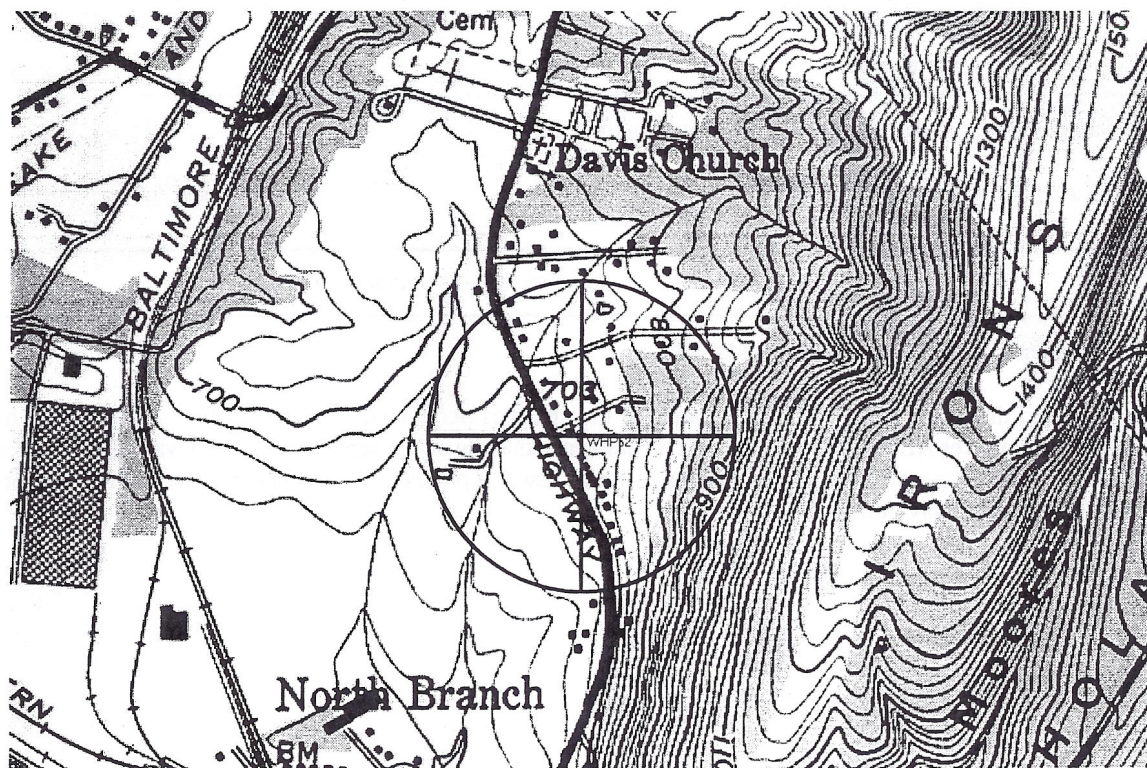
24. Well Location Diagram (1 in. = 1250 ft.) with Approximate Distances from Potential Contaminant Sources (i.e. septic, sewer lines, structures, petroleum storage, surface water bodies, etc.):

The resultant delineation is shown on the "Water Plant Information" survey form (Appendix B) and encompasses approximately 67% of the circle (originally 72 acres in size) or 48 acres. Within an assumed 600 gallons per day per acre (gpd/ac) of annualized groundwater recharge (Slaughter and Darling, 1962, Table 37), slightly less than 29,000 gallons per day exists within the aquifer beneath this surveyed area. In actuality, the modest demand of this well is much smaller than the total available in the surveyed area, lending a high degree of conservatism to this analysis.
