**WELLHEAD AREA SURVEY
TOWN HILL RESTAURANT AND HOTEL
ACHD SITE NO. 82
Belle Grove, Allegany County, Maryland**

ALWI Project No. AL7N001

Wellhead Area Survey
Town Hill Restaurant and Hotel; Site No. 82

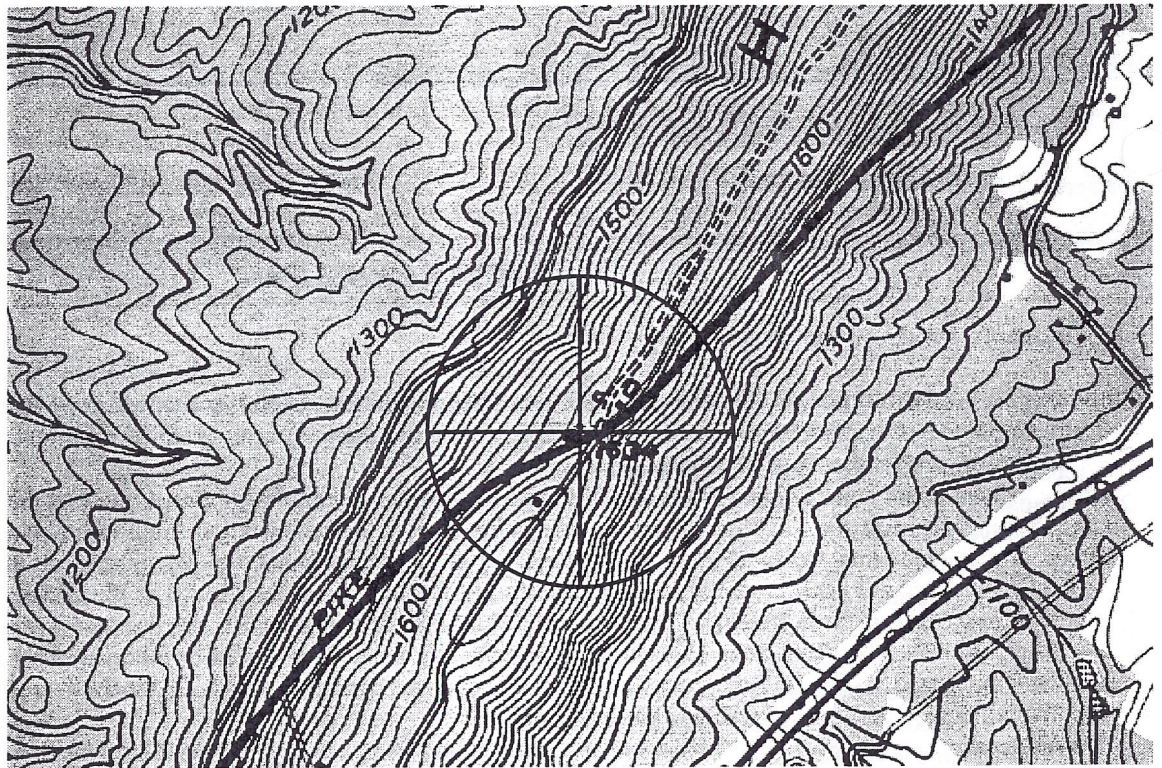
24. Well Location Diagram (1in. = 1250 ft.) with Approximate Distances from Potential Contaminant Sources (i.e. septic, sewer lines, structures, petroleum storage, surface water bodies, etc.):

Based solely on visual observation and interview information, ALWI identified the following potential sources of contamination within the surveyed area: possible remnant surficial and subsurface fuel spills from gasoline USTs formerly on site², various remnant hydrocarbons from a former speed shop situated on a neighboring property³ possible stormwater infiltration along the wells' casing, salt from parking lot deicing, a basement fuel oil AST, the on-site septic system, and the aforementioned risks associated with the wells' frost pits.
