**WELLHEAD AREA SURVEY
WILLOWBROOK SEVENTH DAY ADVENTIST SCHOOL
ACHD SITE NO. 60
Cumberland, Allegany County, Maryland**

ALWI Project No. AL7N001

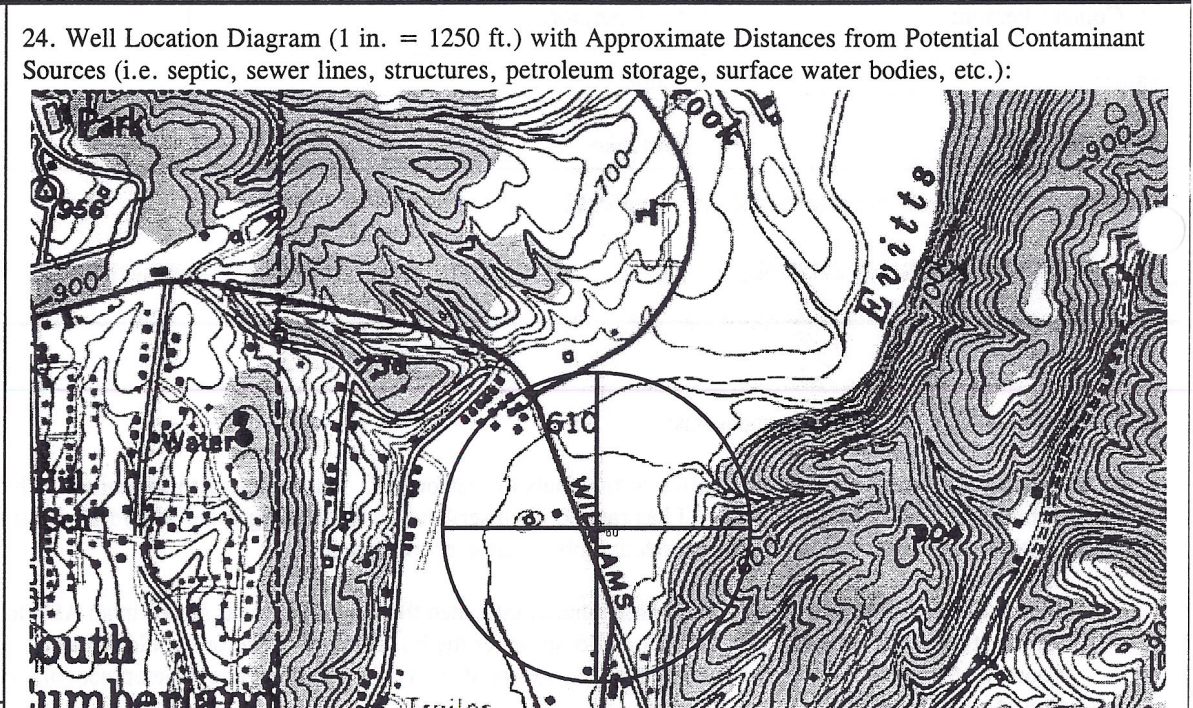
Design, construction and present condition are important factors in determining a well's susceptibility to contamination. However, no well tag was visible. Accordingly, ALWI could not assess the initial design nor present condition of the casing or grout seal. ALWI observed that the portion of the casing exposed at ground surface appeared intact and was equipped with a conventional pitless-style cap of the type that can sometimes allow insects to enter the well. An upgrade to a more modern cap would provide greater protection against microbial contamination.
