Source Water Assessment

Cecil Woods Mobile Home Park Water System

Cecil County, Maryland

May 2003

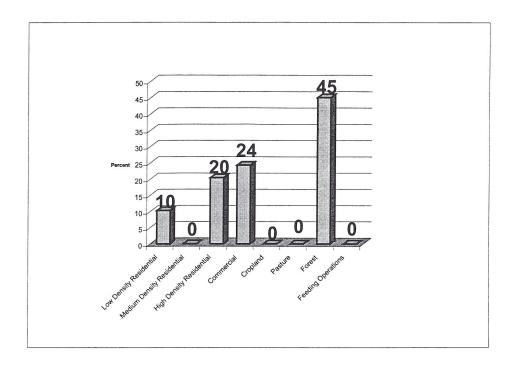
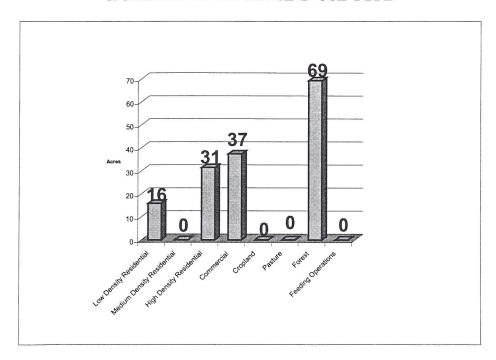
From an interpretation of the figures above, forest (69 acres) and residential areas (47 acres) accounts for a majority of the SWPA (154 acres). The only non-point source of pollution generally associated with forests is from logging activities. Overuse of fertilizers, pesticides, and herbicides on residential areas can be a non-point source of SOC. Therefore, there is some potential for the migration of potential contaminants into the ground water.

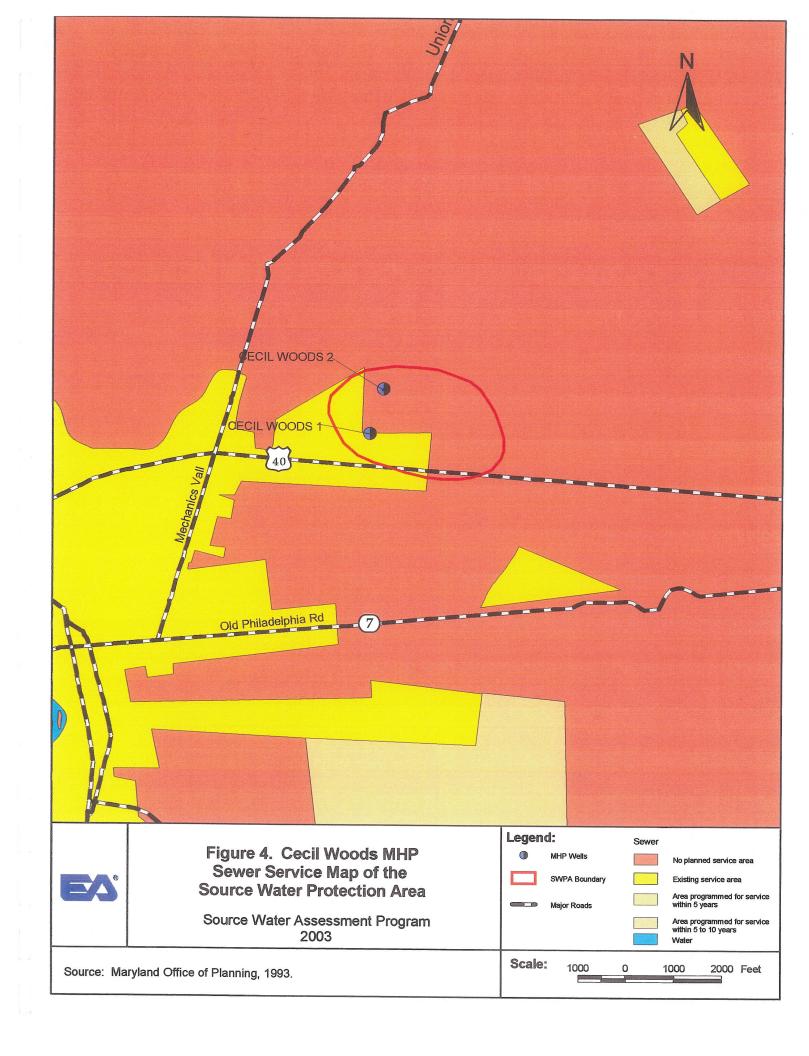
Using the 1995 Maryland Office of Planning's Cecil County sewerage coverage, potential non-point sources from other septic system users in the SWPA were assessed (Figure 4). By overlaying the SWPA over the sewerage coverage layer in ArcView GIS, it was determined that approximately 71 percent of the SWPA does not have public sewer service while 29 percent is either on public sewer service or is under construction.
