Maryland Department of Environment
Water and Science Administration
Compliance Program
1800 Washington Blvd, Suite 420
Baltimore, MD 21230-1719
410- 537-3510, 1-800-633-6101

Site Name: Back River WWTP
Facility Address: 8201 Eastern Ave, Baltimore, MD 21224
County: Baltimore County

Complaint Number: 28368
Media Type(s): NPDES Municipal Major Surface Water

Inspection Reason: Follow-up (Non-Compliance)

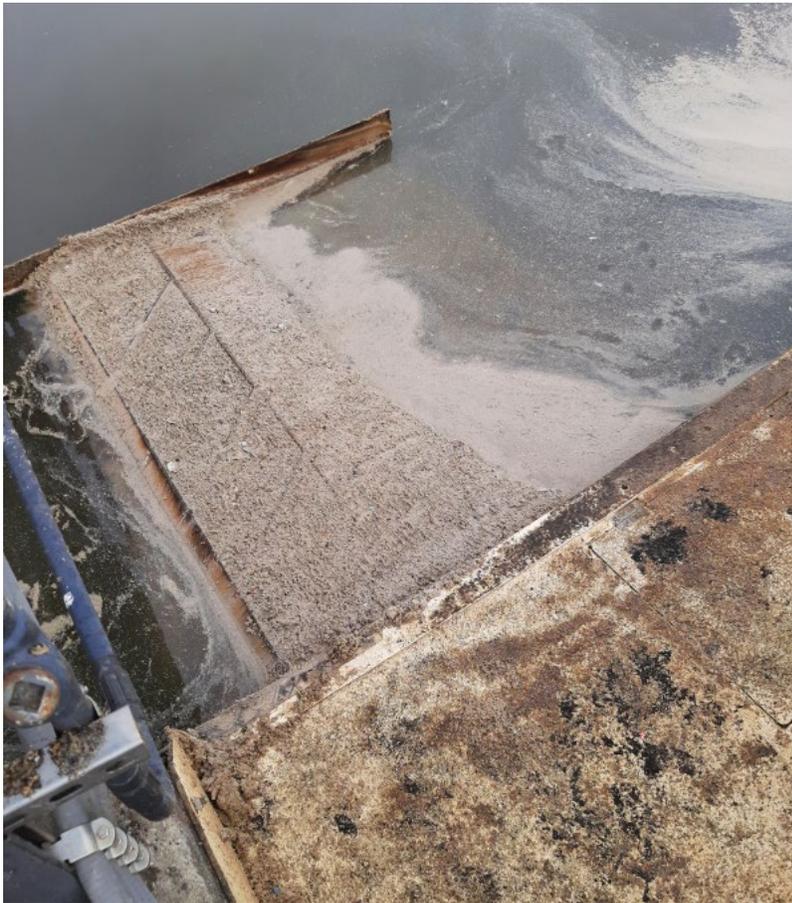
After the discussion, I conducted a site review accompanied by Mr. Kroen, Ms. Paton, Ms. Garris, and Mr. Latova. The first stop was at the primary settling tanks (PST). There, I found that only two (#8 and #11 PST) of the eleven PSTs were in operation. I was informed that previously there were three PSTs in operation, however the motor on the center drive arm for PST #10 failed taking that PST offline. I was informed that there is a PST #4 that is currently being cleaned. The March 14, 2022, status report from the permittee shows that there are 5 available PSTs indicating there has been no progress in getting all 11 PSTs operating as designed. During an inspection of the two PSTs in operation, found excess floating scum in PST# 11. The skimming arm was functional however during an inspection of the scum trough, I found that it was clogged, and the scum needed to be cleaned out. See picture below:

Scum trough at PST # 11 clogged due to floating scum 3/22/22

- A. With respect to item #1 above, the Back River WWTP should get the PST cleaned and operational to improve the quality of the final effluent. There should be sufficient functioning PSTs in service to accommodate expected influent flows.
- B. With respect to item #2 above, the Back River WWTP should determine the cause of the problems with the out of service denitrification filters and make the necessary repairs. The problem with the clogged filters should be repaired so that the ENR treatment is not bypassed.
- C. With respect to item #3 above, The Back River WWTP should improve operational maintenance, evaluate wasting practices and make changes as necessary and provide better preventive maintenance practices to improve the solids concentrations throughout the processes.

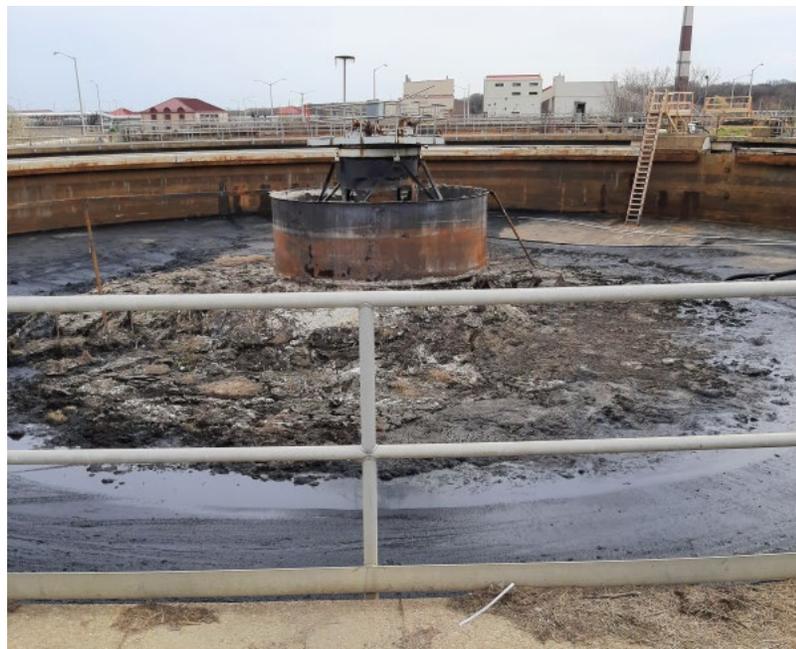
Inactive PST due to solids buildup 3/22/22

I asked staff that accompanied me what would be the minimum number of PSTs required for satisfactory primary settling based on current flows of 120 MGD. The consensus was at minimum four PSTs are required. Therefore, currently the treatment system is operating with half the number of PST necessary for satisfactory primary settling and scum removal.

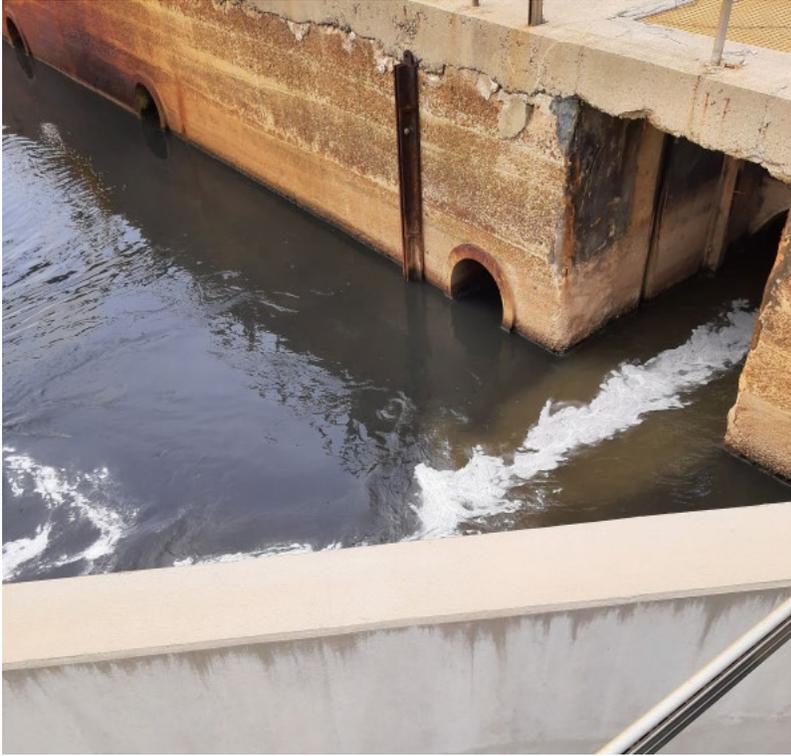
3/22/22 wastewater from PSTs going to the biological reactors
Ferric chloride is added to the waste stream at this point

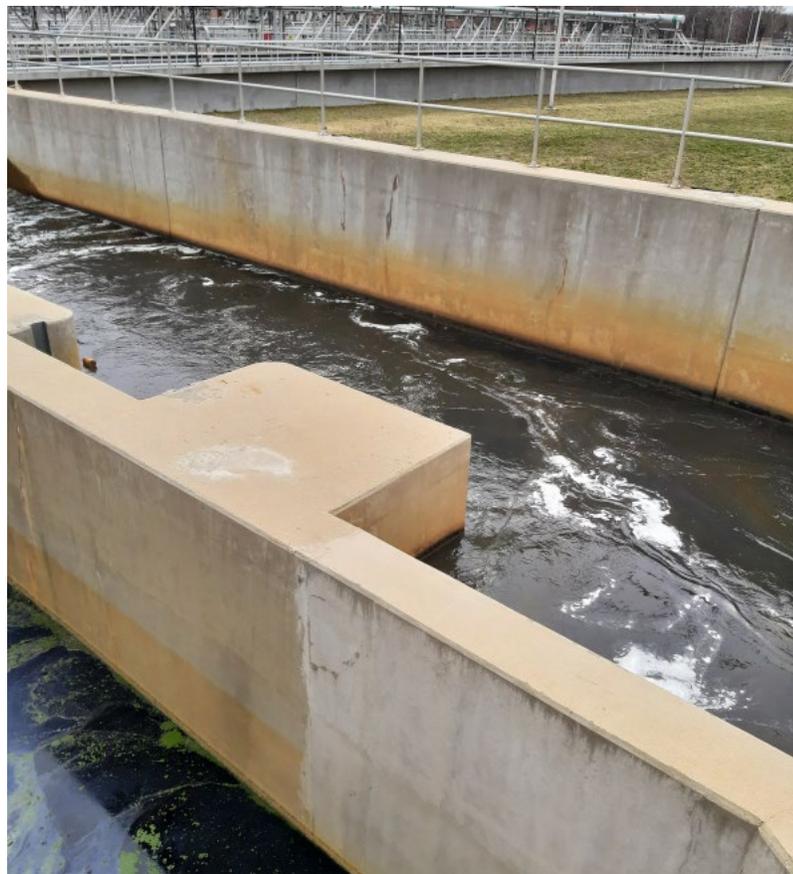
The wastewater leaving the PSTs flows to a series of biological reactors for nitrogen removal. The facility has two trains with six reactors in each train for a total of 12. Each reactor has a three-pass design designated A, B and C. There is also a third activated sludge plant called activator #4 that is still under construction and when completed there will be 18 reactors. According to Mr. Latova, #4 plant is covered under contract #882 and will be in operation soon. The wastewater traveling in the channels from the PSTs to the activated sludge plants was a dark grey color indicating a high concentration of solids in the waste stream. See pictures below:

Turbid dark grey wastewater traveling to the biological reactors 3/22/22

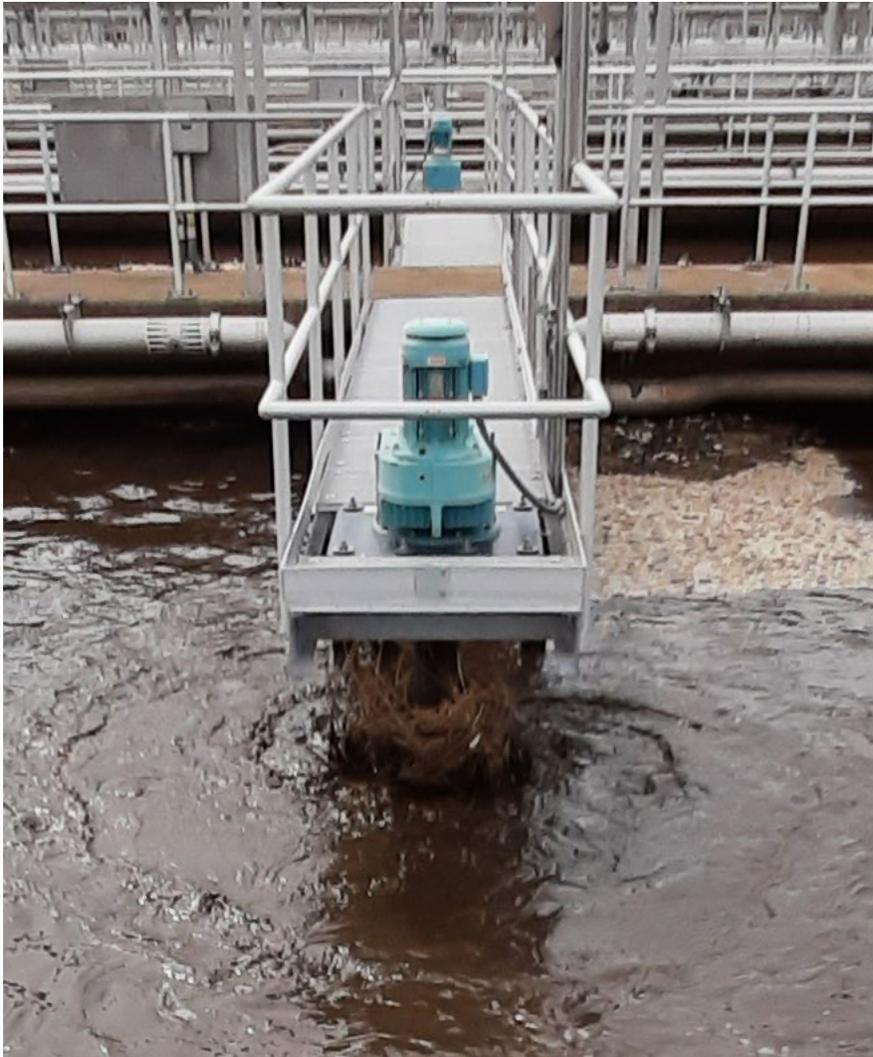
1. Some of the mixers in the A pass have vegetation growing on the blades which is hindering mixing capabilities. See picture below:
2. There is a heavy accumulation of solids with vegetation growing at the end of the reactor before going to the clarifiers. See pictures below:
3. The mixed liquor concentration (MLSS) is currently being maintained at 4,000 – 4,500. Ideally the MLSS should be maintained around 3,000. The facility's target is between 2,600 – 2,800, however according to Mr. Latova due to the amount of solids in the system they cannot meet that goal.

3/22/22 vegetation growing on the mixers on A pass in the reactors

7. Reed grasses and other vegetation are established in the biological reactors preventing satisfactory operations.
8. Total suspended solids concentrations of the waste stream going into the denitrification filters or influent has increased considerably compared to past operational data. The facility is experiencing BOD, total phosphorous violations due to the high concentrations of TSS throughout the processes and in the final effluent. These high TSS concentrations are also a violation of the above authorization.

- G. With respect to item #7 above reed grasses and other vegetation should be removed from the biological reactor and mixers.
- H. With respect to item #8 above, the Back River WWTP should improve operational maintenance, get all treatment process functioning properly, evaluate wasting practices and make changes as necessary and provide better preventive maintenance practices to improve the solids concentrations throughout the processes. The Back River WWTP must take the necessary steps to improve the treatment processes throughout the system and eliminate violations at Outfall 001.

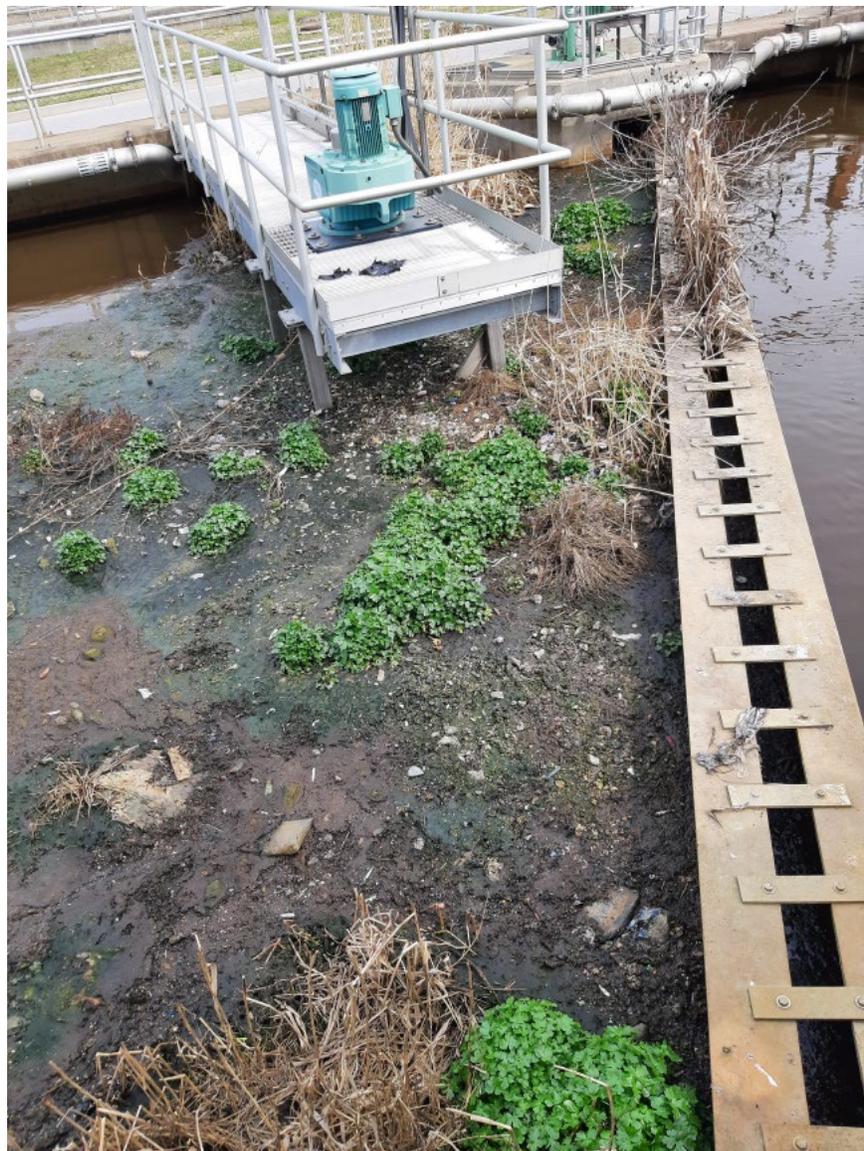
Solids buildup with growing vegetation in biological reactor 3/22/22

5. There are unacceptable accumulations of solids in the bioreactors and the secondary clarifiers that should be removed to improve the quality of the final effluent and improve operations.

- E. With respect to item #5 above, vegetation and solids should be removed from the secondary clarifiers and biological reactors.
- F. With respect to item #6 above, all vegetation should be removed from the secondary clarifiers.

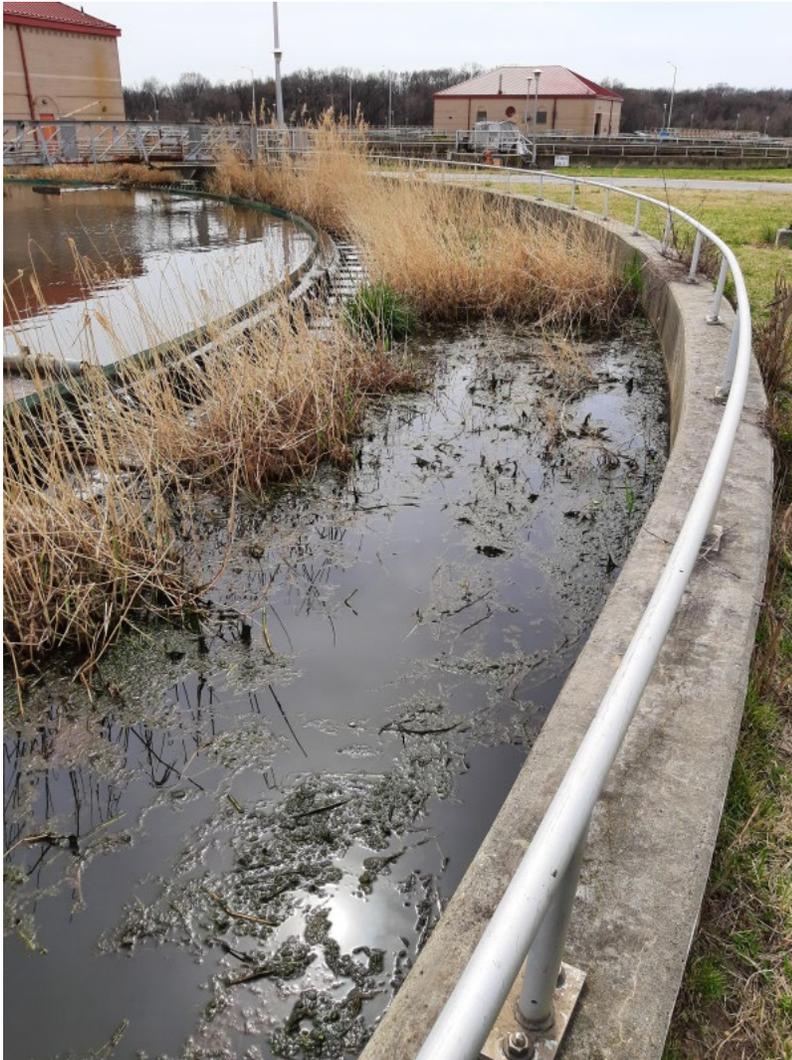
There was an excessive buildup of solids in the clarifiers and within the center well. Because of the nutrients available, the reed grasses, vines, algae, and other vegetation have taken over the clarifiers leading to the following operational problems:

1. Settling dead zones in the clarifiers
2. Short circuiting of the weirs of the clarifiers
3. The Sludge blanket in the clarifier may rise to the surface and wash over the effluent weir of the clarifiers
4. The influent flow distribution hampered by solids and vegetations. Satisfactory distribution is a critical for secondary clarifier operational performance.
5. The final effluent TSS concentrations are in most cases dependent on the performance of the secondary clarifiers.

3/22/22 Secondary clarifier filled with algae, reed grasses and other vegetation

6. Established vegetation such as reed grasses were observed in the secondary clarifiers causing operational problems and unsatisfactory settling within the clarifiers.

- D. With respect to item #4 above, the weirs on the secondary clarifiers should be routinely scrubbed to prevent aggressive algae growth. All vegetation should be removed from the secondary clarifiers and routine maintenance should be done to prevent the recurrence of the problem.

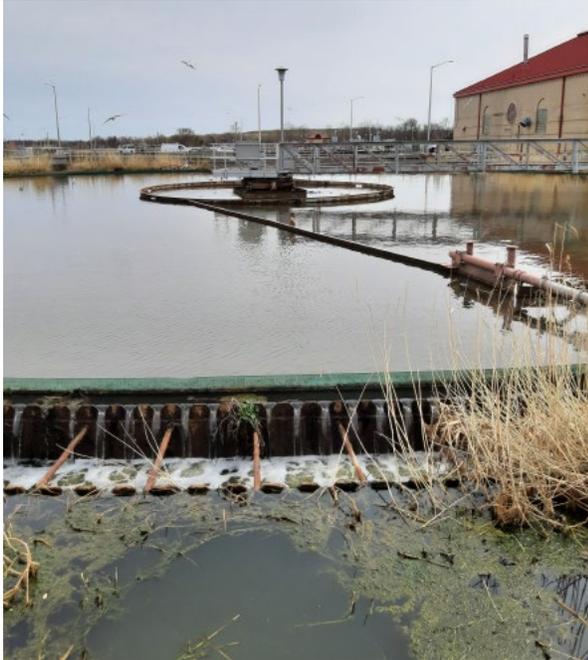
Pictures below show concerns over the operation of the secondary clarifiers.

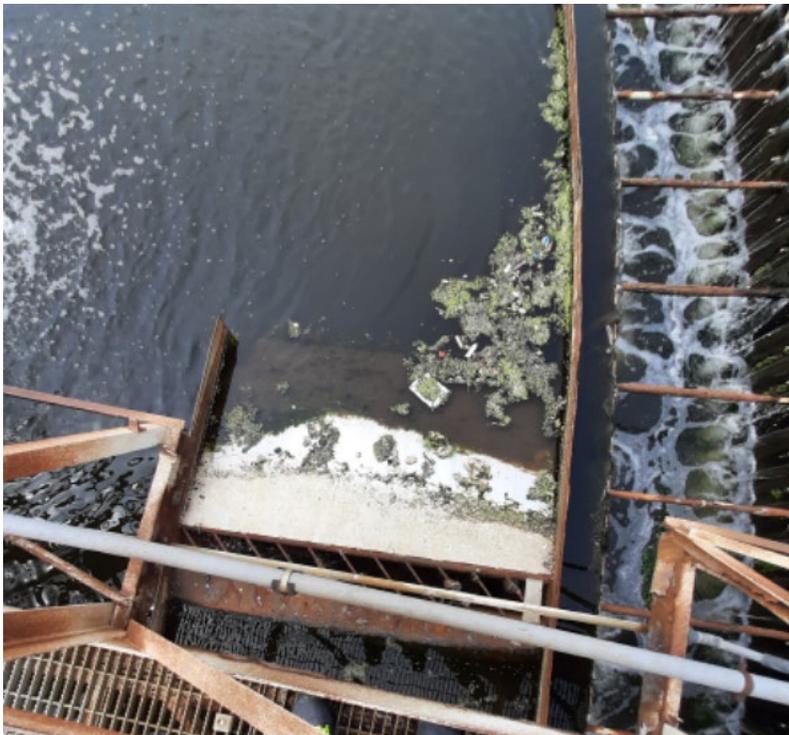
The scum troughs clogged on some of the clarifiers
The center wells clogged with scum and the removed scum is being placed on the deck of the clarifier instead of being placed in containers.

3/22/22 secondary clarifier. Scum trough clogged

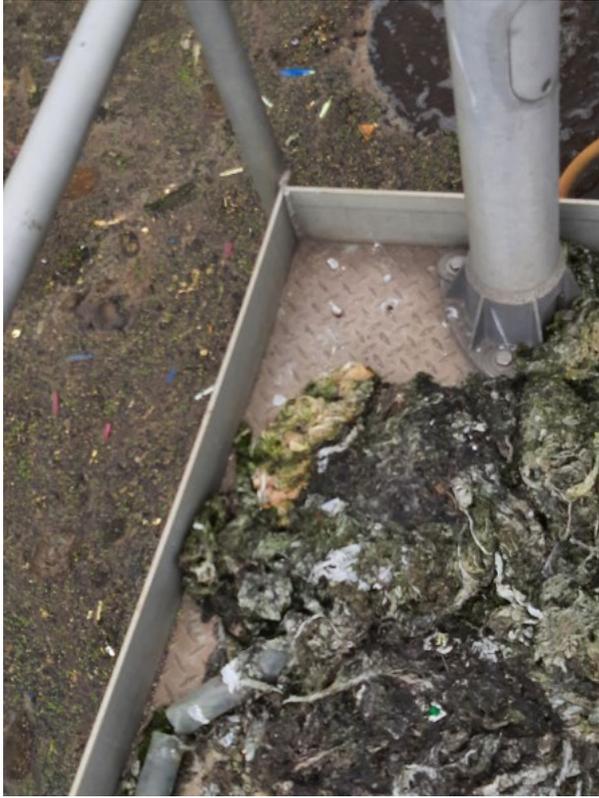
3/22/22 Scum collected from center well is not being disposed of properly

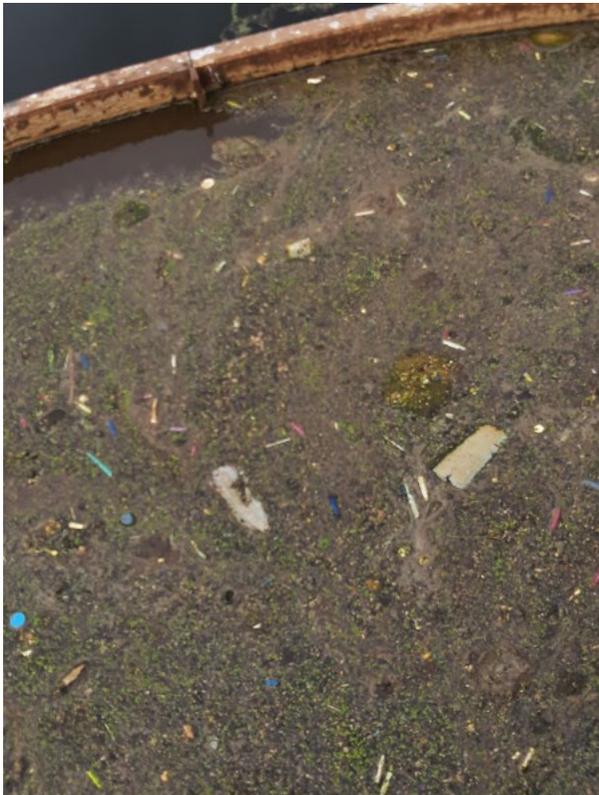
3/22/22 Center well of clarifier filled with floating debris

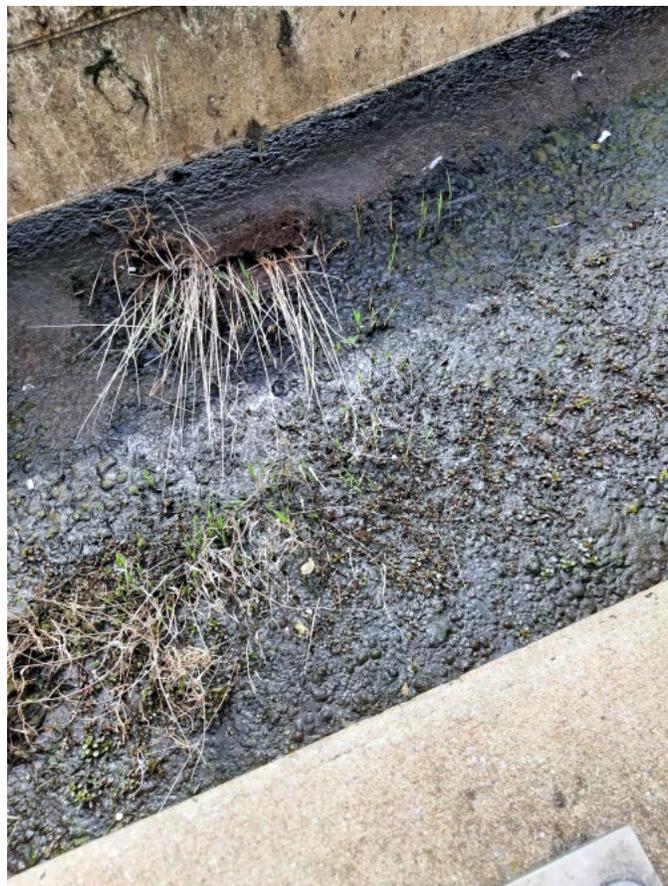
Solids and vegetation in secondary clarifier.3/22/22

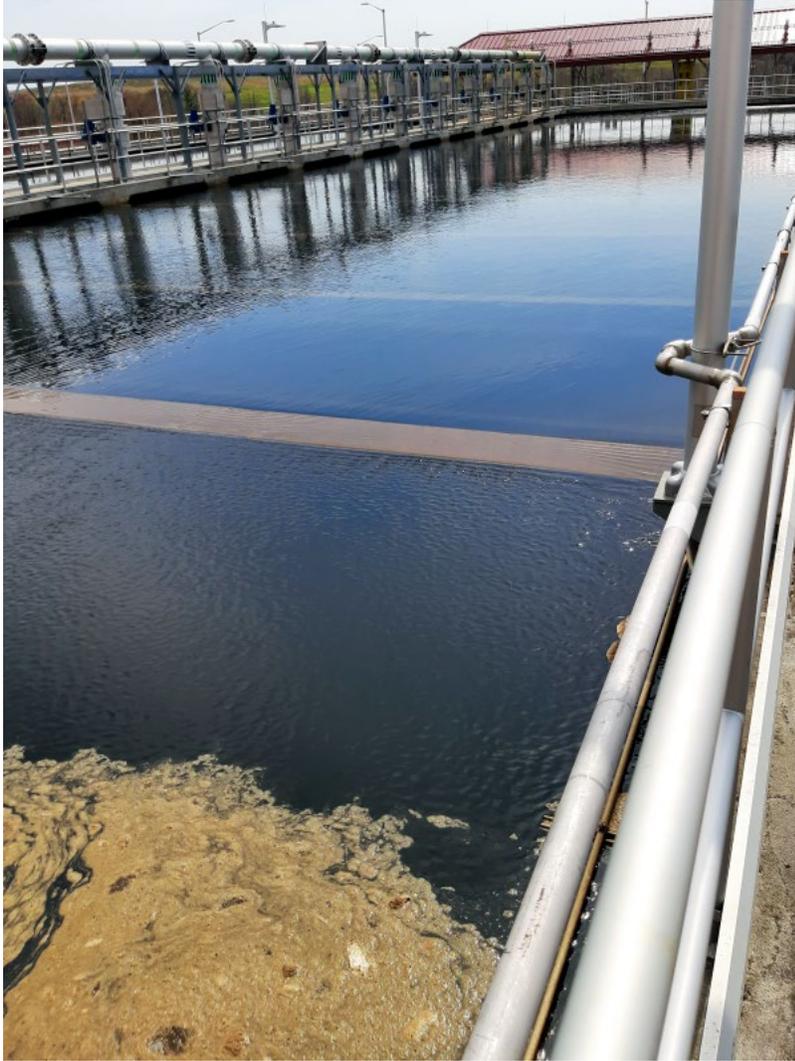
During this inspection, I found that not all the filters were functioning as designed. Quads #1, #2 and #4 were all submerged under water due to clogging. Many of the filters had a floating layer of scum that appeared to be emulsified fats oil and grease (FOG) that carried over from primary treatment. This oily scum will prevent functional operation of the filter and affect the efficiency of the filters. According to the control panel, there were 14 of the 52 filters were not operational and requiring various types of service maintenance. However, I found that there was only one quad (13 filters) that was functioning as designed. The other 39 filters were not functioning because of clogging due to solids. I noticed a strong odor of hydrogen sulfide gas coming from the filters. Hydrogen sulfide is a corrosive gas and can cause human health problems.

3/22/22 floating scum on submerged filter quad

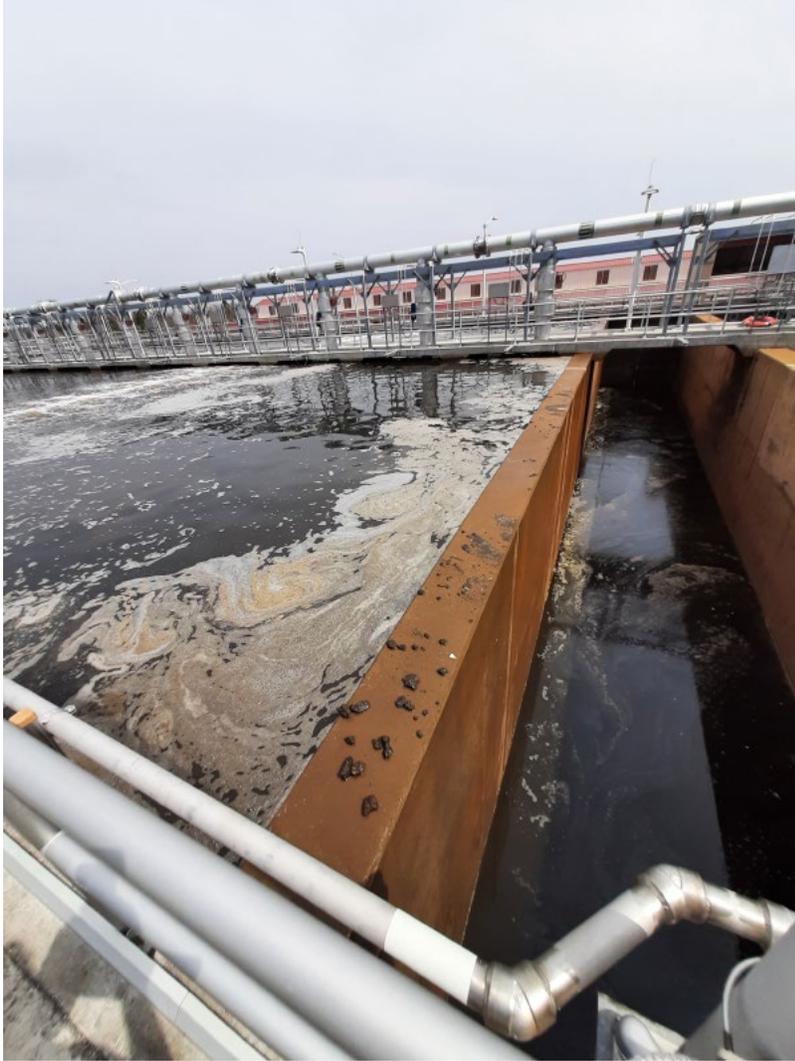
Submerged filters and mud well to right 3/22/22

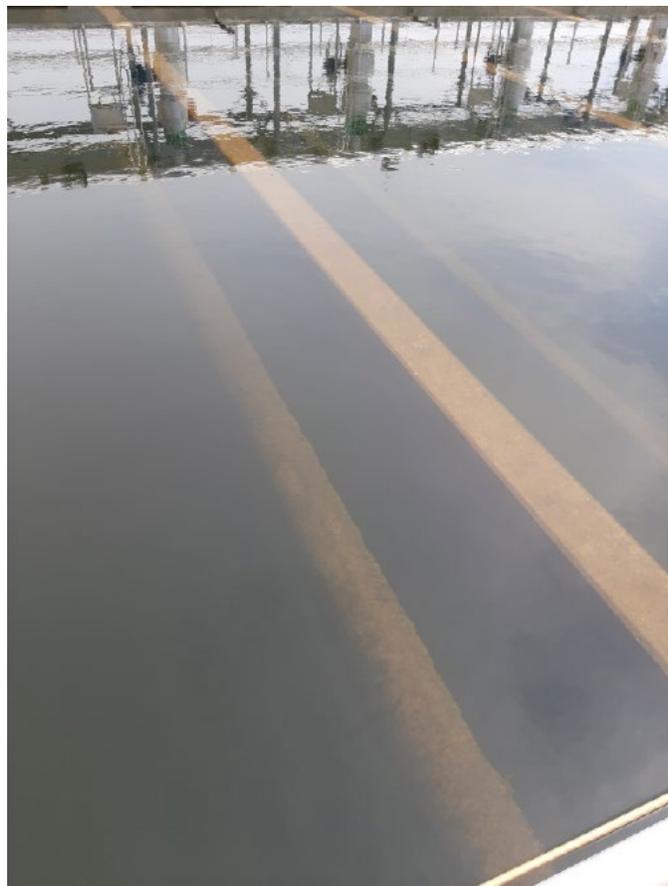
Filter as above on 3/22/22 submerged not functioning properly

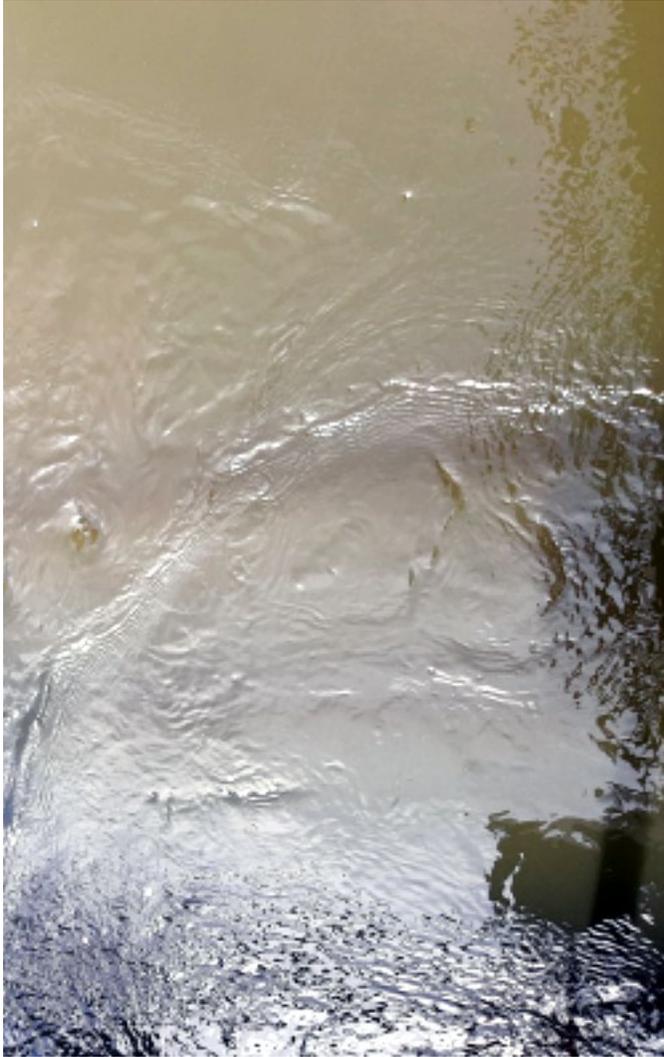
The wastewater travels from the sand filters to the contact chambers where the wastewater is disinfected and then dechlorinated. The wastewater in the contact chambers was a dark grey color with intermittent small black clumps of floating solids flowing to the final discharge point. Next, I inspected the final effluent at the step post aeration system. The final effluent was grey in color with some turbidity.

3/22/22 floating black clumps of solid material

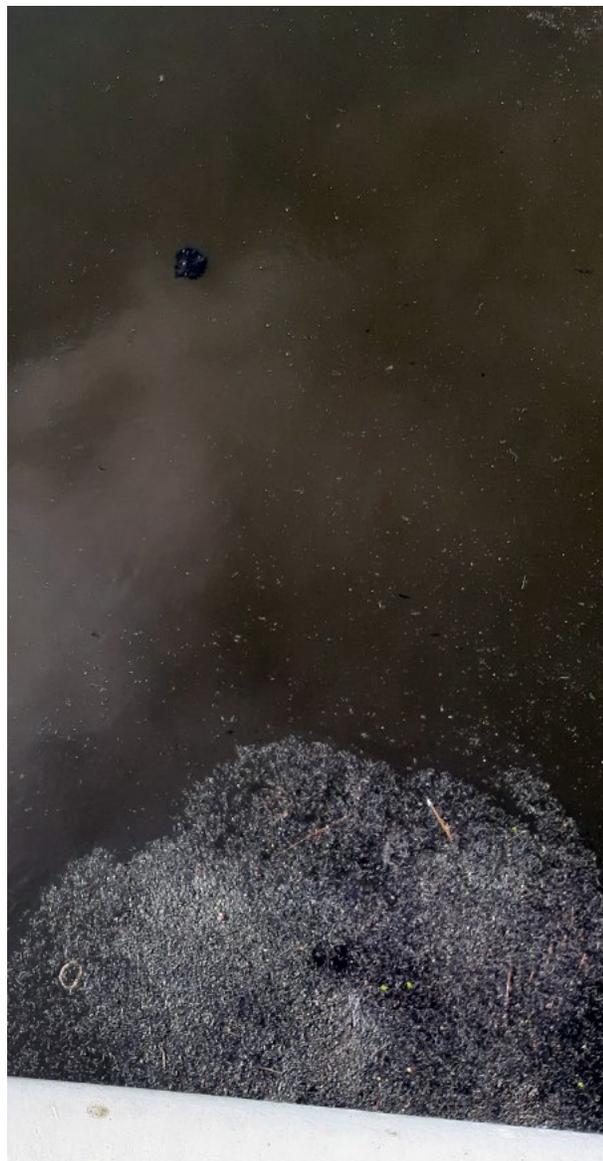
Scum and black solid particles in the final effluent 3/22/22
