ARM Group LLC

July 15, 2020

Re: Comment Response Letter:
Response and Development Completion
Report - Area B: Parcel B15, Revision 0
Tradepoint Atlantic
Sparrows Point, MD 21219

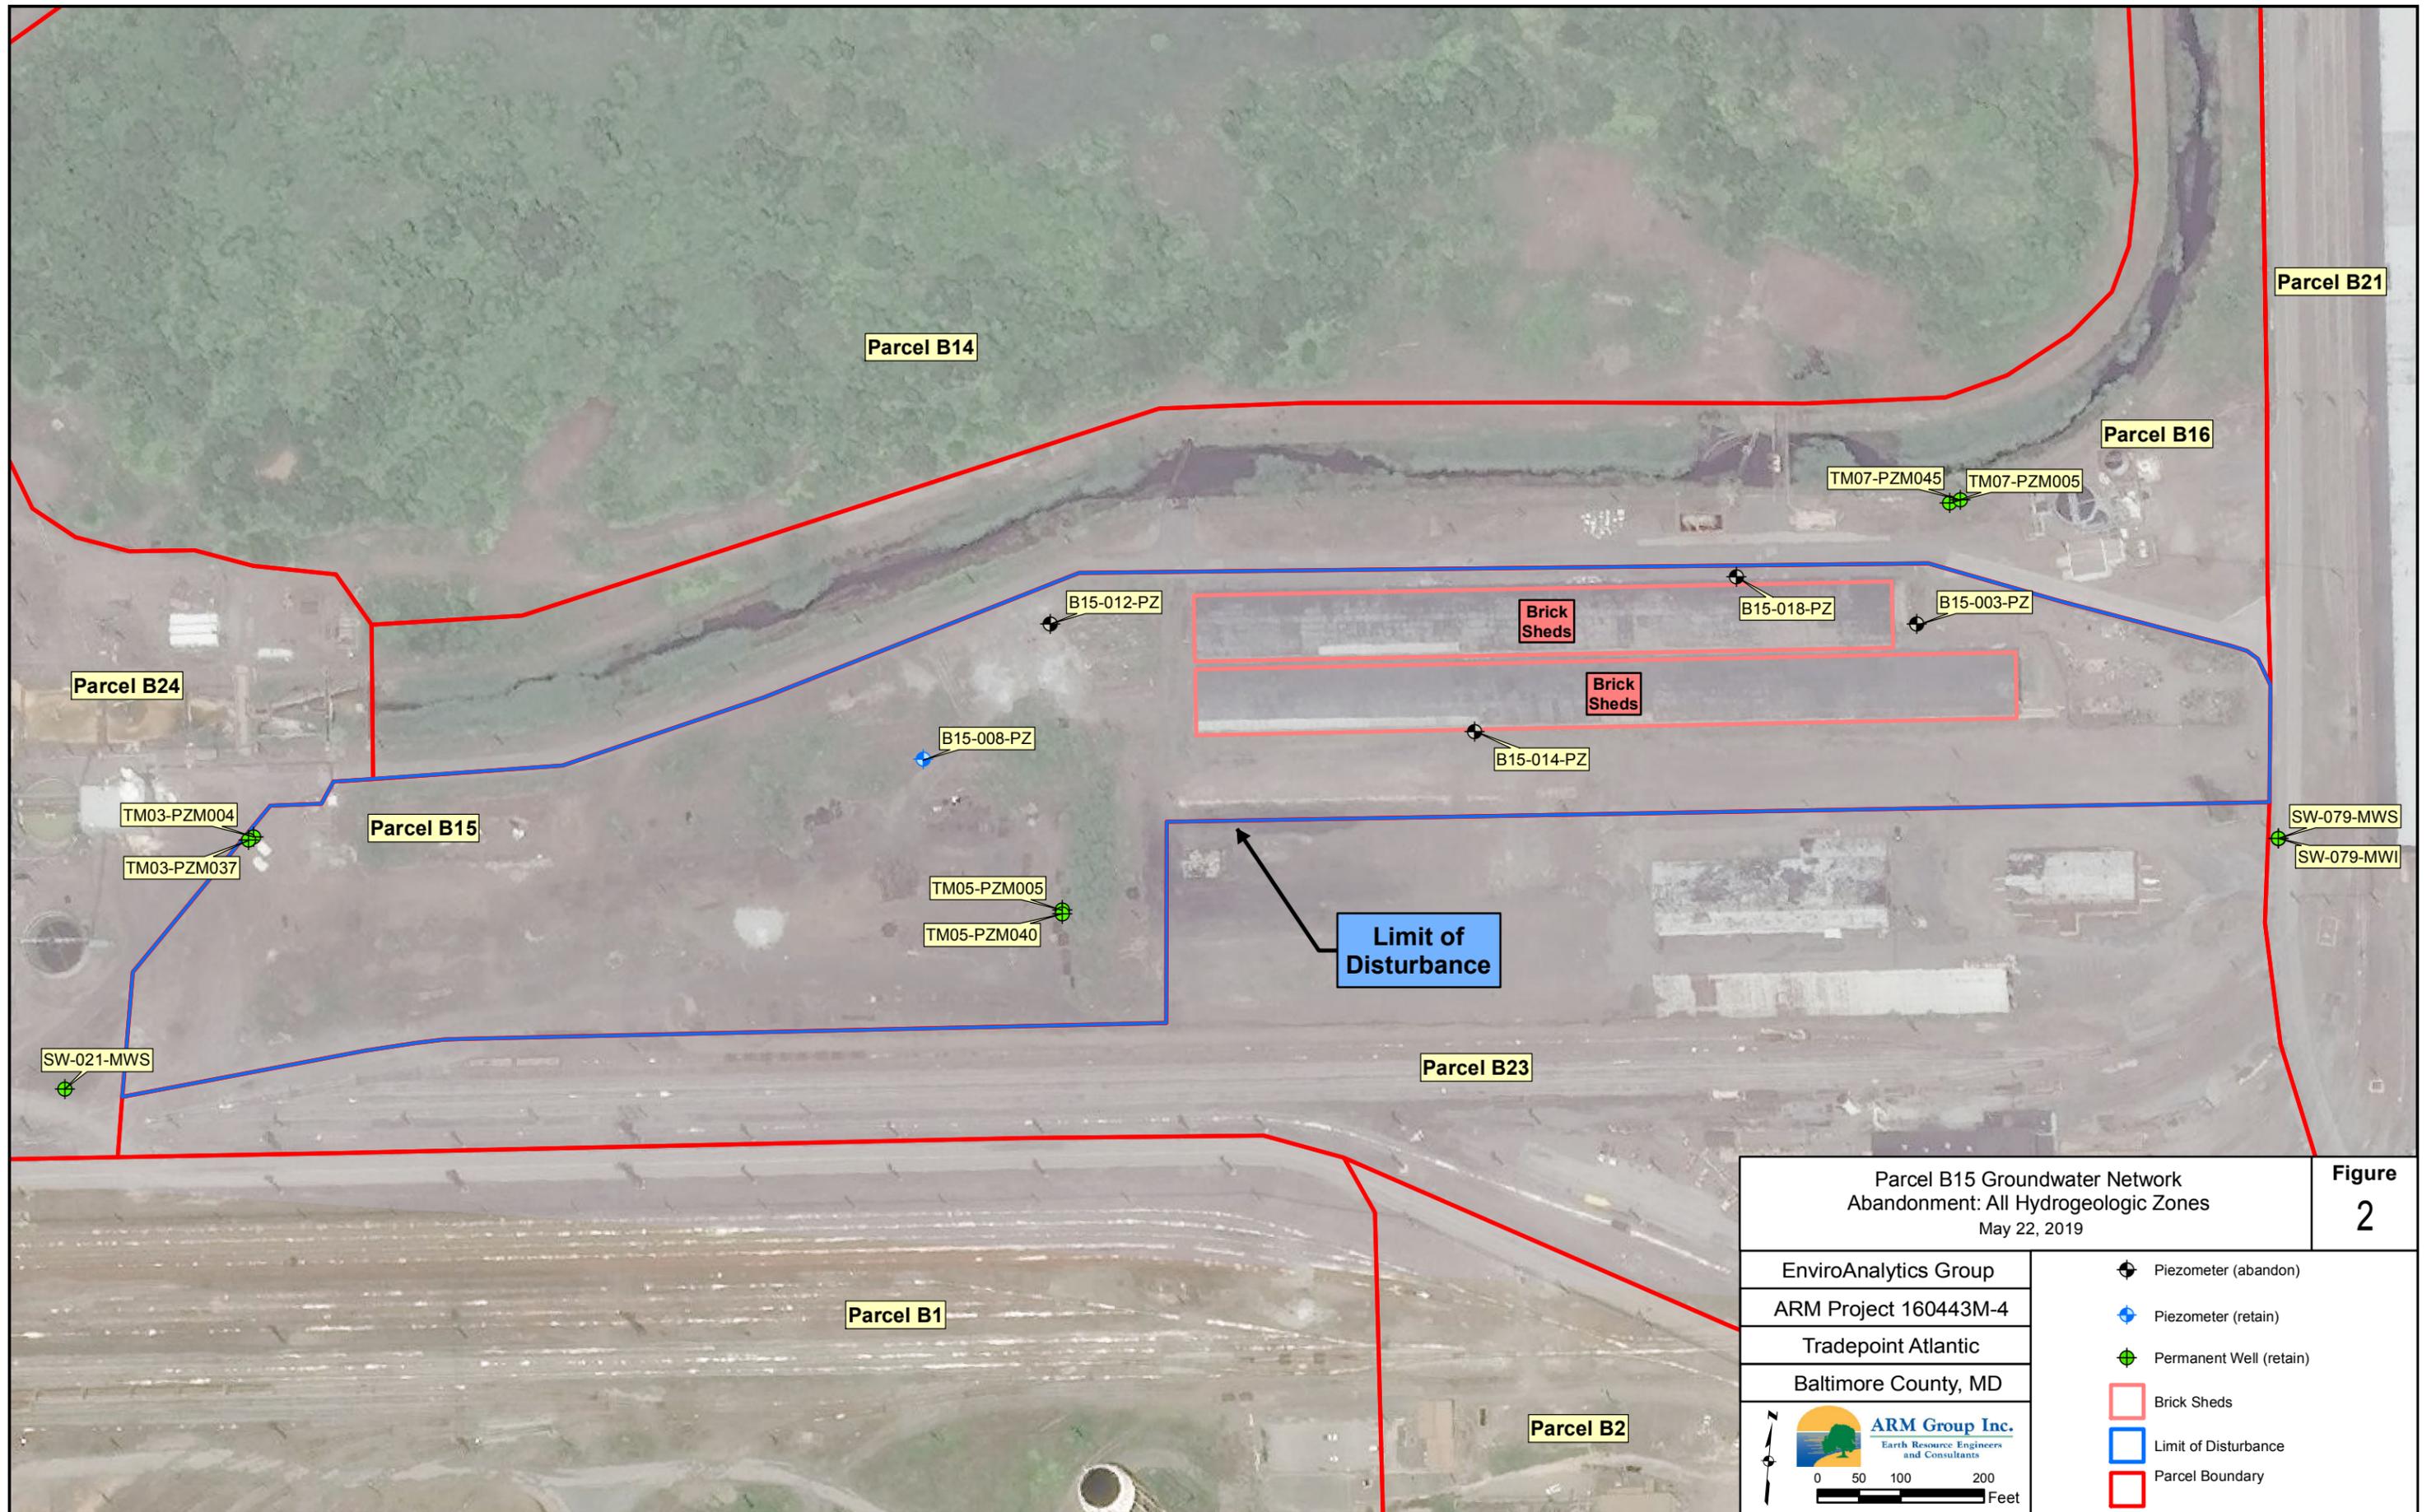
A revised version of **Figure 2** showing the locations of NAPL piezometers B15-008-PZ and B15-003-PZ is included with this Comment Response Letter.

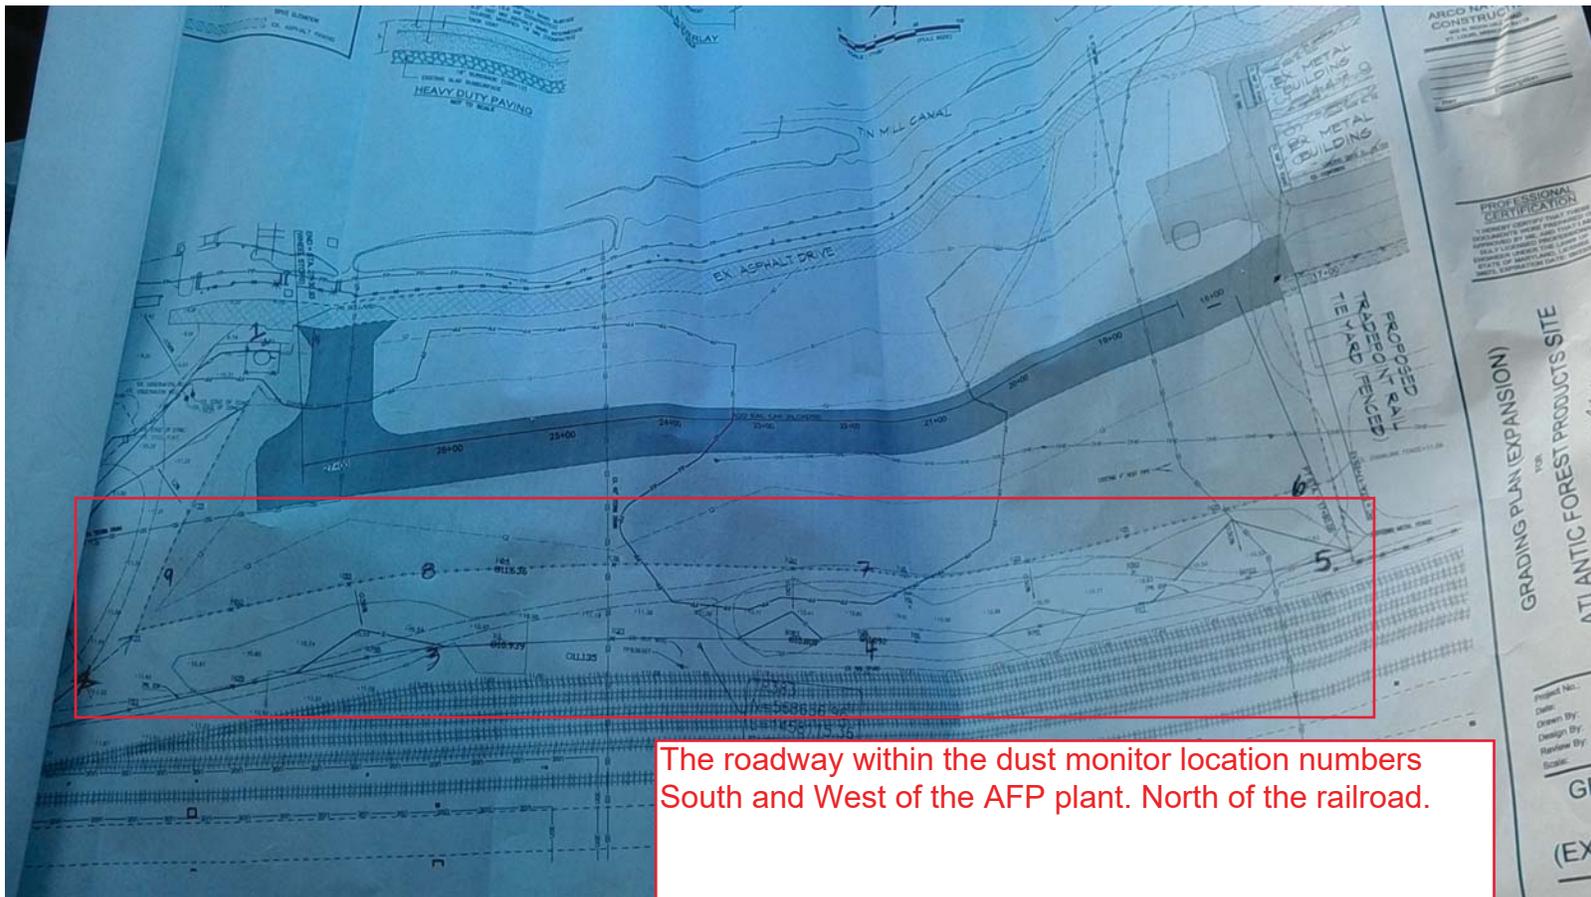
Date: 04 / 14 / 2017
Sketch No. 1

The roadway within the dust monitor location numbers South and West of the AFP plant. North of the railroad.

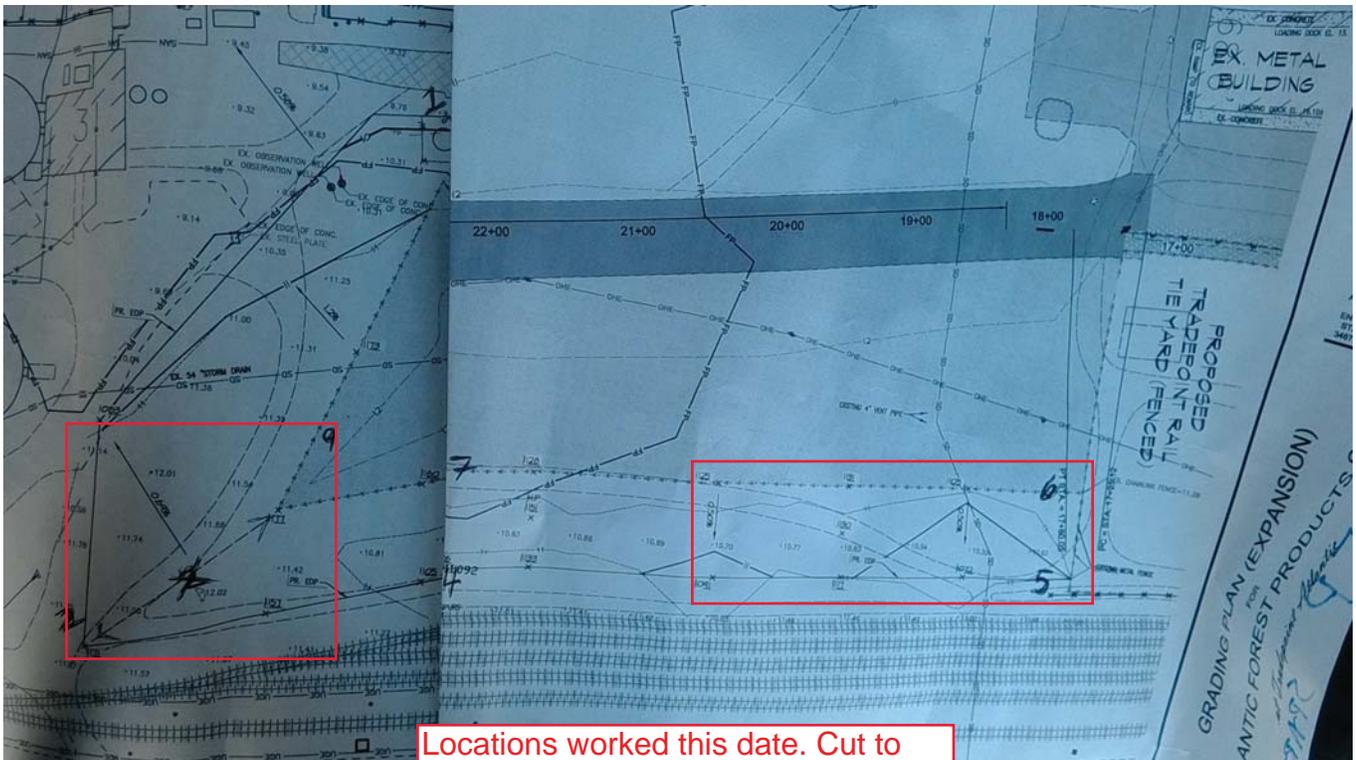
Date: 04 / 18 / 2017
Sketch No. 1

Locations worked this date. Cut to sub grade.

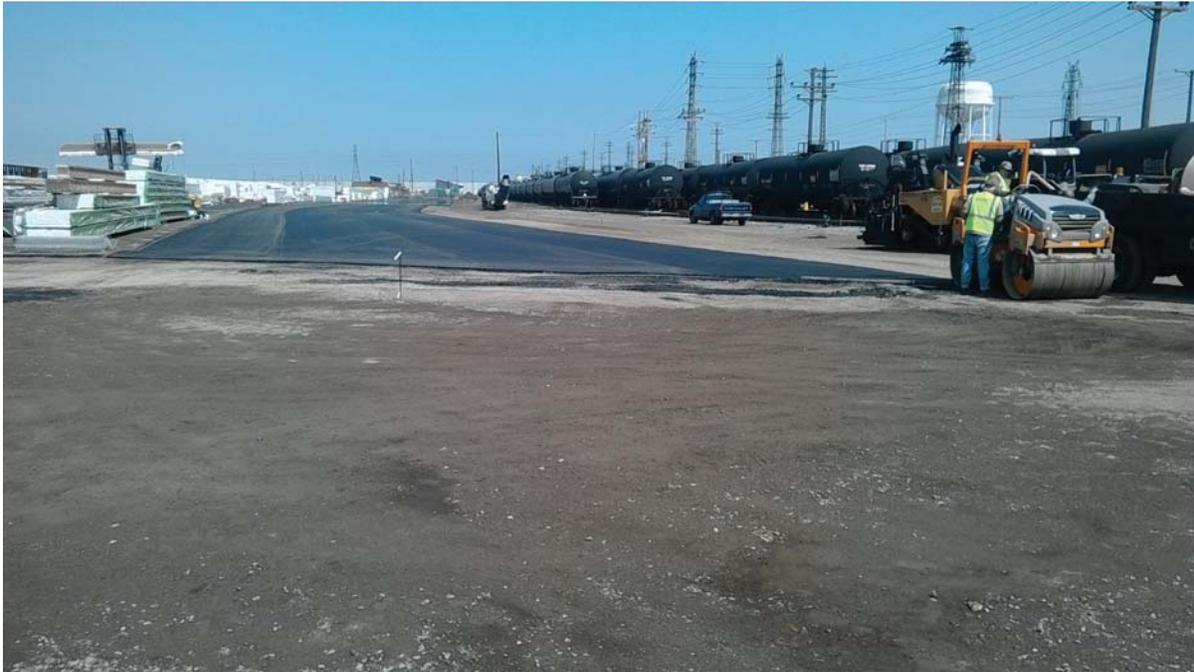
Southern, Eastern side of lot- asphalt

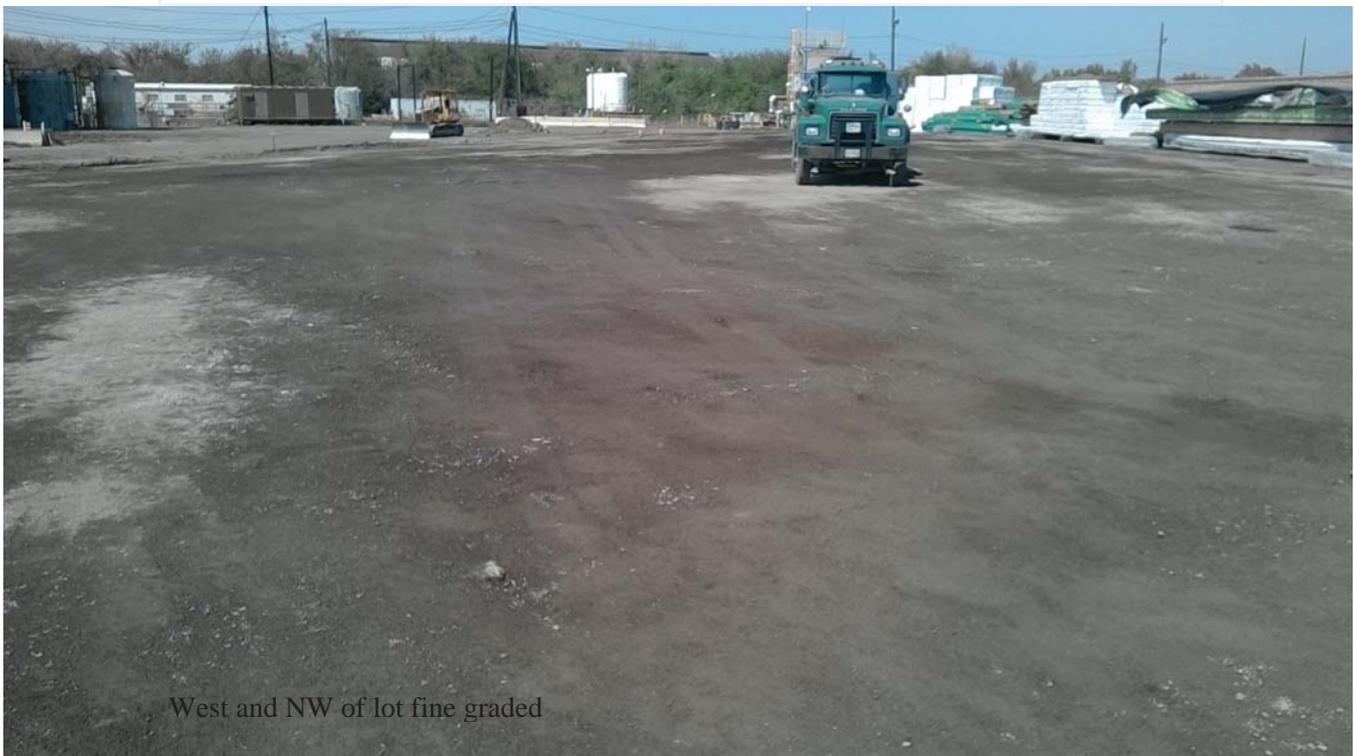
West and NW of lot fine graded

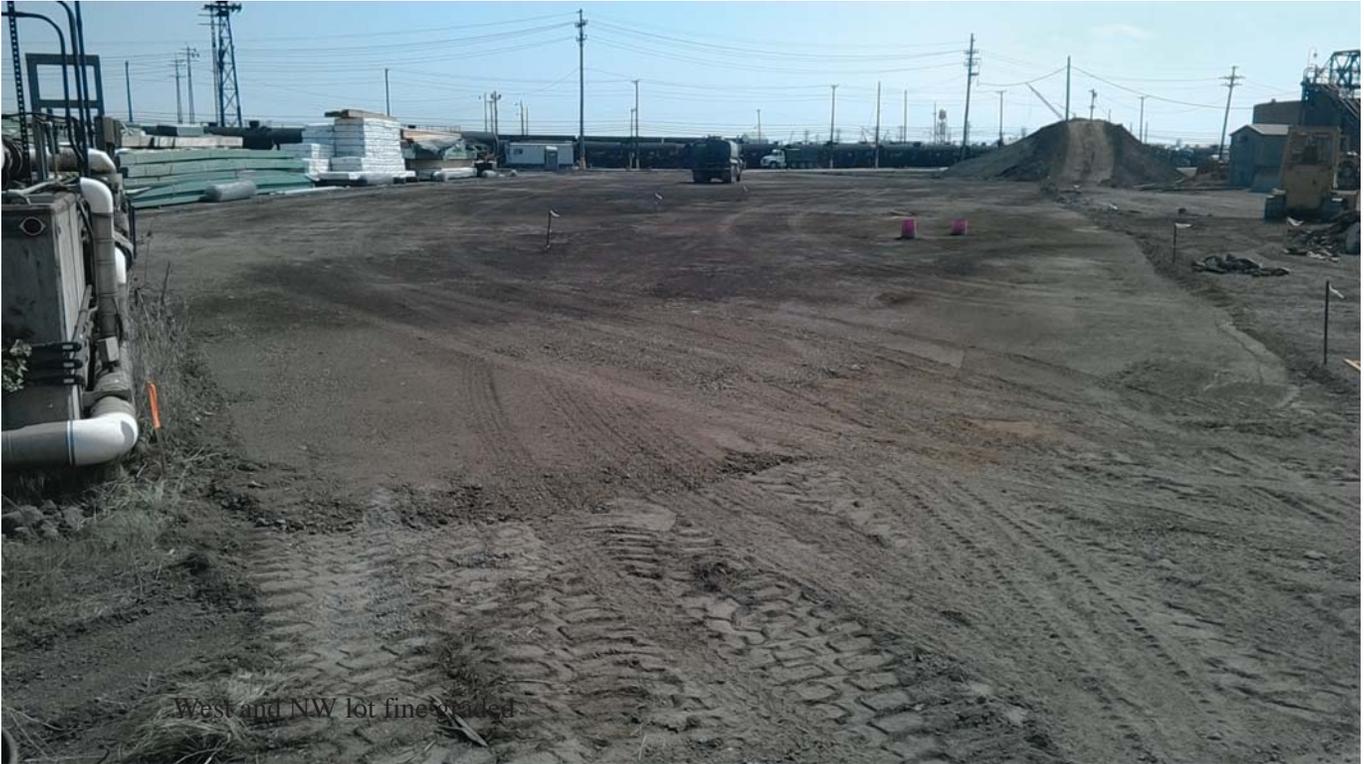
West and NW lot fine graded

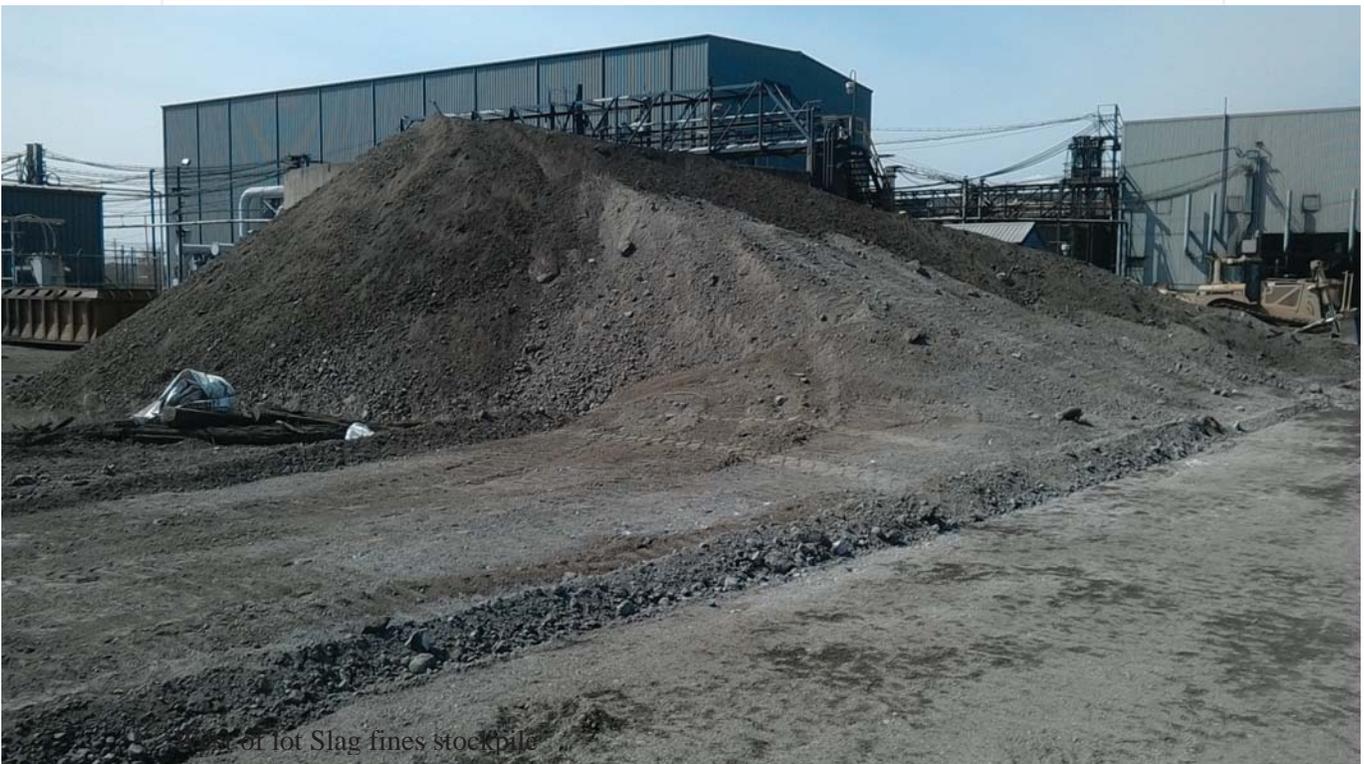
West and NW lot Slag fines stockpile

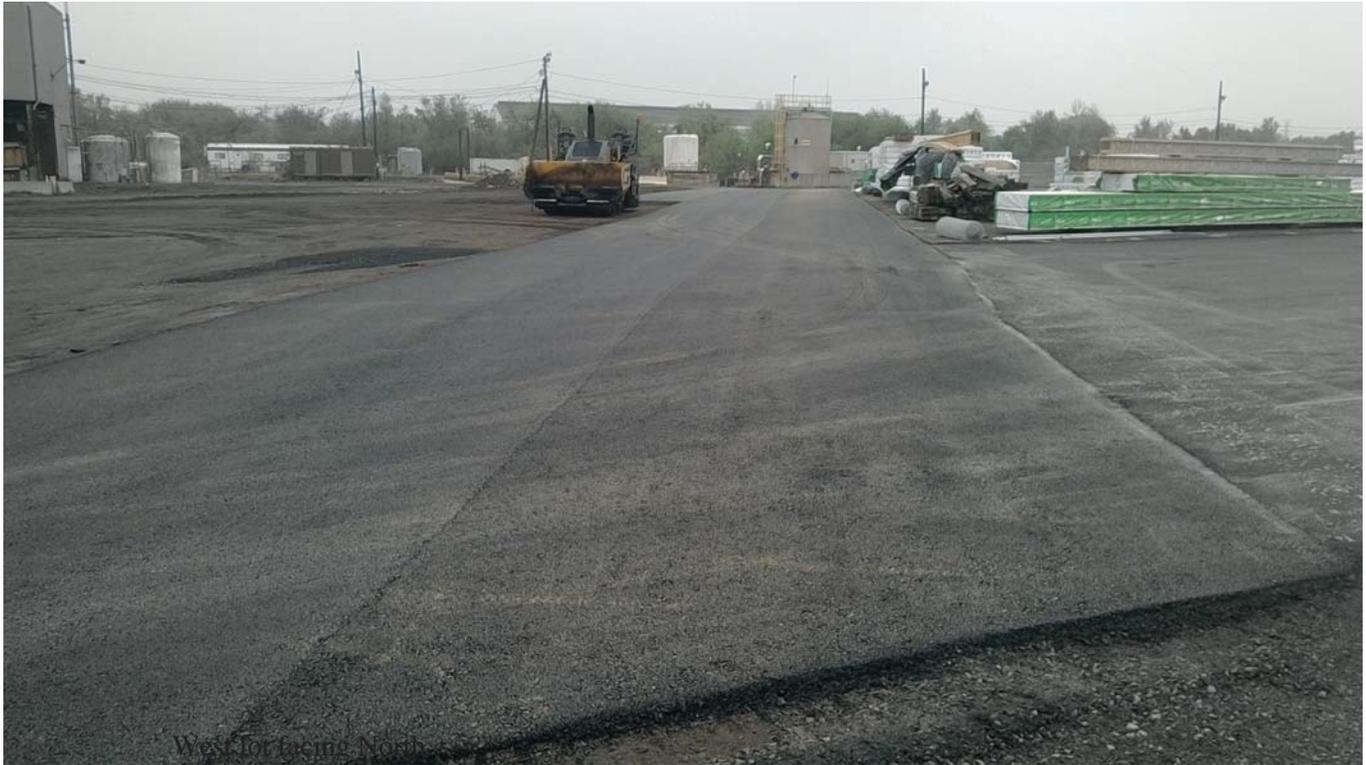
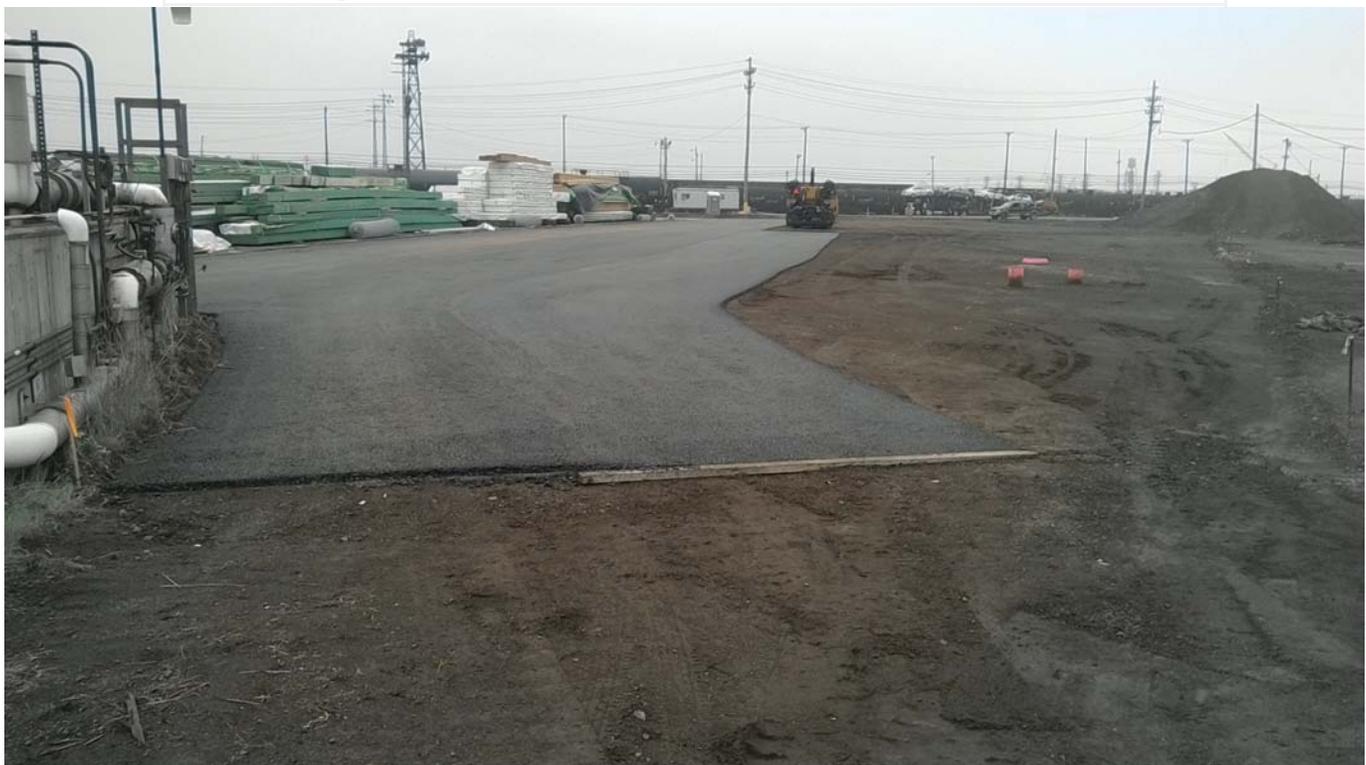
West lot facing North
West lot facing South

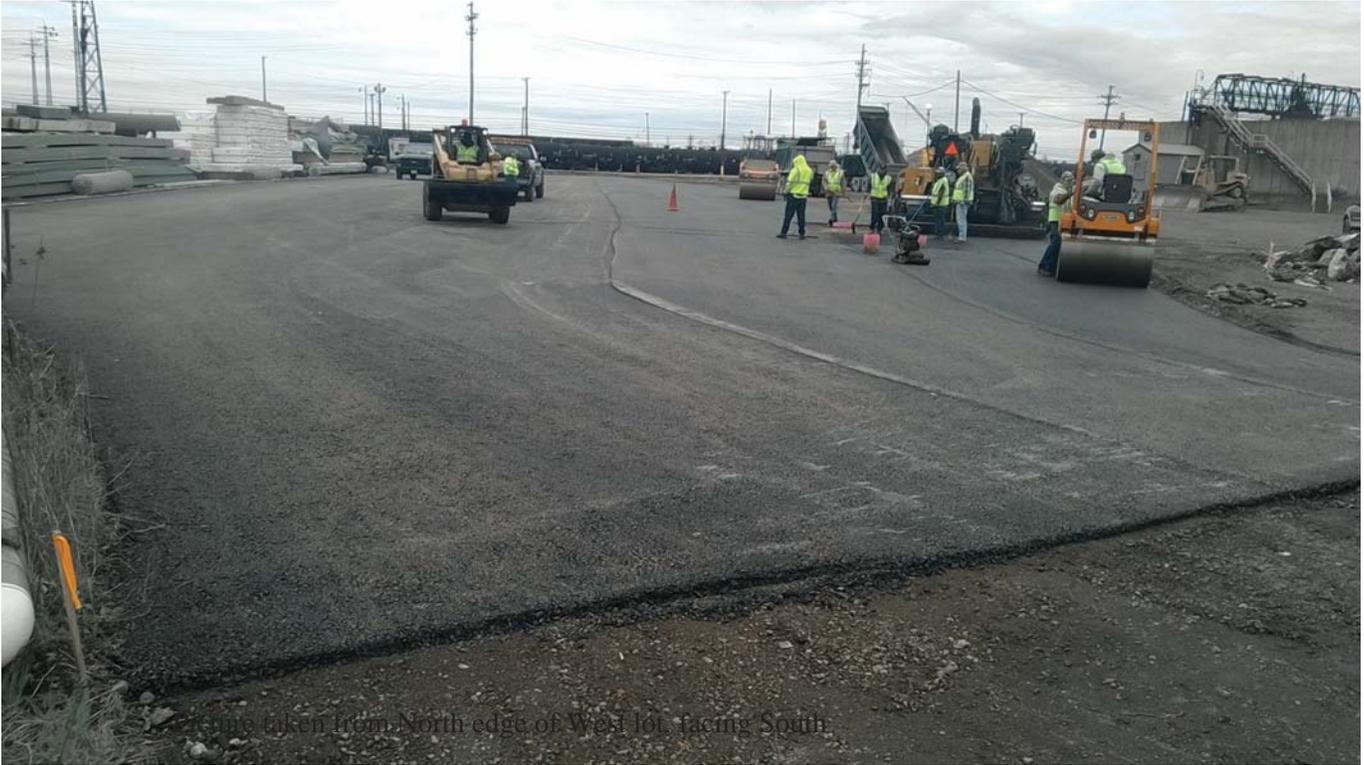
Photo taken from North edge of West lot, facing South
