DEVELOPMENT COMPLETION REPORT

AREA B: SUB-PARCEL B4-1
TRADEPOINT ATLANTIC
SPARROWS POINT, MARYLAND

ARM Project No. 20010204

Revision 1 – July 15, 2020

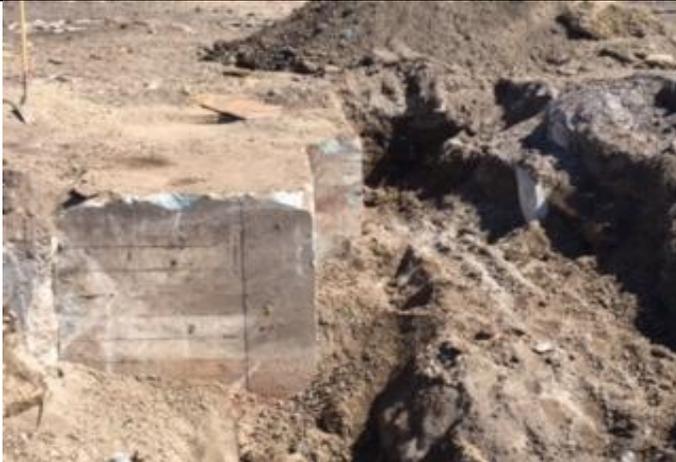
Figure 3: Concrete foundation obstructions found during excavation of swales.

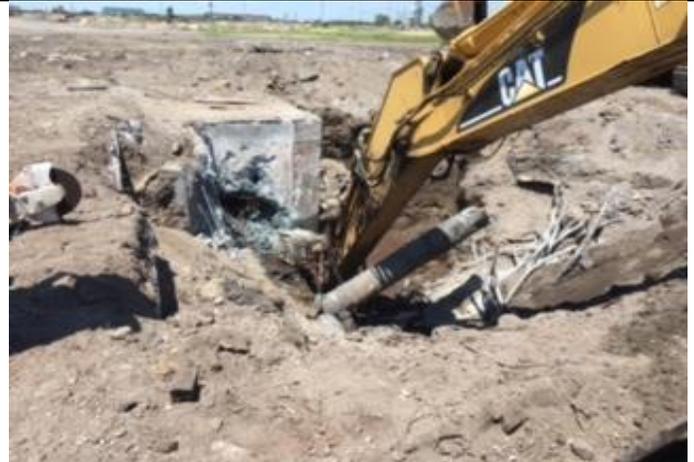
Figure 4: Removal of unforeseen concrete and rebar during excavation.

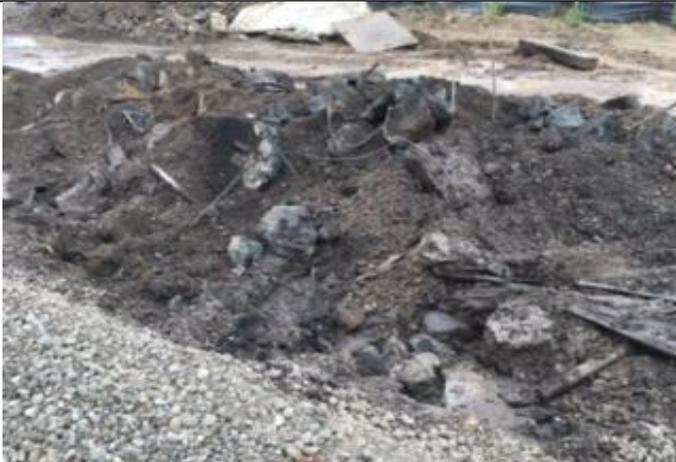
Figure 5: Misc. concrete and debris found during swale excavations.

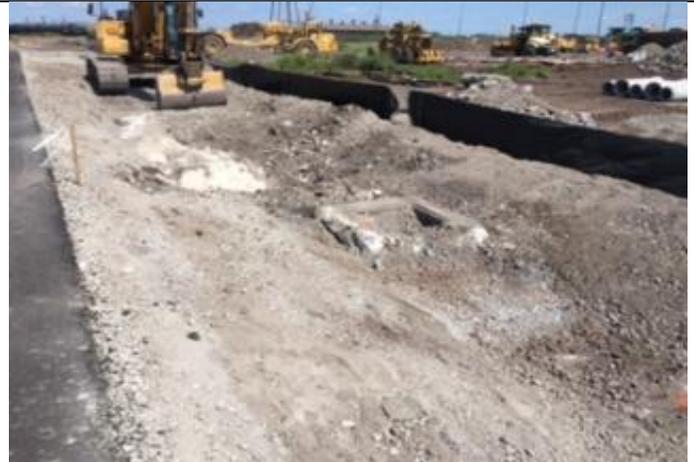
Figure 6: Grading of storm swales. Concrete obstructions in foreground.

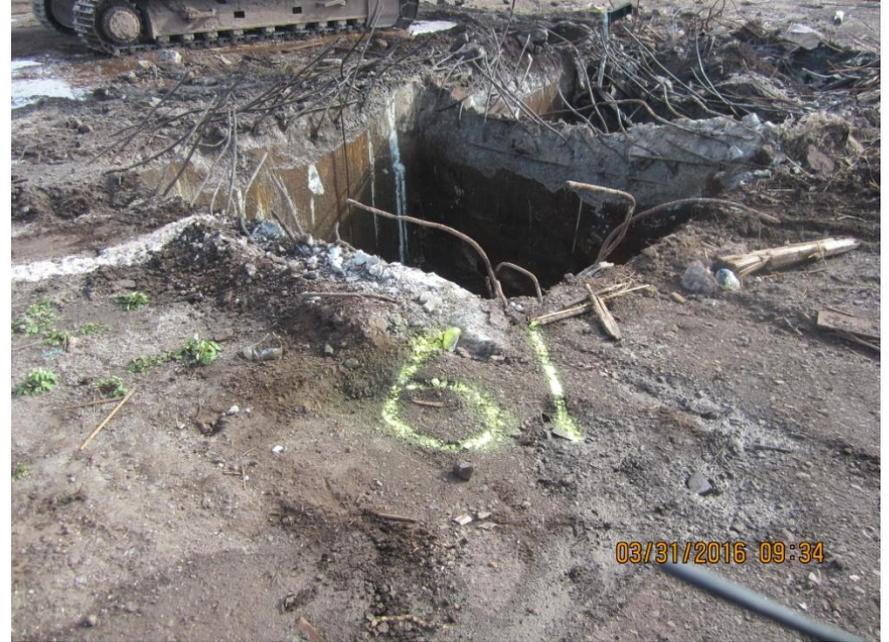
SGS-61 Utility Vault

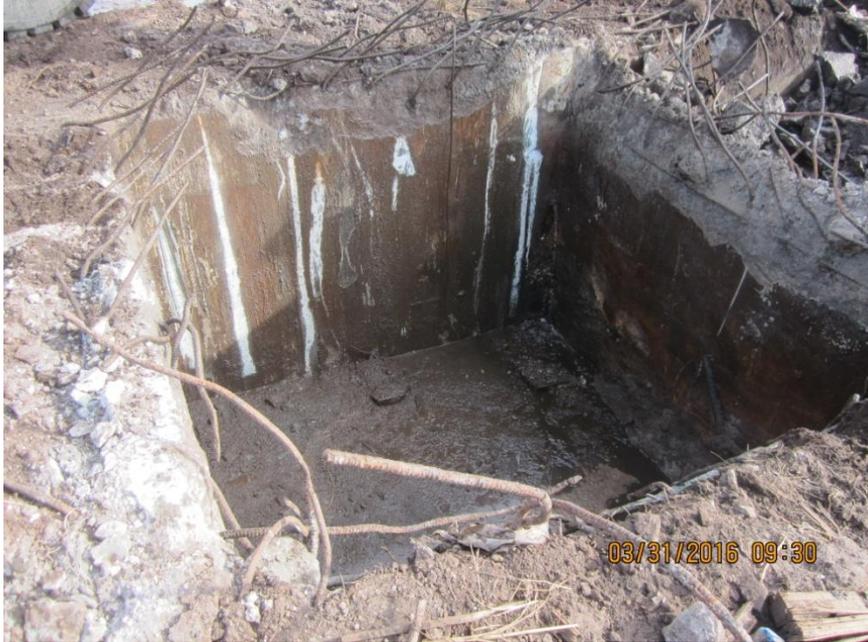
SGS 61 Minimal GW Infiltration

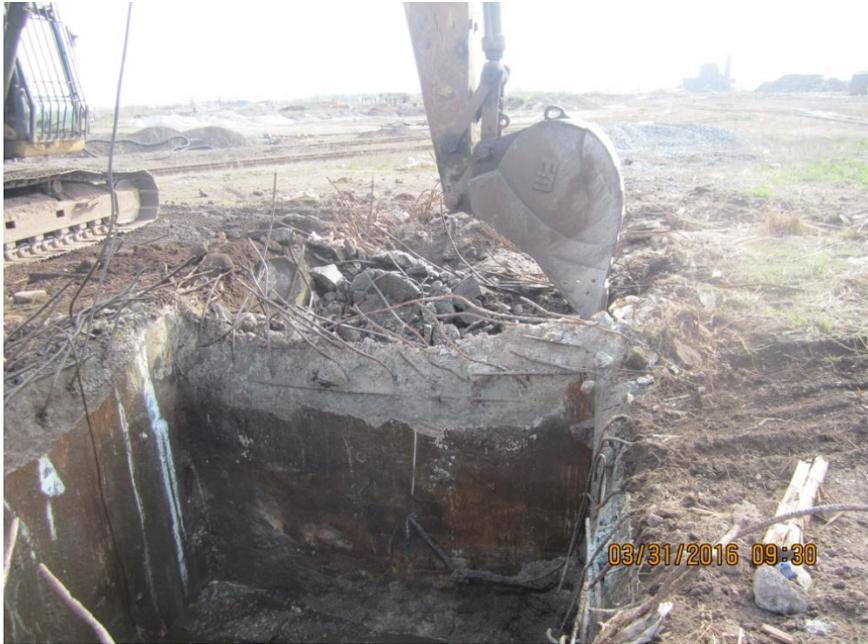
SGS 61 Cleanout Work

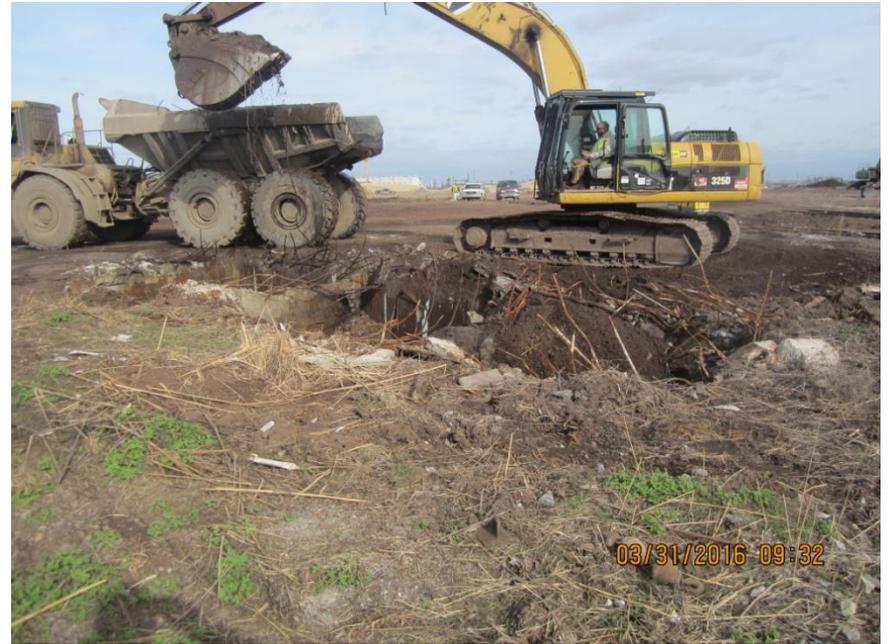
SGS 61 - Backfilling
