Re: NAPL Delineation Completion Report and  
Permanent Well Installation Work Plan  
B22-119-PZ (PORI Lagoon)  
Area B: Parcel B22  
Tradepoint Atlantic  
Sparrows Point, MD 21219

**Parcel B22 - PORI Lagoon Aerial  
NAPL Delineation**

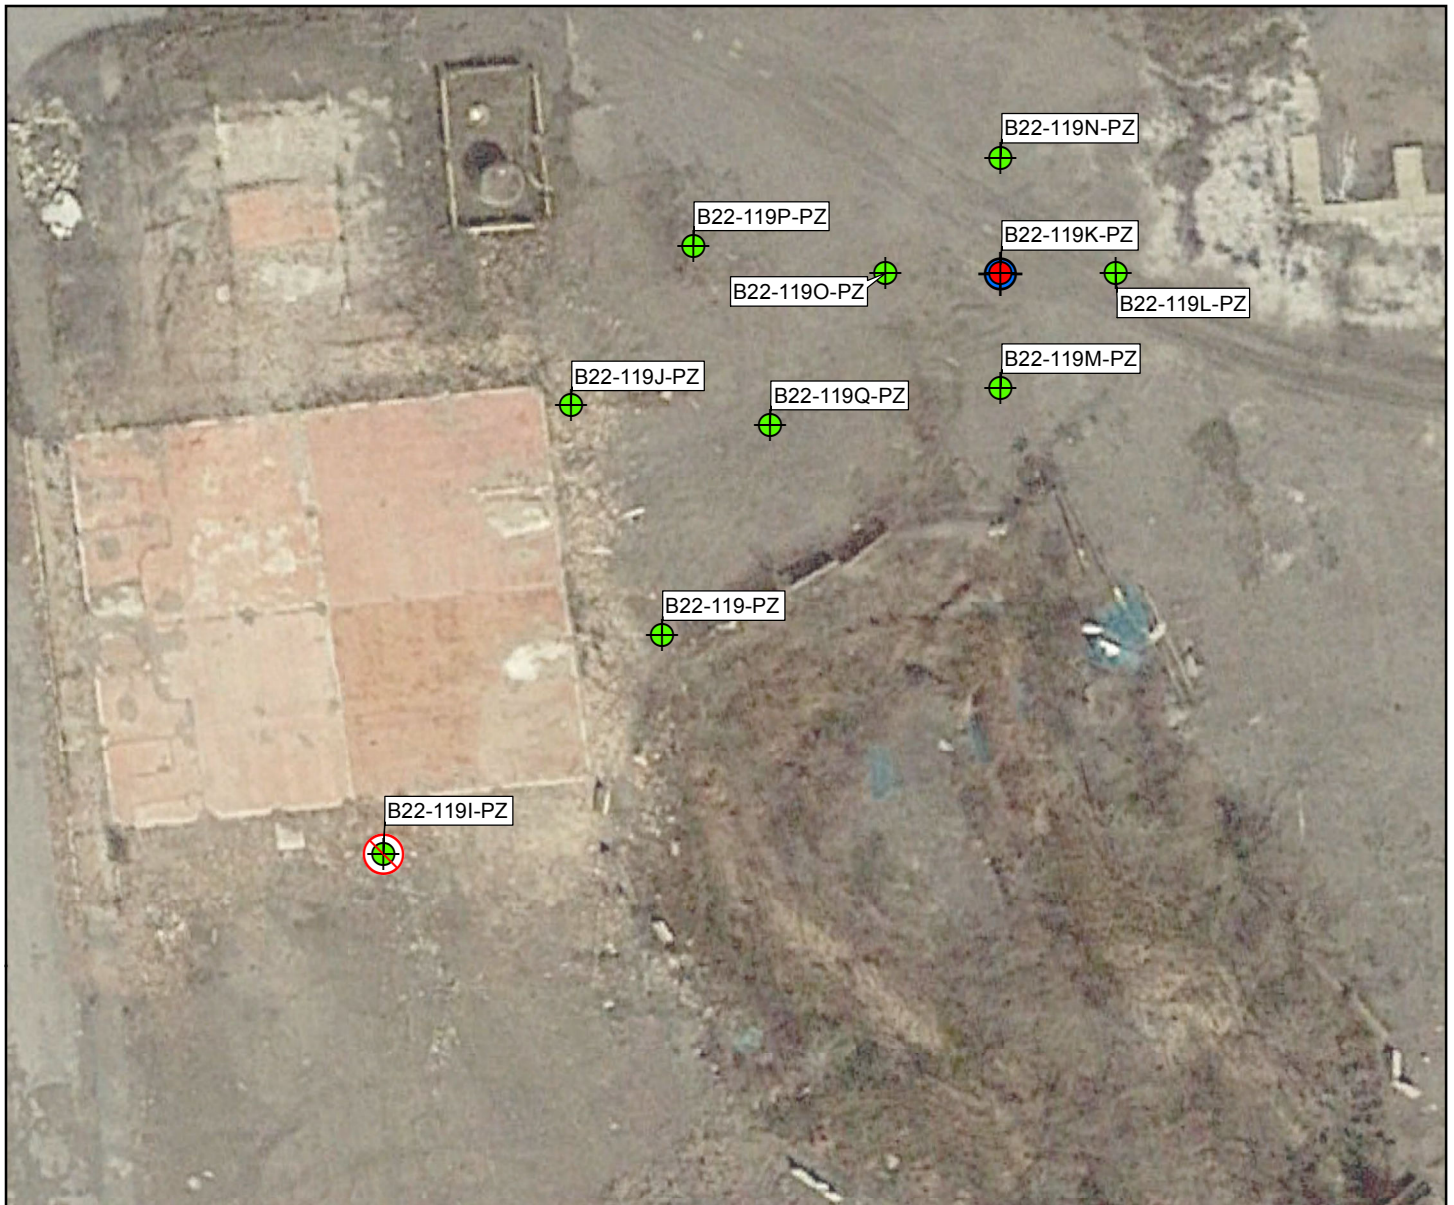
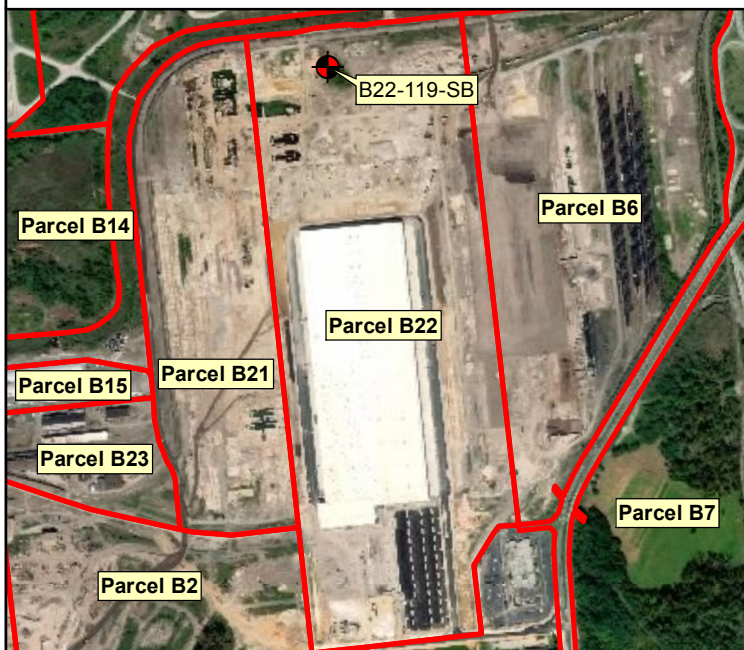
**Figure  
1**

During a NAPL gauging event on September 3, 2019, it was discovered that piezometer B22-119I-PZ had apparently been destroyed during the construction of a staging lot that was being used to store Volkswagen vehicles. There were no historical detections of NAPL at this location and the piezometer was located relatively distant from the piezometer containing NAPL (B22-119K-PZ).

The NAPL impacts in the vicinity of B22-119-PZ have been adequately defined to implement a more formal monitoring and recovery program. Therefore, approval is requested to abandon the remaining NAPL screening piezometers within the B22-119-PZ delineation area. The NAPL delineation piezometers will be gauged a final time on the abandonment date as recommended by the MDE, and the MDE will be notified if NAPL is detected in any piezometers which were not previously determined to be impacted.

It is recommended that continued NAPL monitoring, along with recovery of any accumulated NAPL, occur in the vicinity of B22-119-PZ. The monitoring/recovery will be facilitated through the installation of one permanent 2-inch diameter groundwater well. The proposed depth of the well is 23 feet with a screen interval from 3 to 23 feet bgs. The new permanent well will be installed at the location of B22-119K-PZ, which has accumulated NAPL during prior gauging events. The location of the proposed permanent well is shown on **Figure 1**.

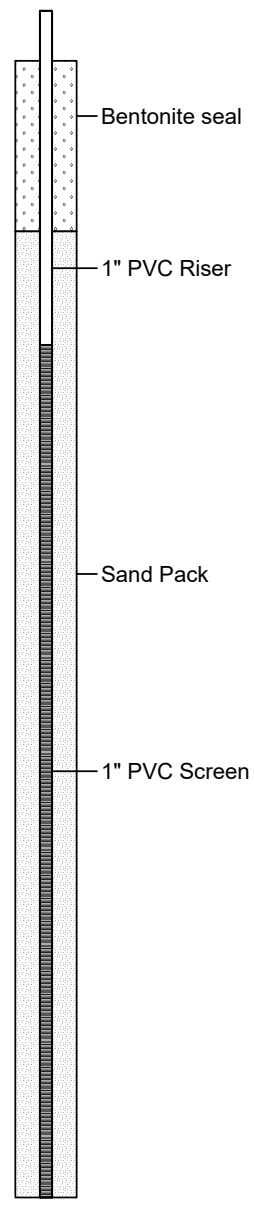
**Boring ID: B22-119-SB/PZ**

Oil throughout from 7-10' bgs, with prominent oil at 8' bgs and 9' bgs

Trace NAPL at 19' bgs
