Re: Comment Response Letter:
Parcel A7 Phase II Investigation Report
(Revision 1)
Tradepoint Atlantic
Sparrows Point, MD 21219

APPENDIX E

Test Pit Photograph Log
Area A: Parcel A7
Sparrows Point, Maryland

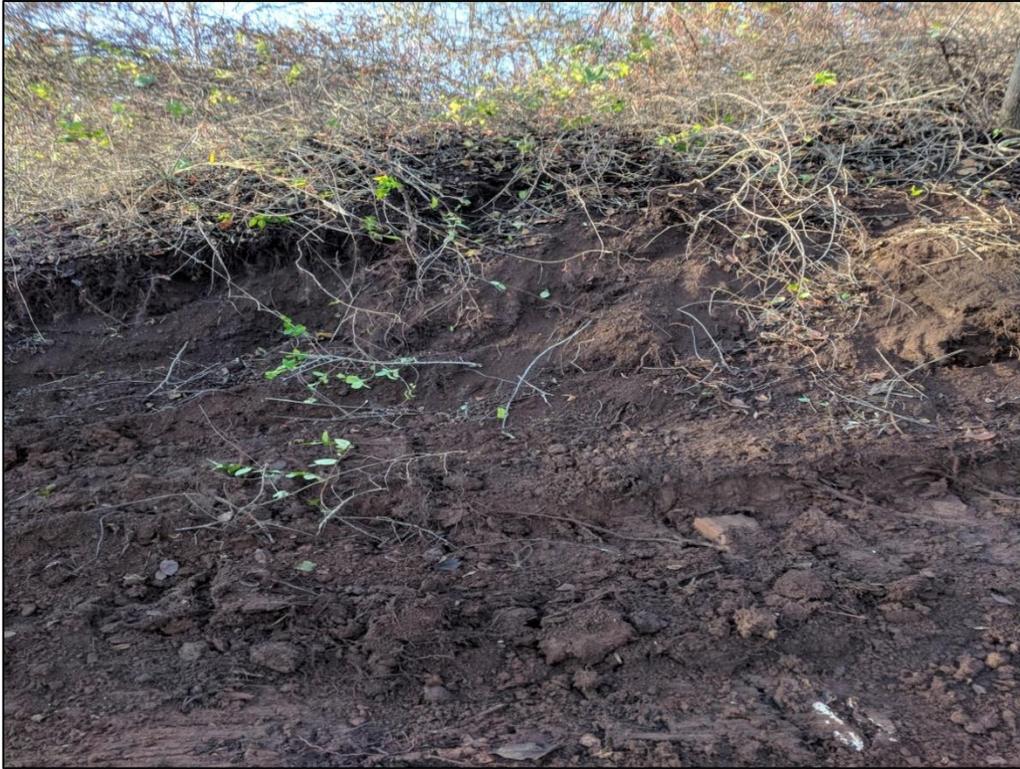
Photo 1: View of test pit at A7-001-TP before excavation.
No visible contamination is evident.

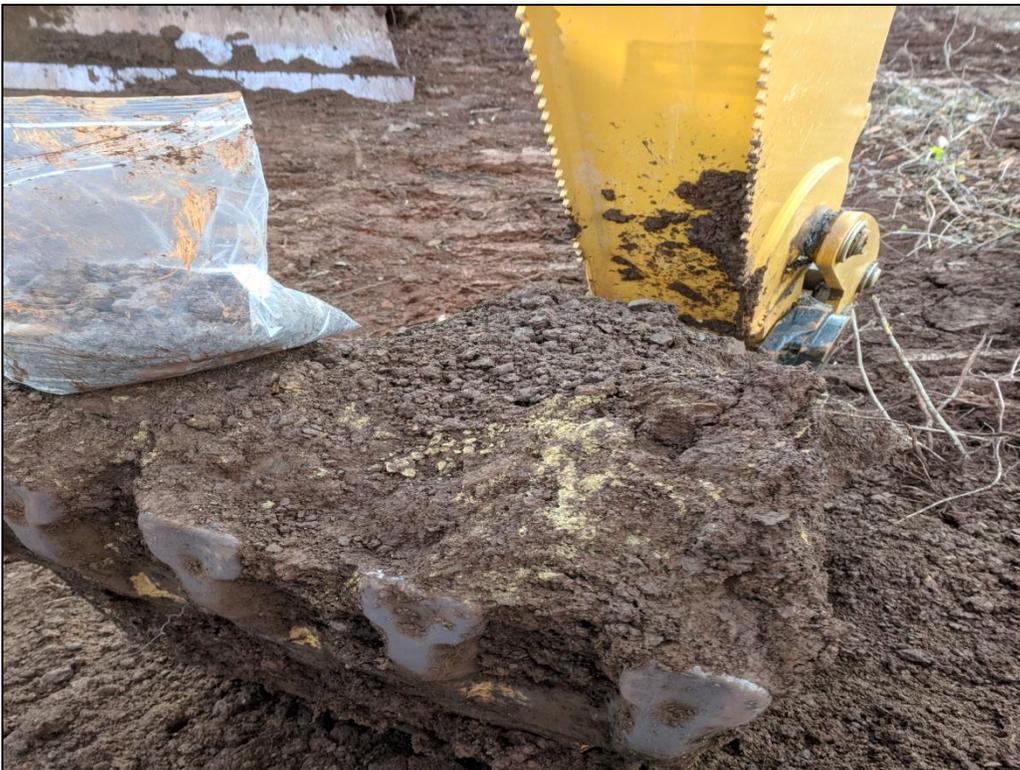
Photo 2: View of the soil observed during test pit activities at A7-001-TP.
Soils appear to consist of silty clay. No visible contamination is evident.

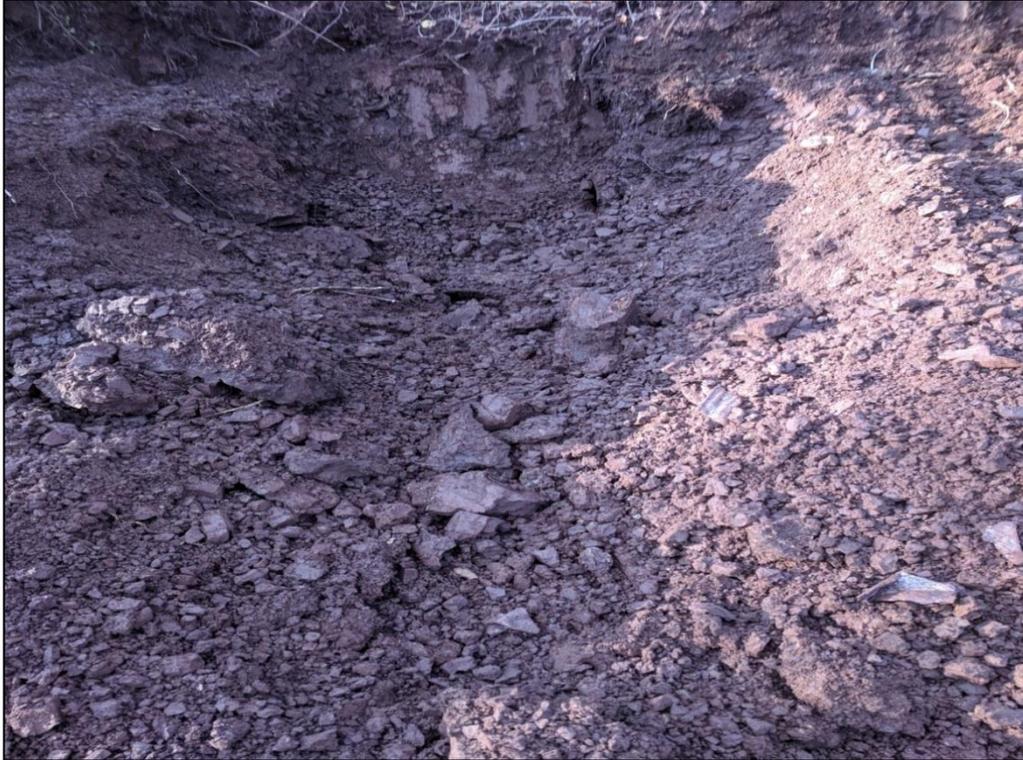
Photo 3: View of test pit at A7-001-TP after excavation.
No visible contamination is evident and PID reading equals 3.9.

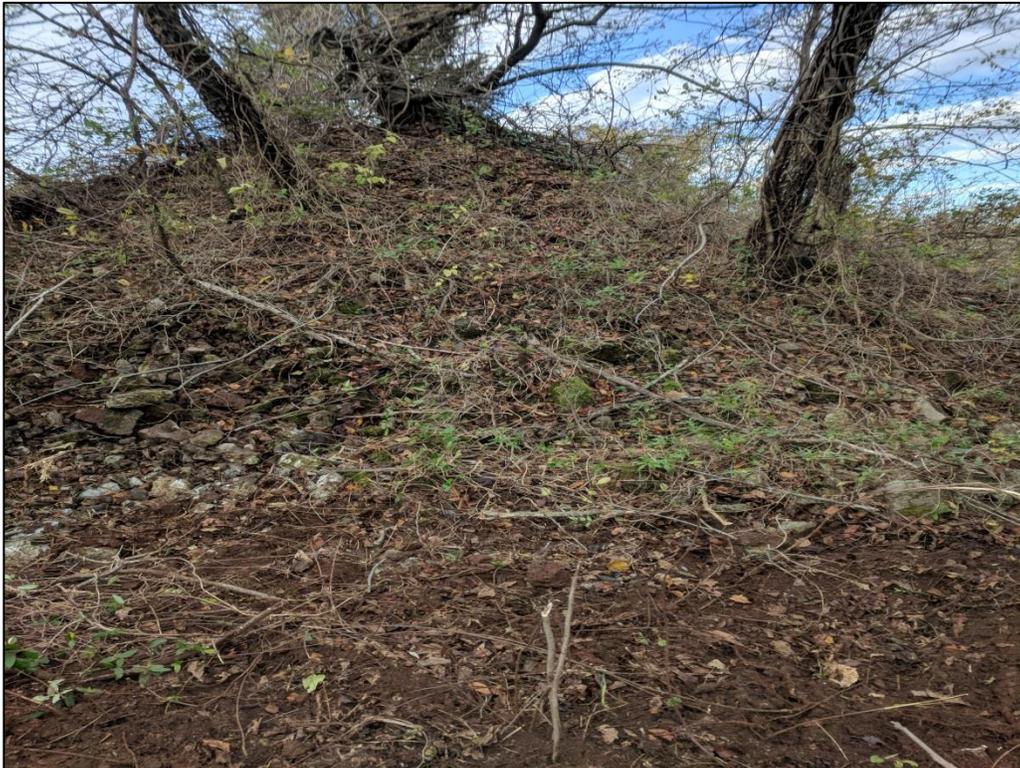
Photo 4: View of test pit at A7-002-TP before excavation.
No visible contamination is evident.

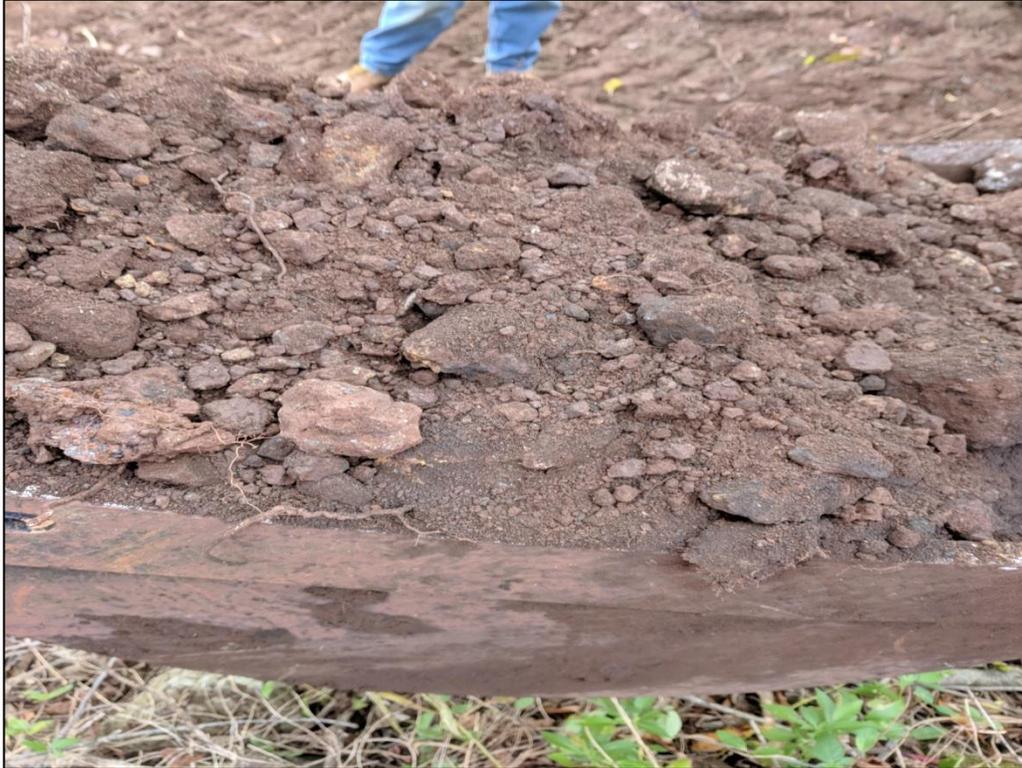
Photo 5: View of the soil observed during test pit activities at A7-002-TP.
Soils appear to consist of silty clay with gravel. No visible contamination is evident.

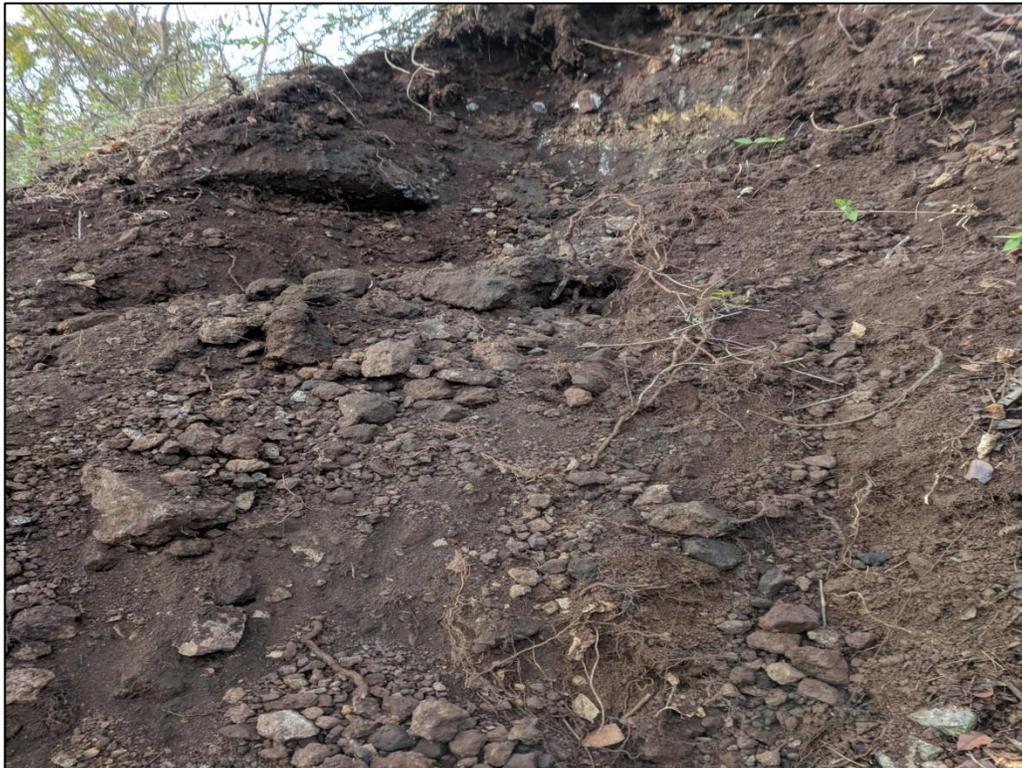
Photo 6: View of test pit at A7-002-TP after excavation.
No visible contamination is evident and PID reading equals 4.1.

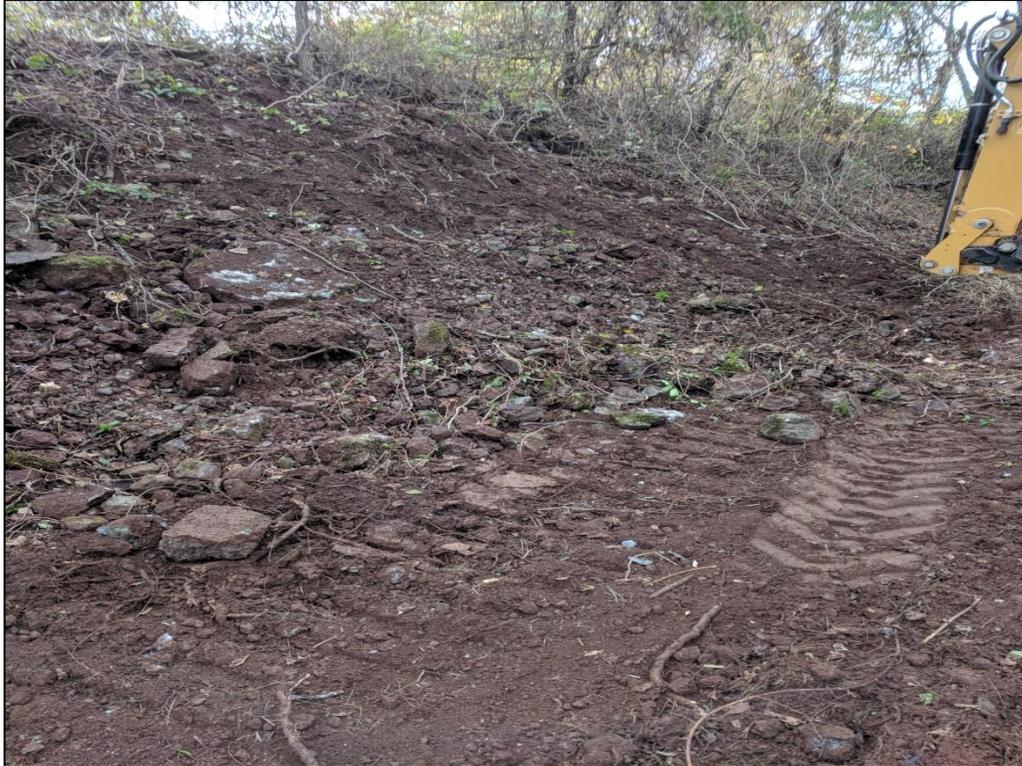
Photo 7: View of test pit at A7-003-TP before excavation.
No visible contamination is evident.

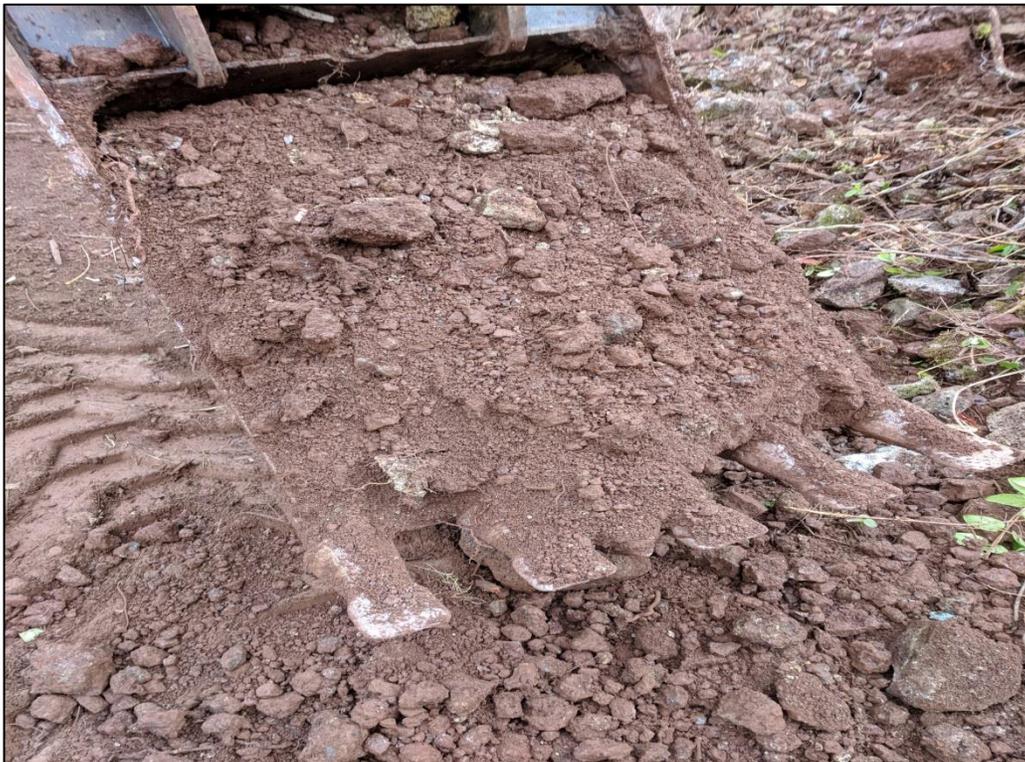
Photo 8: View of the soil observed during test pit activities at A7-003-TP.
Soils appear to consist of silty clay with gravel. No visible contamination is evident.

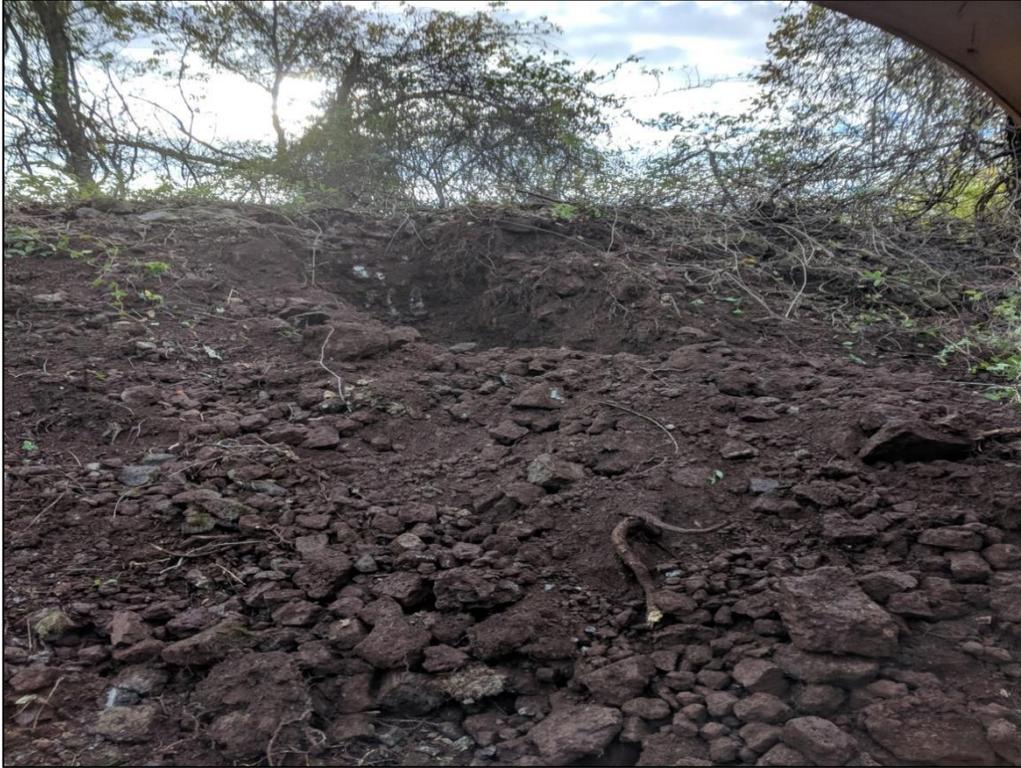
Photo 9: View of test pit at A7-003-TP after excavation.
No visible contamination is evident and PID reading equals 2.8.

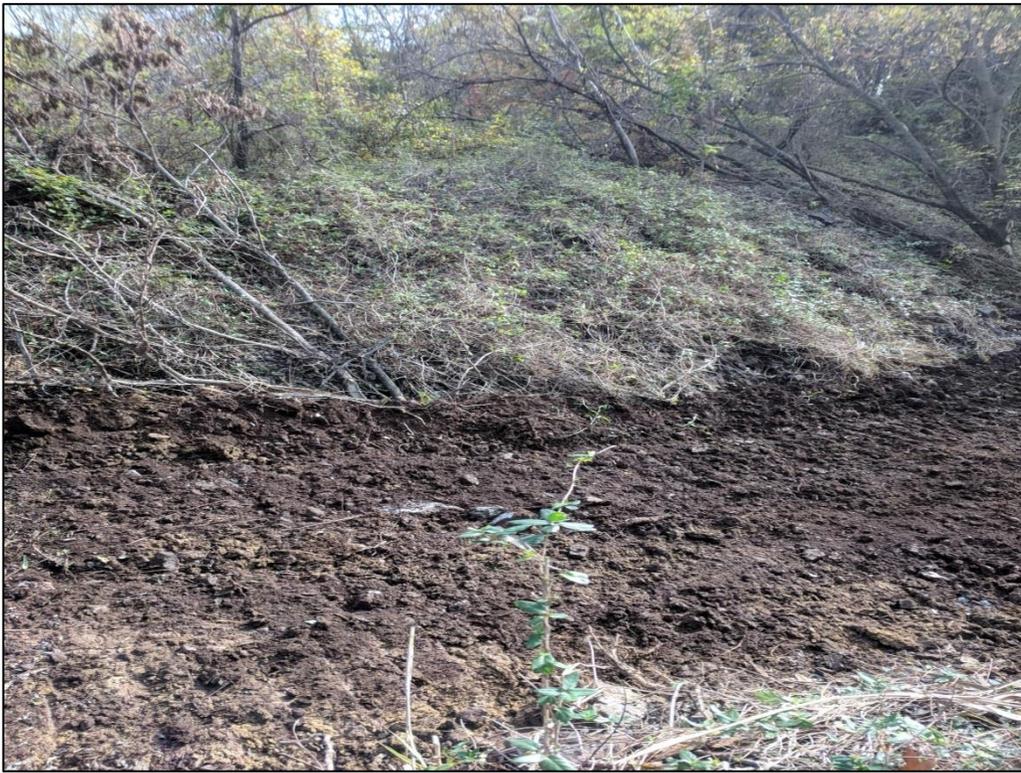
Photo 10: View of test pit at A7-004-TP before excavation.
No visible contamination is evident.

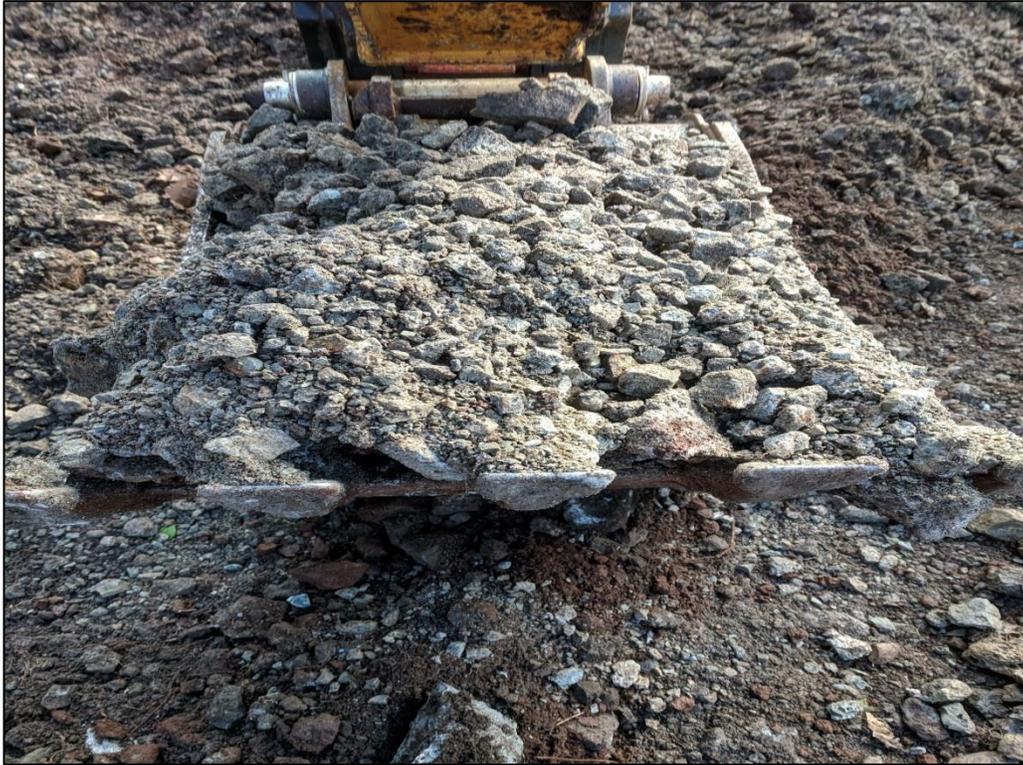
Photo 11: View of the soil observed during test pit activities at A7-004-TP. Soils appear to consist of gravel. No visible contamination is evident.

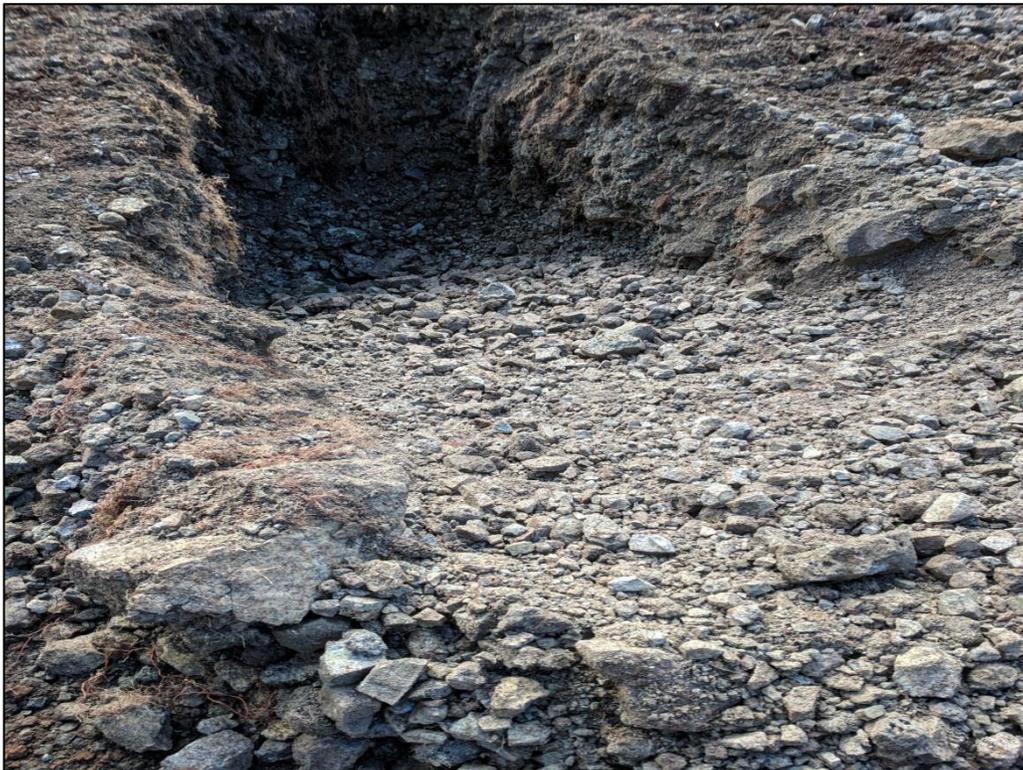
Photo 12: View of test pit at A7-004-TP after excavation. No visible contamination is evident and PID reading equals 2.3.

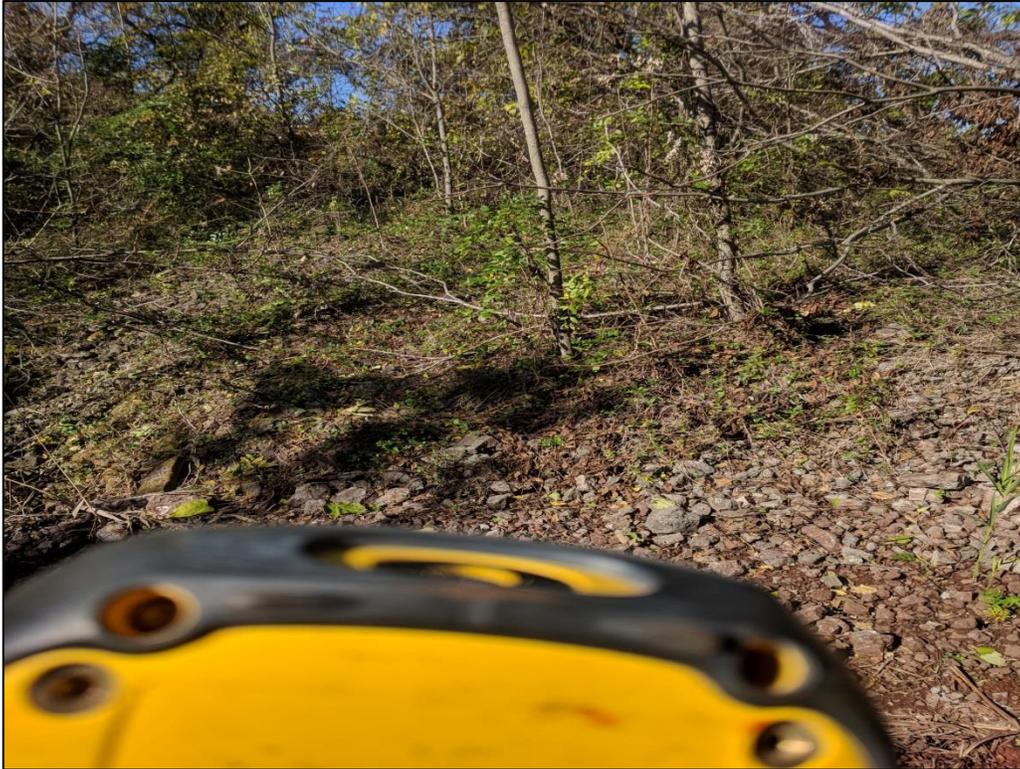
Photo 13: View of test pit at A7-005-TP before excavation.
No visible contamination is evident.

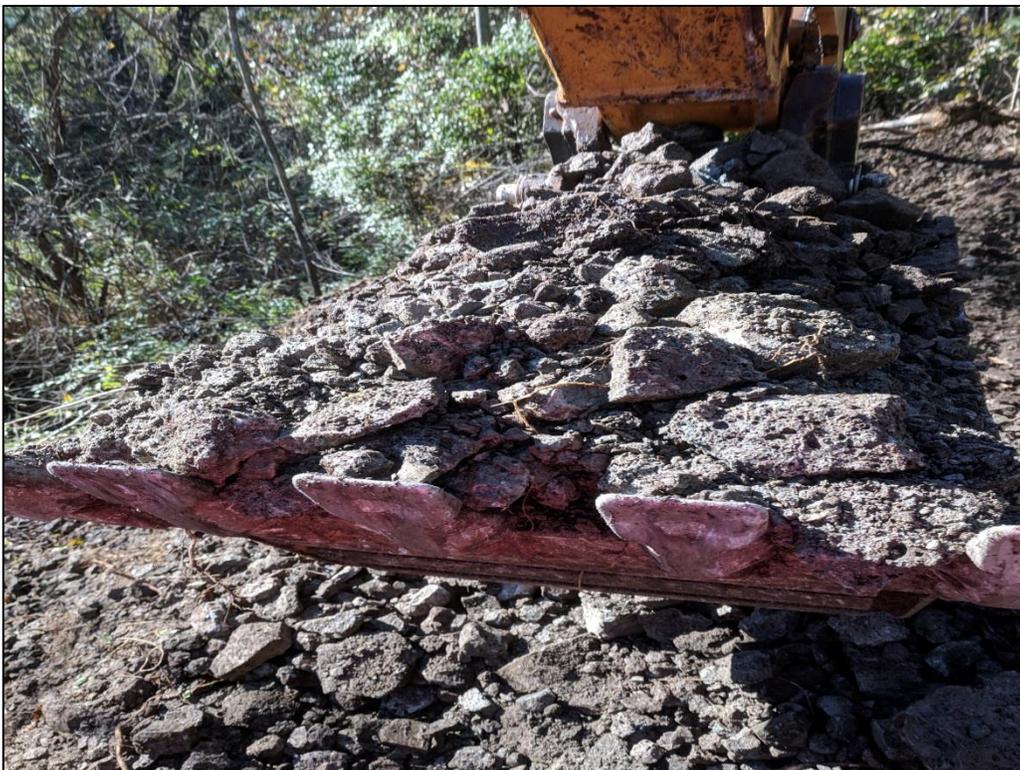
Photo 14: View of test pit at A7-005-TP after excavation. Soils appear to consist of gravel.
No visible contamination is evident and PID reading equals 4.6.

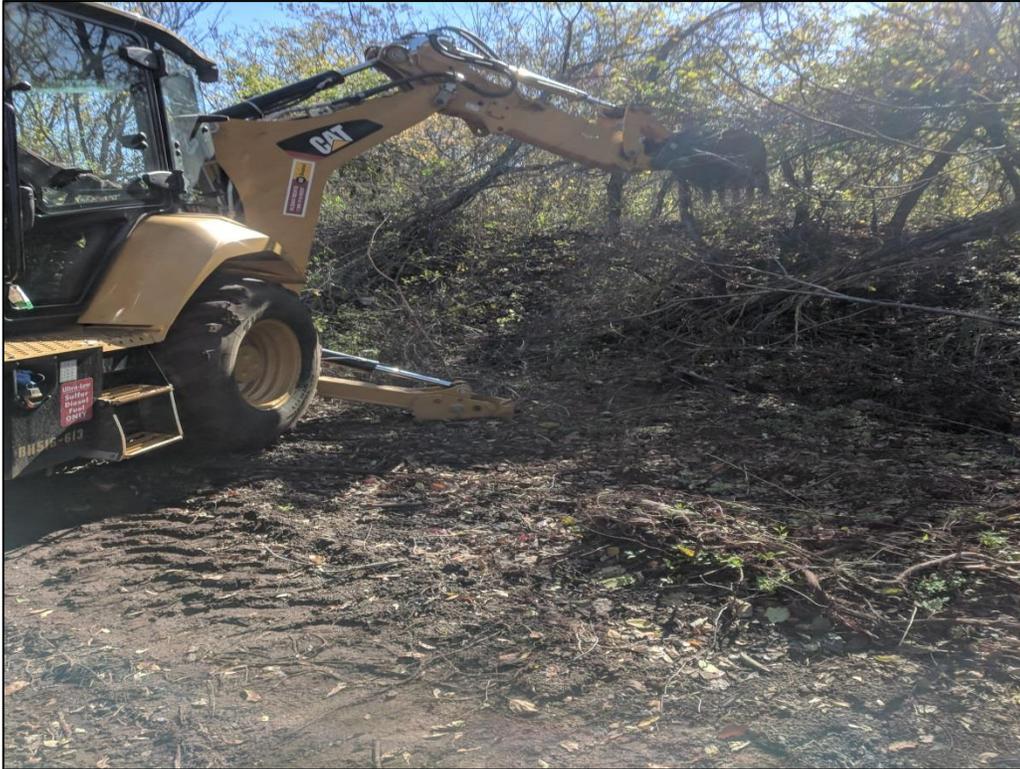
Photo 15: View of test pit at A7-006-TP before excavation.
No visible contamination is evident.

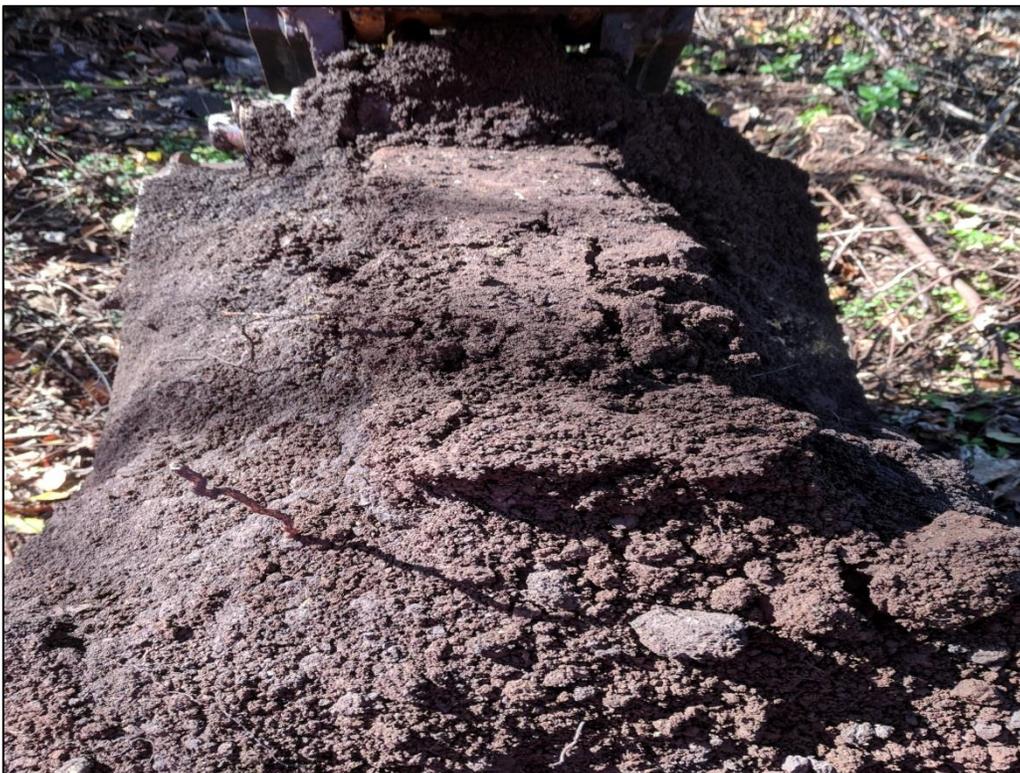
Photo 16: View of the soil observed during test pit activities at A7-006-TP.
Soils appear to consist of sandy silt. No visible contamination is evident.

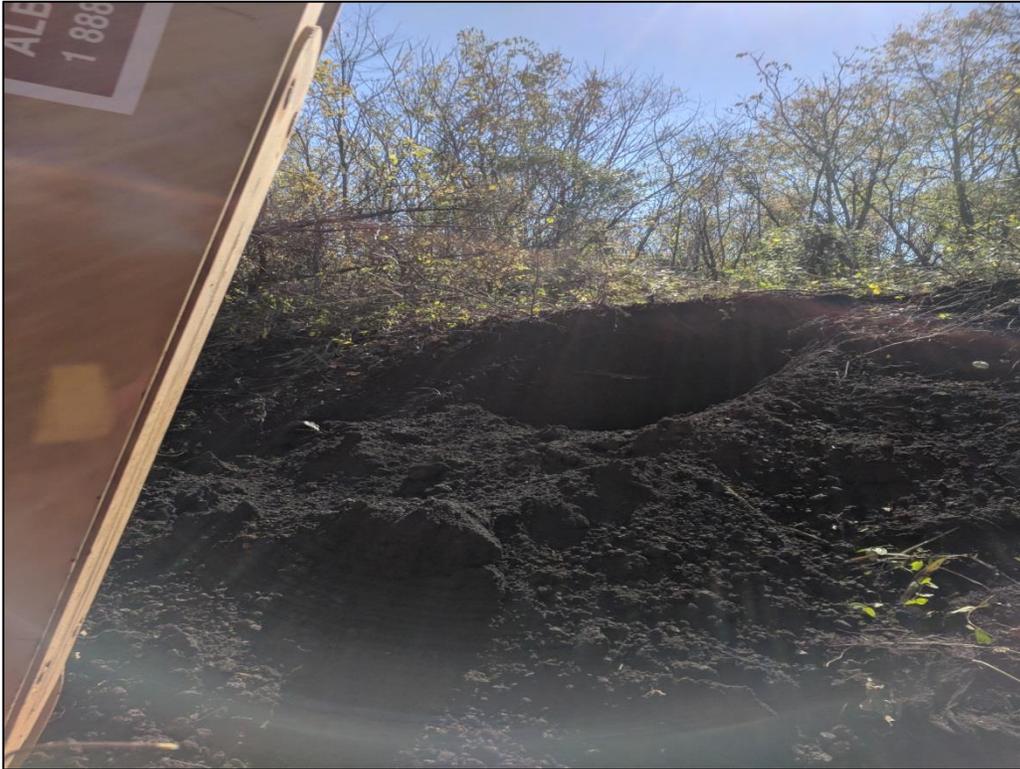
Photo 17: View of test pit at A7-006-TP after excavation.
No visible contamination is evident and PID reading equals 7.0.

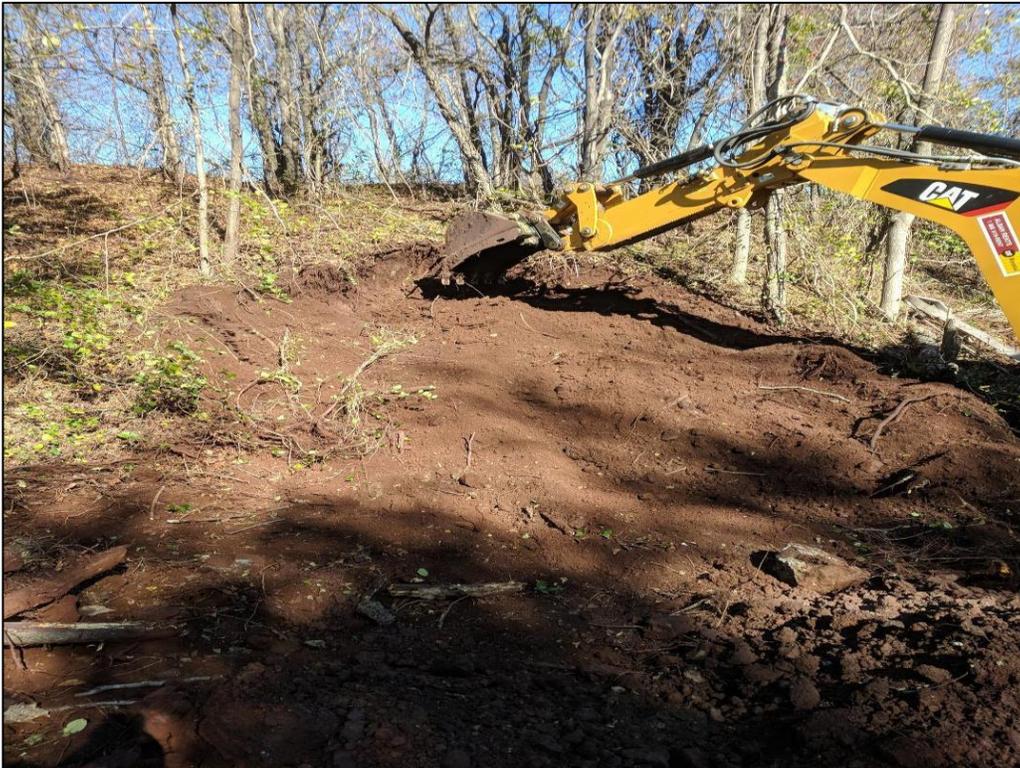
Photo 18: View of test pit at A7-007-TP before excavation.
No visible contamination is evident.

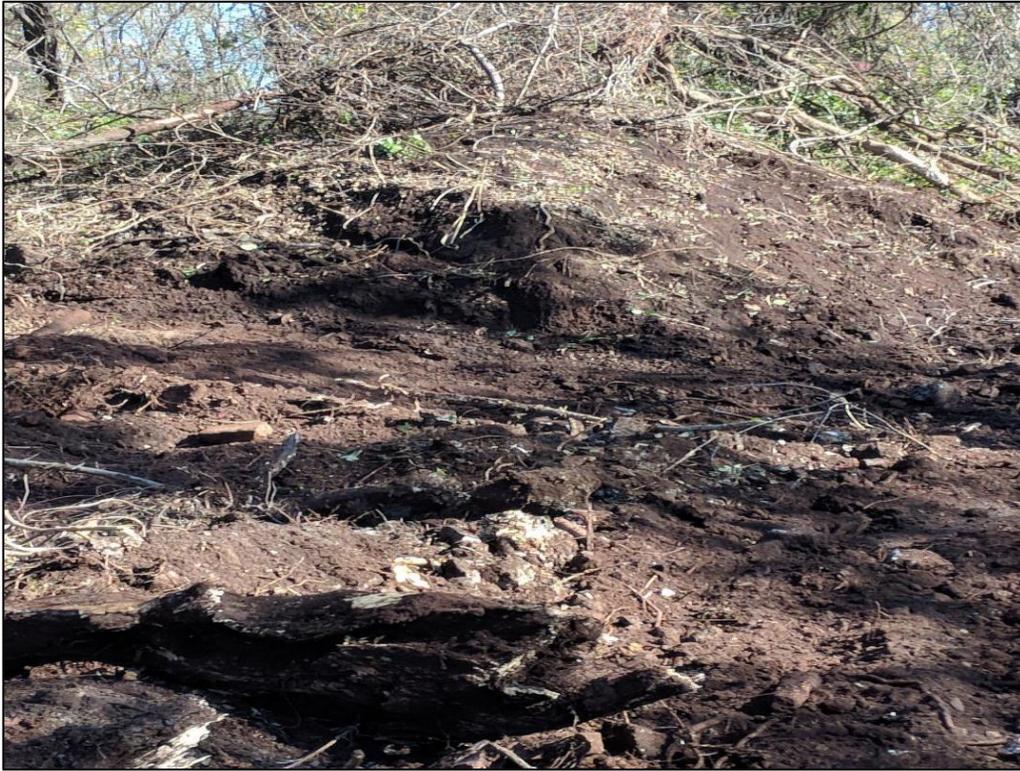
Photo 19: View of test pit at A7-007-TP after excavation. Soils appear to consist of sandy silt. No visible contamination is evident and PID reading equals 7.1.

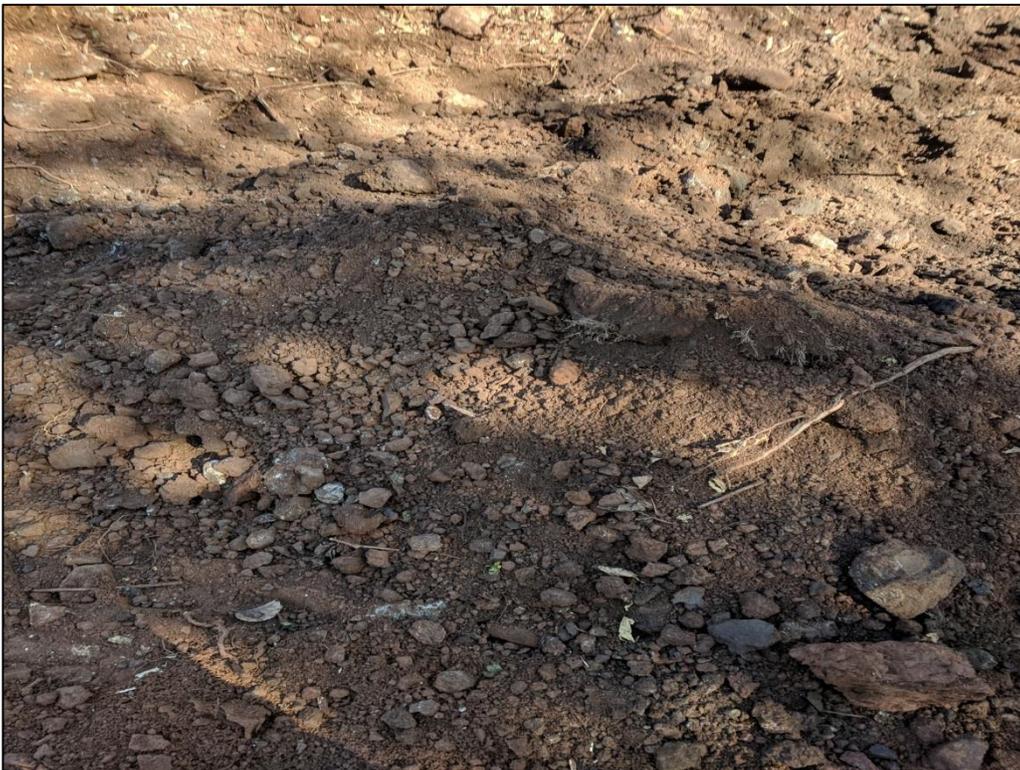
Photo 20: View of test pit at A7-008-TP before excavation. No visible contamination is evident.

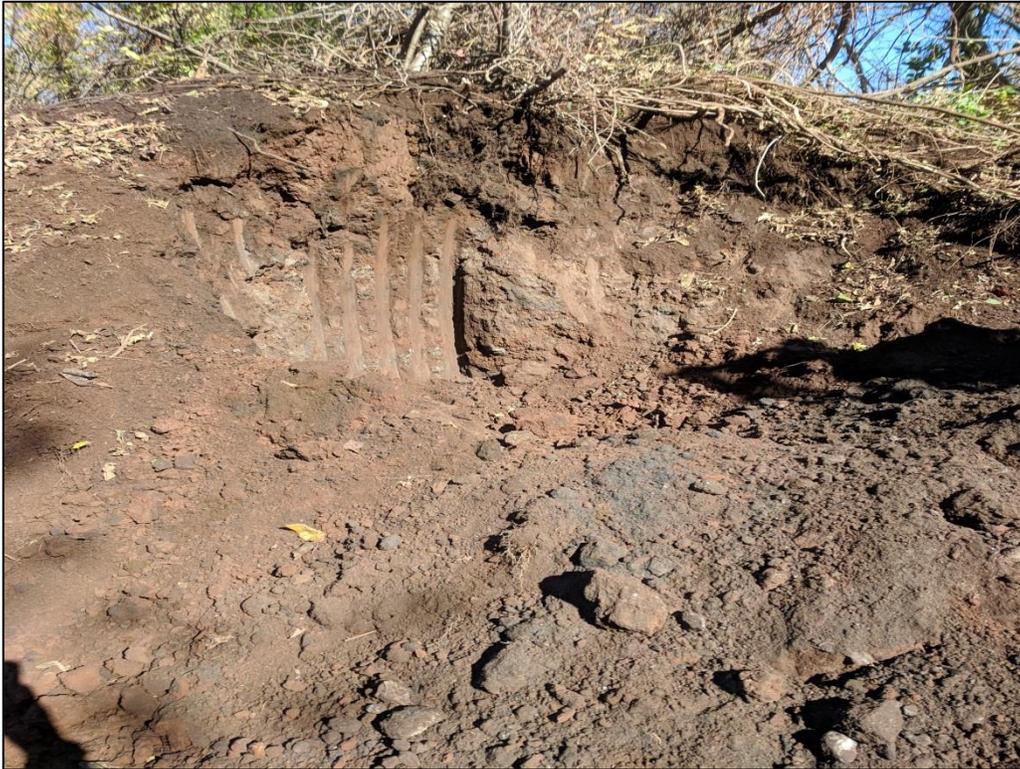
2. *Appendix [E]: There is no photo of the material excavated during the test pitting at A7-008-TP. There is also not a description of the material observed. This is also true for A7-007-TP. Please provide this detail as was done for the additional test pitting areas.*

No additional photographs are available, but a photograph of the excavated sidewall and loose material at A7-008-TP is provided as Photo #21. A description of the material observed at A7-008-TP is provided in the Photo #21 caption. A description of the material observed at A7-007-TP was absent and has been added to the Photo #19 caption. Hard copy pages for the revised **Appendix E** are provided with this letter to replace the pages in the prior version of the report.

Photo 21: View of test pit at A7-008-TP after excavation. Soils appear to consist of silty clay. No visible contamination is evident and PID reading equals 6.7.

A delineation investigation associated with test pit A7-008-TP will be completed as requested. A Delineation Work Plan has been submitted under separate cover (dated September 1, 2020) to detail the proposed lead and thallium delineation. The results of the delineation will be reported outside of the Parcel A7 Phase II Investigation Report.

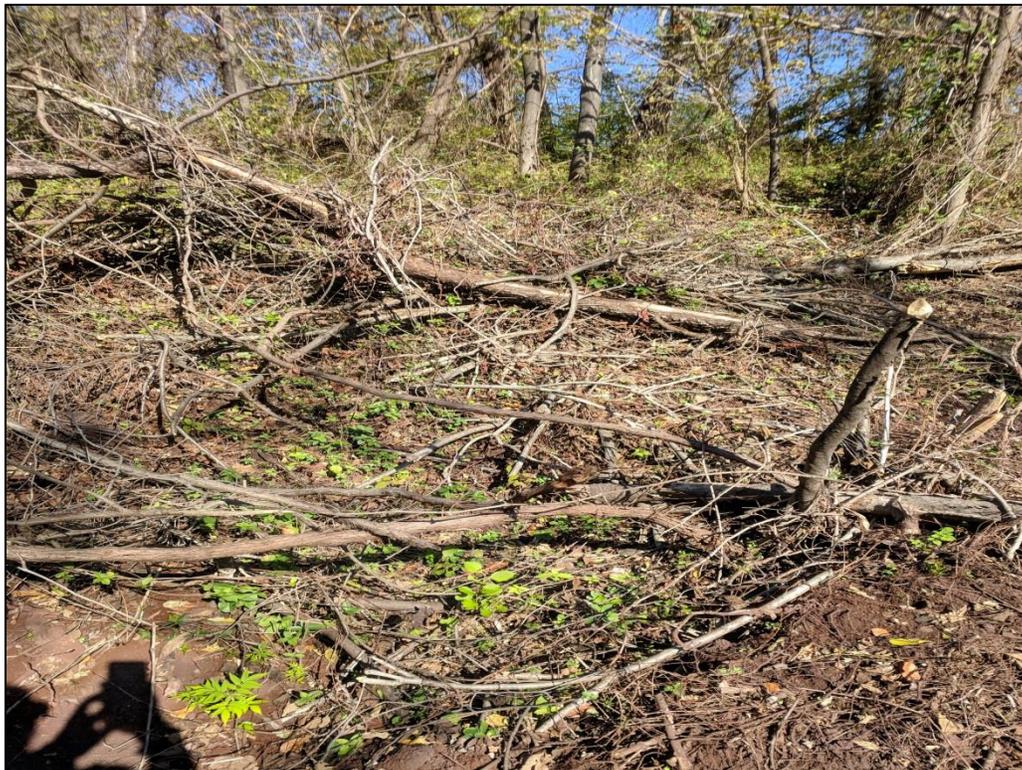
Photo 22: View of test pit at A7-009-TP before excavation. No visible contamination is evident.

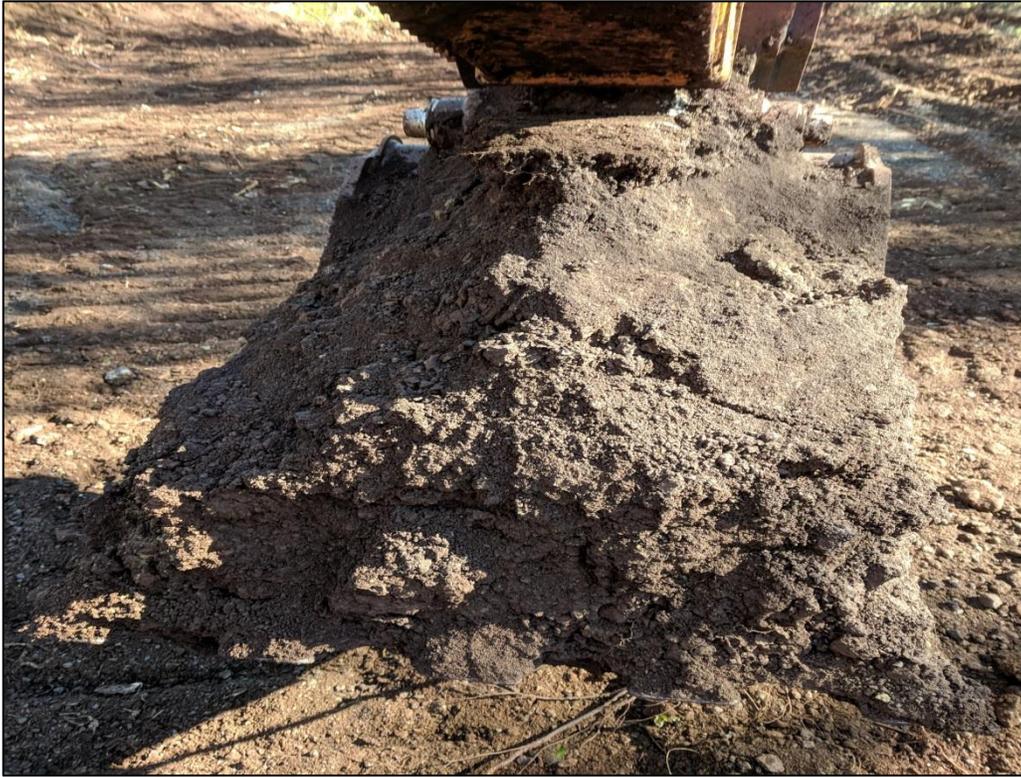
Photo 23: View of the soil observed during test pit activities at A7-009-TP. Soils appear to consist of sandy silt. No visible contamination is evident.

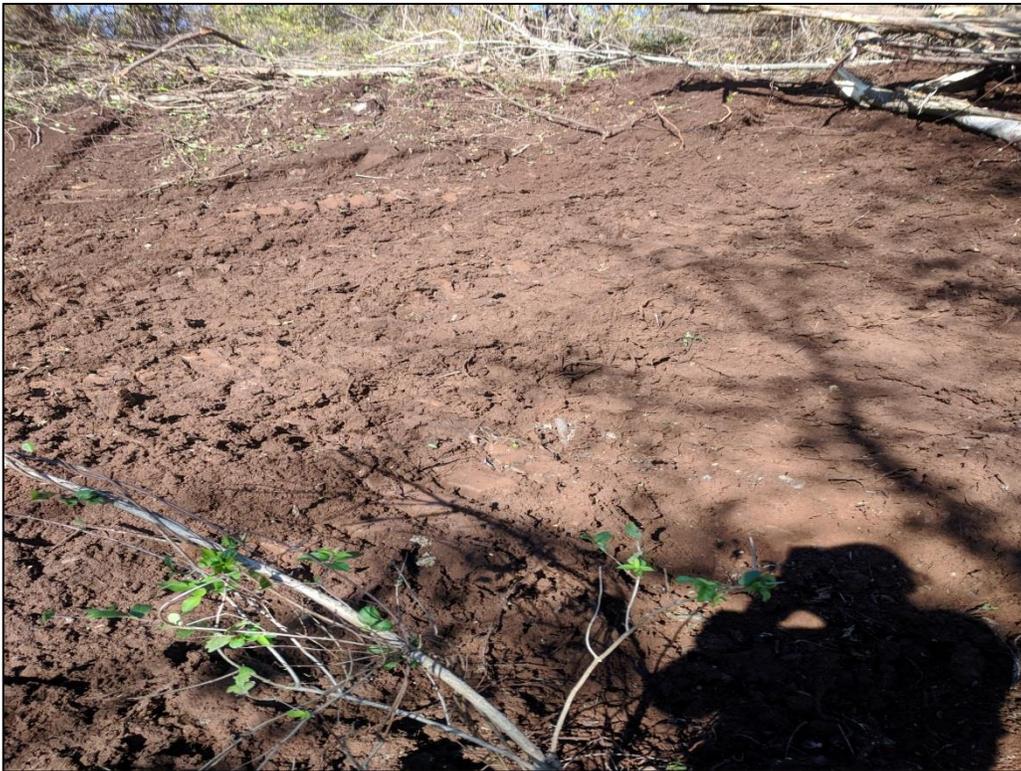
Photo 24: View of test pit at A7-009-TP after excavation. No visible contamination is evident and PID reading equals 3.6.

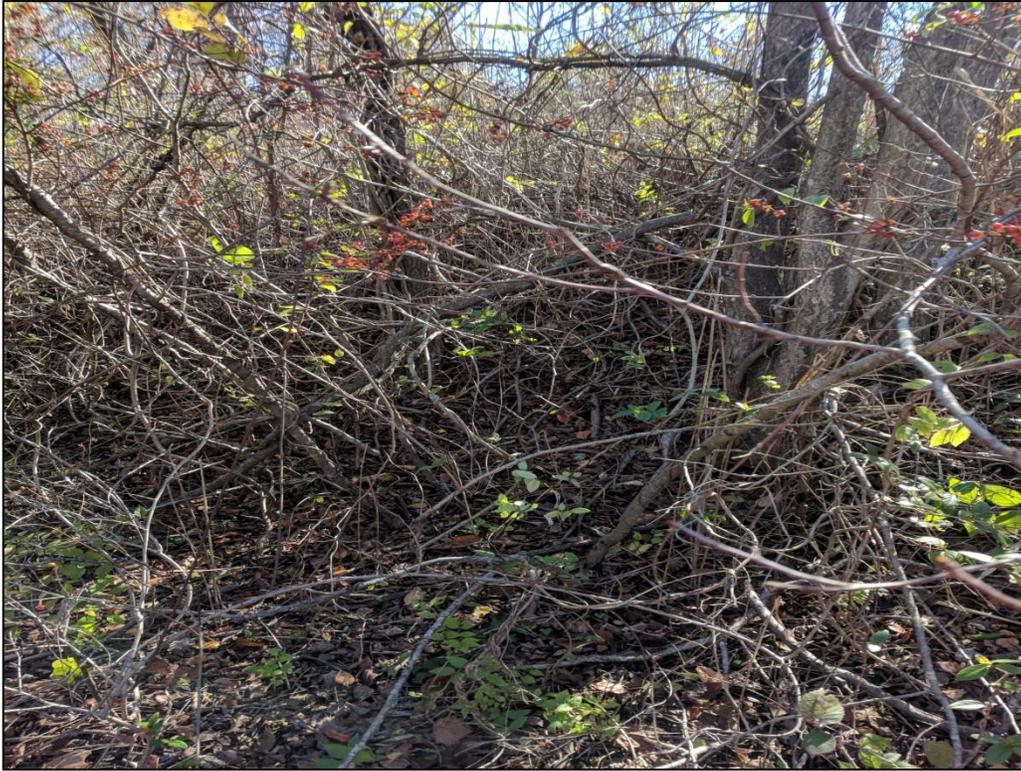
Photo 25: View of test pit at A7-010-TP before excavation.
No visible contamination is evident.

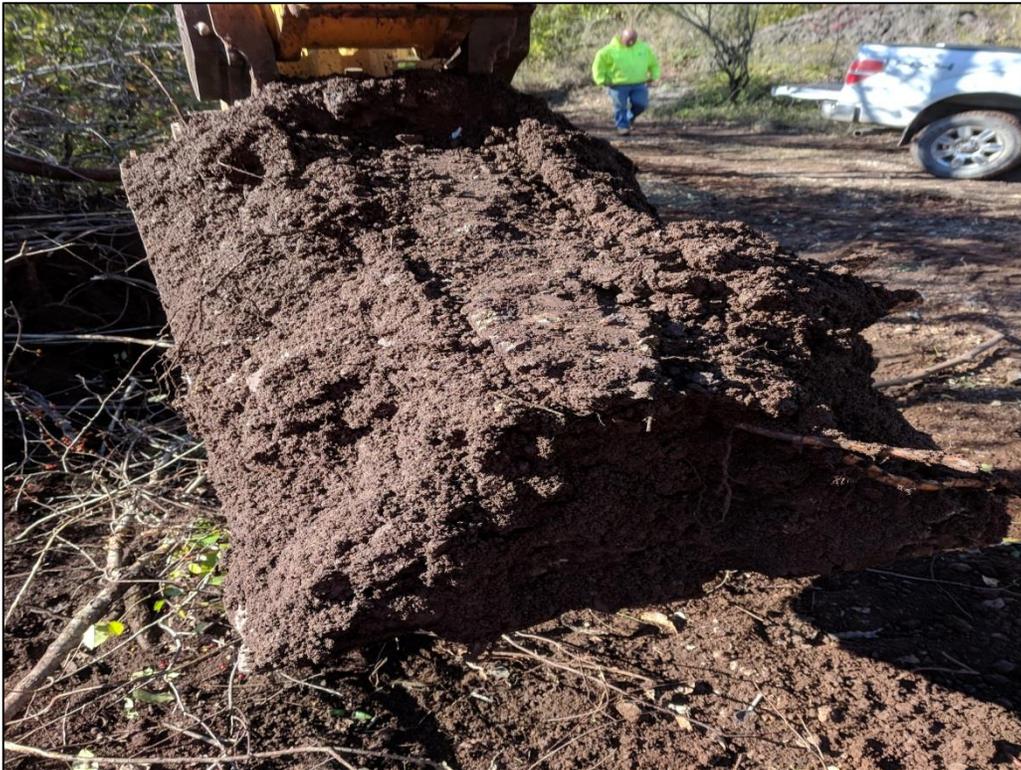
Photo 26: View of the soil observed during test pit activities at A7-010-TP.
Soils appear to consist of sandy silt. No visible contamination is evident.

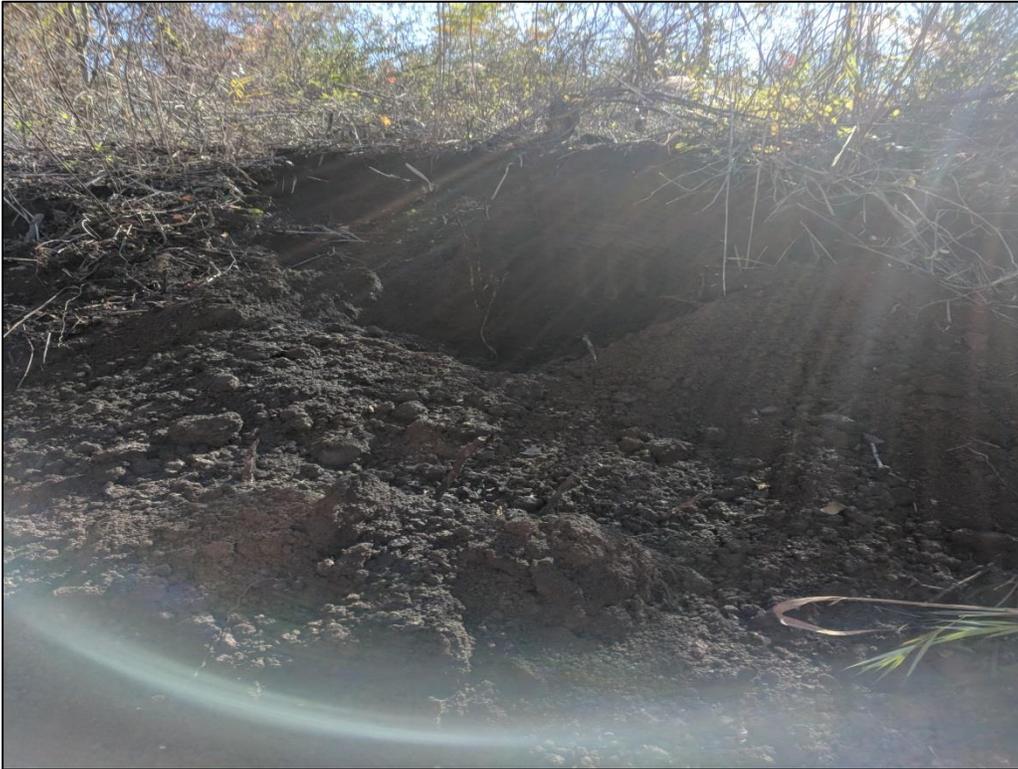
Photo 27: View of test pit at A7-010-TP after excavation.
No visible contamination is evident and PID reading equals 5.4.
