May 29, 2019

Re: Lead Based Paint Survey Report
Former Lumber Shed
Area B: Parcel B23
Tradepoint Atlantic
Sparrows Point, MD 21219

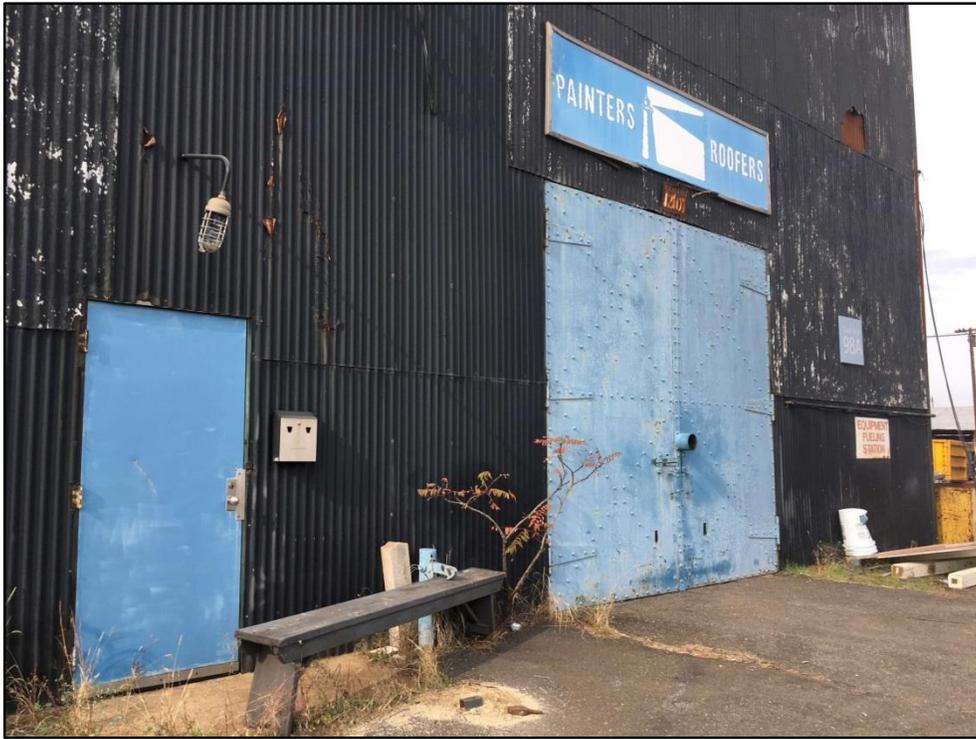
111218-1: View of the blue paint on the doors on the eastern side of the Lumber Shed. Pictured are sample locations 1, 2, and 17.

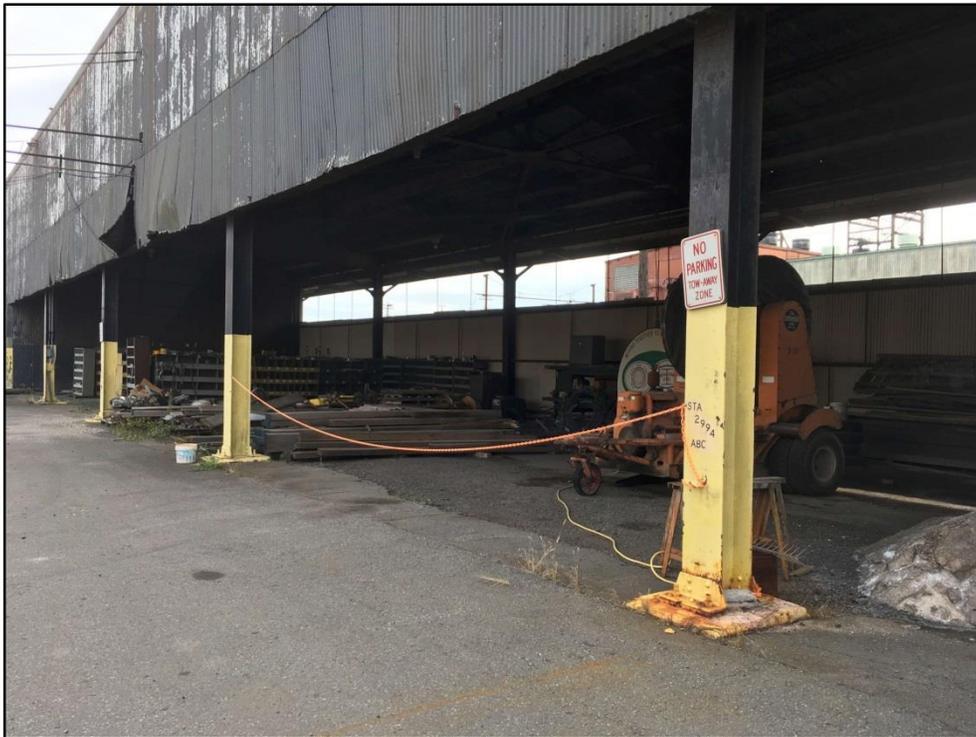
111218-2: View of the northern side of the Lumber Shed that shows the yellow paint and the lower and upper black paint. Pictured are sample locations 3, 4, 5, 6, 7, 8, and 9.

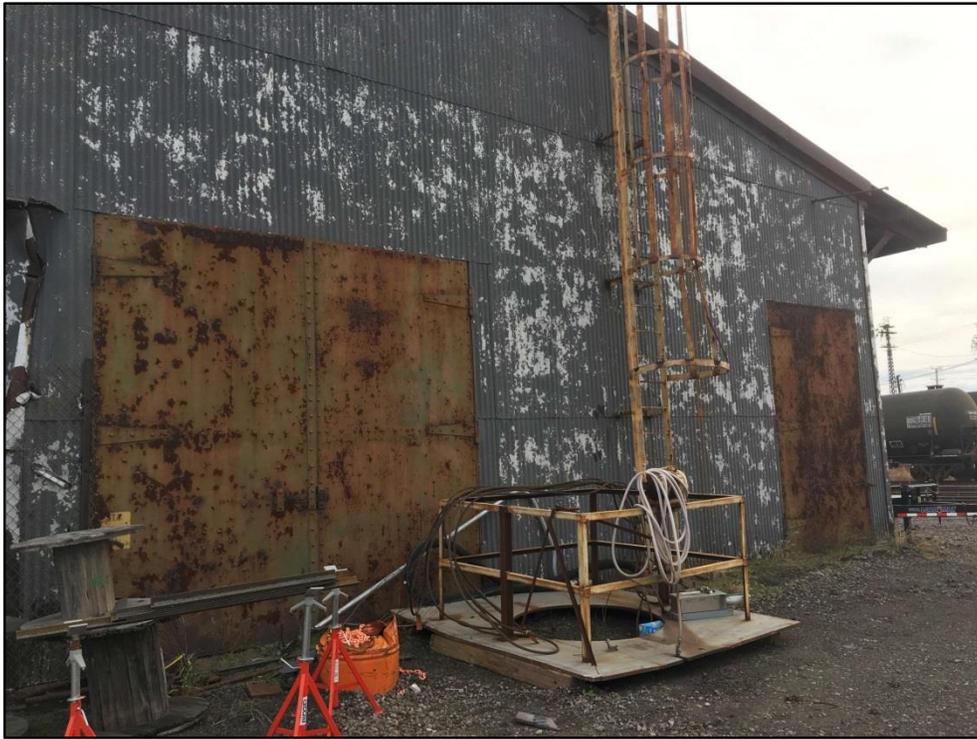
paint. However, the green doors and yellow ladder on the western side of the building showed weathering and severe flaking was observed.

111218-3: View of the green door paint and yellow ladder on the western side of the Lumber Shed. Pictured are sample locations 10, 11, 12, and 13.

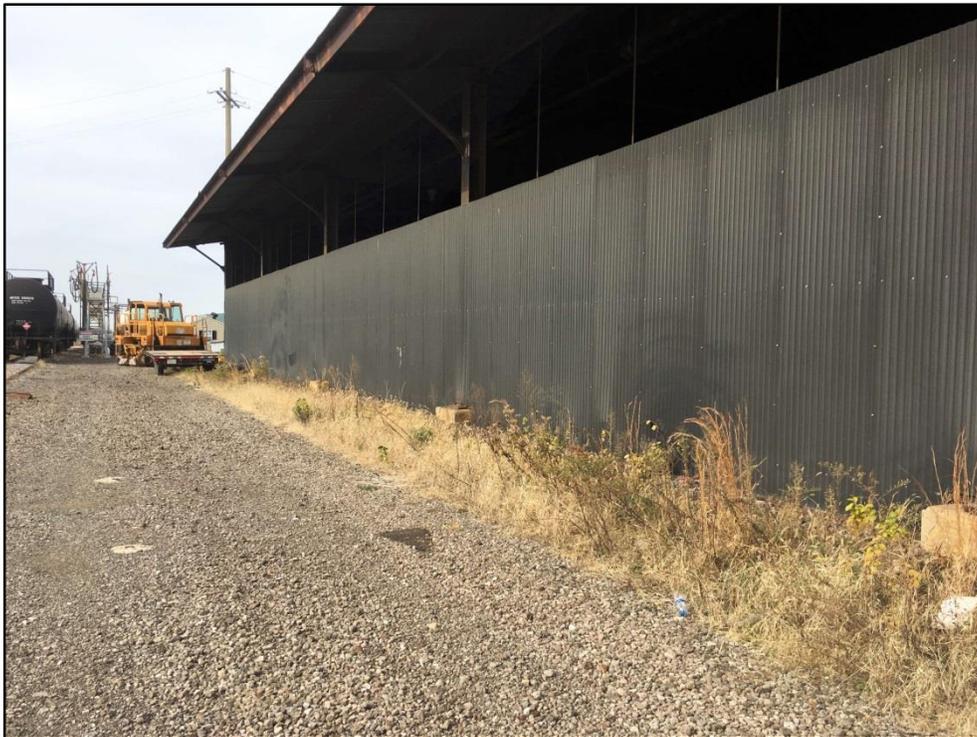
111218-4: View of the southern side of the Lumber Shed that shows the black paint. Pictured are sample locations 14, 15, and 16.

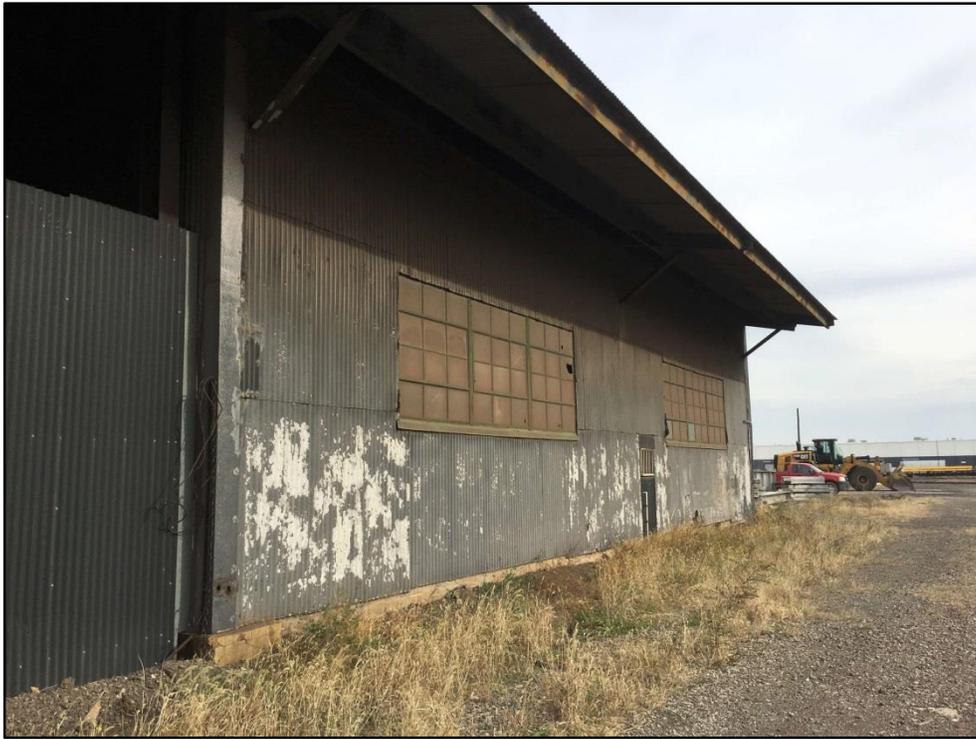
111218-5: View of the southern side of the Lumber Shed that shows the black paint. Pictured is sample location 20.

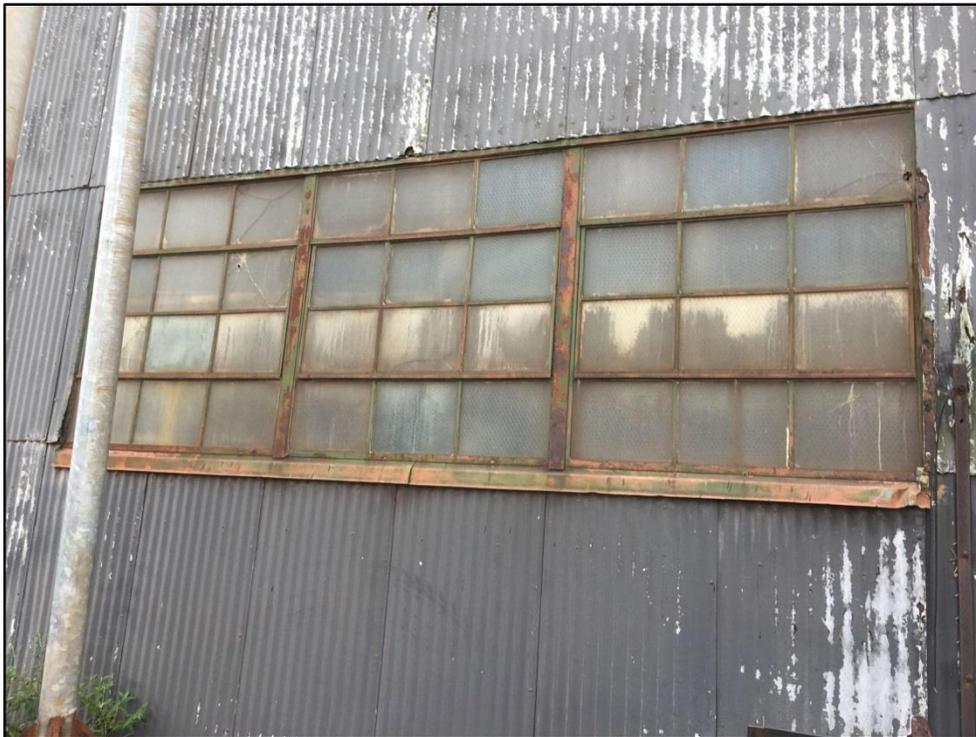
111218-6: View of northern side of the Lumber Shed that shows the green windowsill paint. Pictured are sample locations 18 and 19.
