# RECENT FAILURES OF LARGE CORRUGATED METAL PIPE SPILLWAYS

Harald W. Van Aller, P.E.  
Geotechnical Engineer  
Maryland Dam Safety Division

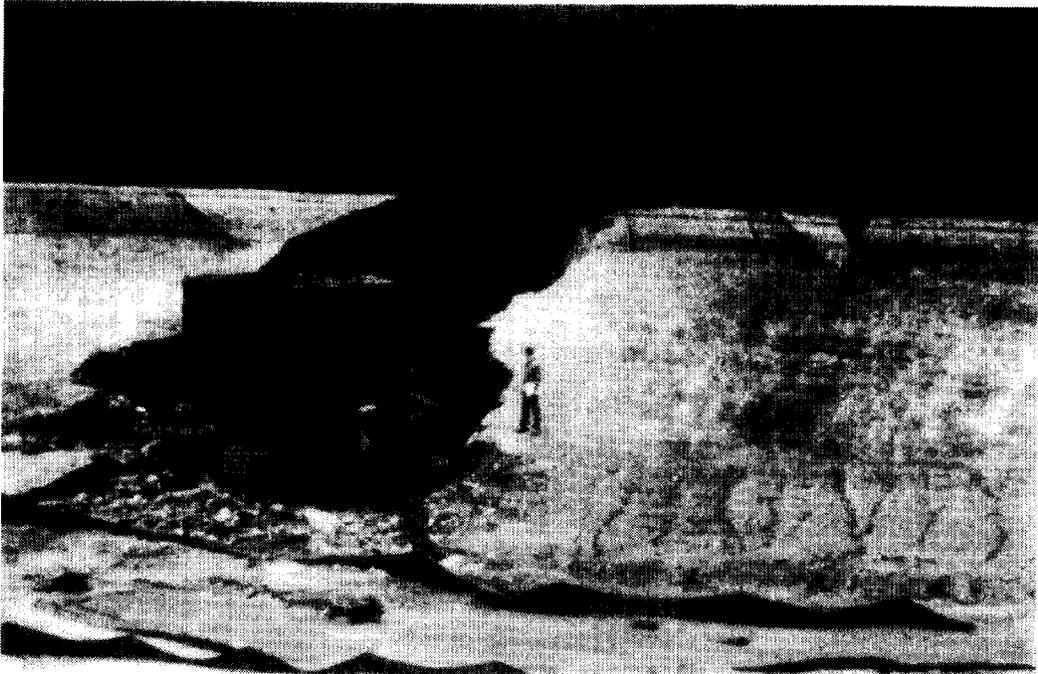
Complete failure of 25 foot high dam for "dry" pond, viewed from the pool area. The structure does not normally impound water. The 72-inch barrel pipe was apparently installed in a vertical trench cut through nearly completed embankment fill. Failure occurred during a storm that filled pool to just below enlarged top of riser.

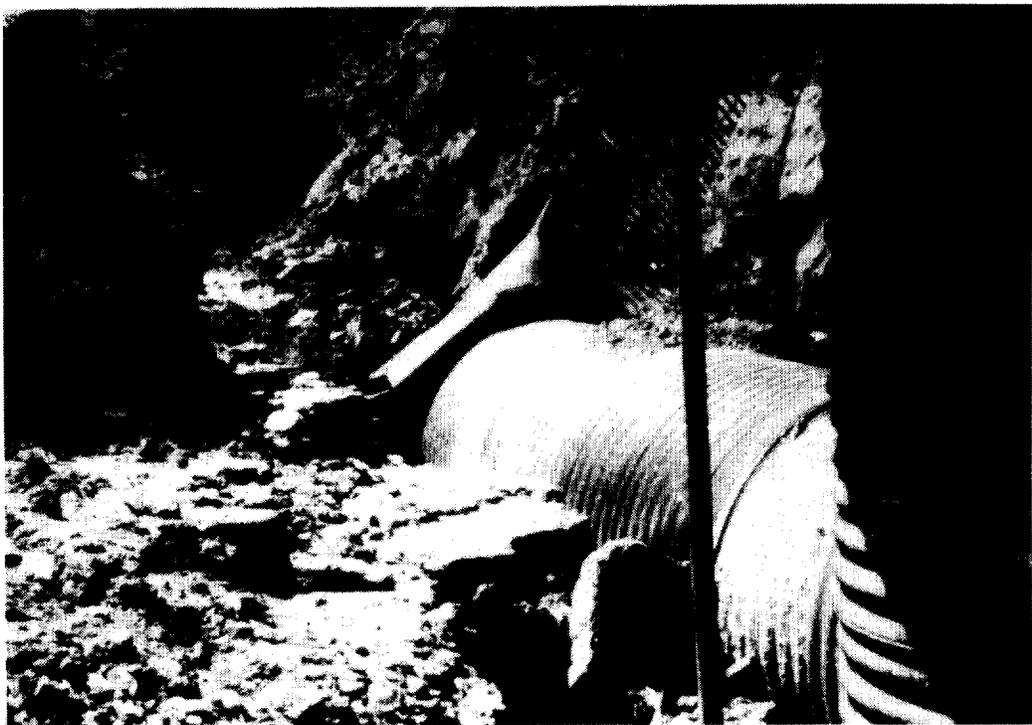
Detail of above, looking downstream along pipe from riser. Note collapse of 14-foot square anti-seep collar and the near vertical trench wall parallel to pipe in center of picture.
