March 31, 2021

**RE: Response to MDE Notice of Violation**  
Calvert Citgo  
2802 North East Road (Harrison Residence)  
2794 North East Road (O'Brien Residence)  
North East, Maryland 21901  
Facility No. 5678  
**REPSG Project Reference No. 005977.130**

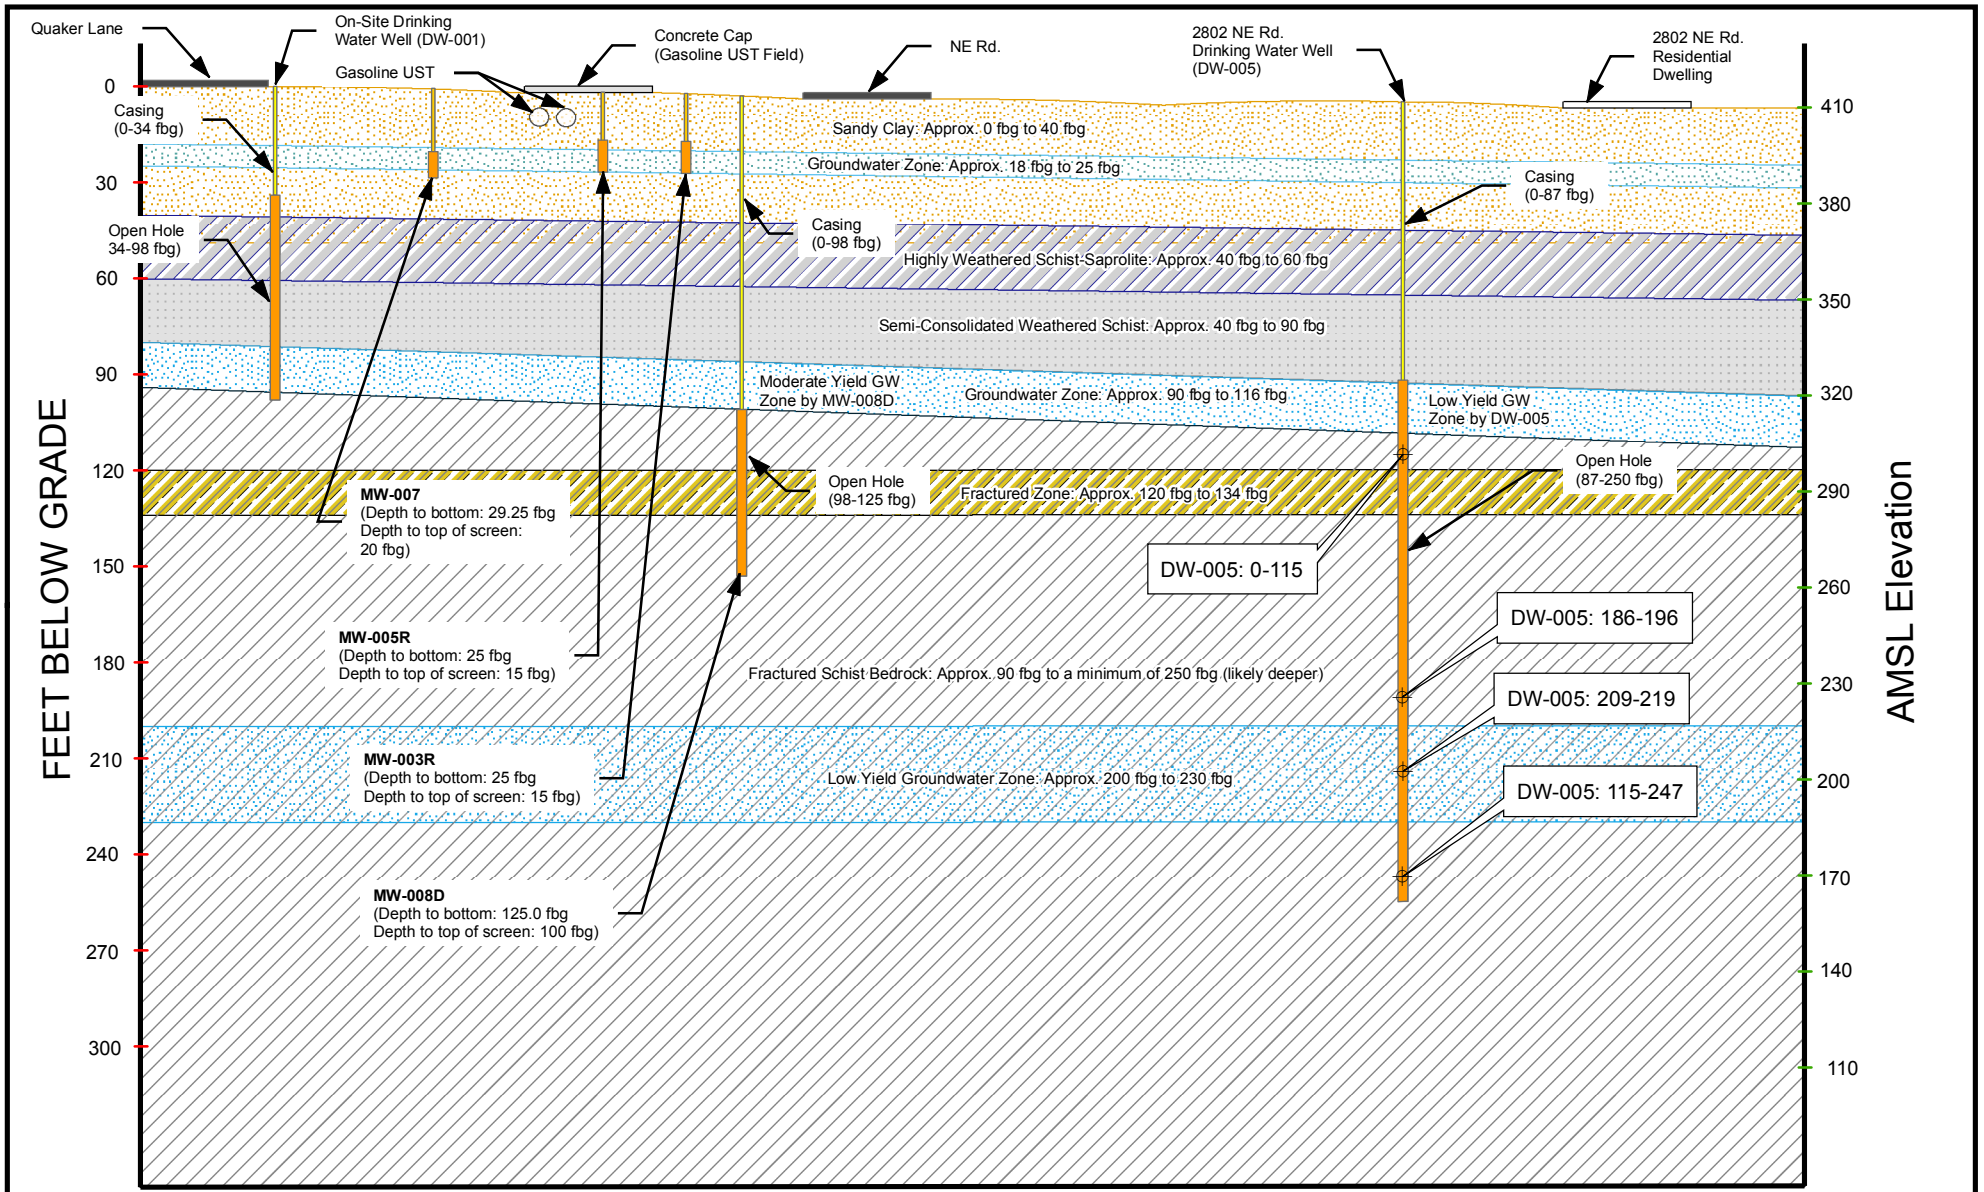
**Soil and Groundwater Cross-Sectional Diagram**

It should be noted that while the March 2015 packer testing identified MTBE impacts at all of the tested intervals, the concentrations of MTBE and TBA were lower in the 115-247 fbg interval than in the 0-115 fbg interval, as shown in **Table 3** below. Furthermore, both of these intervals exhibited a similar sustainable yield (approximately 4 gpm) during the pumping test which purged at least one full well volume. As shown in the enclosed cross-section, the 115-247 fbg interval does not bisect the shallow moderate-yield water-bearing zones in the unconsolidated aquifer located at 18-25 fbg and 90-115 fbg; rather the 115-247 fbg interval bisects a fractured zone of the schist bedrock aquifer at 120-134 fbg as well as a low-yield water-bearing zone at 200-230 fbg.
