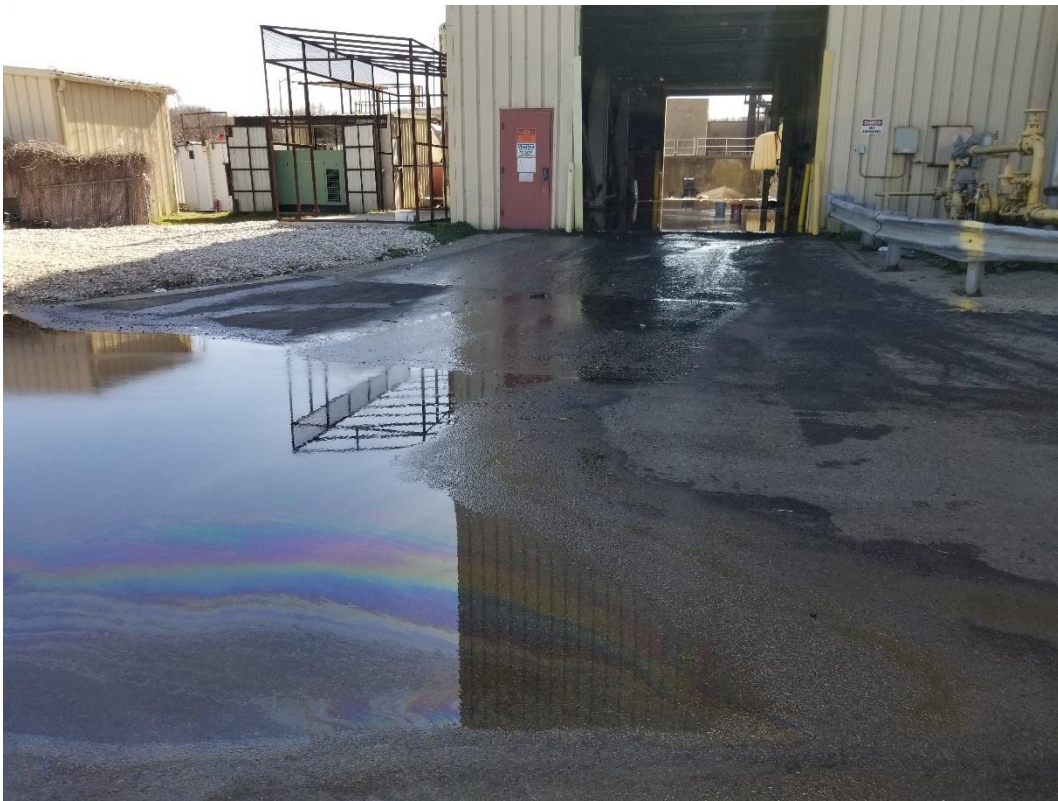
Picture 1: Water was observed flowing from the pelletech building. An oily sheen and green-ish color were observed in the flow water along the flow path from the pelletech building towards the dried sludge loading building.

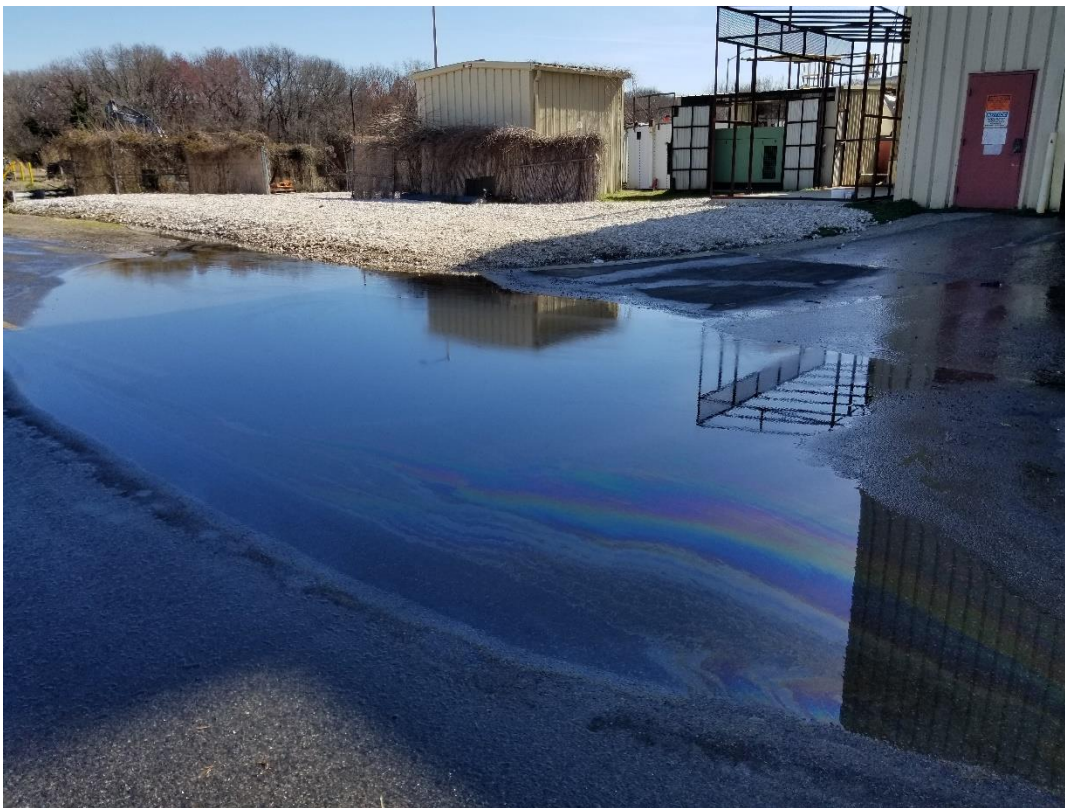
Picture 2: An oily sheen and green-ish color were observed in the flow water along the flow path from the pelletech building towards the dried sludge loading building.

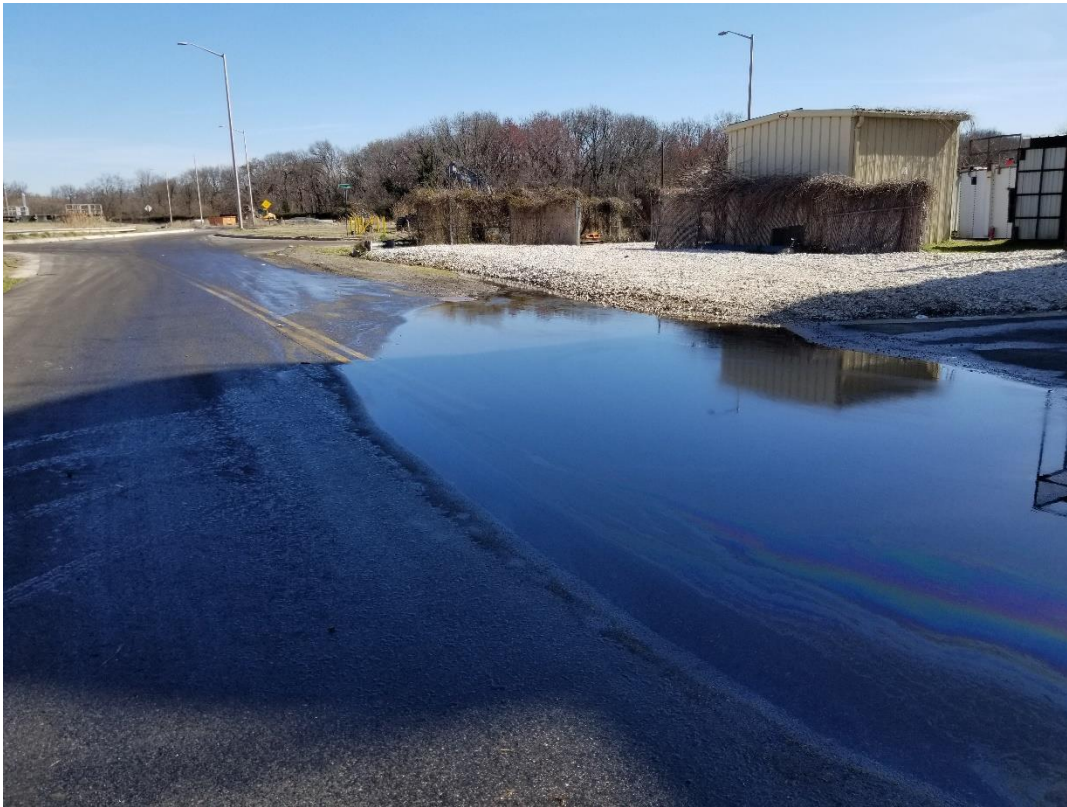
Picture 3: An oily sheen and green-ish color were observed in the flow water along the flow path from the pelletech building towards the dried sludge loading building.

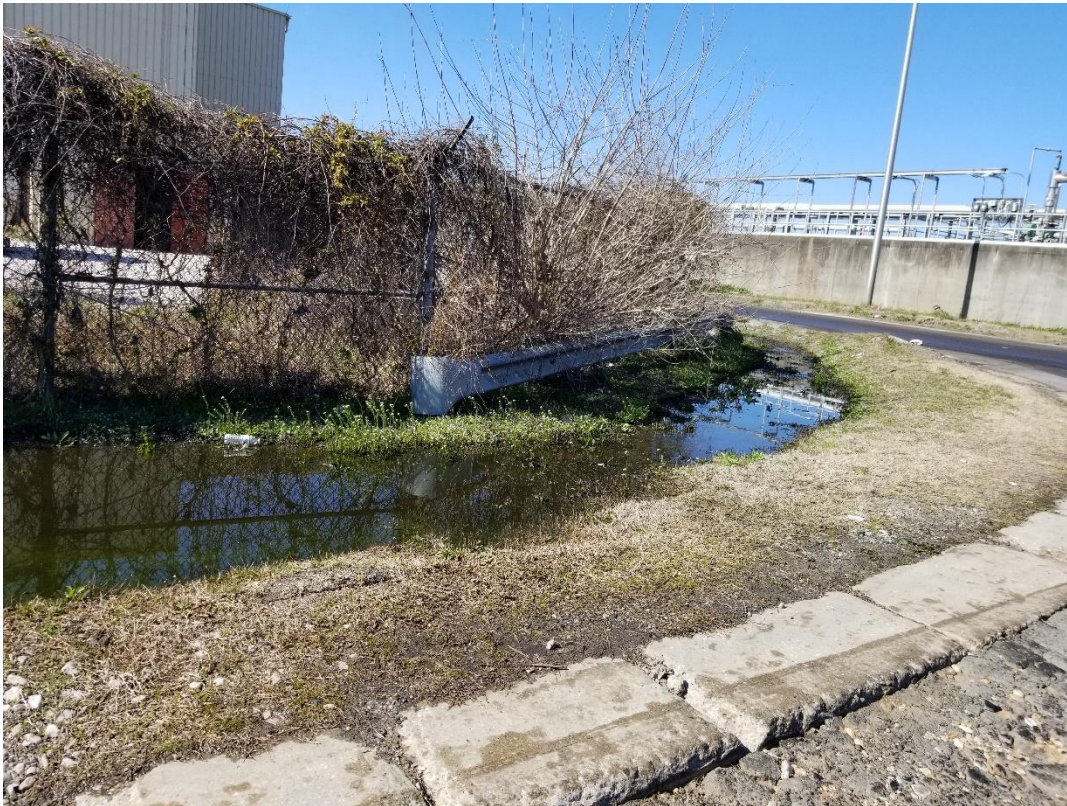
Picture 4: An oily sheen and green-ish color were observed in the flow water along the flow path from the pelletech building towards the dried sludge loading building.

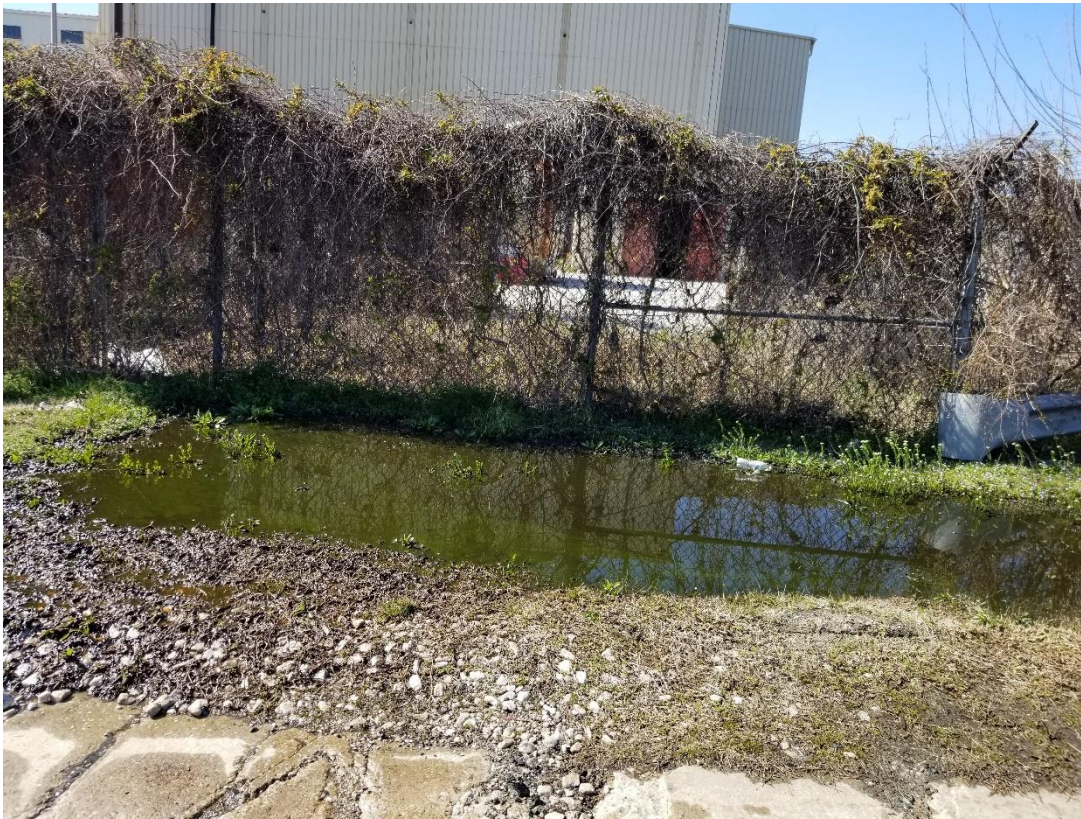
Picture 5: An oily sheen and green-ish color were observed in the flow water along the flow path from the pelletech building towards the dried sludge loading building.

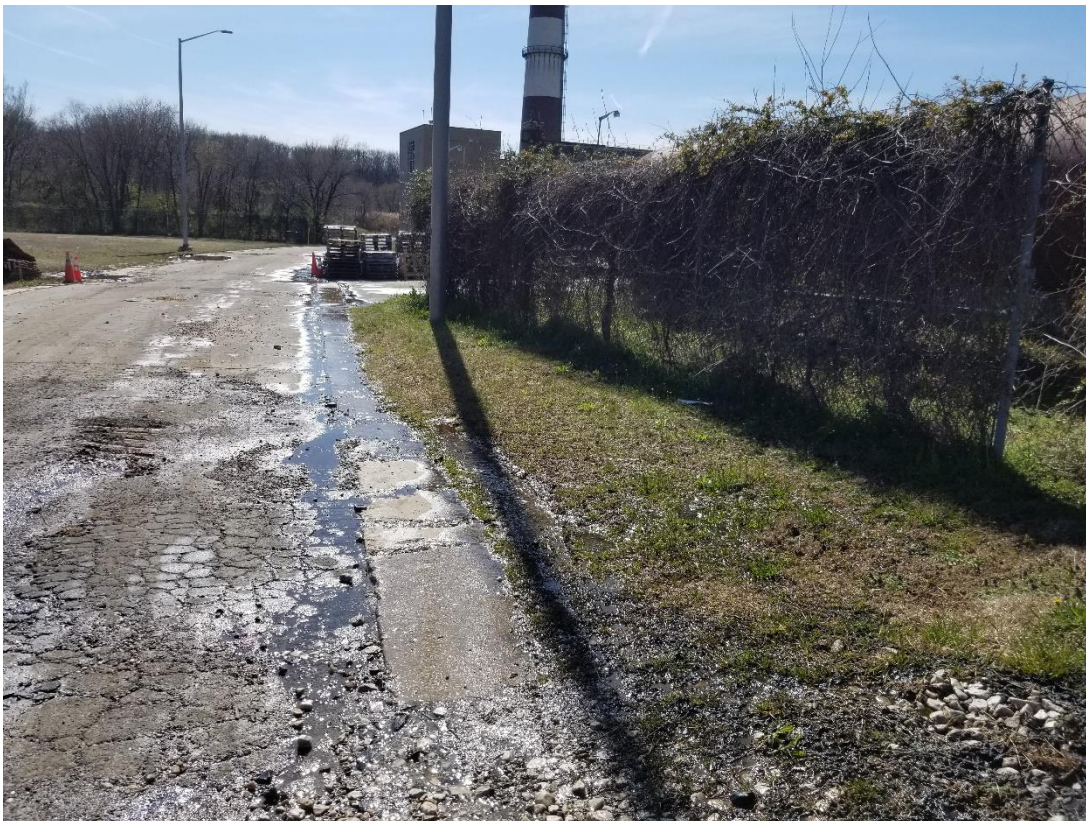
Picture 6: An oily sheen and green-ish color were observed in the flow water along the flow path from the pelletech building towards the dried sludge loading building.

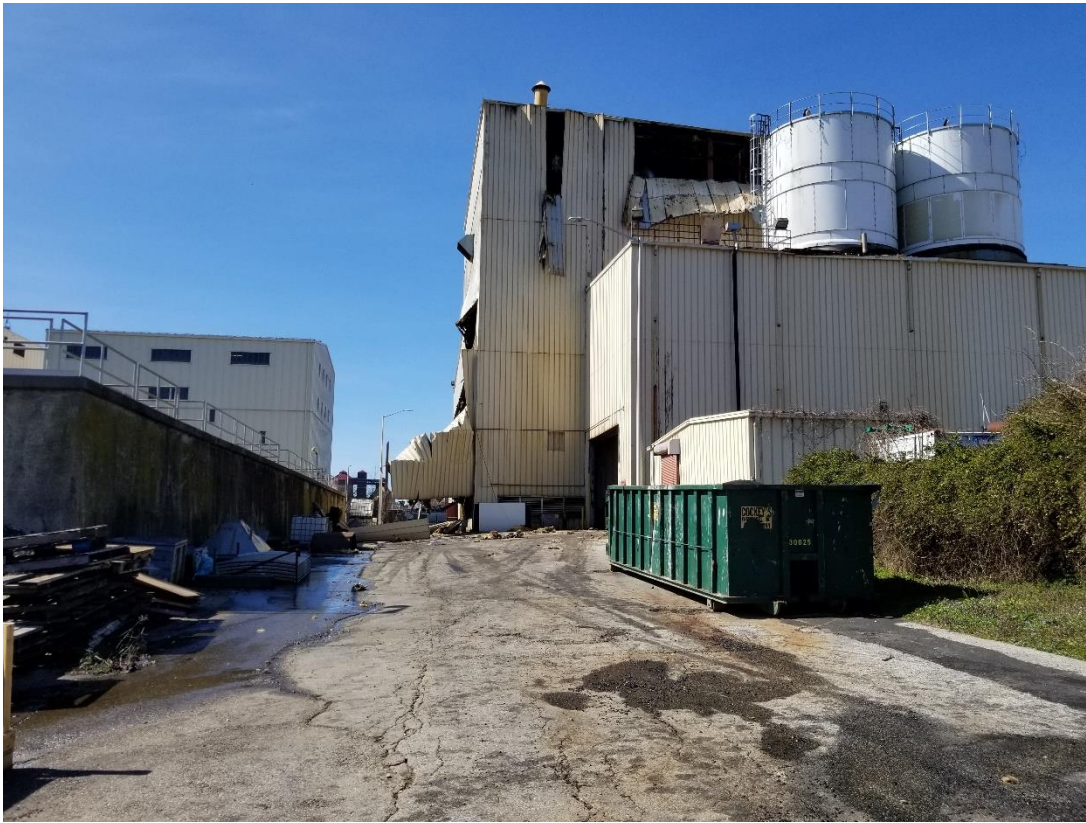
Picture 7: An oily sheen and green-ish color were observed in the flow water along the flow path from the pelletech building towards the dried sludge loading building.

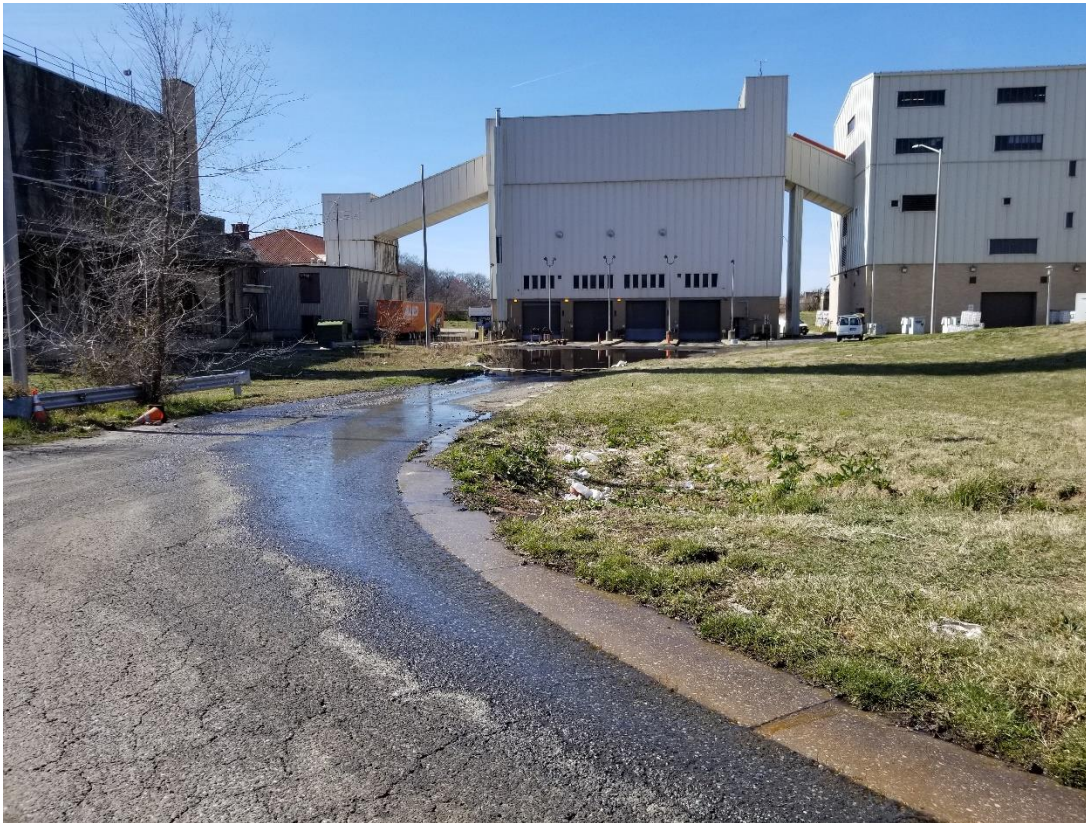
Picture 8: An oily sheen and green-ish color were observed in the flow water along the flow path from the pelletech building towards the dried sludge loading building.

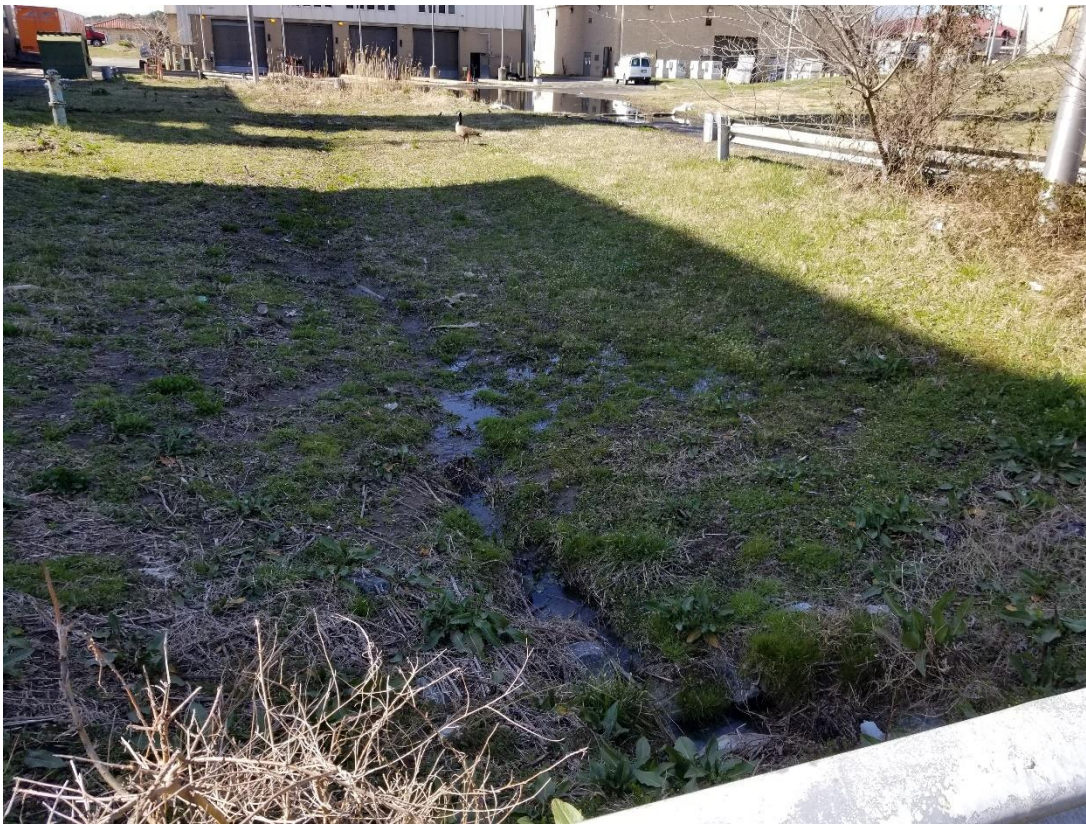
Picture 9: South-east of the dried sludge loading building, some of the flow water was observed to be flowing to a stormwater management culvert.

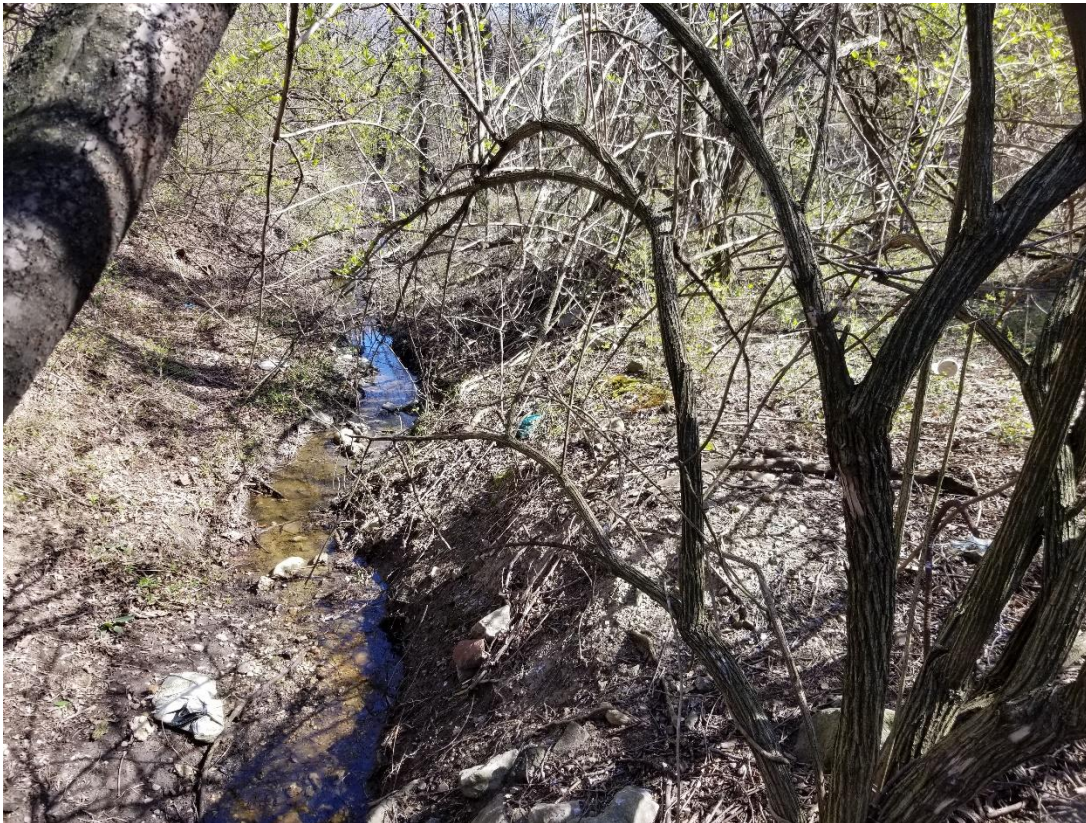
Picture 10: The flow (from the stormwater management culvert located south-east of the dried sludge loading building) leaving the site was observed to have an oily sheen.

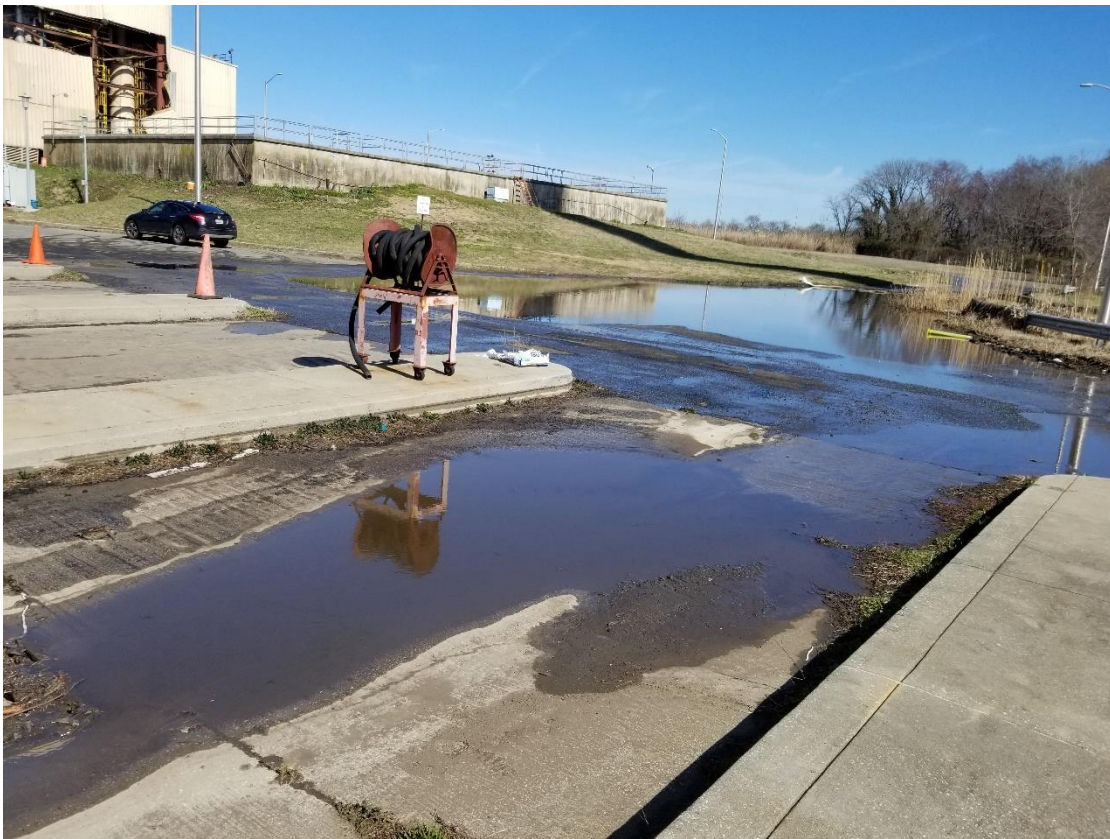
Picture 11: An area of pooled water was observed behind the dried sludge loading building past the trench drains.

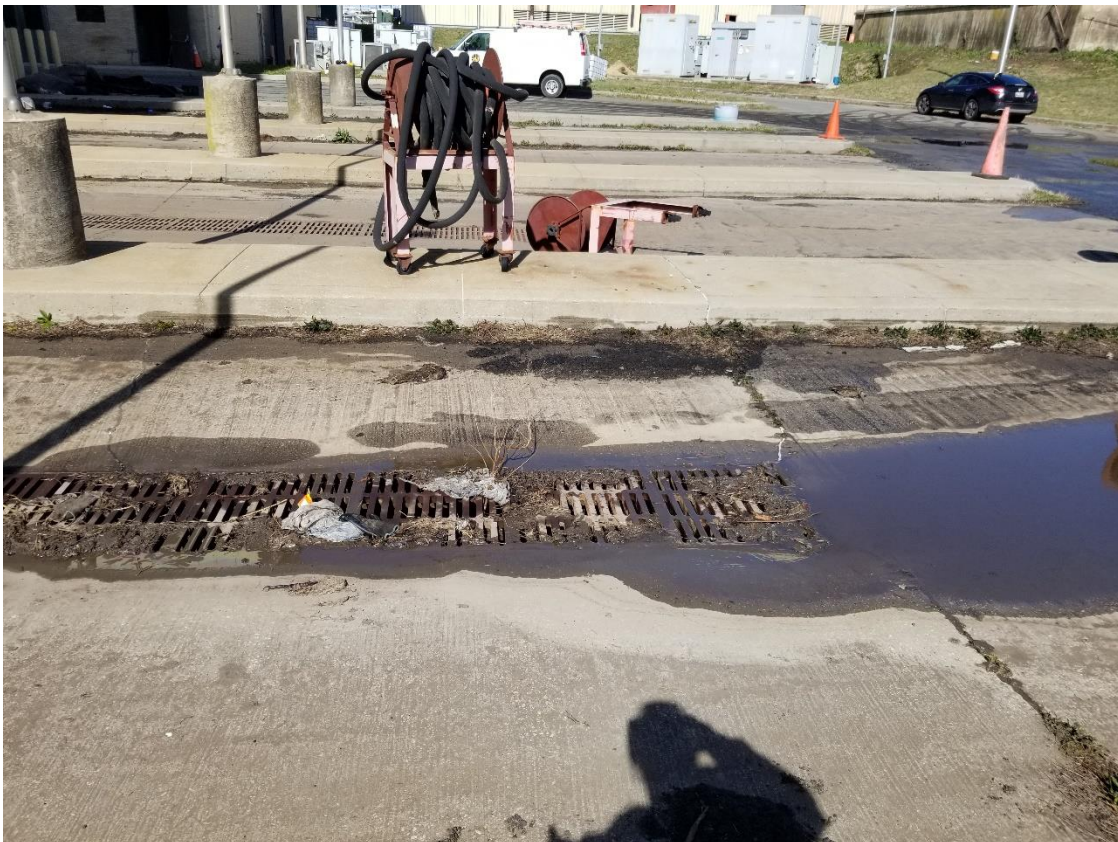
Picture 12: Trench drains were observed behind the dried sludge loading building.

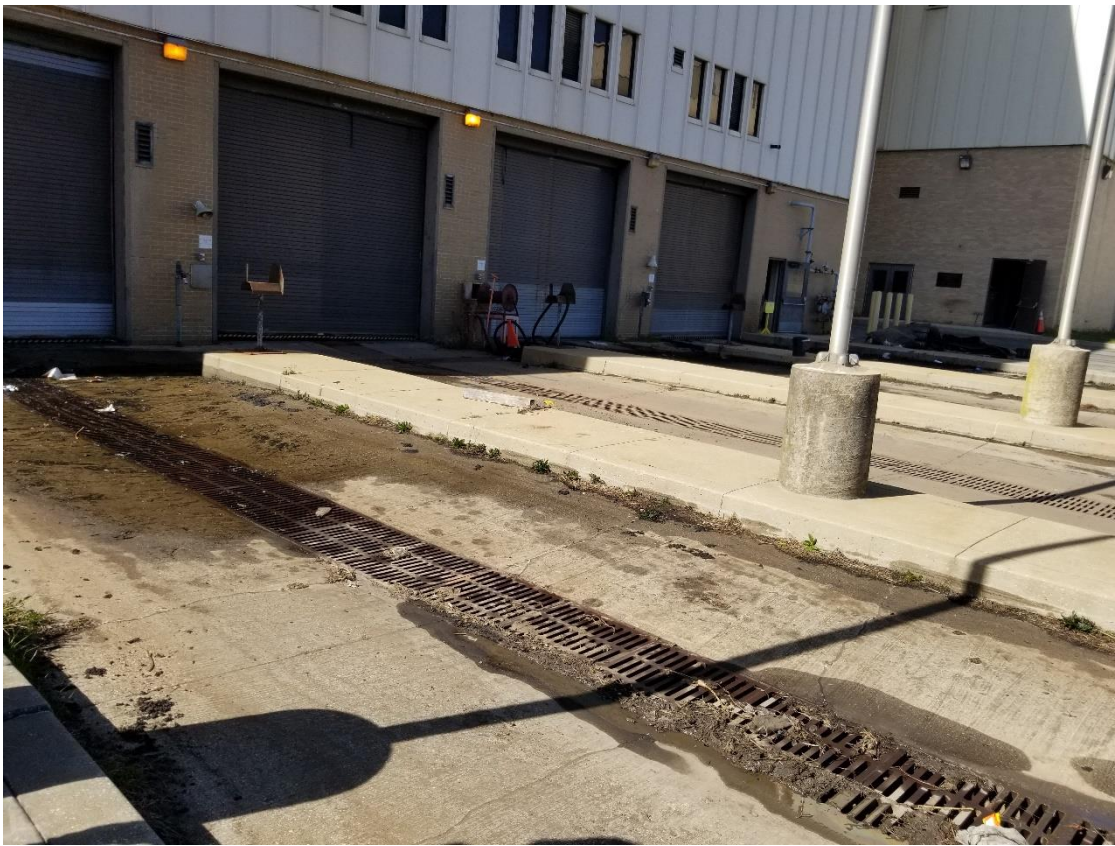
Picture 13: Trench drains were observed behind the dried sludge loading building.

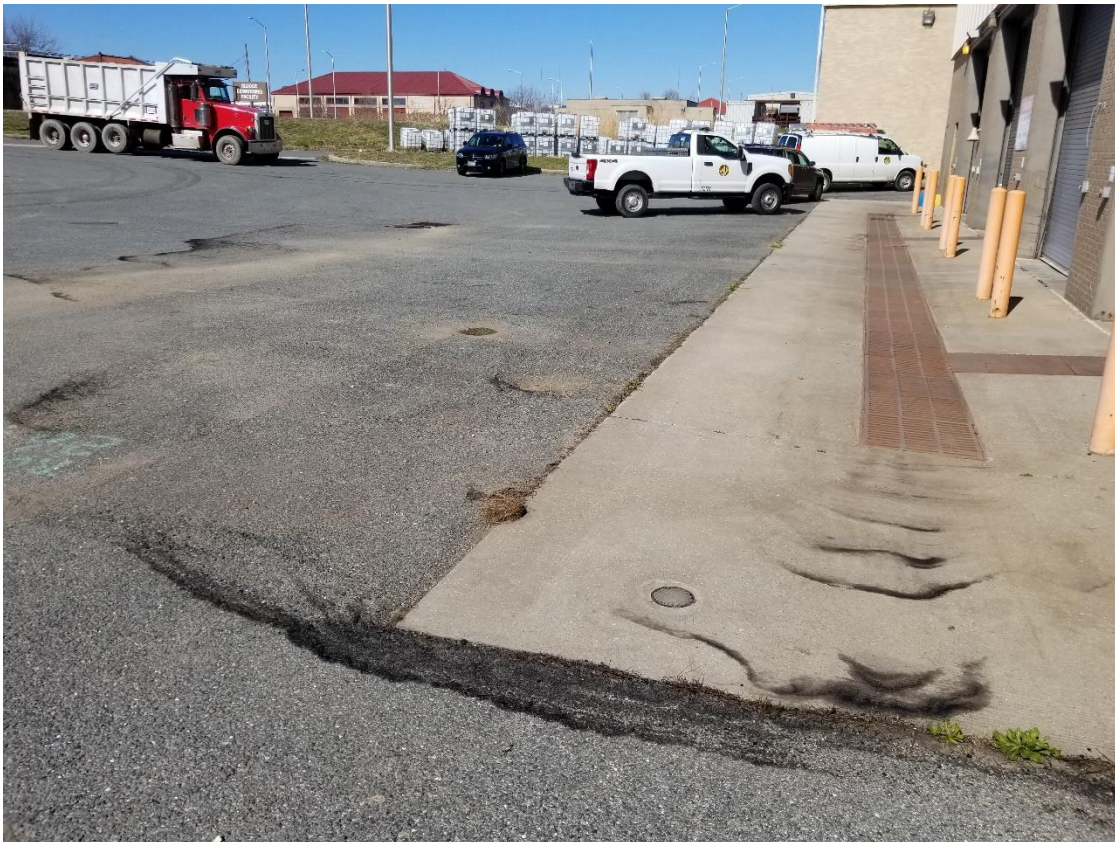
Picture 14: The area in front of the dried sludge loading building was observed to be dry.

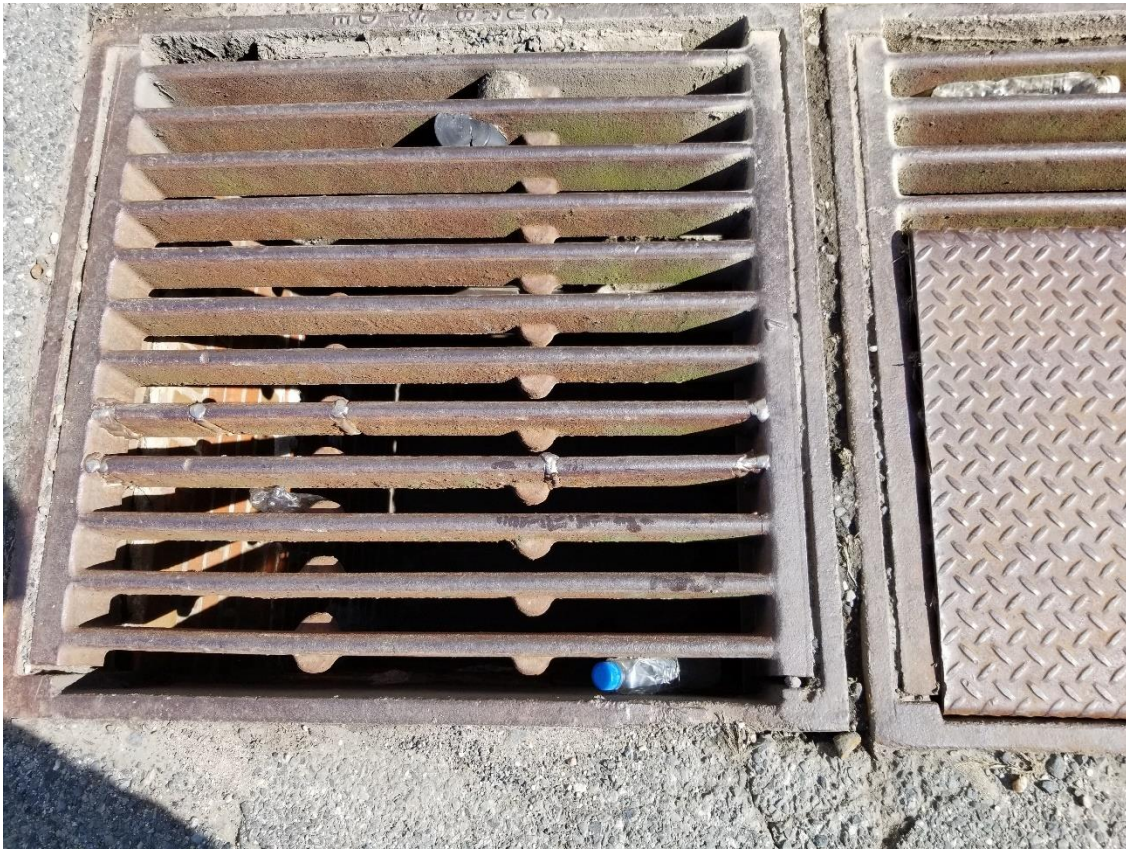
Picture 15: In front of the dried sludge loading building, no water was observed entering the storm drain inlet.
