Maryland Department of Environment
Water and Science Administration
Compliance Program
1800 Washington Blvd, Suite 420
Baltimore, MD 21230-1719
410- 537-3510, 1-800-633-6101

Site Name: Back River WWTP
Facility Address: 8201 Eastern Ave, Baltimore, MD 21224
County: Baltimore County

Start Date/Time: June 02, 2022 09:18 AM
End Date /Time: June 08, 2022 05:28 PM

Permit / Approval Numbers: 15DP0581
NPDES Numbers: MD0021555
Inspection Reason: Follow-up (Non-Compliance)
Site Status: Active
Compliance Status: Noncompliance
Site Condition: Noncompliance
Recommended Action: Additional Investigation Required
Evidence Collected: Photos or Videos Taken, Record Review, Samples Taken
Delivery Method: Email
Weather: Clear Average

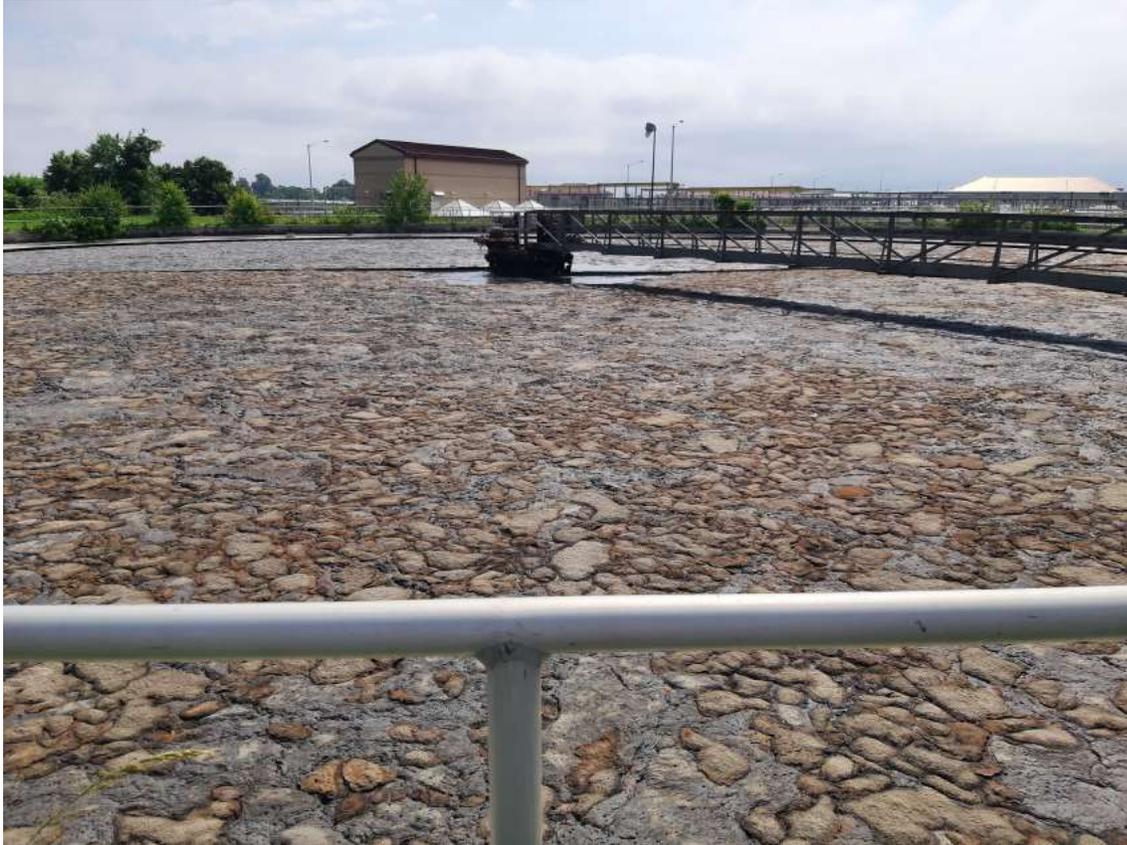
6/2/22 PST #9. This PST is being used for primary treatment. There is minimal settling of solids and no scum or FOG removal of the wastewater flowing through this PST. This PST was reported as functional by Baltimore City during the 4/25/22 weekly meeting with the Maryland Department of the Environment (MDE of Department)). However, today Dan LaTova, plant engineer, explained that the arm ... “fell off” ... of PST# 9 making the PST nonfunctional. The PST is not being operated as designed.

- A. With respect to item #1 above, the Back River WWTP shall get the PSTs cleaned and operational to improve the quality of the final effluent. There should be sufficient functioning PSTs in service to accommodate expected influent flows. Within 15 days of the receipt of this inspection report, the Back River WWTP shall submit to the Department a status report on the condition of all PSTs and a schedule of when the repairs necessary to make each PST functional will be completed. The Back River WWTP shall also submit a progress report every 14 days detailing the status of each PST.

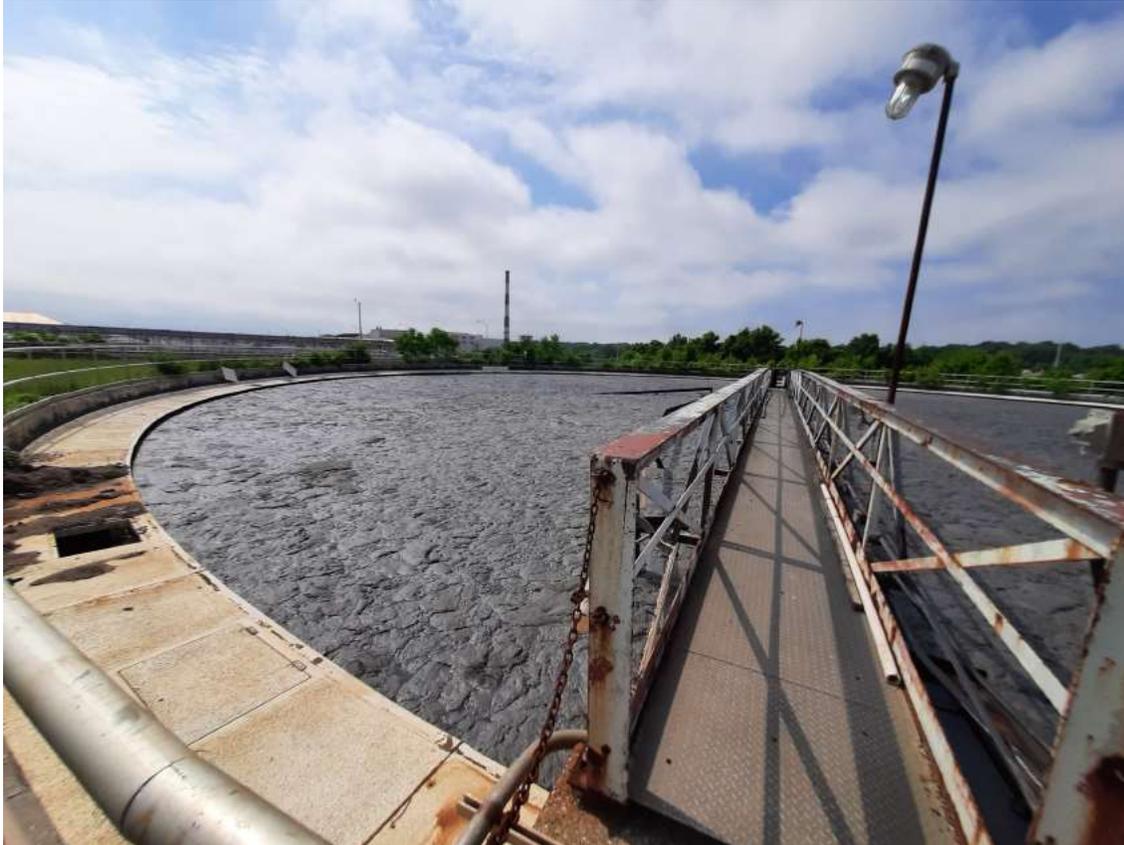
PST #10. This PST is being used for primary treatment. There is minimal settling of solids and no scum or FOG removal of the wastewater. The PST is not being operated as designed.

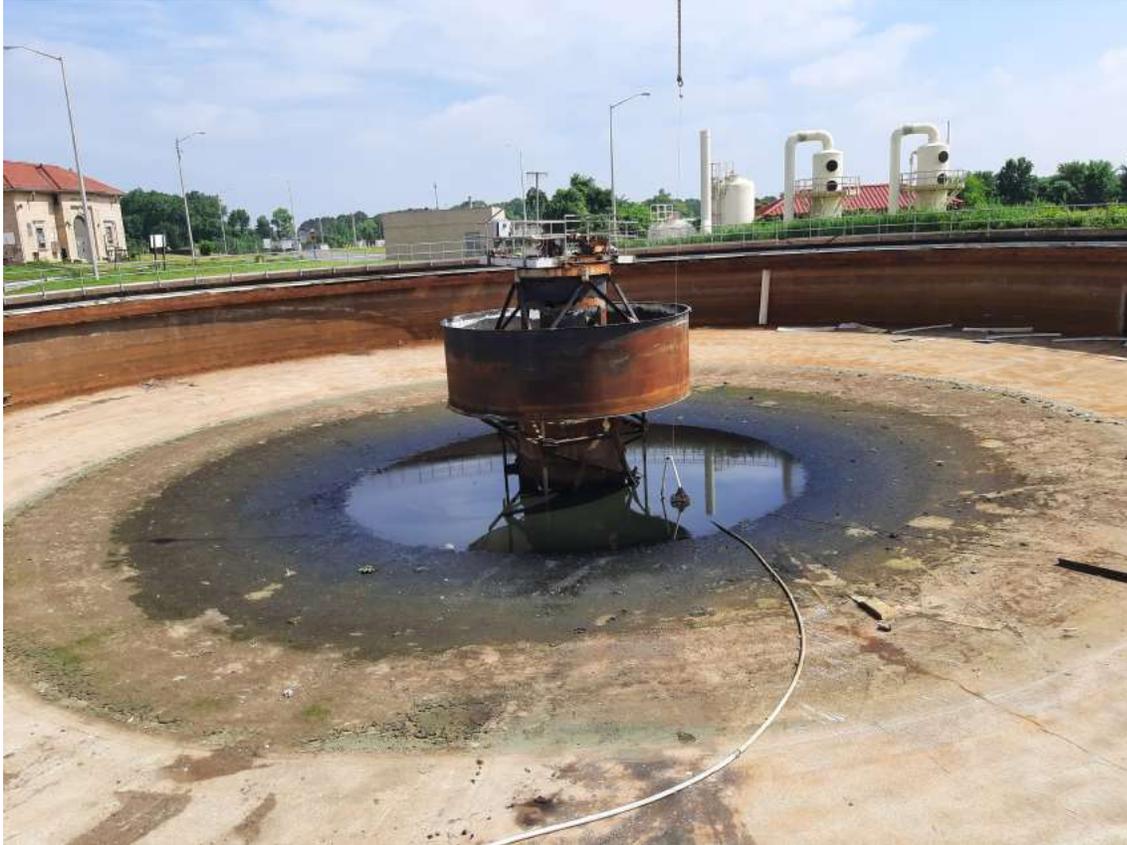
6/2/22 PST recently cleaned. There was no identifying number for this PST and McEachern was unsure as to the identity of this PST. No one was available for assistance.

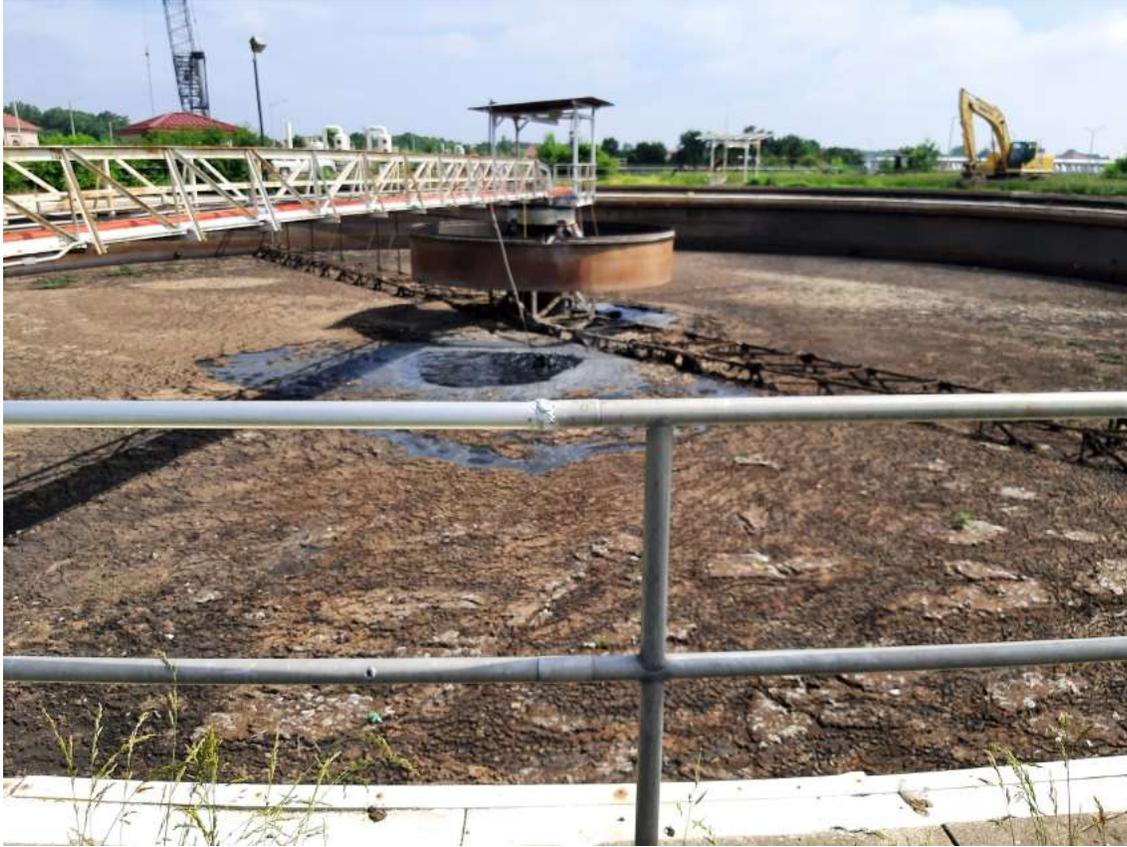
6/2/22 Nonfunctioning PST #1 being drained

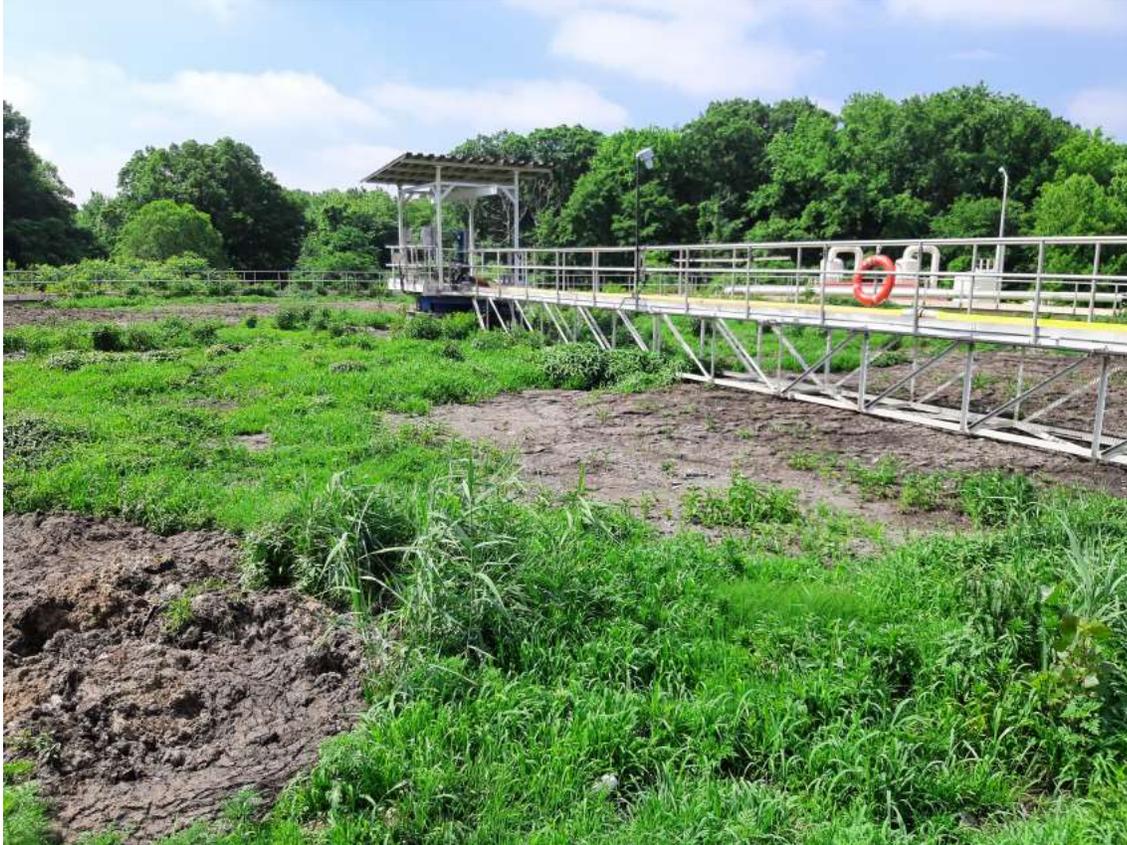
6/2/22 PST #6 Nonfunctioning PST filled with solids and vegetation

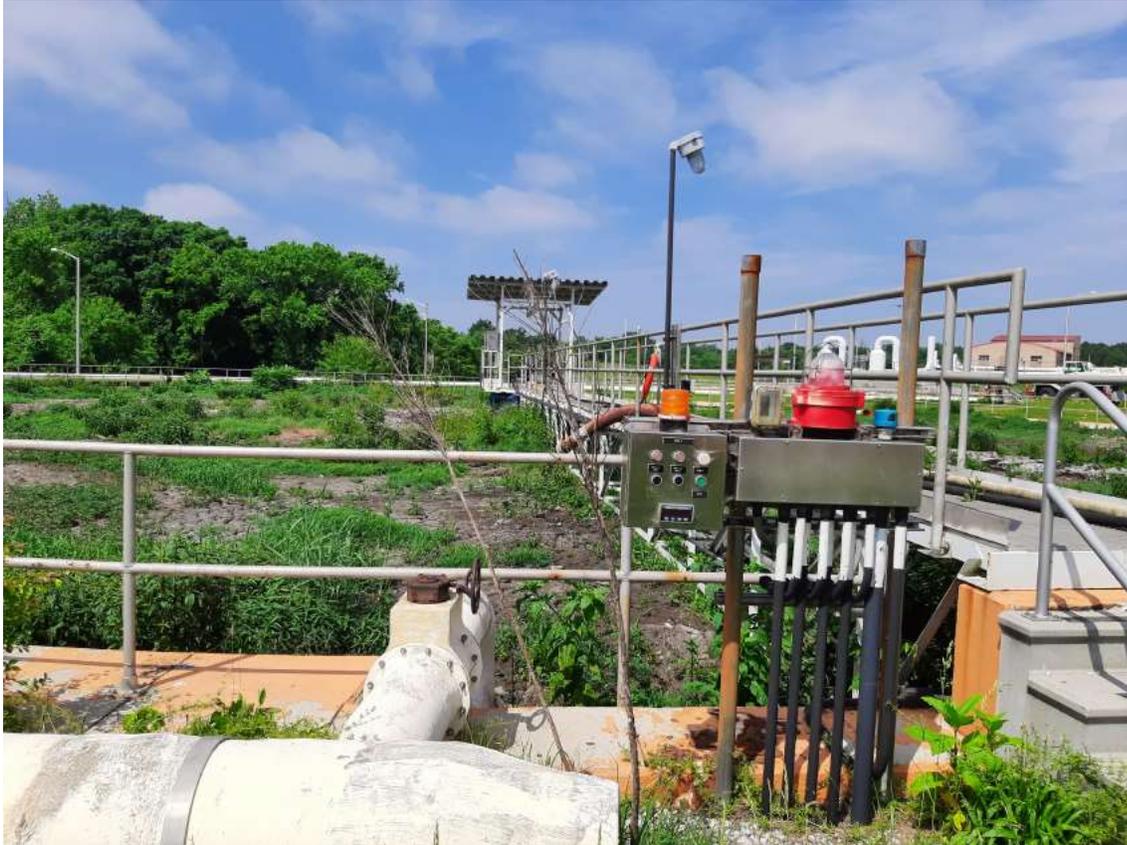
6/2/22 PST #5 Nonfunctioning PST filled with vegetation

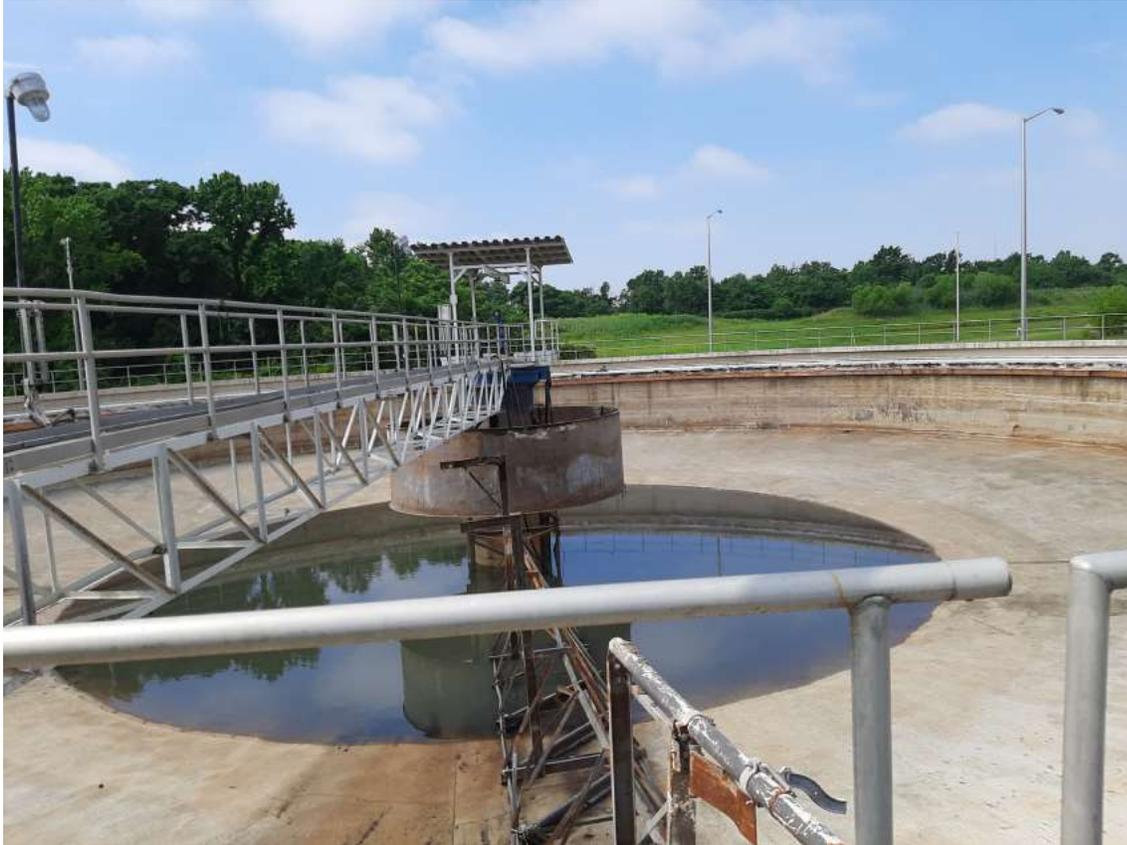
6/2/22 PST #7 was recently cleaned by the Maryland Environmental Service (MES) contractors. This PST is scheduled to be online by August 2022.

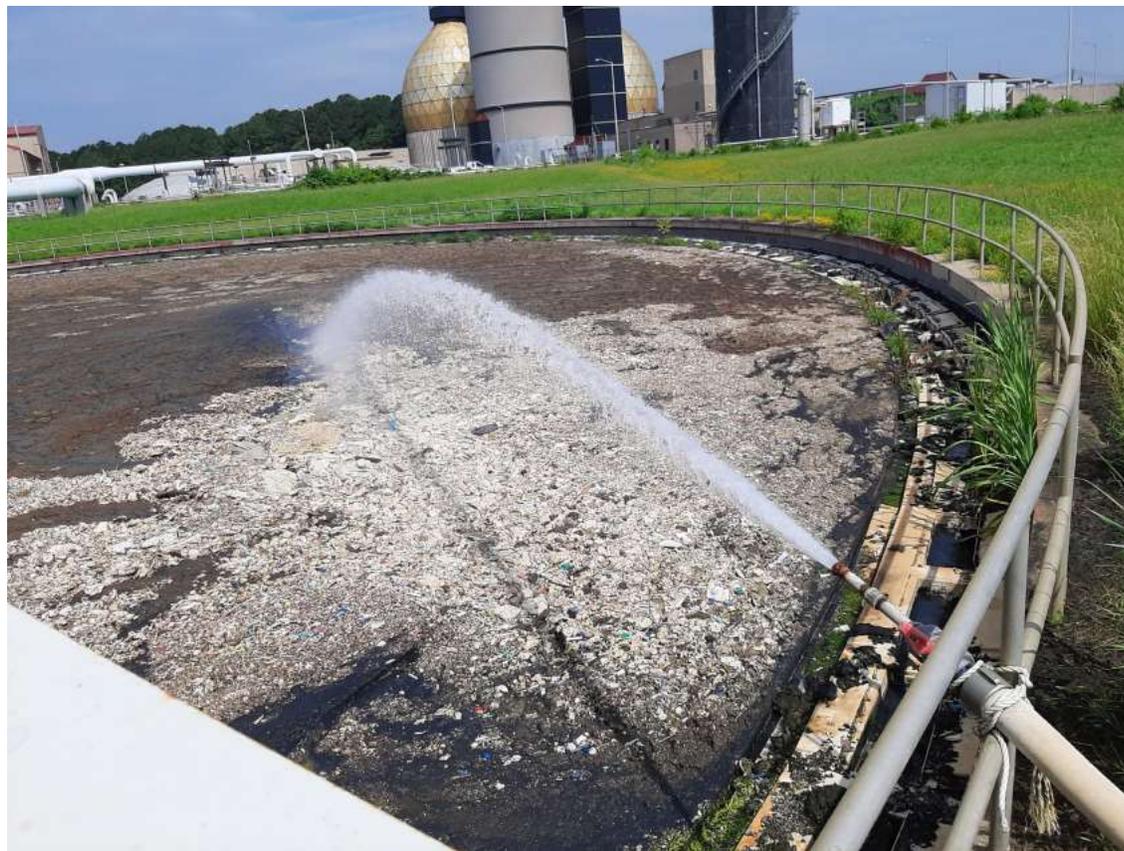
6/2/22 PST with no identifying number, however according to McEachern, this is PST #2
The solids are being broken up with water spray.

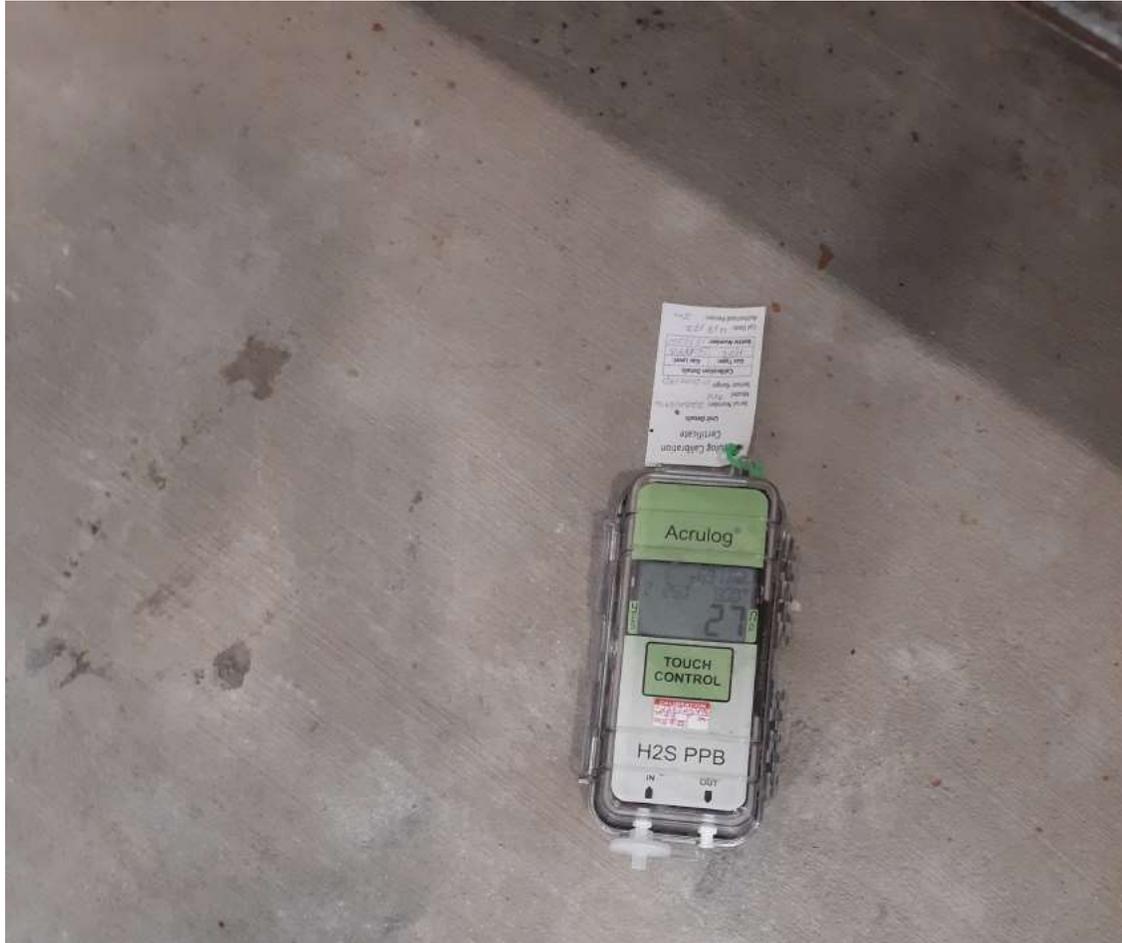
In early 2022, there were ventilation problems identified in the headworks building causing a buildup of hydrogen sulfide (H₂S). The ambient concentration of H₂S led to corrosion of certain circuits within the headworks building. During my discussion with Bendolph, I was told that the ventilation filter system had become clogged with filter particles preventing the removal of H₂S. Now the filters are changed every 3 months and the H₂S monitors were moved to different

6/2/22 H2S monitor in the headworks building

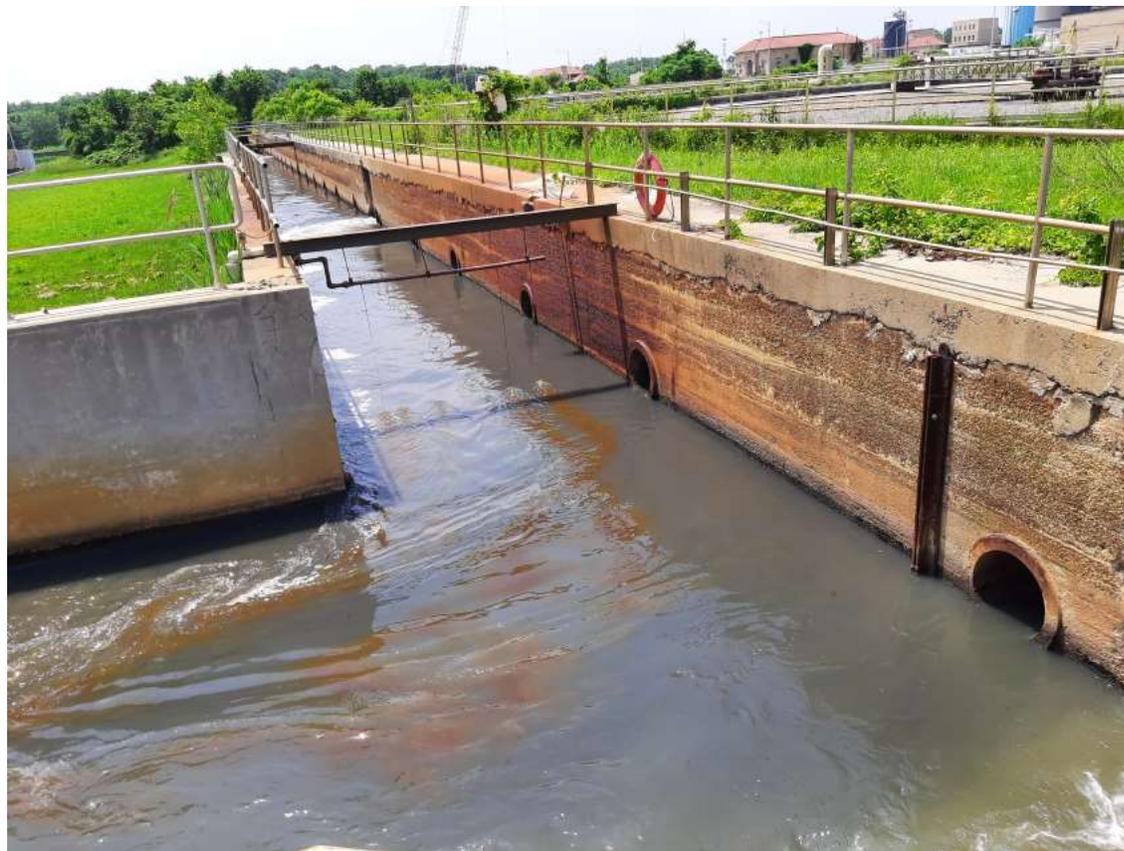
The wastewater traveling in the channels from the PSTs to the activated sludge plants was a dark gray color indicating a high concentration of solids in the waste stream.

6/2/22 Effluent from the PSTs flowing to the first stage of biological treatment, activator plants 2, 3, and 4, The effluent had a medium gray color. Brown color due to ferric chloride addition for phosphorus removal.

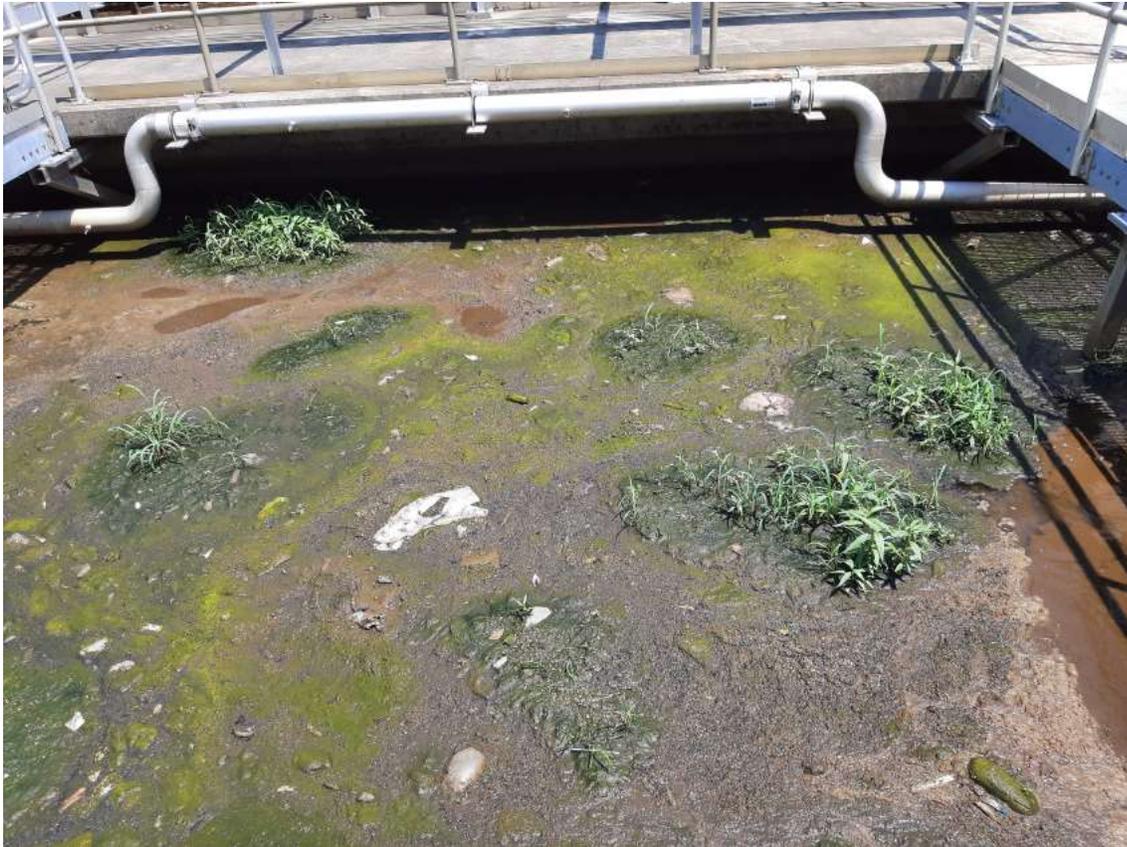
6/2/22 Heavy layer of solids and vegetation preventing proper operation of the reactor

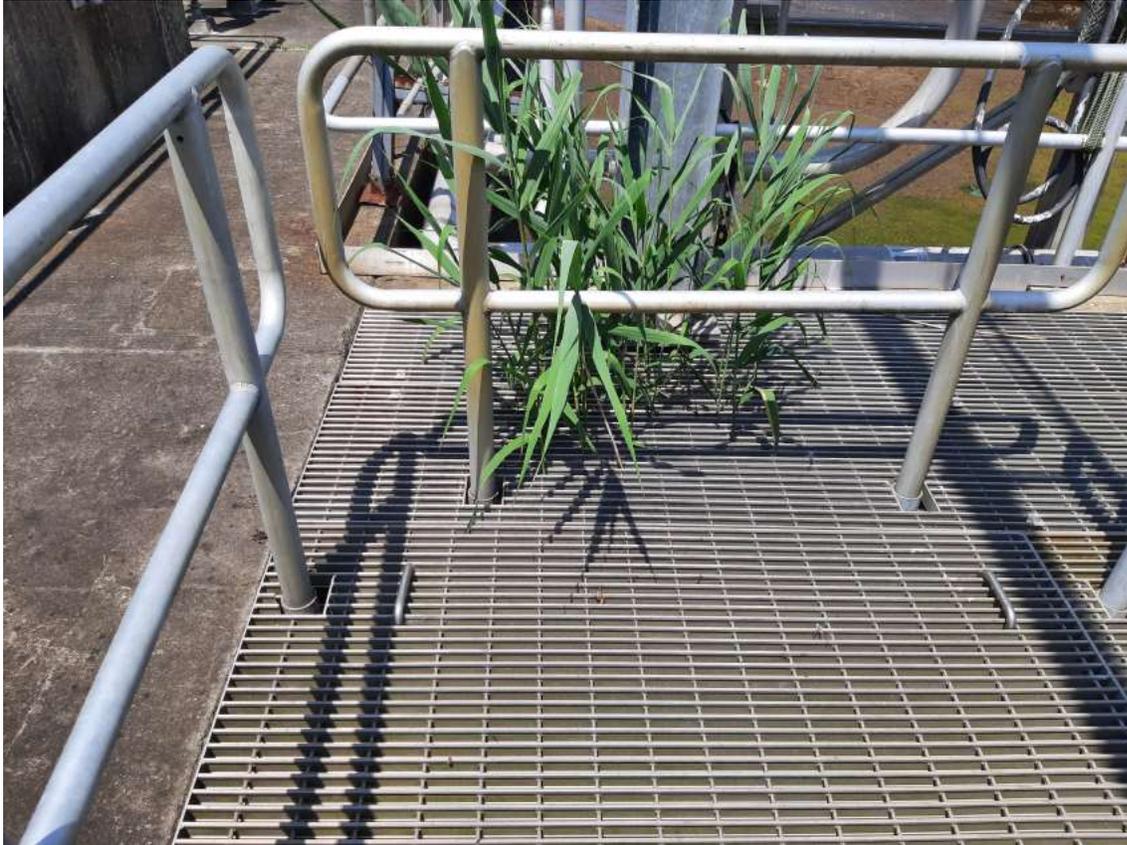
6/2/22 Reed grass coming up through grating above a reactor basin.

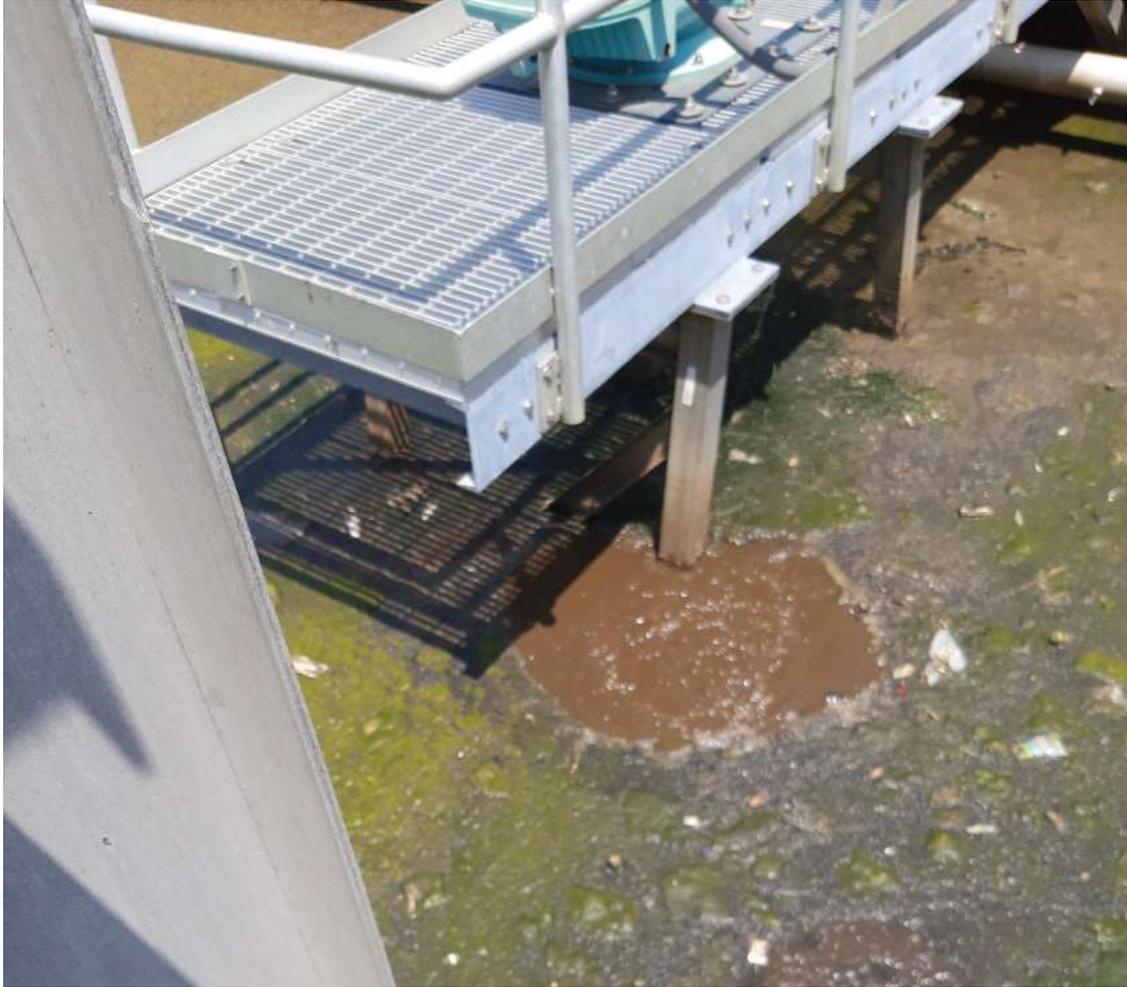
1. Some of the mixers were either not functioning or barely turning causing a buildup of floating solids. Mixing raises the dissolved oxygen (DO), and increases the activity of the microorganisms and keeps the organic materials thoroughly mixed within the reactors improving efficiency.
2. The DO monitoring equipment used to continuously monitor the DO were not functional, so the DO is being measured manually.
3. Vegetation growing in certain areas of the reactors due to high solids levels.

6/2/22 Mixer in reactor barely turning. Note accumulation of solids due to poorly functioning equipment.

- E. With respect to item #5 above, within 15 days of the receipt of this report, the Back River WWTP shall submit to the Department a status report on the condition of all nonfunctioning mixers and a schedule of when the repairs necessary to make each mixer functional will be completed.

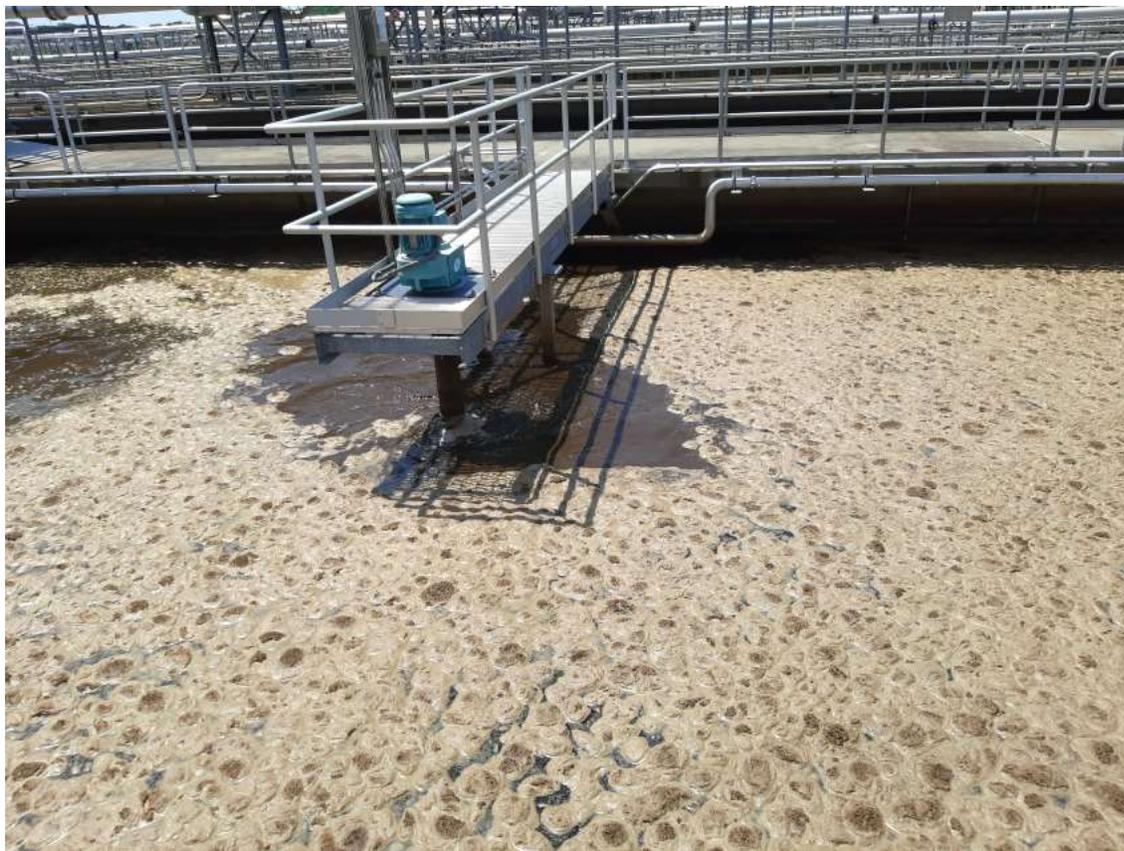
6/2/22 Mixer not functioning in biological reactor. The mixers keep the organic materials thoroughly mixed within the reactors improving efficiency.

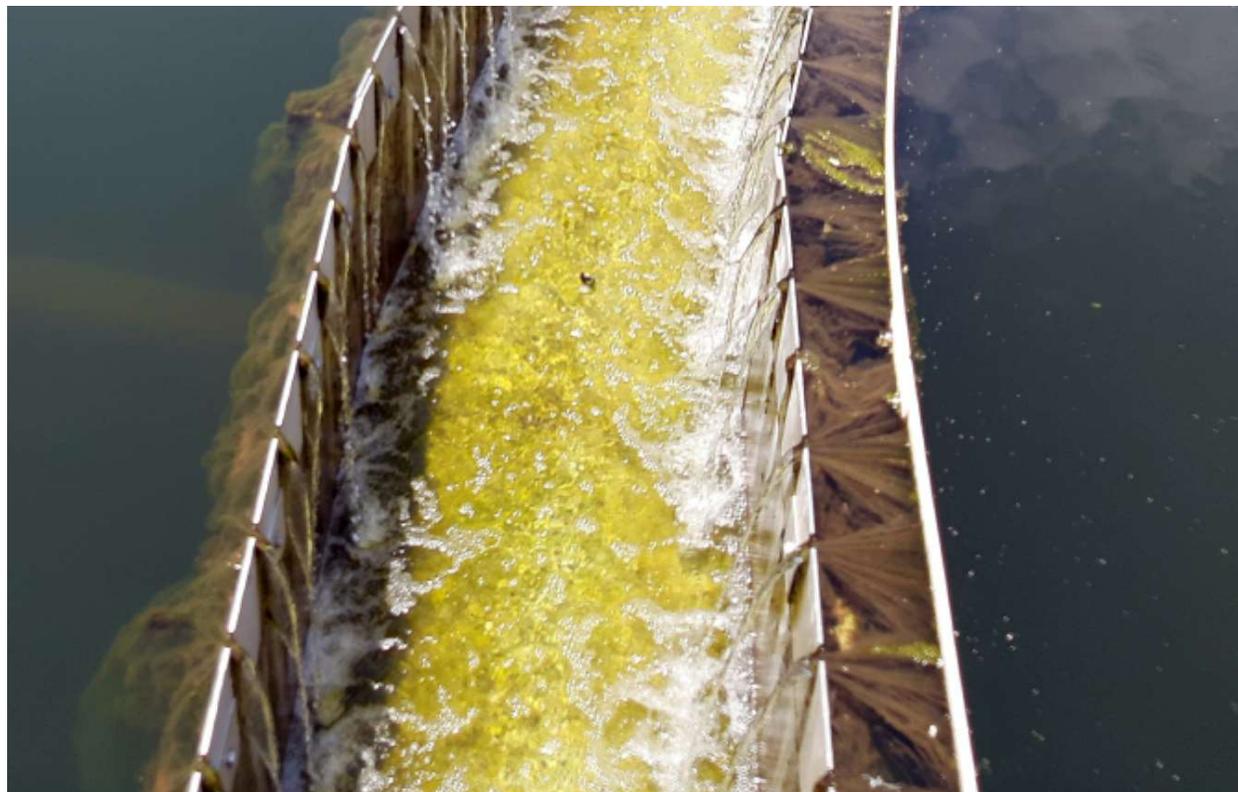
During an inspection of the associated secondary clarifiers for Activator Plant #4, I observed that algae was growing on the weirs of the clarifiers. According to Garriss, Baltimore City is not responsible for maintaining these clarifiers. She told me that the city has a contract with Prostart to manage Activator Plant #4, and to contact Prostart.

6/2/22 Clarifier # 17B algae growing on the weirs

8. Unacceptable algae and vegetation growth was observed on the weirs of the secondary clarifiers that is causing the short circuiting of the system. This condition can impact total suspended solids in the waste stream being treated.
9. There are unacceptable accumulations of solids and vegetation in the bioreactors that are interfering with the biological process.
10. There are no quality assurance records for the DO test SM 4500 O G. Records as required by the approved method.
11. There are no quality assurance records for the Amperometric Procedure SM 4500 Cl D for TRC.

- G. With respect to item #7 above, the Back River WWTP shall order and replace the scum scraper flange on clarifier 16 B.
- H. With respect to item #8 above, the weirs on the secondary clarifiers shall be routinely inspected and scrubbed as necessary to prevent aggressive algae growth. All vegetation should be removed from the secondary clarifiers and routine maintenance shall be performed to prevent the recurrence of the problem. The Back River WWTP shall submit a progress report every 14 days detailing the status of the vegetation removal from the clarifiers.

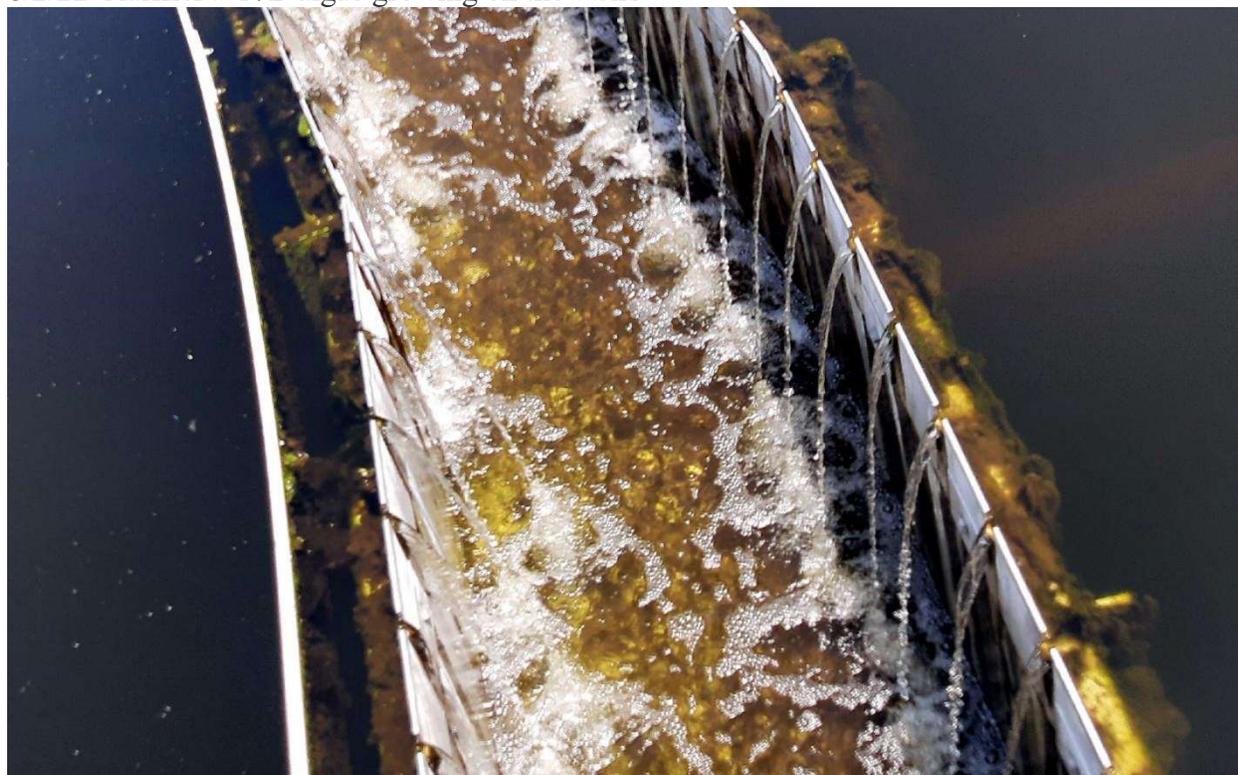
6/2/22 Clarifier 17 A algae growing on weirs

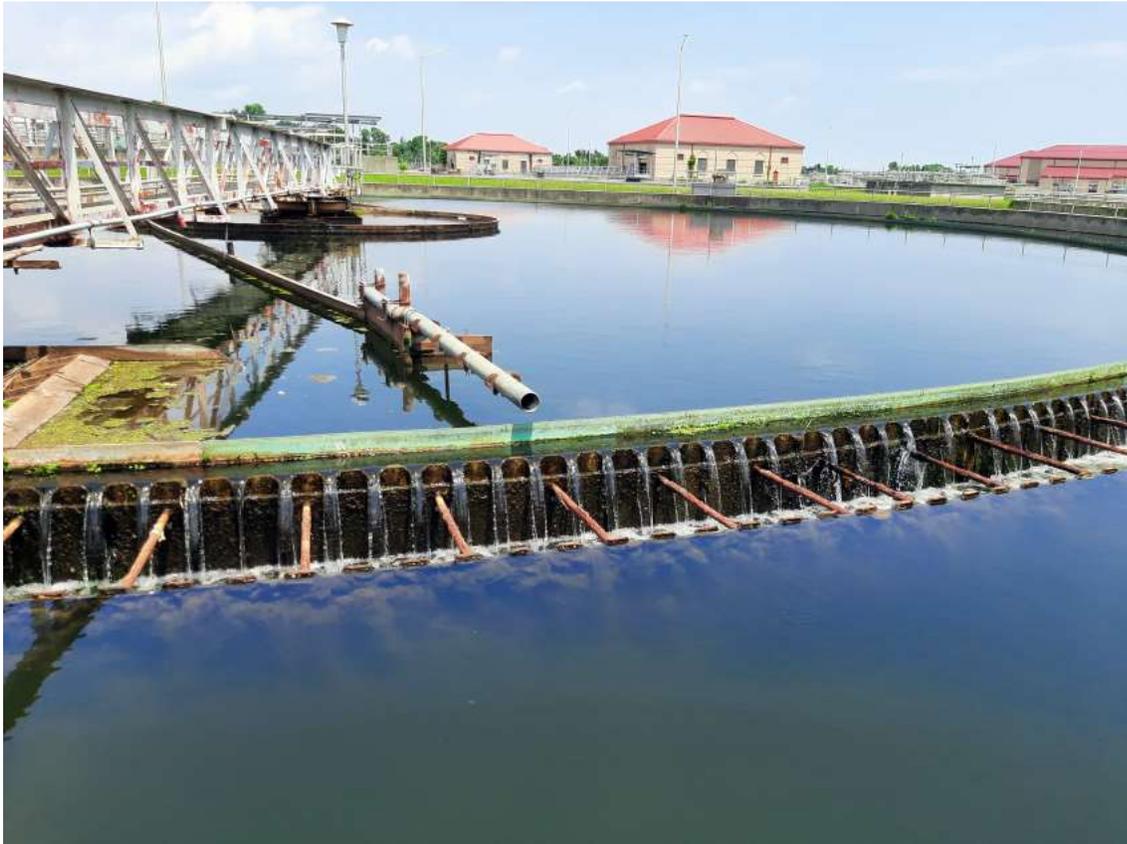
In addition, I observed that the scraper arm on secondary clarifier 16 B was broken. The scraper flange on the arm was missing so it was incapable of skimming for surface scum. The facility should have the arm repaired to get the clarifier back in operation.

6/2/22 Secondary clarifier 16 B missing scraper flange.

7. Secondary clarifier 16 B was missing the scum scraper flange.

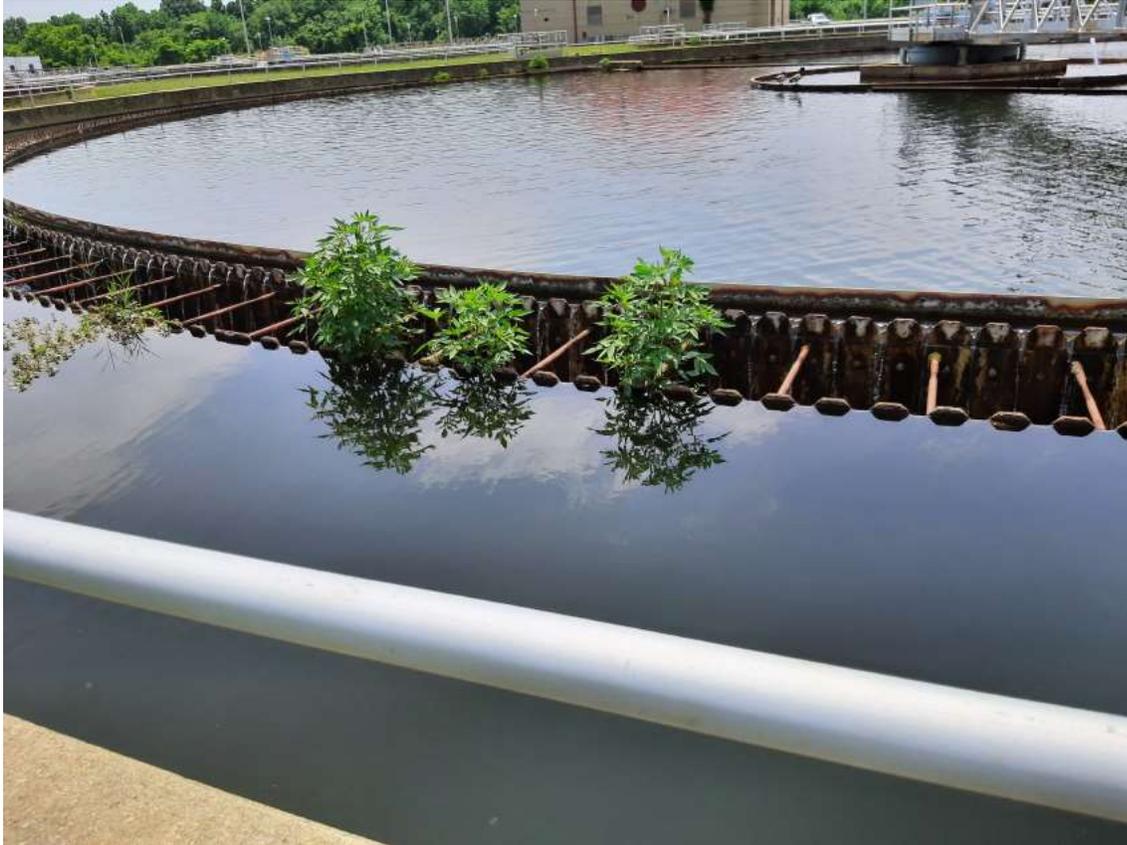
6/2/22 Vegetation growing in secondary clarifier 14A

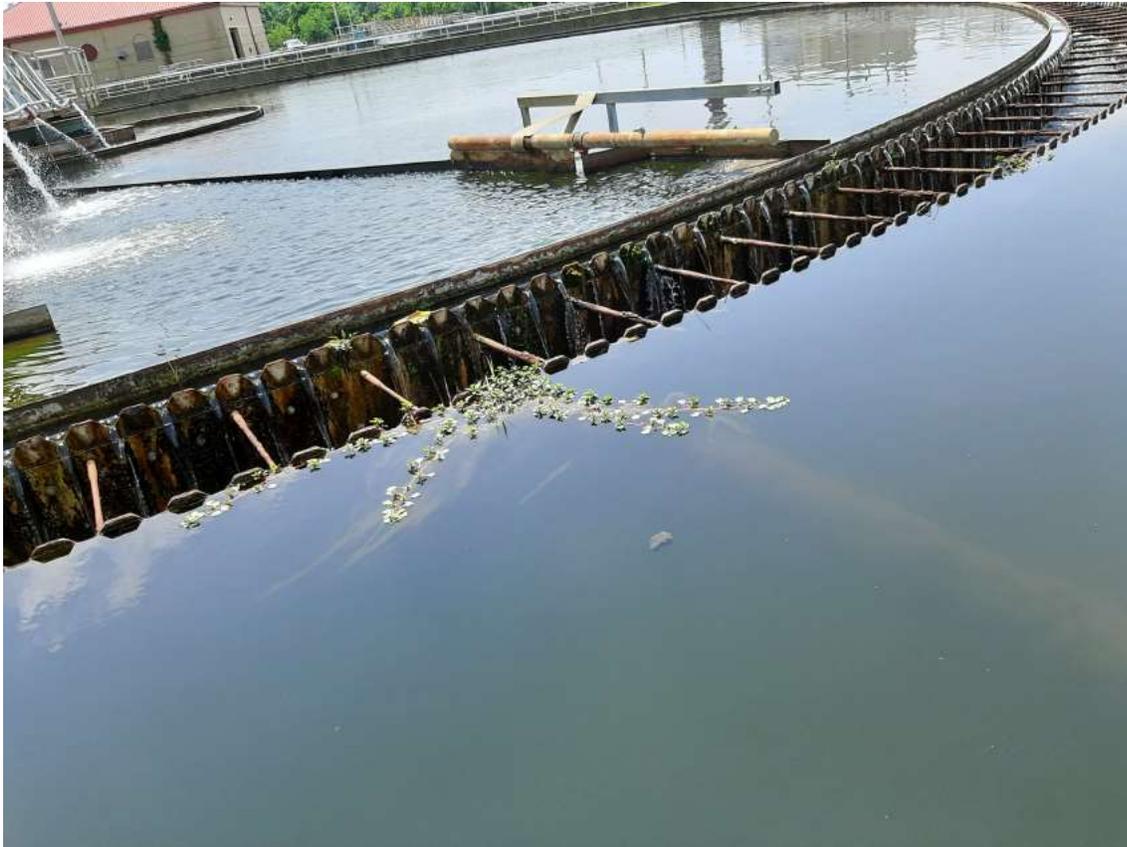
6/2/22 Vegetation growing in a secondary clarifier

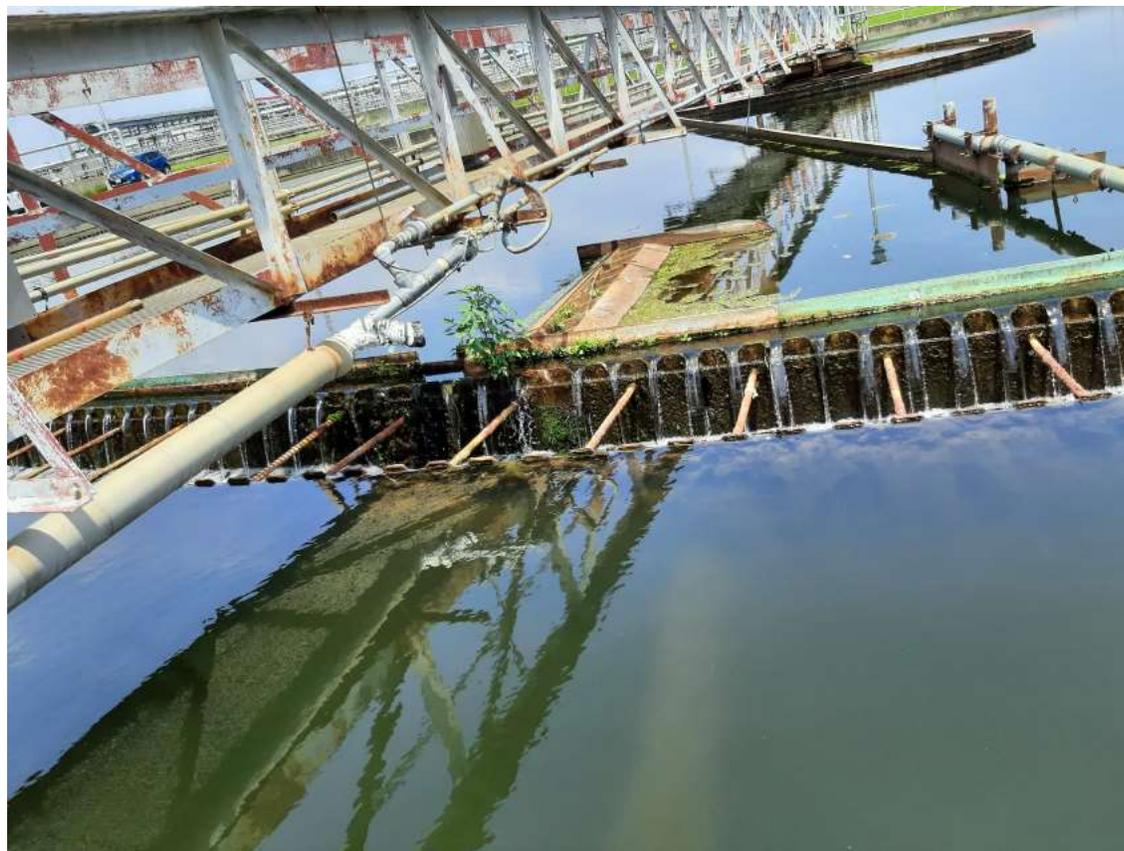
6/2/22 Vegetation in secondary clarifier 16 B

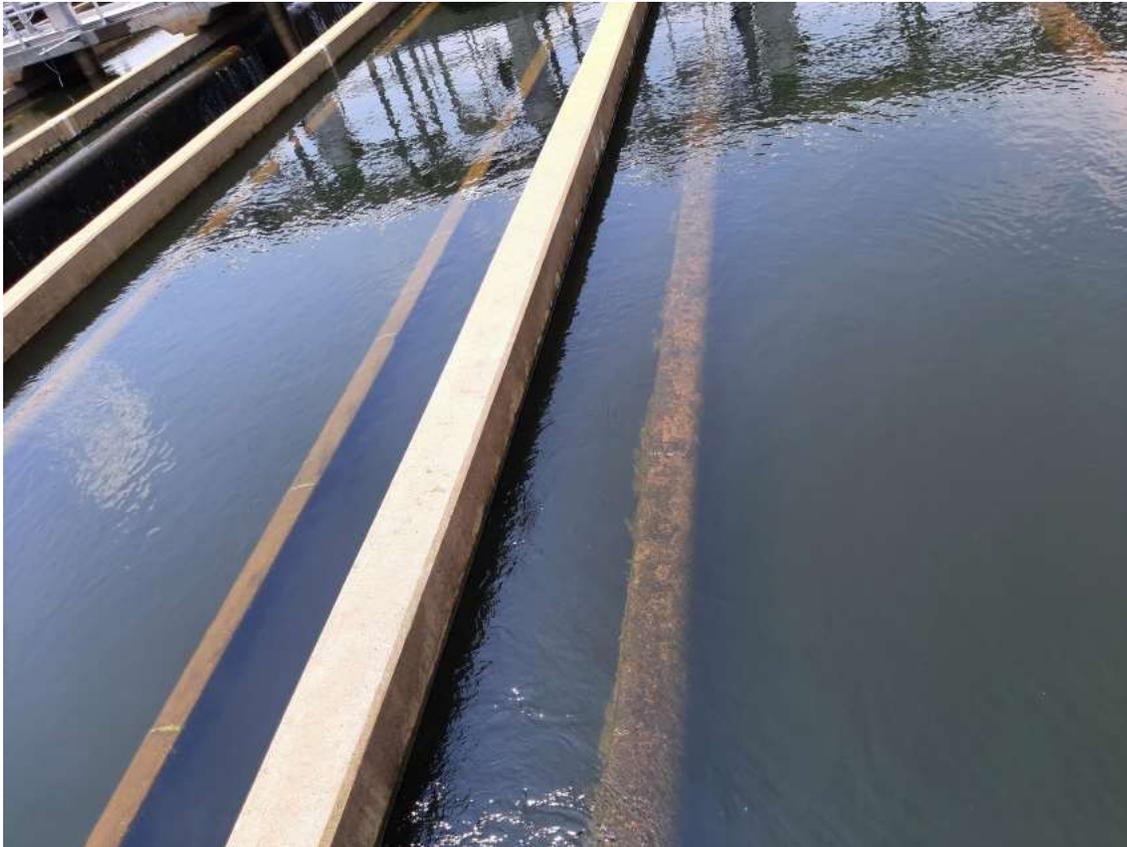
During an inspection of the DNF, I found that not all the filters were functioning as designed. Many of the filters were submerged under water due to clogging. Many of the filters had a floating layer of scum that appeared to be emulsified FOG that may be due to inadequate primary treatment. This oily scum will prevent functional operation of the filter and affect the efficiency of the filters. I found that 16 of the 52 filters were not functioning as designed. Some of the filters have been out of service for so long that the water in the filters have become septic. Several of the submerged filters had water flowing through and may have been showing as functional. However, a submerged filter should not be counted as operational. After inspecting the filters, I traveled back to the control room to speak with the Prostart operator, to obtain more information regarding the DNF, however I was not able to find him and no one else was available.

6/2/22 Submerged DNFs

- F. With respect to item #6 above, the Back River WWTP shall determine the cause of the problems with the out of service denitrification filters and make the necessary repairs. The problem with the clogged filters should be repaired so that the ENR treatment is not bypassed. Within 15 days of the receipt of this report, the permittee shall submit a status report to the Department detailing the status of all 52 DNF with a scheduled date for all maintenance and repair items.
