Maryland Department of Environment
Water and Science Administration
Compliance Program
1800 Washington Blvd, Suite 420
Baltimore, MD 21230-1719
410- 537-3510, 1-800-633-6101

Site Name: Back River WWTP
Facility Address: 8201 Eastern Ave, Baltimore, MD 21224
County: Baltimore County

Start Date/Time: June 02, 2022 09:18 AM
End Date /Time: June 08, 2022 05:28 PM

Permit / Approval Numbers: 15DP0581
NPDES Numbers: MD0021555
Inspection Reason: Follow-up (Non-Compliance)
Site Status: Active
Compliance Status: Noncompliance
Site Condition: Noncompliance
Recommended Action: Additional Investigation Required
Evidence Collected: Photos or Videos Taken, Record Review, Samples Taken
Delivery Method: Email
Weather: Clear Average

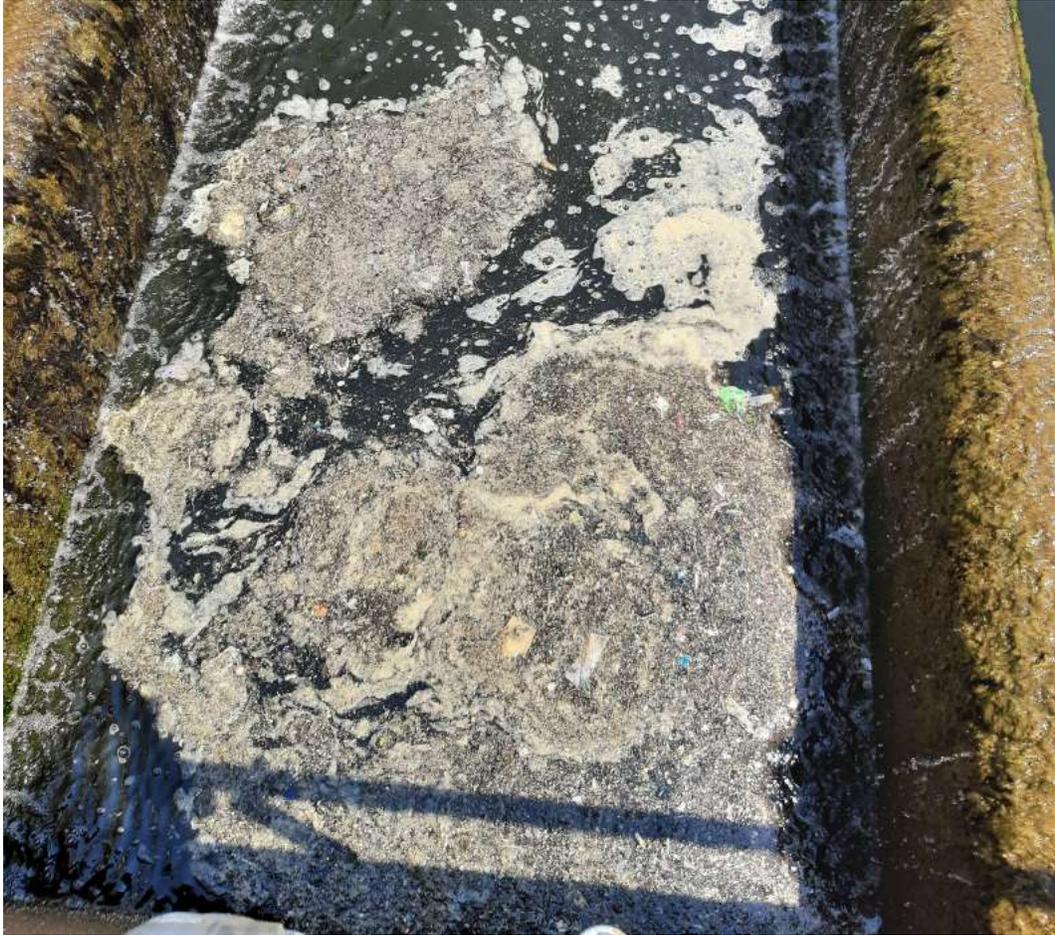
6/2/22 Floating scum and emulsified FOG in DNF

- F. With respect to item #6 above, the Back River WWTP shall determine the cause of the problems with the out of service denitrification filters and make the necessary repairs. The problem with the clogged filters should be repaired so that the ENR treatment is not bypassed. Within 15 days of the receipt of this report, the permittee shall submit a status report to the Department detailing the status of all 52 DNF with a scheduled date for all maintenance and repair items.

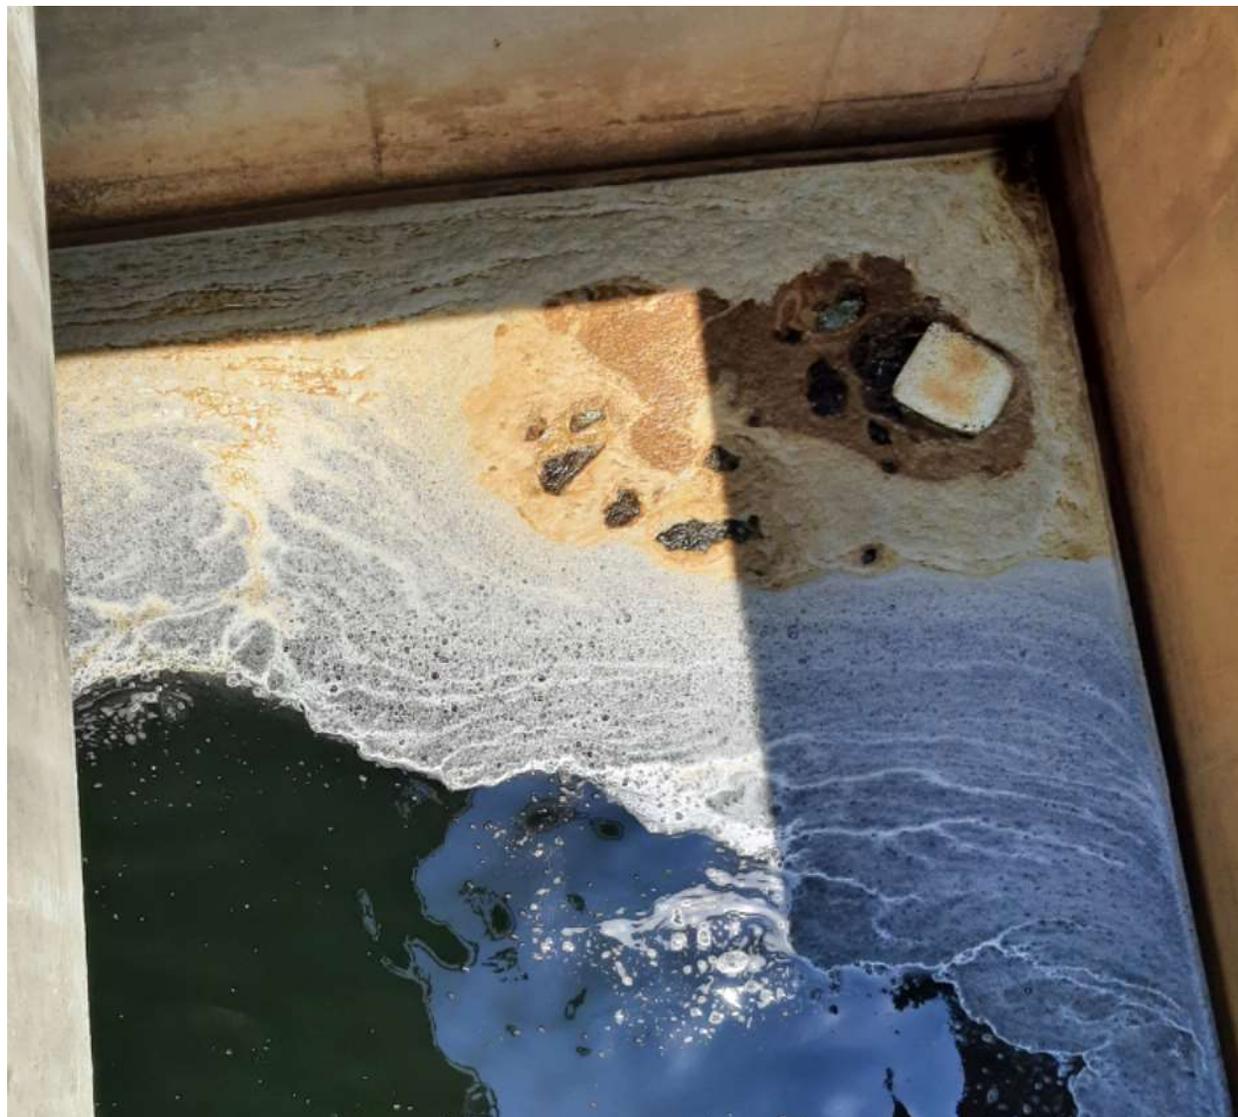
6/2/22 – Effluent from the DNF system. There is a layer of floating scum in one corner of the chamber
