**Maryland Department of Environment**  
**Water and Science Administration**  
**Compliance Program**  
**1800 Washington Blvd, Suite 420**  
**Baltimore, MD 21230-1719**  
**410- 537-3510, 1-800-633-6101**

**Site Name:** Back River WWTP  
**Facility Address:** 8201 Eastern Ave, Baltimore, MD 21224  
**County:** Baltimore County

**Permit / Approval Numbers:** 15DP0581  
**NPDES Numbers:** MD0021555  
**Inspection Reason:** Follow-up (Non-Compliance)  
**Site Status:** Active  
**Compliance Status:** Noncompliance  
**Site Condition:** Noncompliance  
**Recommended Action:** Refer to Others (See Findings)  
**Evidence Collected:** Photos or Videos Taken, Visual Observation  
**Delivery Method:** Email  
**Weather:** Dry Average

### **Inspection Findings:**

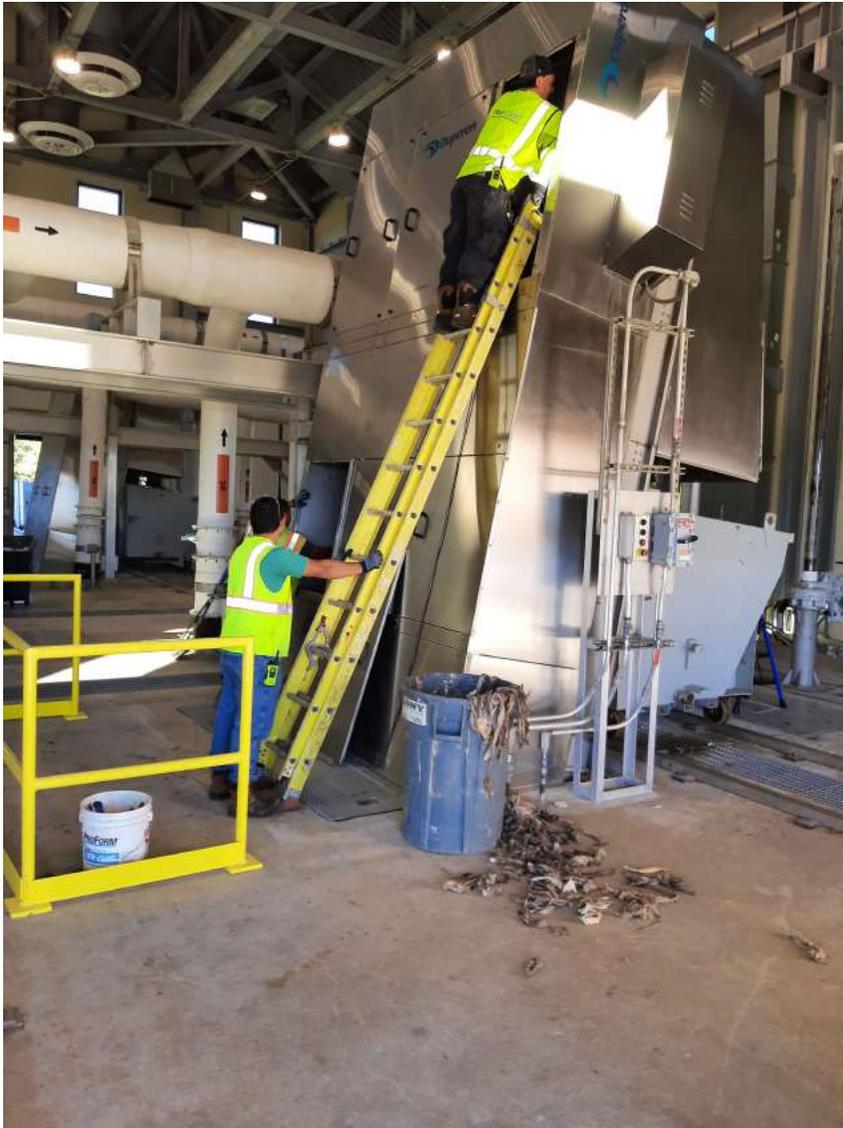
Sewage enters the plant at the mechanical screen building where there are four coarse screening units. There was one unit in service during this inspection. According to the ProStart operator, only one coarse screening unit is needed for the current flow. The coarse screened sewage flows from the coarse screens to the deep wet wells. There are two deep wet wells that are over 50 feet deep that receive wastewater from the Coarse Screening units. Wastewater travels from the deep wet wells through suction pipes that draw water into the Headworks Influent Pumping Station. The influent headworks pump station has eight lift pumps. The lift pumps are used to pump the screened sewage from the wet wells to the fine screening system. During this inspection, two of the lift pumps were being used. **During an inspection of the coarse screen system, I inspected the inside of the functioning unit where I observed that there was an excessive amount of rags and trash coiled around the racks.** According to the ProStart operator, the cutter was not functioning, and the coarse screening units have not been cleaned since the last rain event. He further stated that each coarse screen has a 2000 lb. weight capacity and once that weight is reached, the unit trips off and another coarse screen unit will come on. The coarse screens should be routinely cleaned and as soon as possible after rain events. The screening equipment should be properly maintained and repaired to protect the downstream equipment by capturing and removing floating debris. Routine maintenance can dramatically improve water and wastewater treatment plant system processes while preventing and minimizing potential problems with clogging and other maintenance issues downstream due to trash and debris. Before I left the area, I observed that the rags were being removed from the coarse screening units. The Back River WWTP should ensure that the coarse screens are maintained satisfactorily and repaired as required.

9/27/22 The coarse screening units are being cleaned during the inspection.

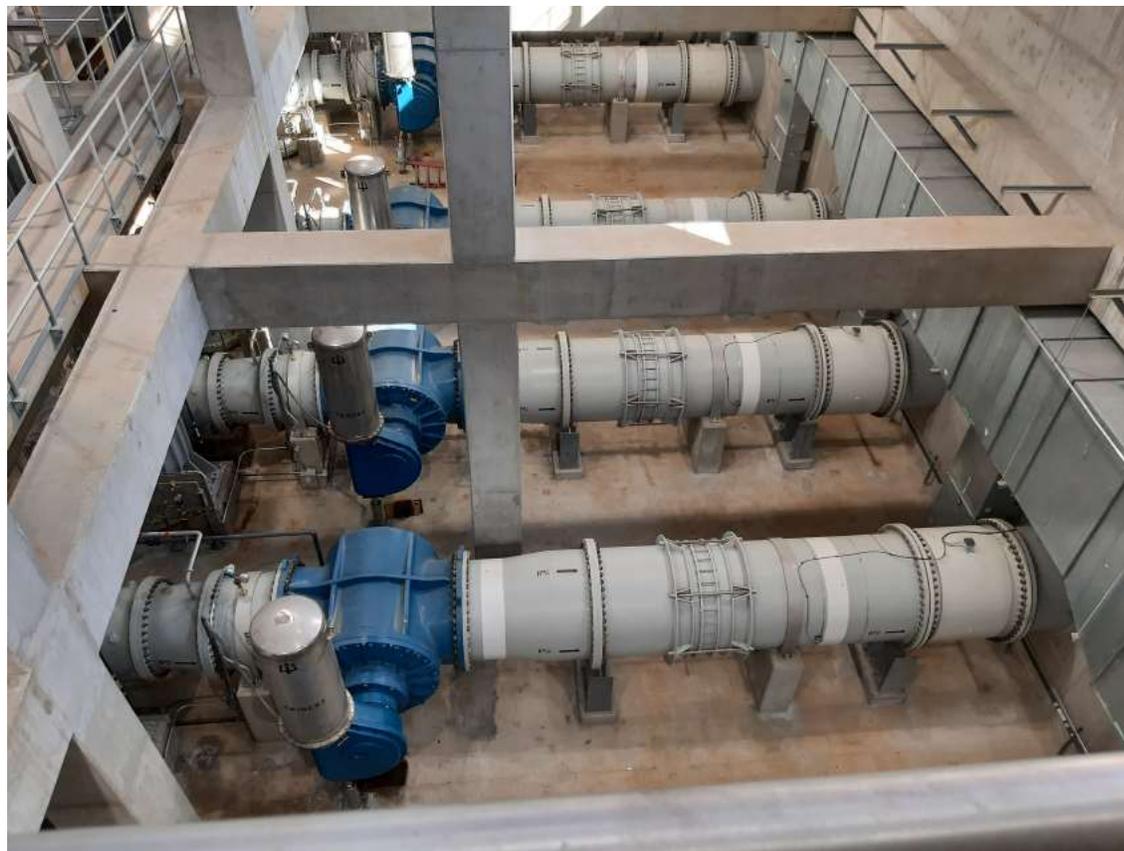
9/27/22 Picture shows Pumps #1-4. Today, 2 were being used for the headworks operation. Pumps #1- #4 have pumping capacities of 100 MGD each and pumps #5 - #8 (not shown) have pumping capacities of 120 MGD each.

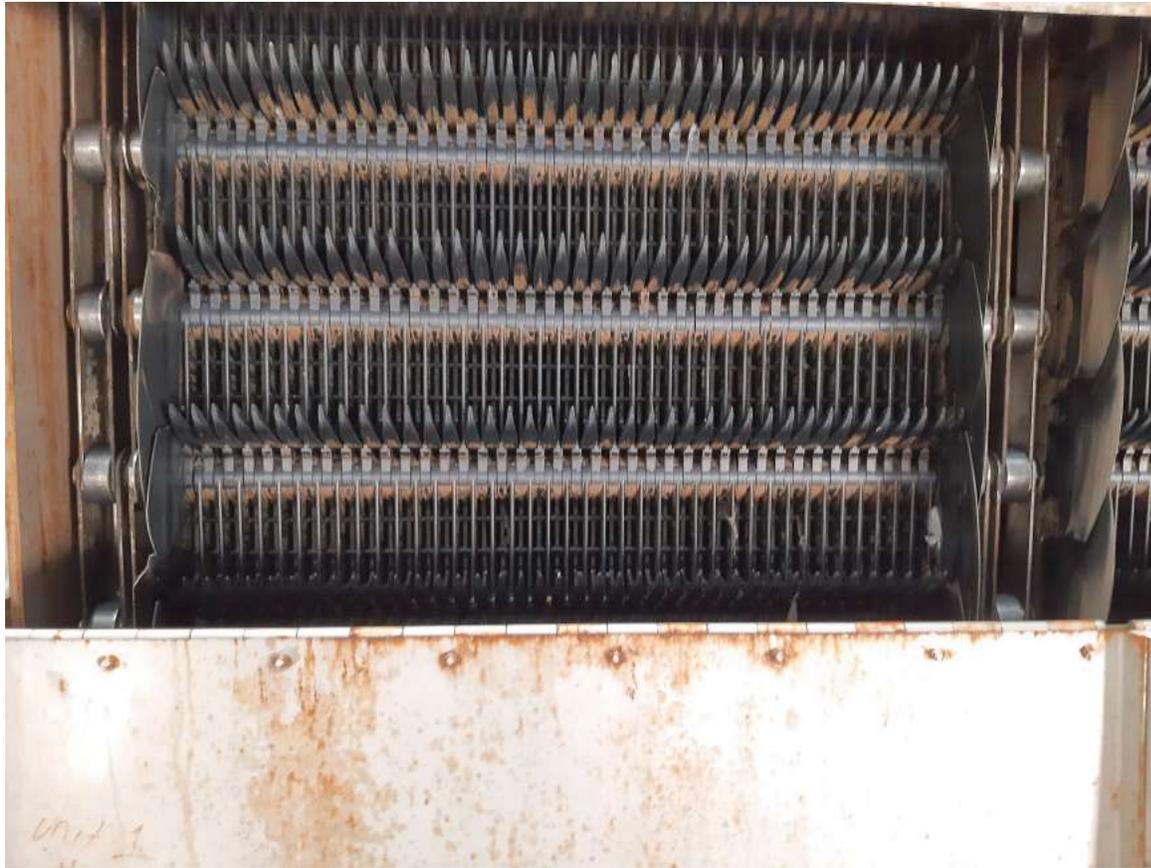
The headworks is equipped with six fine screening units with a processing flow rate of up to 100 MGD. During this inspection, all six units were online, but I noticed that the fine screening unit that I was inspecting was not operating. According to the ProStart operator, the operation of the fine screening unit is based on the differential pressure. Once the flow rate increased, the unit would come back online. After checking the other units, I found that none of the six fine screening units were receiving flow. According to the operator, the fine screening units are triggered to come on based on the water level in the influent channel. An infrared water level detector tracks the water level, and the fine screens operation is triggered on and off by the water level in the channel. The fine screened sewage then travels to the grit removal system.

8/27/22 Fine screening unit.

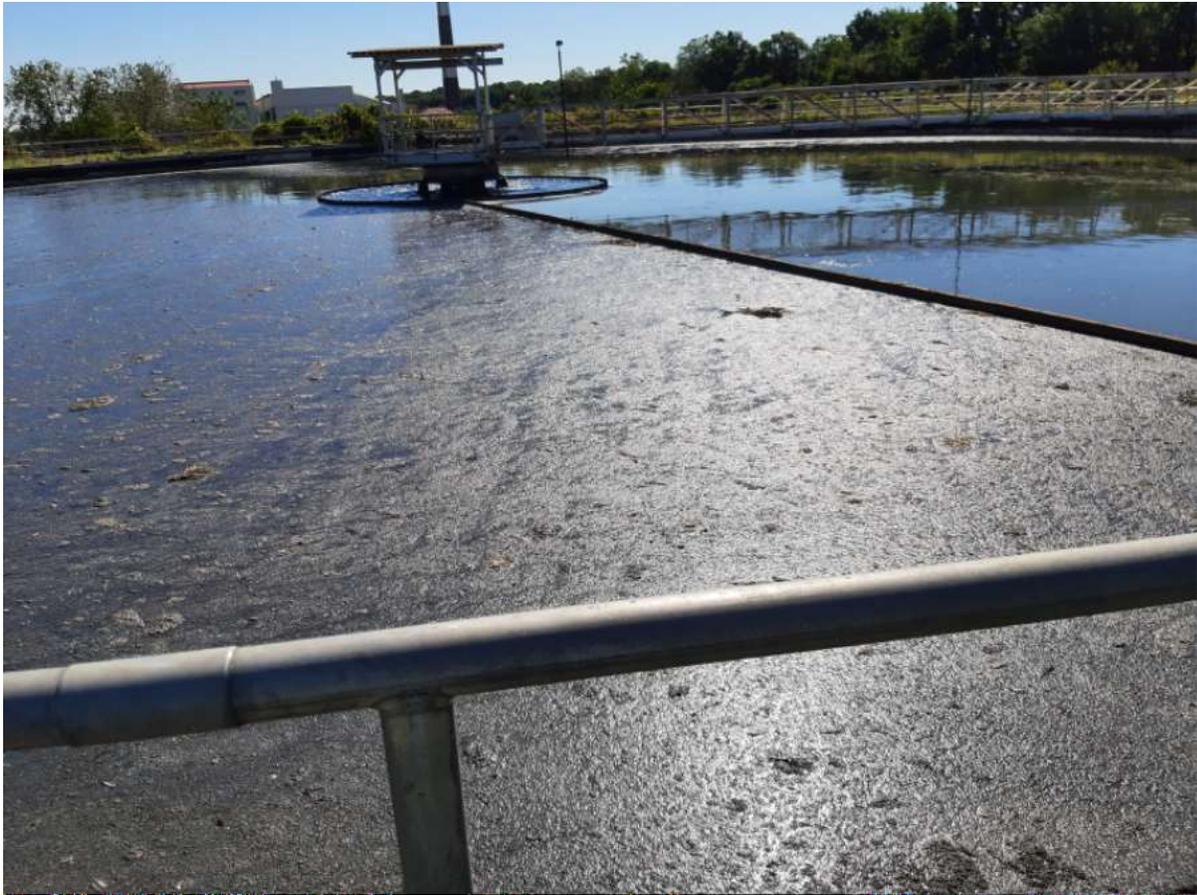
During the inspection of PST #1, I observed that the sludge blanket appeared to be higher than observed during the last evaluation in August. There was a floating layer of sludge that had come up from the bottom of the tank. Generally, this condition can occur when there are anoxic conditions in the water due to overaged sludge causing the solids from the bottom to rise to the surface. I also observed solids discharging over the weir and flowing to the next treatment stage.

According to Payton, rainstorms since my last inspection caused the excess solids in the PST #1, which in turn caused the high sludge blanket and the high sludge blanket caused the skimmer arm to start torquing. The PST was shut down for a short period while the skimmer arm was being repaired.

9/27/22 PST #1; Note: floating solids and scum.

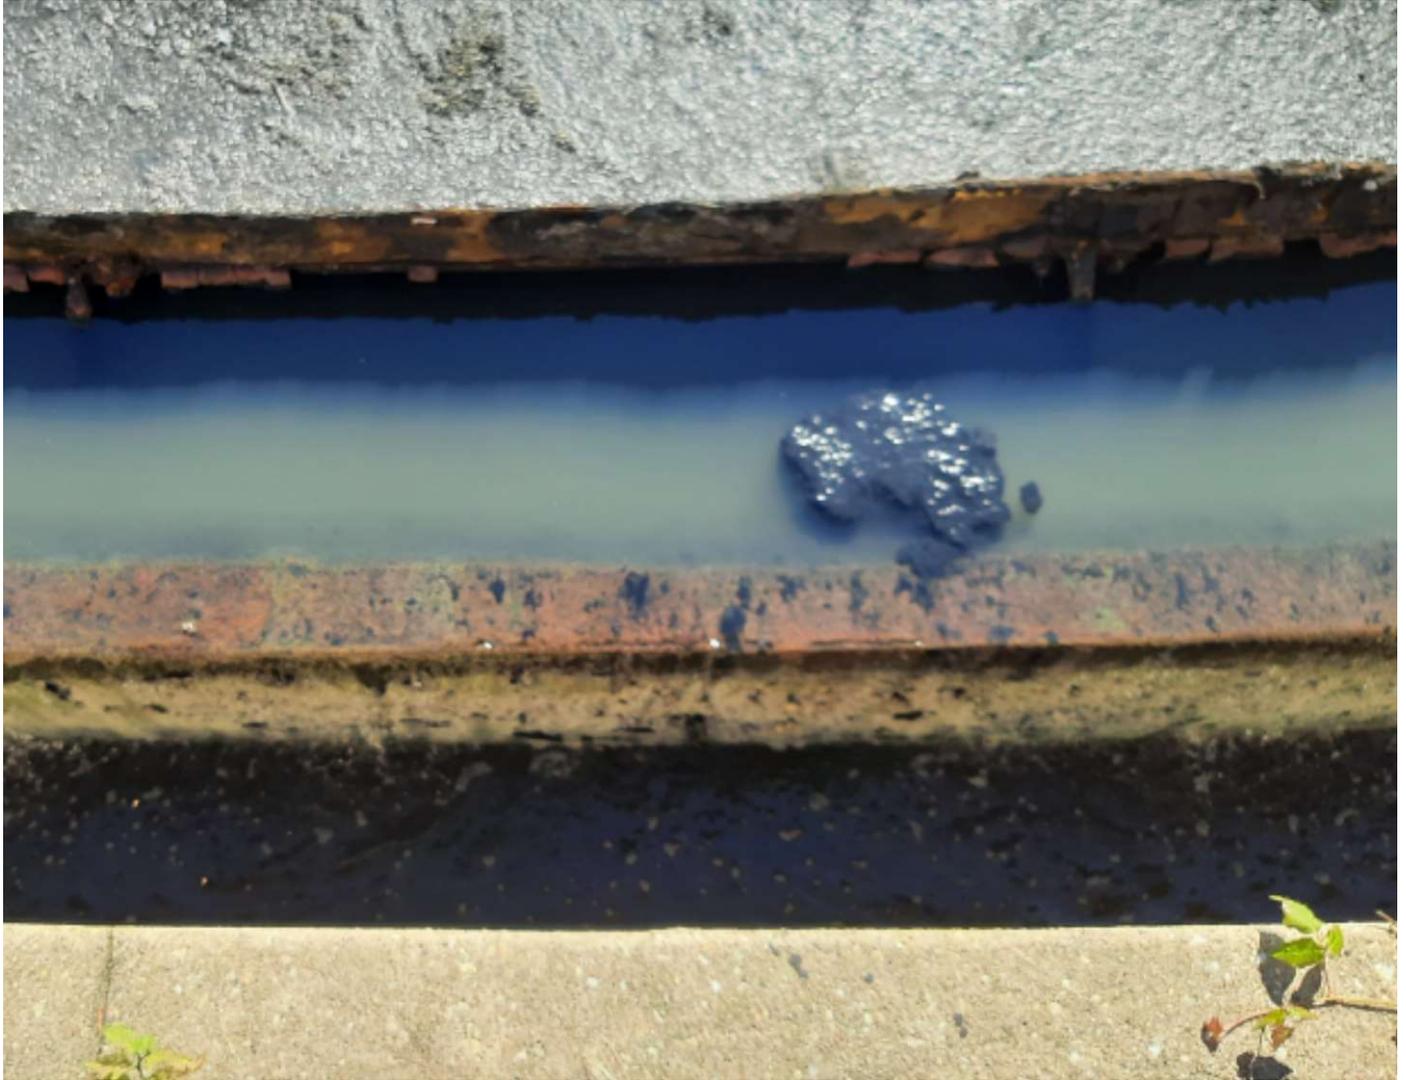
9/27/22 PST #1; Note: Floating solids flowing into the main channel to the next treatment process.

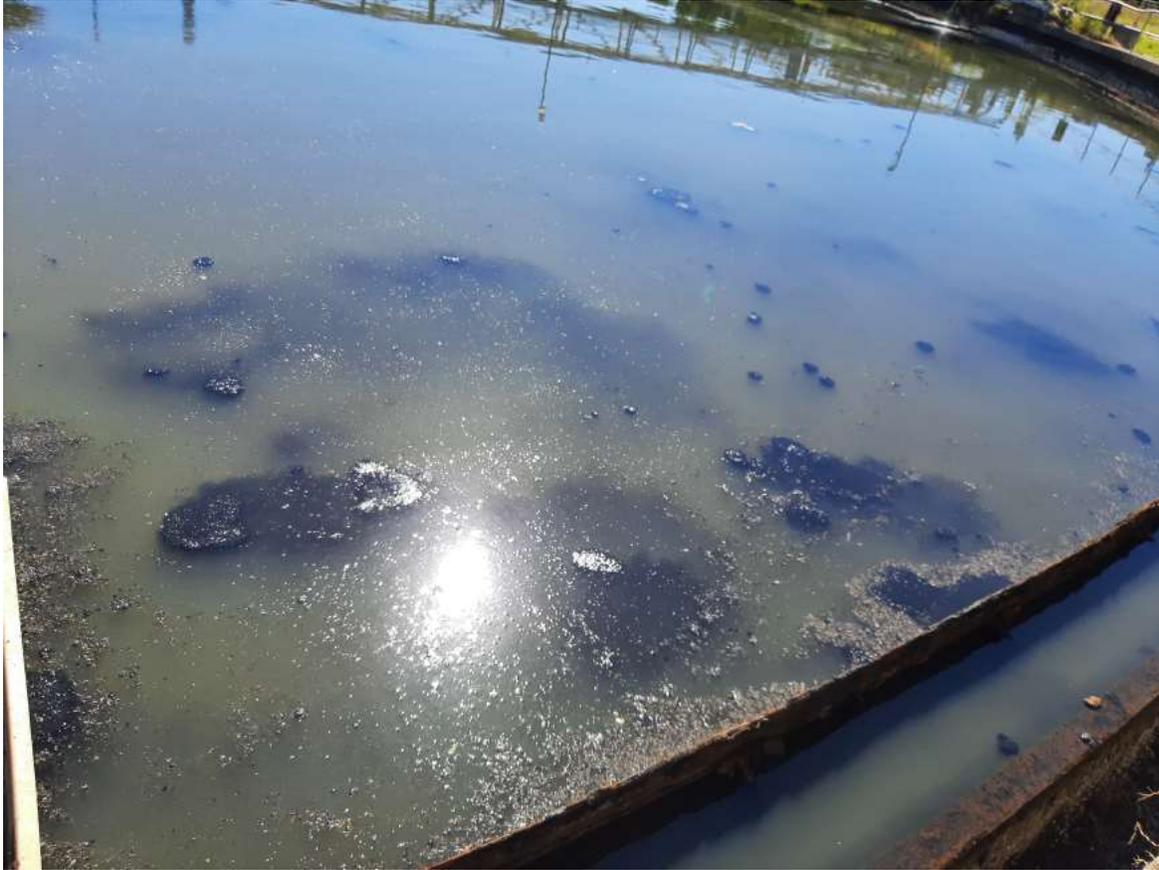
9/27/22 PST #1 floating solids.

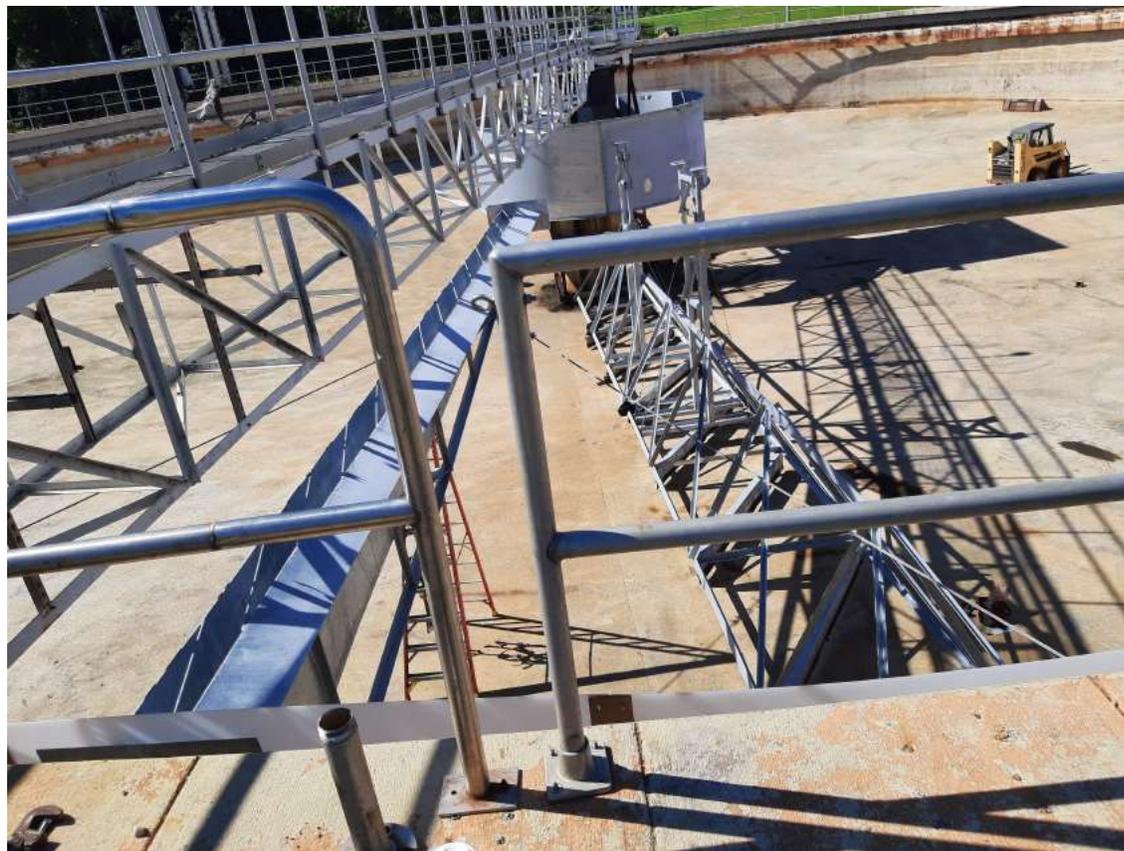
9/27/22 PST #7, skimmer arm being fabricated. Scheduled to be online in mid-November 2022.

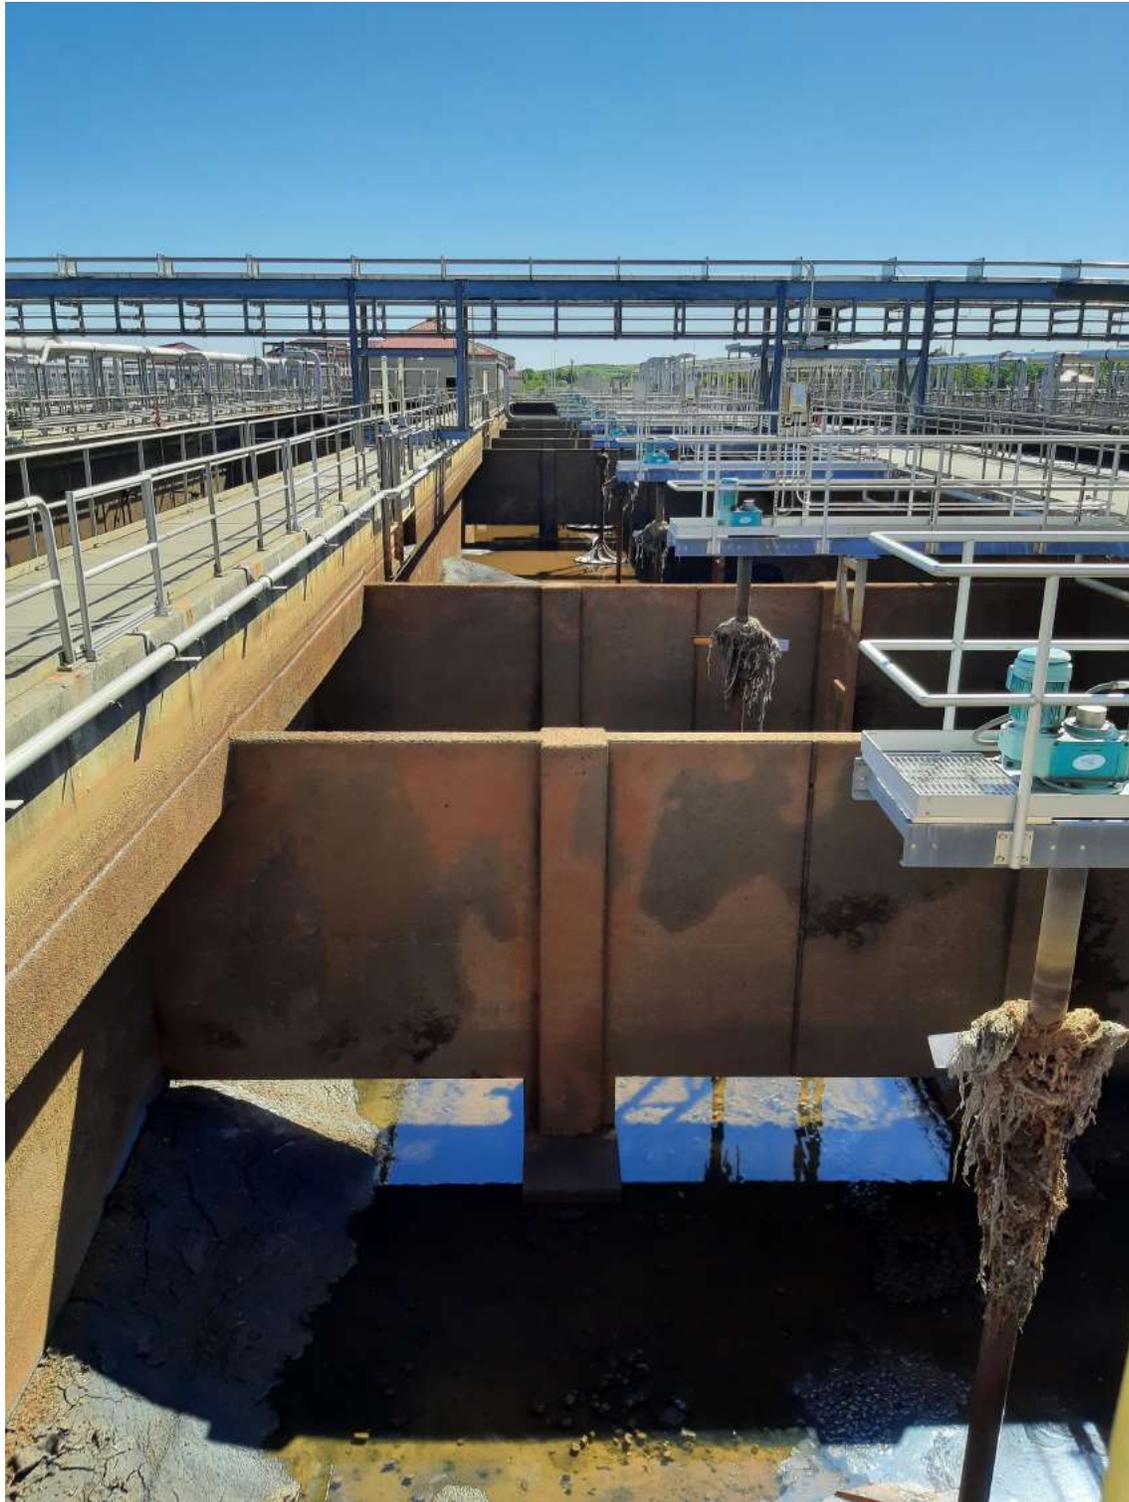
During the next phase of this evaluation, I inspected the Activated Sludge Plants #2 and #3. Reactor #6 was drained and offline for repairs. **The problems previously observed and reported are still an issue.** The reactor tanks require maintenance. Some of the mixers in the reactors were not functioning as designed due to rags being wound around the mixer shafts impeding operation and the many of the reactor basins need to be cleaned of solids. The computerized dissolved oxygen (DO) monitoring equipment, designed to continuously monitor the DO, is not functional.

9/27/22 Reactor #6: Rags were wound around the mixer shafts. This condition was observed with online reactors as well.

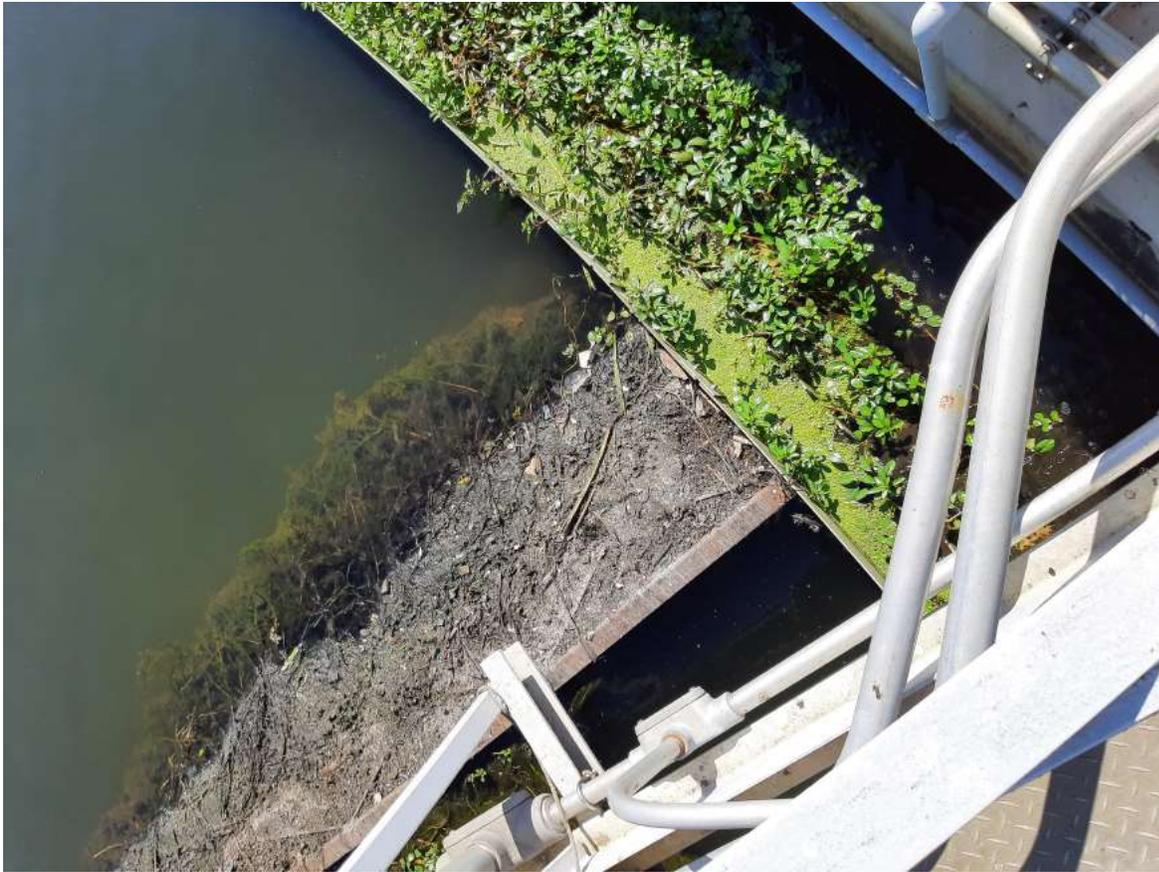
Secondary Clarifier #	Condition	In service during the inspection (Y or N)
7A	This clarifier cannot function as designed because of thick vegetation growing over the weirs and the opening to the scum collection trough is blocked by vegetation	Y
5A	This clarifier cannot function as designed because the opening to the scum collection trough is blocked	Y
16A	Not in service. Requires parts	N
14 A	The water level was lowered in order to clean the draft tube. Currently on standby until the service is completed.	N
10A	This clarifier cannot function as designed because there was algae, phragmites and other vegetation growing on the weirs and the opening to the scum collection trough is blocked	Y
8A	This clarifier cannot function as designed because the opening to the scum collection trough is blocked

9/27/22 Secondary clarifier #7A – Vegetation growing over the weirs and adjacent scum collection trough clogged with solids and submerged vegetation.

- E.** With respect to item #5 above, within 30 days of the receipt of this report, the Back River WWTP shall repair the skimmer arms on the secondary clarifiers and pump out the scum troughs on the secondary clarifiers. The Back River WWTP shall notify the Department once these tasks have been completed.

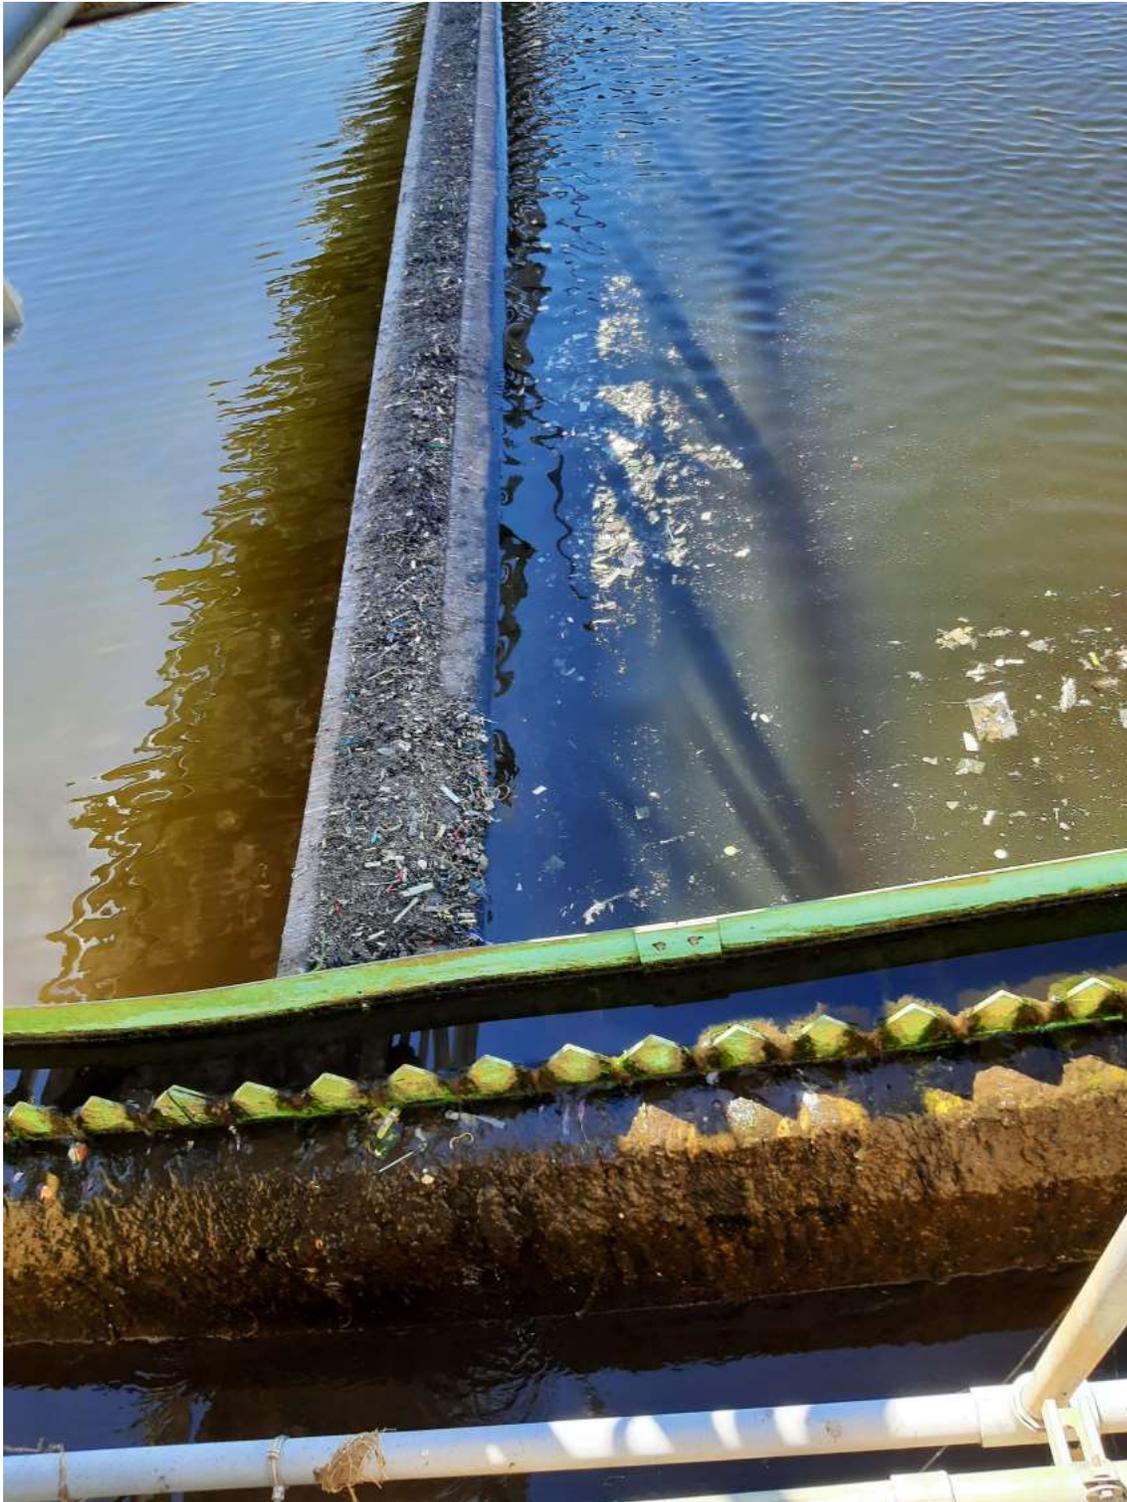
9/27/22 Secondary clarifier 5A – Scum collection trough clogged with solids.

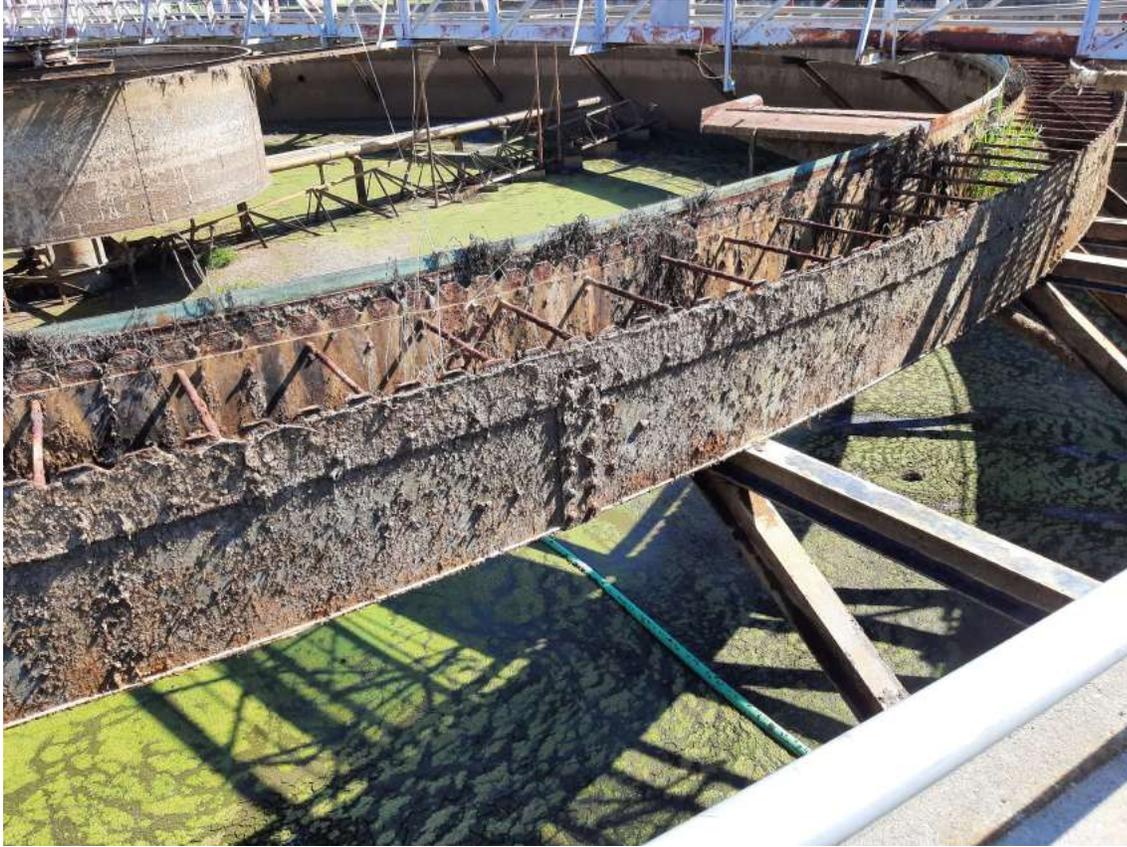
9/27/22 Secondary clarifier 16A being drained to prepare for maintenance.

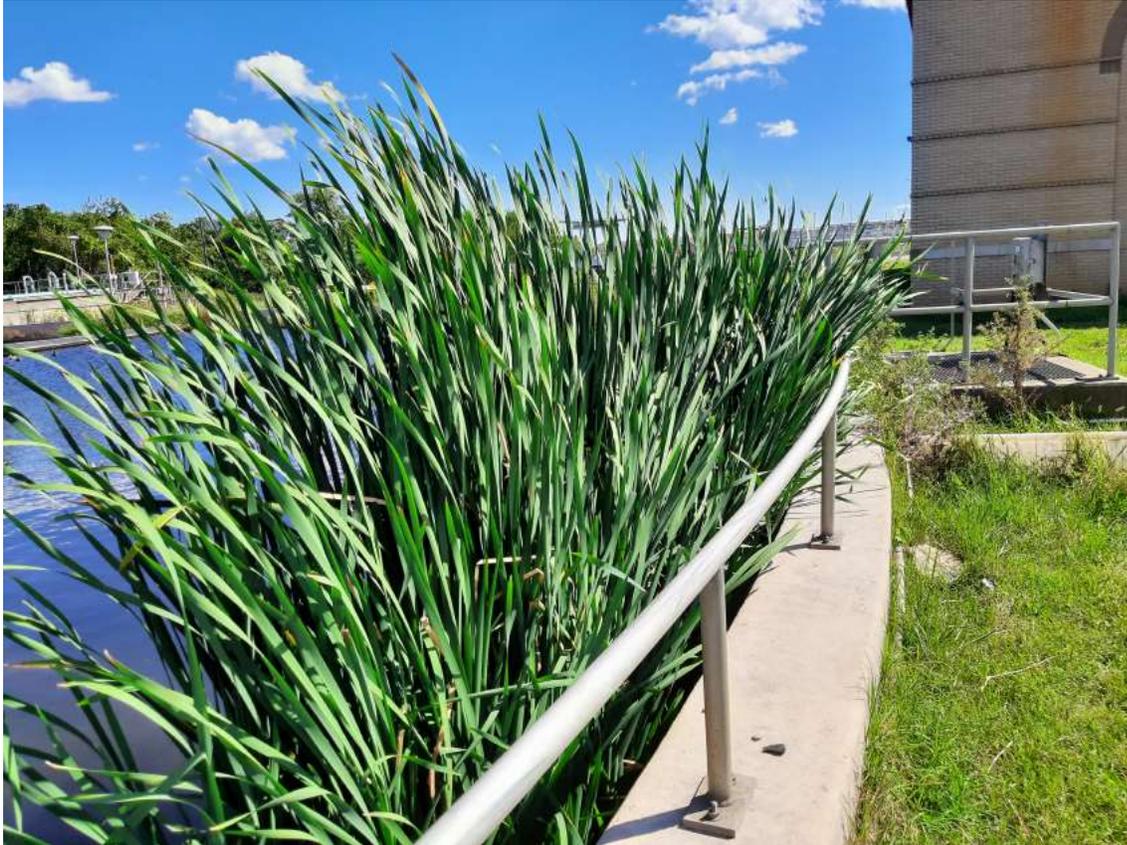
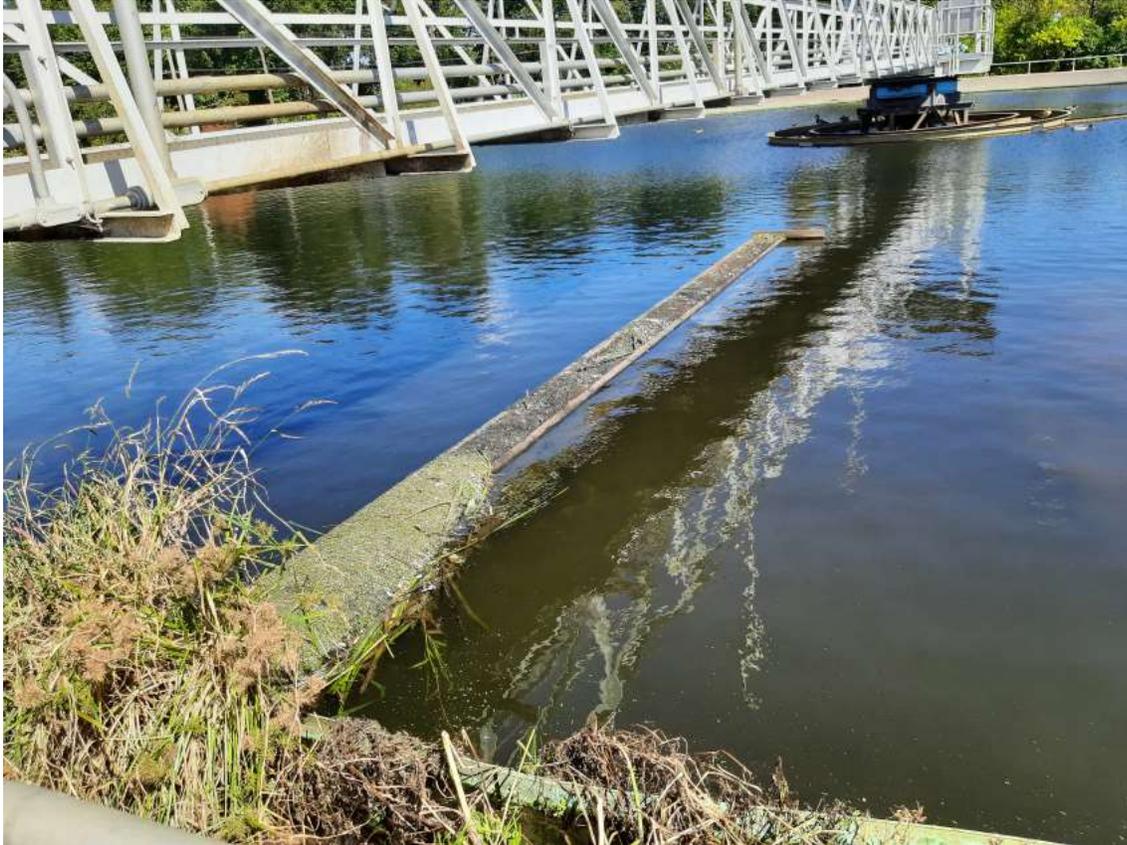
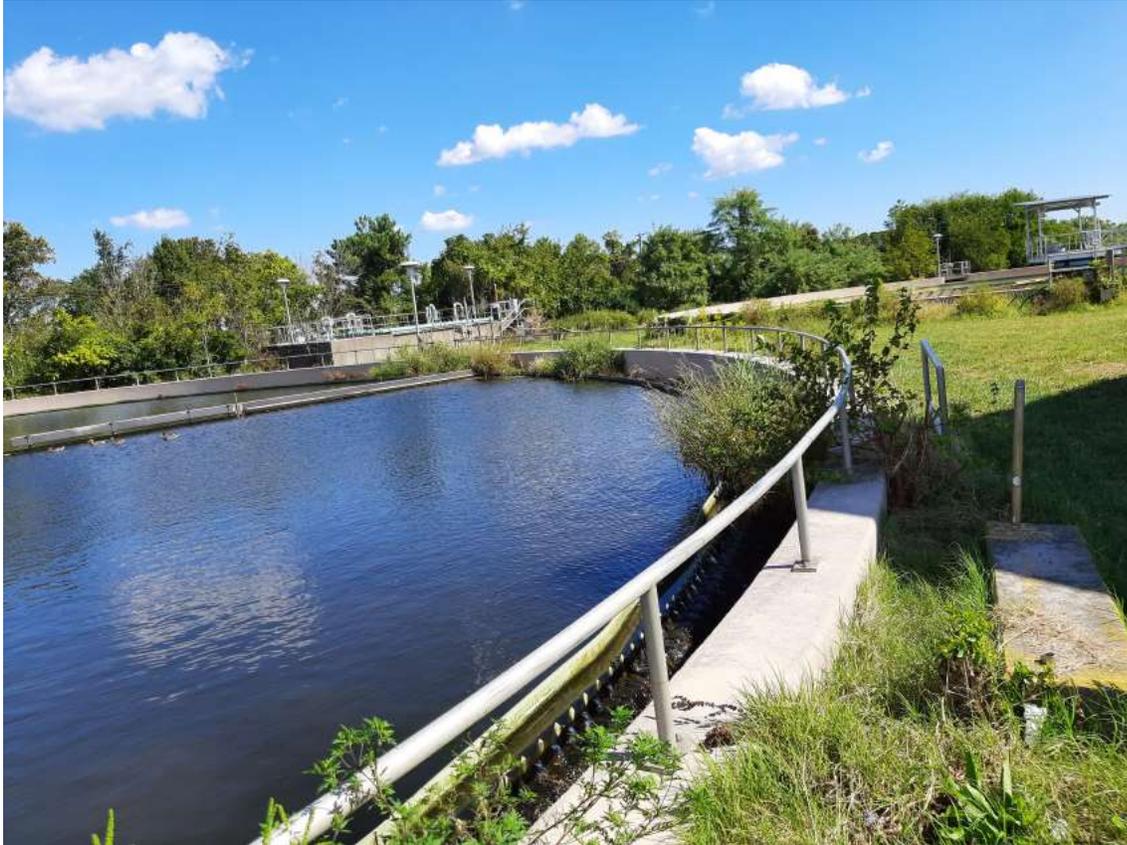
9/27/22 Secondary clarifier 10A - Phragmites growing on weirs and inside launders.

9/27/22 Secondary clarifier 10A scum collection trough opening clogged and vegetation growing on the weirs.

9/27/22 Another view of secondary clarifier 10A.

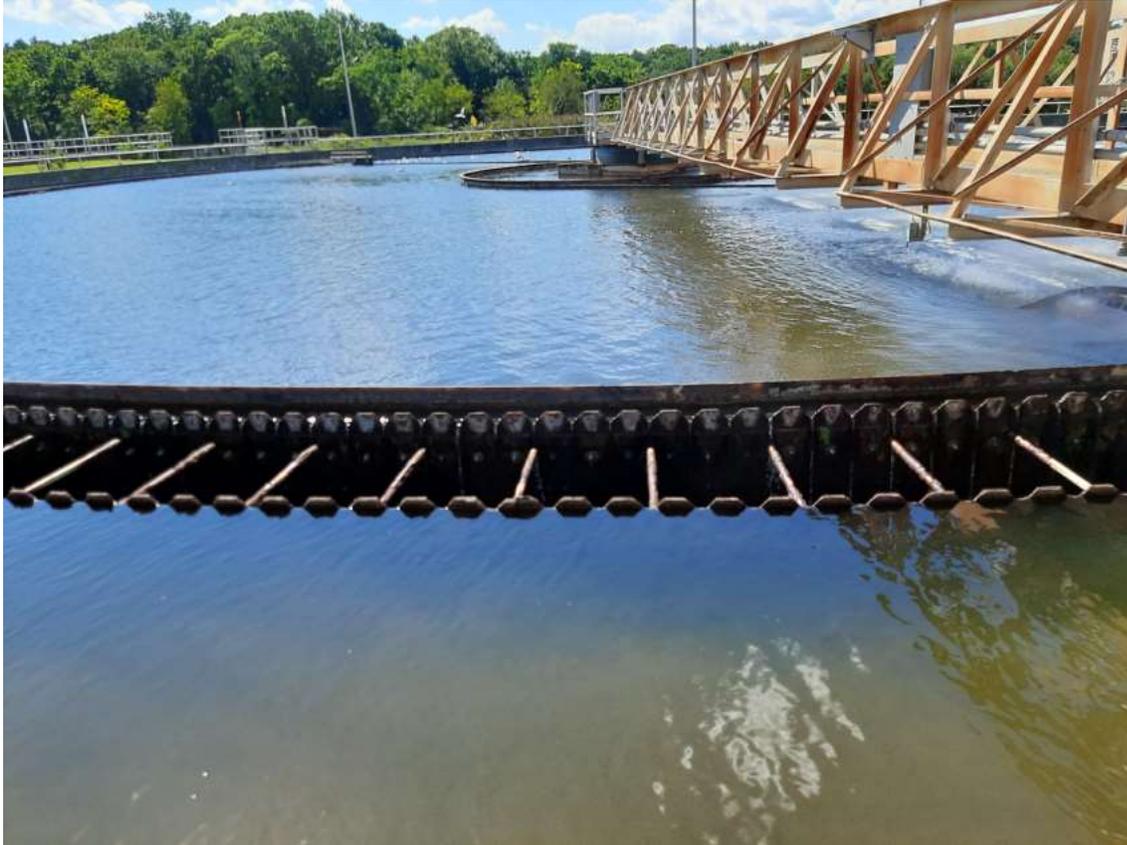
9/27/22 Secondary clarifier 11 A – No visible problems with this clarifier.

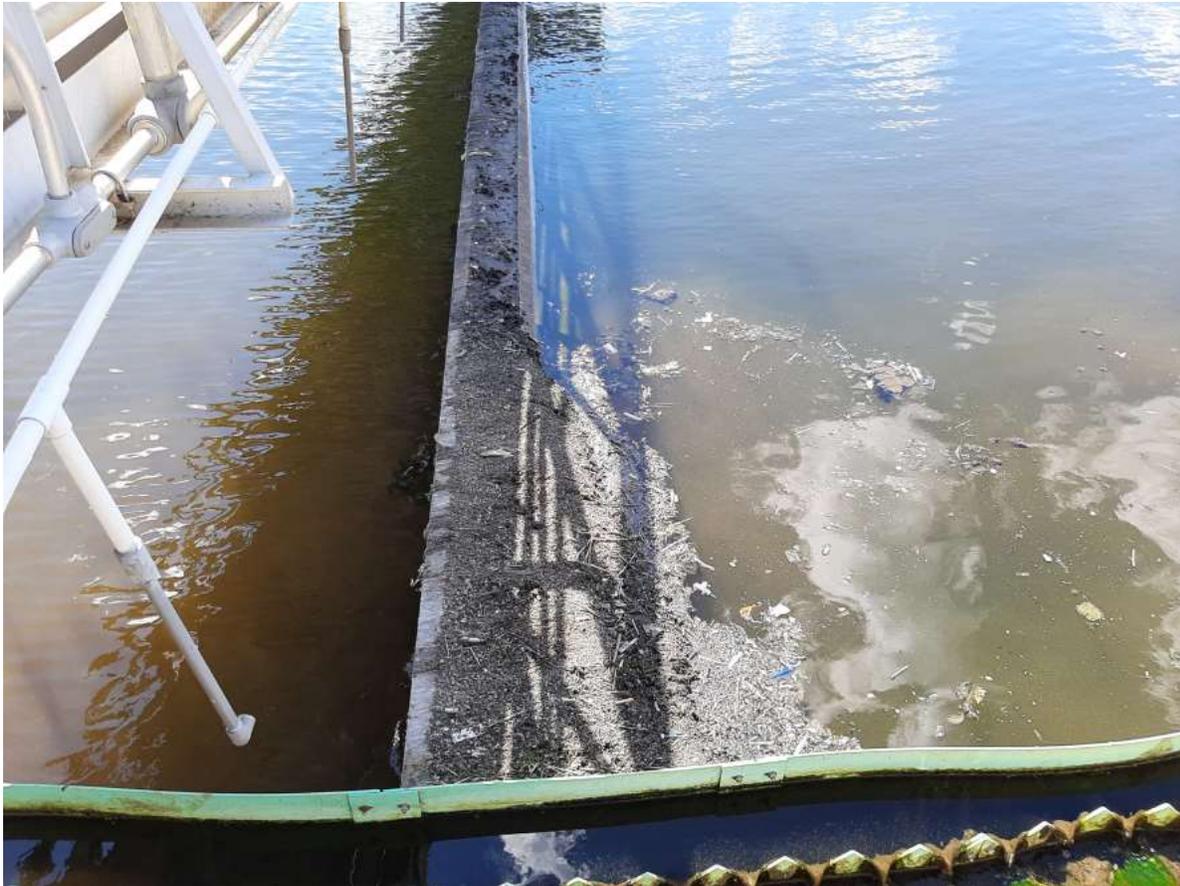
9/27/22 Secondary clarifier 8A scum trough clogged. The clarifier is not being operated as designed.

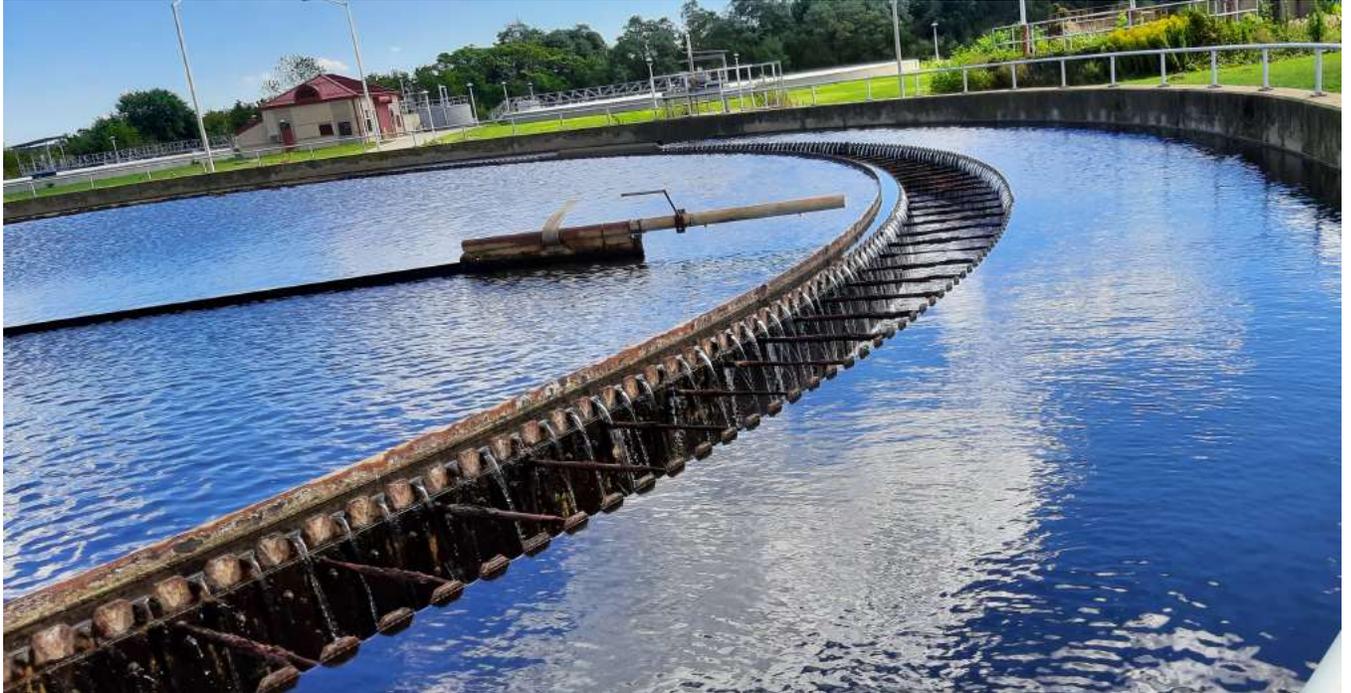
14B	This clarifier cannot function as designed because the scraper on the skimmer arm was missing. Therefore, the scum collection is not functioning as designed.	Y
16B	Not in service.	N
15A	Down for service	N
15B	This clarifier cannot function as designed because the scraper on the skimmer arm was missing. Therefore, the scum collection is not functioning.	Y
12A	This clarifier cannot function as designed because of algae and thick vegetation growing over the weirs and floating vegetation on the water surface.	Y
12B	This clarifier was down for service. No information available at the time of the inspection.	N
11B	This clarifier cannot function as designed because of algae and thick vegetation growing over the weirs.	Y
13B	No visible problems with this clarifier	Y
9A	This clarifier cannot function as designed because of algae and thick vegetation growing over the weirs.	Y
10B	This clarifier was down for service. No information available at the time of the inspection.	Y

9/27/22 Secondary clarifier 15B – There is no blade or flapper on the outer part of the skimmer arm to collect floating solids and scum.

5. The skimmer blades on some of the secondary clarifiers are missing and require maintenance and the scum troughs on many of the secondary clarifiers require maintenance.

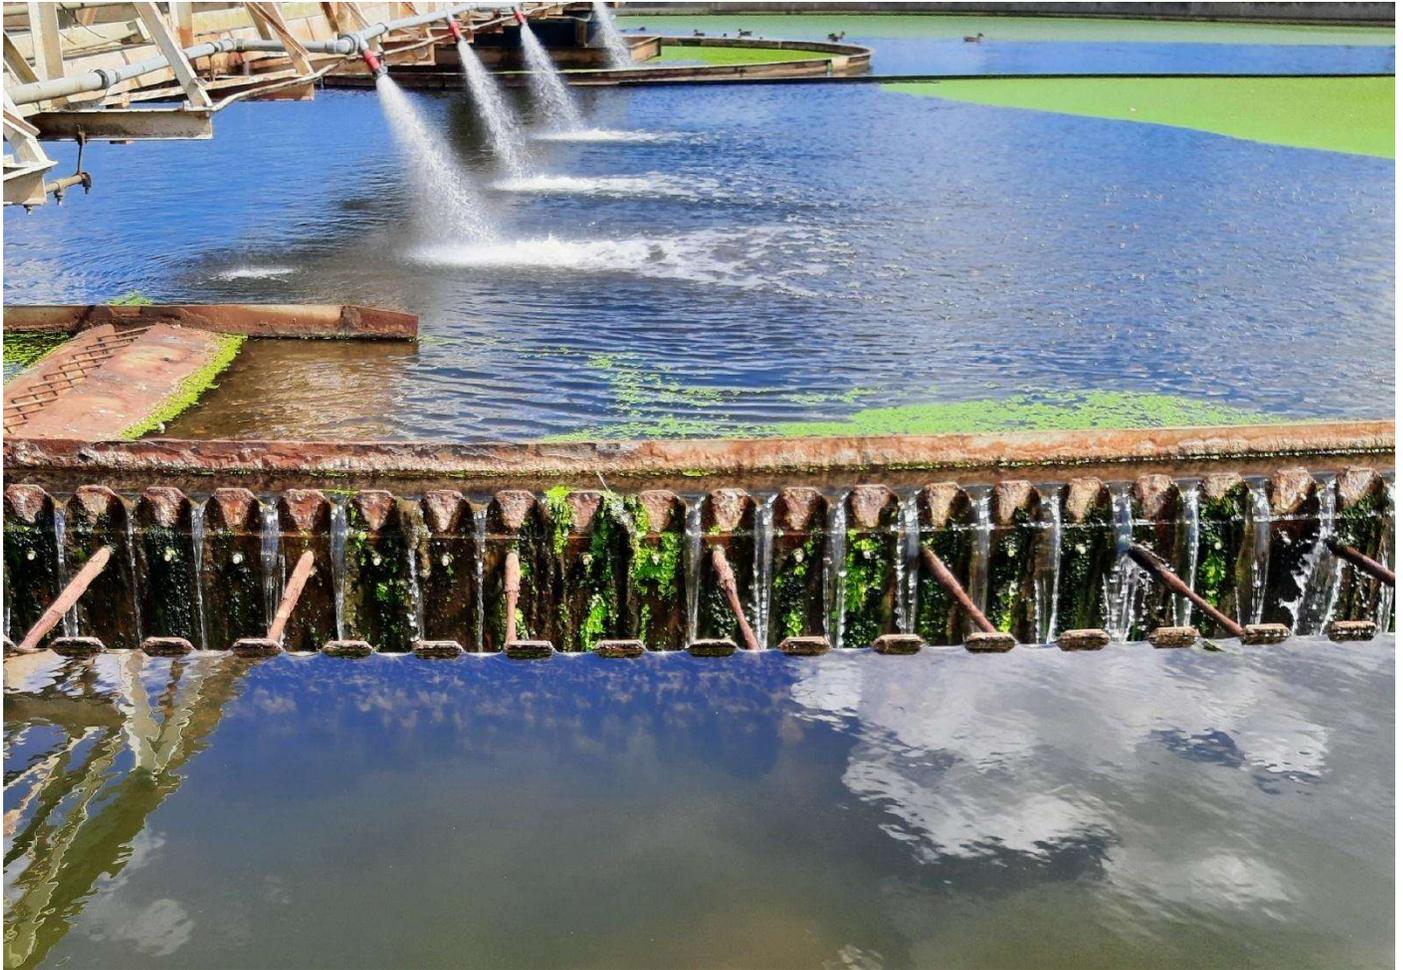
Algae growth in secondary clarifiers is a common problem for all uncovered weirs on secondary clarifiers. It requires regular measures to keep the problem under control. Algae can cause problems with TSS within the treatment system and can cause problems with pumps by increasing the chances of clogging. The weirs on all secondary clarifies should be routinely scrubbed to remove the algae or other control measures as deemed necessary.

9/27/22 Secondary clarifier 12A- Algae growing on weirs along with vegetation.

2. Algae and vegetation were observed on and around the weirs of the secondary clarifiers that is causing the short circuiting of the system. This condition can impact downstream equipment and treatment processes.
