**Maryland Department of Environment**  
**Water and Science Administration**  
**Compliance Program**  
**1800 Washington Blvd, Suite 420**  
**Baltimore, MD 21230-1719**  
**410- 537-3510, 1-800-633-6101**

**Site Name:** Back River WWTP  
**Facility Address:** 8201 Eastern Ave, Baltimore, MD 21224  
**County:** Baltimore County

**Permit / Approval Numbers:** 15DP0581  
**NPDES Numbers:** MD0021555  
**Inspection Reason:** Follow-up (Non-Compliance)  
**Site Status:** Active  
**Compliance Status:** Noncompliance  
**Site Condition:** Noncompliance  
**Recommended Action:** Refer to Others (See Findings)  
**Evidence Collected:** Photos or Videos Taken, Visual Observation  
**Delivery Method:** Email  
**Weather:** Dry Average

### **Inspection Findings:**

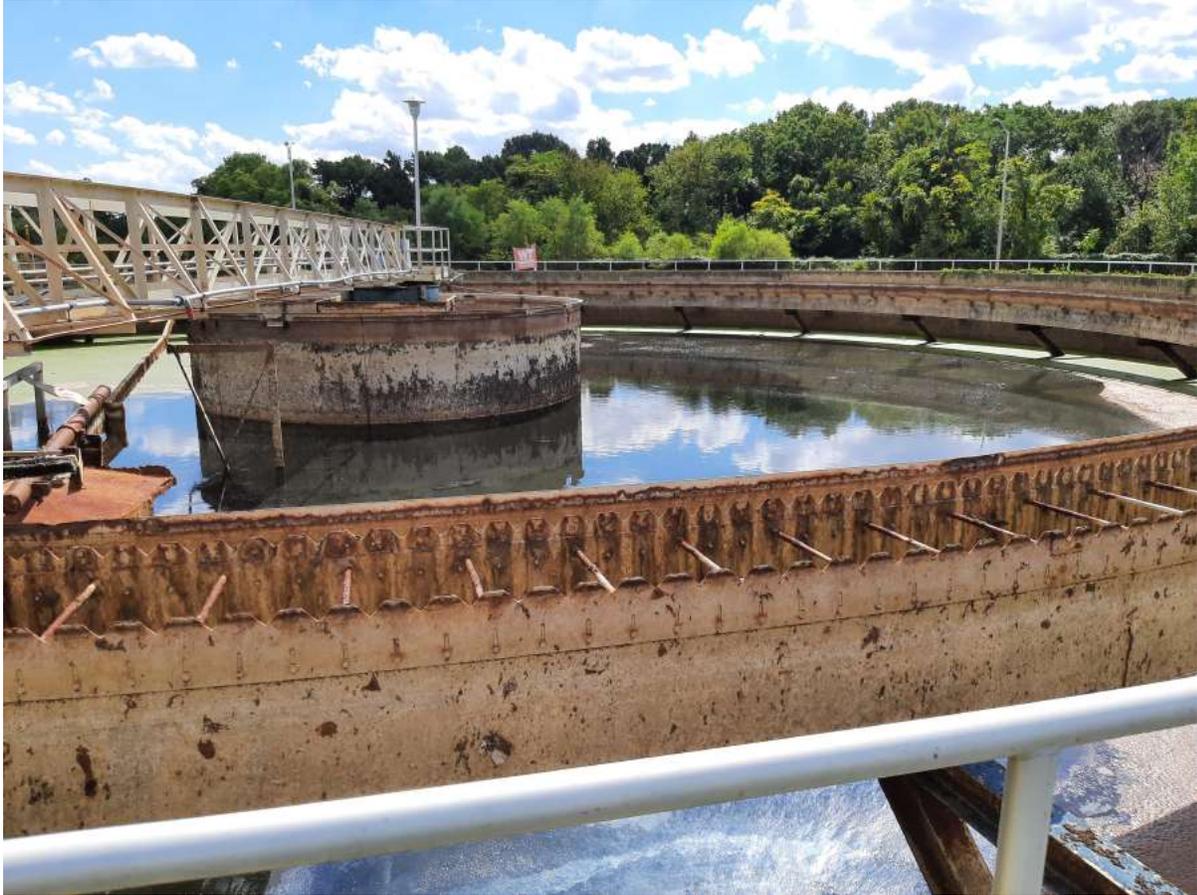
9/27/22 Secondary clarifier 12B down for repairs.

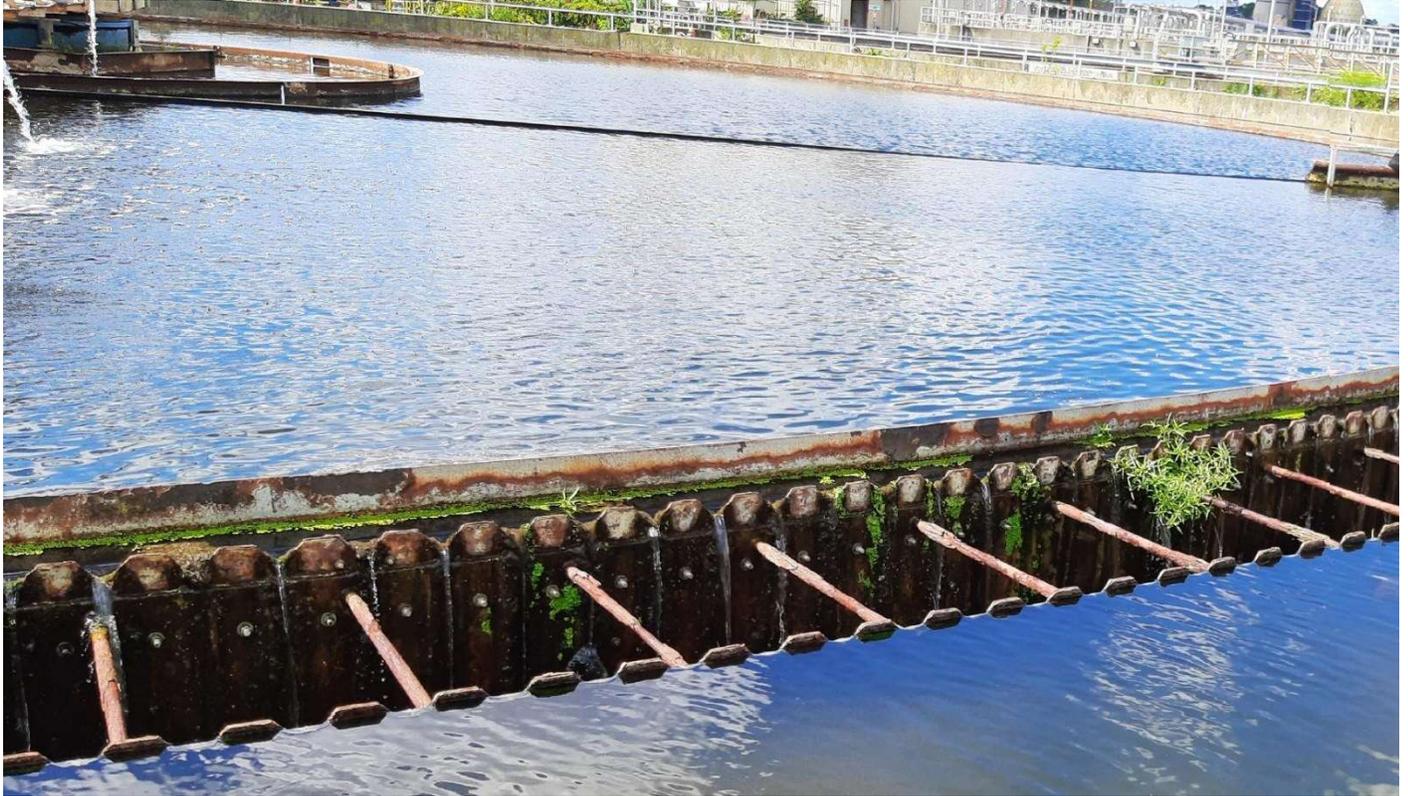
Algae growth in secondary clarifiers is a common problem for all uncovered weirs on secondary clarifiers. It requires regular measures to keep the problem under control. Algae can cause problems with TSS within the treatment system and can cause problems with pumps by increasing the chances of clogging. The weirs on all secondary clarifies should be routinely scrubbed to remove the algae or other control measures as deemed necessary.

9/27/22 Secondary clarifier 11B – Algae, duck weed and vegetation growing on the weirs.

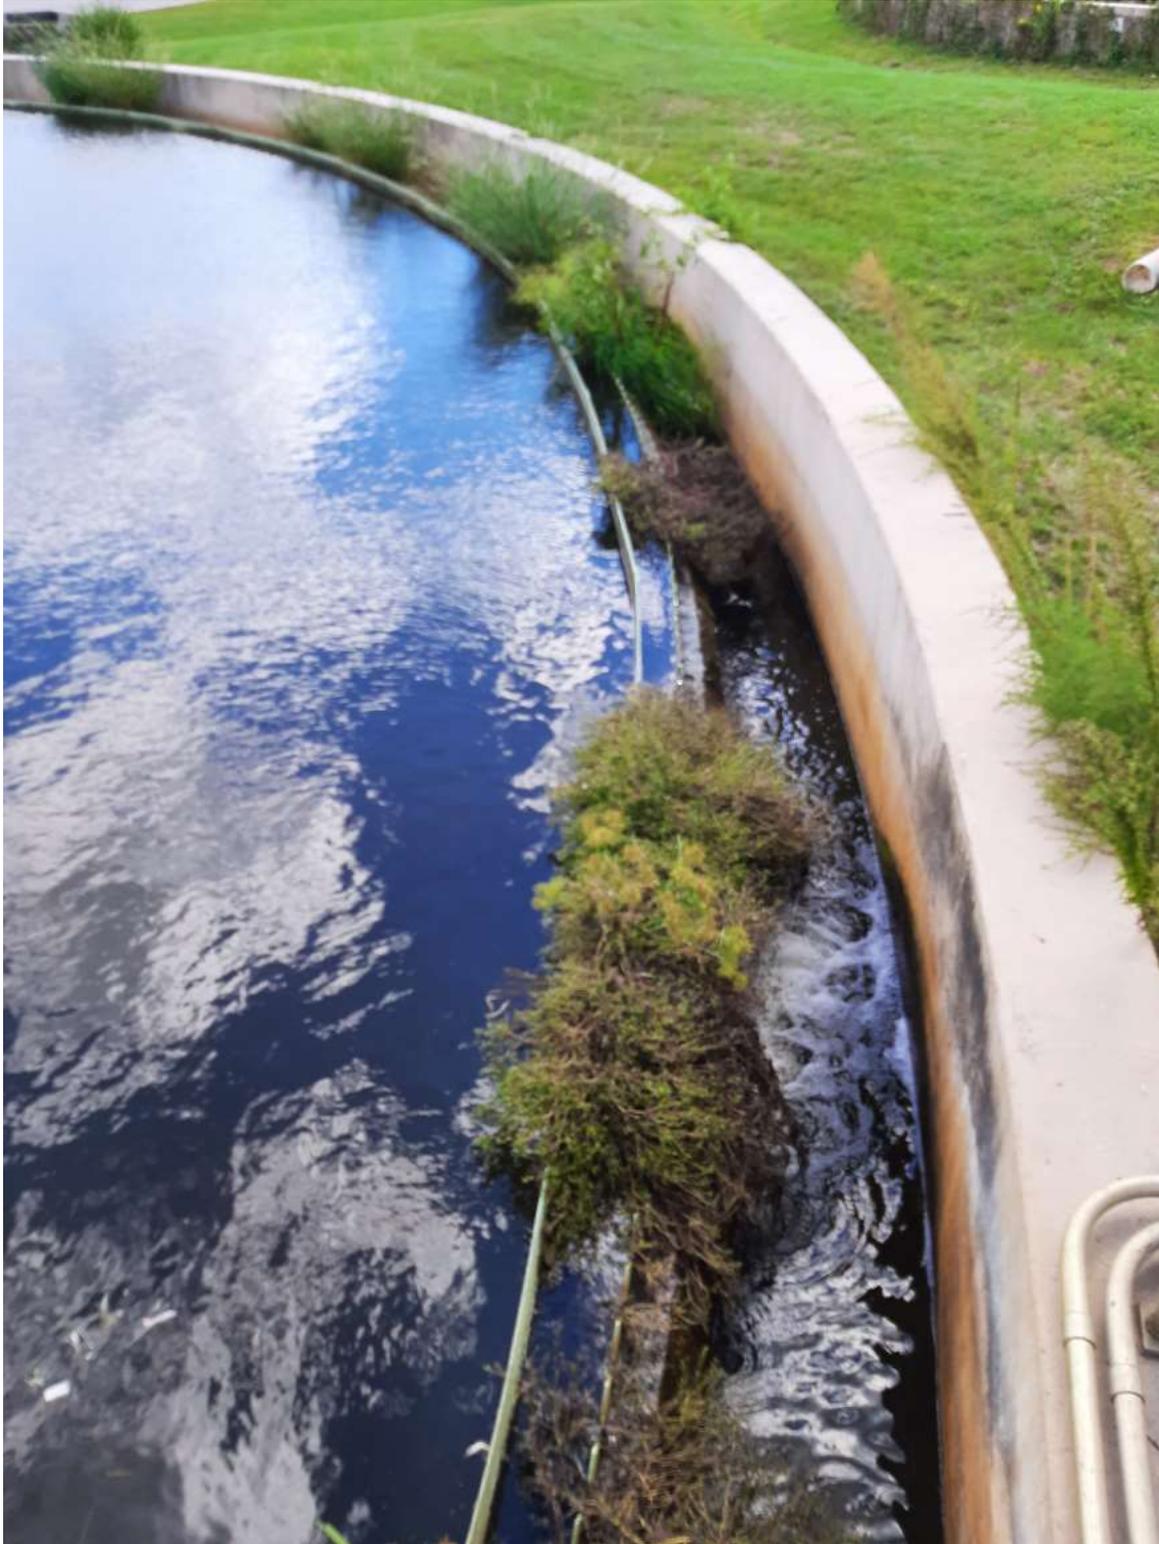
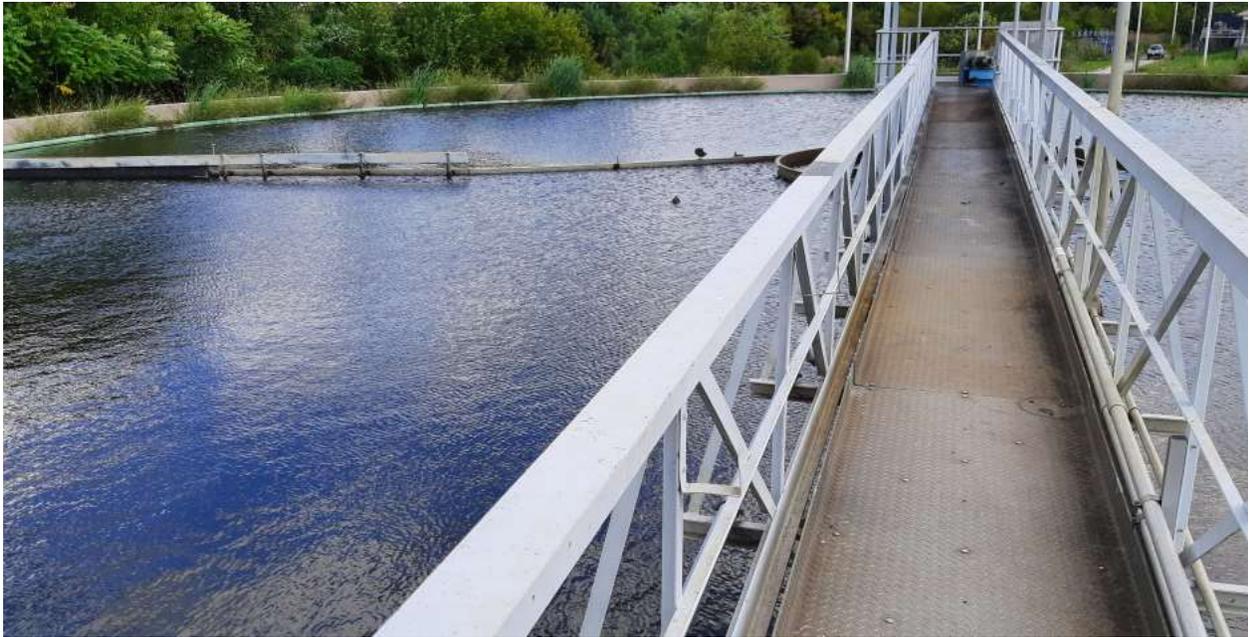
9/27/22 Secondary clarifier 9A – vegetation covering the weirs along the perimeter of the clarifier.

9/27/22 Secondary clarifier 9A – vegetation growing on and covering the weirs along the perimeter of the clarifier,

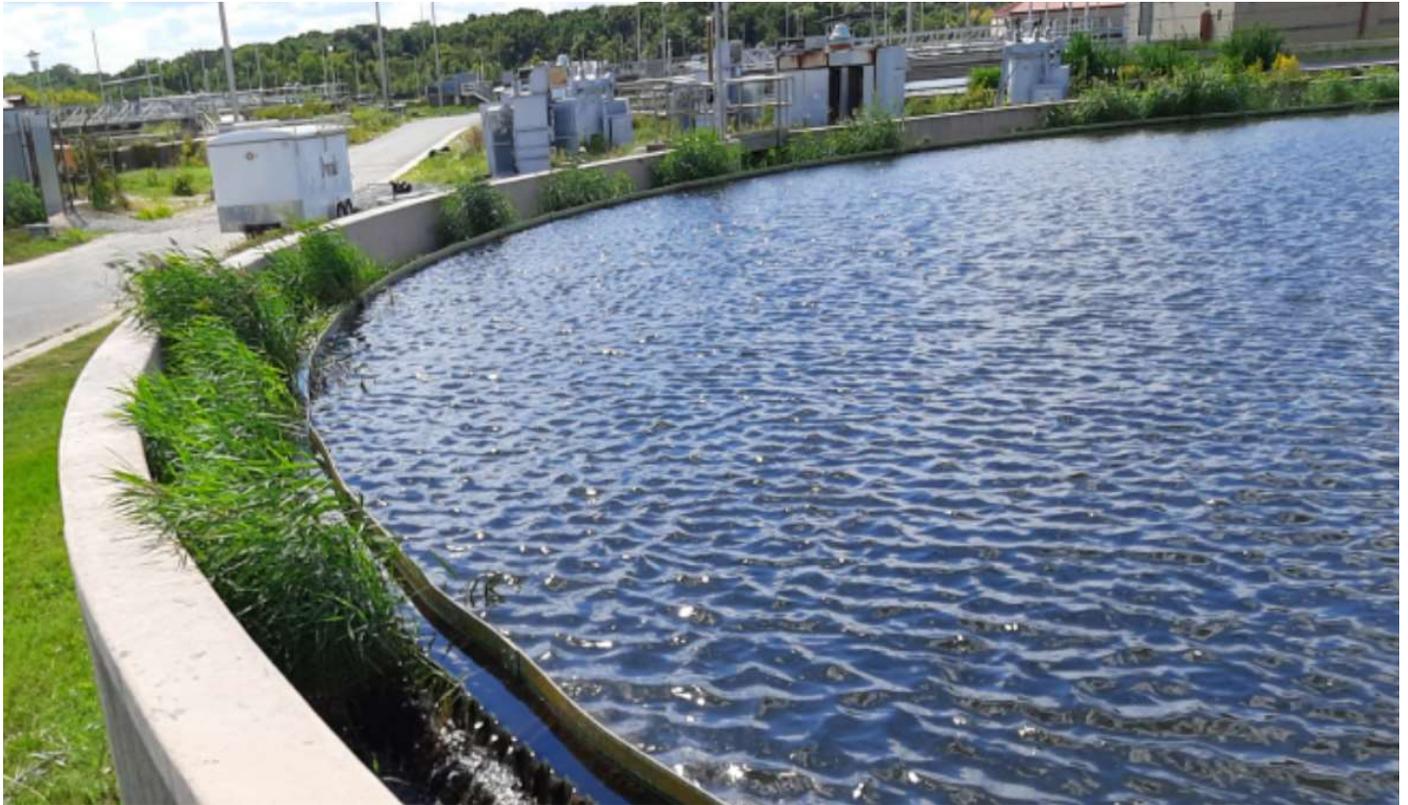
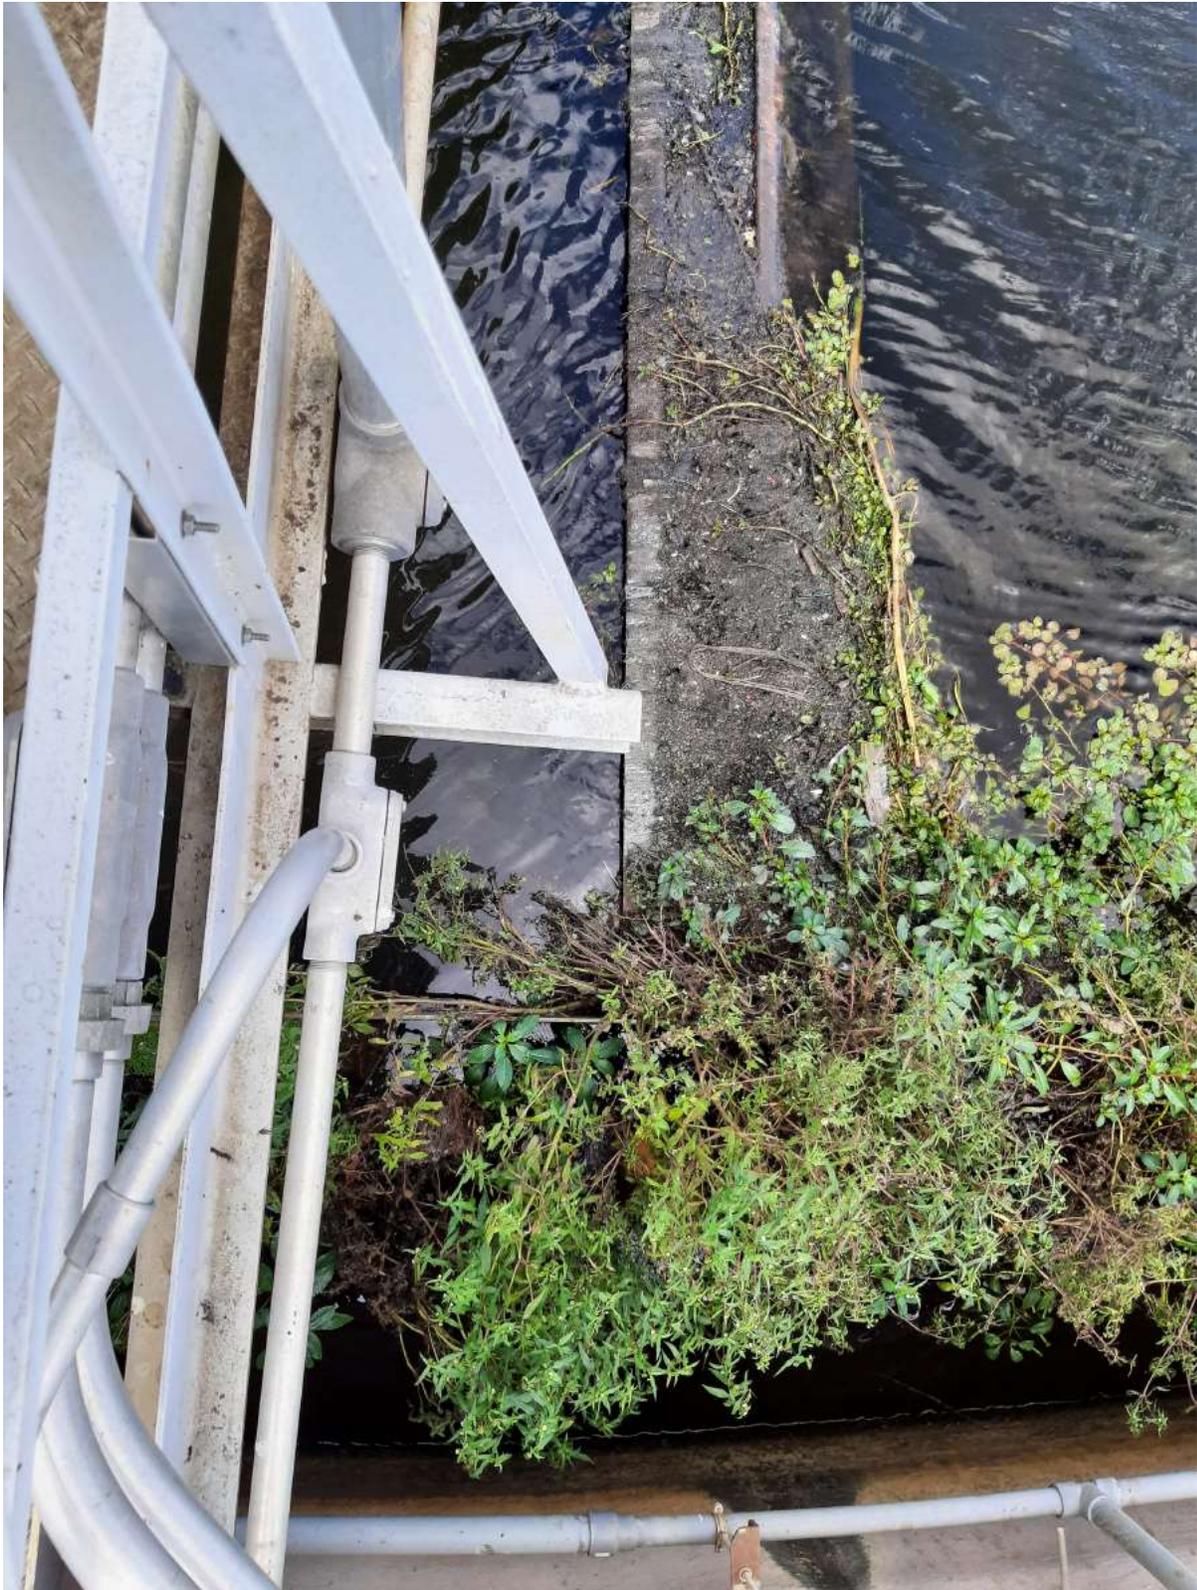
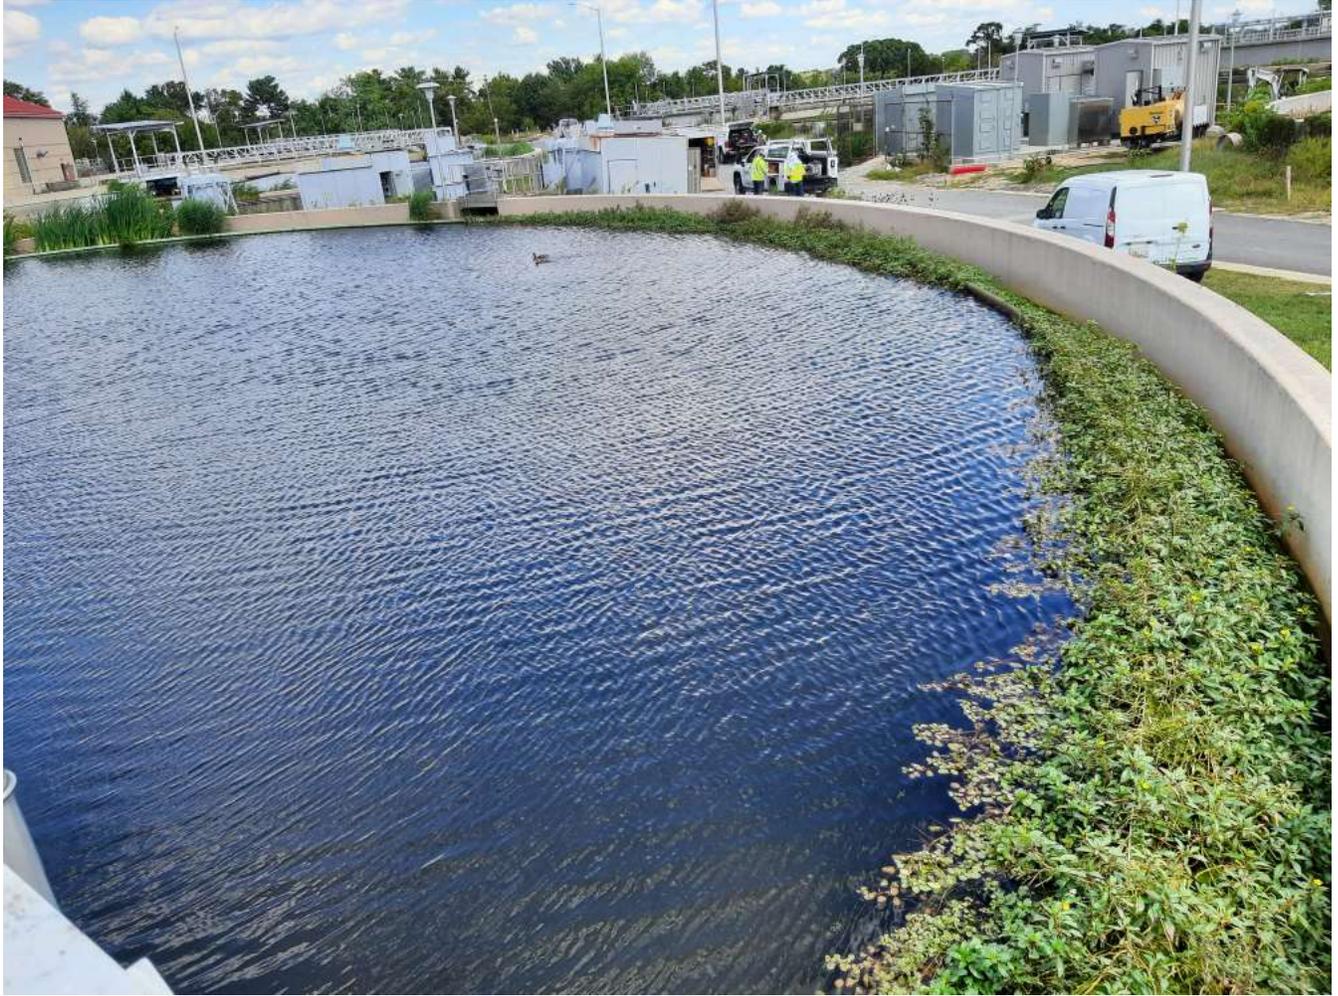
9/27/22 Secondary clarifier 7B – Thick vegetation growing around the weirs and blocking the flow.

9/27/22 Secondary clarifier 7B - Vegetation growing on the weirs and the scum trough is clogged.

9/27/22 Secondary clarifier 7B - Vegetation growing on the weirs hindering operational performance.

- E.** With respect to item #5 above, within 30 days of the receipt of this report, the Back River WWTP shall repair the skimmer arms on the secondary clarifiers and pump out the scum troughs on the secondary clarifiers. The Back River WWTP shall notify the Department once these tasks have been completed.

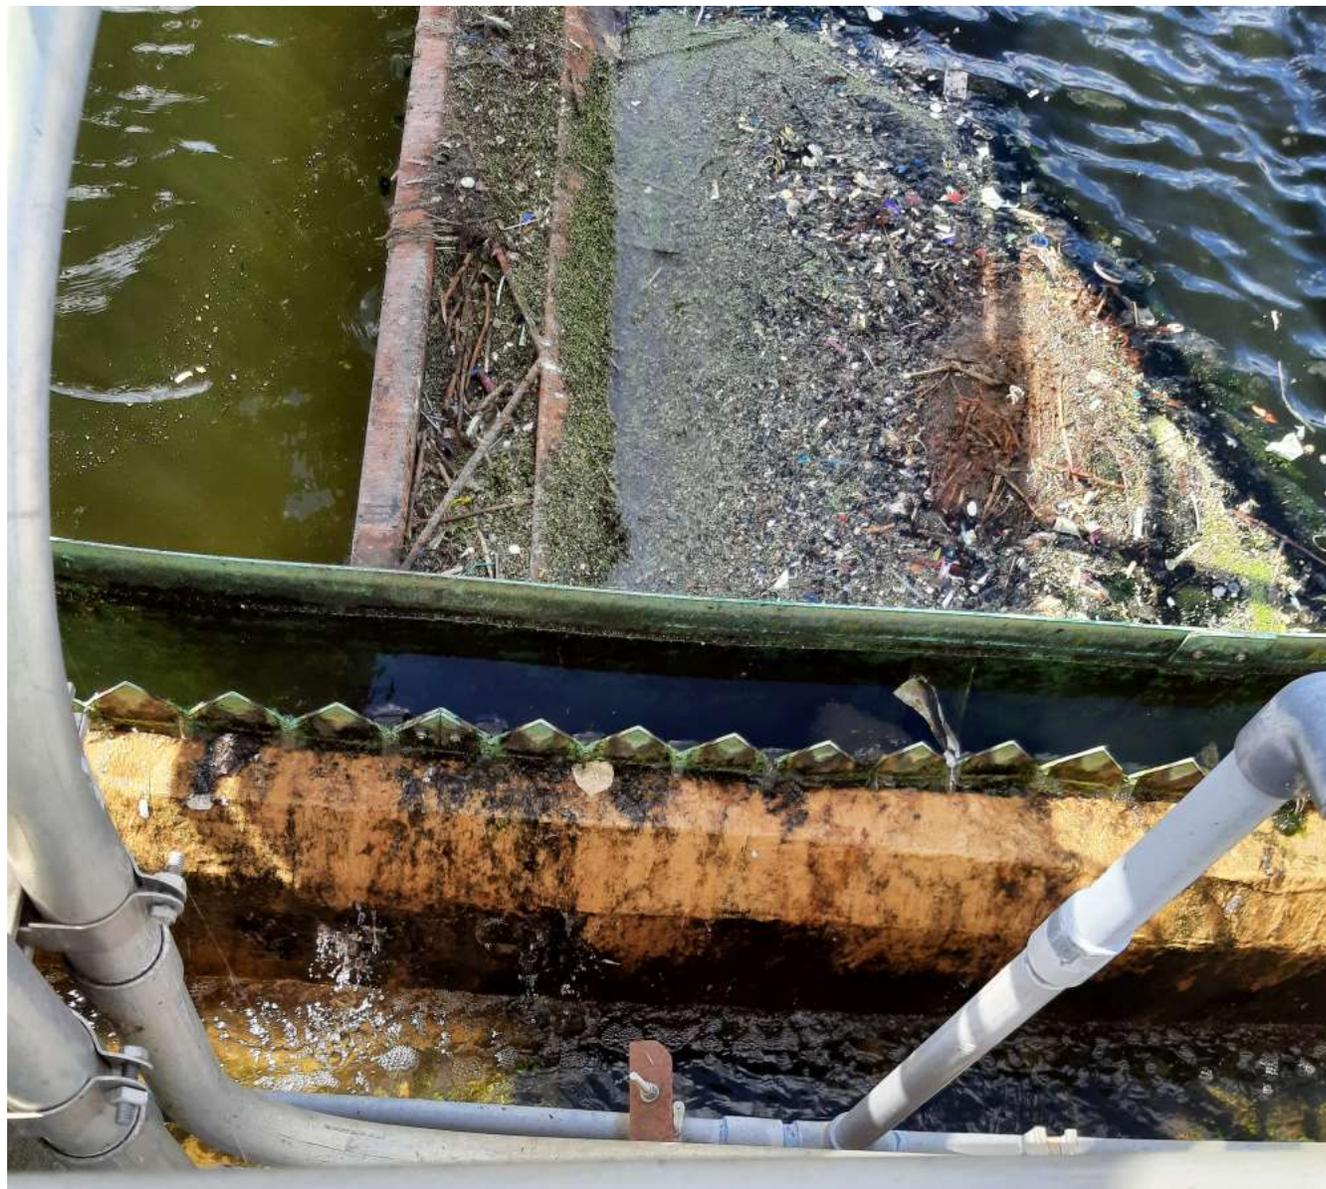
9/27/22 Secondary clarifier 5B - Scum collection trough clogged preventing the removal of scum and floating solids.

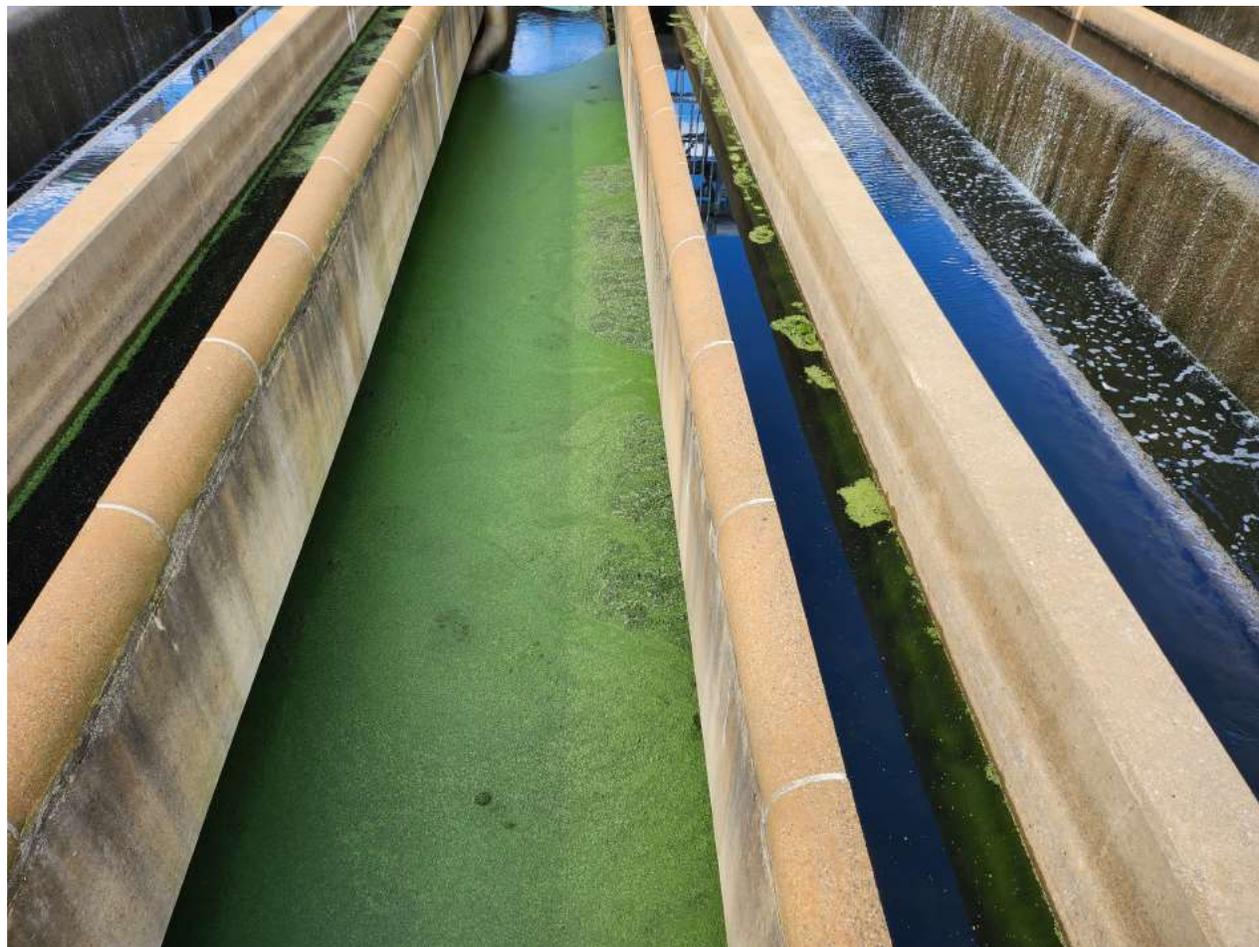
During an inspection of the four filter quads, I found that one of the filters was not active. This filter appeared to have been out of service for a while due to the undisturbed top layer of floating algae and floating duckweed. I went back to the control room to speak with the control room

9/27/22 Inactive DNF.

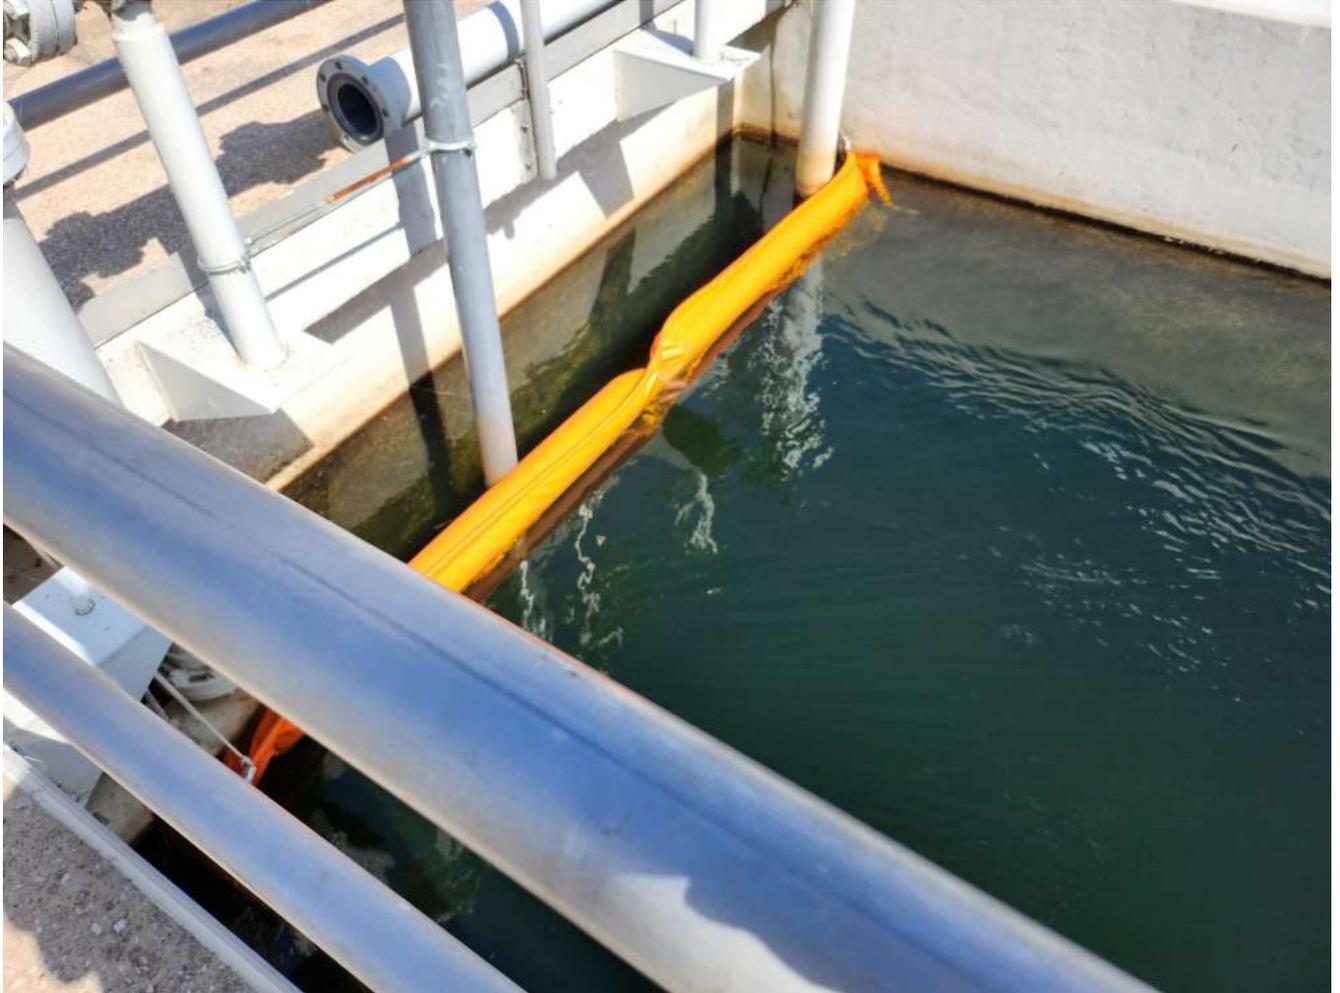
9/27/22 One of the floating booms at the left channel CCC being used to prevent floating solids from entering the final discharge canal.

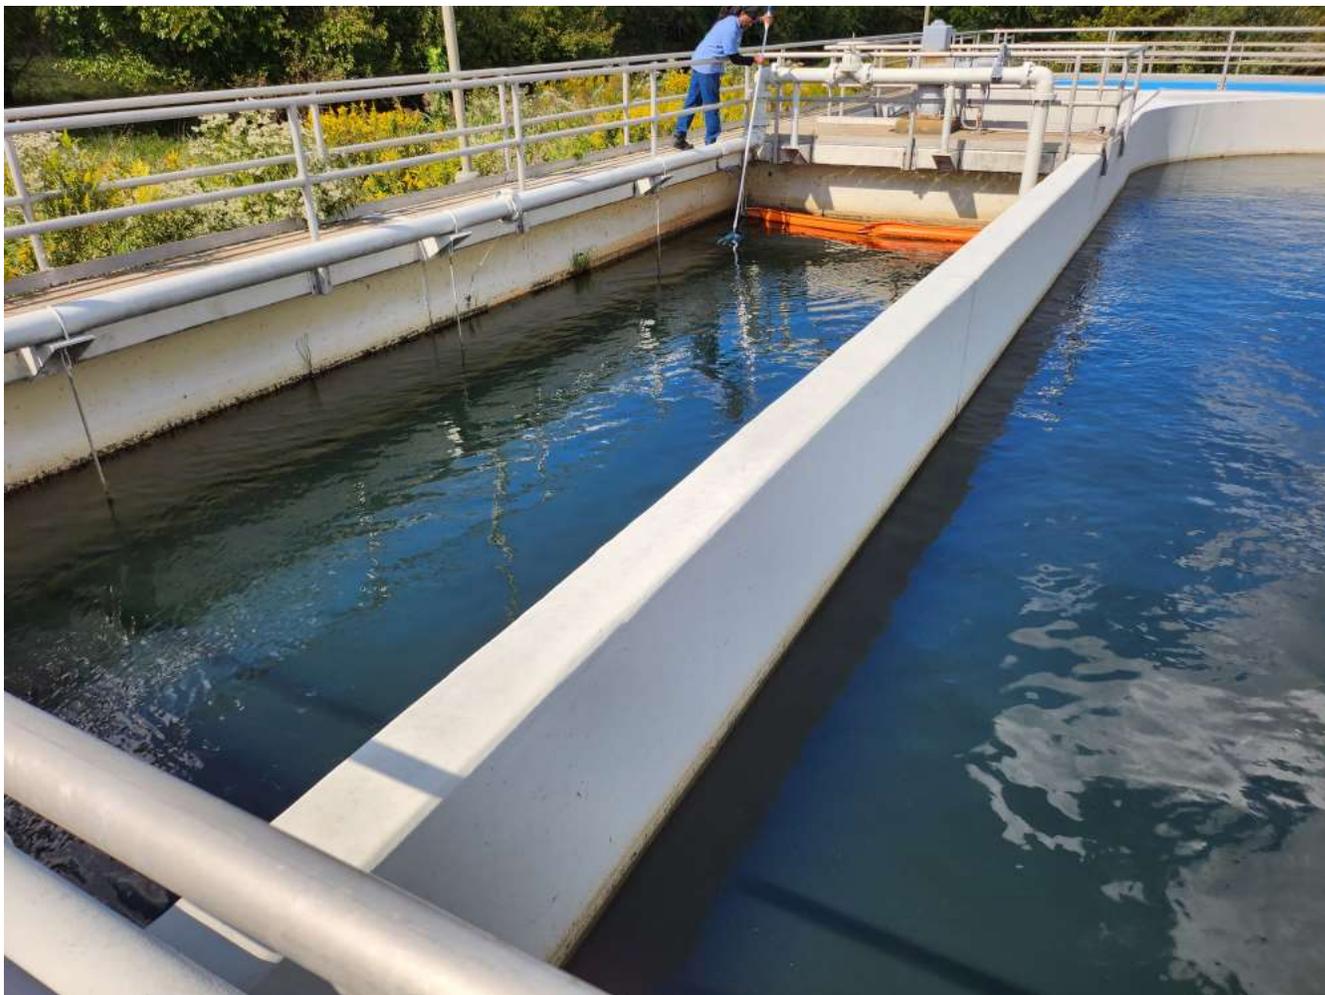
9/27/22 Operator skimming floating solids and scum at the right channel CCC.

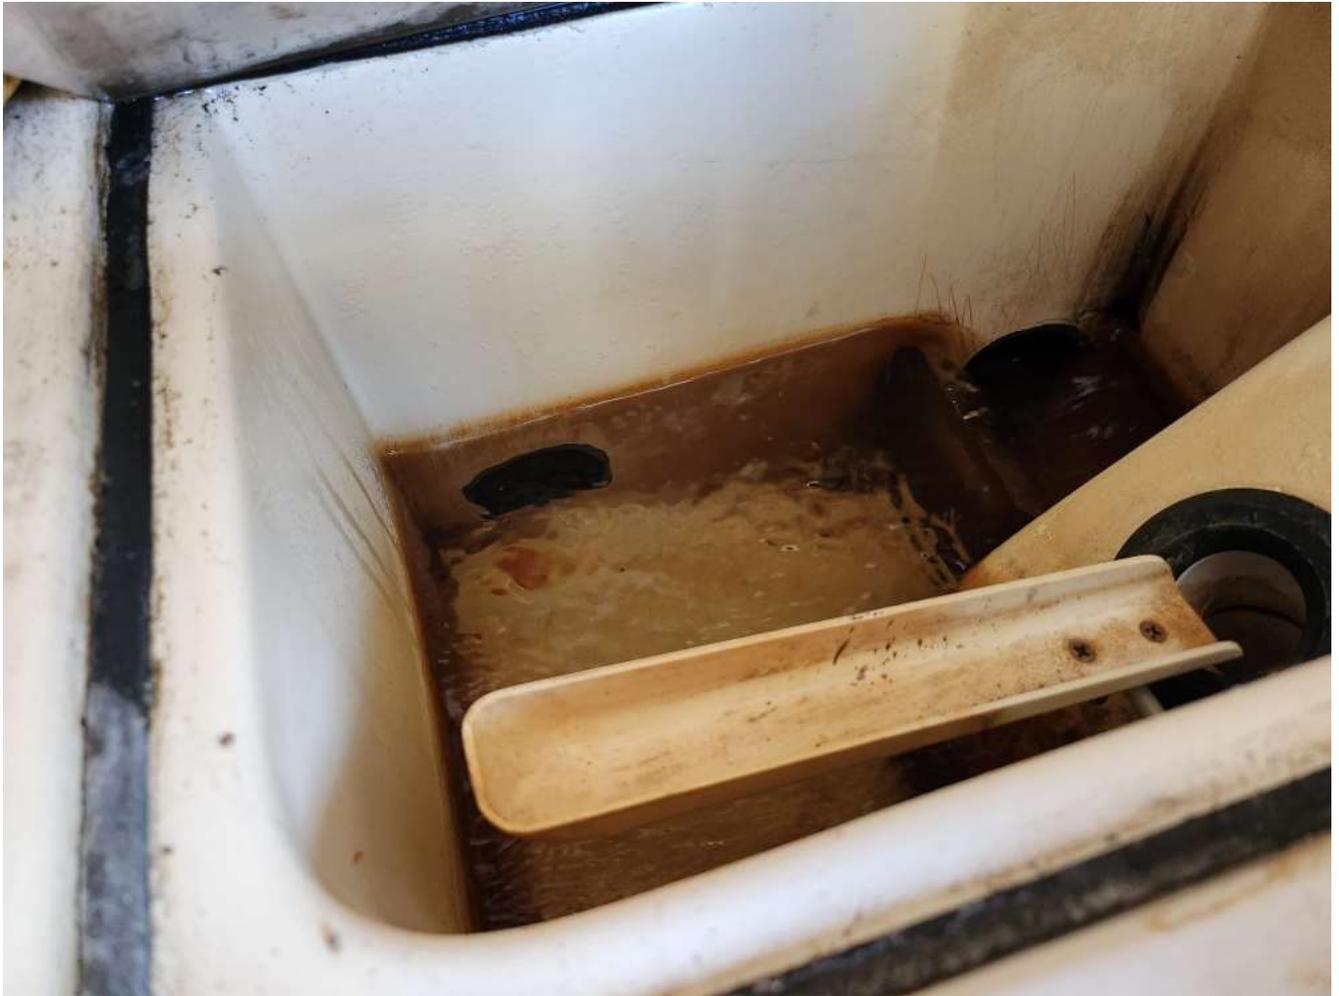
During an inspection of the automatic sampler, I observed that the sample collection trough needs to be cleaned. The compartment should be cleaned with detergent (phosphate-free detergent like Liquinox or Luminox) and using a brush to remove particulate matter and surface film, then rinsed with water, and finally, rinsed with a Polychlorinated Biphenyls free solvent like methanol rinsed before use.

9/27/22 Sample collection trough in unsatisfactory condition. The trough should be cleaned per instructions above.

- C.** With respect to item #3 above, the Back River WWTP shall immediately maintain the automatic sampler in satisfactory condition. The sampler should be decontaminated and routinely cleaned to prevent sample contamination during use.
