**Maryland Department of Environment**  
**Water and Science Administration**  
**Compliance Program**  
**1800 Washington Blvd, Suite 420**  
**Baltimore, MD 21230-1719**  
**410- 537-3510, 1-800-633-6101**

**Site Name:** Back River WWTP  
**Facility Address:** 8201 Eastern Ave, Baltimore, MD 21224  
**County:** Baltimore County

**Media Type(s):** NPDES Municipal Major Surface Water

**Permit / Approval Numbers:** 15DP0581  
**NPDES Numbers:** MD0021555  
**Inspection Reason:** Follow-up (Non-Compliance)  
**Site Status:** Active  
**Compliance Status:** Noncompliance  
**Site Condition:** Noncompliance  
**Recommended Action:** Additional Investigation Required  
**Evidence Collected:** Photos or Videos Taken, Visual Observation  
**Delivery Method:** Email  
**Weather:** Clear, Windy

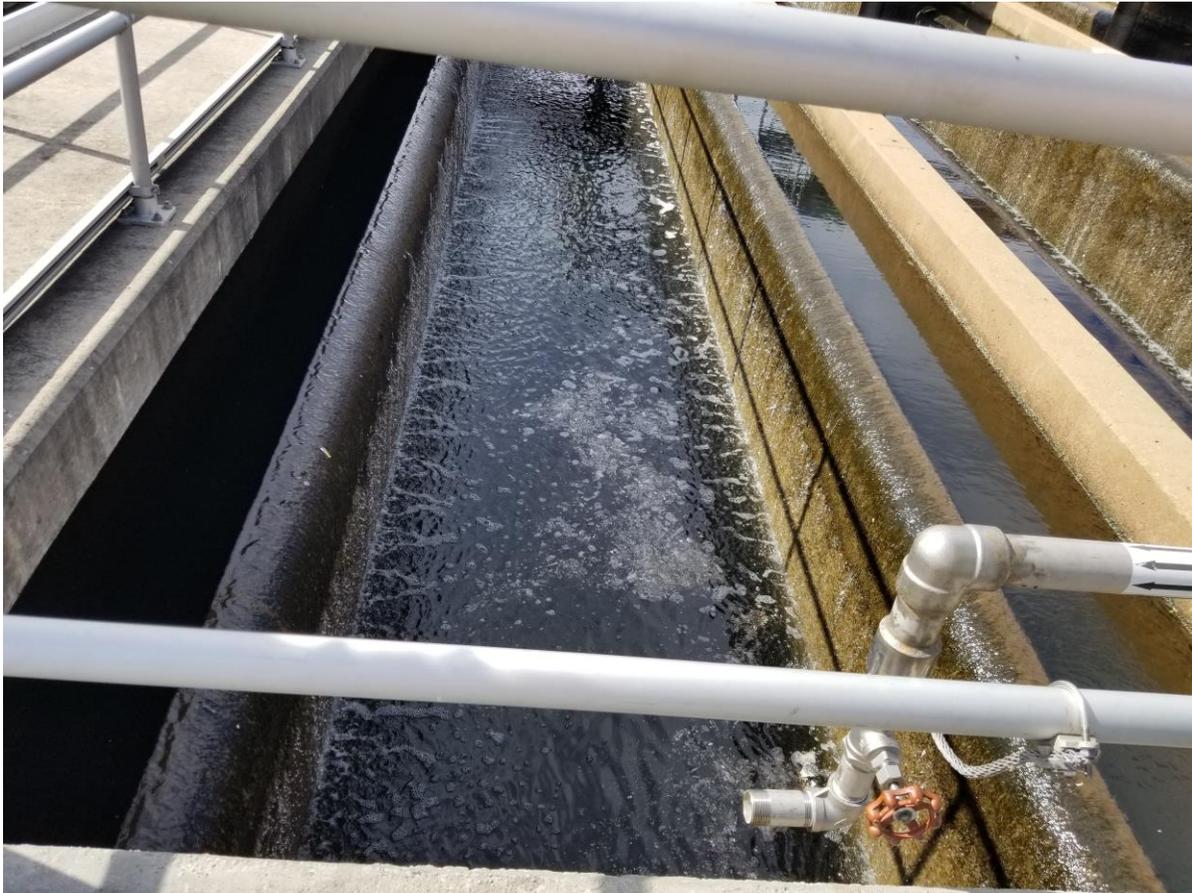
During an inspection of the filters in quads #1 and #2, there were still floating solids observed in the filter at the end of the quad (also observed during inspection on 1/26/23). A temporary power line was observed to be in use for Quad 2.

2/24/23 Solids and trash floating on water surface in the DNFs.

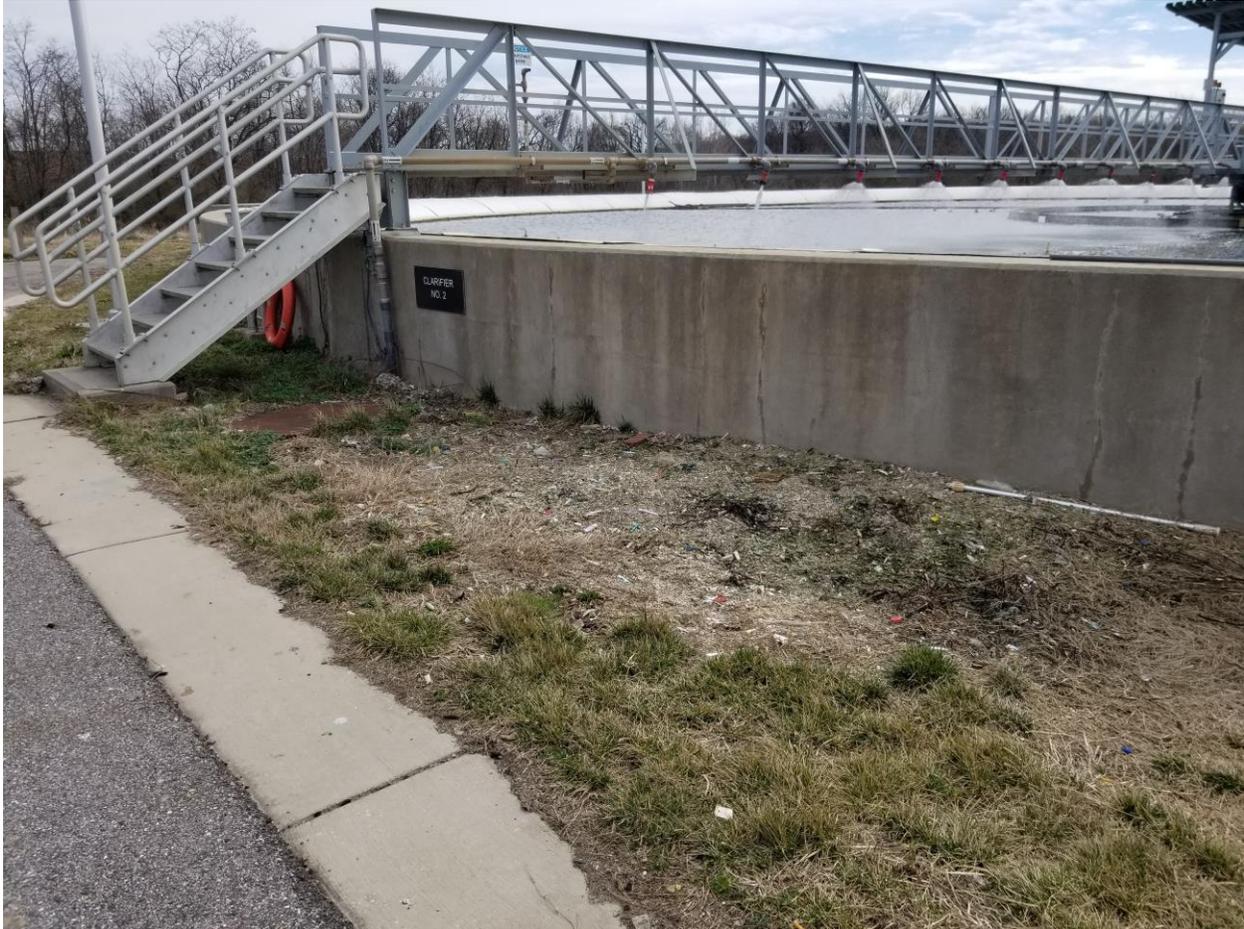
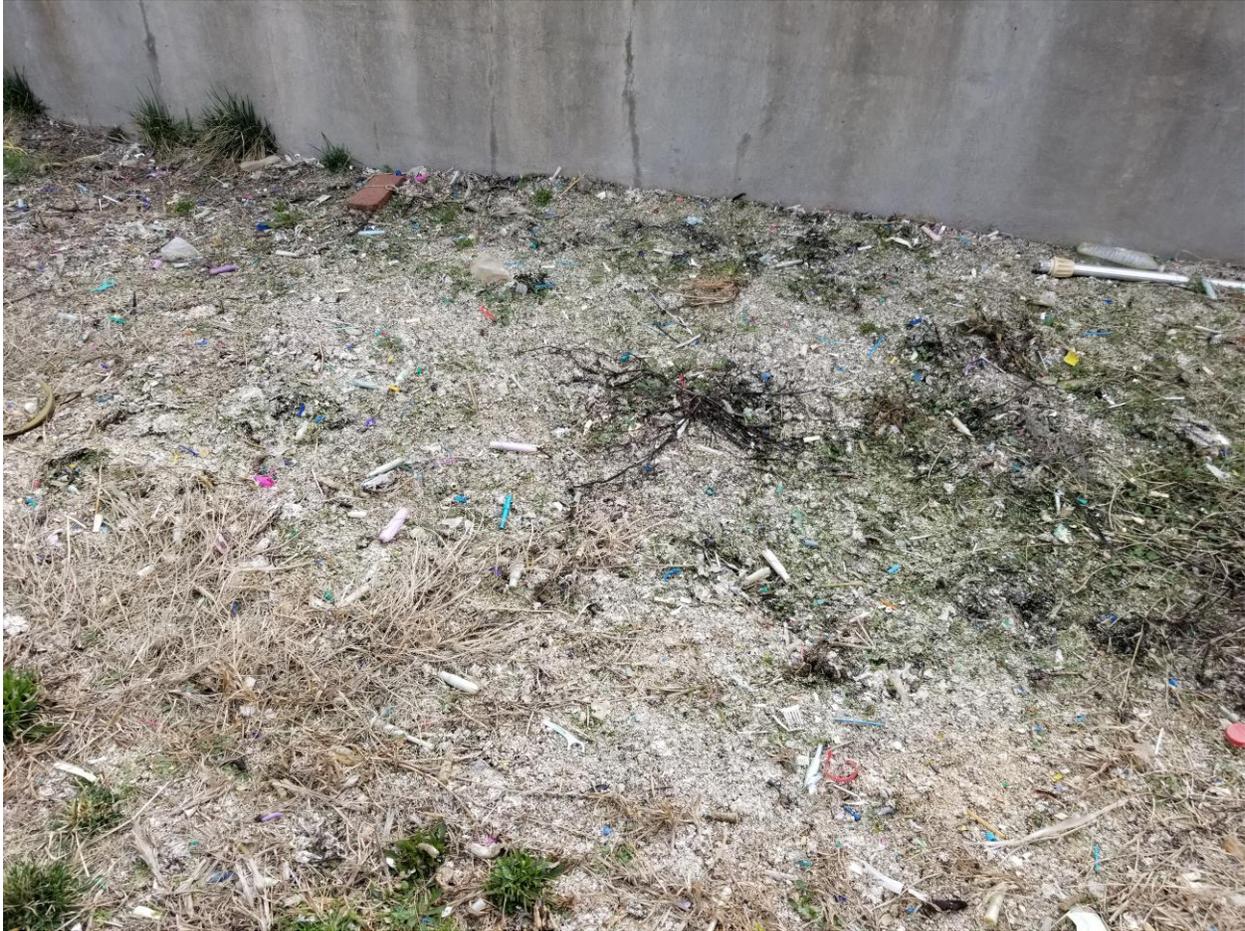
During inspection, backwash clarifier #2 was observed. Next to backwash clarifier #2, solids and trash were observed on the ground. According to Timothy Simmons, the grit removal facility services the backwash clarifier. The dumpsters at the grit removal facility were observed to have little to no grit in them.

2/24/23 Solids and trash on the ground next to backwash clarifier #2.

8. There are solids and trash on the ground next to backwash clarifier #2.

- H. With respect to item #8 above, the Back River WWTP should remove and properly dispose of the solids and trash on the ground next to backwash clarifier #2.

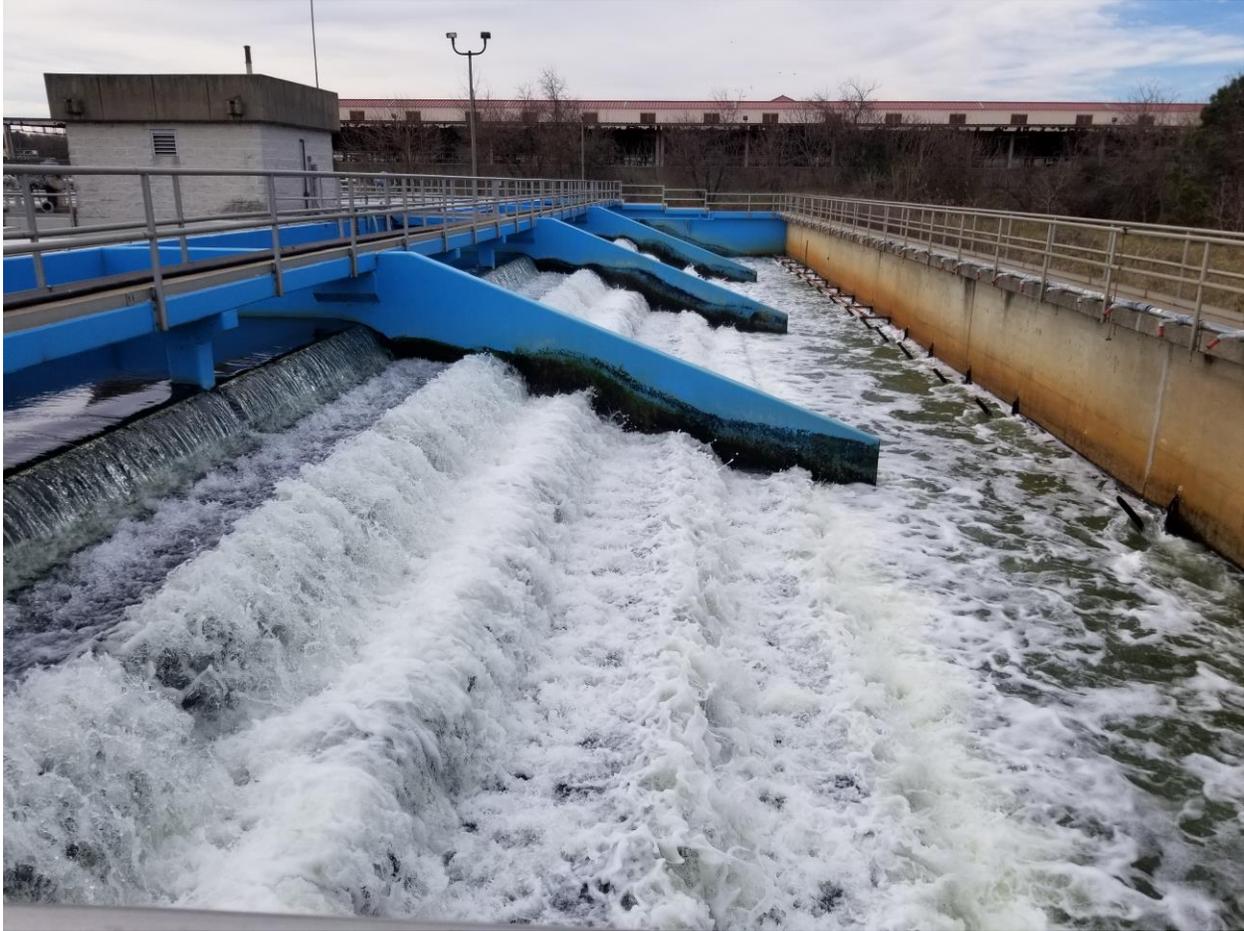
Next, I inspected the final effluent at the step aeration system. During an evaluation of the final effluent, I observed that the effluent was clear with no visible particulates.

2/24/23 Final Effluent at the step aeration system.
