Maryland Department of Environment
Water and Science Administration
Compliance Program
1800 Washington Blvd, Suite 420
Baltimore, MD 21230-1719
410- 537-3510, 1-800-633-6101

Site Name: Back River WWTP
Facility Address: 8201 Eastern Ave, Baltimore, MD 21224
County: Baltimore County

Start Date/Time: August 16, 2022 09:48 AM
End Date /Time: August 19, 2022 12:18 PM

Permit / Approval Numbers: 15DP0581
NPDES Numbers: MD0021555
Inspection Reason: Follow-up (Non-Compliance)
Site Status: Active
Compliance Status: Noncompliance
Site Condition: Noncompliance
Recommended Action: Continue Routine Investigation
Evidence Collected: Photos or Videos Taken, Record Review, Visual Observation
Delivery Method: Email
Weather: Dry Average

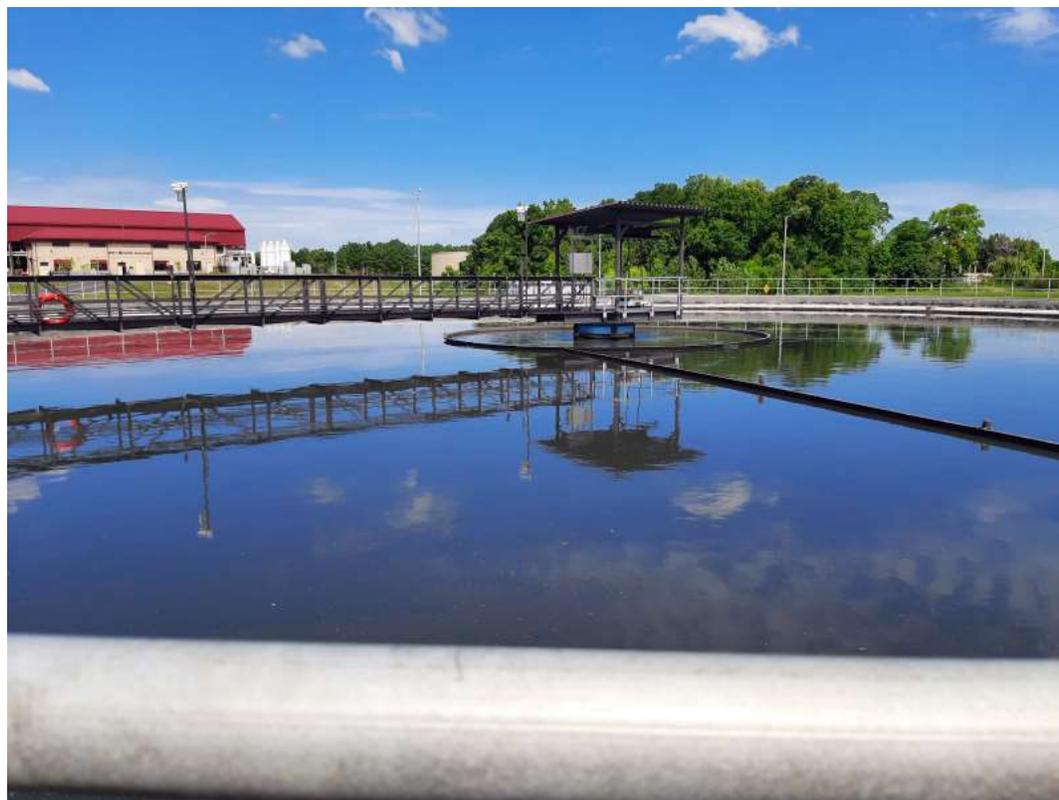
8/16/22 PST #1

There were no problems observed with the three PSTs #1, #8 and #11 that were online. These PSTs appeared to be functioning as designed and the skimmers were working on all three PSTs. The PST #5 is being cleaned of solids by the independent contractor, Badger Daylighting Corporation. As previously mentioned, PST #2 and #7 have been cleaned out and #7 is scheduled to be online in about one month bringing the number of active PSTs up to four.

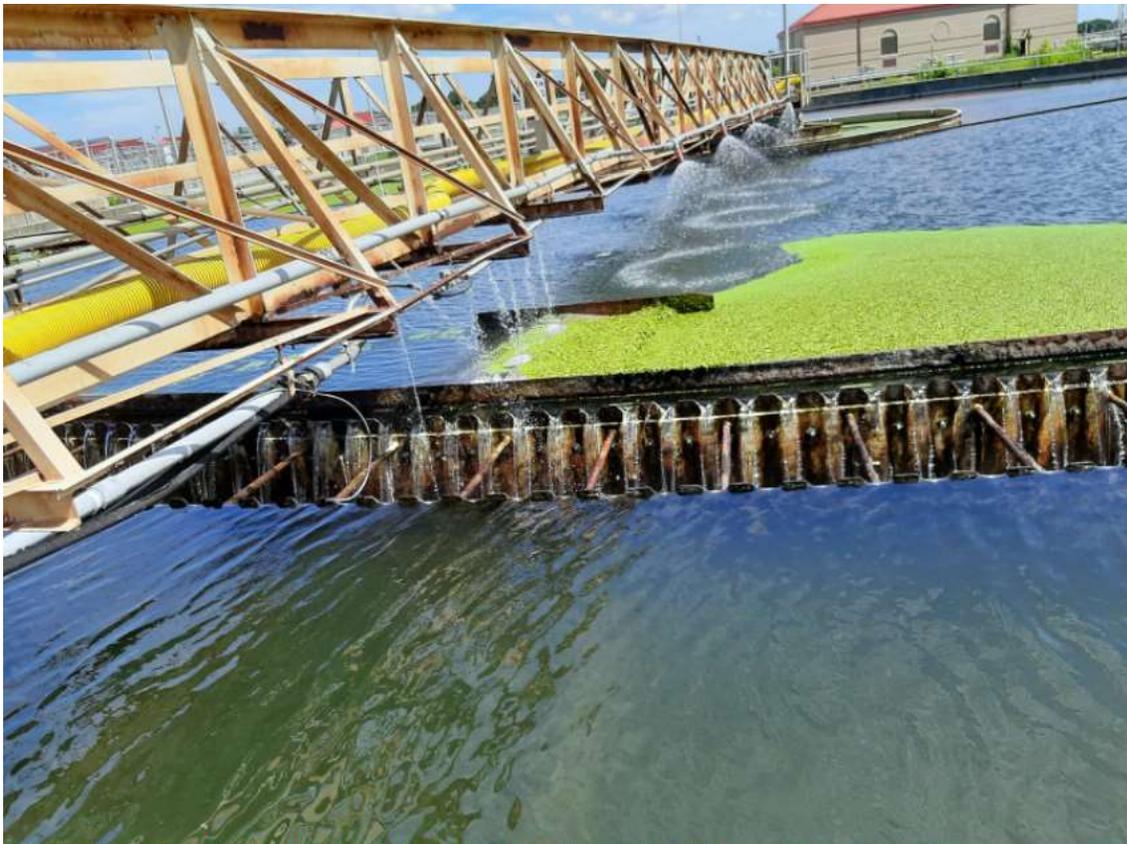
Next, I inspected the secondary clarifiers. During the preliminary meeting, I was told that seven of the 37 secondary clarifiers were not in service. However, I observed that secondary clarifier #13A was not functioning as designed due to floating vegetation that had clogged the scum collection opening to the scum pit. Due to the blockage, the skimmer cannot function as designed to collect the floating scum. According to Kroen, the crew from Badger was going to begin cleaning this clarifier today.

8/16/22 Secondary clarifier 13A. Opening to the scum pit is clogged. Water spray is being used to try to keep the pit open.

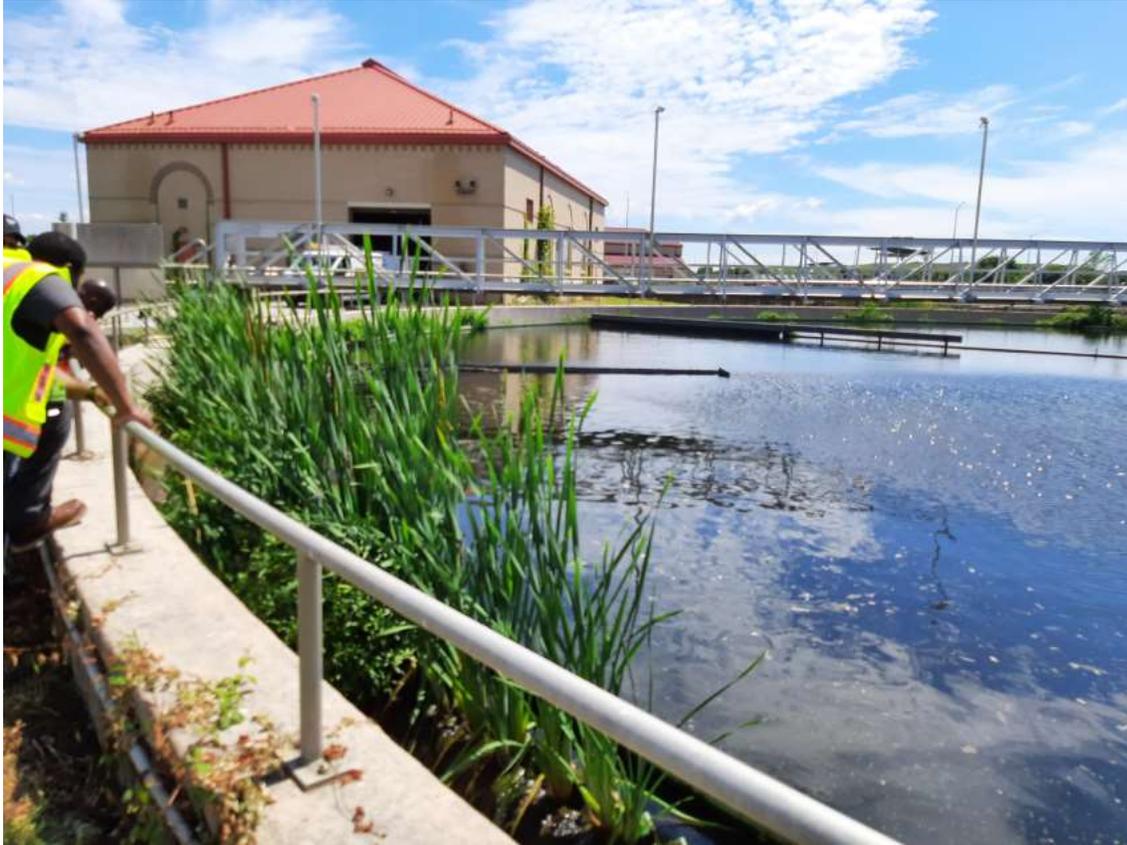
There was algae and vegetation growing on and around the weirs of the clarifiers that were being used for wastewater treatment. This is causing short circuiting of the weirs. This problem has been reported during previous inspections. According to Latova, the influent flow is down causing the water in the clarifiers to move through at a very slow pace causing the algae buildup. Control measures should be taken to address the problem on a continuous basis.

8/16/22 Secondary clarifier #5A. Reed grass growing on and around the weirs.

3. Algae and vegetation were observed on and around the weirs of the secondary clarifiers that is causing the short circuiting of the system. This condition can impact TSS in the waste stream being treated. In addition, vegetation on the surface of the water of the clarifiers is preventing the adequate removal of surface scum. This has been an ongoing problem that has not been resolved due to unsatisfactory maintenance. On August 5, 2022, the Department received a letter from Baltimore City DPW stating that Badger Daylighting (Badger) has submitted a proposal and scope of work to clean algae and vegetation from 24 of the secondary clarifiers. As noted in this report, Badger was onsite during this evaluation. The cleaning of the clarifiers by Badger will correct current unsatisfactory conditions in the secondary clarifiers but the one-time cleanings are not a long-term solution to this problem.

- C. With respect to item #3 above, the weirs on the secondary clarifiers shall be routinely inspected and scrubbed as necessary to prevent aggressive algae growth. All vegetation shall be removed from the secondary clarifiers and routine maintenance shall be performed to prevent recurrences of the problem.

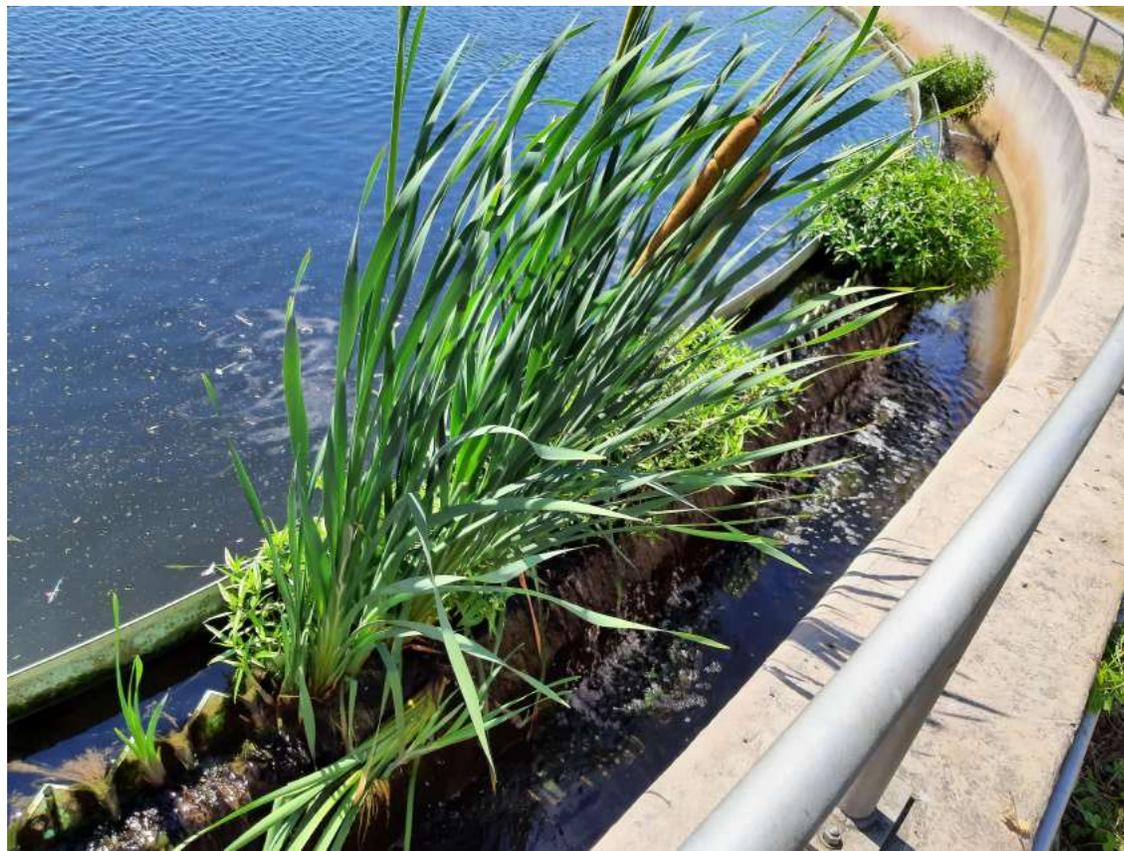
Algae growth in secondary clarifiers is a common problem for all uncovered weirs on secondary clarifiers. It requires regular measures to keep the problem under control. Algae can cause problems with total suspended solids (TSS) within the treatment system and can cause problems with pumps by increasing the chance of clogging. The weirs on all secondary clarifies should be routinely scrubbed to remove the algae or other control measures as deemed necessary.

8/16/22 Vegetation on the weir of a secondary clarifier

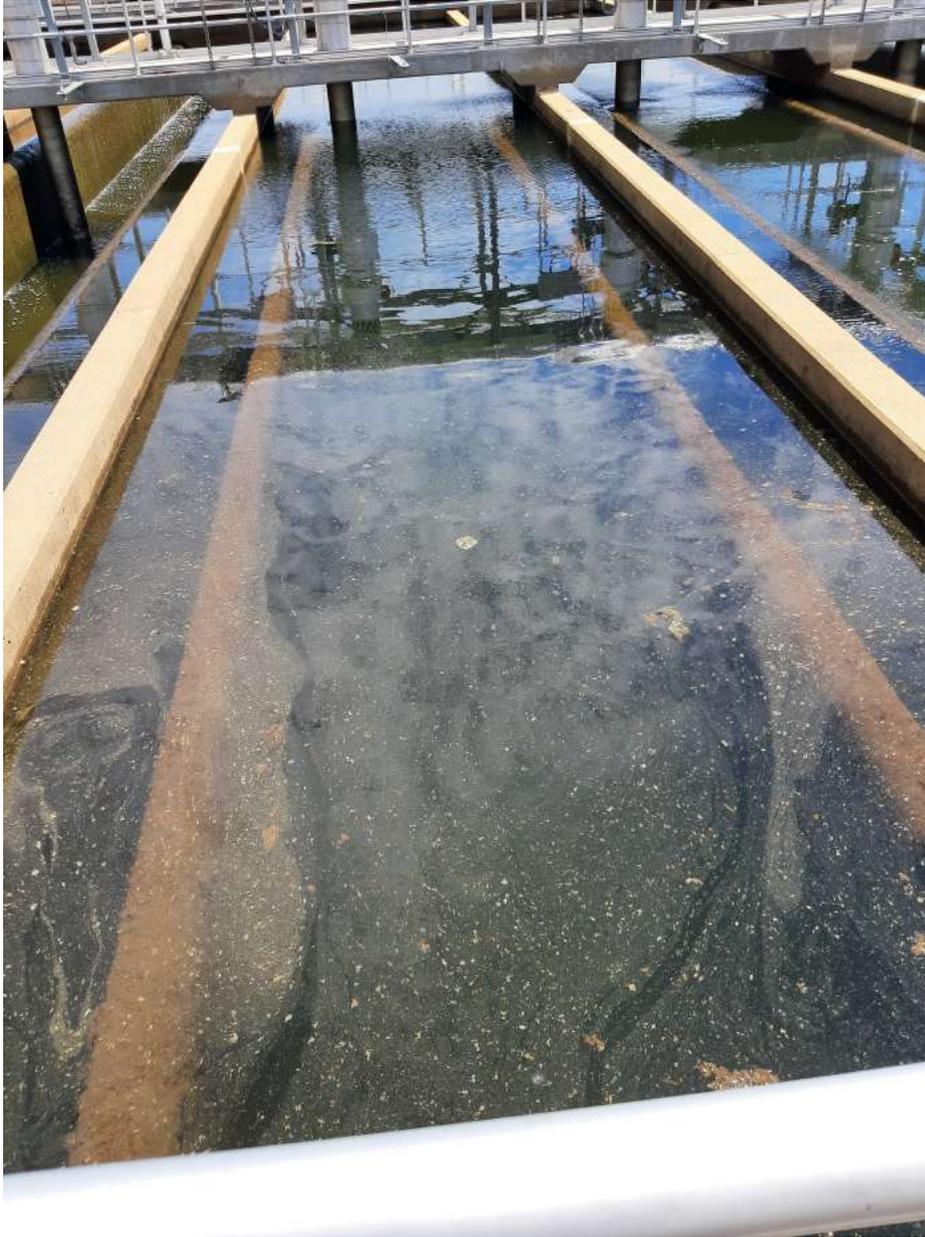
During an inspection of the filters in quads #1 and #2, I found that not all of the filters were functioning as designed. I asked Foreman, to accompany me to quads #1 and #2, and showed him that some of the filters were not functioning as designed. Many of the filters were submerged under the wastewater being treated. According to Foreman, the filters contained solids that were preventing them from filtering and functioning properly. He further indicated that these filters need to backwash to remove the solids. I asked him why the filters had not been backwashed. He indicated that the filters are being backwashed; however, only one filter per quad can be backwashed at a time. Foreman further stated that the filters were functioning satisfactorily on the previous day, but around 3:00 a.m. this morning they received influent with a high solids concentration much higher than the filters were designed to treat. According to Foreman, the filters were not designed to handle influent with a solid's concentration of more than 10 milligrams per liter. He stated that he collected a sample of the influent, which he later showed to me and Buie-Branam. The sample had settled and floating particles.

8/16/22 Submerged filter

1. There are not enough qualified staff to adequately operate and maintain the Back River WWTP.
2. The DNF are not functioning as designed and many of the filters were submerged under the wastewater entering the filters because of solids clogging the filters. Consistent backwashing is required to unclog the filters and keep them functional. According to the ProStart operator, solids concentrations going into the filters are sometimes above what the filters are designed to handle. In addition, during the nitrogen release cycle or bump, some of the filter media is rising to the surface and entering the clear well. This media may compromise downstream processes and equipment. During the 6/2/22 Compliance evaluation report, it was determined that the DNF required service due to various mechanical reasons or were clogged preventing satisfactory performance. The permittee was required to submit, by August 10, 2022, a status report to the Department detailing the status of all 52 DNF with a scheduled date for all maintenance and repair items. In a response letter dated August 5, 2022, Baltimore DPW informed the Department that the electrical problems associated with the performance of the DNF has been addressed by temporary means and reported the following: “ENEY Electric has completed all work to provide temporary power supply to Quad #2. All but one filter are operational as of August 4, 2022. ProStart is developing a contract with ENEY Electric to supply a permanent power supply”. The Back River WWTP has only addressed the power supply problem required to bring the DNF in Quad #3 online. The problem with the clogging of the filters in all four Quads has not been addressed. During this 8/16/22 inspection, I found that filter #11 in Quad #3 was down for repairs and twelve filters were submerged due to clogging by solids.

- B. With respect to item #2 above, the Back River WWTP shall adequately address the problem associated with the DNF quads to comply with II Special Condition 2A footnote ⁵, which states that “The permittee shall operate the ENR facility in a manner that optimizes the nutrient removal capability of the facility as stipulated in the Grant Agreement for ENR upgrade”. Within 30 days of the receipt of this report, the Back River WWTP shall provide to the Department a strategic plan for the control of solids into the DNF system to prevent the clogging of the filters in order to optimize and enhance nutrient removal.

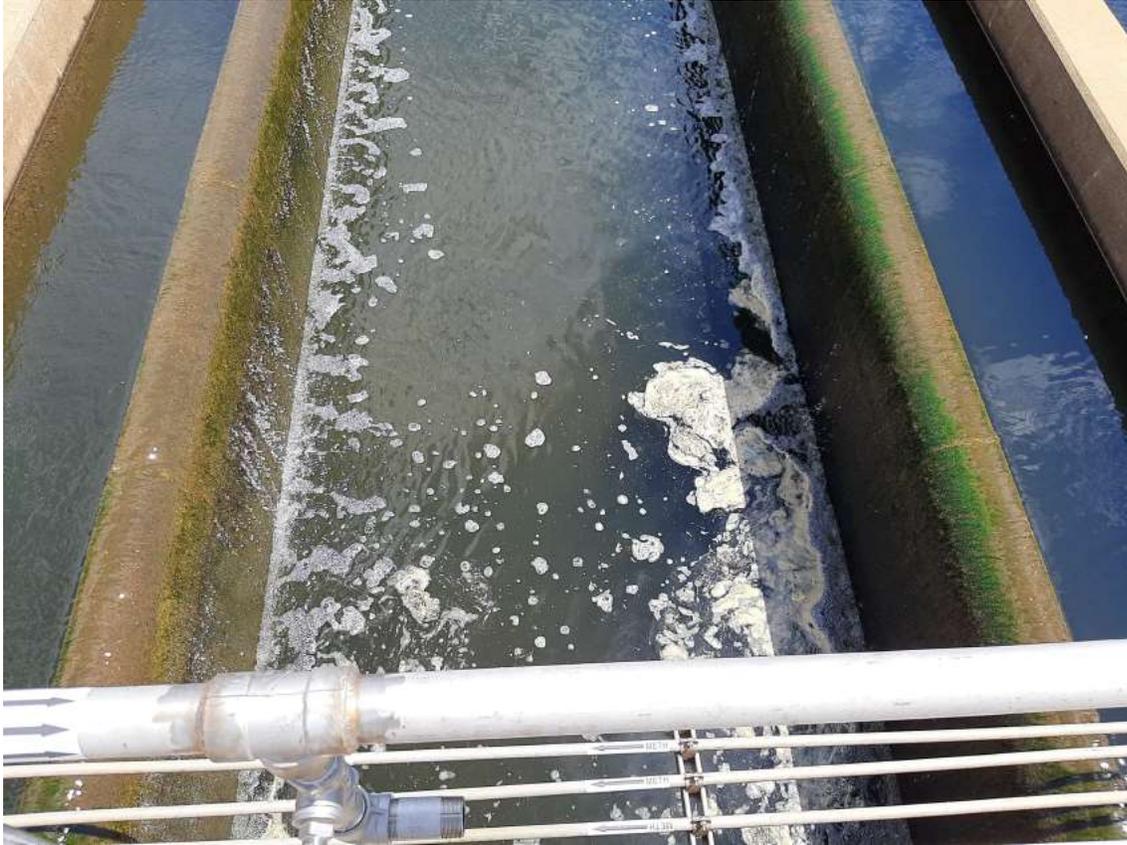
8/16/22 DNF with floating scum layer

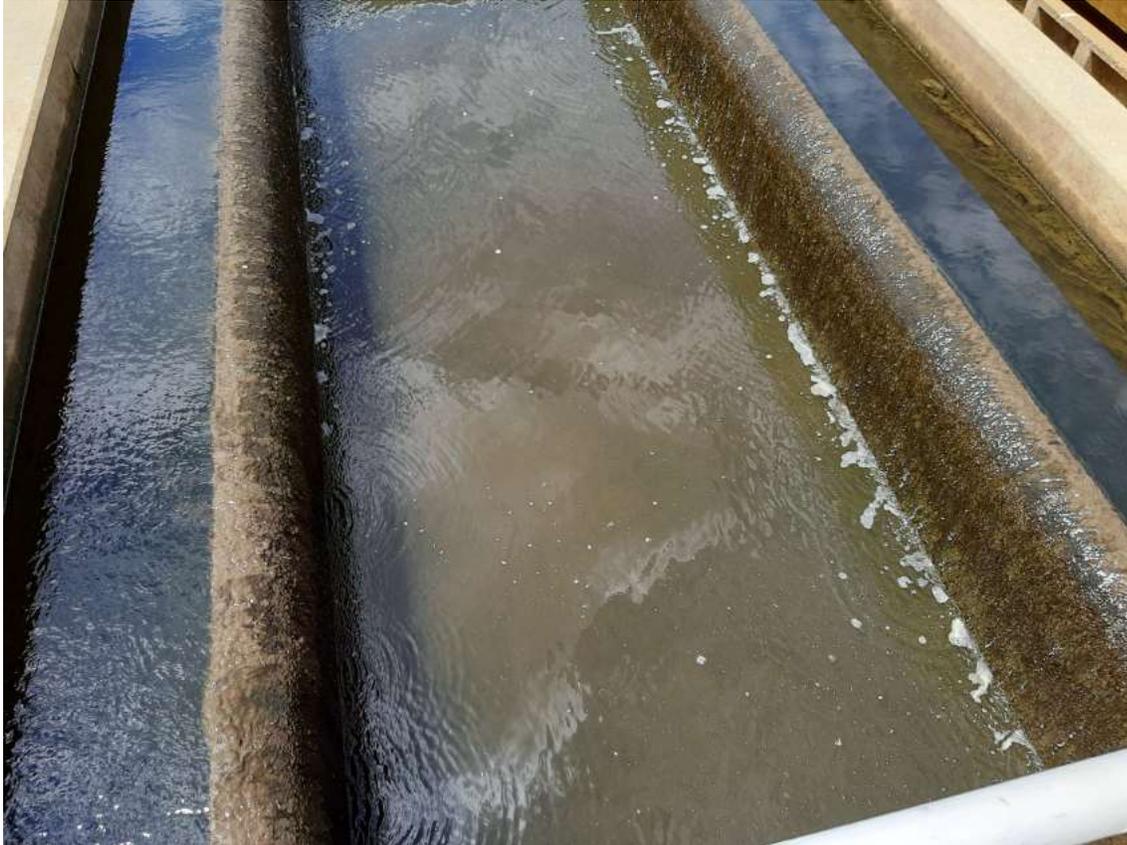
8/16/22 DNF in Quad #3 Note dark grey water showing high solids concentration

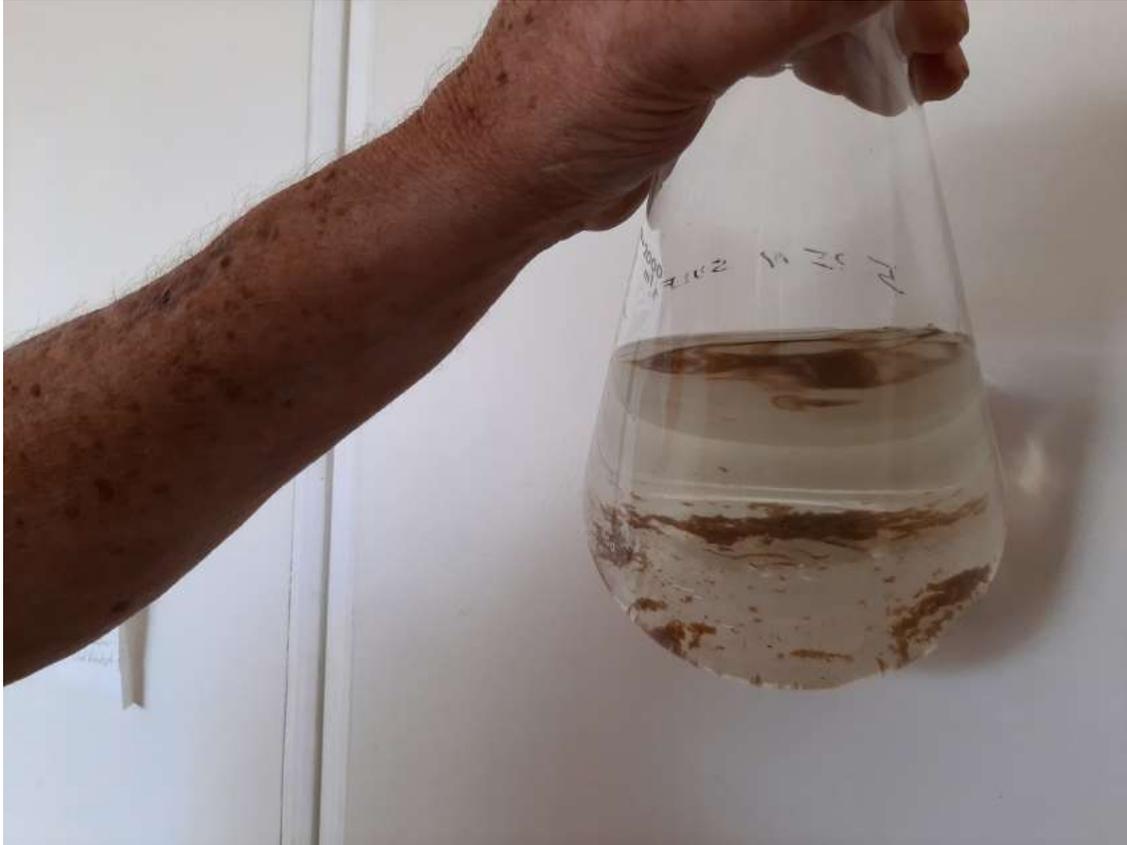
8/16/22 Sample of influent with high amount of suspended solids entering the DNF system at approximately 3:00 a.m.

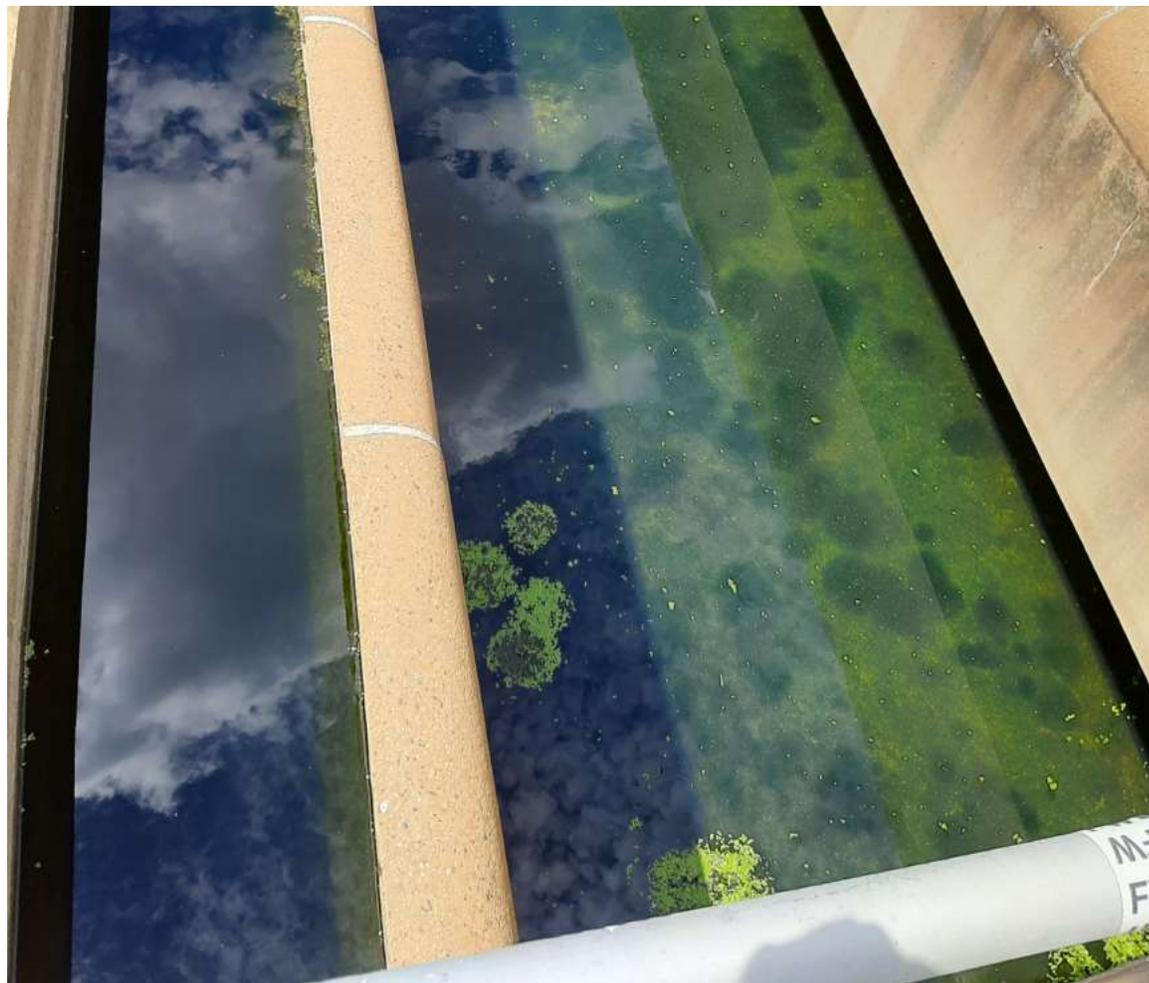
6/16/22 Quad #3 filter #11 out of service filter.

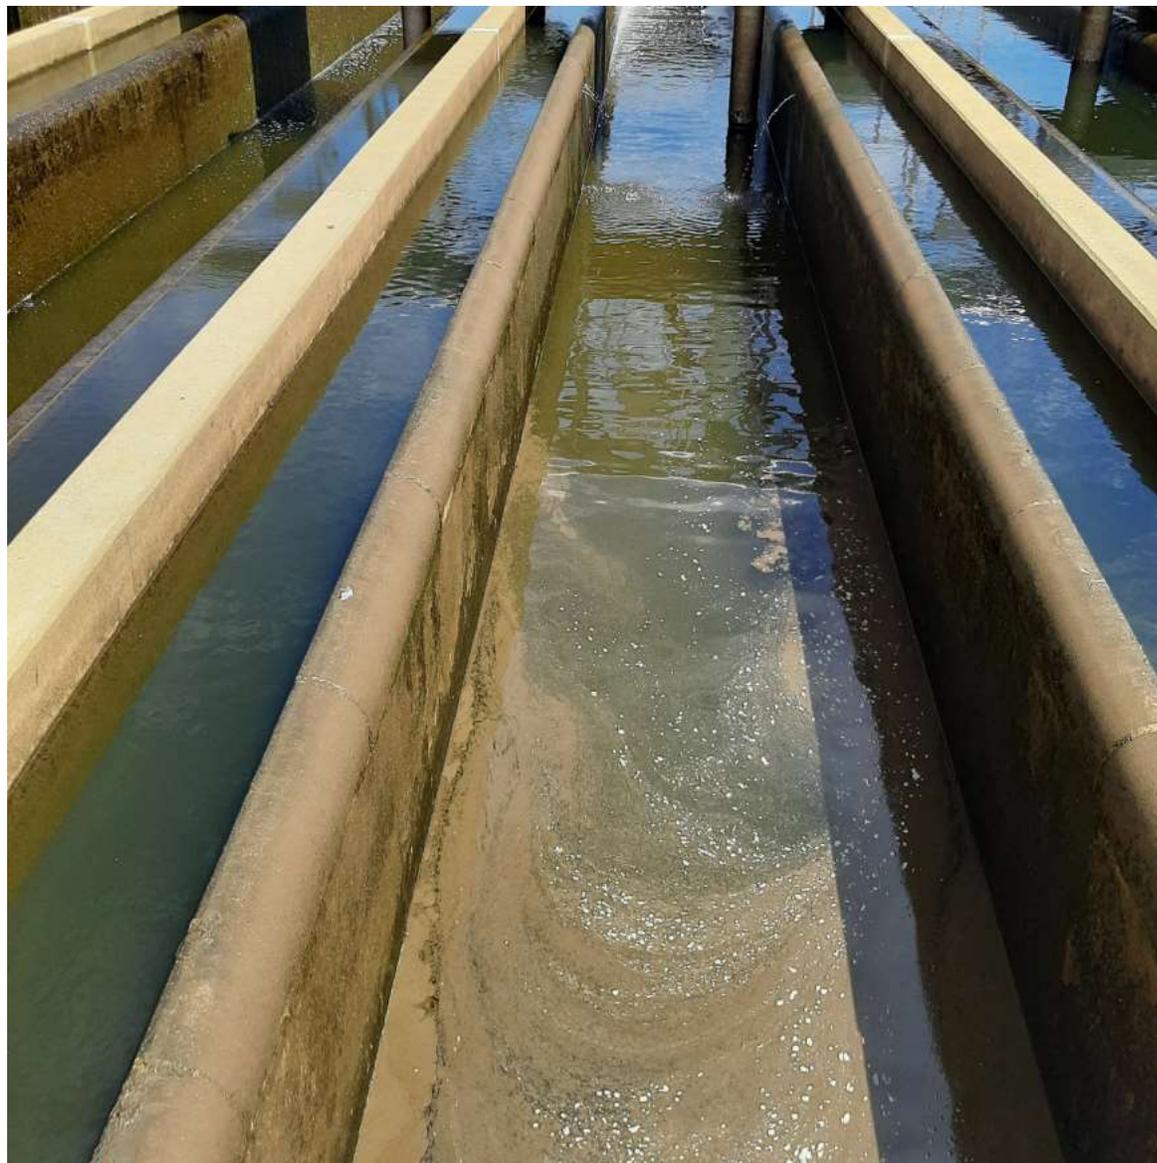
8/16/22 Solids in filter located in Quad 3. This should be investigated.

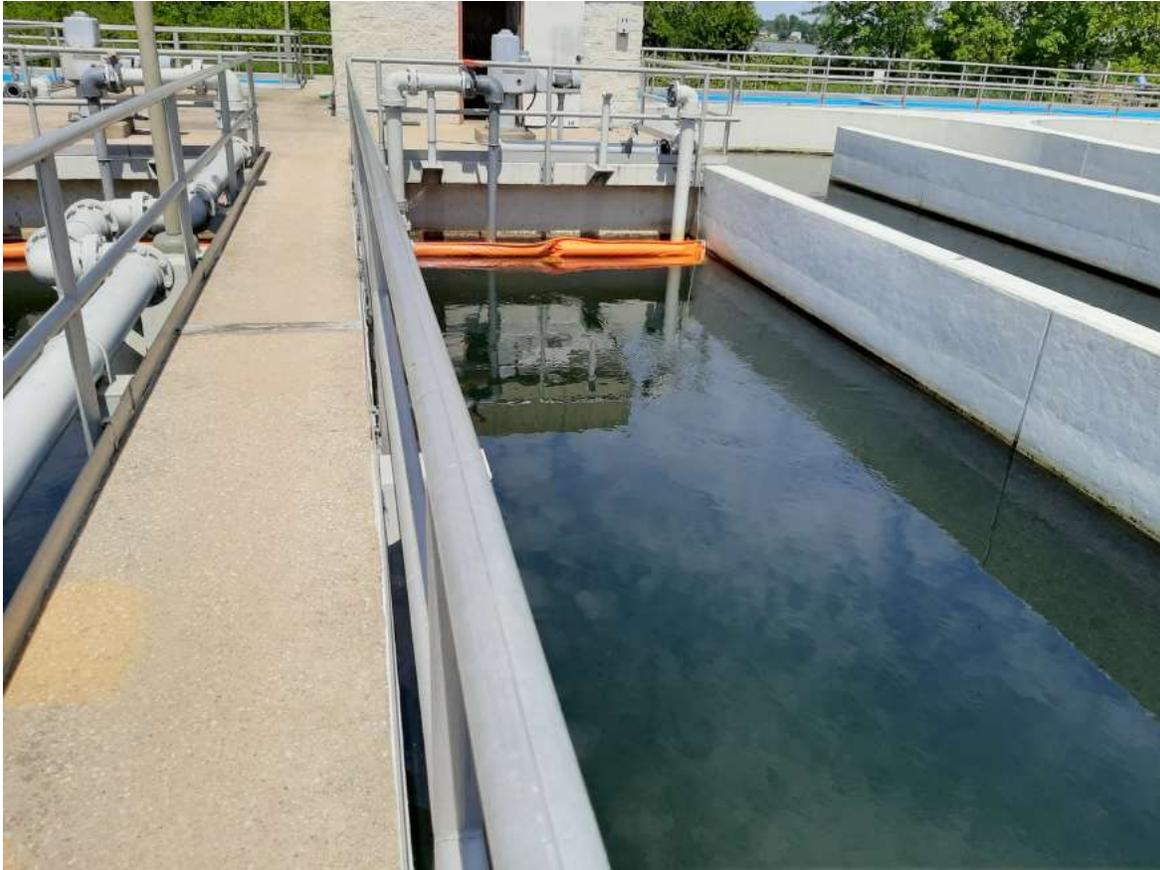
small portion of the floating solids were floating through. Today, I observed that the Back River WWTP has installed additional booms downstream of the original booms as an extra measure. There was no evidence of floating material breaching the final booms during this evaluation.

8/16/22 Recently installed booms since the last evaluation

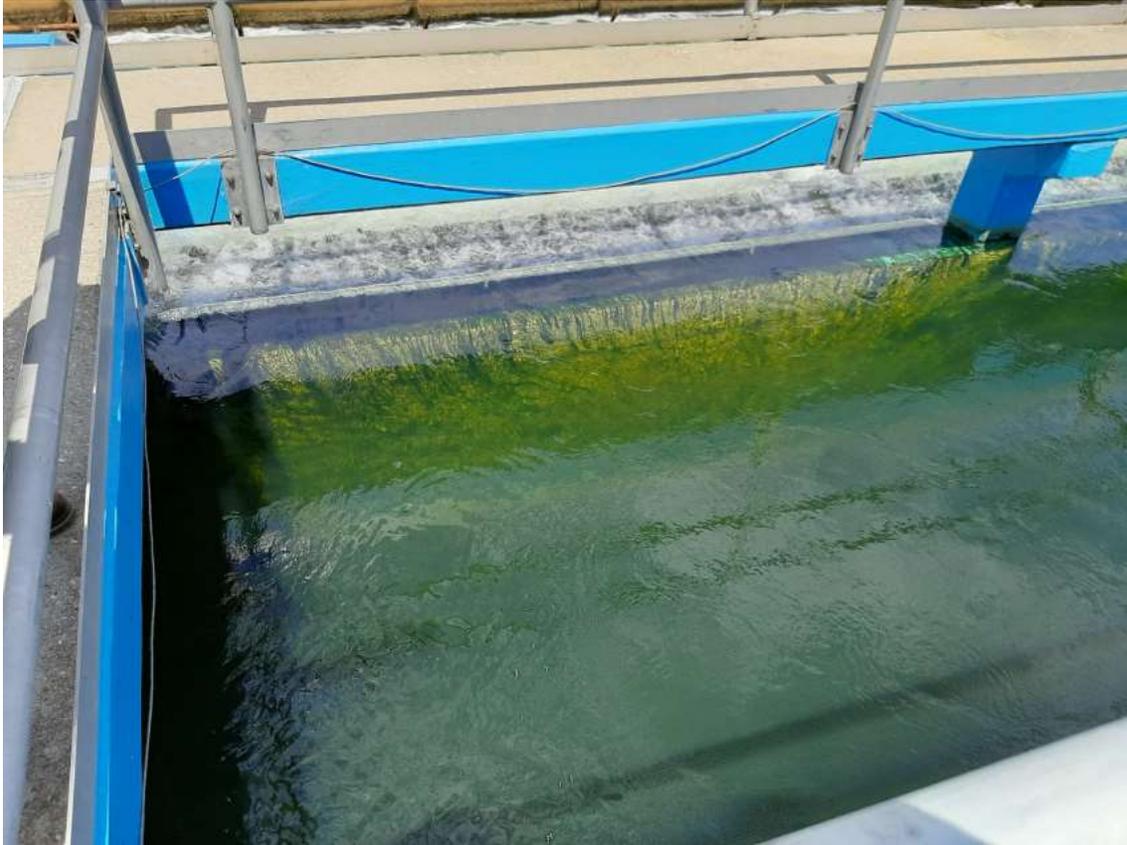
Next, I inspected the final effluent at the step aeration system and at the sampling station. I found the final effluent to be clear with a slight green tint and no suspended or floating particulates.

8/16/22 Final effluent prior to step aeration

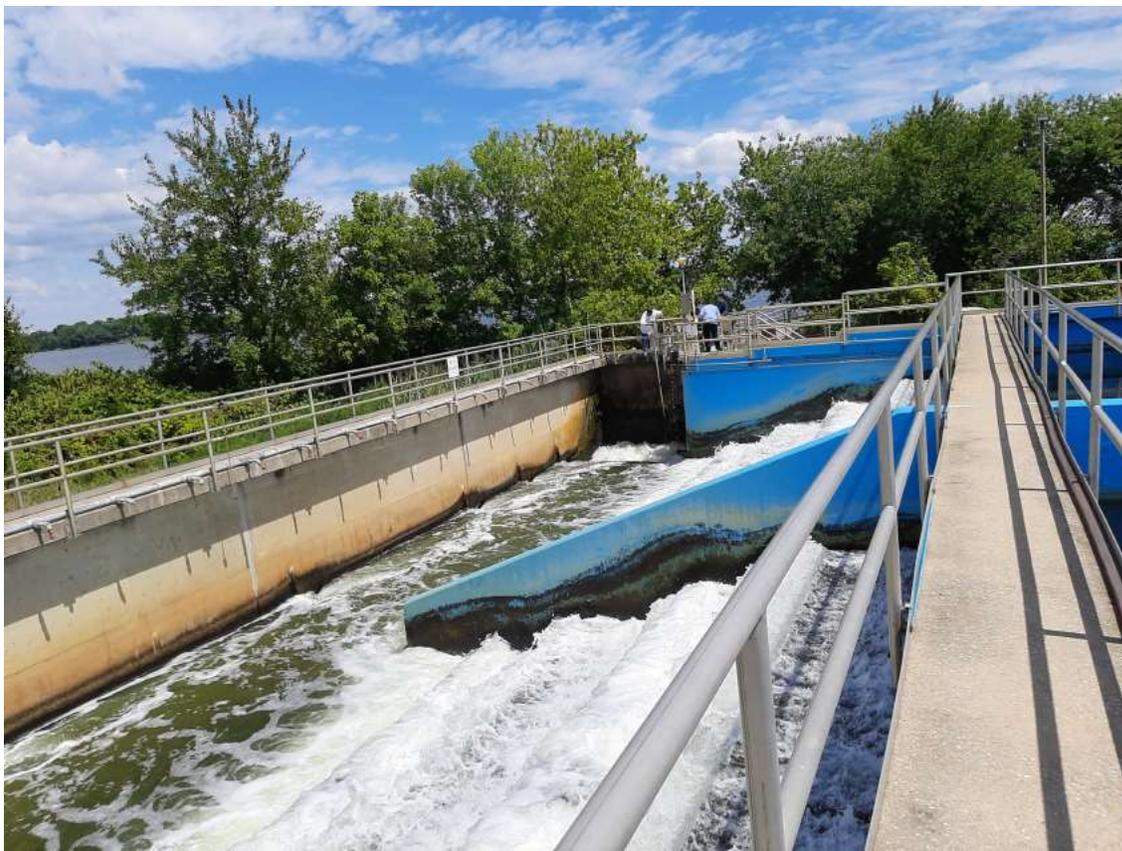
8/16/22 Final effluent at step aeration system
