Maryland Department of Environment

Site Name: Back River WWTP
Facility Address: 8201 Eastern Ave, Baltimore, MD 21224
County: Baltimore County

Inspection Reason: Follow-up (Non-Compliance)

Today, a follow-up inspection was conducted for compliance with NPDES permit #MD0021555, and state discharge permit #15-DP-0581 at the Back River WWTP. The permit effective date is May 1, 2018 , expiration date of April 30, 2023. I was joined by Environmental Compliance Specialist Kari Hanson and Joseph Miller with the Maryland Department of the Environment (MDE or the Department), Water and Science Administration, Compliance Program.

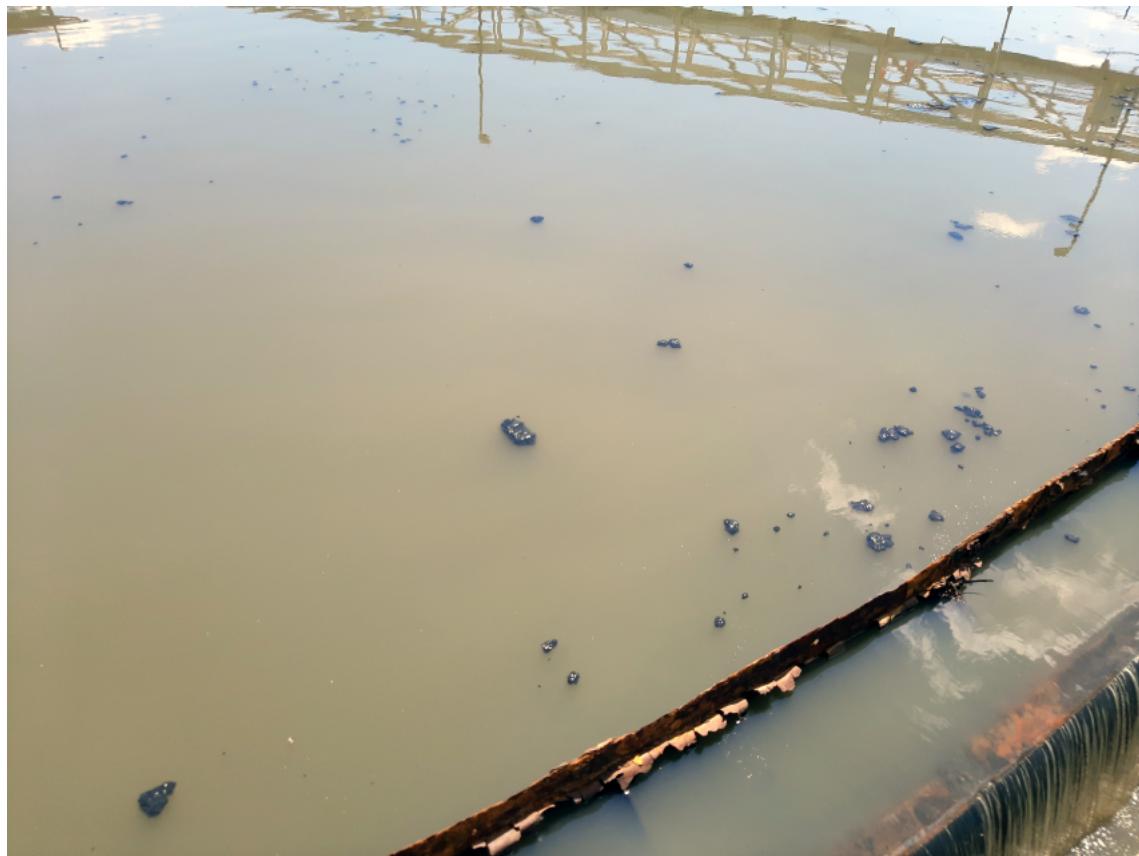
During the inspection of PST #1, I observed that the scum rake did not appear to be working and there were a lot of floating black solids similar to what I have observed in the CCC and secondary clarifiers. This condition is caused by anoxic conditions in the water due to over-aged sludge. According to Latova, problems developed with the pump and the skimmer arm after getting the PST online. He explained that the ingoing lines have been closed since the PST has been offline. The black balls were in the lines and when the valves were opened the black balls entered the PST.

7/14/22 PST #1 when not functioning.

I was informed by Latova on July 18, 2022 that the repairs had been made to PST#1 by the service contractor, Ross Technical Services, and it was now functioning satisfactorily.

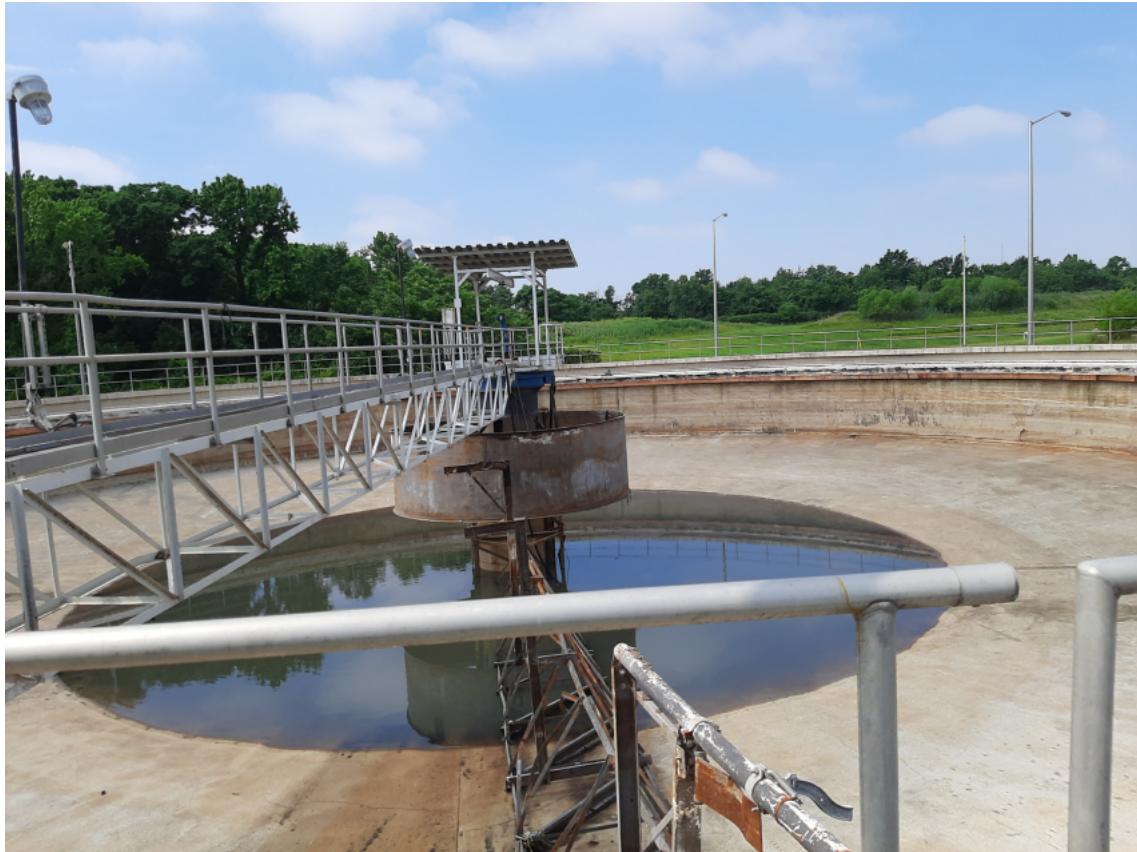
7/14/22 PST #7 was recently cleaned by MES. Parts are on order and this PST is scheduled to be online in August 2022.

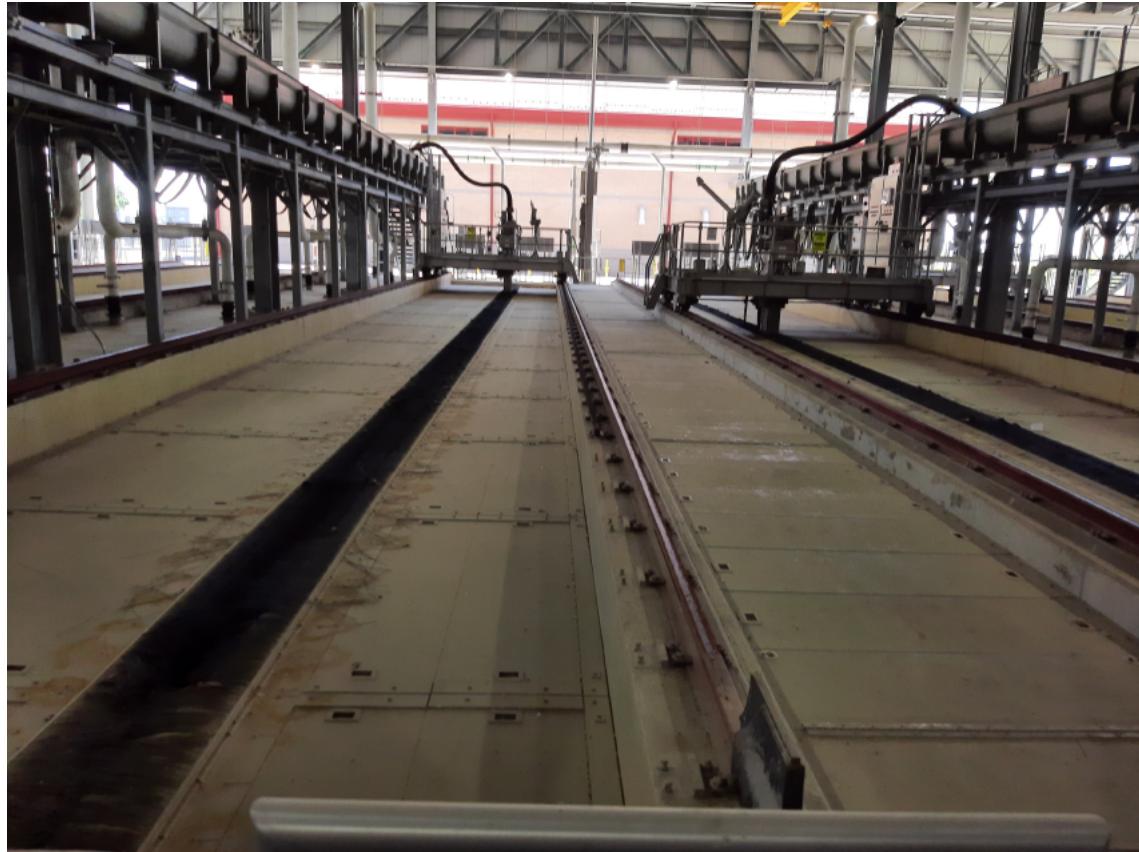
7/14/22 Grit removal system - Traveling Bridges suction the grit from the tanks to overhead conveyors that convey the grit to a dewatering system consisting of spinning classifiers.

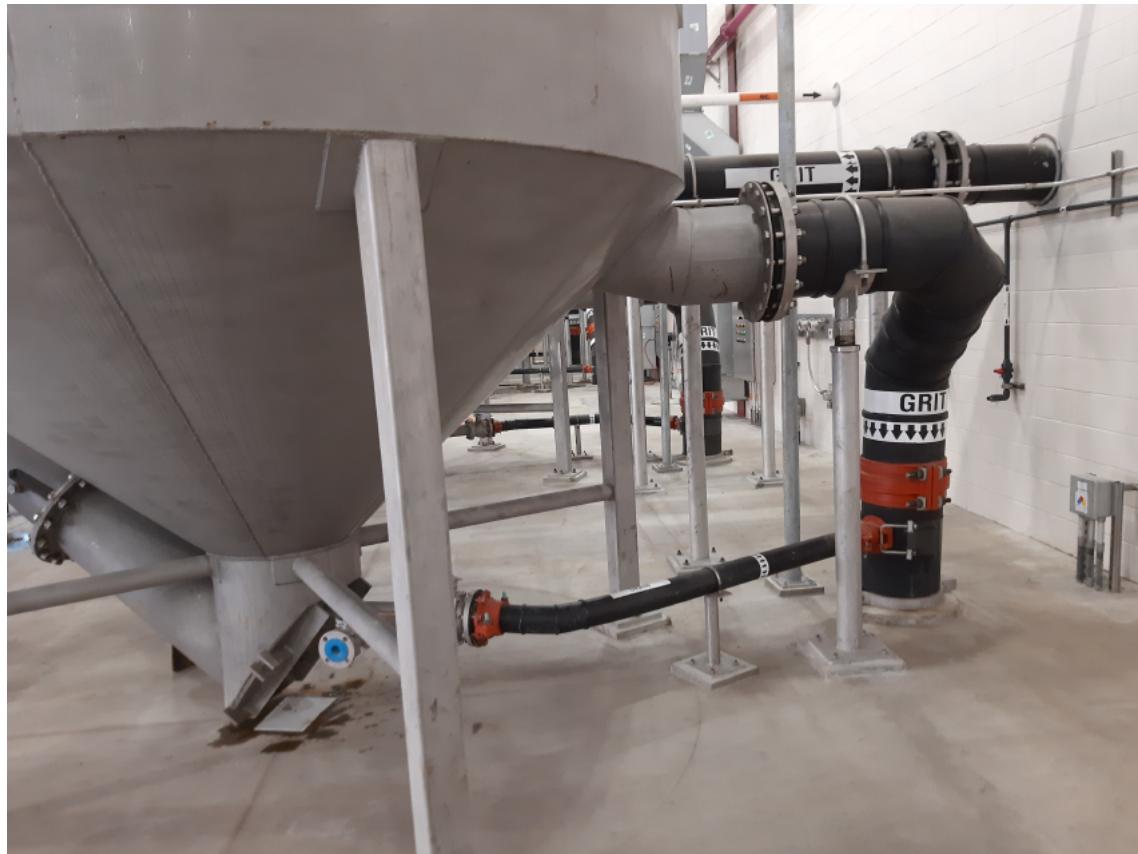
7/14/22 Grit dewatering system

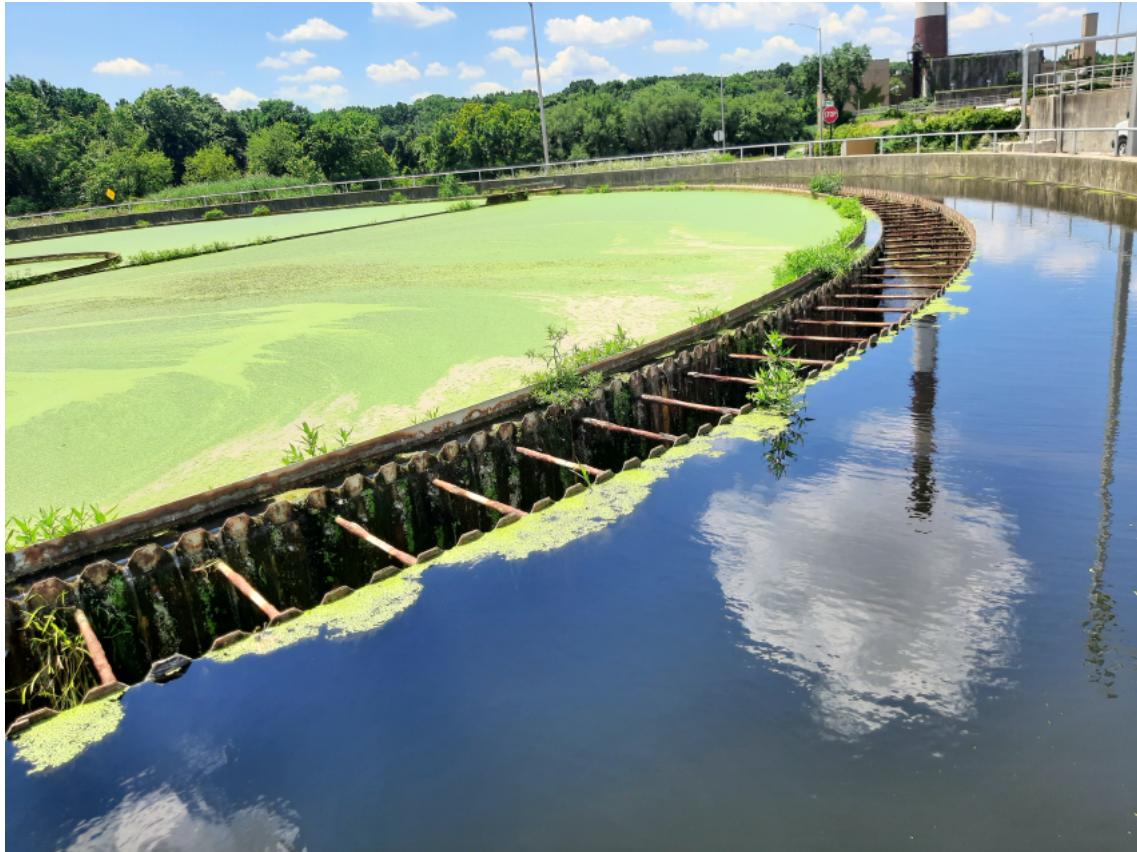
Activators #2, #3, and #4 have 36 associated clarifiers and during this inspection, 34 were online. During an inspection of the clarifiers for the Activator #2 and Activator #3, I observed problems with maintenance, operation, and performance of the clarifiers. There was algae, duckweed and vegetation growing on and around the weirs of the clarifiers. This is causing short circuiting of the weirs. **This problem has been reported during previous inspections.** According to Latova, the influent flow is down causing the water in the clarifiers to move through at a very slow pace causing the algae buildup. Steps should be taken to manually scrap the weirs.

7/14/22 Blocked weirs due to algae and vegetation causing short circuiting of the weirs.

As stated in the March 22, 2022, inspection report, algae growth in secondary clarifiers is a common problem for all uncovered weirs on secondary clarifiers. It requires regular maintenance to remove and is a normal maintenance issue for these secondary clarifiers. Algae can cause problems with TTSs within the treatment system and can cause problems with pumps by increasing the chances of clogging. The weirs on all secondary clarifiers should be routinely scrubbed to remove the algae. This should be done at least weekly in the summer and more frequently as necessary. The algae and vegetation should be removed from all of the secondary clarifiers. On July 21, 2022, per my request, the plant manager, submitted to the Department a service proposal from Badger Hydrovac to clean all of the secondary clarifiers. The contractor will clean the 24 final clarifiers as the plant can operationally make them available. Once cleaned, the Back River WWTP should conduct proper maintenance of the secondary clarifiers.

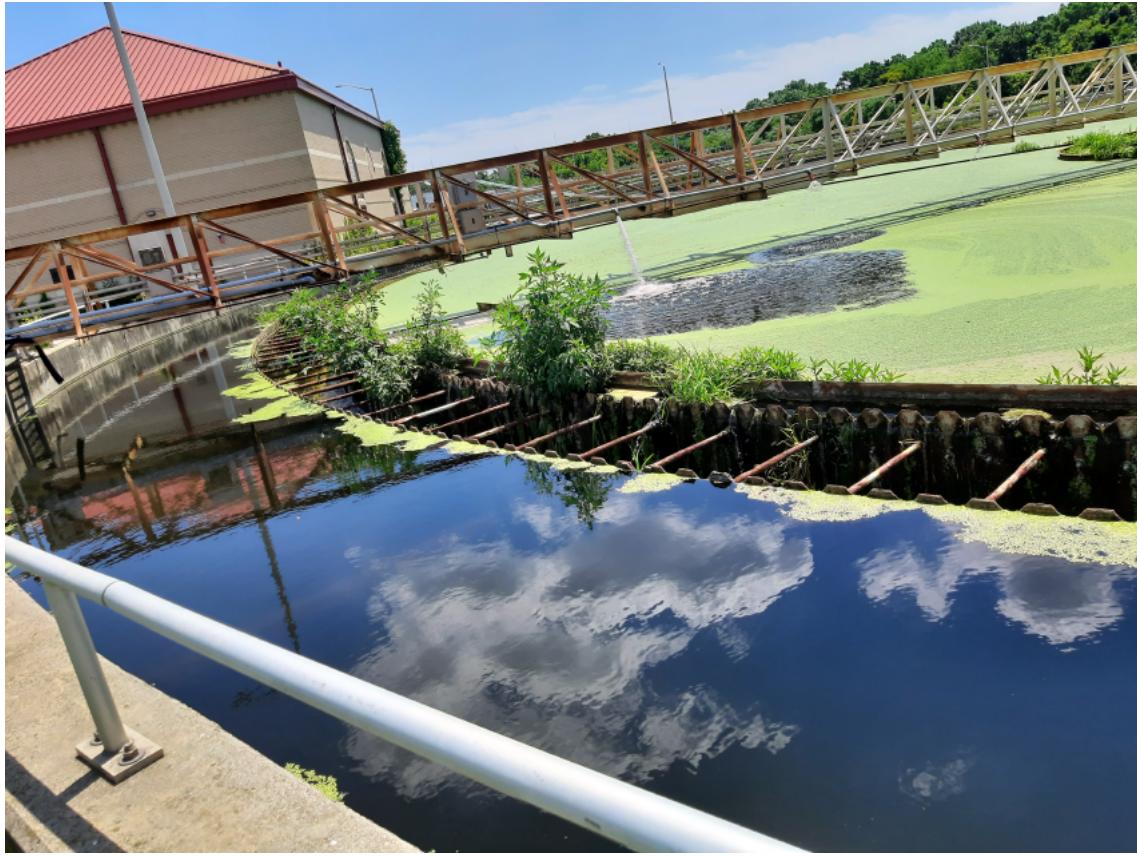
7/14/22 Vegetation growing in the secondary clarifiers that are compromising settling.

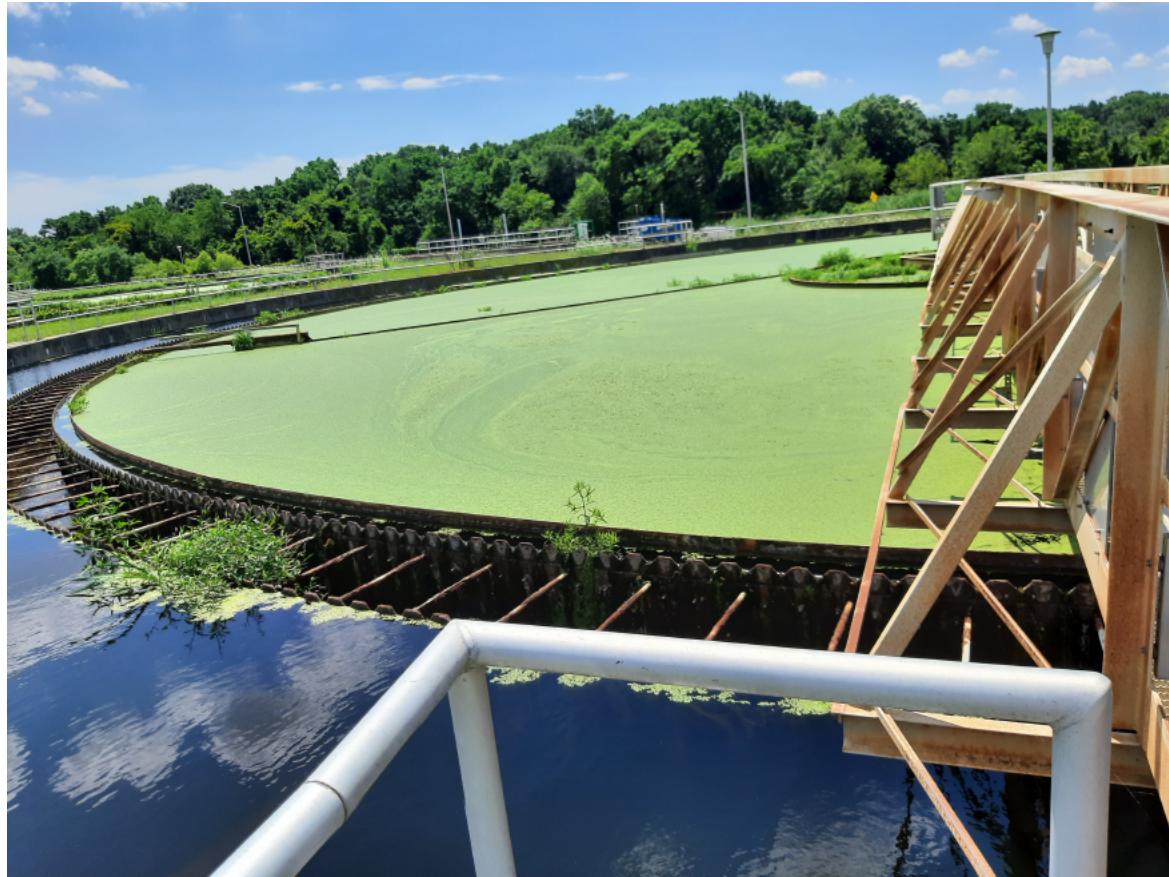
7/14/22 Vegetation and algae causing short circuiting of the weirs on the secondary clarifiers and large amounts of vegetation in the stilling well and floating on the surface of the water in the clarifiers.

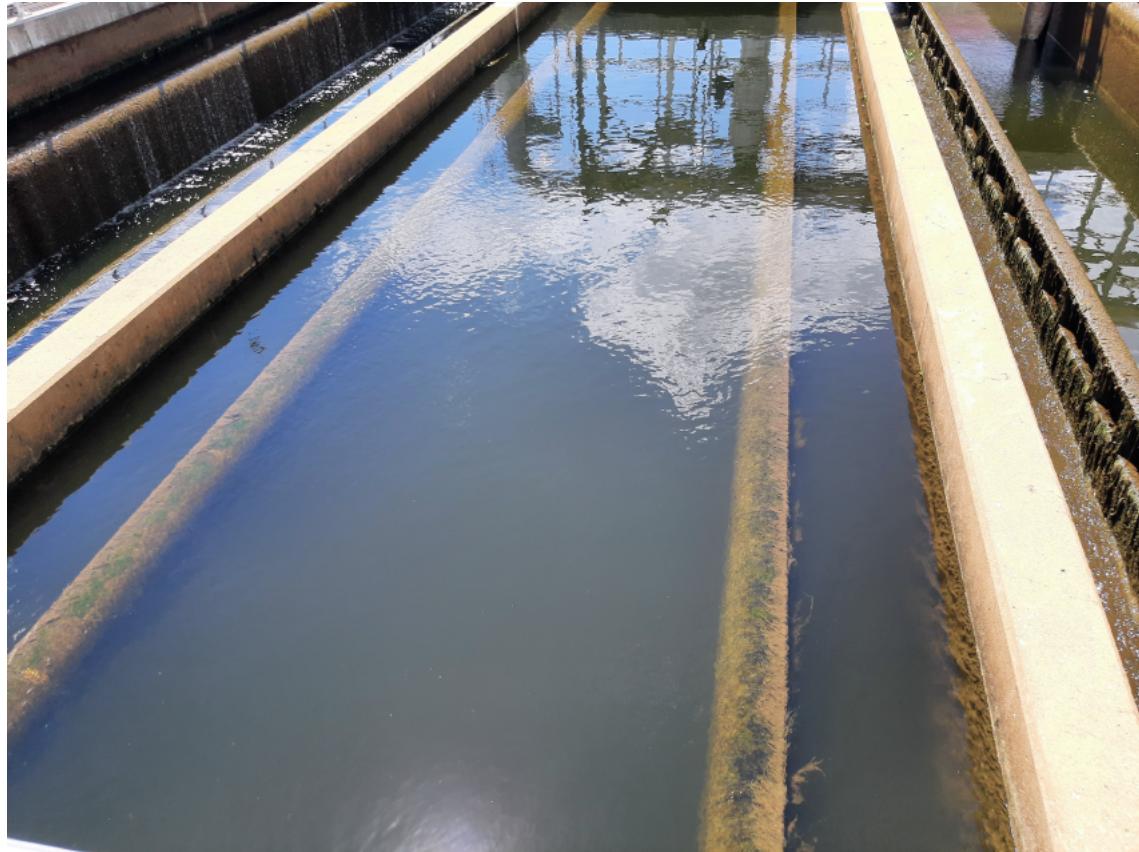
During an inspection, I found that the DNF was in various stages of disrepair. **Although there were problems, the DNF was in much better condition than I found during the June 2, 2022, inspection.** Some of the filters were submerged under water due to clogging. The water was moving through the filters, but due to being submerged there was minimal filtration. Some of the filters had a layer of floating solids and the remainder contained stagnant water with either floating scum or floating black sludge. With flow rates down, I observed that some of the overflow weirs were not level, and the overflow of water was limited to a small section of the filter. There was also a breach in the filter that should be addressed to prevent a greater issue at a later date. Midge flies were observed around the DNF.

7/14/22 Submerged DNF filter

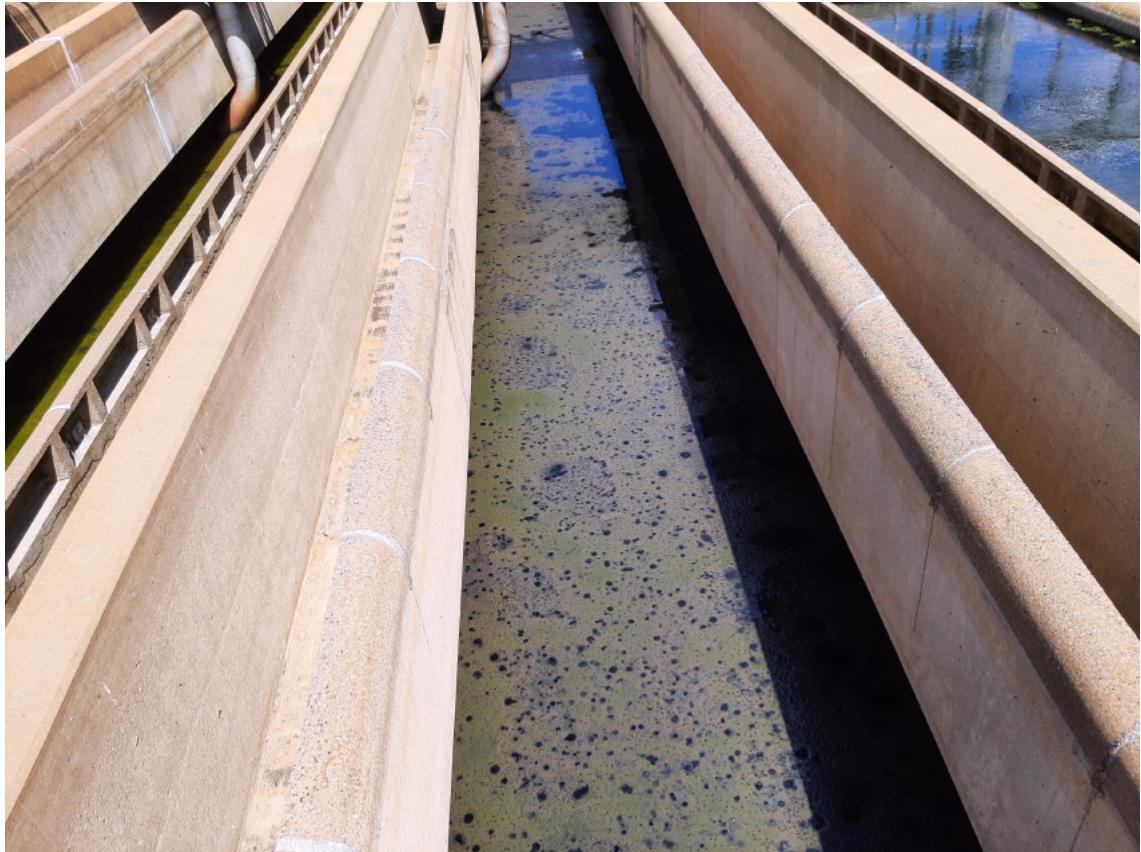
7/14/22 Nonfunctioning DNF with stagnant water

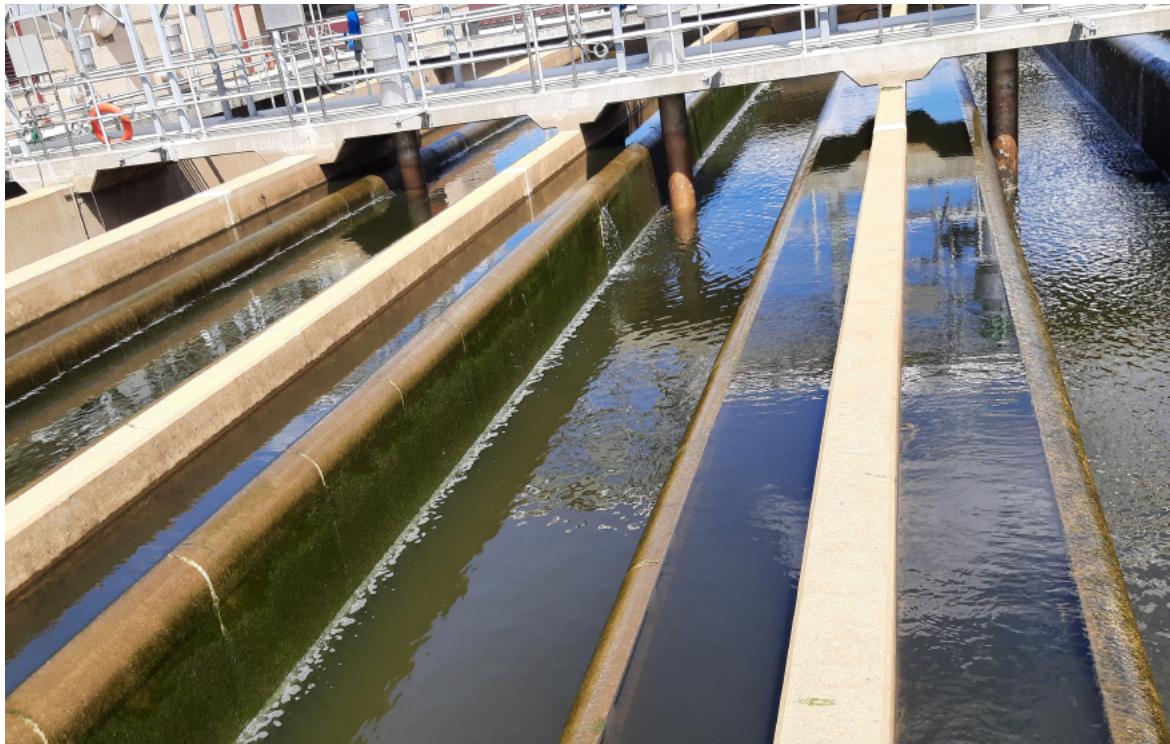
7/14/22 Floating solids

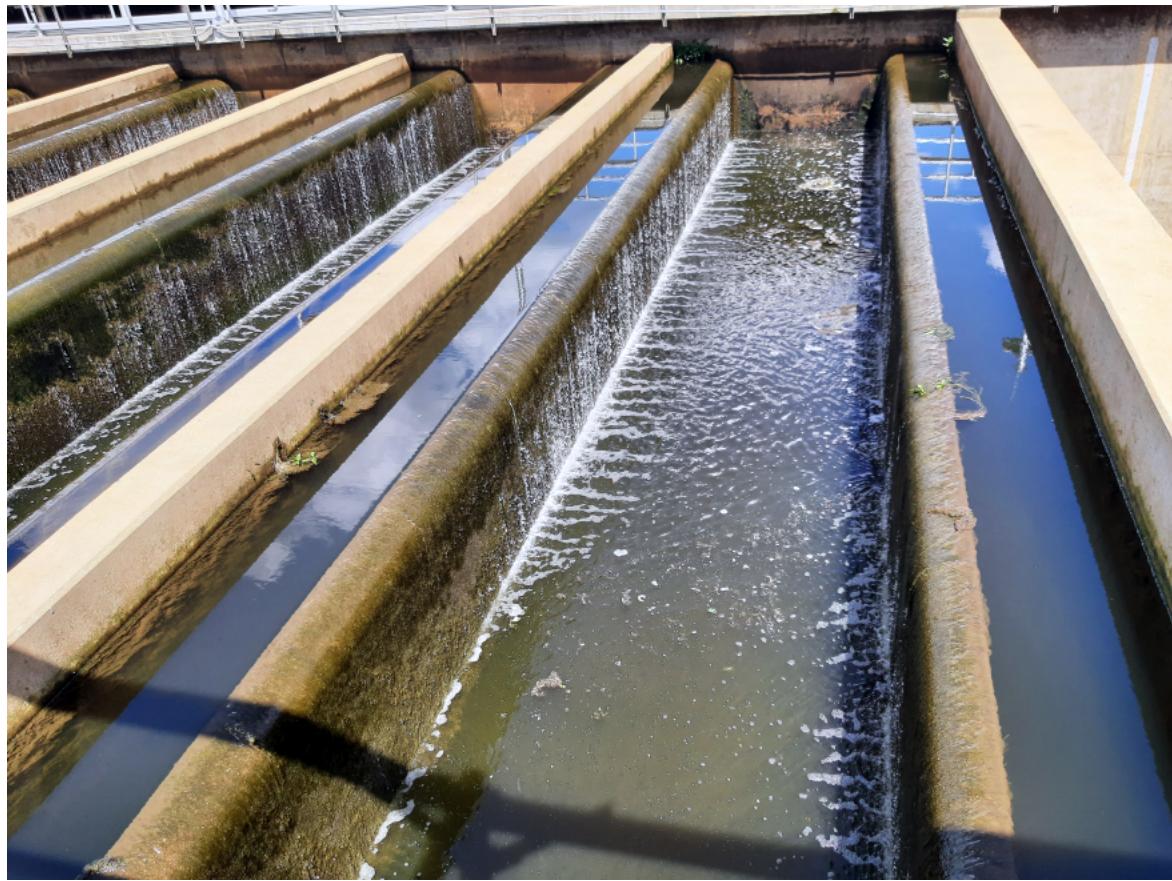
7/14/22 Unlevel weir. Overflow limited to the far end.

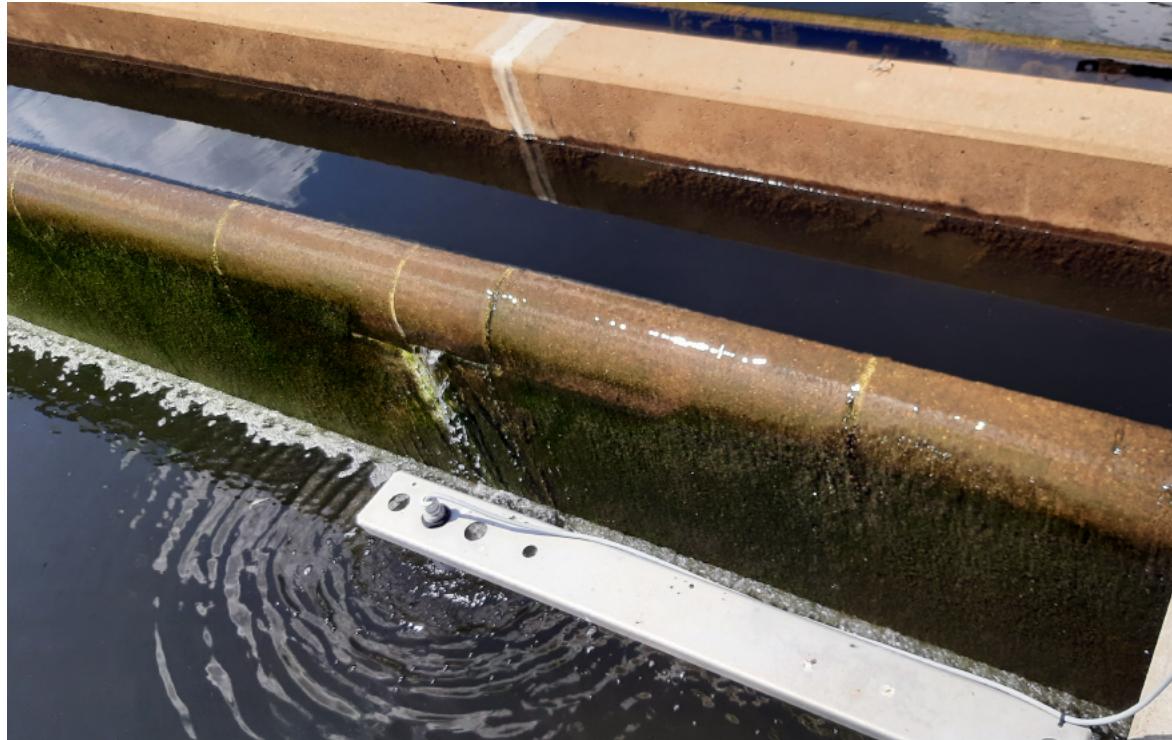
7/14/22 Water breach near the top of the weir

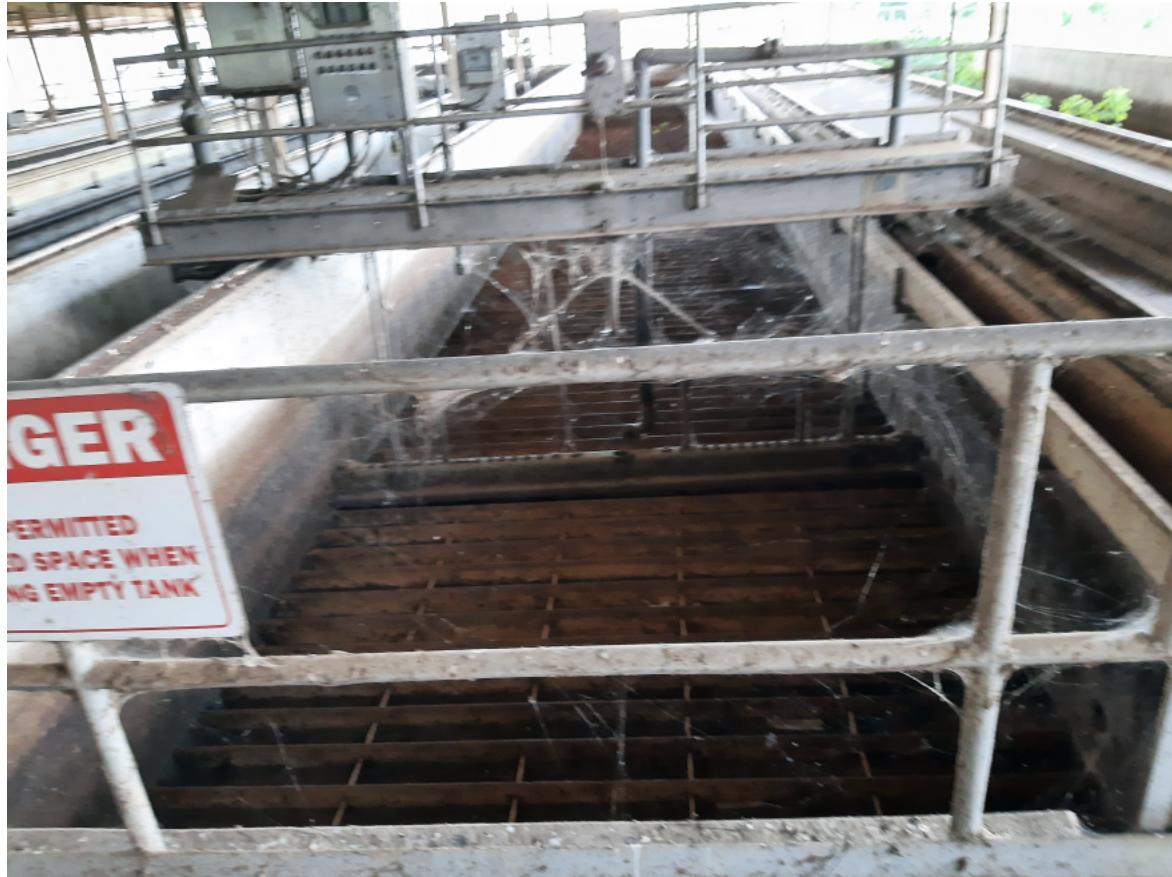
The effluent from the DNF flows to the clear well and then to the sand filters. I continued this inspection with an inspection of the sand filters. During this morning's opening meeting I was told that 24 of the 48 sand filters are in operation. The reported number of operational sand filters varies and goes up and down during the weekly status reports. In order for the Department to assess the progress being made to get all of the sand filters back in operation, the Back River WWTP shall provide a report weekly detailing the current status of all 48 sand filters. The status report shall detail which filters are operational, filters requiring repairs, type of repairs necessary to get each filter back online, and timeframe for getting each filter back in service.

7/14/22 Out of service sand filter

- B. With respect to item #2 above, within 30 days of the receipt of this report, the Back River WWTP shall provide a report detailing the current status of all 48 sand filters. The status report shall detail which filters are operational, filters requiring repairs, type of repairs necessary to get each filter back online and timeframe for getting each filter back in service. An update on the status of the repairs to the sand filter shall be submitted every 30 days until all of the sand filters are operational.

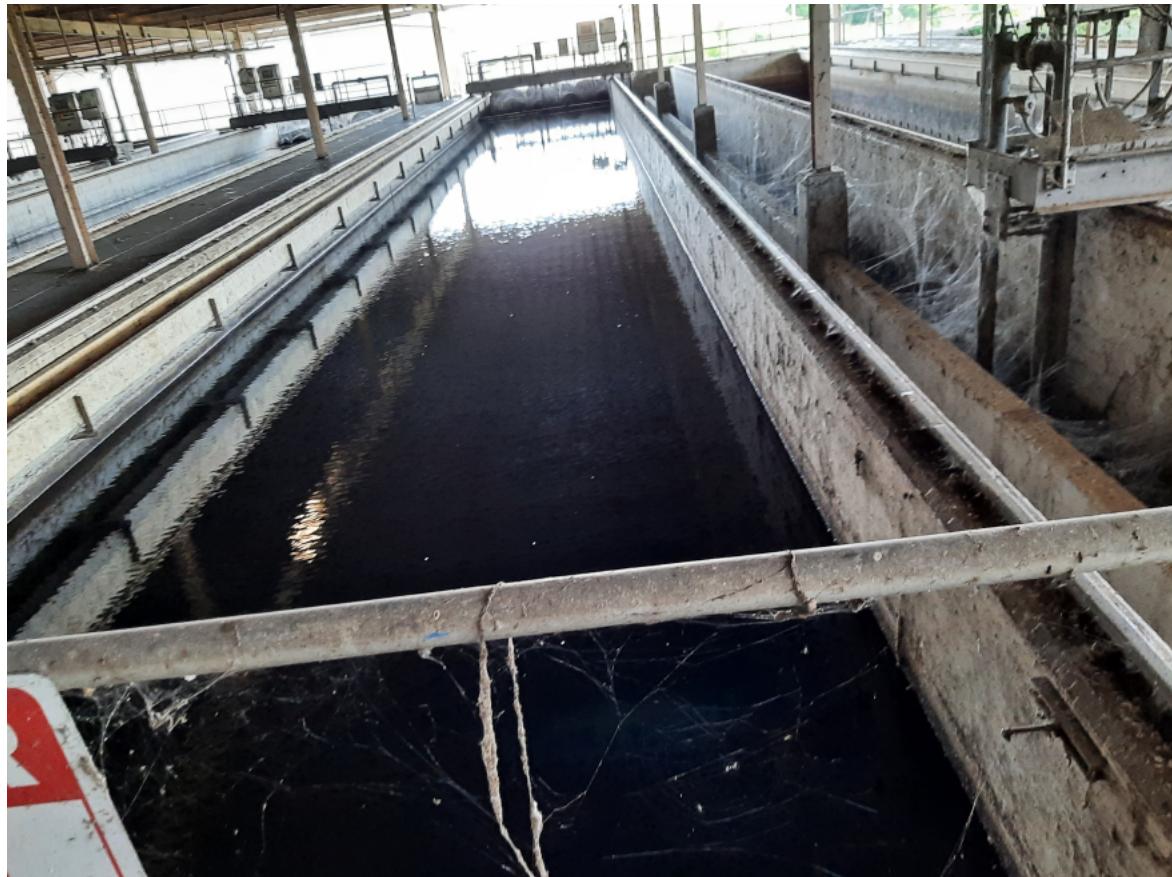
7/14/22 In service sand filter
