Maryland Department of Environment

Inspector:	Ronald Wicks
AI ID:	8449
Site Name:	Back River WWTP
Facility Address:	8201 Eastern Ave, Baltimore, MD 21224
County:	Baltimore County
Start Date/Time:	December 14, 2022, 09:00 AM
End Date /Time:	December 21, 2022, 06:02 PM
Complaint Number: Media Type(s):	NPDES Municipal Major Surface Water
Contact(s): Ronald Turner Betty Jacobs Andrea Buie-

NPDES Municipal Major Surface Water

Permit / Approval Numbers: 15DP0581 NPDES Numbers: MD0021555 Inspection Reason: Follow-up (Non-Compliance) Site Status: Active Compliance Status: Noncompliance Site Condition: Noncompliance Recommended Action: Continue Routine Investigation Evidence Collected: Photos or Videos Taken, Visual Observation Delivery Method: Email Weather: Clear Average

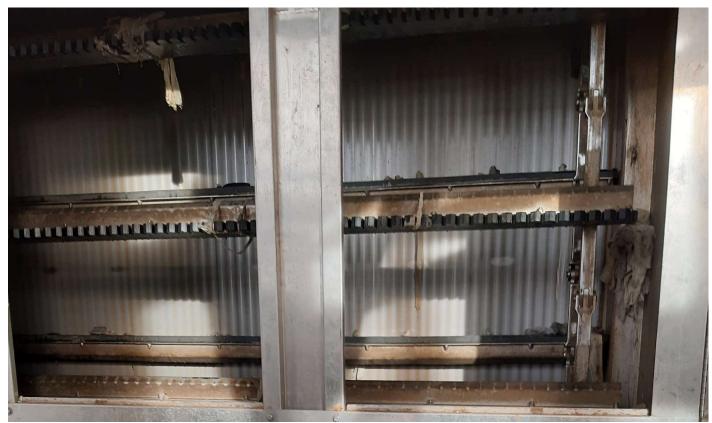
During the previous inspection of the coarse screen system, I observed that there was an excessive amount of rags and trash coiled around the racks. At that time, the cutter was not functioning, and the coarse screening units had not been cleaned since the last rain event. During this inspection, no problems were observed with the active coarse screening unit.

12/14/22 Inside of the functioning coarse screening unit. No problems observed.

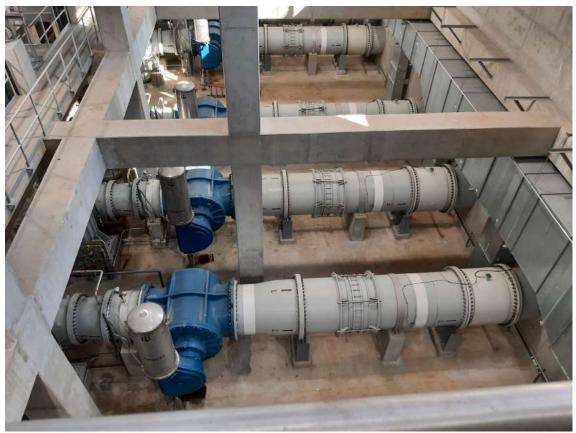
12/14/22 Picture shows Pumps #1-4. Today, 2 were being used for the headworks operation. Pumps #1- #4 have pumping capacities of 100 MGD each and pumps #5 - #8 (not shown) have pumping capacities of 120 MGD each.

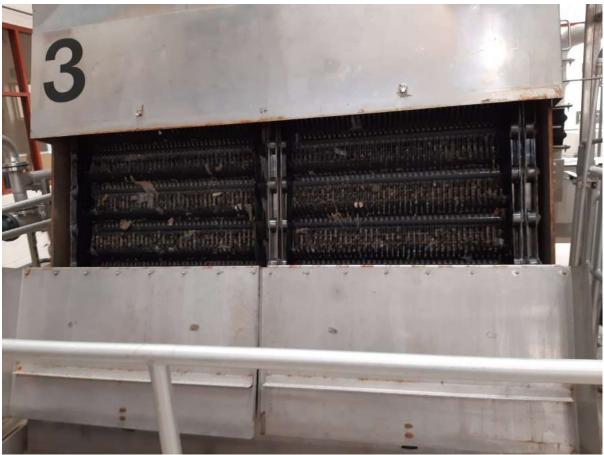
The headworks is equipped with six fine screening units with a processing flow rate of up to 100 MGD each. The fine screened sewage then travels to the grit removal system. The fine screening units that were checked and appeared to be functioning satisfactorily.

12/14/22 Fine screening unit in service.

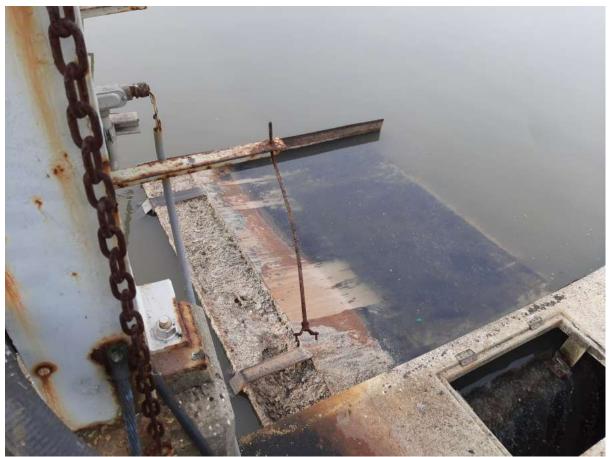
be the next PST to come online sometime next month. The issues with PST #7 are detailed above in the opening conference. During my evaluation of PSTs #1, #8 and #11, I found problems with the skimming system on PSTs #1 and #8. The scum collection troughs on both PST #1 and PST#8 were clogged with FOG and floating scum. The scum pit and collection trough must be cleaned out to prevent possible equipment issues and clogging of pipes further downstream.

12/14/22 PST #8 scum collection trough filled. The scum pit requires cleaning.

- 4. The scum troughs on PST #1 and #8 are clogged with scum and require routine maintenance. This is a violation of General Condition B3 of the NPDES permit. This condition has been observed and reported during previous inspections.

- D. With respect to item #4 above, the Back River WWTP shall immediately maintain the PSTs as required to keep them functioning properly. Within 30 days of the receipt of this report, the scum pits shall be pumped out and the scum trough shall be cleaned. Going forward, the scum troughs on the PST shall be routinely inspected and the scum pits pumped out as necessary to keep the scum trough openings clear.

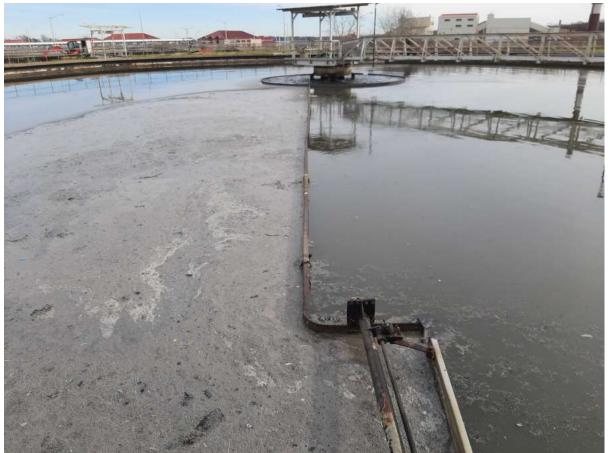
During the inspection of PST #1, I observed that the sludge blanket was above an acceptable level for this unit. There was a floating layer of sludge and scum that was covering the surface of the water. Solids were floating on the surface and overflowing the weirs sending the solids downstream to the next treatment stage.

12/14/22 PST #1 shows heavy scum layer on the surface along with floating solids.

- 2. The Back River WWTP has not provided adequate records and monitoring data to confirm satisfactory air quality at the headworks building.
- 3. Excess solids are being discharged from PST #1 due to a high sludge blanket. Sludge is not being processed at the quantity necessary to maintain PST sludge blankets at an acceptable level. This is a violation of General Condition B3 a and b of the NPDES permit.

I recommended that the Back River WWTP waste more of the sludge from PST #1 to reduce the sludge blanket to an acceptable level. According to Turner, their goal is 3 feet or less, however currently they are not able to process additional sludge. He further stated that they are currently running 4 of the 8 gravity belt thickeners (GBTs) and 4 is the minimal needed, however 6 would be better.

- **C.** With respect to item #3 above, to comply with the requirements under General Condition B3a of the permit, the Back River WWTP shall process sludge at the rate necessary to maintain the sludge blankets in the PSTs at acceptable levels. General Condition B3a, specifies that facilities shall be operated efficiently to minimize upsets and discharges of excessive pollutants.

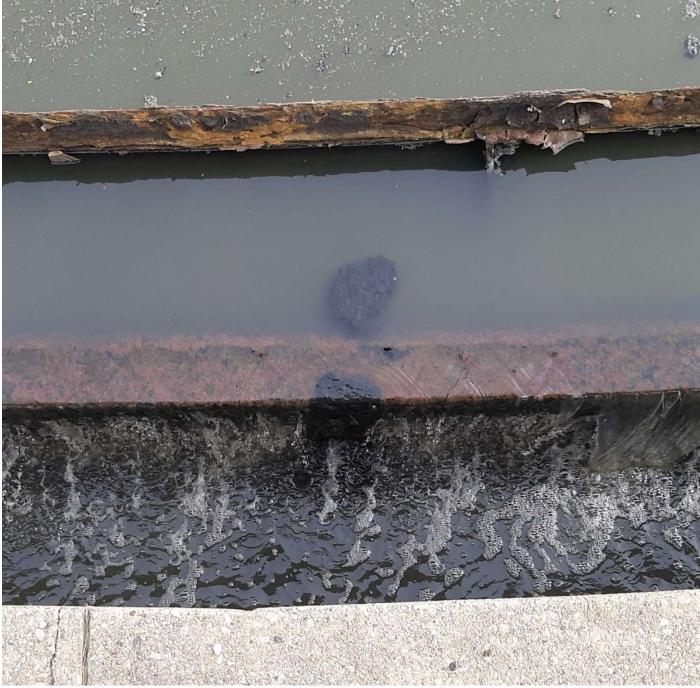
12/14/22 PST #1 solid masses overflowing the weir

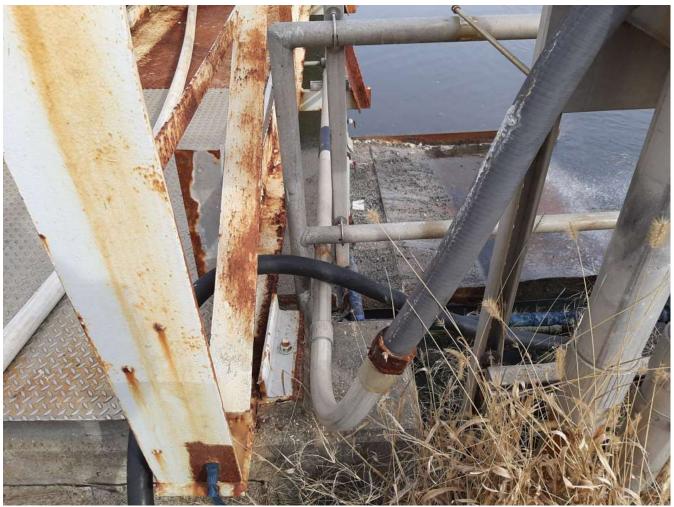
12/14/22 PST #1 scum collection trough clogged. Scum pit requires cleaning

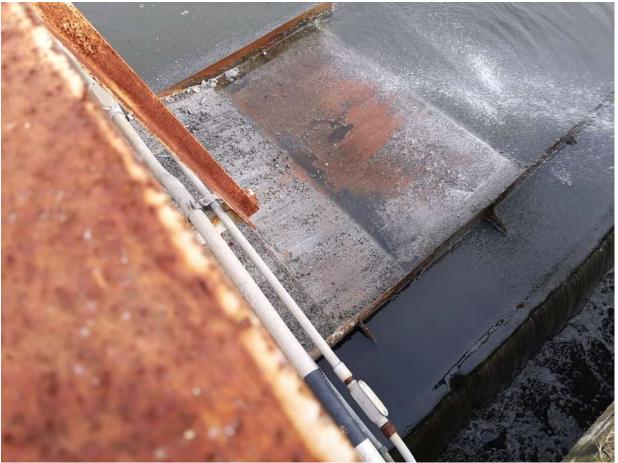
12/14/22 PST #1 another view of scum trough

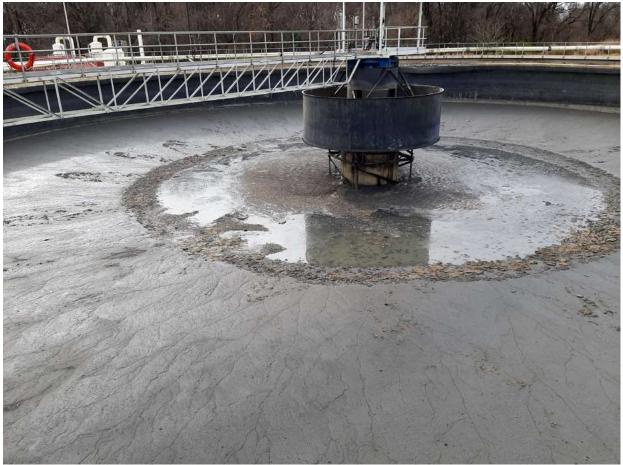
12/14/22 PST #5 is in the process of being cleaned. There is still some sludge remaining with a septic odor. This PST was used on the following day, 12/15/22, as a flow through tank due to a rain event that caused a hydraulic overload.

Since there has been an odor problem associated with PST#5, I asked Turner why the cleaning of PST #5 had not been completed. According to Turner, the cleaning of PST #9 took priority over the cleaning of PST#5, but it is now next on the list to be cleaned. As of 12/21/22, PST #5 has not been cleaned and according to the MES daily report for 12/21/22, PST #5 is still full of raw sewage from the last storm event, and it appears that there is a thicker sludge layer forming on the surface of the water in PST #5 since an inspection two days earlier.

6. The Back River WWTP has not completed the cleaning of the sludge from PST #5, which has been responsible for citizen odors complaints.

- **F.** With respect to item #6 above, the Back River WWTP shall complete the cleaning of the sludge from PST #5.

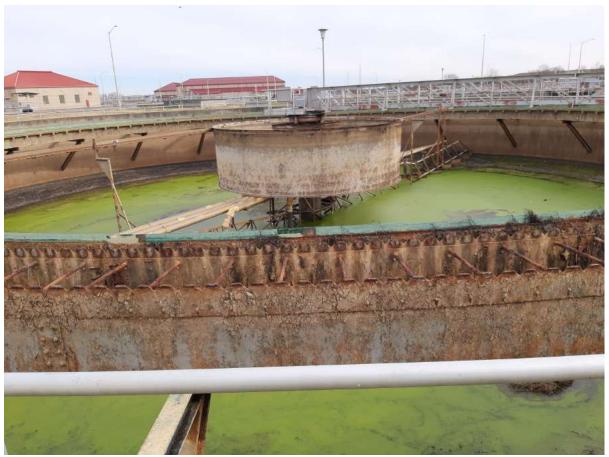
During the next phase of this evaluation, I inspected the Activated Sludge Plant #3. Reactor # 6 was drained and offline for repairs. The problems previously observed and reported are still an issue. The reactors tanks require maintenance. Some of the mixers in the reactors were not functioning as designed because rags were wound around the mixer shafts impeding operation and the many of the reactor basins need to be cleaned of solids.

12/14/22 Activated Sludge Plant 3 – Secondary clarifier 16A out of service due to broken mixer

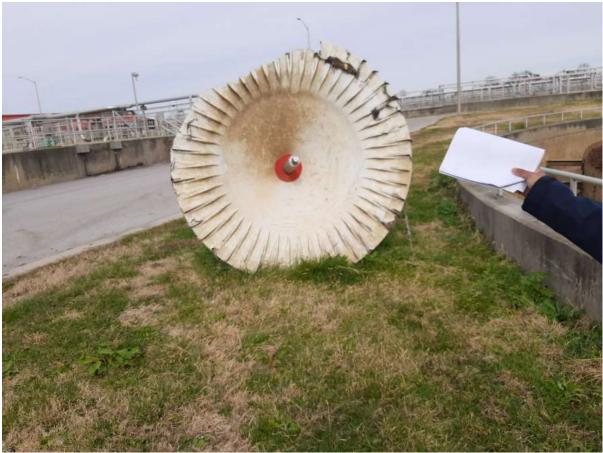
12/14/22 16 A broken mixer- The mixer fell off the assembly and cracked.

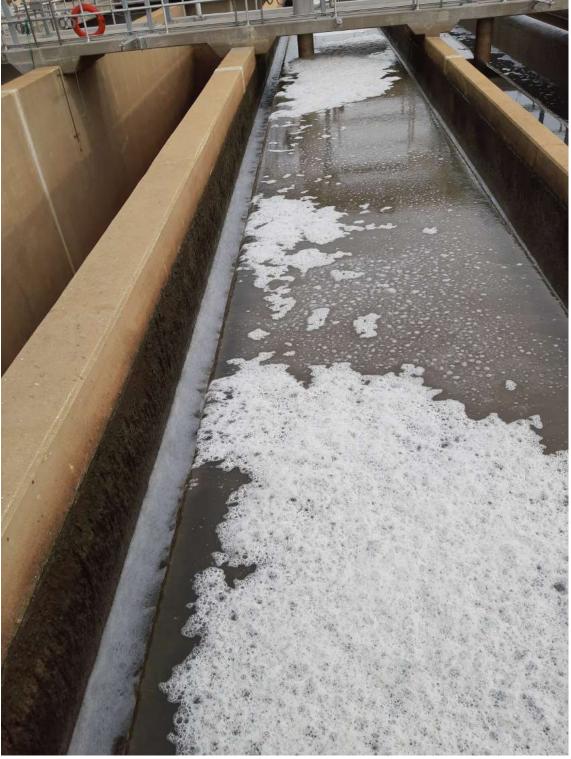
12/14/22 DNF during a "bump" cycle used to release nitrogen gas trapped in the filter causing temporary foaming during the process.

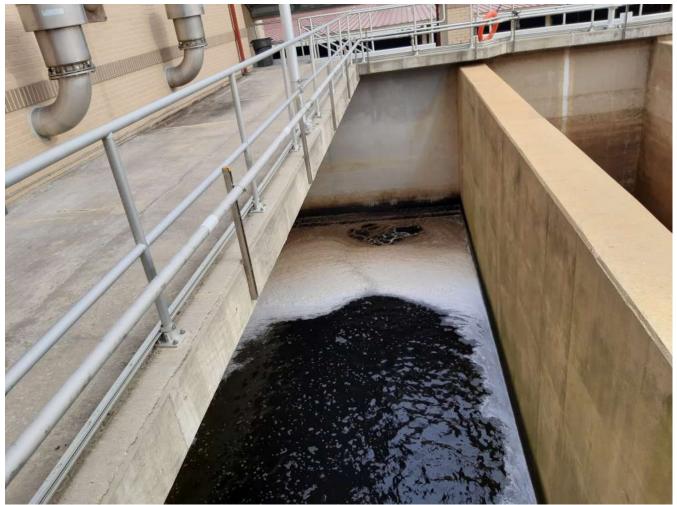
12/14/22 effluent clear well for the DNF. There is some foaming due to microbiological activity

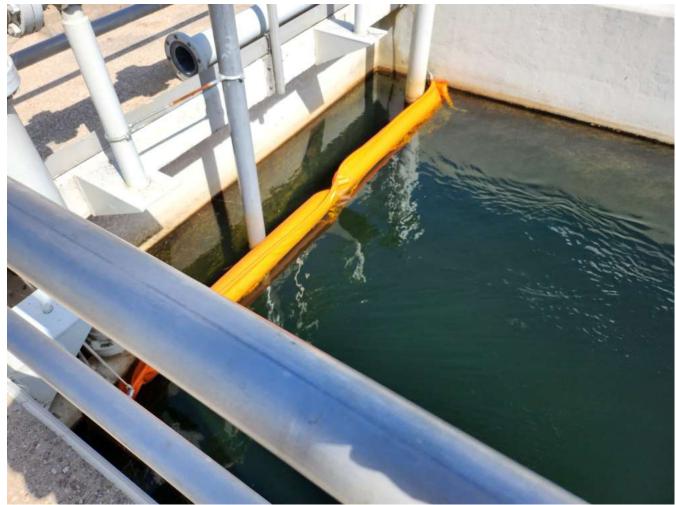
After leaving the DNF building, I traveled to the chlorine contact chambers. The Back River WWTP installed floating booms upstream of the final overflow at the request of the Department to prevent floating scum and solids from discharging. The booms were all in place and there was no evidence of floating material breaching the booms during this evaluation.

12/14/22 The floating boom at the left channel CCC used to prevent floating solids from entering the final discharge canal.

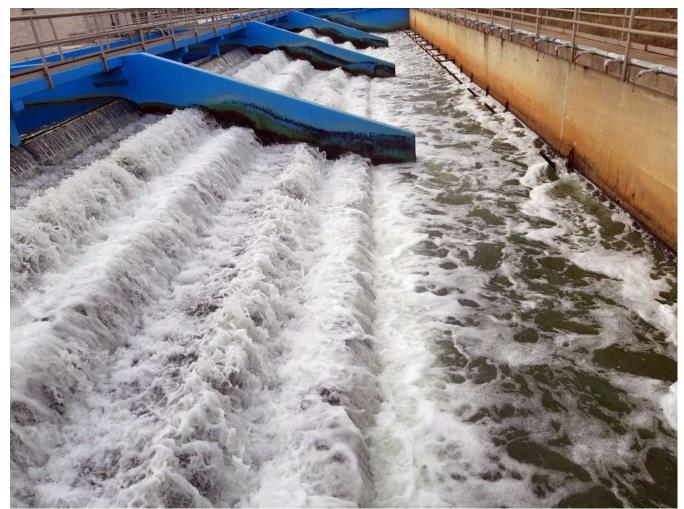
Next, I inspected the final effluent at the step aeration system and at the sampling station. During an evaluation of the final effluent, I observed that the effluent was clear with no visible particulates. During the last inspection, I observed that the sample collection trough on the automatic sampler needed to be cleaned. Today, I found that the sampler had been cleaned and was in better condition than I found previously.

12/14/22 Final effluent at the step aeration discharge configuration
