Maryland Department of Environment
Water and Science Administration
Compliance Program
1800 Washington Blvd, Suite 420
Baltimore, MD 21230-1719
410- 537-3510, 1-800-633-6101

Site Name: Patapsco WWTP
Facility Address: 3501 Asiatic Ave, Curtis Bay, MD 21226
County: Baltimore City County

Start Date/Time: May 18, 2022 09:30 AM
End Date /Time: May 21, 2022 03:00 PM

Permit / Approval Numbers: 15DP0580
NPDES Numbers: MD0021601
Inspection Reason: Follow-up (Non-Compliance), Routine Scheduled
Site Status: Active
Compliance Status: Noncompliance
Site Condition: Noncompliance
Recommended Action: Additional Investigation Required
Evidence Collected: Photos or Videos Taken, Record Review, Visual Observation
Delivery Method: Email
Weather: Clear Good

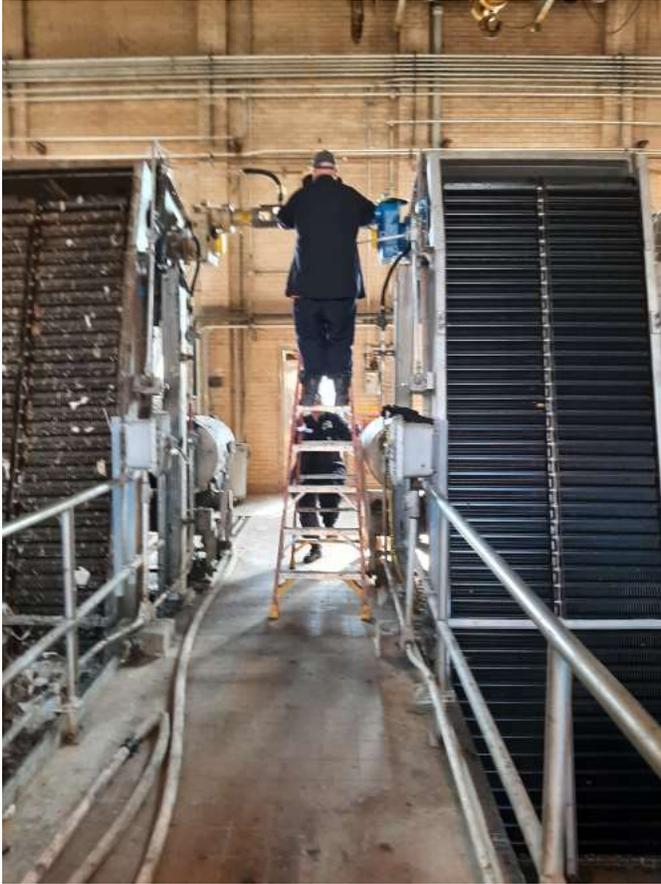
5/18/22 Number 5 fine screen unit being connected to electricity

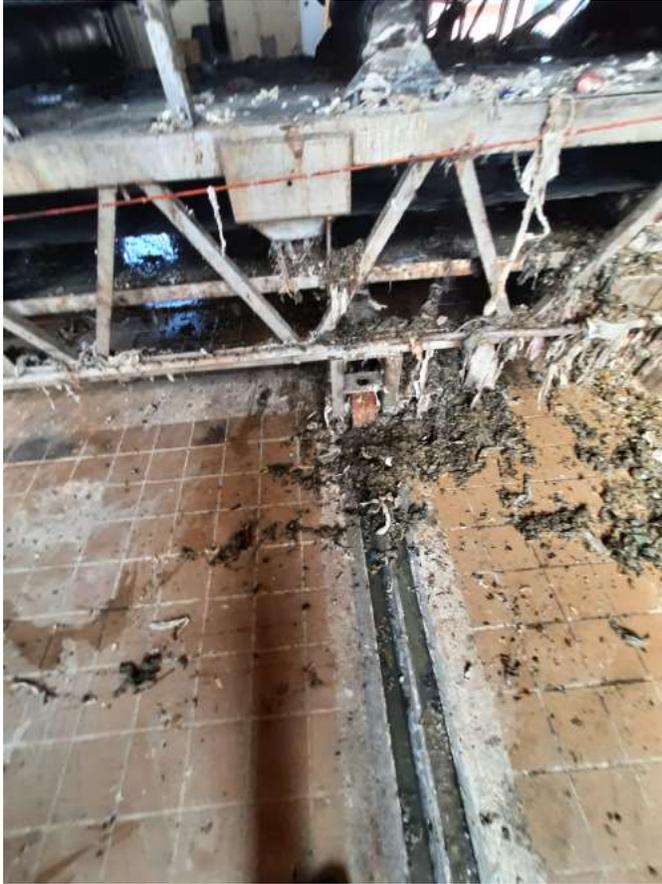
5/18/22 Housekeeping problems at Fine Screens Building

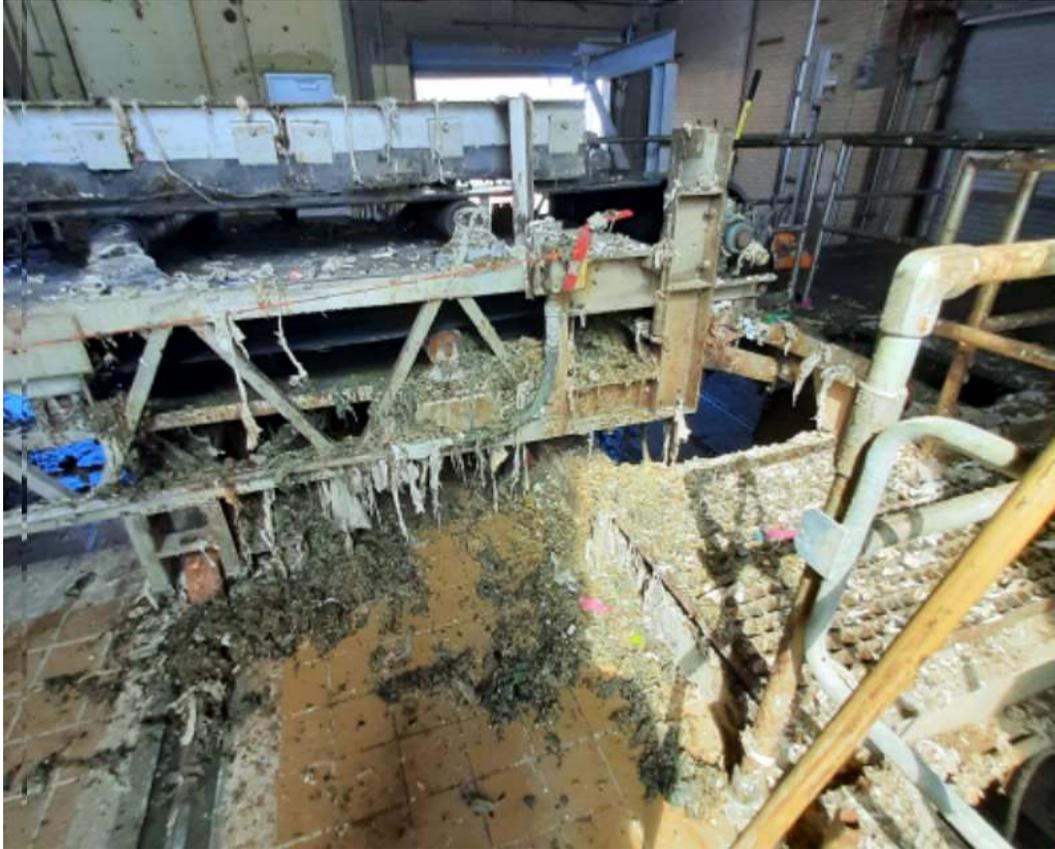
5/19/22 Housekeeping problems at the conveyor belt system.

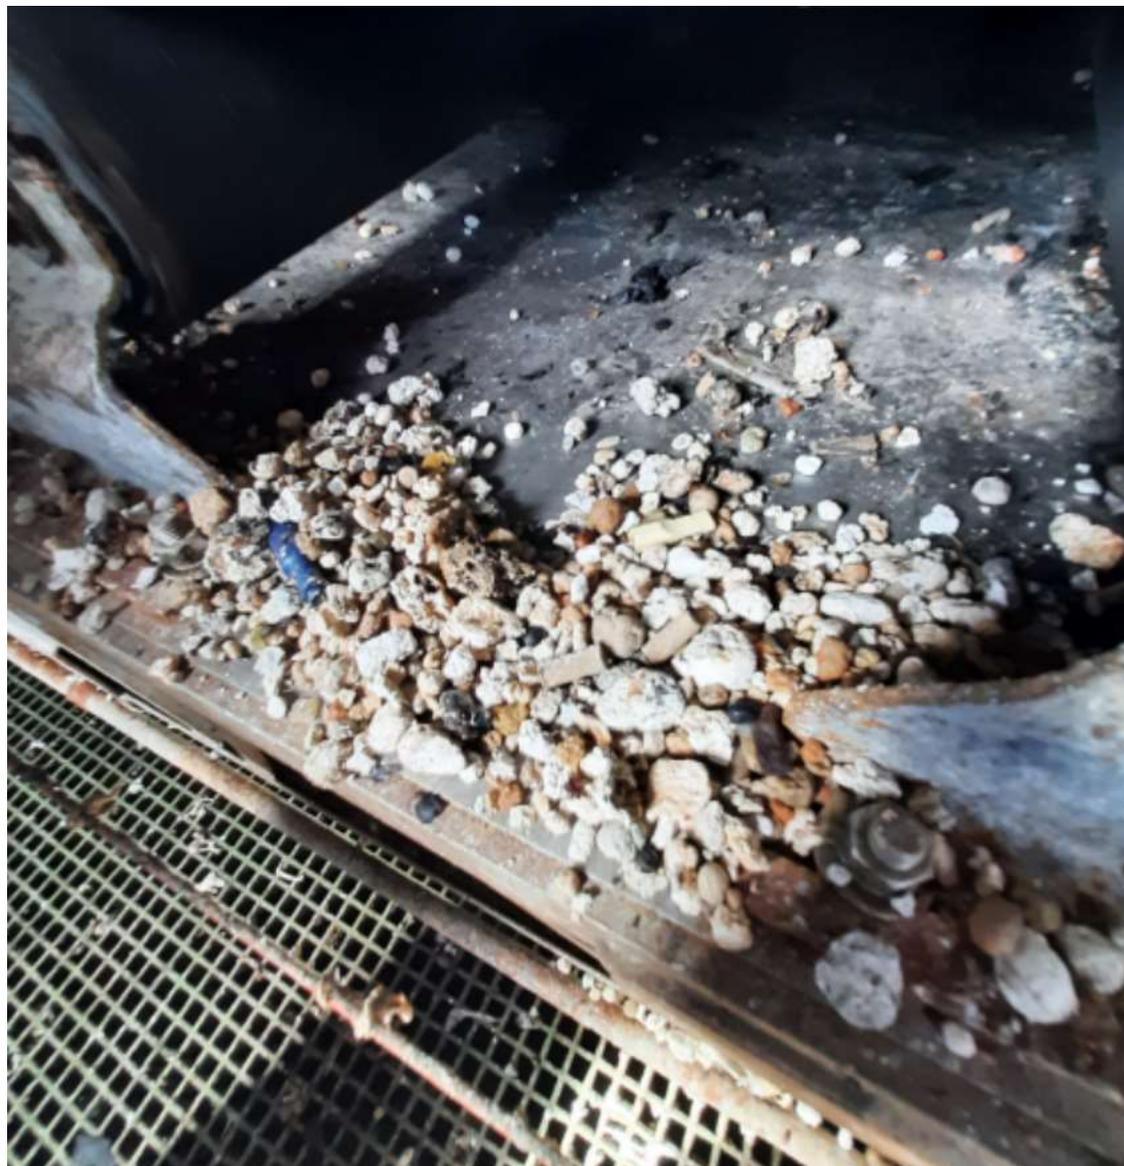
5/18/22 Trash and debris falling from the conveyor belts at the fine screening building

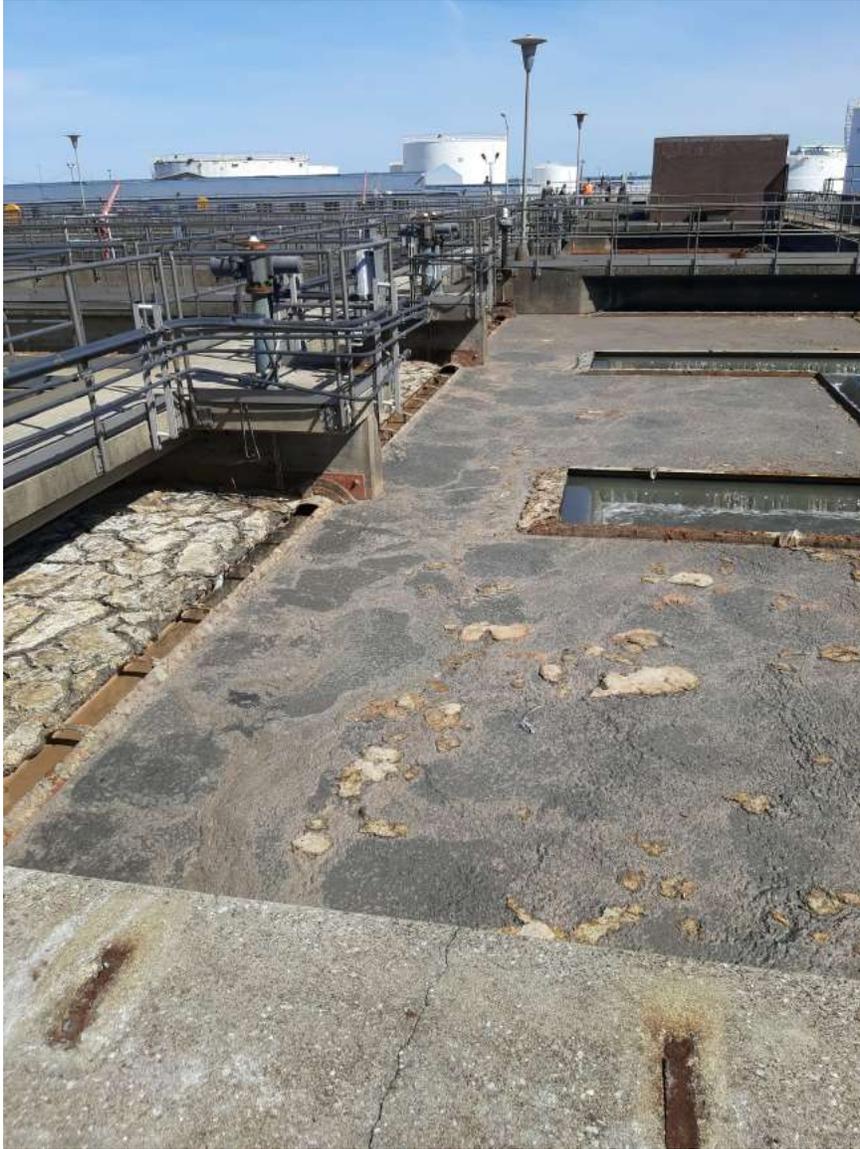
Three of the six PSTs were online at this time. PSTs currently online are #1, #4 and #5. According to Mr. Jackson PST #6 will be back online later today after repairs are made. I observed a considerable amount of floating scum and FOG floating on the surface of the active PSTs. According to Mr. Jackson, the increase in flow due to recent rainfall caused an increase in FOGs going through the plant creating a build of FOG in the PSTs. The condition of the PSTs is similar to what I observed during my April 6, 2022, inspection, which occurred the day after a rainfall event. There was rainfall four days prior to this inspection. I observed that the PSTs had floating

5/18/22 floating scum and FOG in PSTs

- N. The PSTs had an accumulation of floating scum and FOG which may impede and impact downstream treatment processes.
- O. The Patapsco WWTP is currently bypassing the DNF treatment at the ENR facility and bypassing this system is a violation of Special Condition A2 footnote 5 of the permit and General Condition B5

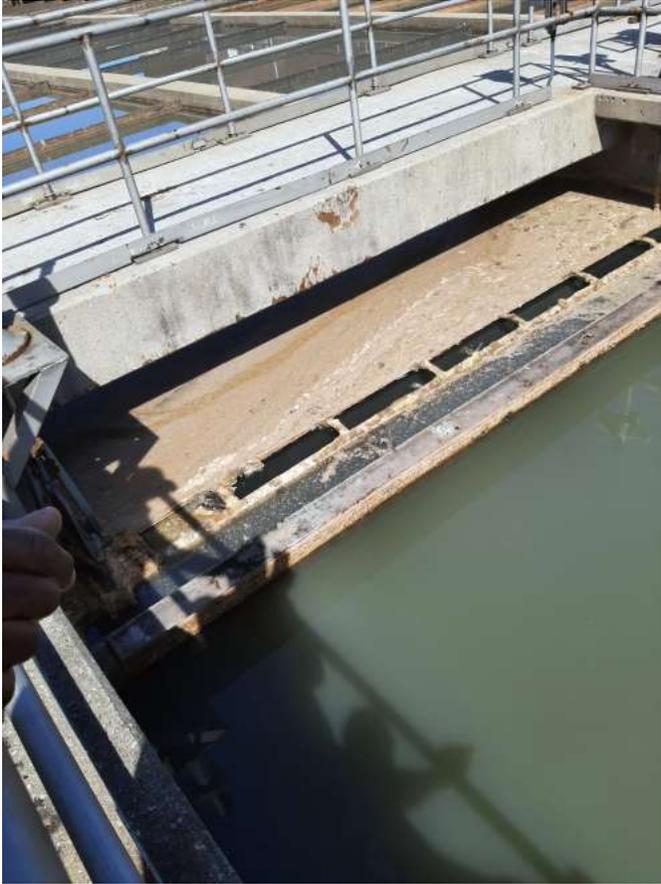
5/18/22 scum and FOG at scum trough. When rotated the scum trough will collect the FOG and scum

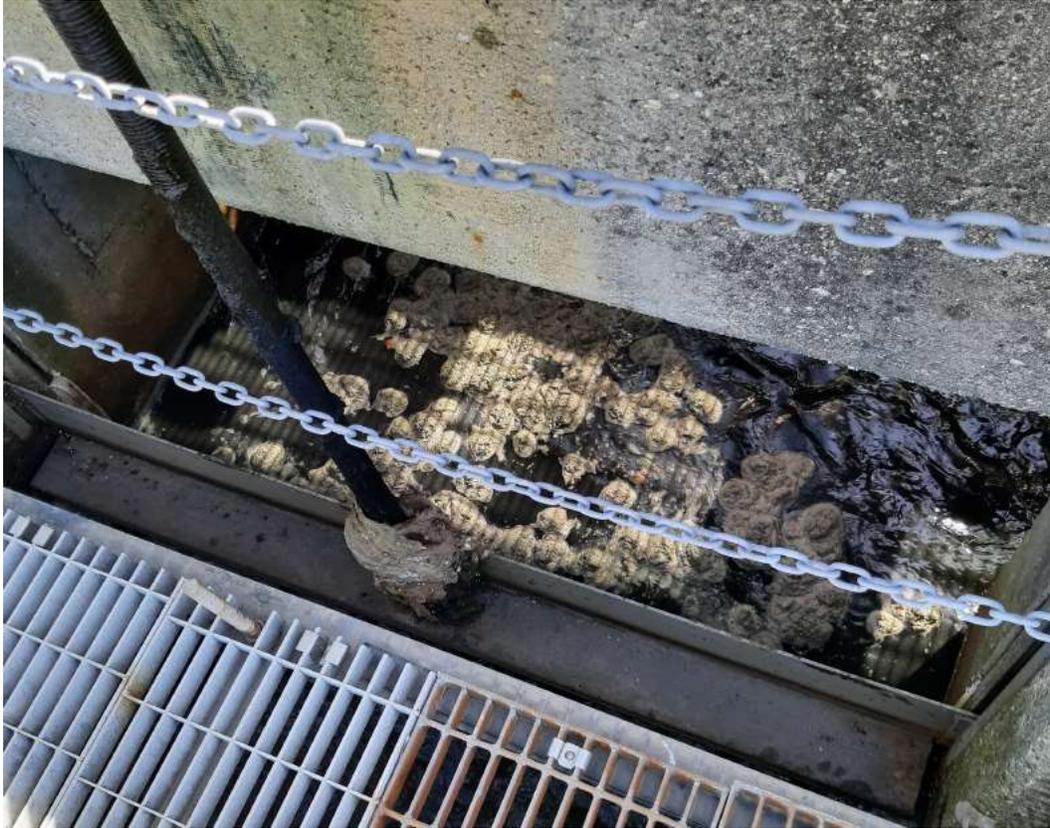
I inspected the final effluent from the scum troughs and observed no floating scum going over the weir at this time. However, later during an evaluation of the entire area, I observed FOG that was not captured by the scum troughs or skimming efforts. One of the operators was asked to contain and collect the FOGs to prevent the FOGs from going to the reactors. The FOGs in the PSTs have begun to solidify in some areas and could cause potential problems such as clogging of pipes and pumps if not addressed. The facility shall ensure the operational integrity of primary treatment system and shall take a proactive approach by removing the accumulation of FOGs that have accumulated in some of the PSTs.

5/18/22 FOG and floating scum that passed through scum troughs and skimming

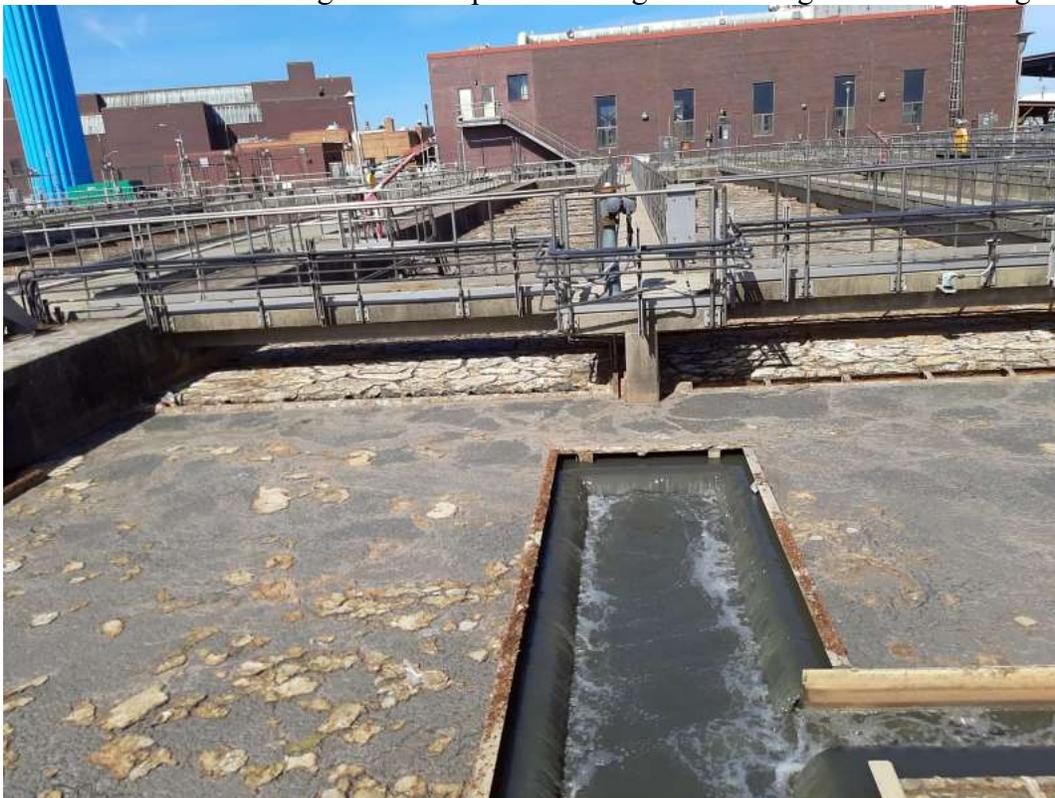
5/18/22 Floating scum and FOG at PSTs.

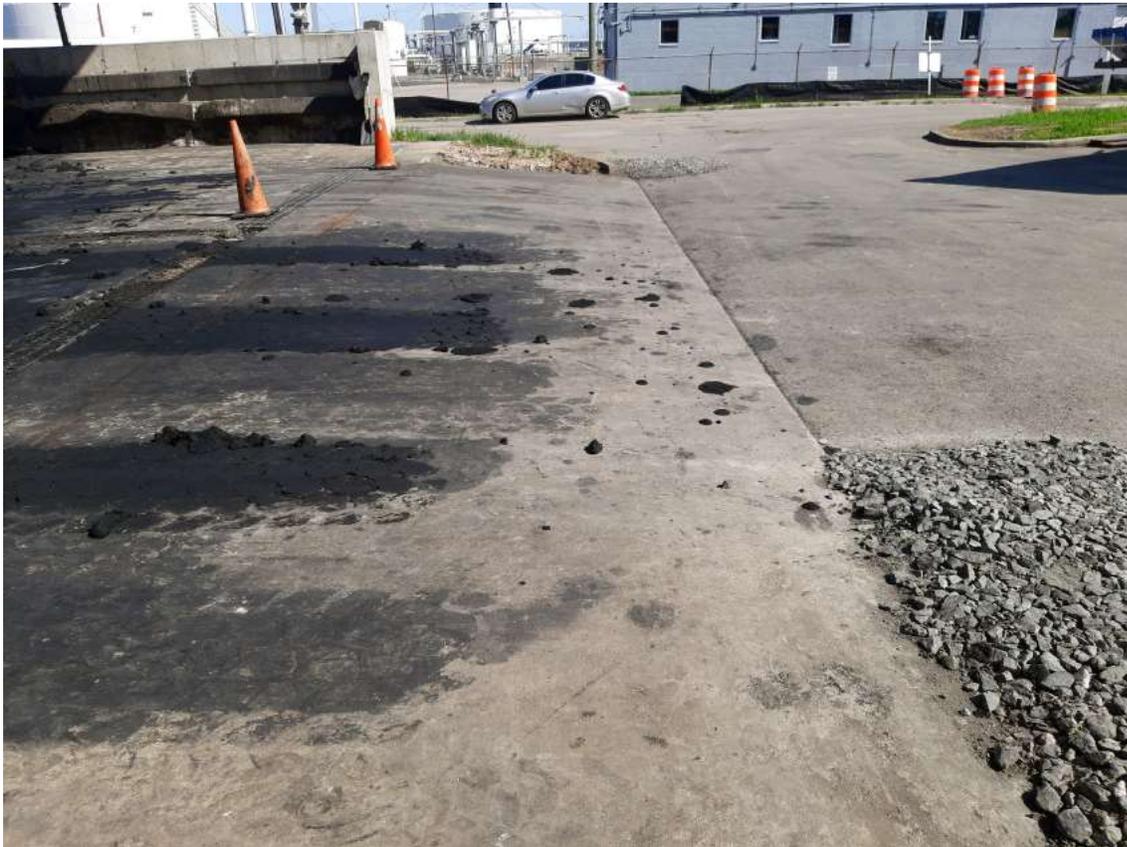
The Patapsco WWTP is using the former Tailings Transfer Station as a temporary sludge storage area to store unprocessed sludge. The area is partially covered, and the concrete pad of the transfer station is sloped slightly to the rear. There are drains at the front of the pad that are connected back to the WWTP. The pad drains were designed to collect any drainage from the pad and preventing drainage from going into the roadway. The grates of the drains were clogged with solid material and therefore not able to function as designed. Therefore, any drainage from the pad can flow over these grates into the roadway where there are two storm drains. During this inspection, a sludge hauler truck was being loaded. The loading is conducted in close proximity to the storm drains, there was some spillage during the process. According to Mr. Jackson, the area is cleaned after each loading event to prevent stormwater contamination. A pollution prevention plan is required to ensure that the stormwater pollution is prevented.

5/18/22 Sludge transfer station after loading a sludge hauler truck

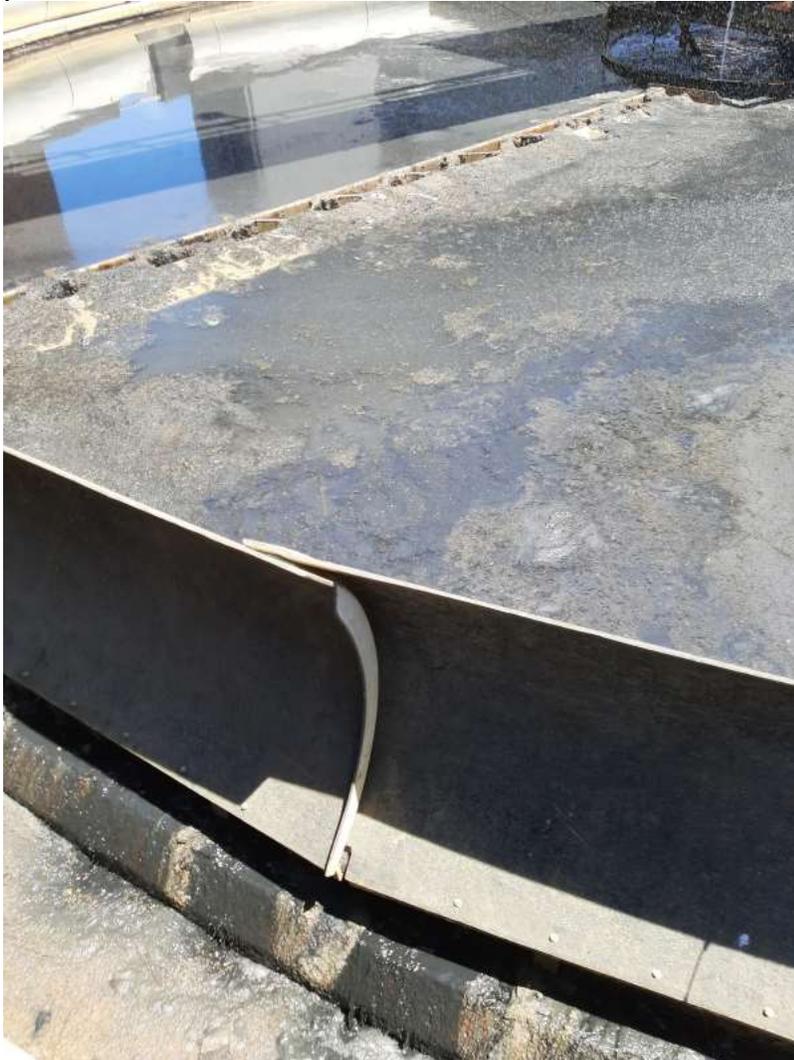
The sludge blankets were above an acceptable level. This condition is causing the effluent (supernatant) from the GST to have a higher-than-normal solids concentration. The solids are also accumulating on the effluent weirs blocking the flow of the supernatant. Because of this problem, operational staff must manually clean the weirs, to maintain the flow of the supernatant. The # 2 GST skimmer was not in complete alignment with the surface of the water. The high sludge blanket is also causing the top layer of supernatant to be charcoal in color.

The GSTs are designed to thicken biosolids to produce a concentrated solids material and a comparatively solids-free supernatant. The #1 and #2 GSTs are not producing a relatively solids-free supernatant. This problem along with inadequate wasting of the secondary and primary clarifiers have led to monthly effluent violations for BOD, TP and TSS as mentioned above and process control issues.

5/18/22 GST showing thick layer of solids

- 4. With respect to item D above, the Patapsco WWTP shall operate and process sludge in the GSTs in a manner that maintains a solids-free supernatant. Within 15 days of the receipt of this report, the Patapsco WWTP shall submit to the Department a status report on the progress of the repairs to the #3 GST with an updated report every 30 days until the #3 GST is back in service.**

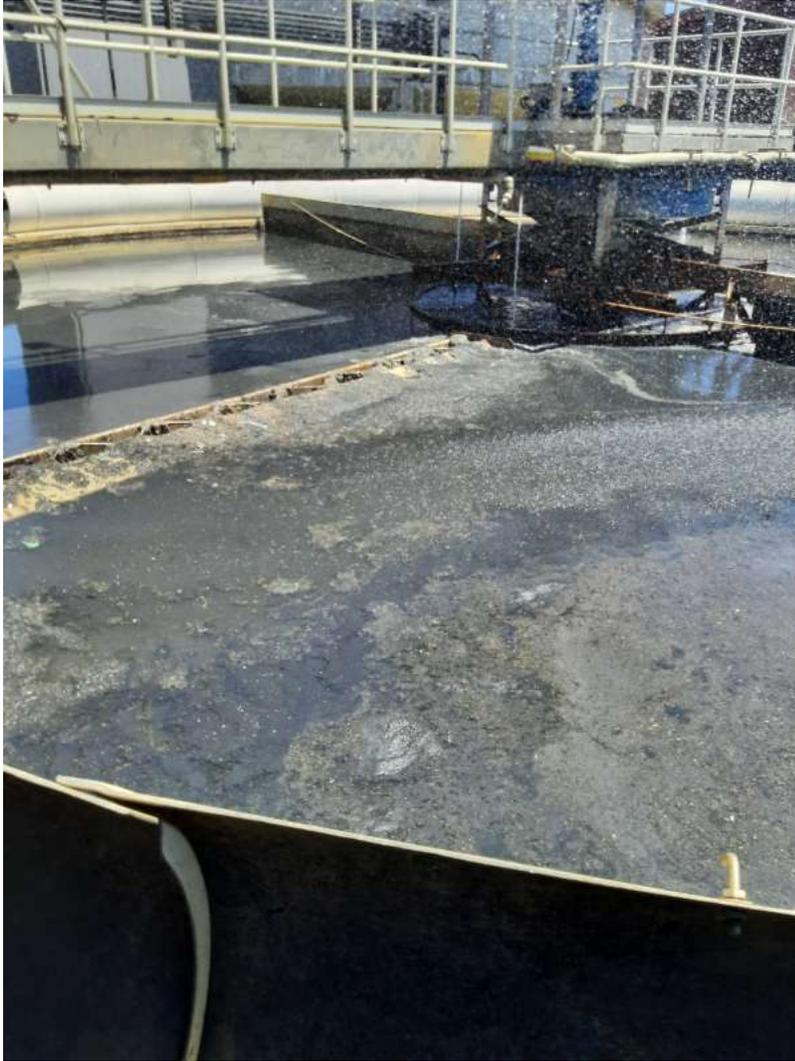
5/18/22 GST #1 note heavy layer of floating solids.

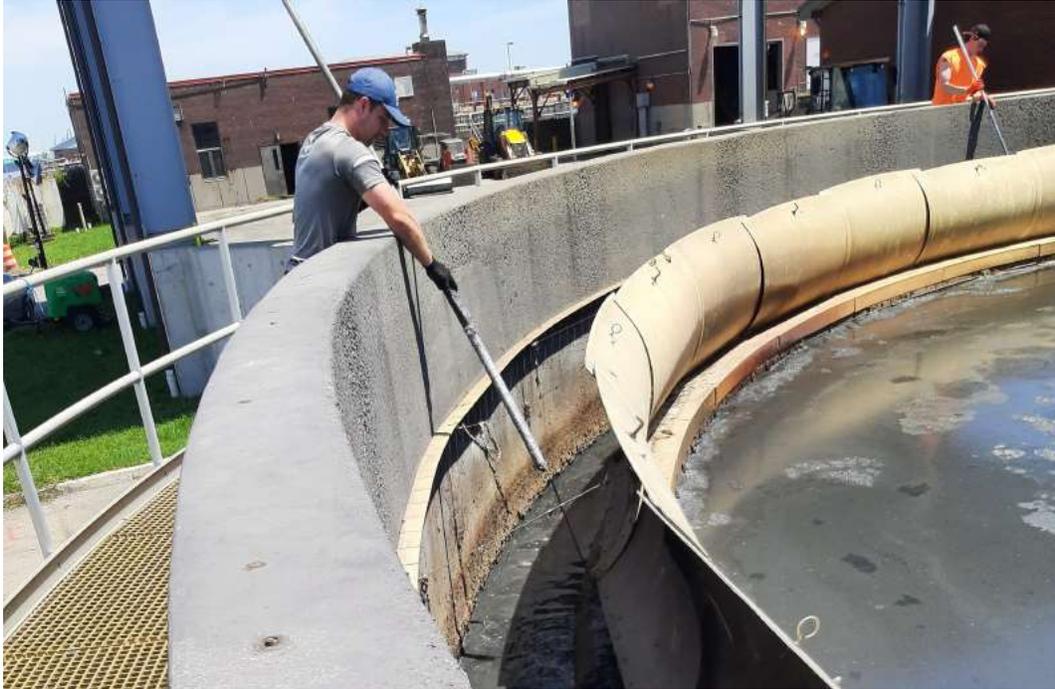
5/18/22 operators cleaning the solid particles that are accumulating on the weirs of the GST #1.

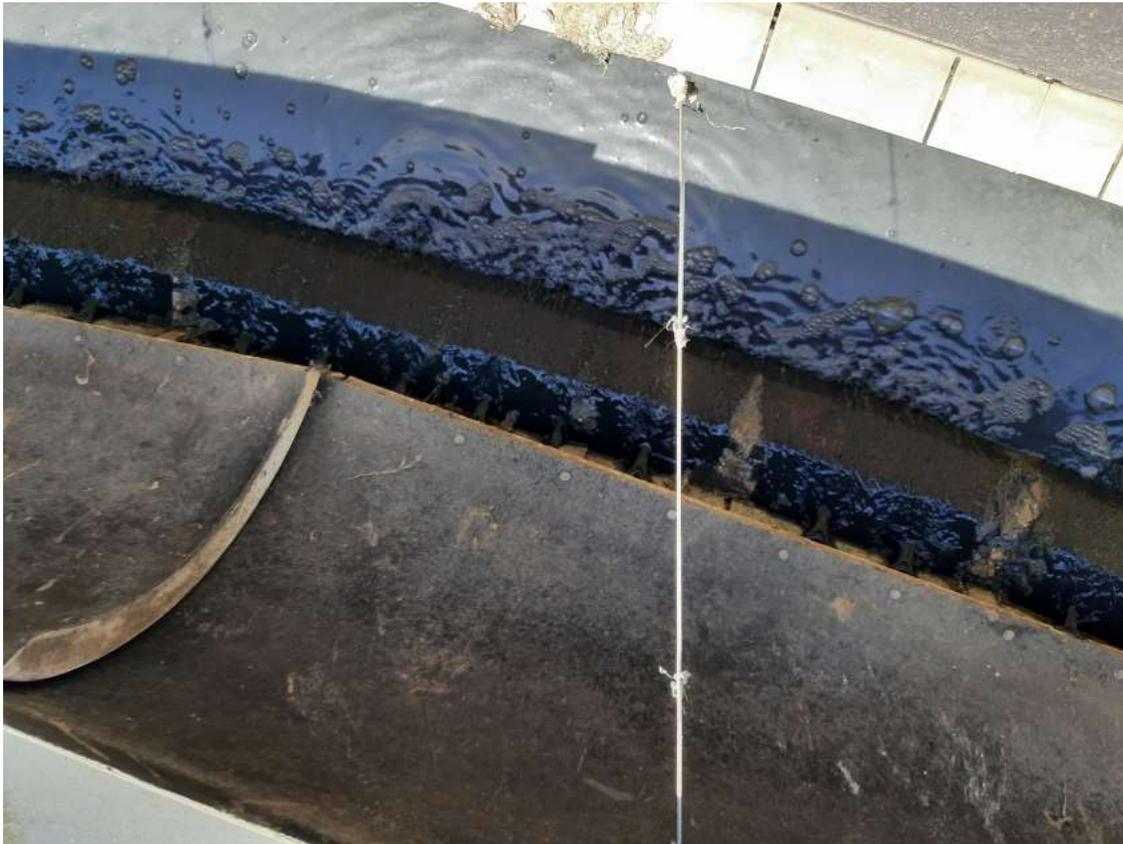
5/18/22 effluent from GST #1

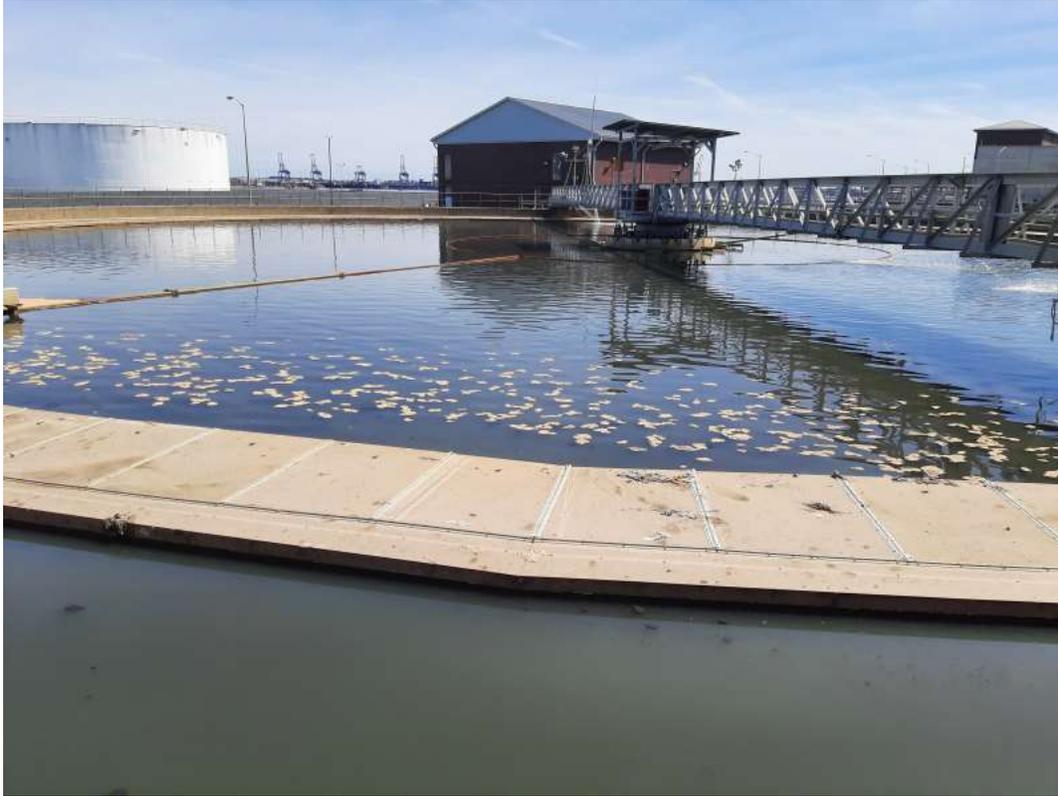
5/18/22 Secondary clarifier Note floating BAF media

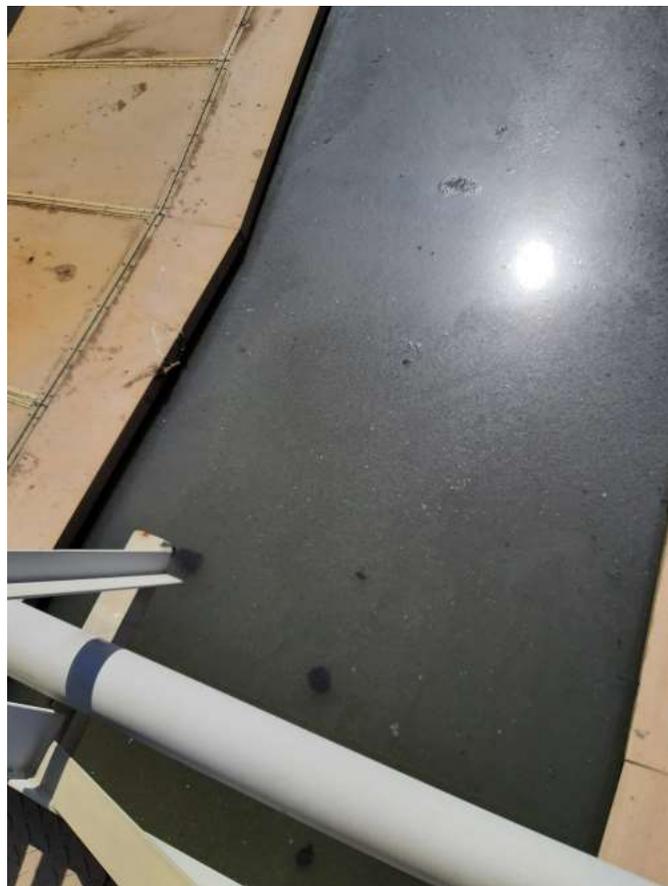
The next I conducted an evaluation of the secondary clarifiers. The waste streams from reactors are split between eight secondary clarifiers. Clarifier #6A has been out service for over one year because the return activated sludge (RAS) pumps are not working. According to Mr. Johnson, the repairs will be made some time in June of 2022. In addition, today I learned that one of the secondary clarifiers is now being used to store sludge. During this inspection, a total of five of the eight clarifiers are active and being used for wastewater treatment to settle solids. The water in the clarifiers was grey due to the TSS concentration. There were also media pellets from the BAF system observed in the water of secondary clarifier #1 and the skimmer arm on clarifier #5A was bent. I also observed bubbling of the water in the secondary clarifiers along with floating balls of black solids caused by anoxic conditions in the water due to over-aged sludge.

5/18/22 Secondary clarifier note floating black balls of solids

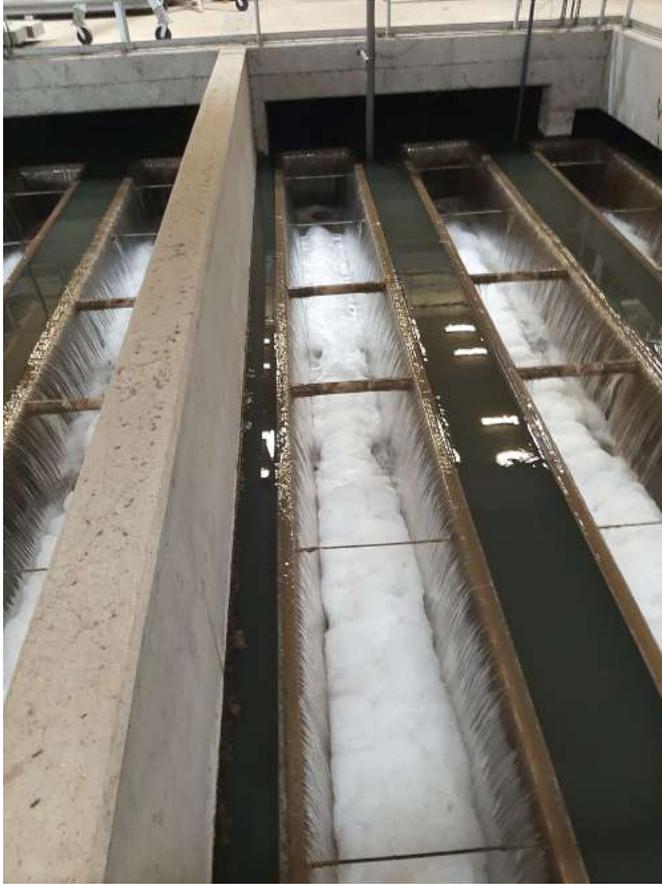
During an evaluation of the Biological Aerated Filter system (BAF), I observed excessive foaming in the filter cells and at the effluent overflow tanks. The foaming is due to the high BOD concentration in the water. Based on these conditions and my observations, I believe that the BAF nitrification process is impaired or diminished in function. I asked the operator assigned to this area if he could provide today's process information on the TSS and ammonia as N concentrations. The TSS concentration going into the BAF from the secondary clarifiers was 80 mg/L, which is twice the maximum desirable concentration of 40 mg/L and the ammonia as N concentration of the influent going to the BAF is 14.3 mg/L and the ammonia concentration of the effluent leaving the BAF is 10.3 mg/L, which is a 28% ammonia removal rate. The BAF should be capable of removing 75 – 90 % of Ammonia as N from the wastewater. Therefore, complete ammonia oxidation is not being performed by the BAF due to solid concentrations that are elevating the BOD and hindering nitrification. This data indicates that the BAF is not functioning to ENR standards as required by the permit.

5/18/22 BAF effluent overflow cell Note excessive foaming caused by high BOD concentration

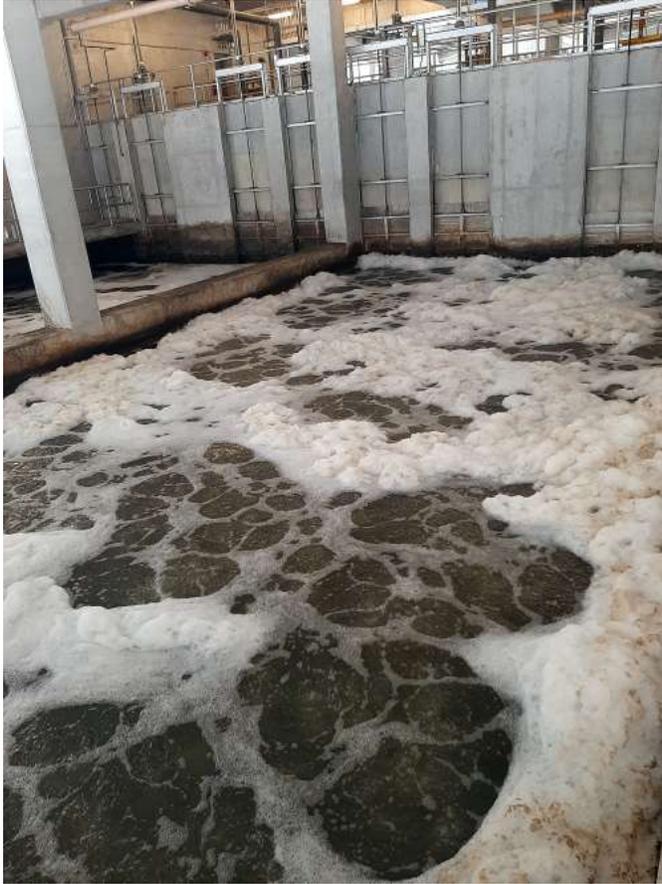
5/18/22 BAF filter cell Note excessive foam containing solids

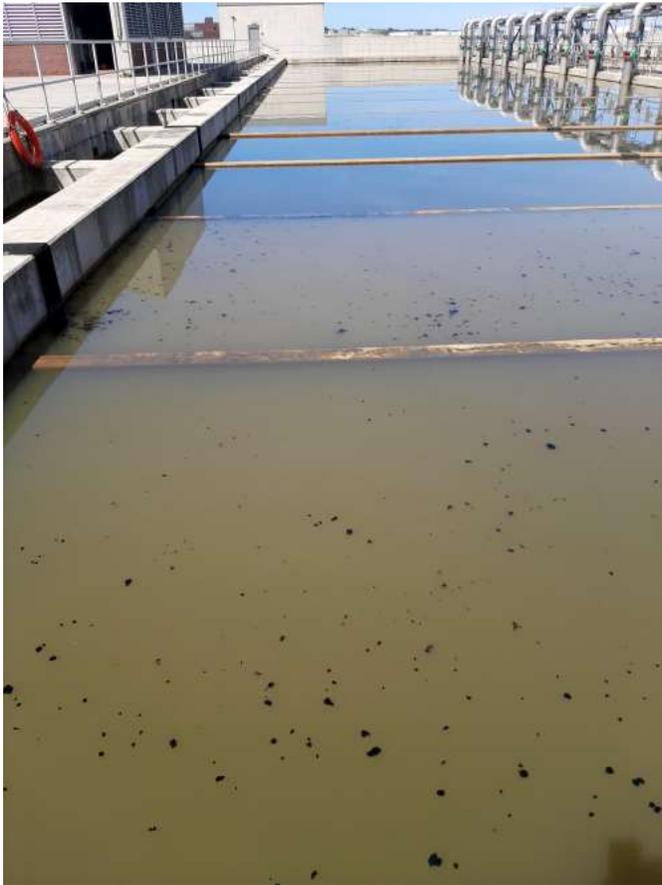
The Denitrification Filter System (DNF) was the next stop during the site review. The facility has thirty-four denitrification filters for denitrification. During my evaluation of the DNF, I found that the DNF was not functioning. The cells are submerged and incapable of filtration and there was floating sludge in the filters indicating clogging of the system. The conditions indicate that the biosolids in the filters have been there for an extended period of time and the old sludge is coming up to the surface. According to Mr. Jackson, they are currently bypassing the DNF treatment. I was not informed of this bypass, so I asked if the Department had been notified of the bypass. Mr. Jackson stated that the Department had not been informed of the bypass. The bypass is a violation under III General Condition B 5 which is discussed under the operations and maintenance section of this report. I asked Mr. Jackson to report the bypass today. In addition, the DNF system is an integral component in the ENR process and bypassing this system is a violation of Special Condition A2 footnote 5 of the permit which states:

5/18/22 DNF – Nonfunctioning submerged filters

During the course of the site review, I found that the permittee is bypassing the DNF without prior authorization by the Department. This is violation under III General Condition B 5, which states the following:

- 15. With respect to item O above, all treatment system bypassing shall be done in accordance with General Condition 5 of the permit. The Patapsco WWTP shall immediately inform the Department of any bypassing and all bypassing shall not result in an effluent violation. In addition, the Patapsco WWTP shall operate the ENR facility in a manner that optimizes the nutrient removal capability of the facility as stipulated in the Grant Agreement for ENR upgrade. Therefore, the ENR processes shall not be bypassed without prior approval or an agreement with the Department.**

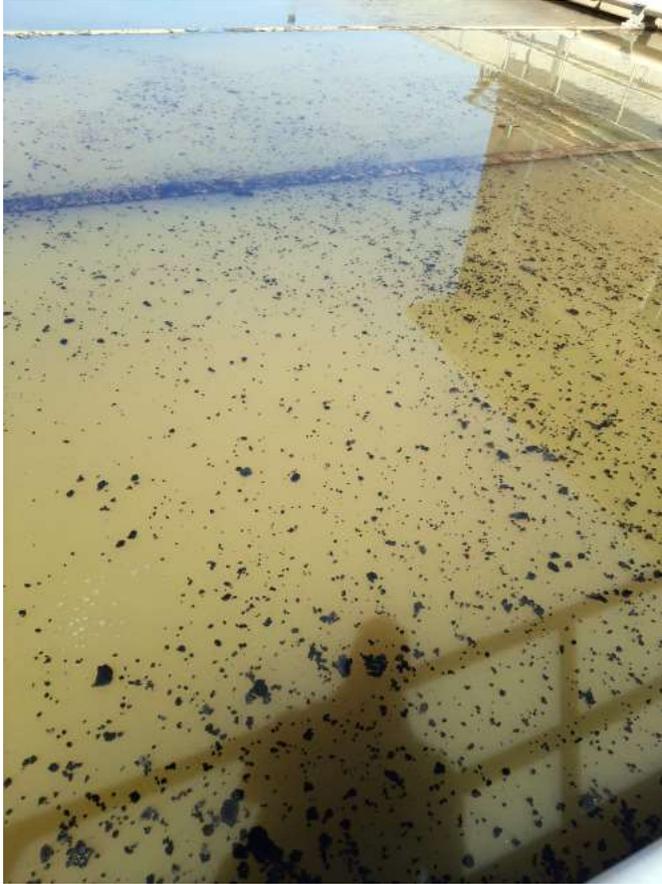
5/18/22 DNF cell Note black balls of floating solids and stagnant water

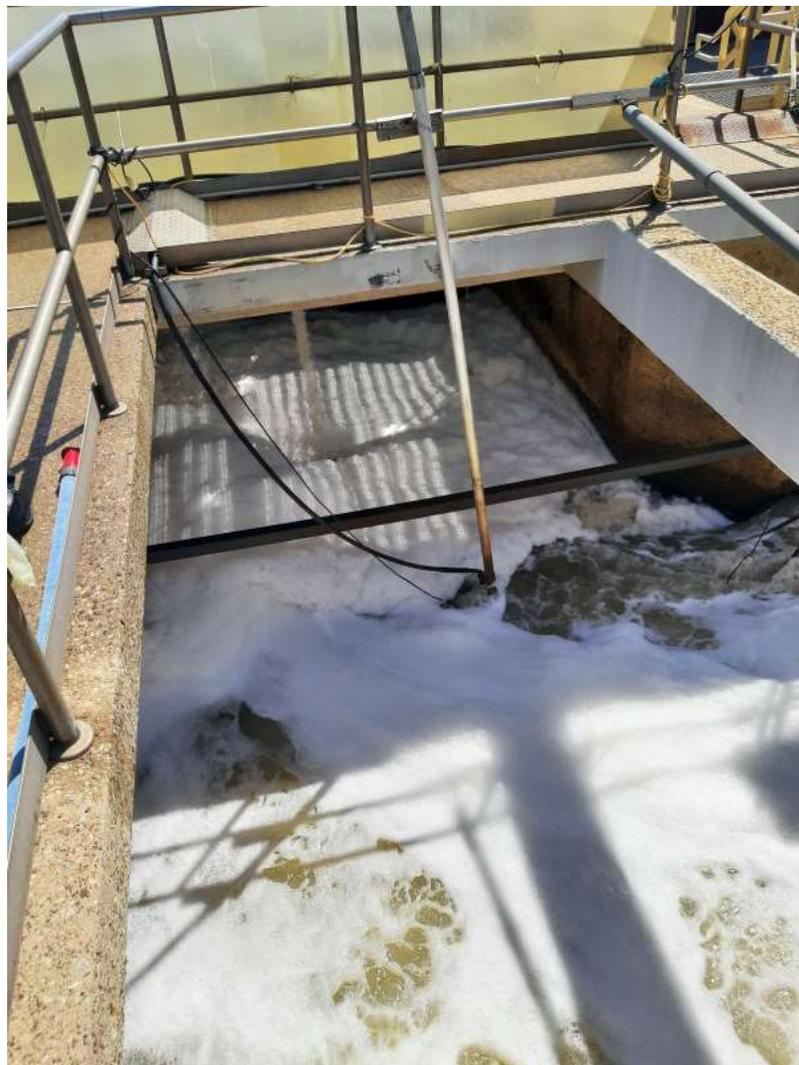
Next, I inspected the chlorine contact basins prior to the final discharge. There are 4 contact chambers and 3 of the 4 are currently online. Each contact chamber has 3 scum logs or troughs to remove floating scum. There was an operator skimming the floating scum and solids. I observed excessive foaming at the final common discharge chamber prior to overflow. I could not see the final effluent because of the excessive foaming. I also notice a heavy scum layer on the surface of the water in the chlorine contact basins.

5/18/22 Final discharge Note persistent foam and scum

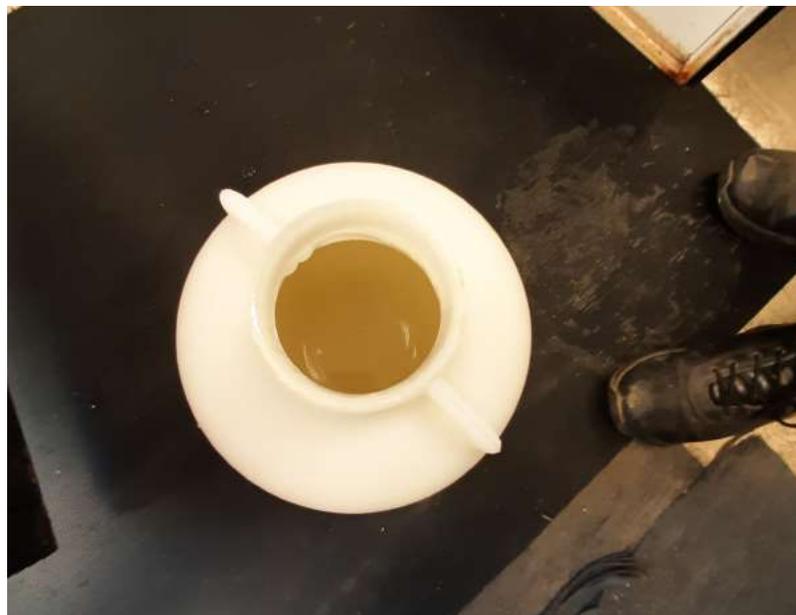
5/18/22 Effluent sample Amber color with suspended particulates
