Maryland Department of Environment

Site Name: Patapsco WWTP

Inspection Reason: Follow-up (Non-Compliance)

Inspection Findings:

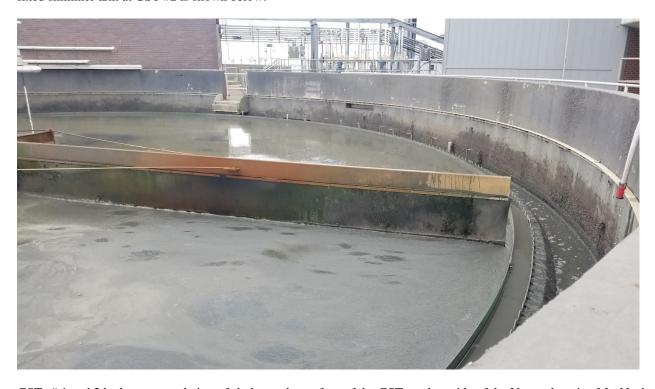
The facility has three GSTs (GSTs #1, 2, and 4). All GSTs were inspected. At the time of this inspection, water was being sprayed on the water surface of GSTs #1 and 2. One out of the two skimmer arms for GST #2 has been fixed to allow for the skimmer arm to be at the water surface to move additional sludge into the trough. The picture showing a fixed skimmer arm at GST #2 is shown below:

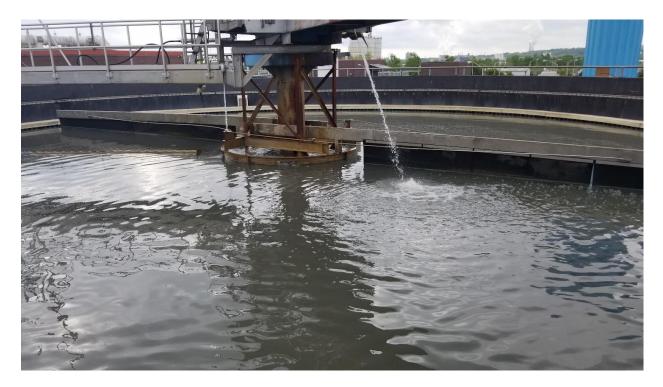
GST #4 is continuously receiving high pressure effluent water and is idle. Grime was observed at the outer weir of the GST. Mr. Neal Jackson and Mr. Chris Saunders stated that outer weirs will be cleaned before placing them back in service. Picture of GST #4 is shown on the next page.

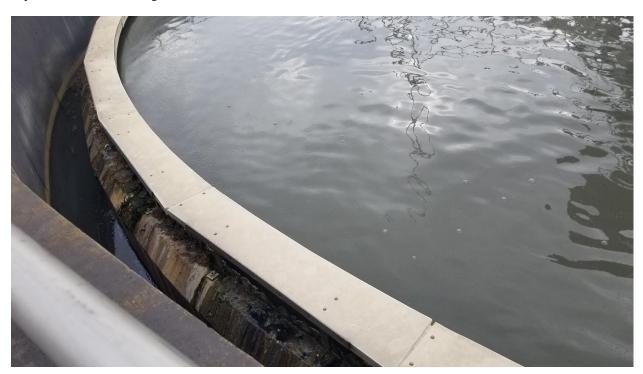
A picture of GST #4 with grime on the outer weir is shown below:

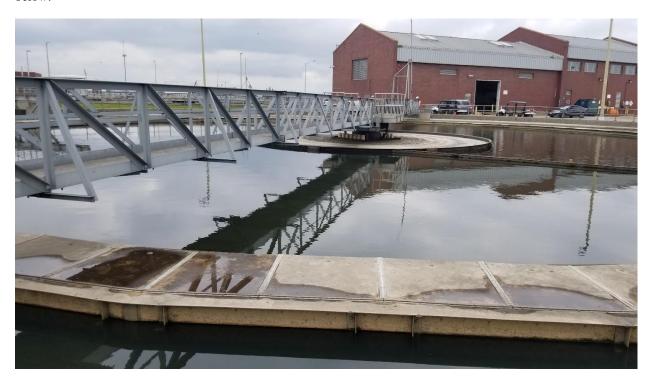
The facility has eight clarifiers. Inspection of all eight clarifiers (Clarifiers # 1- 4, 5A, 5B, 6A, and 6B) was conducted. The surfaces of the clarifiers that are in operation were being sprayed with water to further break up the scum. Clarifier #3 was not operational and was being used as a mud well to contain backwash water from the denitrification filters and biological activated filters (BAFs). Wastewater from Clarifier #3 flows back into the PST. Clarifier #2 is not running but can be turned on as needed. Since the previous inspection on 3/30/2023, the shrub at the center of clarifier # 6B (instead of clarifier #5A as noted on the 3/30/2023 inspection report) has been removed. The picture of clarifier 6B is shown below:

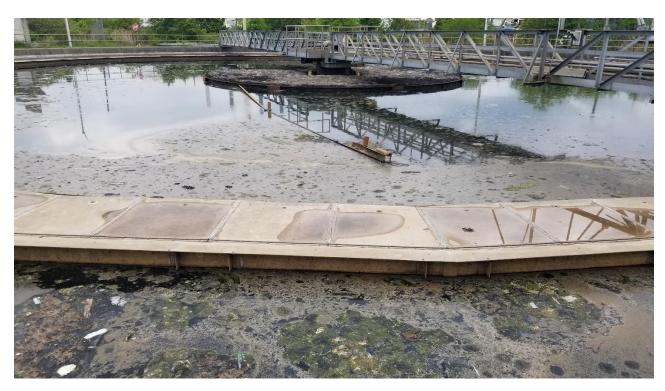
During the time of this inspection, Clarifier # 5B was turned off for maintenance. A staff member of Patapsco WWTP was actively removing scum from the surface of the clarifier. A picture of Clarifier # 5B is shown on the next page.

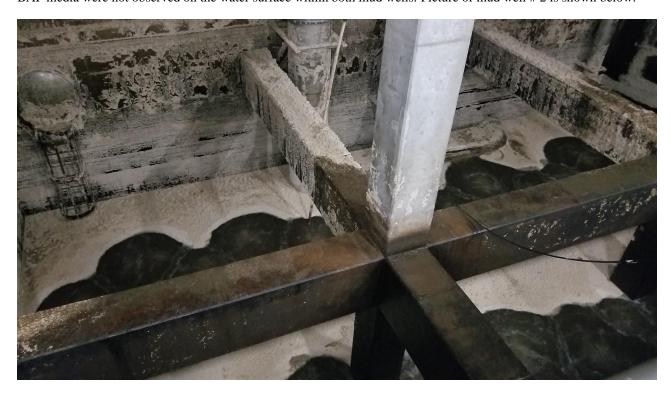
All BAF cells were active, with air being injected into the water for nitrification and BOD removal. The BAF has 24 individual cells. Mr. Chris Saunders showed me the monitoring device for BAF effluent, with ammonia concentration of 0.18 mg/L. Mud wells #1 and 2 were inspected and foam was observed on the water surface in both mud wells. FOGs BAF media were not observed on the water surface within both mud wells. Picture of mud well # 2 is shown below:

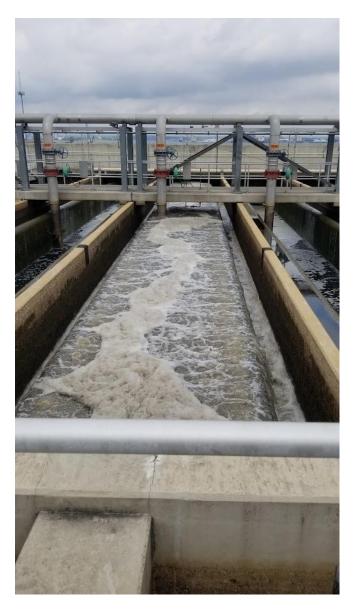
The denitrification system has 34 individual filters. During the time of this inspection, filters # 1, 6, 20, 33, and 34 were out of service, not functional, and waiting for repairs to be made. Methanol is added into the water before flowing into the denitrification filters. Water enters the denitrification filters from the top after overflowing the concrete weir walls. FOGs and BAF media were not observed in all denitrification filters. Water then exits the denitrification filters by flowing through the sand filter. Sand filters are located at the bottom of each individual denitrification filter. The denitrification filters are automatically backwashed every four hours for approximately 46 minutes. There was some water within filter #6 but Mr. Neal Jackson explained that the observed water was from a recent rain event. Filter #3 was actively being backwashed during the time of the site walk through, with water from the filter overflowing back to the concrete weir walls. A picture of filter #3 backwashing is shown on the next page.

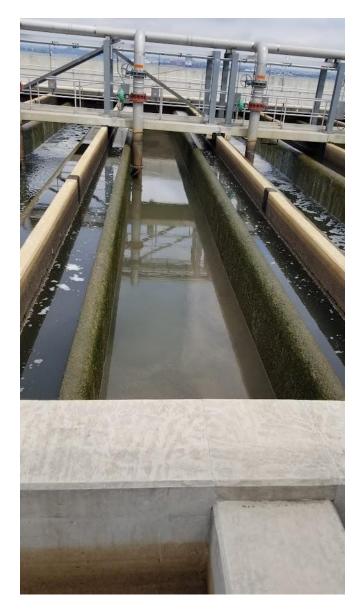
Filter #24 was prepping for backwash during the time of the site walk through and a picture of the filter is shown on the next page.

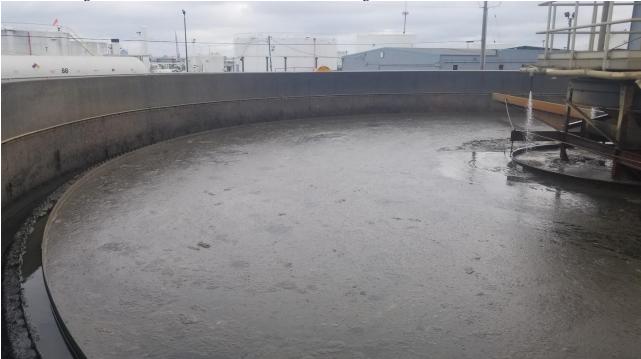
1) The GSTs are overloaded with sludge and solids and are not able to function as designed. The function of the GST is to allow for most of the biosolids to be at the bottom of the GST and for a relatively solids-free

supernatant to be at the top. The high concentrations of biosolids in GST effluent can negatively impact the pure oxygen reactors' ability to remove BOD and can cause nitrification issues within the plant. Pictures of GST #1 are shown in Figures 1a and 1b. Pictures of GST #2 are shown in Figures 1c and 1d.

1a: Excessive amounts of sludge at the surface of GST #1. The skimmer arm is above the water surface level.

The Patapsco WWTP should operate and process sludge in the GSTs in a manner consistent with the function and design of the equipment. Rags and solids should be removed from the GSTs regularly.

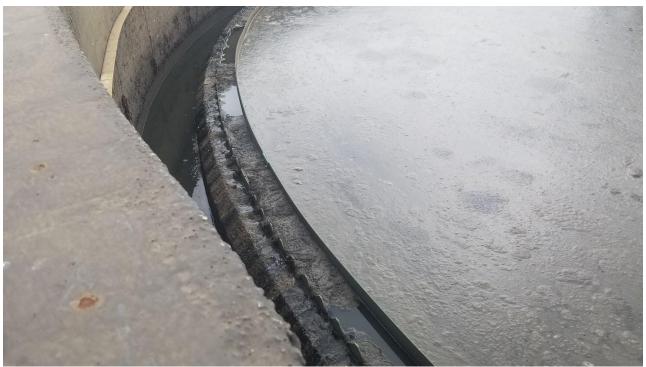
Figure 1b: Close up view of sludge next to the V- notch weir within GST #1.

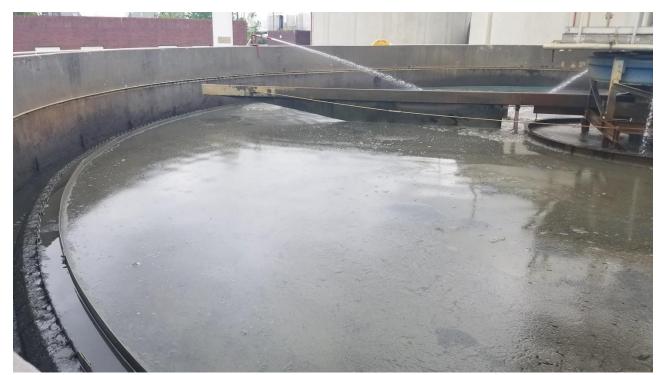
Figure 1c: Sludge at the surface of GST #2. One of the skimmer arms has not been fixed yet and is partially above the water surface level.

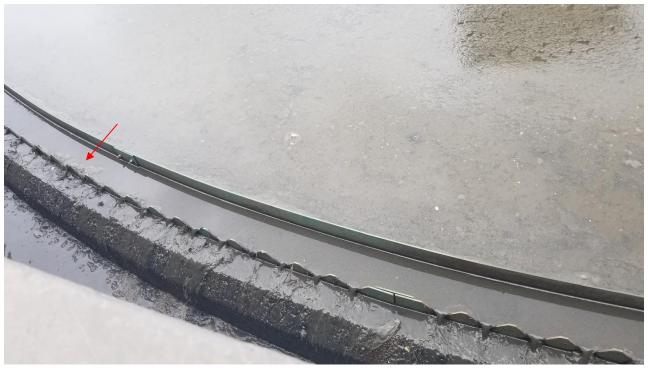
Figure 1d: Close up view of rags and solids next to the V- notch weir (pointed with a red arrow) of GST #2.

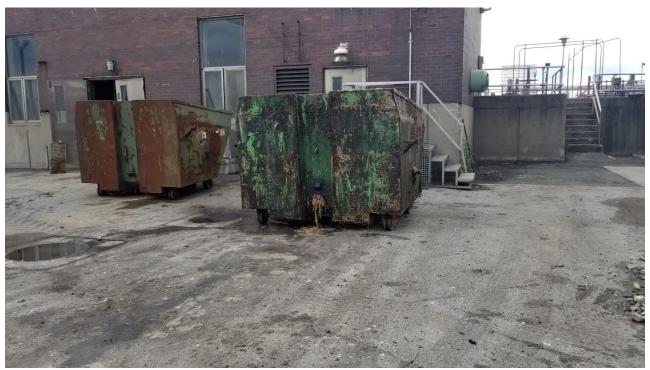
2) Hoppers that contain FOGs were observed to be leaking onto the ground outdoors and outside of containment. These hoppers are located next to the west side of the combined influent building. The FOGs can contaminate stormwater. Pictures of the leaking hoppers are shown in Figures 2a and 2b.

Figure 1a: A leaking hopper with FOGs by the transfer station and the northwest side of the combined influent building.

All leaking containers should be placed in containment. FOGs that were previously leaked onto the ground should be shoveled and placed into the transfer station or into a leak proof container that is clean on the surface.

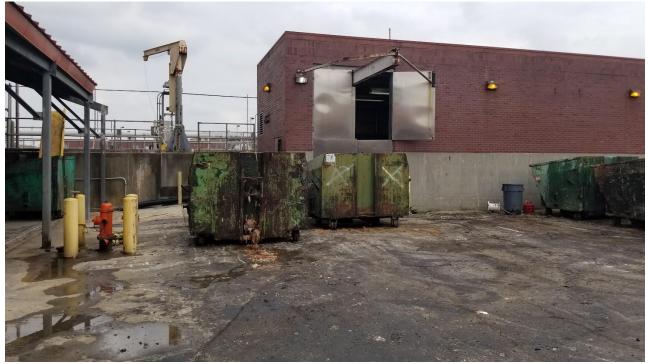
Figure 2b: A leaking hopper by the southwest side of the combined influent building. FOGs are on the ground surface.

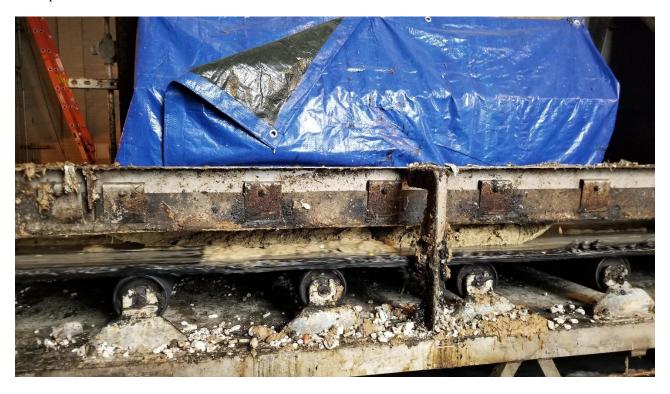
3) FOGs are stuck on the belt press tarp that is placed at the output side of bar screen #8. Mr. Neal Jackson explained that the clog is due to a high volume of FOGs entering the system. A picture of FOGs being stuck to the tarp at bar screen #8 is shown below:

In addition, the floor around the belt press is covered in FOGs liquid and residue, making it slippery.

Readjust the tarp to ensure that FOGs and grit are not stuck/ clogged at the conveyor belt. Implement routine housekeeping to ensure that the conveyor is running smoothly and the floor in the combined influent building has a minimal amount of FOGs residue and liquid.

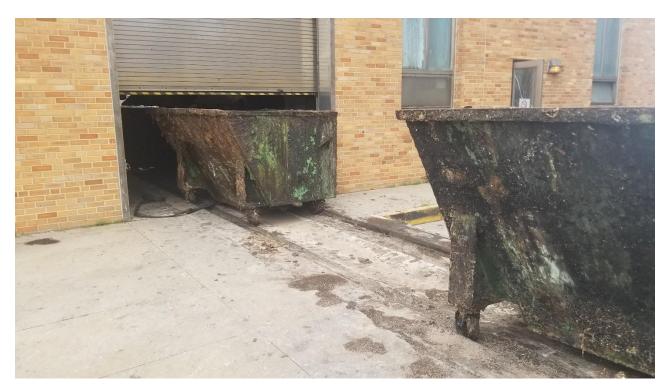
4) Solids were observed on the ground outside next to the hoppers and the IPI building. A picture of solids on the ground by the hoppers is shown on the next page.

Remove all solids from the ground and place them into a leakproof container, under cover.

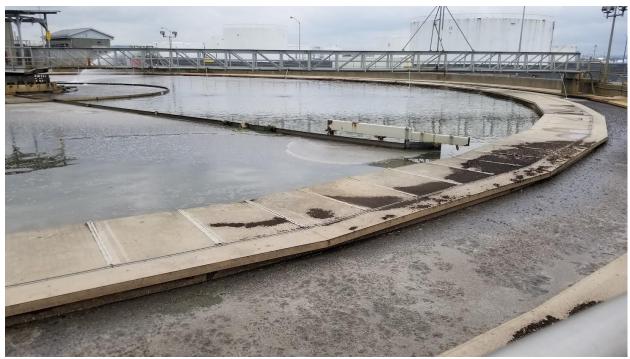
5) The secondary clarifiers are not operating as designed. Both scraper arms are missing in Clarifiers # 5A and 5B. All scraper arms within Clarifiers # 1 and 6A have been replaced but, the rubber part at the edge of one of the two scraper arms within both clarifiers are missing. One of the two scraper arms at Clarifier #6B has not been replaced yet. Clarifier #4 has one of the two scraper arms that has been replaced but the rubber part at the edge of the fixed scraper arm has not been replaced yet. The purpose of the scraper is to skim off any solids that have accumulated on the water surface and push the solids into a trough. The purpose of the rubber part at the edge of the scraper is to scrape off any accumulated solids from the weir of the clarifier. Mr. Neal Jackson and Mr. Chris Saunders explained to me that the reason for all the scraper arms and rubber parts not being replaced is due to a supply chain issue. The facility is struggling to get the parts needed to fix all scrapers.

Figure 5a: Rubber part missing at the edge of the scraper arm of Clarifier # 1

Repair and maintain the clarifiers to ensure that they are functioning per design. Install scraper arms and rubber parts to all clarifiers immediately, once the parts are received. Remove vegetation from the aforementioned clarifiers.

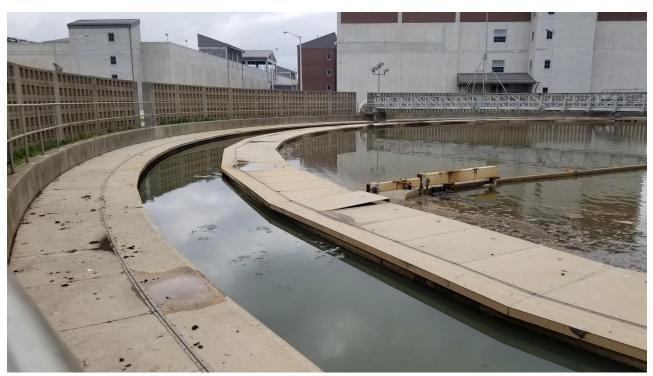
Figure 5b: Rubber piece missing at the edge of one of the scraper arms in Clarifier # 4

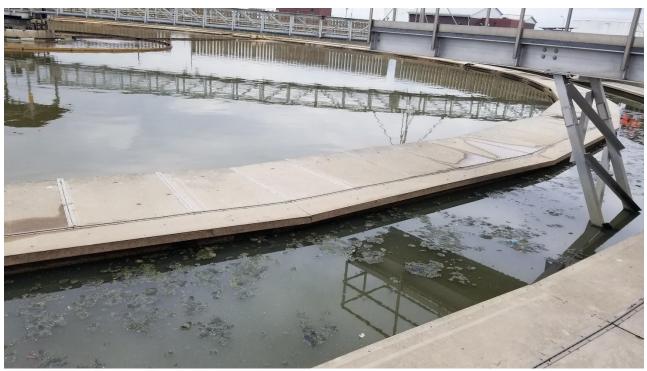
Figure 5c: Algae outside of the launder cover of Clarifier # 4

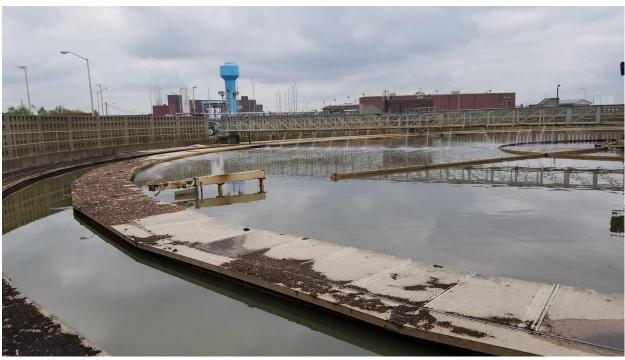
Figure 5d: One of the two scraper arms in Clarifier # 4 is missing.

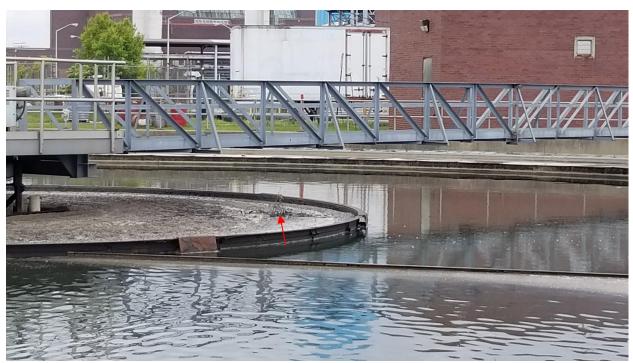
In addition, woody vegetation was observed at the center of the clarifier and grass was observed to be growing between the weir and launder cover of Clarifier #6A. Grass was observed at the center of Clarifier #5A. Vegetation growth can damage the clarifier and reduce its ability to function properly.

Figure 5e: Woody vegetation growing at the center/influent side of Clarifier # 6A (pointed to with a red arrow)

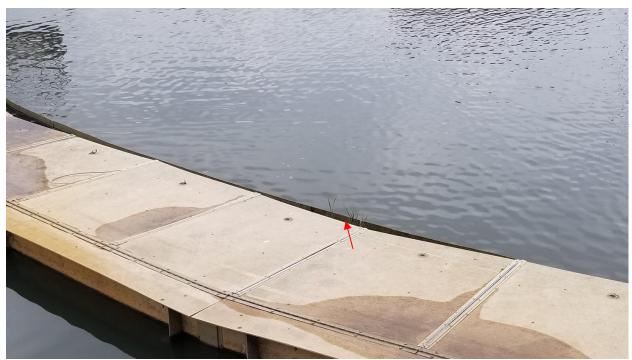
Figure 5f: Grass growing between the weir and launder cover of Clarifier # 6A (pointed to with a red arrow)

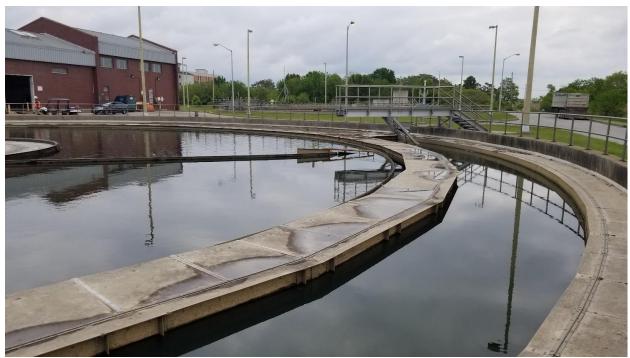
Figure 5g: One of the scraper arms in Clarifier # 6B is missing.

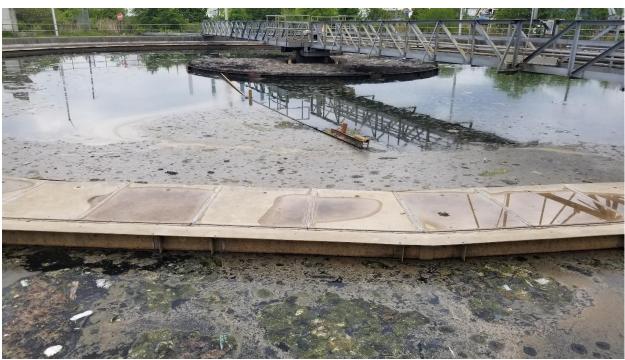
Figure 5h: Scraper arm in Clarifier # 5B. Clarifier # 5B is turned off for maintenance.

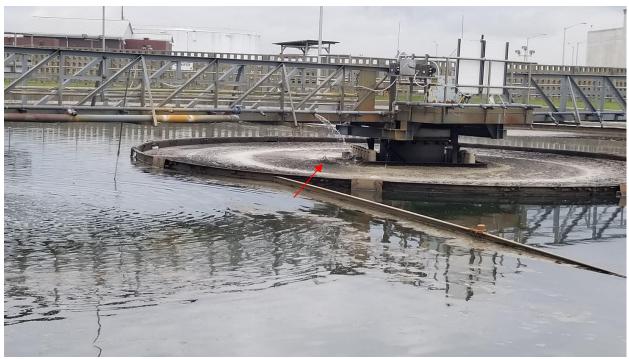
Figure 5i: Grass at the center/ influent side of Clarifier # 5A (pointed to with a red arrow)

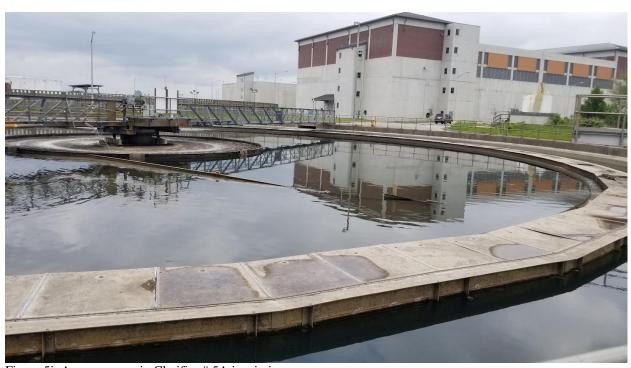
Figure 5j: A scraper arm in Clarifier # 5A is missing.
