Maryland Department of Environment

Site Name: Patapsco WWTP

Inspection Reason: Follow-up (Non-Compliance)

Inspection Findings:

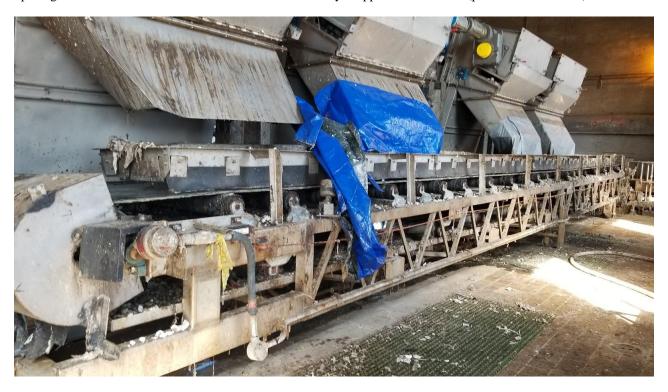
Domestic sewage and industrial influent enter this building. Solids are removed from sewage with fine screens. During the time of this inspection, the fine screens were being cleaned, maintained, or installed. Tarps were observed at the opening side of the fine screen where solids are mechanically dropped onto the belts (picture shown below).

There are grit and debris on the ground within the combined influent building. Remove all debris and grit from the ground routinely.

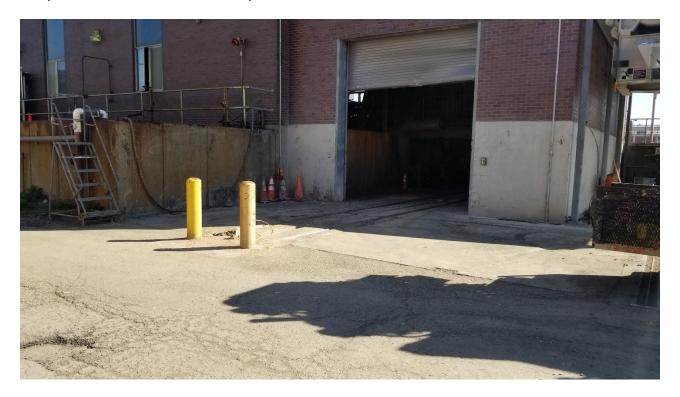
Multiple puddles of brown liquid were observed outside of the combined influent building during the time of the previous inspection on 2/27/2023. During the time of this inspection, there were no liquids outside of the combined influent building (picture shown next page). Mr. Neal Jackson informed me that the site unclogged a drain within the combined influent building after the last inspection, which contributed to the reduction in liquids leaving the building.

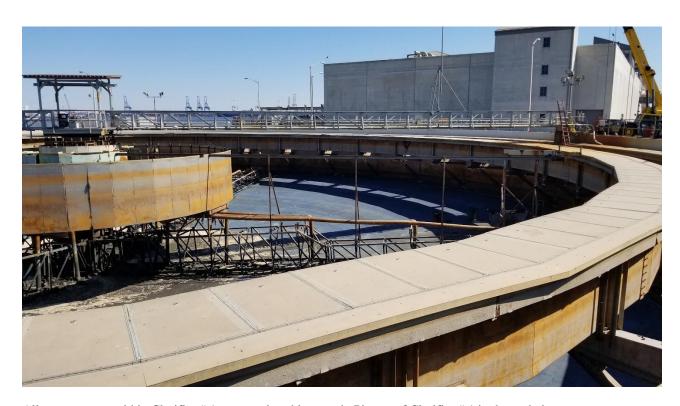
The facility has eight clarifiers. Inspection of all eight clarifiers was conducted (clarifiers # 1- 4, 5a, 5b, 6a, and 6b). The surfaces of the clarifiers that are in operation were being sprayed with water to further break up the scum. Clarifier #3 was not operational and was being used as a mud well to contain backwash water from the denitrification filters. Wastewater from Clarifier #3 flows back into the PST. Clarifier #2 was turned off for maintenance (picture shown next page):

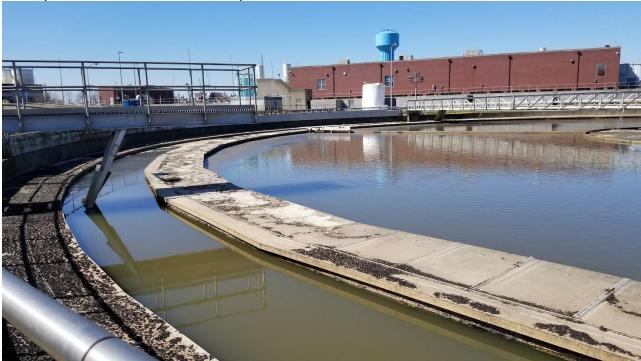
All scraper arms within Clarifier # 1 were replaced last week. Picture of Clarifier # 1 is shown below:

There were dry solids on the launder covers of Clarifier #1. The solids should be removed from the launder covers. The scraper arm within Clarifier #6A has been repaired but the rubber part at the edge of the scraper arm has not been installed yet. One out of the two scraper arms has been installed at Clarifier #6B.

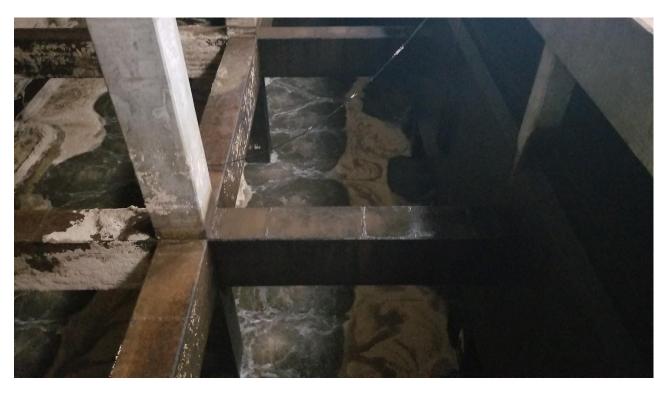
All BAF cells were active, with air being injected into the water for nitrification and BOD removal. The BAF has 24 individual cells. Mud wells #1 and 2 were inspected and foam was observed on the water surface in both mud wells. Picture of mud well # 2 is shown below:

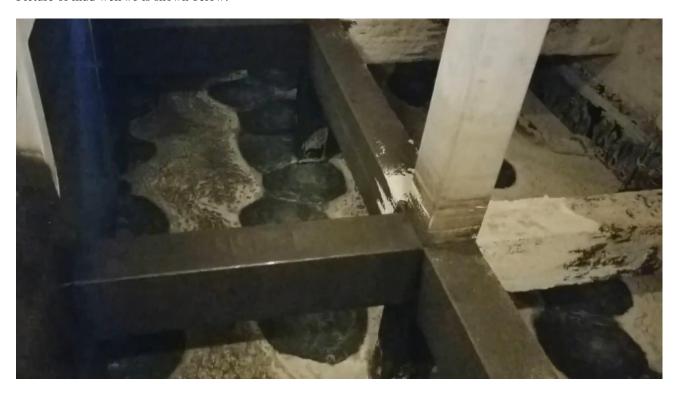
Picture of mud well #1 is shown below:

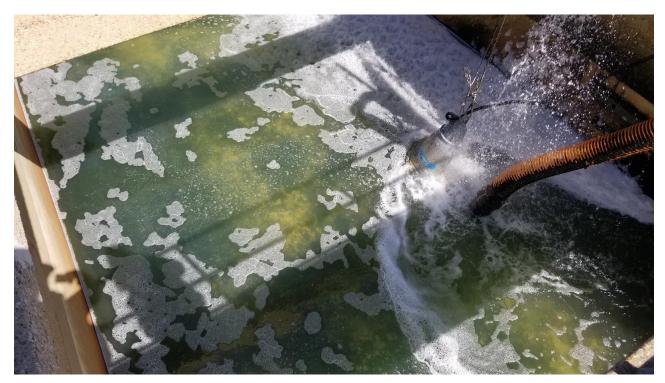
The wastewater treatment plant has four chlorine contact chamber units, which were all running at the time of this inspection. Some brown foam was observed to be floating on the water surface at the influent side of the chlorine contact chamber; however, most of the chambers appear to have been skimmed earlier. The operator lab maintains daily chlorine contact chamber skim logs. Clear effluent was discharging out of the chlorine contact chamber and into the Patapsco River (picture shown below).

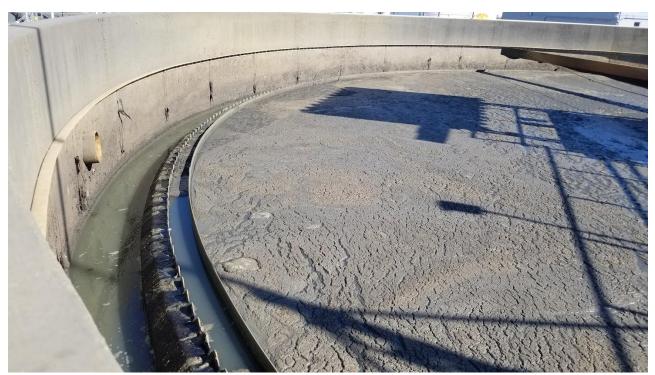
1) The GSTs are overloaded with sludge and solids and are not able to function as designed. The function of the GST is to allow for most of the biosolids to be at the bottom of the GST and for a relatively solids-free supernatant to be at the top. The high concentrations of biosolids in GST effluent can negatively impact the pure oxygen reactors' ability to remove BOD and can cause nitrification issues within the plant. Pictures of GST #1 are shown in Figures 1a to 1c. Pictures of GST #2 are shown in Figures 1d and 1e.

Figure 1a: Sludge next to the V- notch weir and on the surface of GST #1. The skimmer arm is above the water surface level.

The Patapsco WWTP should operate and process sludge in the GSTs in a manner consistent with the function and design of the equipment. Rags and solids should be removed from the GSTs regularly.

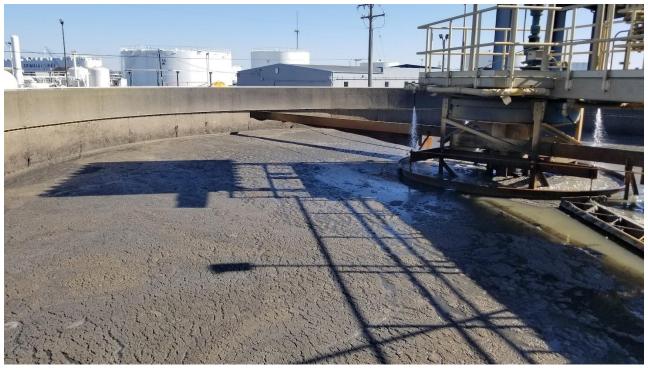
Figure 1b: Skimmer arm above the water surface of GST# 1.

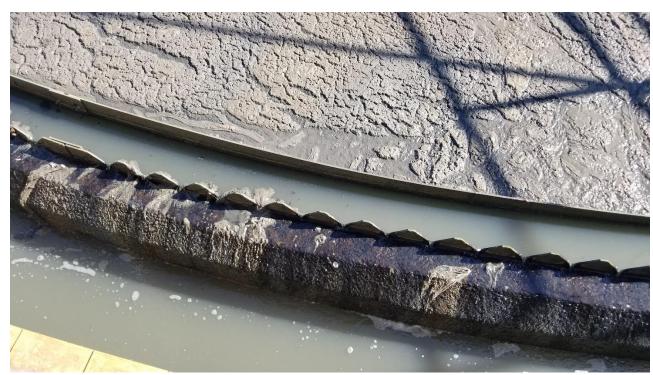
Figure 1c: Close up view of GST #1, with some rags stuck to the V- notch weir.

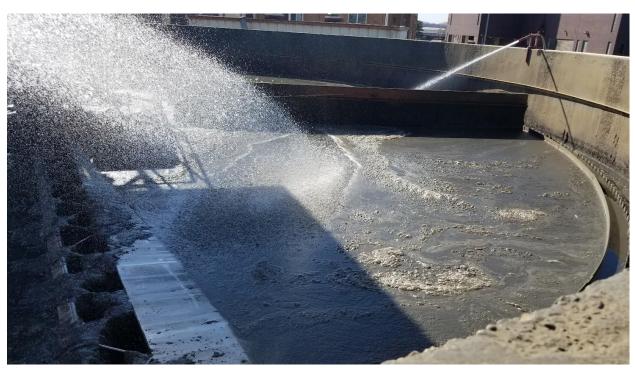
Figure 1d: Sludge on the surface of GST #2.

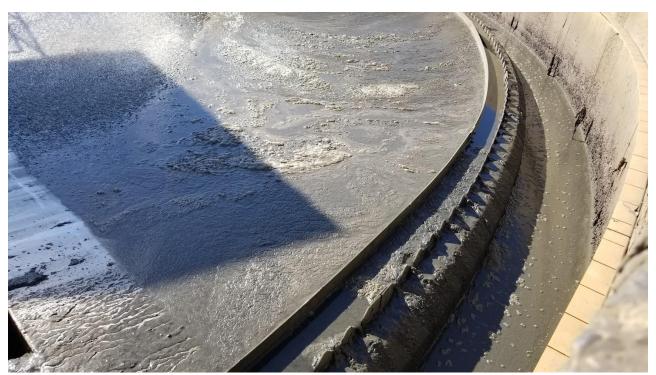
Figure 1e: Sludge next to the V- notch weir at GST #2.

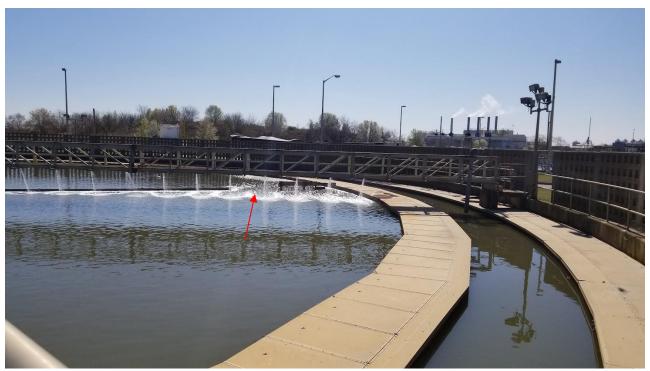
2) The secondary clarifiers are not operating as designed. Scraper arms are missing in Clarifiers # 4, 5A, and 5B. A scraper arm within Clarifier # 6A has been replaced but, the rubber part at the edge of the scraper arm is missing. One of the two scraper arms at Clarifier #6B has not been replaced. The purpose of the scraper is to skim off any solids that have accumulated on the water surface and push the solids into a trough. Mr. Neal Jackson and Mr. Chris Saunders explained to me that the reason for all the scraper arms not being replaced is due to a supply chain issue. The facility is struggling to get the parts needed to fix all scrapers. The problem is compounded by the fact that each scraper arm is different and requires different parts. Solids were observed next to the outer side of the launder covers within Clarifiers # 6A and 6B. In addition, woody vegetation was observed at the center of Clarifier #5A. Vegetation growth can damage the clarifier and reduce its ability to function properly. A picture of Clarifier # 4 is shown in Figure 2a. Pictures of Clarifier # 6B are shown in Figure 2b and 2c. A picture of Clarifier # 6B is shown in Figure 2d. A picture of Clarifier # 5B is shown in Figure 2e. Pictures of Clarifier # 5A are shown in Figures 2f and 2g.

Figure 2a: Scraper arm of Clarifier #4 is missing. The red arrow shows the gap between scum skimmer and the weir.

Repair and maintain the clarifiers to ensure that they are functioning per design. Install scraper arms to all clarifiers immediately, once the parts are received. Remove vegetation from the center of Clarifier #5A.

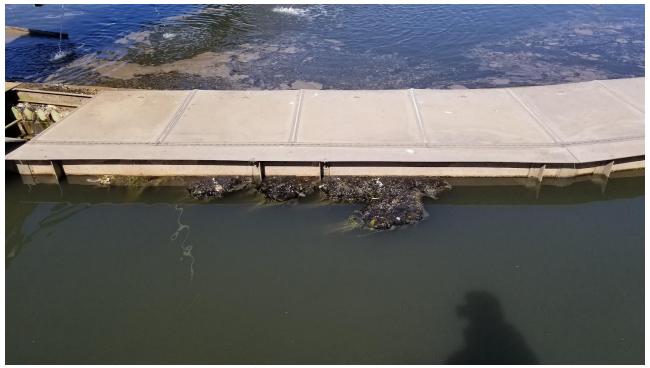
Figure 2b: Solids on the water surface in Clarifier #6A at two sides of the launder cover.

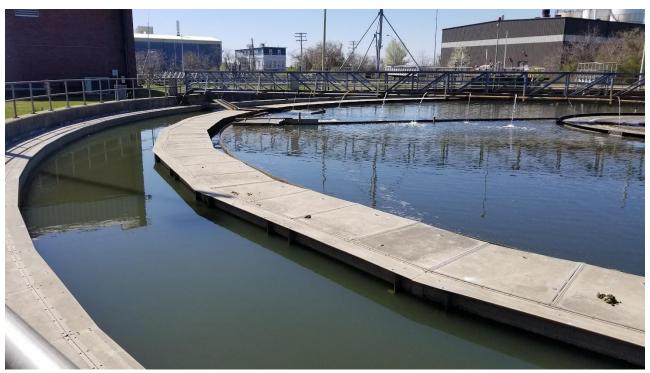
Figure 2c: Rubber part of the scraper arm in Clarifier #6A is missing.

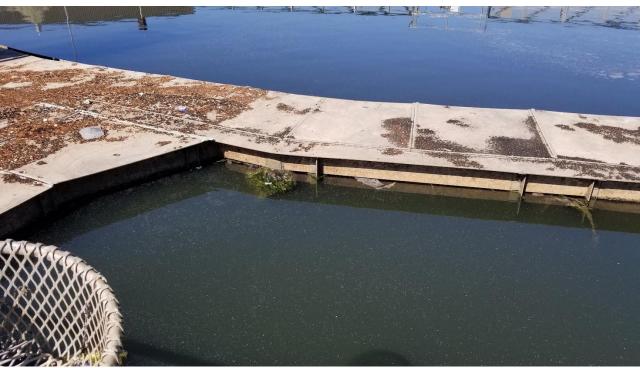
Figure 2d: Solids outside of launder cover within Clarifier # 6B.

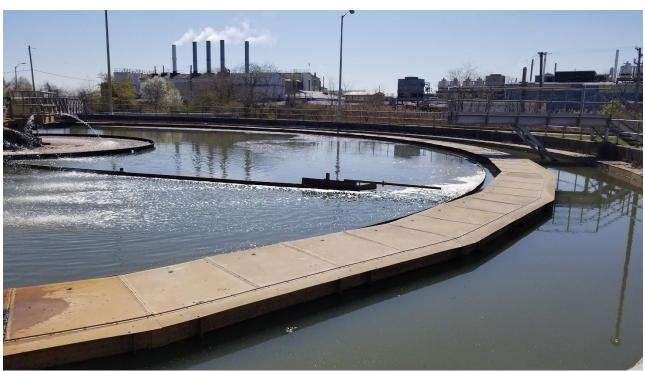
Figure 2e: Scraper arm in Clarifier # 5B is missing.

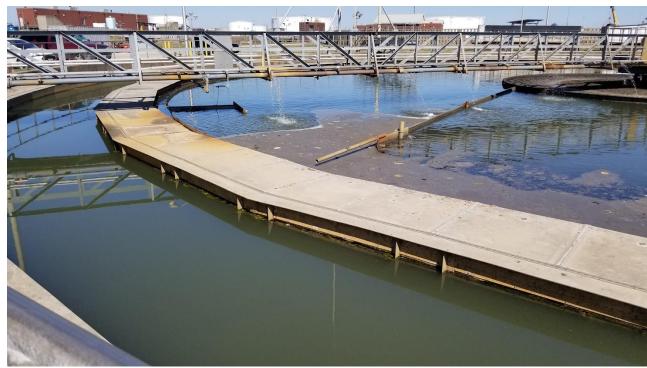
Figure 2f: Scraper arm in Clarifier # 5A is missing.

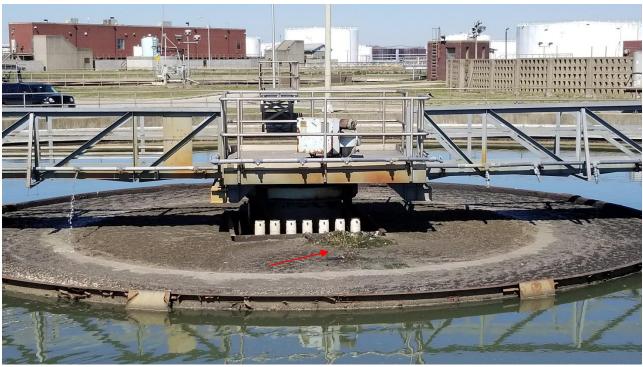
Figure 2g: Woody vegetation in the center of Clarifier # 5A (pointed out with a red arrow).

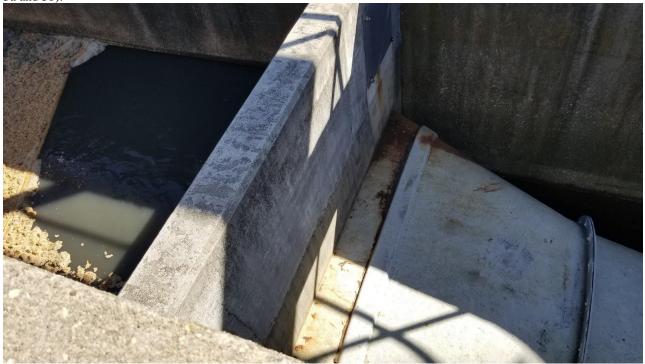
3) FOGs were observed to be backflowing into the outflow side of the PST/ inflow side of the pure oxygen reactors. Media from the BAF cells were observed to be comingled with the floating FOGs (shown in Figures 3a and 3b).

Figure 3a: FOG backflowing into the outflow side of PST and inflow side of the pure oxygen reactors.

This section of the wastewater treatment plant should be maintained to prevent the accumulation of escaped media from the BAF.

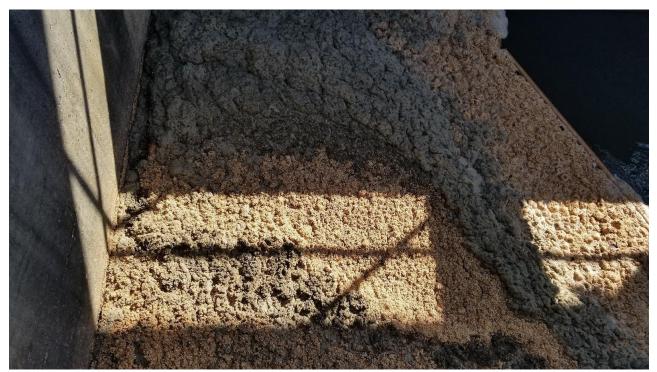
Figure 3b: Close up view of the FOGs comingled with media from the BAF cells. This floating FOG is also shown at the left side of the picture shown in Figure 3a.
