# **Maryland Department of Environment**

Inspector:	Ronald Wicks
AI ID:	3076
Site Name:	Patapsco WWTP
Facility Address:	3501 Asiatic Ave, Curtis Bay, MD 21226
County:	Baltimore City County
Start Date/Time:	January 30, 2023, 08:45 AM
End Date /Time:	February 23, 2023, 11:06 PM
Complaint Number: Media Type(s):	NPDES Municipal Major Surface Water
Contact(s): Neal Jackson Eric Johnson Andrea Buie Wendy Huang MDE

# **NPDES Municipal Major Surface Water**

Today, on January 30, 2023, I conducted a compliance evaluation inspection at the Patapsco WWTP, NPDES Discharge Permit number MD0021601 and State number 15-DP-0580.

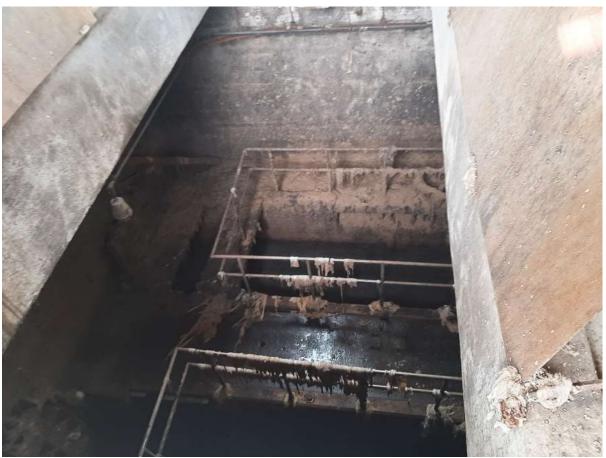
1/30/23 Industrial plant influent. Grease was observed on the screens and floating in the influent.

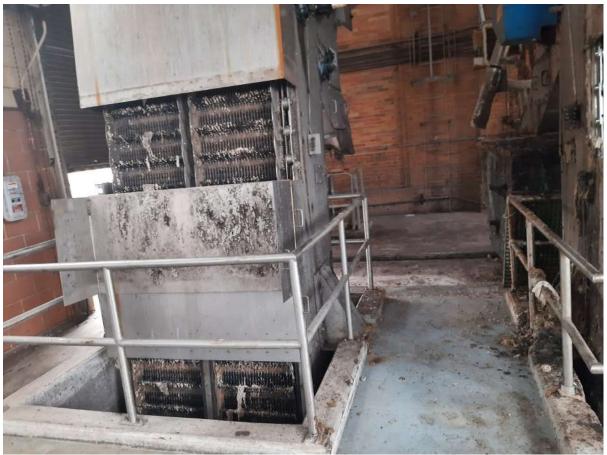
During an inspection of the industrial influent screening facility, I found that 2 screens were operable, 2 (#1 and #4) of the 4 pumps were operable. The #2 and #3 pumps require variable

frequency drives (VFD) in order to function. According to Jackson, they have received a bid for a complete upgrade of the Industrial influent screening facility.

1/30/23 One of the screening units at the industrial influent screening facility

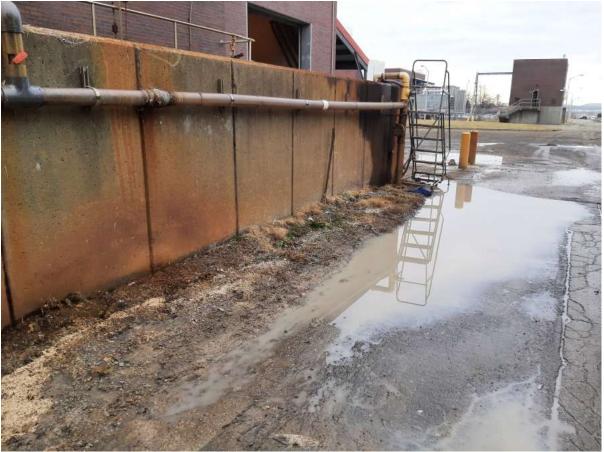
Next, we traveled to the fine screening building. At the entrance to the fine screening building, I observed what appeared to be spilled lime mixed with water in the roadway. Later it was traced back to the inside trash collection and dumpster area. I requested that the area be cleaned up and the water not be allowed to flow to the storm drains in the area. Jackson contacted maintenance and request that the area be cleaned. The second picture is an after shot showing conditions after the cleanup.

1/30/23 spilled lime and water mixture.

The dumpster collection area must be maintained in better condition to prevent reoccurrences. Housekeeping practices should be improved, and all spills must be cleaned up immediately after they occur to prevent these substances from contaminating stormwater that flows to the surface waters of the State. In addition, the Patapsco WWTP should emphasize to its employees and contractors working on site the importance of preventing spills and similar environmental incidents. In addition, there should be an enhancement in management efforts in stressing to staff the importance of the prevention, immediate action and management of spills and potential spill situations.

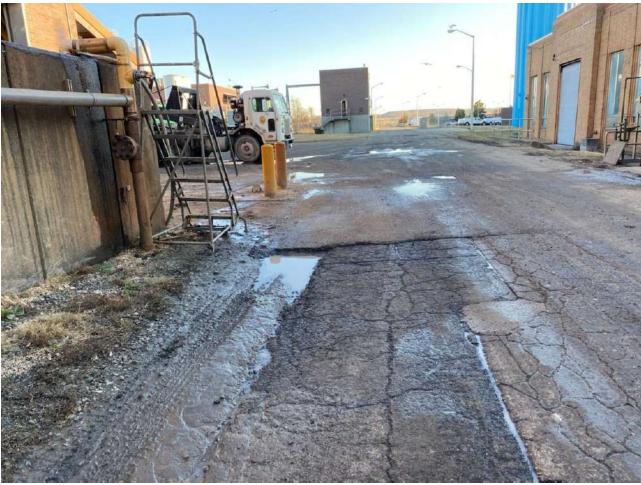
1/30/23 This is a picture taken after the cleanup.

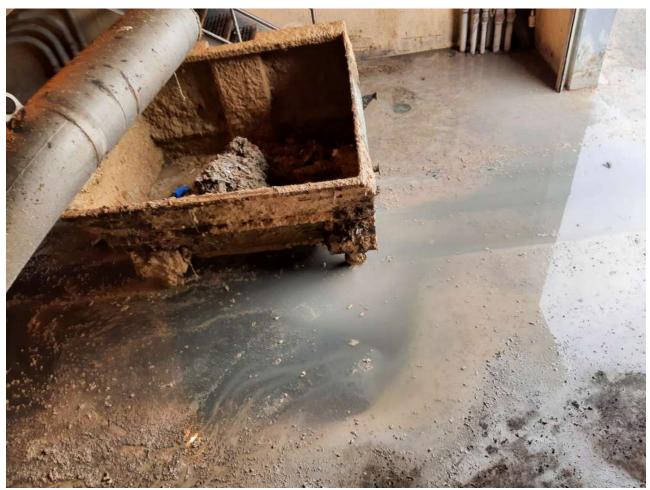
1/30/23 Trash collection dumpster appears to be the source of the lime.

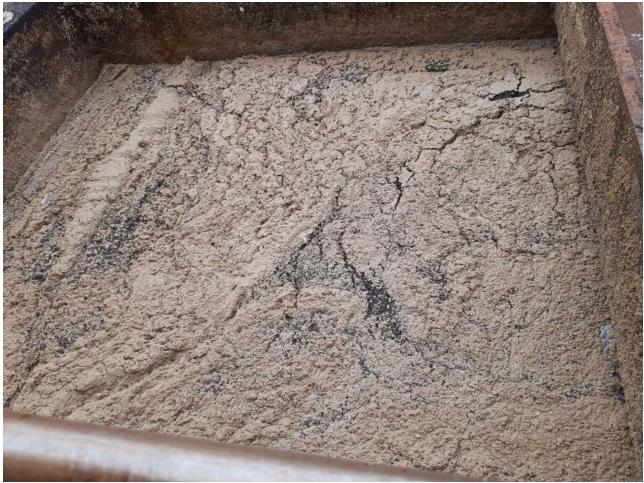
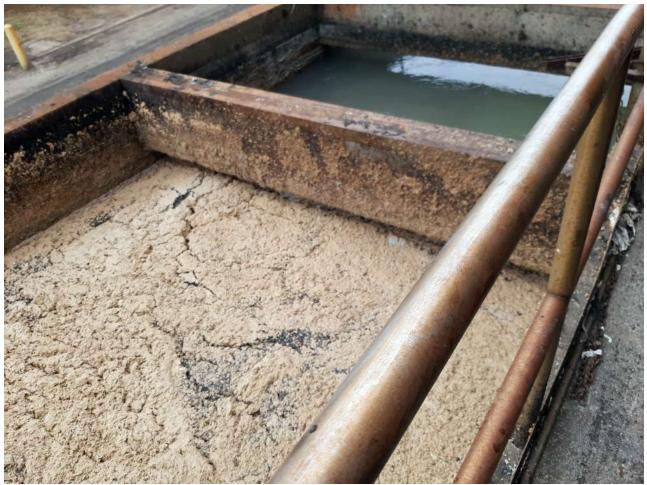
The next area of evaluation was the fine screening building. The influent tank at the fine screening building had a thick layer of grease (see pictures below). According to Jackson, a large amount of grease came through several days ago from an unknow source.

1/30/23 Influent tank at fine screening building showing heavy layer of grease.

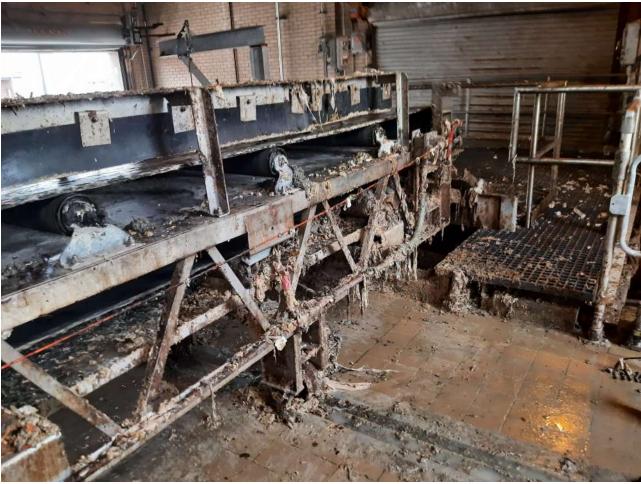
Next, I inspected the fine screening area where I observed an accumulation of rags and debris falling off of the conveyor belts. The housekeeping practices in this area require more attention and improvements are necessary to prevent and minimize potential problems downstream due to trash and debris impairing and clogging equipment. In addition, the bar screening units were clogged with grease making them unable to function as designed.

1/30/23 conveyor belt at fine screening building

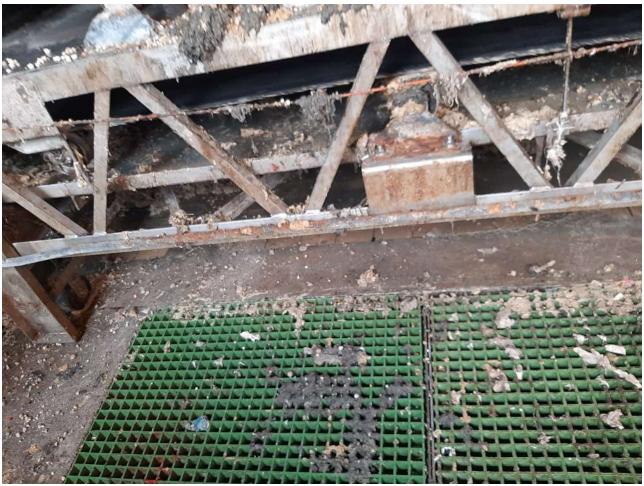
1/30/23 conveyor belt area at fine screening building

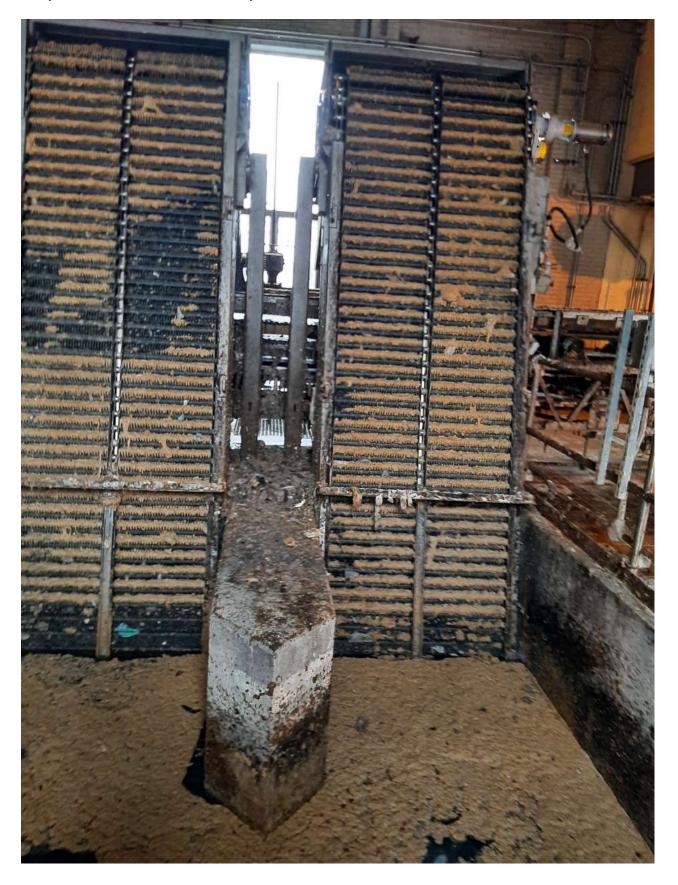
1/30/23 Fine screening units clogged with grease and not functioning as designed.

The fine screening system is not being maintained to the level necessary to ensure that downstream equipment functions satisfactorily. During previous inspections in 2021 and 2022, the belt conveyors were not operable due to the accumulation debris such as rags, paper and plastic items. During this inspection, the belts were functioning; however, there was an accumulation debris on and around the belts. The belts are old with missing and damaged skirting which allows the debris to fall from the belt and clog the mechanical parts. Because of this issue the system requires constant maintenance to prevent blockage of the belt mechanisms. Only 2 of the 3 GSTs are available and the 2 GSTs that are being used are not processing the sludge efficiently because repairs are necessary in order for them to function as designed. Currently, the LOX plant is offline due to mechanical issues. Therefore, oxygen is being trucked in for use in the Pure Oxygen Biological Reactors The facility does not have the redundancy and resiliency required because of the condition of

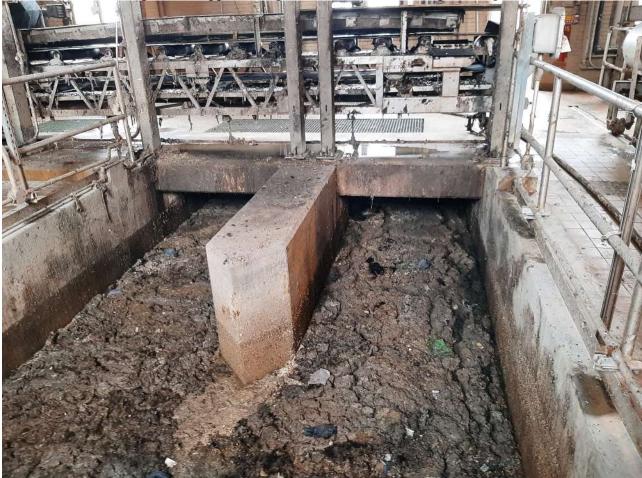
1/30/23 Location for fine screens #6 and #7 that were taken out for repairs. The screens have been refurbished but have not been installed. The channels should be cleaned of the heavy layer of FOG before installation.

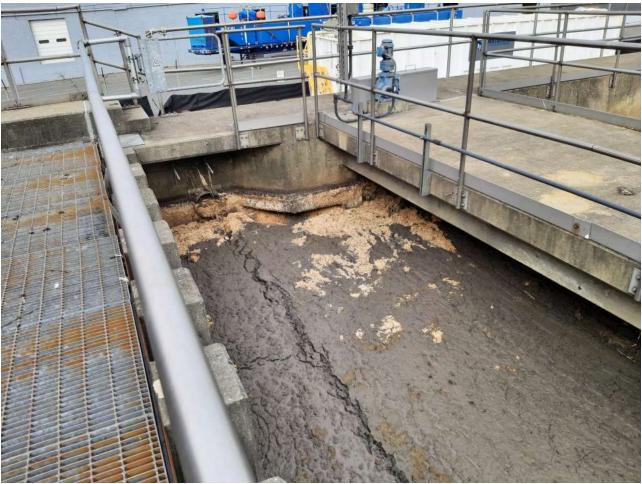
During an inspection of the PSTs, I observed a considerable amount of FOG floating on the surface of the PSTs as well as media recycled from the BAF recycle clarifier. I also observed FOG/media slugs on the overflow weirs at some of the PSTs. Some of this material has breached the weirs and was observed floating in the channel leading to the biological reactors.

1/30/23 PST #1 has a thick layer of FOG.

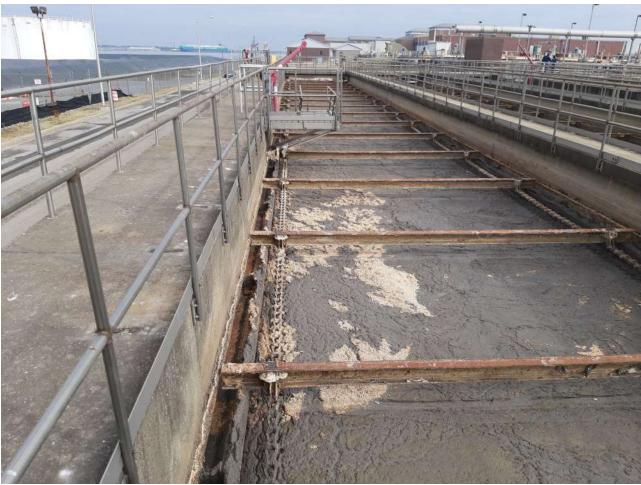
1/30/23 Thick layer of FOG on the PSTs

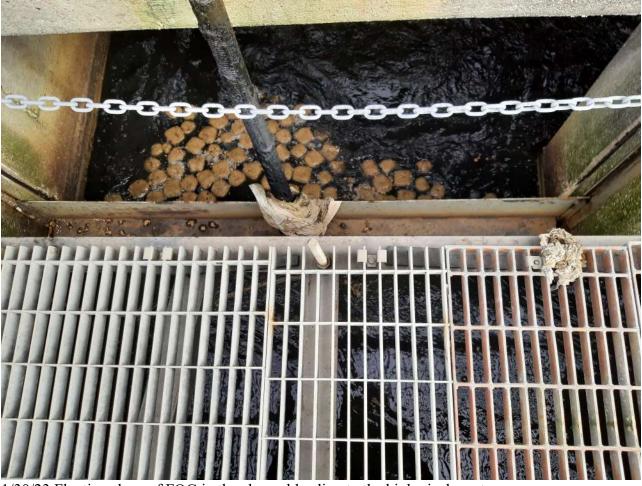
1/30/23 Floating slugs of FOG in the channel leading to the biological reactors.

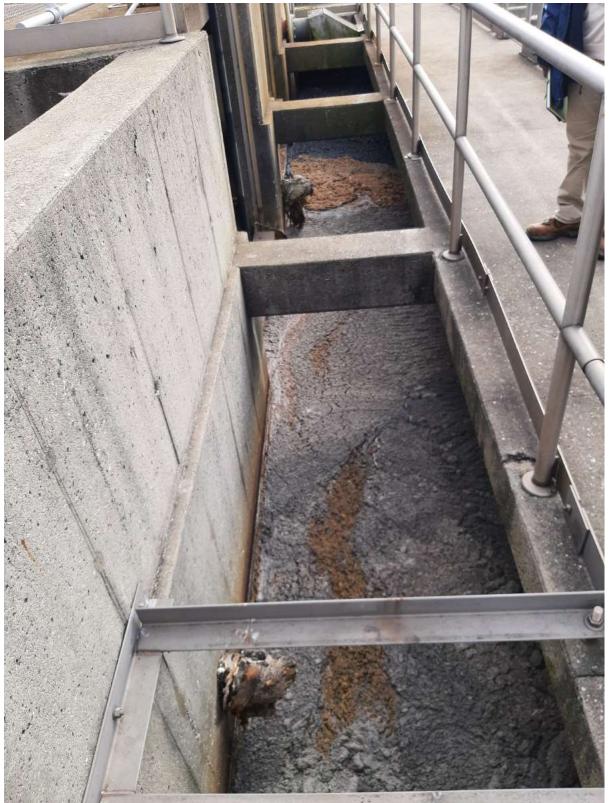
1/30/23 FOG that has breached the weirs of the PSTs.

- B. The PSTs are overwhelmed with FOG and are not able to function as designed. The cause of the FOG has not been identified. However, heavy FOG loads into the plant is a continuing problem for the Patapsco WWTP. FOGs are bypassing treatment and traveling downstream. This can lead to clogged filters, pumps, piping and impede and negatively impact downstream treatment processes. Under the provisions of 40 CFR Part 403.5(c)(1) & (2), a POTW must establish and enforce specific local limits for industrial users to prevent interference with the operation of the municipally-owned treatment works in the following circumstances: (1) POTWs with approved pretreatment programs; (2) POTWs that have experienced Interference or Pass-Through and such violation is likely to recur. Special condition M of the permit specifies that the Patapsco WWTP shall develop and implement an FOG mitigation Plan to protect the treatment works, maintain effluent quality, and ensure full compliance with the narrative discharge standard of this permit, the

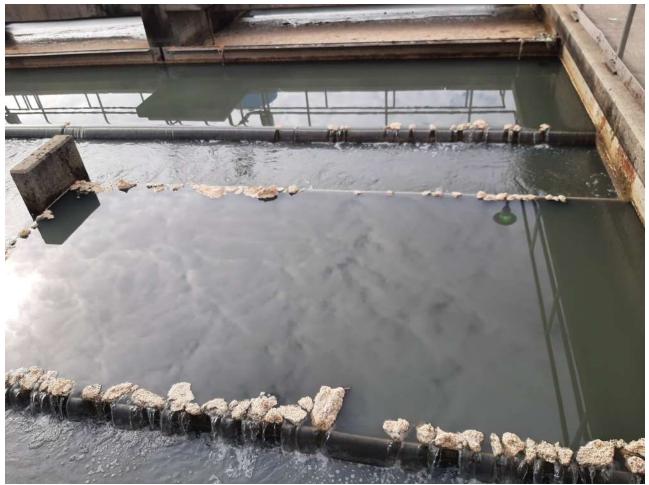
11/30/23 FOG and BAF media clumped together overflowing the PST overflow weirs.

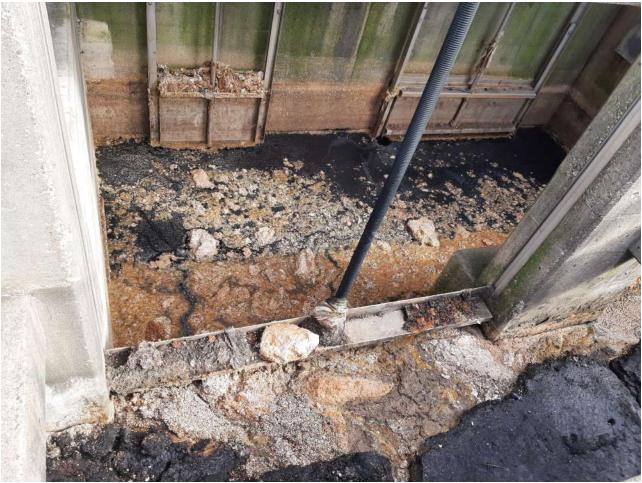
1/30/23 FOG that has breached the PST treatment.

According to Mr. Jackson, the scum troughs are checked twice a day to remove the scum and manual skimming with a net is being conducted as well to try to manage the floating scum and FOGs. There was no manual skimming or rotations being done during my time inspecting the PSTs. Due to the FOG, the scum troughs are overwhelmed. The facility must ensure the operational integrity of primary treatment system and take a proactive approach by removing the accumulation of FOGs that have accumulated in the PSTs and channel leading to the reactors. More frequent checks of the scum troughs and manual skimming should be conducted to prevent media and FOGs from flowing downstream.

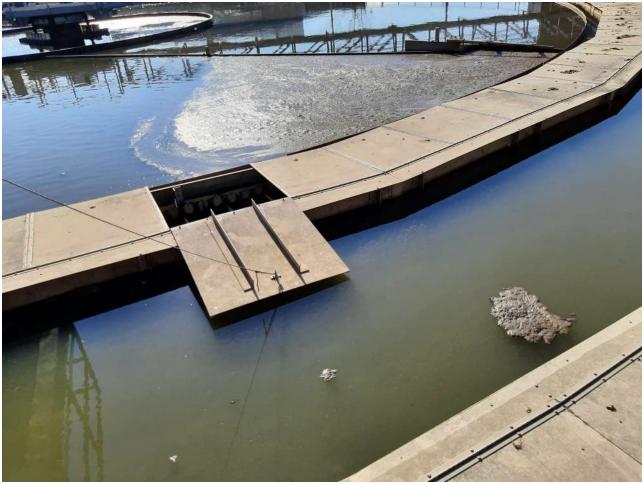
1/30/23 Secondary clarifier #6A scum collection trough/pit was clogged. There was a floating layer of scum on the surface of the water.

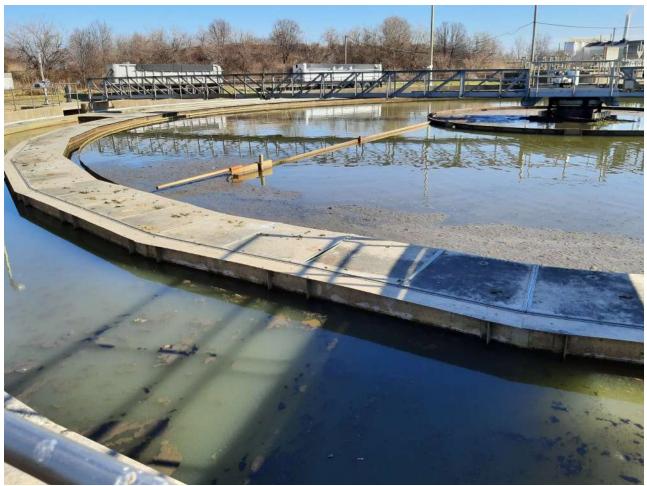
- During the November 2022 inspection the skimmer arm on clarifier #5A was reported as bent and a part of the scum scraper is missing. During today's inspection, I found that the skimmer arm is no longer functioning, and the scum scraper is missing. There is floating sludge that is overflowing the weirs and the sludge blanket appear to be higher than normal. This clarifier requires maintenance.

1/30/23 Secondary clarifier 5A the skimmer arm is no longer functioning, and the scum scraper is missing.

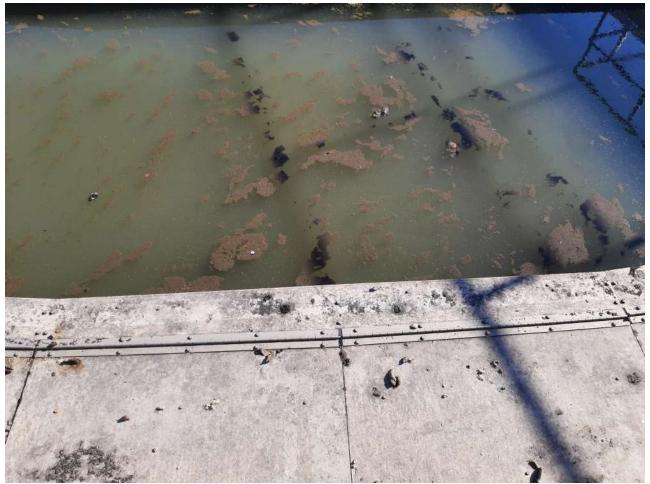
1/30/23 Secondary clarifier 5A with floating biosolids

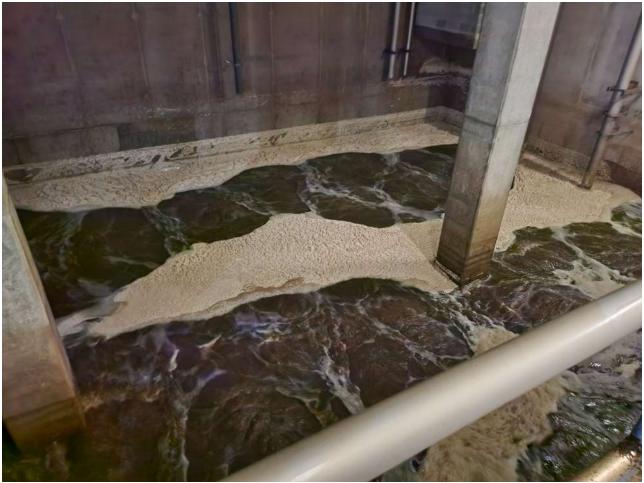
The Patapsco WWTP has been working with VWT to resolve the problem. I was informed that there is no longer a problem with the leakage of media and all media being discharged are from the residual in the backwash mud wells. During an inspection of the BAF mud well where the backwash is discharged before going into clarifier #3, I observed that the amount of media has declined by and the entire surface of the water in the mud well is no longer covered with a heavy layer of media. The Patapsco WWTP submitted on 1/5/23 an SOP informing the Department how

1/30/23 Picture taken today of backwash mud well showing media accumulation. See picture below showing mud well condition on 11/2/22.

the media would be removed. The Patapsco WWTP must continue to clean the mud wells in order to prevent further discharges of media and prevent issues with media clogging pumps and other sensitive treatment works equipment.

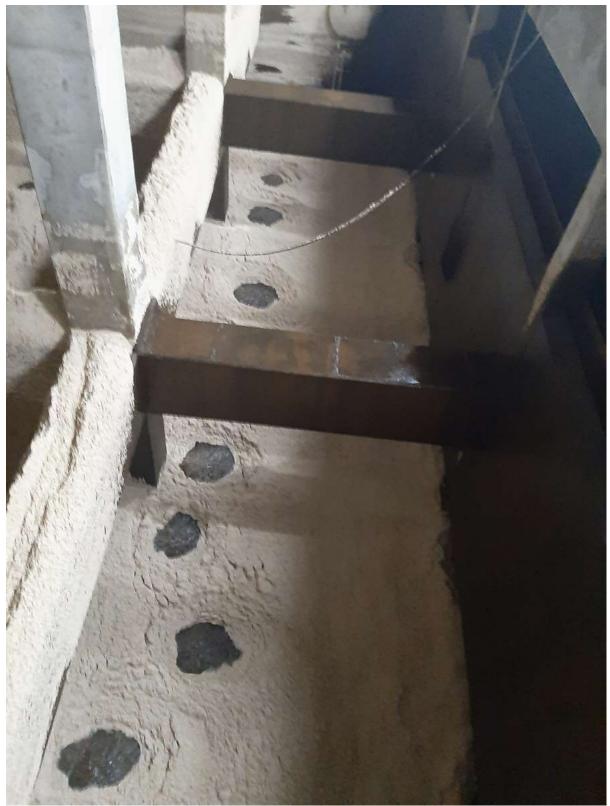
Picture taken 11/2/22 of backwash mud well showing media accumulation.

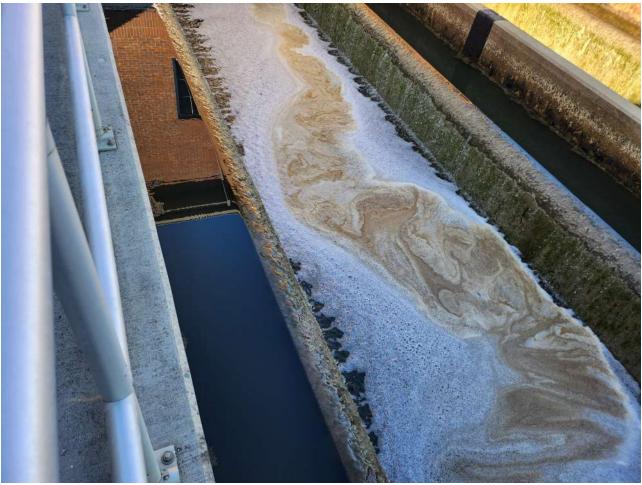
There was a heavy scum layer on some of the DNFs.

1/30/23 DNF with heavy scum layer

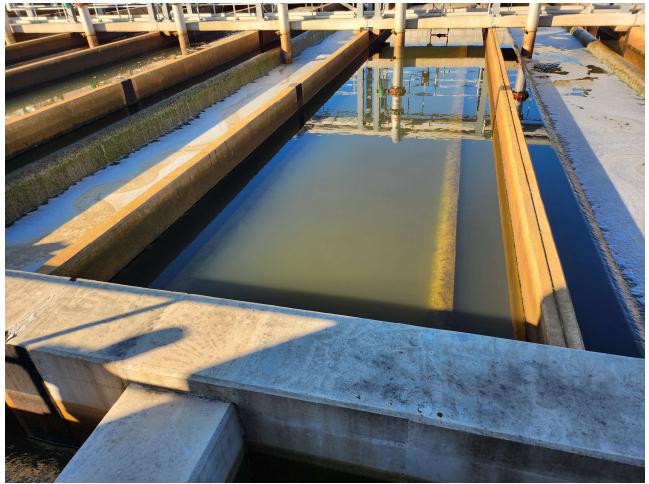
Five of the DNF # 25, 27, 29, 31, and 32 were submerged. The water level was above the overflow height rendering them non-functional.

1/30/23 Center filter submerged and filters to either side have a scum layer.

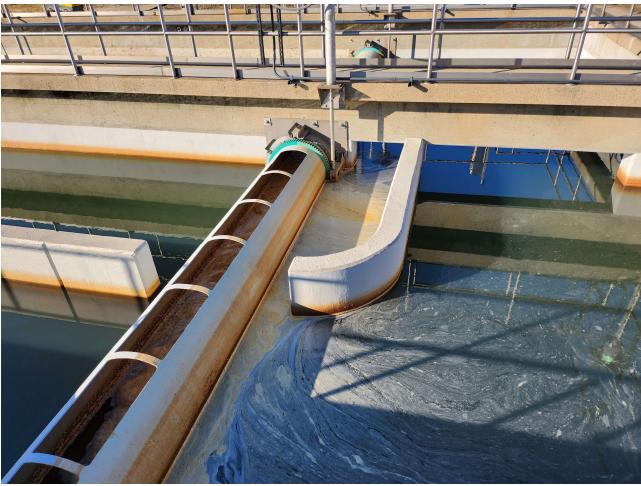
1/30/23 Chlorine Contact basin with scum log.

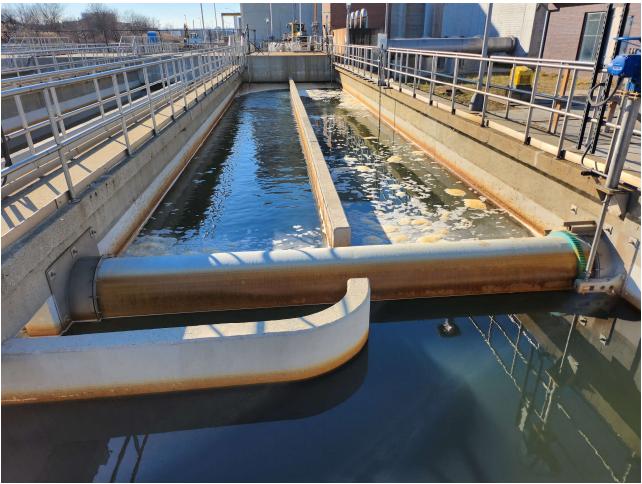
1/30/23 Chlorine contact with scum log

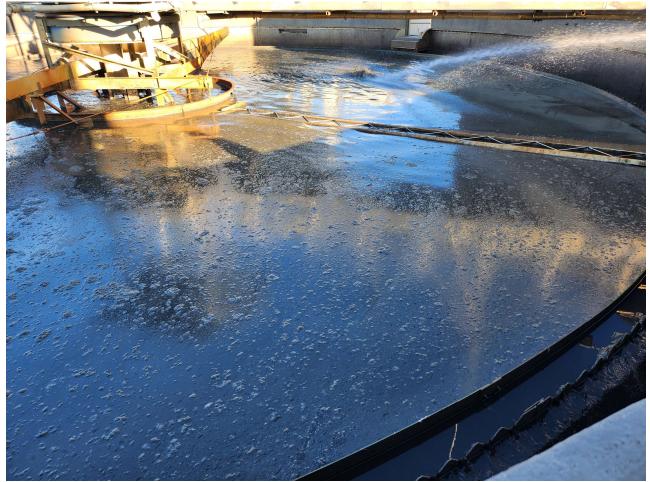
Gravity thickening is the process by which biosolids are condensed to produce a concentrated solids product and a relatively solids-free supernatant. The facility has 3 GSTs (#1, #2 and #4) and during this inspection, I observed that 2 were online. However, the skimmer arm on GST #1 is not functional because the scrapper flaps are broken.

- The sludge blankets were above an acceptable level causing the effluent (supernatant) from the GSTs to have a higher-than-normal solids concentration. The high sludge blanket is also causing the top layer of supernatant to be charcoal in color.
- The # 2 GST skimmer arm was not in complete alignment with the surface of the water and requires reinforcement.
- The skimmer arm on GST #1 is not functional because the scrapper flaps are broken.
- Scum collection baffle openings are impacted with solids and scum and should be cleared of the substances.
- Media from the BAF floating in the tanks.

1/30/23 GST#1 scum layer on the surface due to inability of the skimmer arm to function. Scum and trash observed on the weirs.
