**Maryland Department of Environment**  
**Water and Science Administration**  
**Compliance Program**  
**1800 Washington Blvd, Suite 420**  
**Baltimore, MD 21230-1719**  
**410- 537-3510, 1-800-633-6101**

**Site Name:** Patapsco WWTP  
**Facility Address:** 3501 Asiatic Ave, Curtis Bay, MD 21226  
**County:** Baltimore City County  
**Start Date/Time:** June 09, 2026, 03:30 PM  
**End Date /Time:** June 09, 2026, 06:00 PM  
**Media Type(s):** NPDES Municipal Major Surface Water

## **NPDES Municipal Major Surface Water**

**Permit / Approval Numbers:** 15DP0850  
**NPDES Numbers:** MD0021601  
**Inspection Reason:** Follow-up  
**Site Status:** Active  
**Compliance Status:** Not Applicable  
**Site Condition:** Additional Investigation Required  
**Recommended Action:** Continue Routine Investigation  
**Evidence Collected:** Photos or Videos Taken, Record Review, Visual Observation  
**Delivery Method:** Email  
**Weather:** Clear, Good

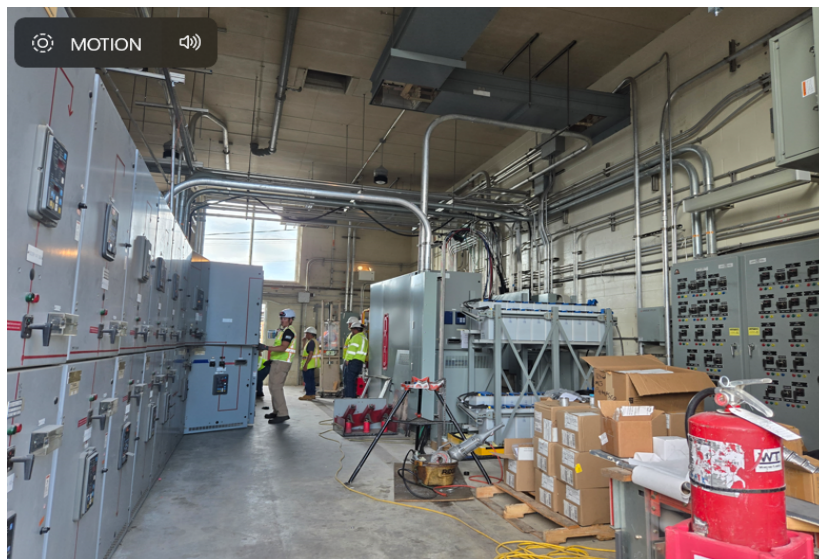
representatives. It was reported that at approximately 1:00 p.m. that day, staff from the electrical contractor handling the SC920 project were assessing the main electrical substation when an electrical failure occurred at the main switch gear. The resulting power outage severely disrupted the facility's power supply and treatment processes, while three of the contractor employees sustained injuries and were transported to the hospital.

Image 01: The electrical failure occurred within the main substation

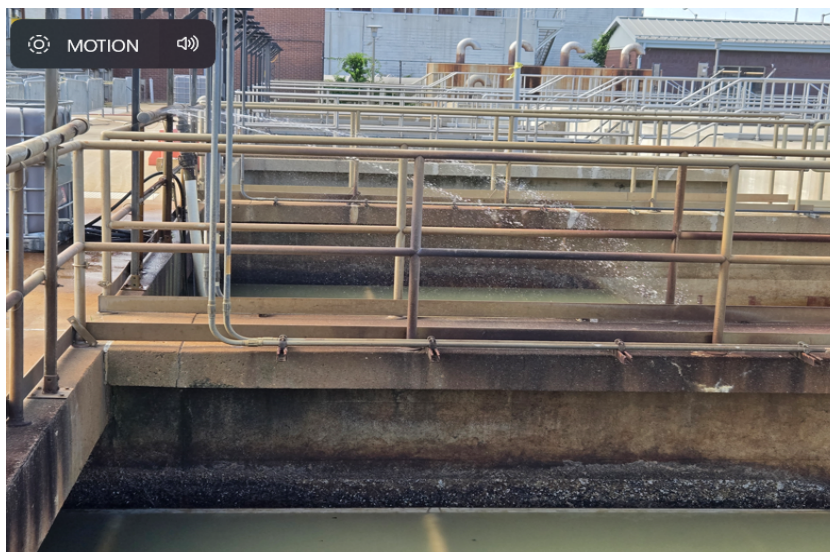
The loss of power immediately affected the plant's treatment process. They reported that the facility deployed two emergency generators: one for powering the primary screens, and a second to run the disinfection system at the Chlorine Contact Chambers. Because power was unavailable to run the tertiary pumps, tertiary treatment was completely bypassed. The wastewater stream was restricted to a gravity-fed flow from the primary bar screens through the primary settling tanks, reactors, and secondary clarifiers, before reaching the chlorine contact chambers for final disinfection.

Image 02: Dosing systems fully operational at contact chamber

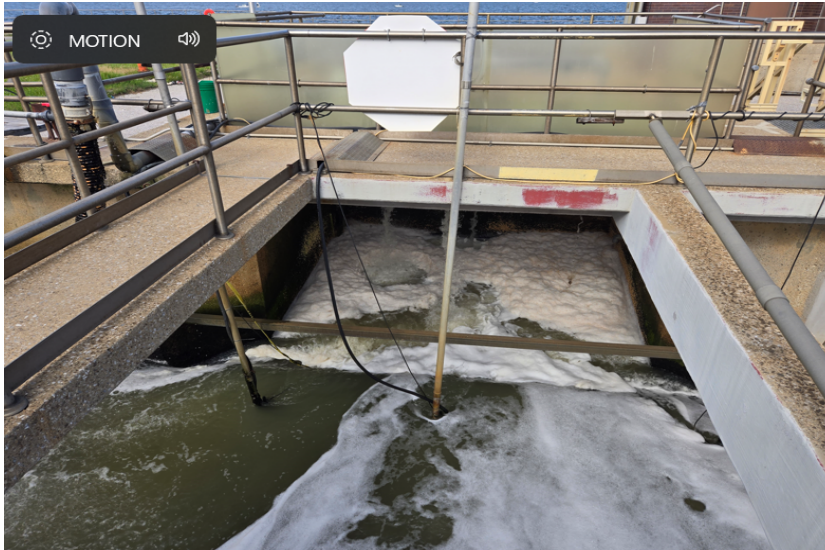
During the walkthrough of the facility's outfall and Chlorine Contact Chambers indicated that while the effluent was successfully receiving chemical disinfection, the lack of tertiary filtration visibly impacted discharge quality. The effluent lacked its typical clarity and exhibited accumulation of persistent foam that did not easily dissipate. Despite the visual characteristics, process control testing conducted by plant staff at 3:30 p.m. review that pH and Dissolved Oxygen (DO) levels remained within limit ranges across all four active contact chambers. Specifically, Chamber 1 recorded a pH of 7.07 and a DO of 7.5 mg/L; Chamber 2 recorded a pH of 6.91 and a DO of 7.1 mg/L; Chamber 3 recorded a pH of 6.83 and a DO of 7.3 mg/L; and Chamber 4 recorded a pH of 6.82 and a DO of 7.9 mg/L.

Image 03: Final effluent discharge with persistent foam
