Maryland Department of Environment

Site Name: Patapsco WWTP

Inspection Reason: Follow-up (Non-Compliance)

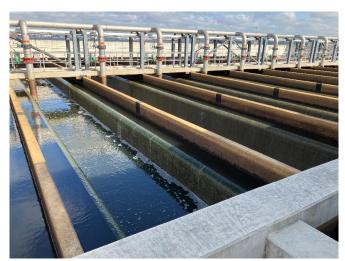
The denitrification filter (DNF) facility contains 34 gravity filters and support systems such as backwash pumps and blowers. 28 filters are in service while filters #20, #34, #6, and #1 are out of service for mechanical repairs. Filters #32 and #33 were out of service and drained in order to allow for the algae buildup to bake in the sun for ease of removal. 24 filters are necessary for design average daily flow. The DNF filters are automatically backwashed every four hours for approximately 46 minutes.

Image 7: DNF Filters.
