Maryland Department of Environment
Water and Science Administration
Compliance Program
1800 Washington Blvd, Suite 420
Baltimore, MD 21230-1719
410- 537-3510, 1-800-633-6101

Site Name: Back River WWTP
Facility Address: 8201 Eastern Ave, Baltimore, MD 21224
County: Baltimore County

Permit / Approval Numbers: 15DP0581
NPDES Numbers: MD0021555
Inspection Reason: Follow-up (Non-Compliance)
Site Status: Active
Compliance Status: Noncompliance
Site Condition: Noncompliance
Recommended Action: Continue Routine Investigation
Evidence Collected: Photos or Videos Taken, Record Review, Visual Observation
Delivery Method: Email
Weather: Clear Average

Inspection Findings:

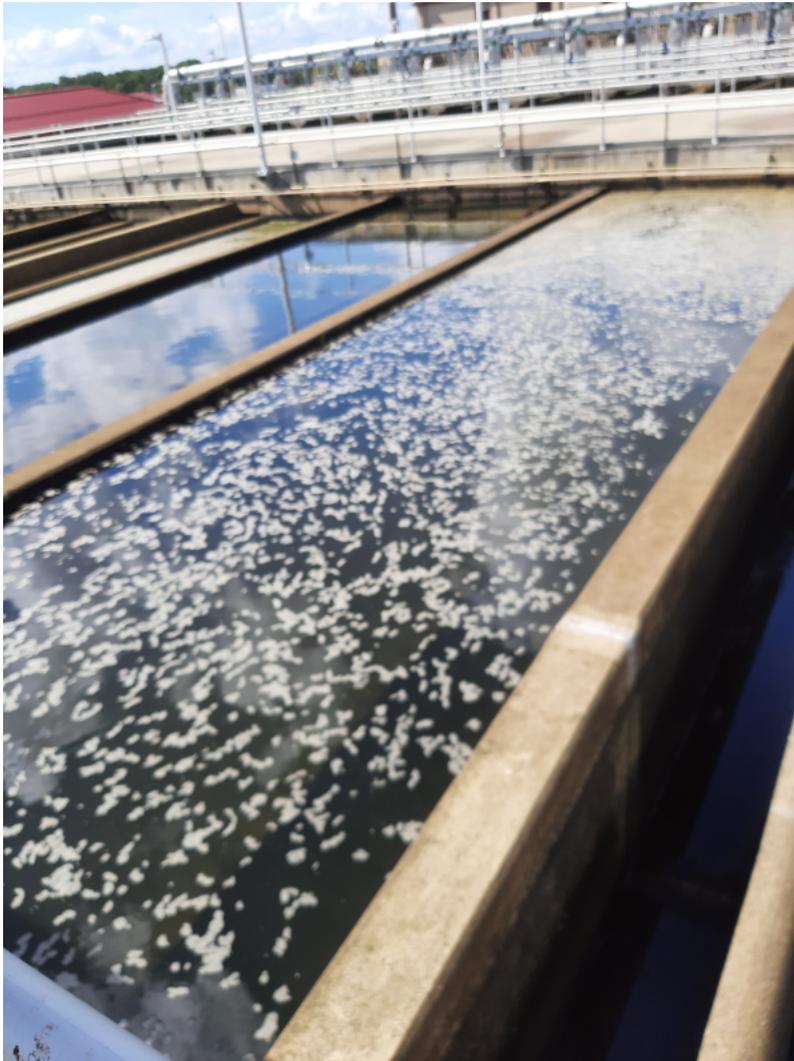
After the discussion, I conducted a site review accompanied by Ms. Paton and Ms. Garris. The first stop was at the denitrification filter building where the TETRA denitrification filters are located. Today, I inspected all the quads and all 52 filters. During this inspection, I found that not all the filters were functioning as designed. Some of the filters appeared to be clogged and the water entering the filter flowed down slowly and excess water overflowed the system. Many of the filters had a floating layer of scum that appeared to be emulsified fats oil and grease (FOG) that carried over from primary treatment. This oily scum will hinder functional operation of the filters and affect the efficiency of the filters. Quad #2 of the system appeared to have the most issues. During a discussion with the Denitrification Filter Control Operator, I found that 16 of the 52 filters were offline and requiring various types of service to be able to be brought back online. Next I inspected the mud wells for the filter backwash. Each mud well manages the back wash for 13 filters. The back wash wastewater flows from the mud wells to the tertiary clarifier for settling. This wastewater then flows back to the treatment system. During my evaluation, I inspected the mud well tanks. There were no discharges of filter back wash into the mud wells during my review and one of the filters was going through the backwash process.

9/20/2021 scum layer on filter in Quad 2

- C. With respect to item #3 above, the Back River WWTP should evaluate and determine the cause for the problems with the out of service denitrification filters and make the necessary repairs.

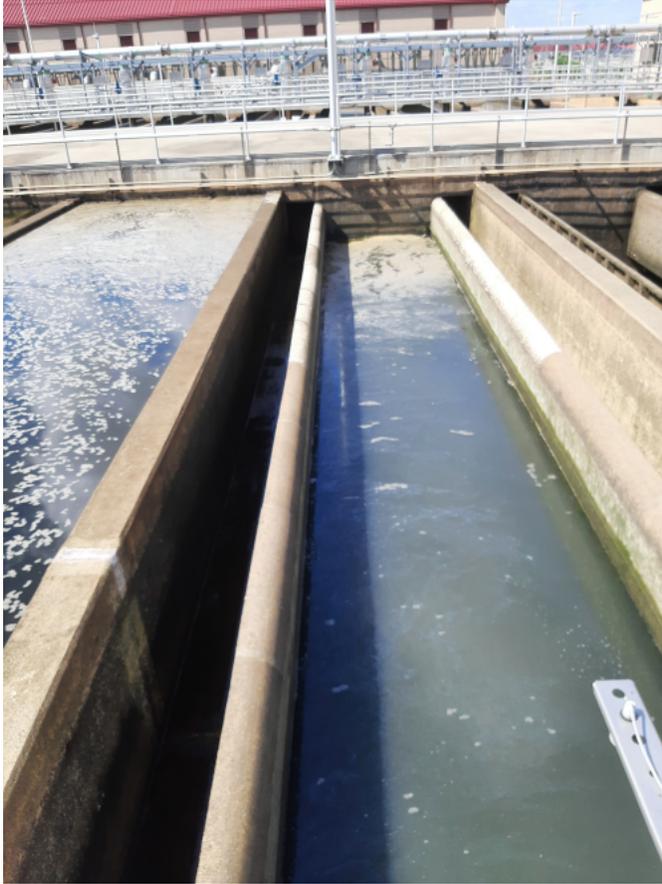
9/20/2021 Emulsified oil and grease in filter

2. Emulsified FOG was observed on the surface of the water in the denitrification filters, which can lead to problems.
3. Sixteen of the denitrification filters require service due to various reasons.

- A. With respect to item #1 above, for operational and process control management, the laboratory's turnaround time should be decreased to ensure that reports are received in time for effective decision making and public health protection.
- B. With respect to item #2 above, the Back River WWTP should address the problem with FOG beginning at primary treatment. The skimming systems should be repaired or replaced on all nonfunctioning FOG skimming systems.

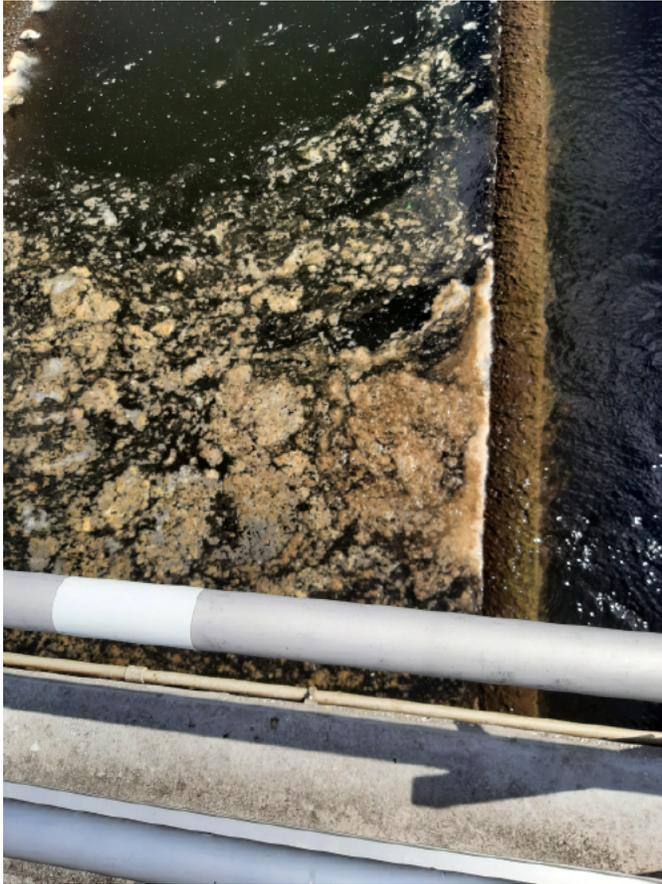
9/20/2021 scum on the surface

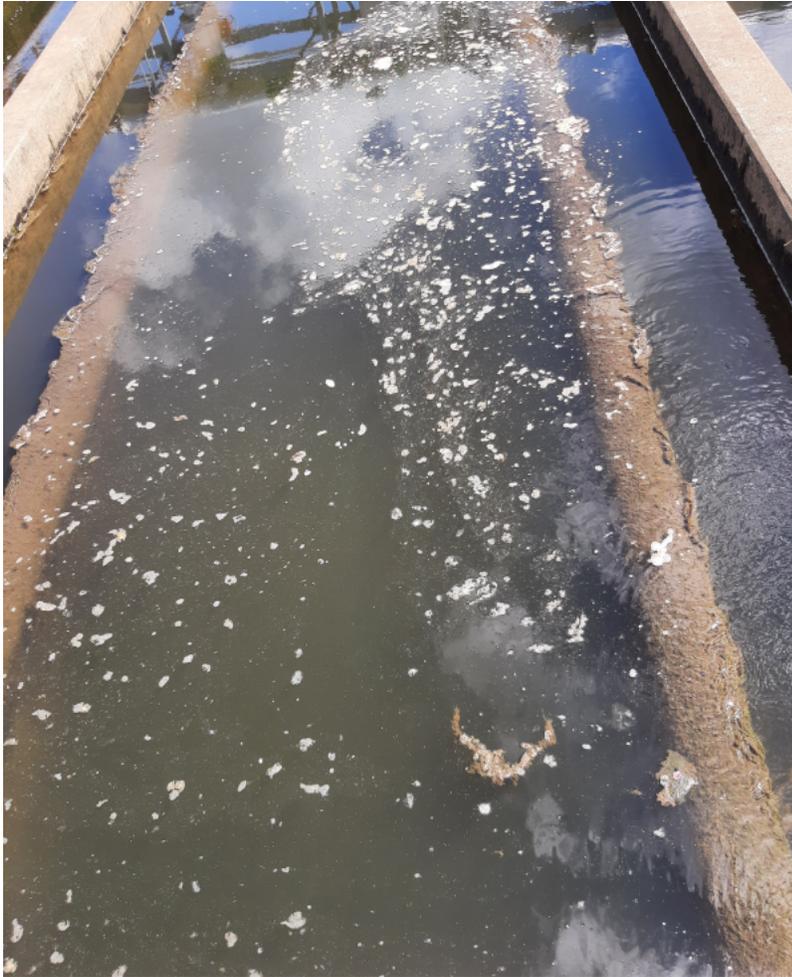
9/20/2021 Filter overflowing in Quad 2

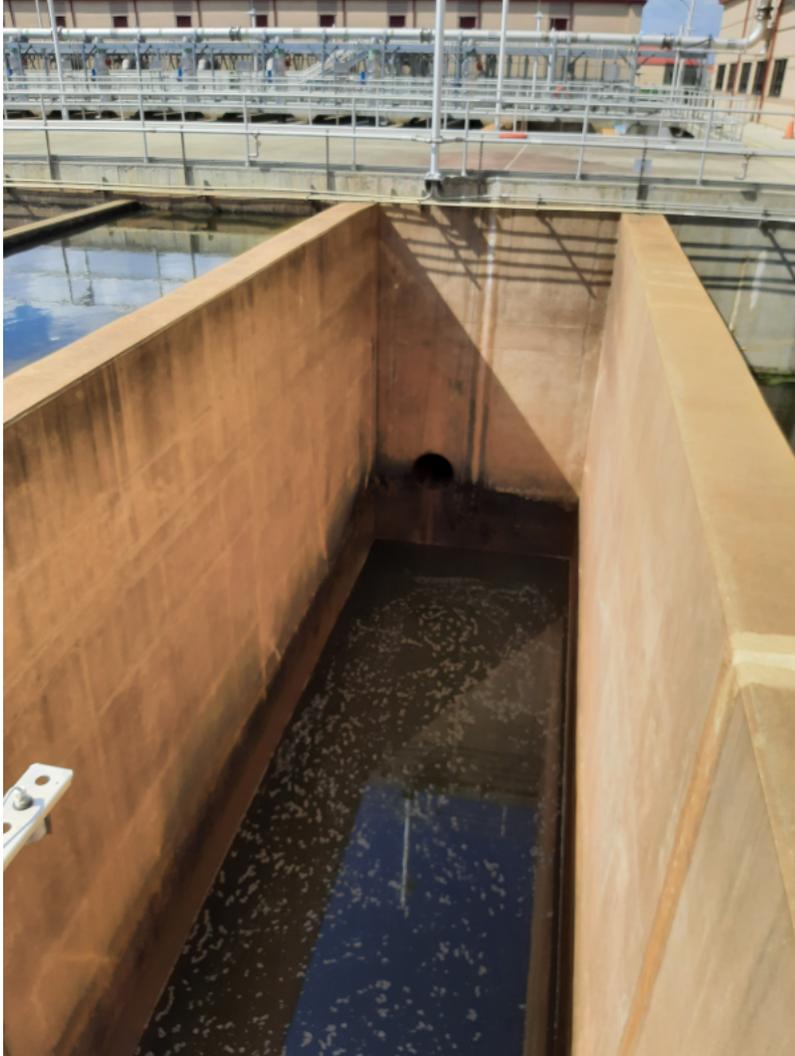
backwash and nitrogen-release cycles and, ultimately, lower backwash water volume requirements. As mentioned in paragraph one above the average total suspended solids concentration going into the TETRA filters has been considerably higher starting around the 1st quarter of 2021 and progressively increasing in 2021. This condition would account for the backwash appearing to contain more solids.

9/20/2021 Mud Well containing backwash

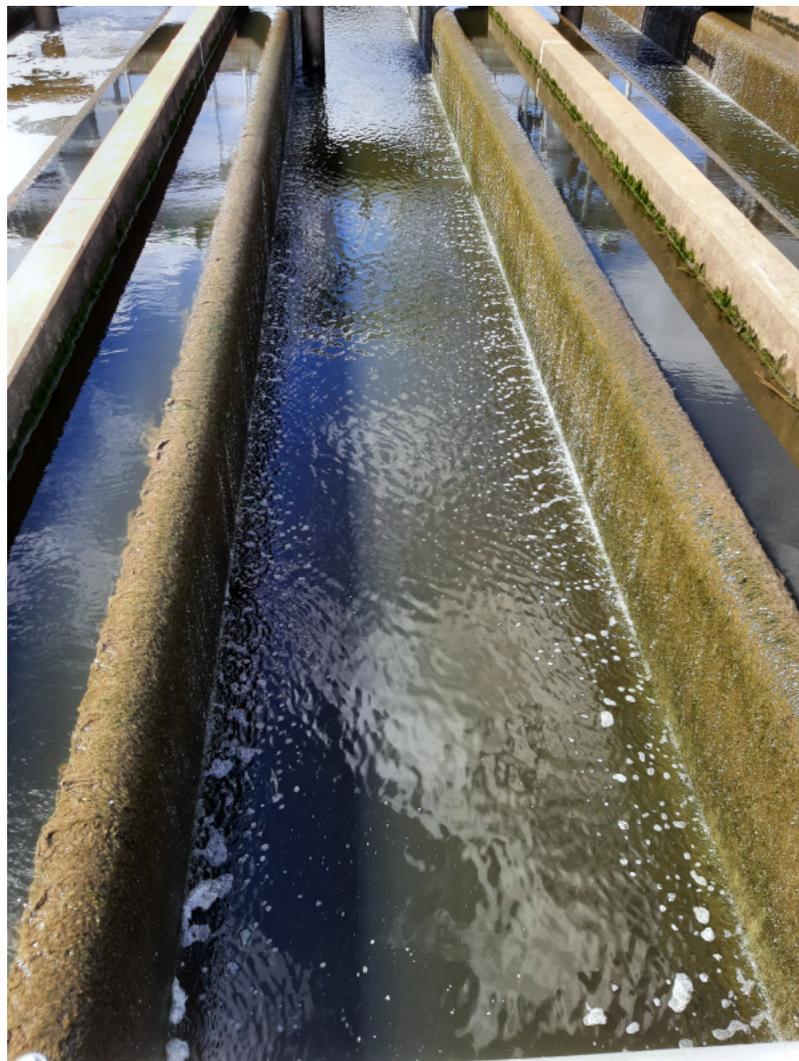
9/20/2021 Filter showing normal operation

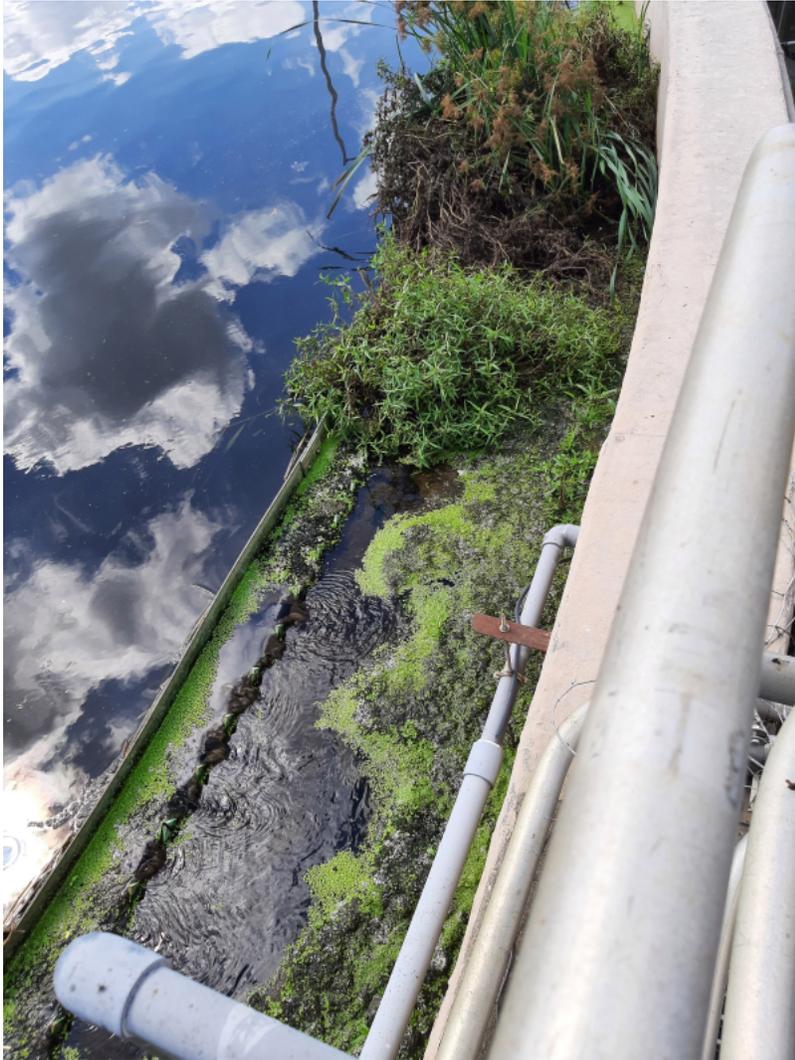
Next, I inspected all the secondary clarifiers to evaluate the wastewater settling process. During an inspection of these clarifiers, I found that most were in unacceptable condition due to unsatisfactory maintenance. I observed unacceptable algae growth on the weirs of the secondary clarifiers that was causing a short circuiting of the system. Because of the phosphorous in the effluent algae blooms can occur during the summer causing this problem. Algae can cause problems with total suspended solids within the treatment system and can cause problems with pumps by increasing the chances of clogging. The weirs on all secondary clarifiers should be routinely scrubbed to remove the algae. This should be done at least weekly in the summer and more frequently as necessary. In addition, I found vegetative growth that blocked the weirs of some of the clarifiers causing short-circuiting of the system as well. This growth is easily removed and should not be allowed to get to the condition that I observed during this inspection.

9/20/2021 Weir of secondary clarifier showing unacceptable blockage by algae and vegetative growth. This condition is impeding proper treatment process.

5. Unacceptable algae growth was observed on the weirs of the secondary clarifiers that was causing the short circuiting of the system. This condition can impact total suspended solids in the waste stream being treated.

- E. With respect to item #5 above, the weirs on the secondary clarifiers should be routinely scrubbed to prevent aggressive algae growth.
- F. With respect to item #6 above, vegetation should not be allowed to grow in the secondary clarifiers.

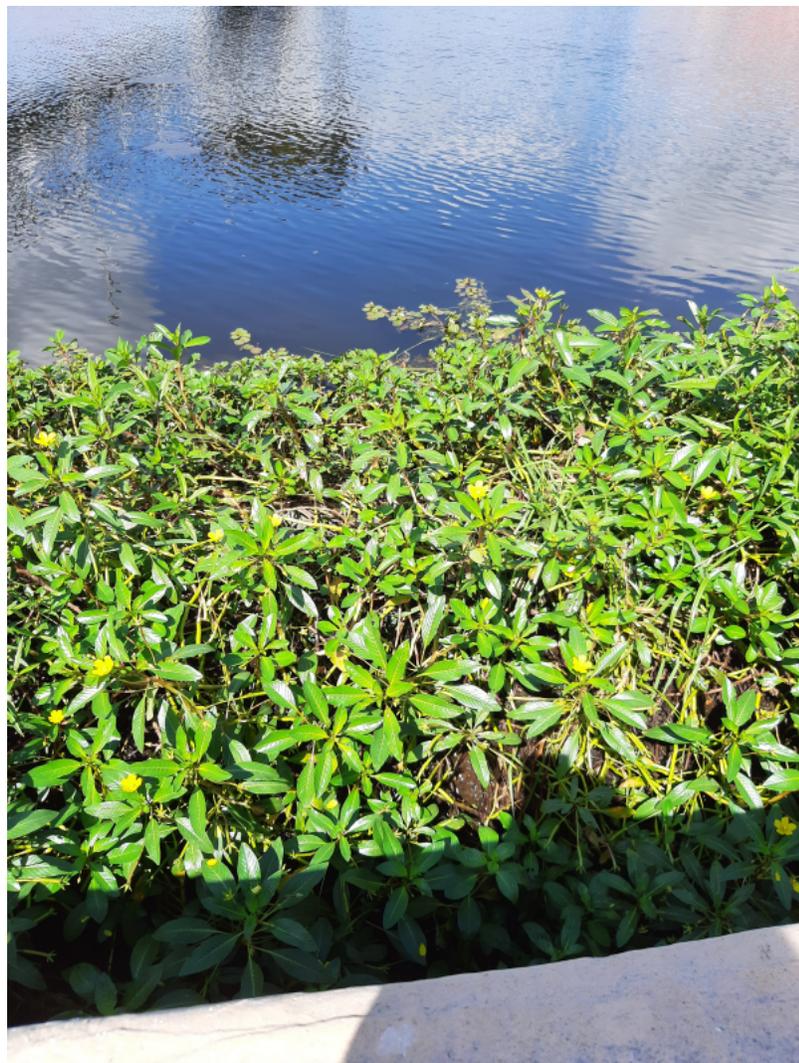
9/20/2021 In this area vegetation growth has been unchecked and allowed to grow on the weir of one of the secondary clarifiers. This condition will hinder the satisfactory treatment of the wastewater leading to poor effluent quality.

6. Vegetation was observed growing on the weirs of the secondary clarifiers, which was also causing a short circuiting of the clarifiers and impede treatment performance.

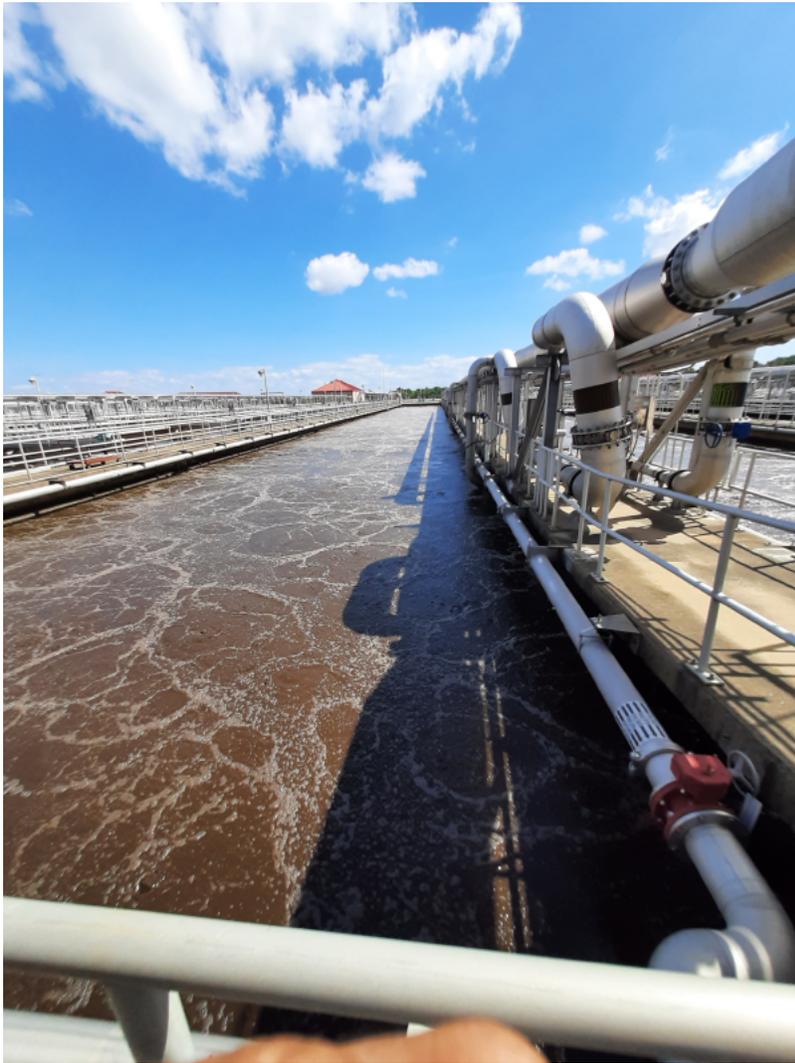
9/20/2021 Biological reactor.

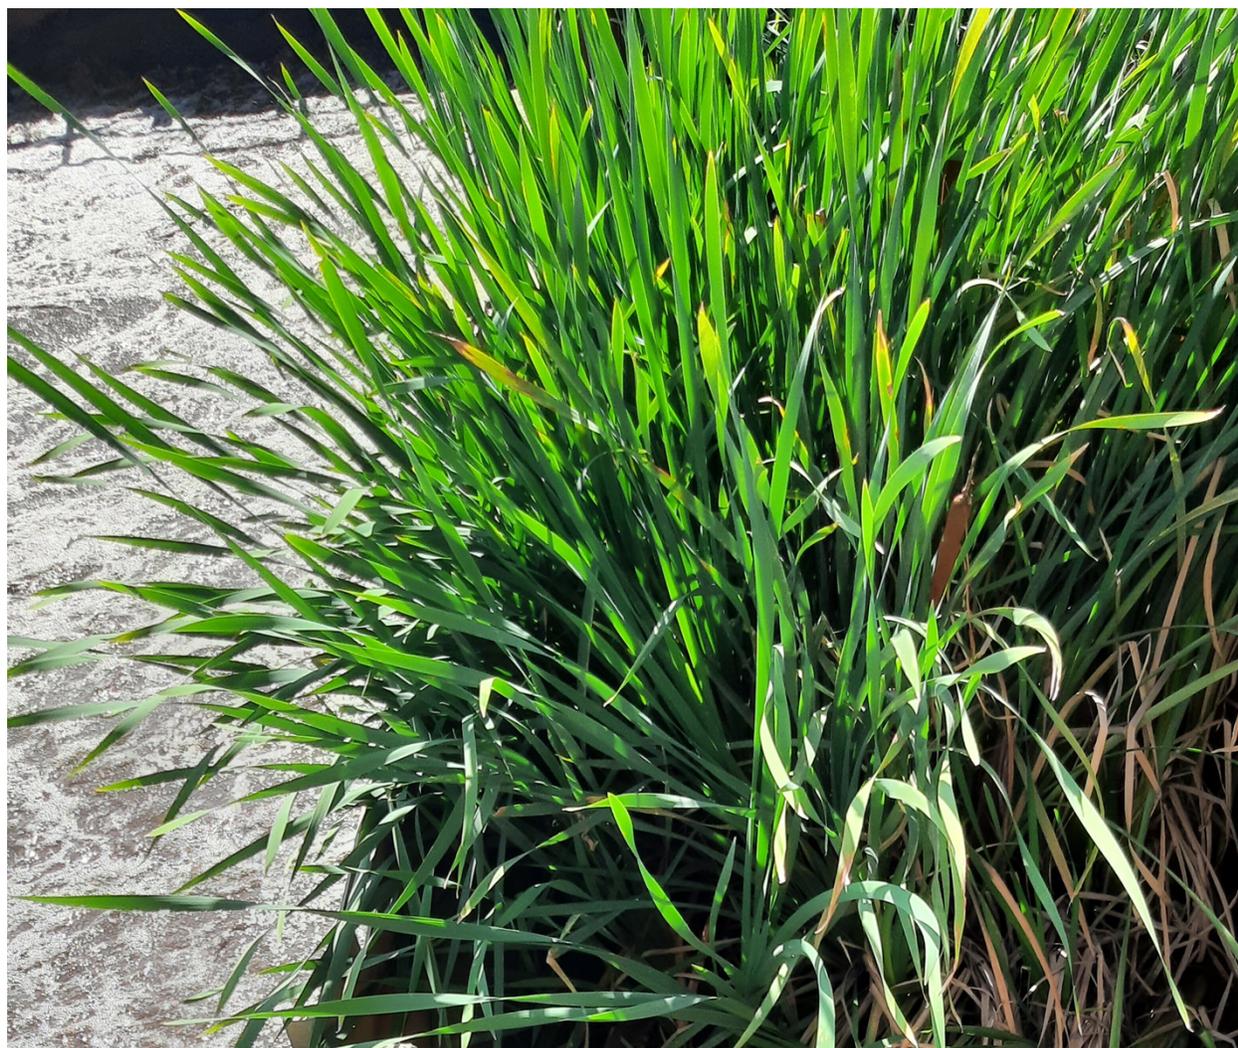
I continued this inspection with an evaluation of the biological reactors. For the most part the biological reactors were functioning as designed. However, in a few sections of the reactors there were small areas where reed grasses e.g., phragmites have begun to take root. This vegetation will thrive in this area due to the phosphorous and nitrogen available. To ensure optimal wastewater treatment, the permittee should maintain this area in better condition. These reed grasses should be removed, and vegetation not allowed to grow within the treatment components. This situation is preventable and should not be allowed to continue.

9/20/2021 Reed grass in the reactor

7. Reed grasses are growing in the biological reactors preventing impeding the performance and preventing satisfactory operations.

- G. With respect to item #7 above, reed grasses or any type of vegetation should not be allowed to grow in the biological reactors.
- H. With regards to items 5, 6 and 7, the problem with vegetation and algae in the treatment system is easily preventable. These conditions can impact total suspended solids removal. Within 30 days of the receipt of this report all reed grass, algae and other vegetation should be removed from all clarifiers and activators and these areas should be properly maintained going forward.

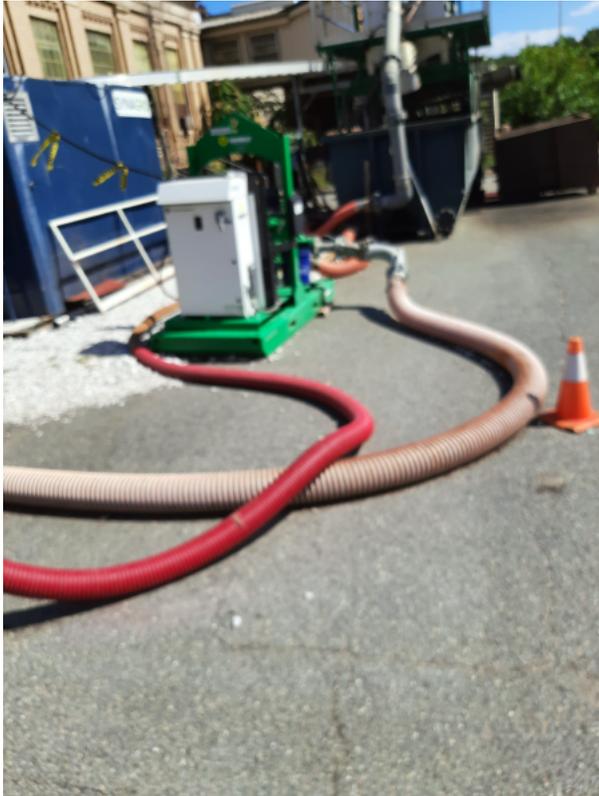
9/20/2021 Outside dewatering operation. No visible problems observed in this area.

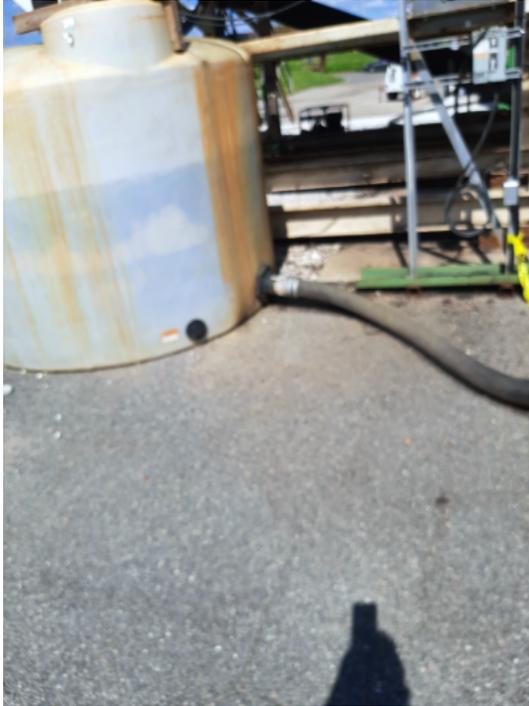
9/20/2021 Outside dewatering operation

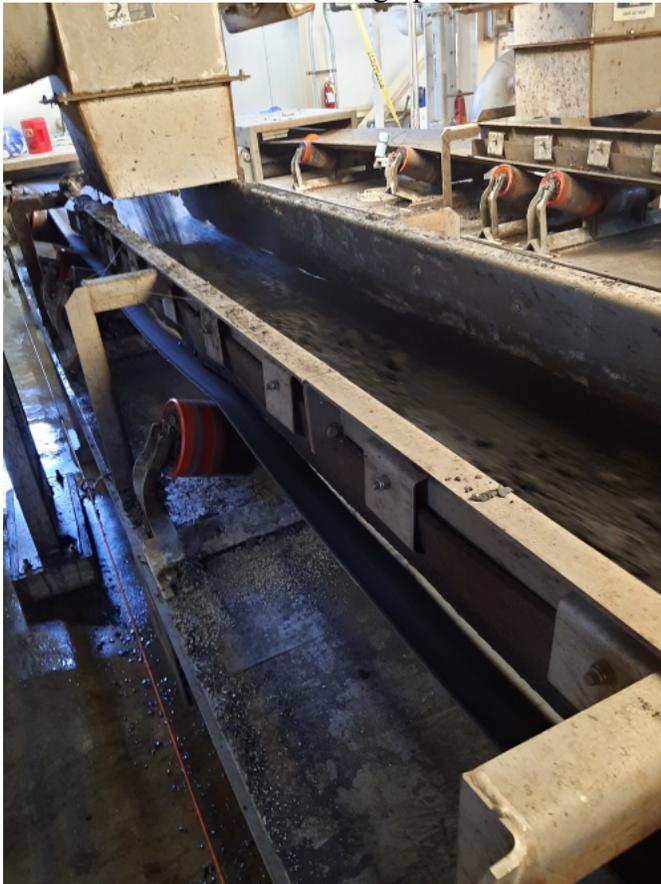
better condition than I observed during my last inspection on June 16, 2021. During the last inspection the solids conveying system and belts were backed up and impeded due to the large amount of solids on the belts. Today the conveyance system was operational and moving satisfactorily.

9/20/2021 Solids handling building. Belt moving without impediments.
