**Maryland Department of Environment**  
**Water and Science Administration**  
**Compliance Program**  
**1800 Washington Blvd, Suite 420**  
**Baltimore, MD 21230-1719**  
**410- 537-3510, 1-800-633-6101**

**Site Name:** Patapsco WWTP  
**Facility Address:** 3501 Asiatic Ave, Curtis Bay, MD 21226  
**County:** Baltimore City County

## **NPDES Municipal Major Surface Water**

**Permit / Approval Numbers:** 15DP0580  
**NPDES Numbers:** MD0021601  
**Inspection Reason:** Follow-up (Non-Compliance)  
**Site Status:** Active  
**Compliance Status:** Noncompliance  
**Recommended Action:** Additional Investigation Required  
**Evidence Collected:** Photos or Videos Taken, Record Review, Visual Observation  
**Delivery Method:** Email  
**Weather:** Clear Average

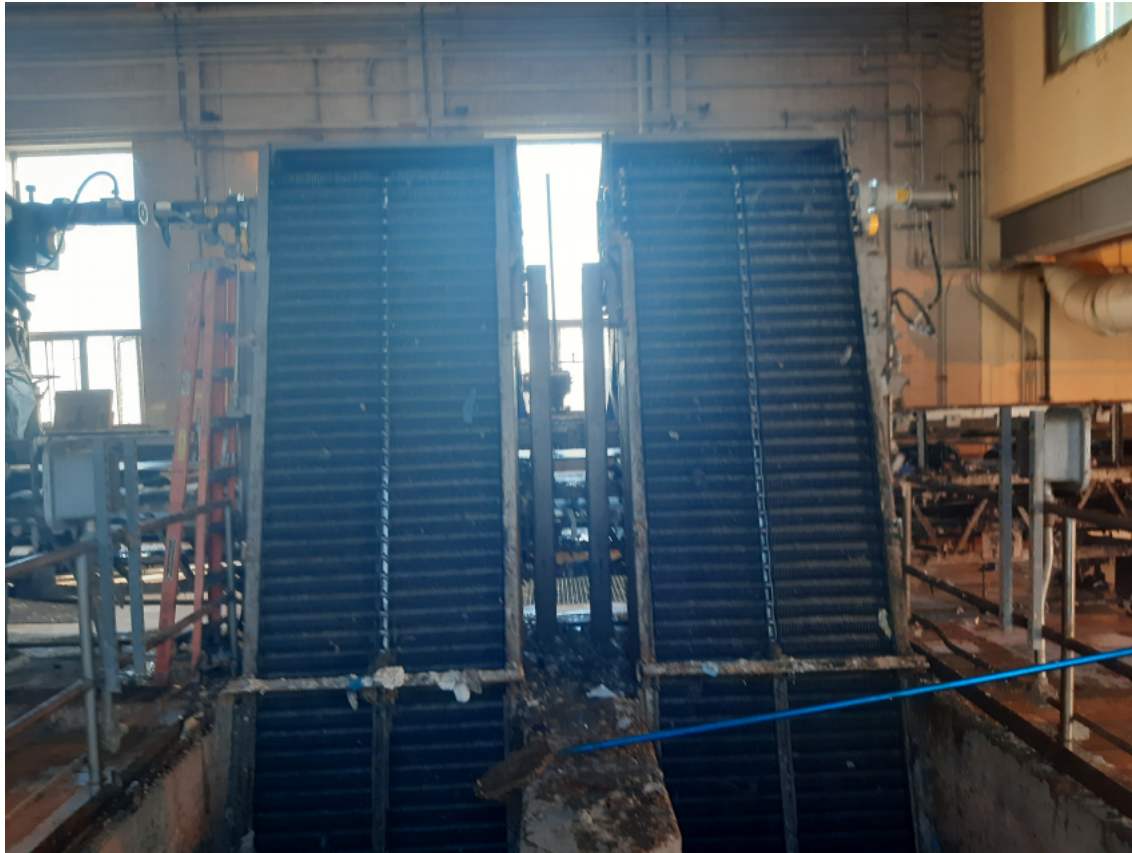
11/2/22 Fine screening unit.

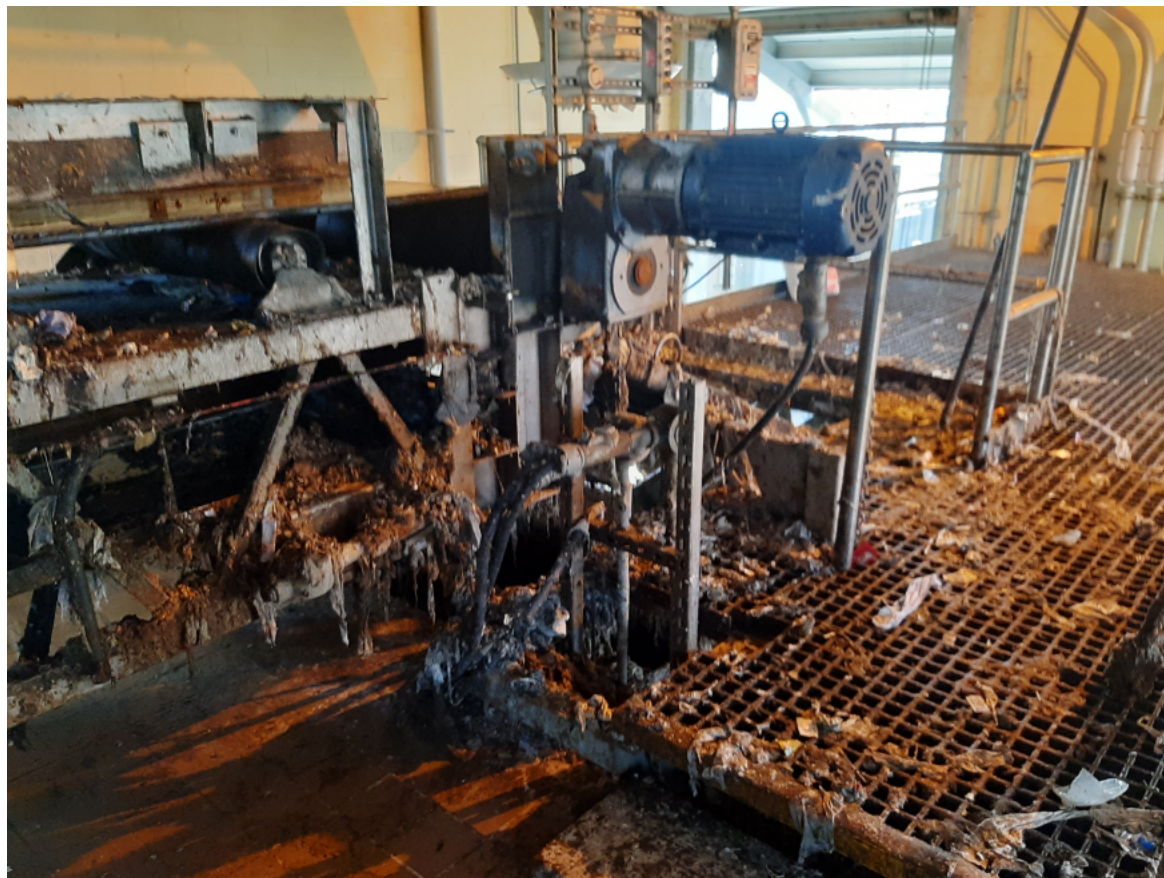
During this inspection, I observed an accumulation of rags and debris falling off of the conveyor belts. **The housekeeping practices in this area require more attention and improvements are necessary to prevent and minimize potential problems downstream due to trash and debris impairing and clogging equipment.**

11/2/22 Fine screening building – unsatisfactory maintenance of the trash conveyor system and housekeeping practices.

- C. The fine screening system is not being maintained to the level necessary to ensure that downstream equipment functions satisfactorily. During previous inspections in 2021 and 2022, the belt conveyors were not operable due to the accumulation of debris such as rags, paper, and plastic items. During this inspection, the belts were functioning; however, there was an accumulation of debris on and around the belts. The belts are old with missing and damaged skirting which allows the debris to fall from the belt and clog the mechanical parts. Due to this issue, the system requires constant maintenance to prevent blockage of the belt mechanisms.

**procedures for regular manual cleaning of the belt transport system. This was reported as a deficiency on the May 18, 2022 inspection report.**

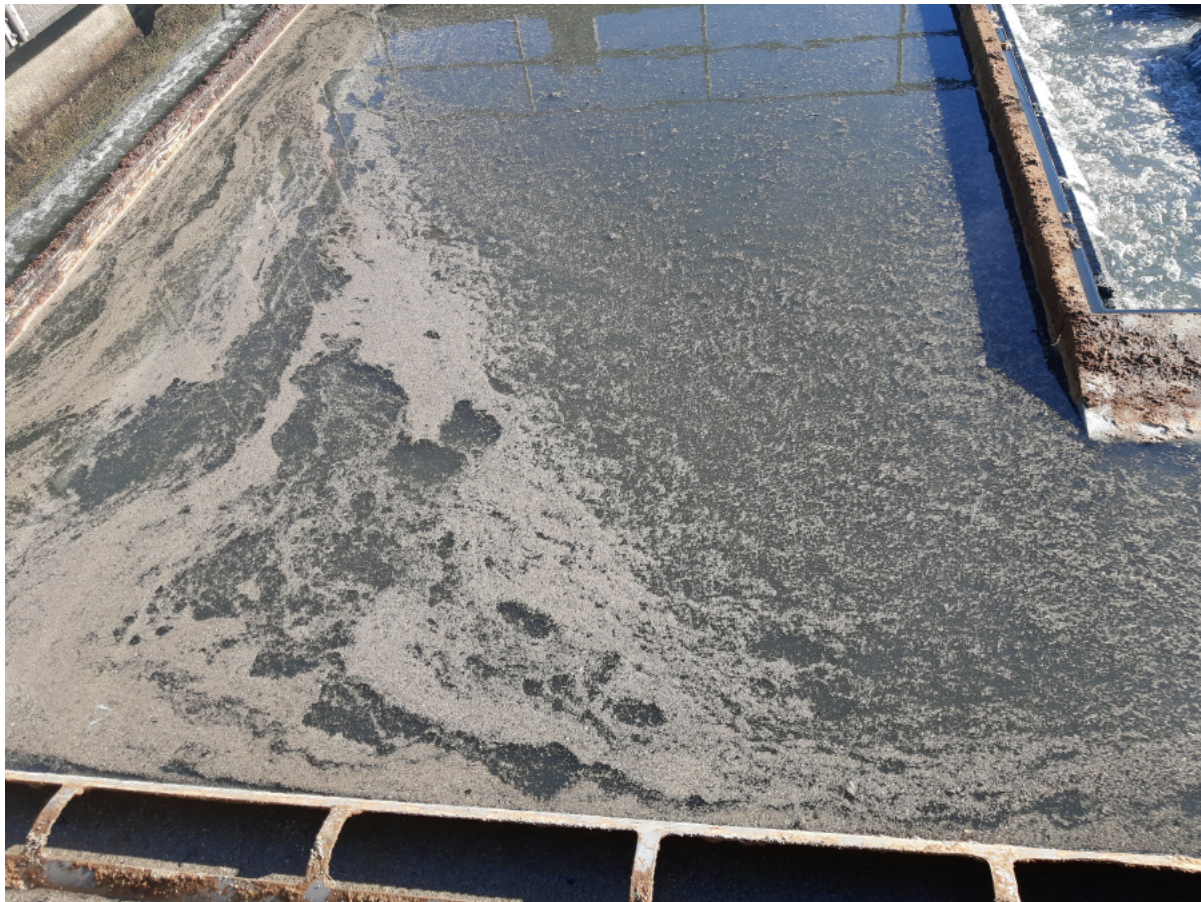
During an inspection of the PSTs, I observed a considerable amount of media as well as scum and FOG floating on the surface of the PSTs especially in #1, #2, and #3. According to Jackson, the scum troughs are checked twice a day to remove the scum and manual skimming, with a net, is

11/2/22 PST #1 Note the floating media and scum.

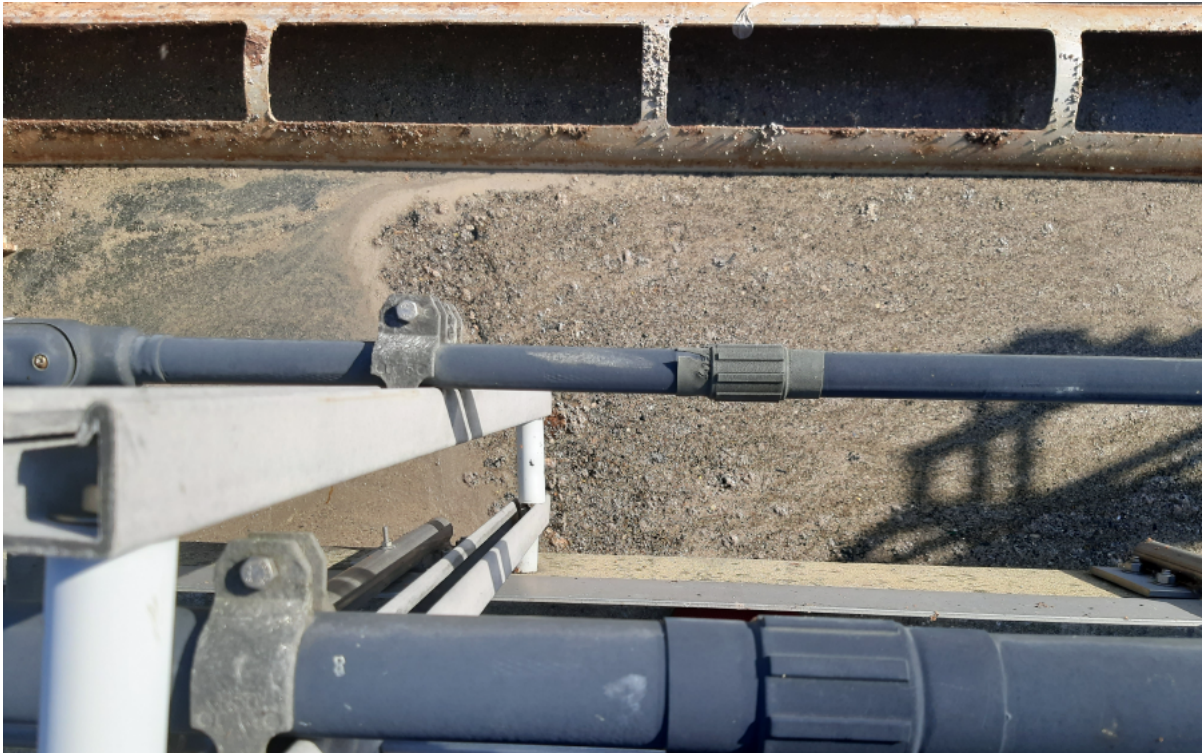
11/2/22 PST #1 – Note the heavy layer of scum and media on the surface of the water.

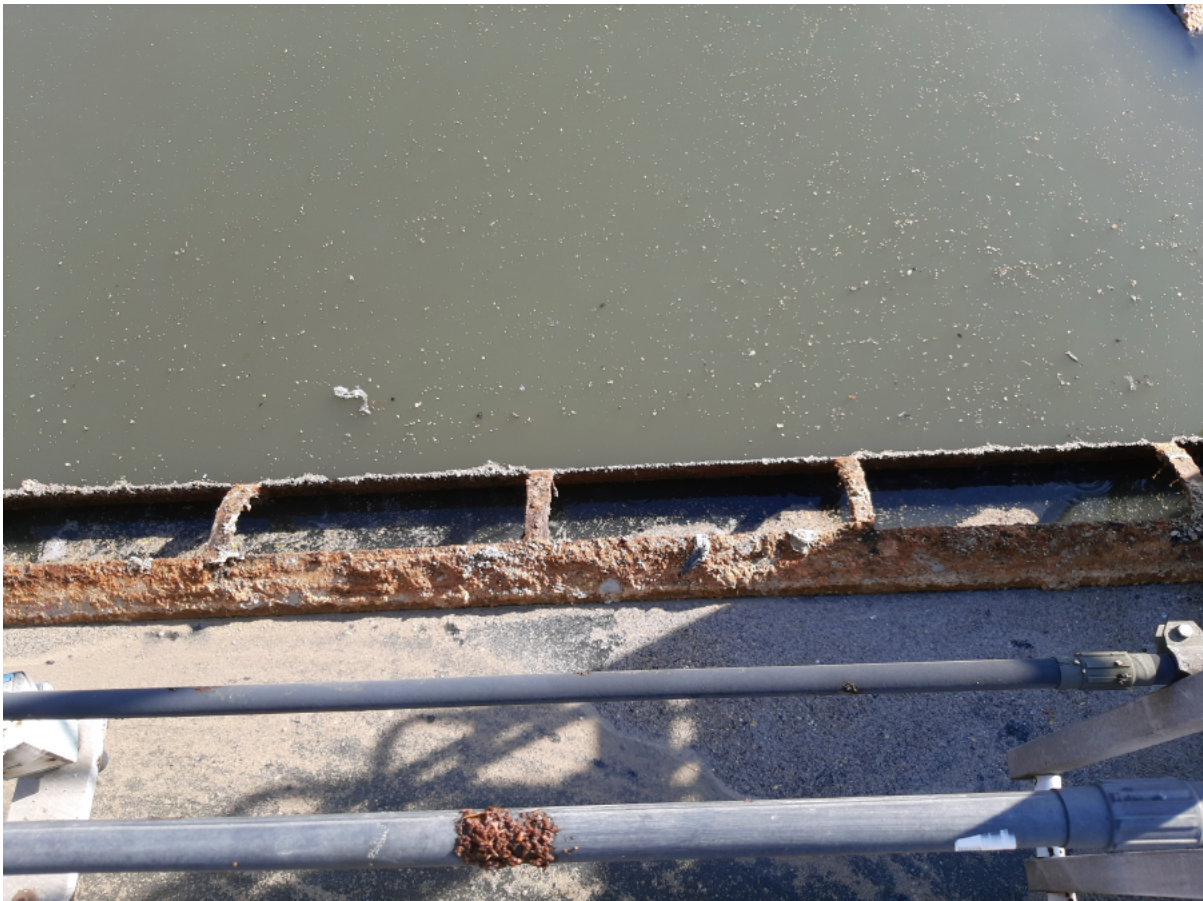
11/2/22 Scum trough at PST #2.

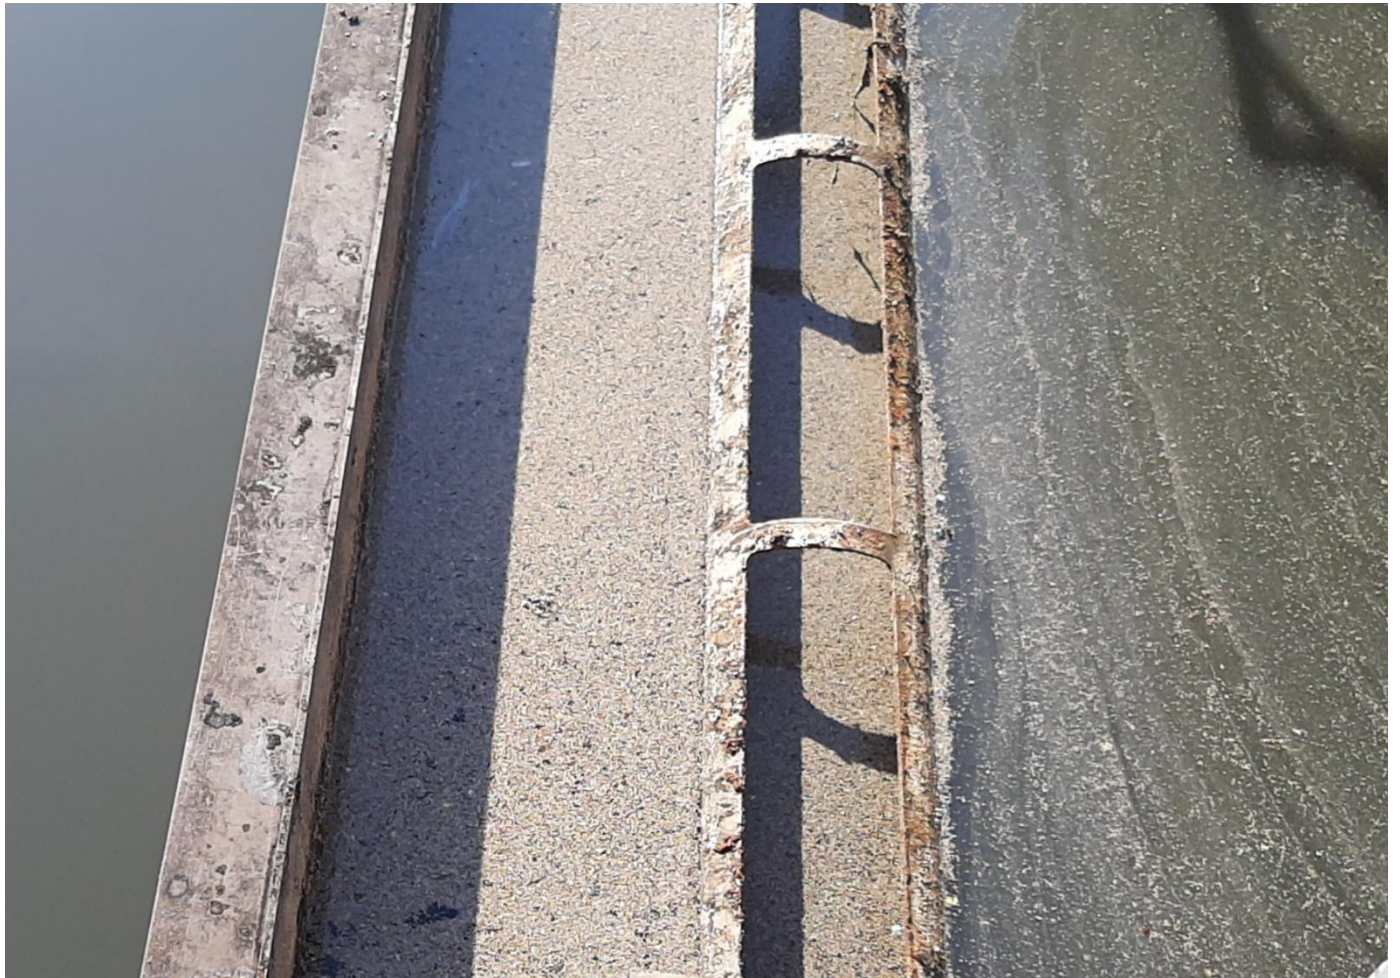
11/2/22 Another scum trough at PST #2.

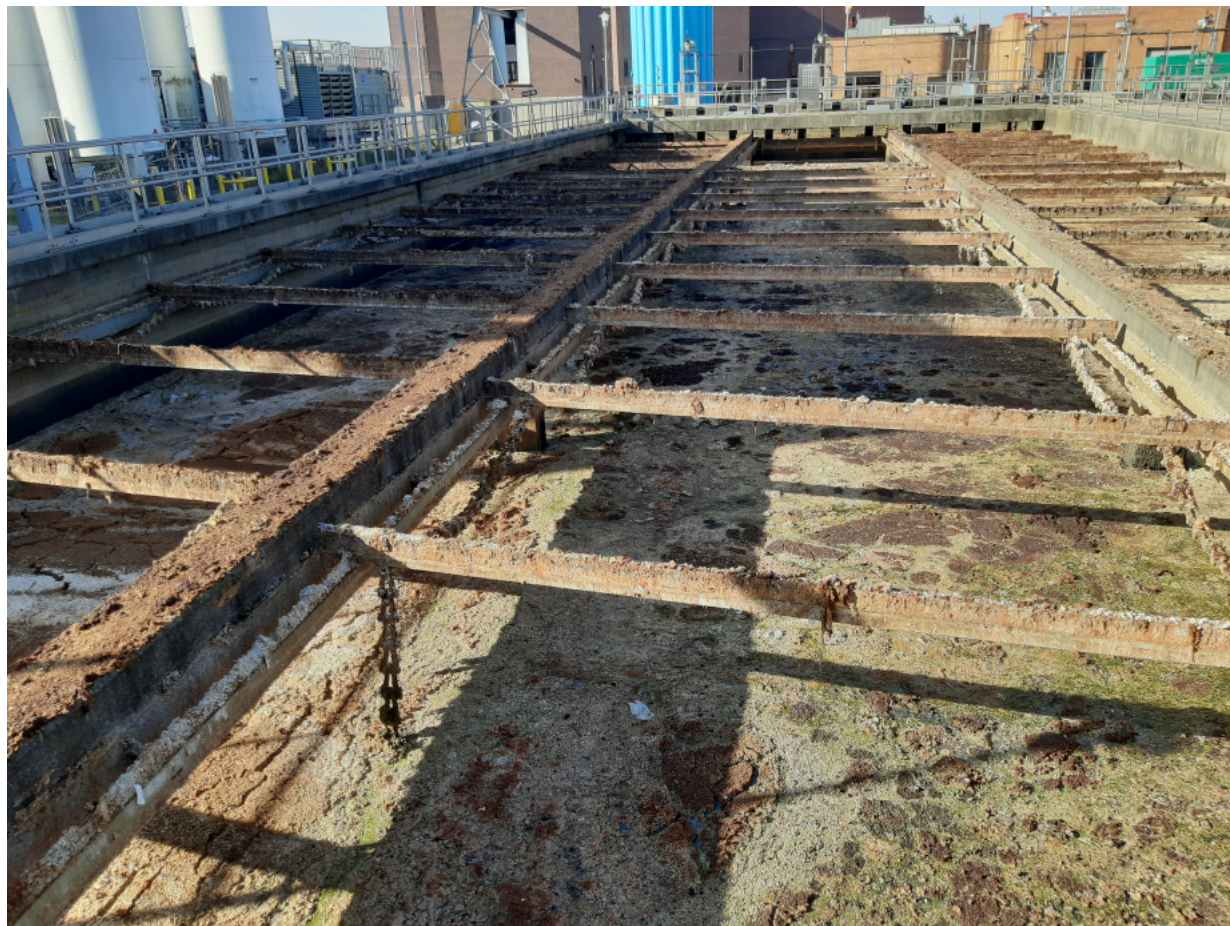
11/2/22 PST#6 Offline for service.

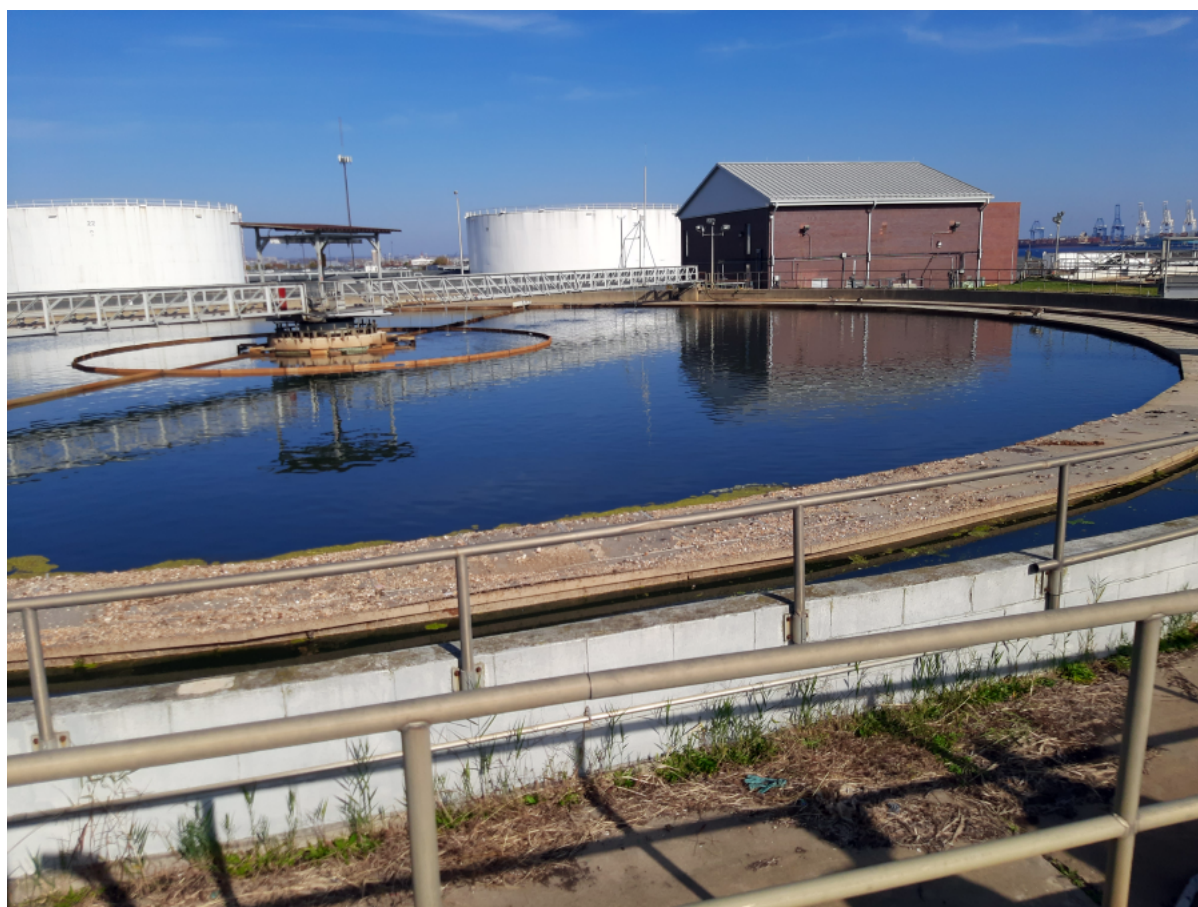
Secondary clarifier #1 note debris on the launder covers.

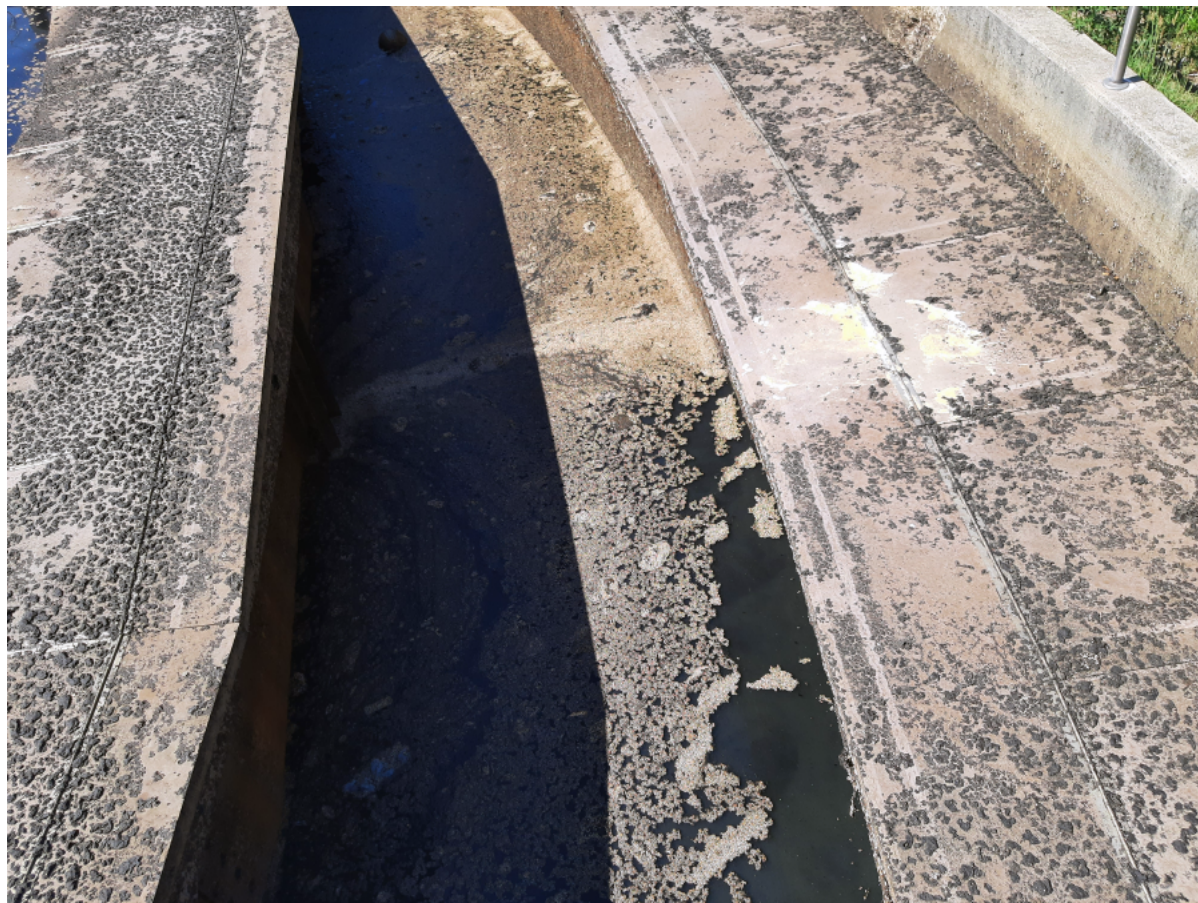
Secondary clarifier #3: the backwash from the BAF discharges to this clarifier in an attempt to isolate and control the media from the BAF mud wells that are being discharged during backwash cycles.

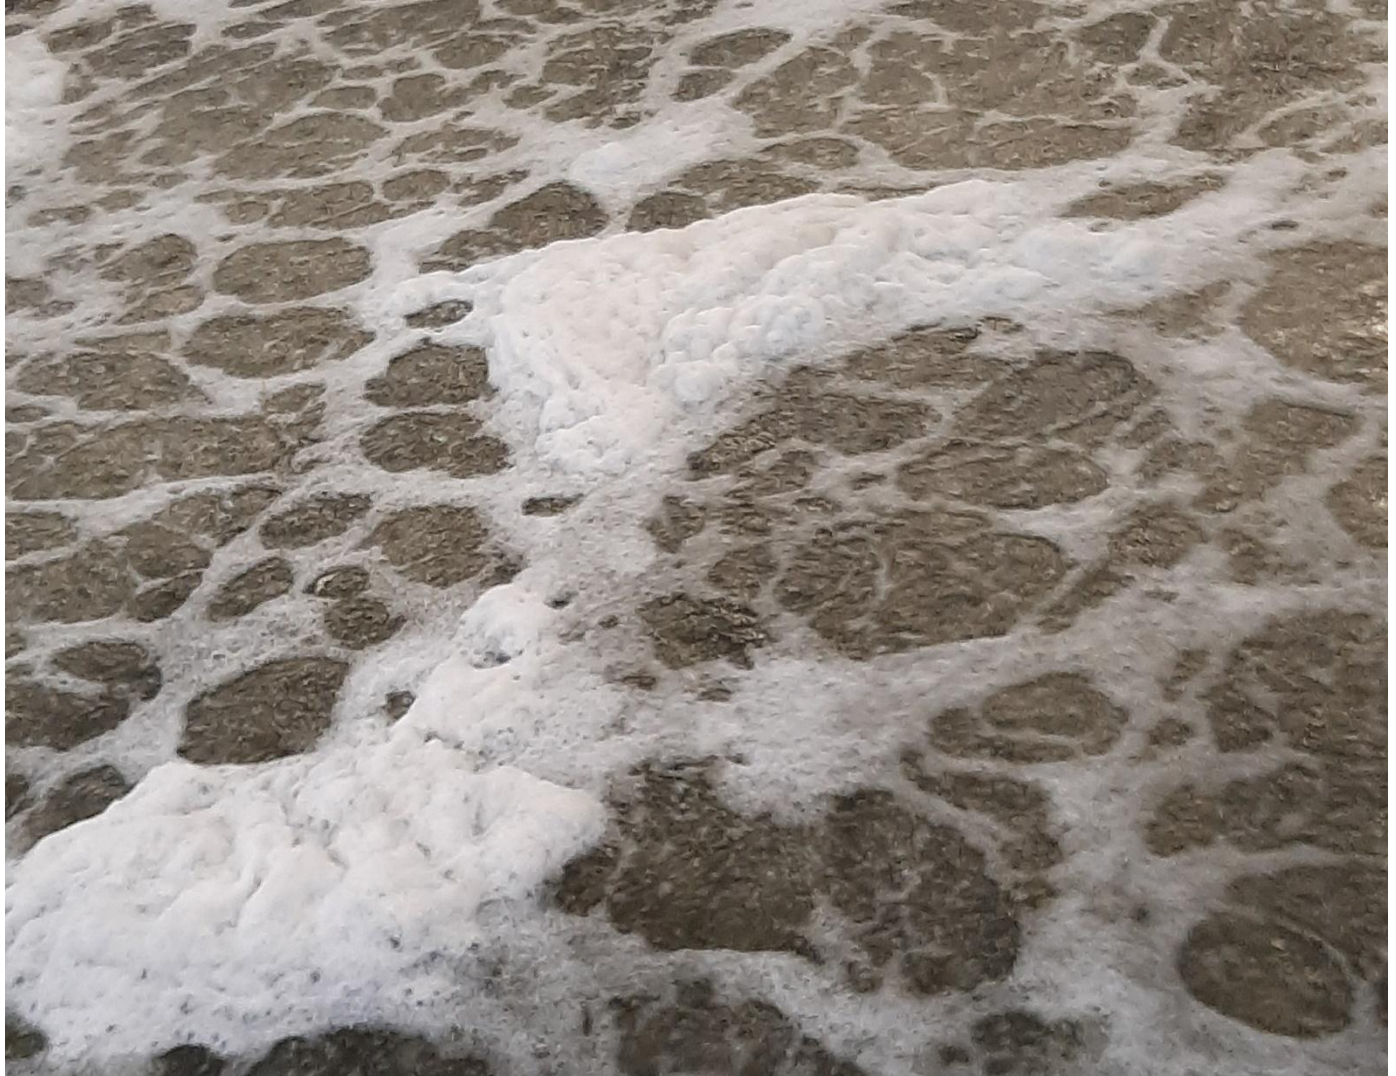
11/2/22 BAF cell #5 heavy foaming due to BOD level.

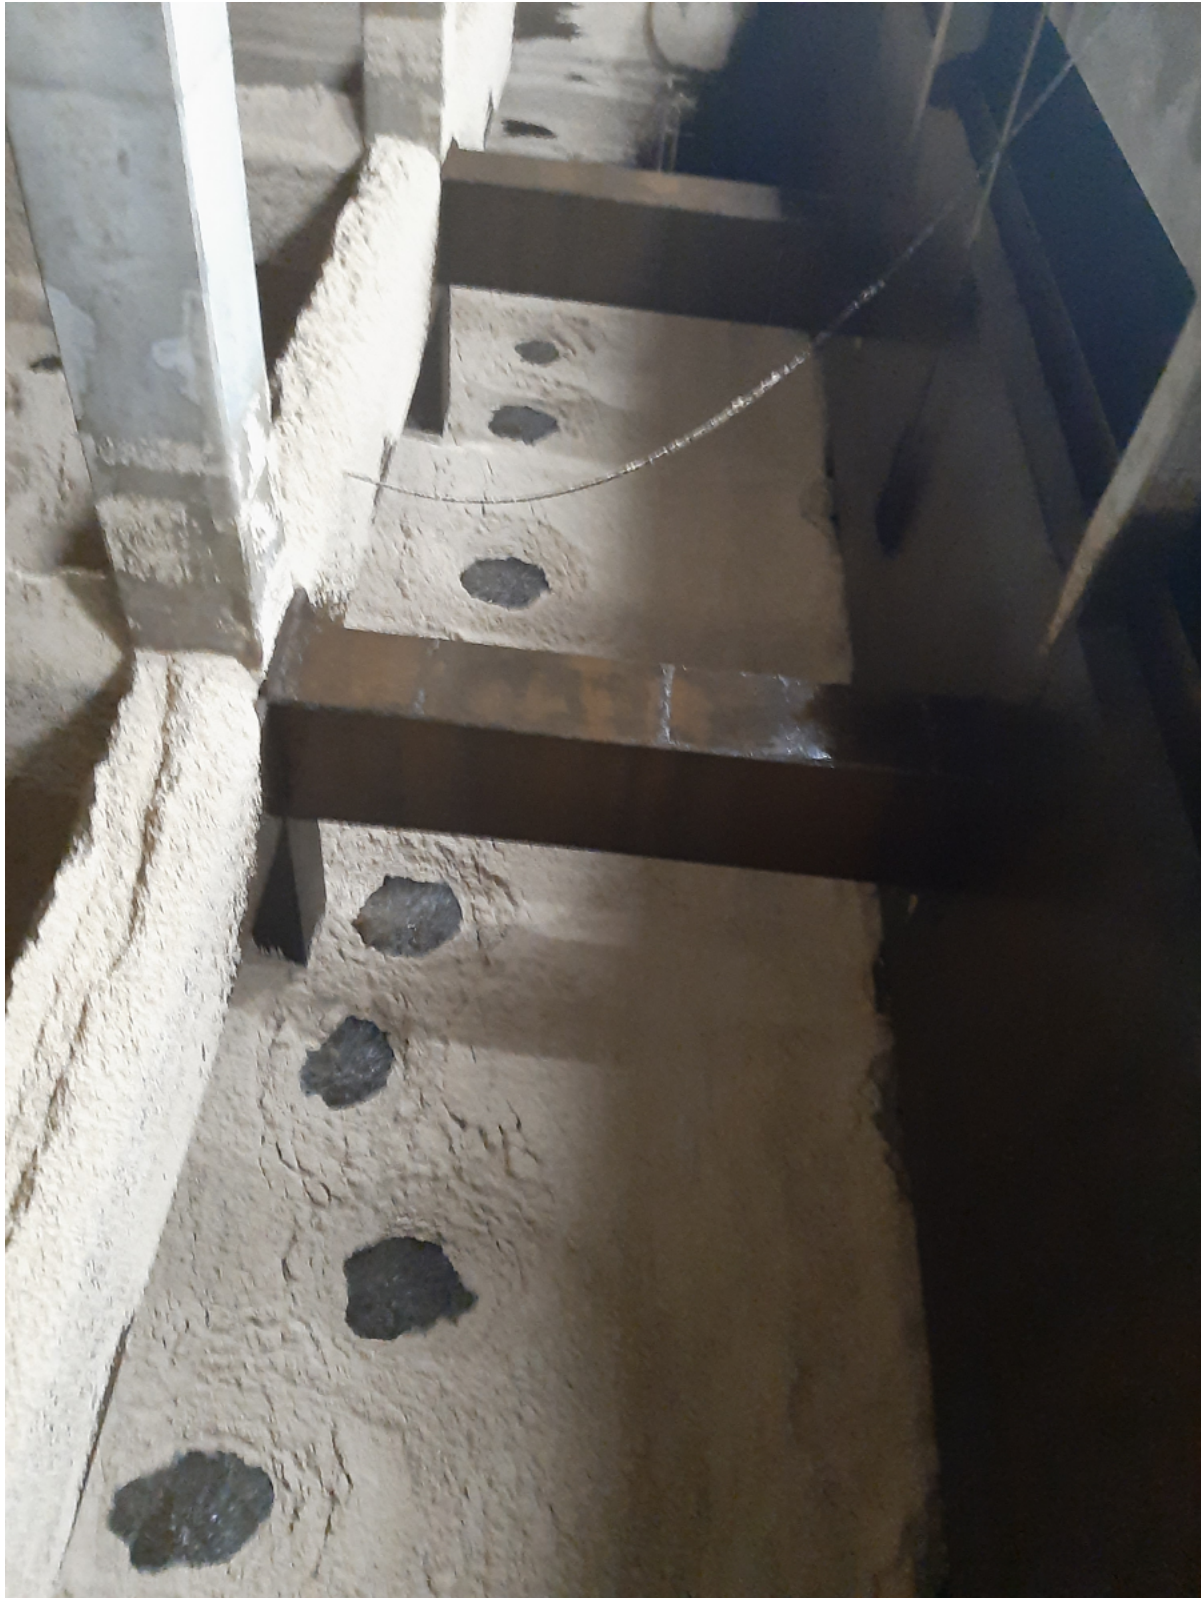
inspection of the BAF mud well, where the backwash is discharged before going into clarifier #3, I observed the entire surface of the water in the mud well is covered with a heavy layer of media with the potential to return to the beginning of the treatment system. **The Patapsco WWTP must clean the mud wells in order to prevent further discharges of media.**

11/2/22 Picture of backwash mud well showing media accumulation. Effluent from the mud wells goes to Secondary Clarifier #3.

The media shall not discharge to the surface waters of the state and final effluent containing media is not acceptable. This issue must be addressed and permanently resolved. This accumulated media must be removed from the backwash mud well and disposed of appropriately, and further investigation on the cause of the media leakage is required. **Baltimore City shall continue to provide updates to the Department every 30 days as specified in the June 29, 2022 and July 7, 2022 report and provide an explanation on how the media will be removed from the mud wells and the disposal method as well as corrective measures taken to address the media leakage.**

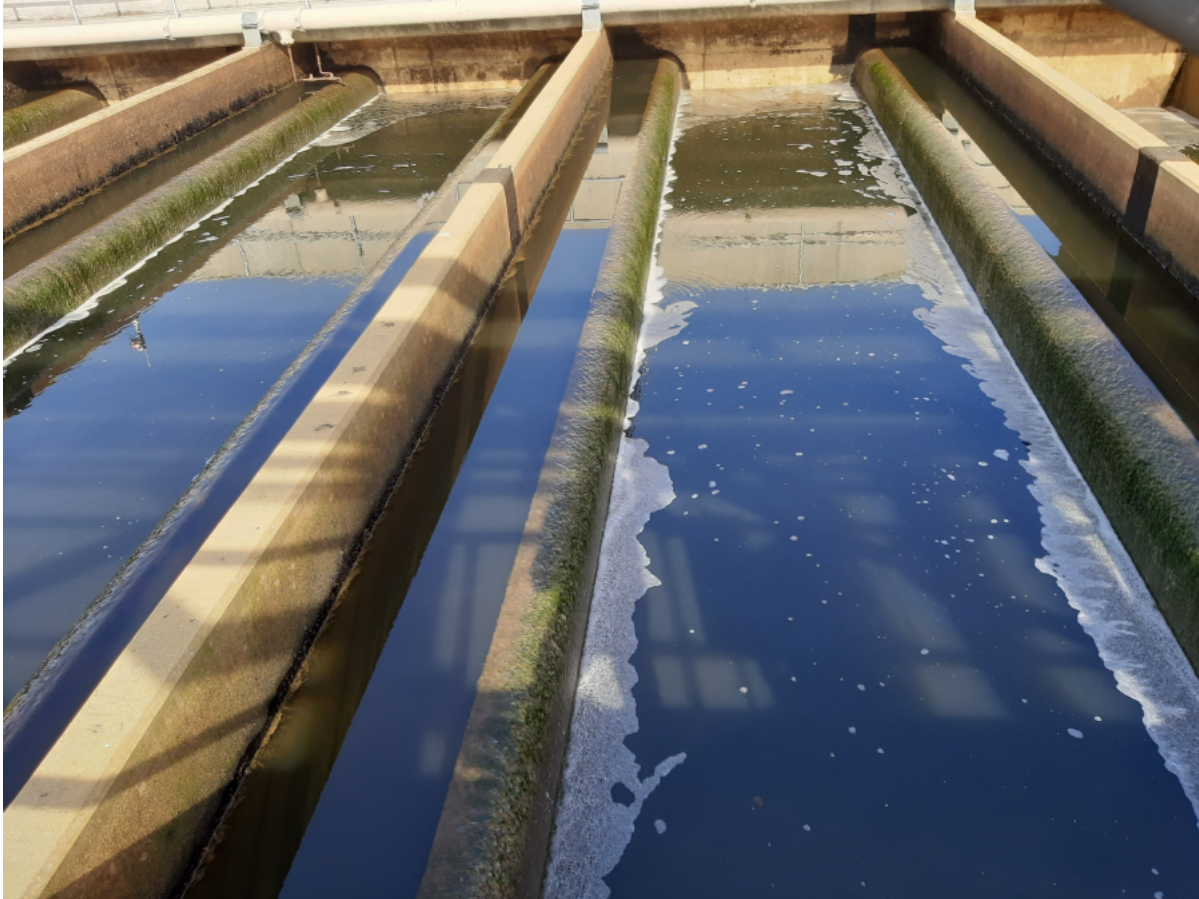
11/2/22 DNF

The DNF was the next step during the site review. The facility has 34 denitrification filters for denitrification and today 31 were in service. There have been issues with overloading the filters with solids requiring the DNF system to be bypassed. During this inspection, the filters in service appeared to be functioning satisfactorily. There was scum floating in some of the filters.

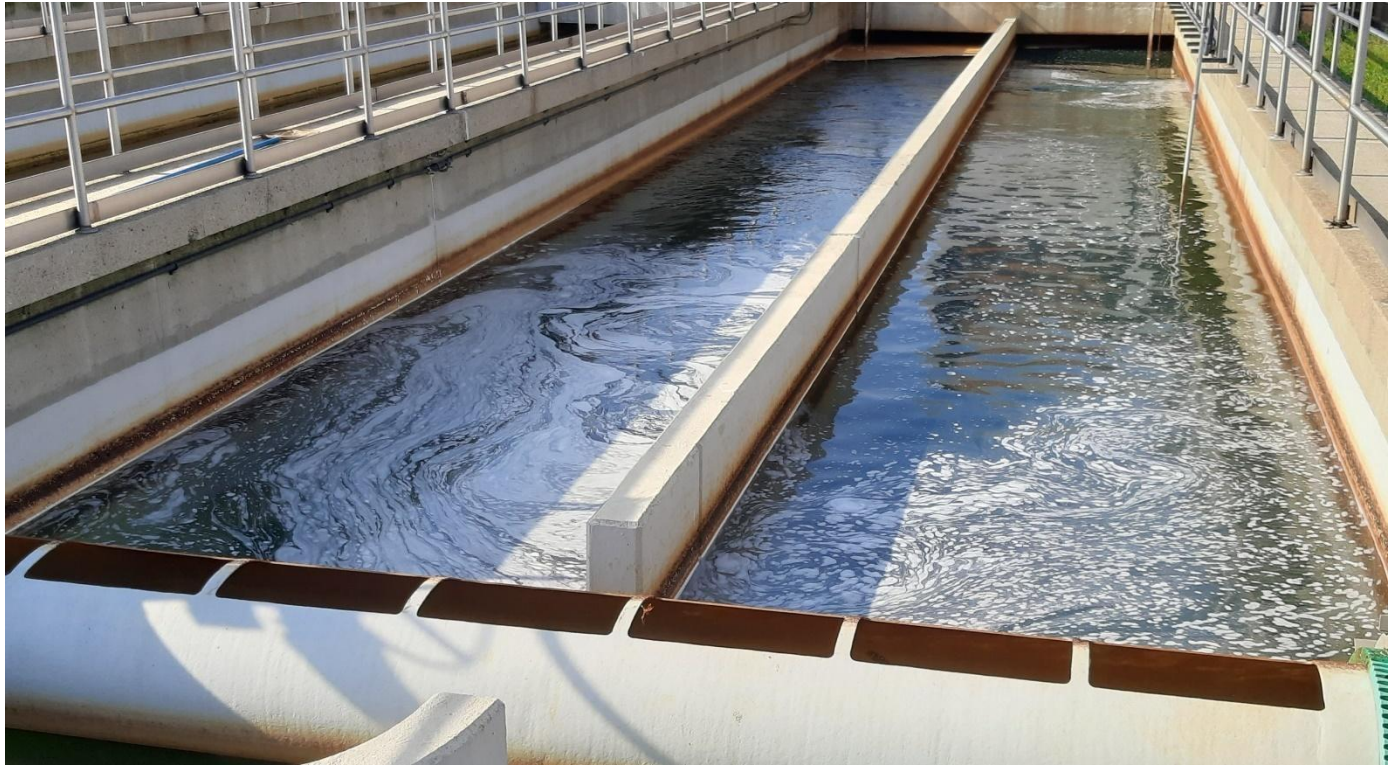
11/2/22 Chlorine contact basin. The water level is at an appropriate height to rotate the scum log in order to collect the floating FOG/scum.

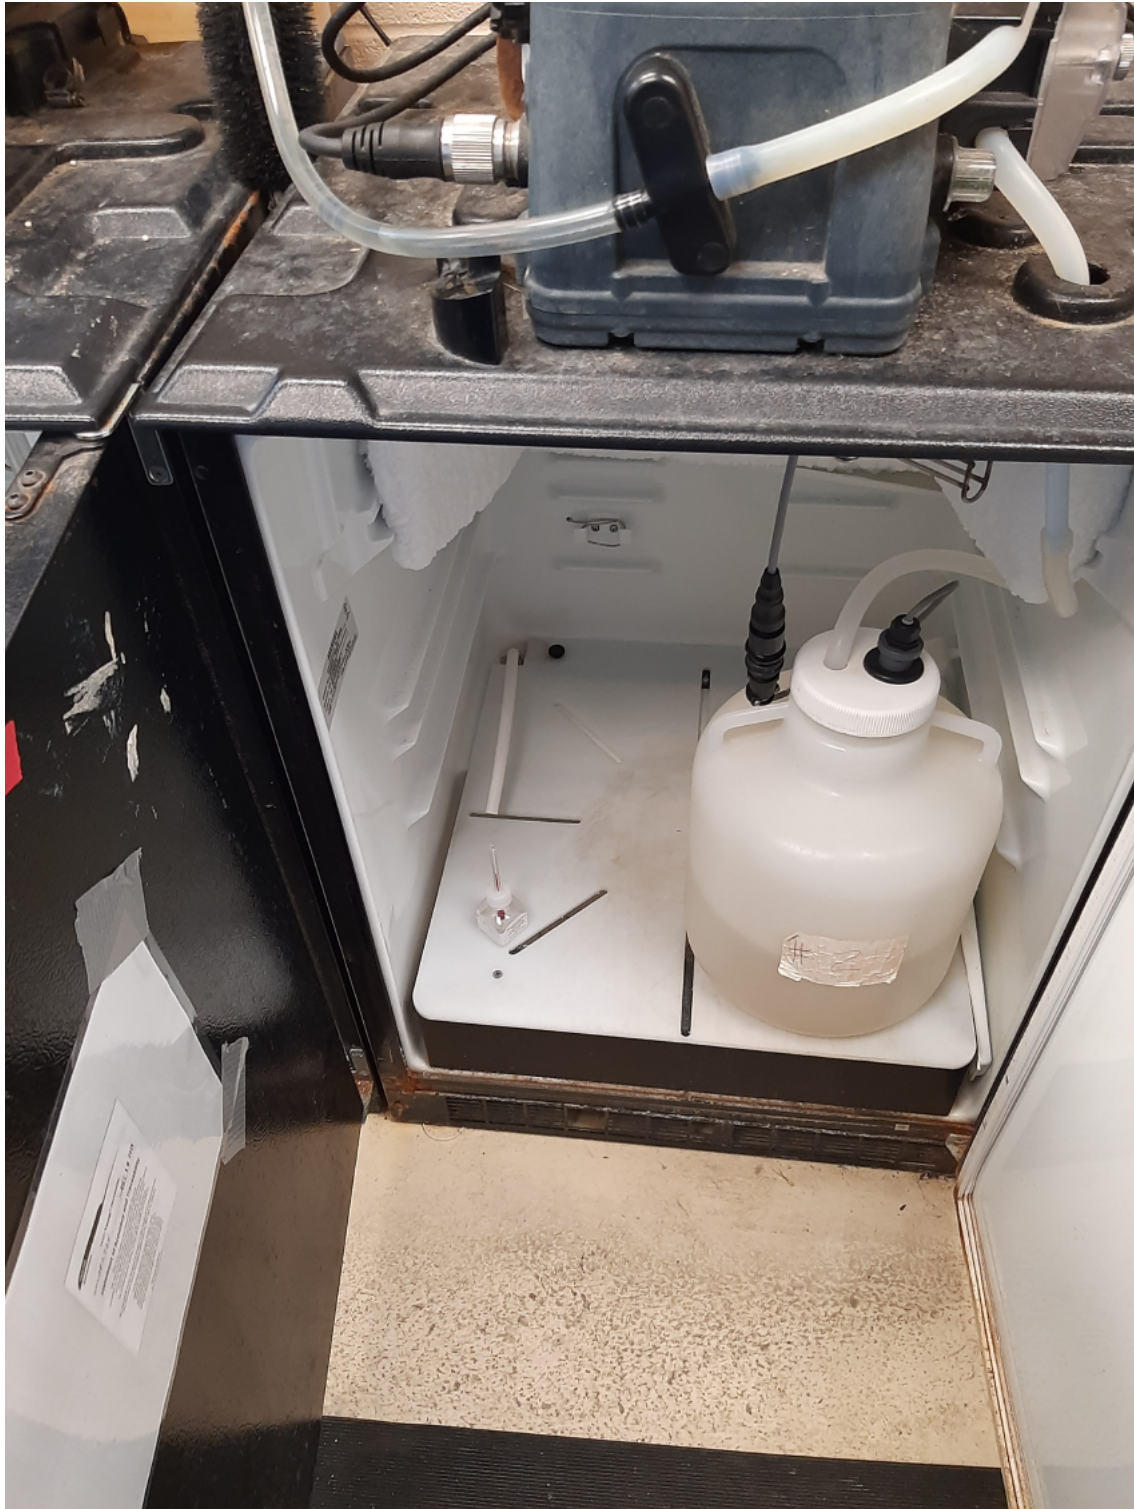
The facility is collecting 24-hour, flow-proportional composite samples at Outfall 001 in accordance with the requirements of the permit. The primary refrigerated, automatic composite sampler was inspected. I found that the temperature of the compartment was satisfactory, and the sampling container was also clean. The temperature of the refrigerated compartment was 5 °C, which meets 40 CFR Part 136 requirements. I inspected the final effluent in the sampling container and observed that the composite sample was a medium amber color with suspended particulates.

11/2/22 Automatic sampling equipment.

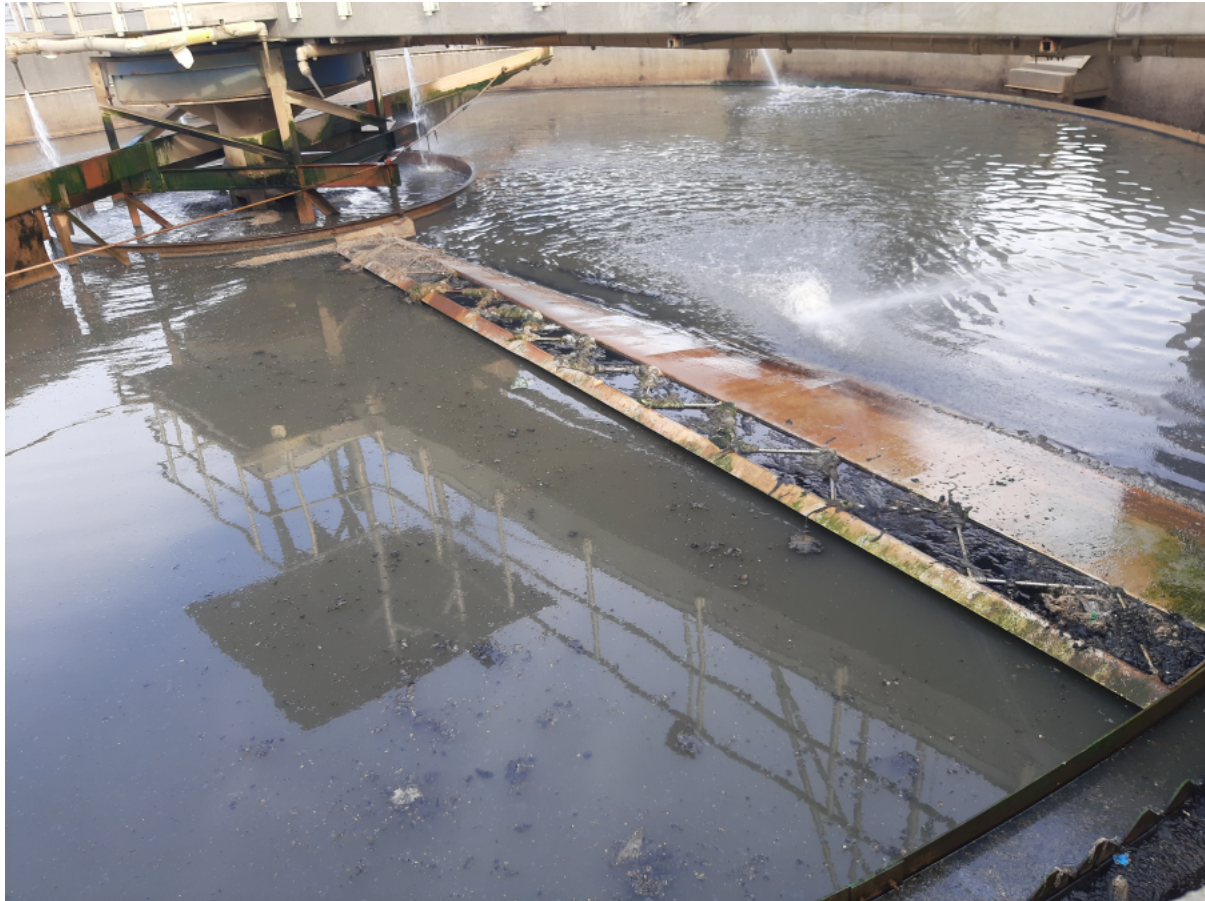
11/2/22 GST#1

Gravity thickening is the process by which biosolids are condensed to produce a concentrated solids product and a relatively solids-free supernatant. The facility has three GSTs (#1, #2 and #4) and during this inspection, I observed that two were online. However, the skimmer arm on GST #1 is not functional due to the scrapper flaps being broken.

- The sludge blankets were above an acceptable level causing the effluent (supernatant) from the GSTs to have a higher-than-normal solids concentration. The high sludge blanket is also causing the top layer of supernatant to be charcoal in color;
- The # 2 GST skimmer arm was not in complete alignment with the surface of the water and required reinforcement;
- There were rags on the weirs of GST #2;
- Scum collection baffle openings are impacted with solids and scum and should be cleared of the substances; and
- Media from the BAF floating in the tanks.

- 4. With respect to item D above, the Patapsco WWTP shall operate and process sludge in the GSTs in a manner that maintains a solids-free supernatant. Since the two operating GSTs are overburdened with solids, the #4 GST should be repaired so that the active GSTs can be taken offline one at a time and cleaned. This action will greatly improve the quality of supernatants from the GSTs. Within 30 days of the receipt of this report, the Patapsco WWTP shall submit to the Department a status report on the progress of the repairs to the #4 GST with an updated report every 30 days until the #4 GST is back in service.**

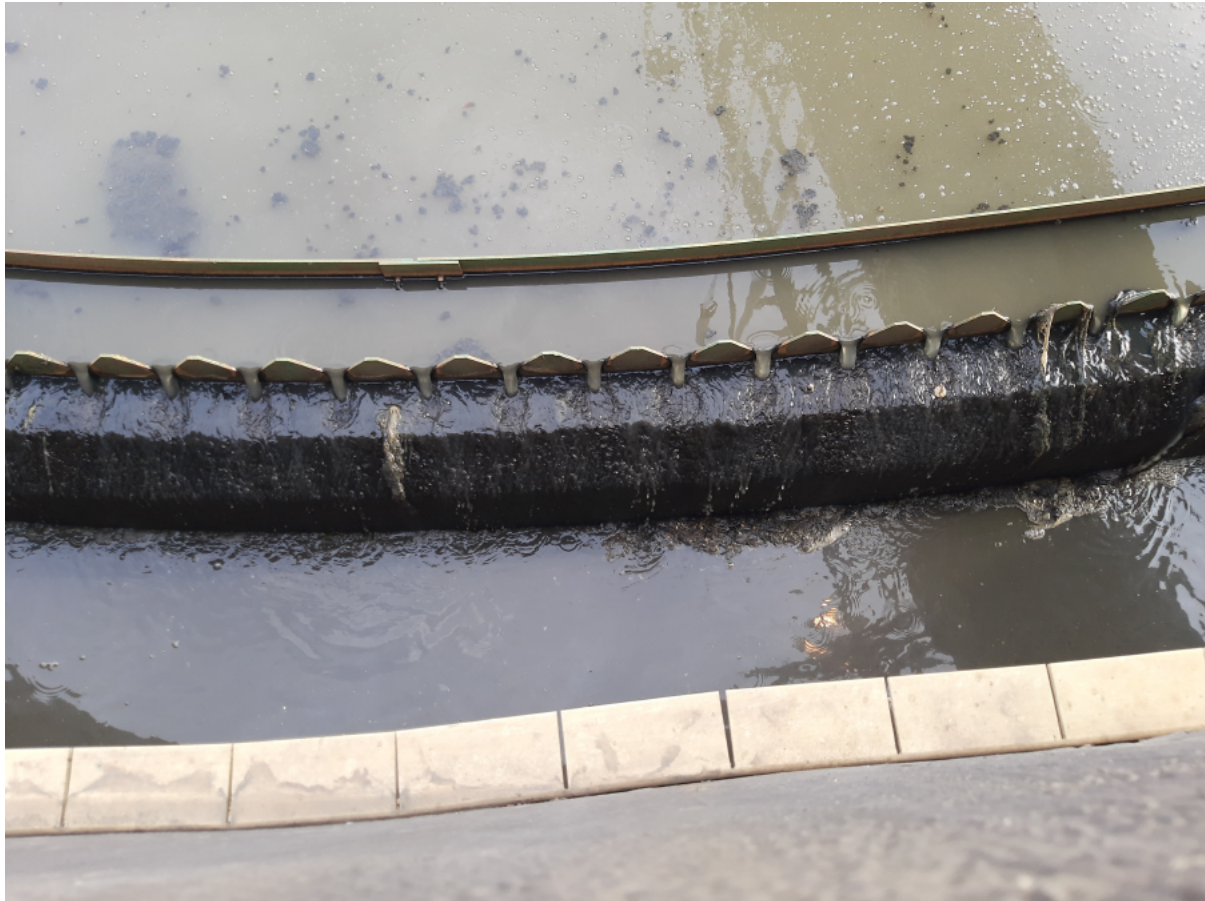
11/2/22 GST #2 rags on the weirs and media floating on the surface.

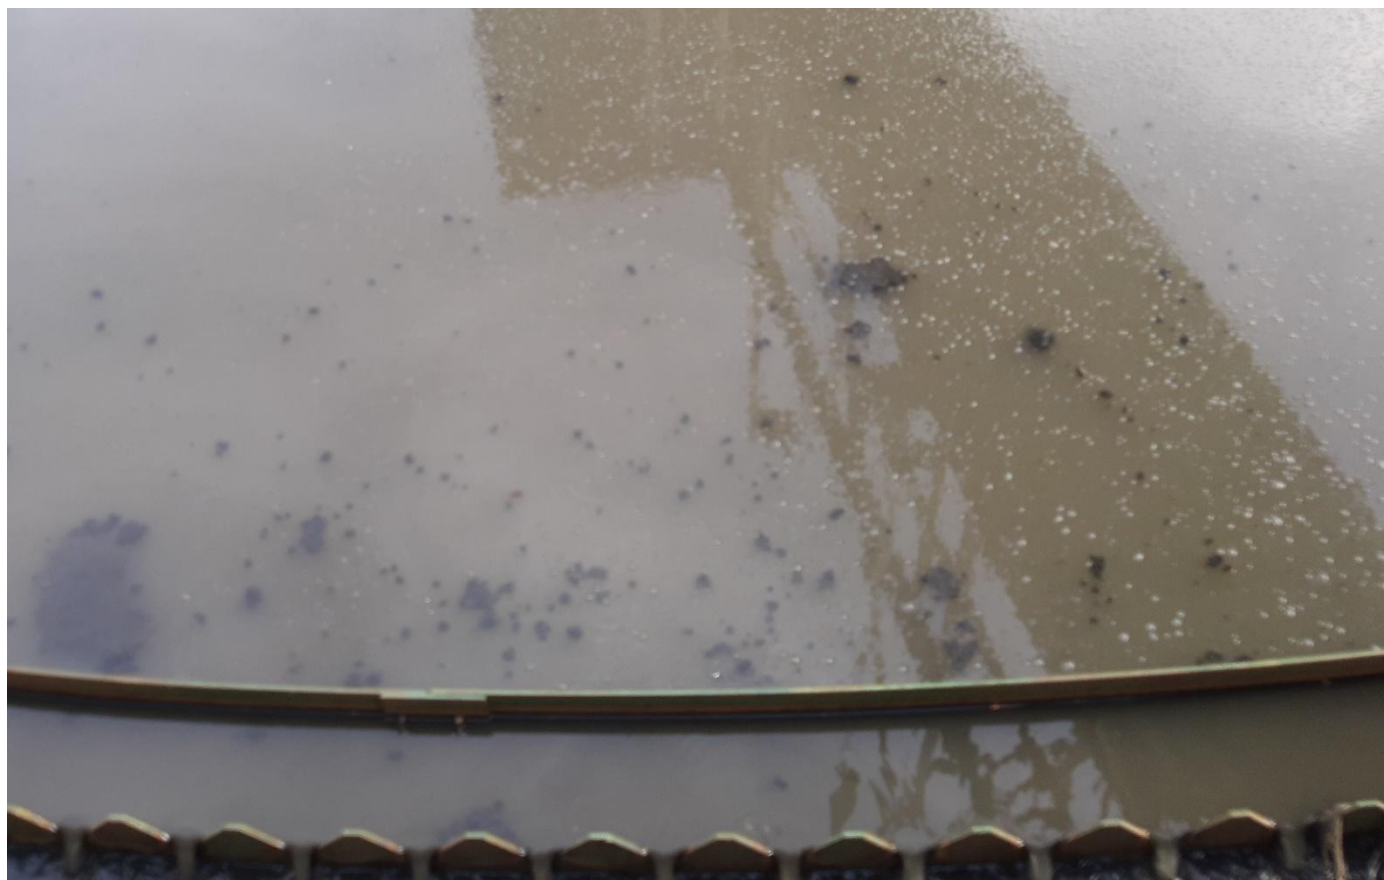
11/2/22 GST #2 media floating on the surface.
