REHABILITATION OF
FAILED CORRUGATED METAL PIPE SPILLWAYS

PRESENTED AT JUNE 1996 REGIONAL CONFERENCE
MID-ATLANTIC COUNCIL FOR SAFE DAMS

by
Harald W. Van Aller, PE
Geotechnical Engineer,
Maryland Dam Safety Division

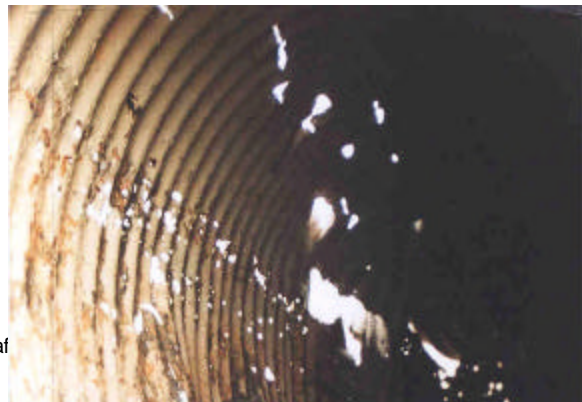
Priestford Hills. The Priestford Hills Dam is an earthen dam about 25 feet high which was constructed in 1974. It impounds a lake that serves as a focal point of a small community. By 1992, the 36-inch CMP conduit had deteriorated to the point where hundreds of holes (see Figure 1) were observed in the pipe invert and sidewalls, subjecting the underlying soil to erosion, which could potentially lead to a "piping" failure. The Dam Safety Division determined that the dam was unsafe and ordered the lake drained. The pipe was deemed "not repairable" and was there completely removed and replaced with concrete pressure pipe (ASTM C-361) using conventional excavation techniques. Cost was about \$100,000 and the lake was drained for three years while the owner could secure financing.

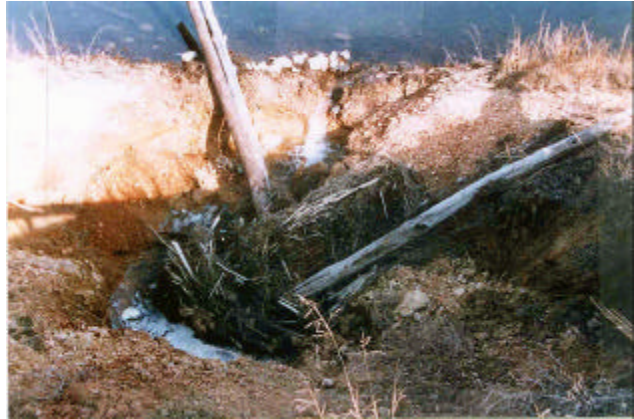
Elk Neck State Forest Dam. This 22-foot high dam was constructed in 1959 with a 36-inch CMP spillway barrel. In the late 1980s an inspection of the dam revealed that the outlet pipe barrel was in good condition, but the base of the riser had deteriorated to the point where collapse was imminent. The owner of the dam (a state agency) performed temporary repairs to the riser base with concrete, and requested funds for spillway replacement. In 1990 a specialty contractor (Insituform) was contacted regarding the feasibility of completely relining the pipe and riser with a cured-in-place resin impregnated tube. The estimated cost at that time was about \$60,000. This exceeded the funds set aside by the owner, and no work was done. In early 1996 the riser collapsed (see Figure 2) and plugged the spillway. The situation developed into an emergency condition during a heavy storm and the dam owner immediately drained the lake and breached the dam.

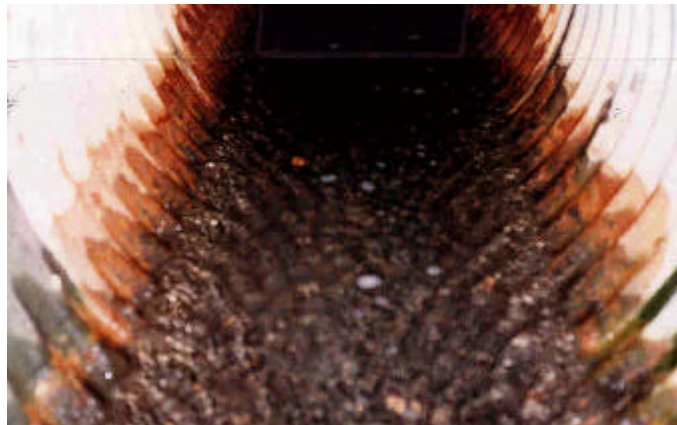
Campus Hills. The Campus Hills Dam is an earthen dam about 30 feet high which was constructed in 1969 for a recreational lake. An inspection of the pipe in 1992 showed that the 24-inch CMP conduit was beginning to show signs of deterioration, as the invert was severely corroded, but no holes were observed. However, the inspecting engineer was able to penetrate the pipe completely with a small blow by a blunt tool.

Because the pipe did not show signs of leakage and the embankment showed no signs of "piping," the Dam Safety Division allowed the owner to investigate sliplining of the conduit as an alternative to conventional removal and replacement. A local engineering firm was retained by the owner to develop the design. A 22-inch, smooth-walled polyethylene (HDPE, type PE3408) pipe with a Standard Dimension Ratio (SDR) of 26 was selected as the slipliner material. The required lengths of pipe were "fusion welded" into a single length on the crest of the dam and then inserted into the conduit from the downstream end. A 36-inch SDR 26 HDPE pipe was inserted vertically into the CMP riser and joined to the barrel with 24-inch and 34-inch flanges field welded (PE extrusion) into the base. The annular space between the new and old pipes was filled with cement grout. The entire process took less than one week and the pool was lowered slightly, but not drained. The total project cost, including design and construction, was about \$50,000.

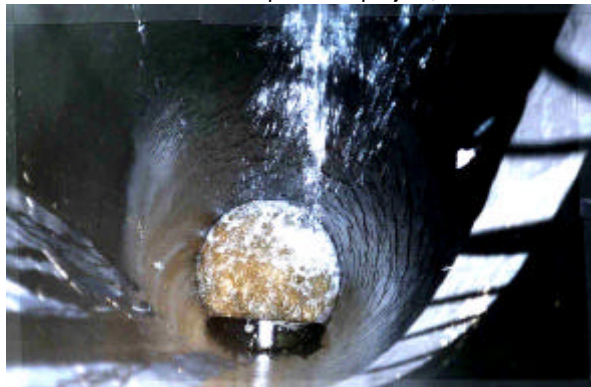
The connection of the barrel liner to the riser is somewhat difficult. At the Campus Hills project, a connection was custom fabricated by the contractor. (See Figure 3)
