Maryland Department of Environment

Inspector:	Wendy Huang			
AI ID:	3076			
Site Name:	Patapsco WWTP			
Facility Address:	3501 Asiatic Ave, Curtis Bay, MD 21226			
County:	Baltimore City			
Start Date/Time:	June 15, 2023, 09:00 AM			
End Date /Time:	June 15, 2023, 02:00 PM			
Media Type(s):	NPDES Municipal Major Surface Water, NPDES Industrial Stormwater			
Contact(s):	Neal Jackson- Plant Manager of Patapsco WWTP			
	Andrea Buie- Branam- Environmental Compliance Manager of Baltimore City			
	Eric Johnson- Wastewater Operations Supervisor of Patapsco WWTP			
	Kevin Mc Fadden- Operation Supervisor II of Patapsco WWTP			
	Donald Taylor- ENR Supervisor of Patapsco WWTP			
	Chris Saunders- Senior Associate of Hazen & Sawyers			
	Sajid Roomi- Engineer for Patapsco WWTP			
	Chris Lepadatu- MDE Regulatory Compliance Engineer

NPDES Municipal Major Surface Water/ NPDES Industrial Stormwater

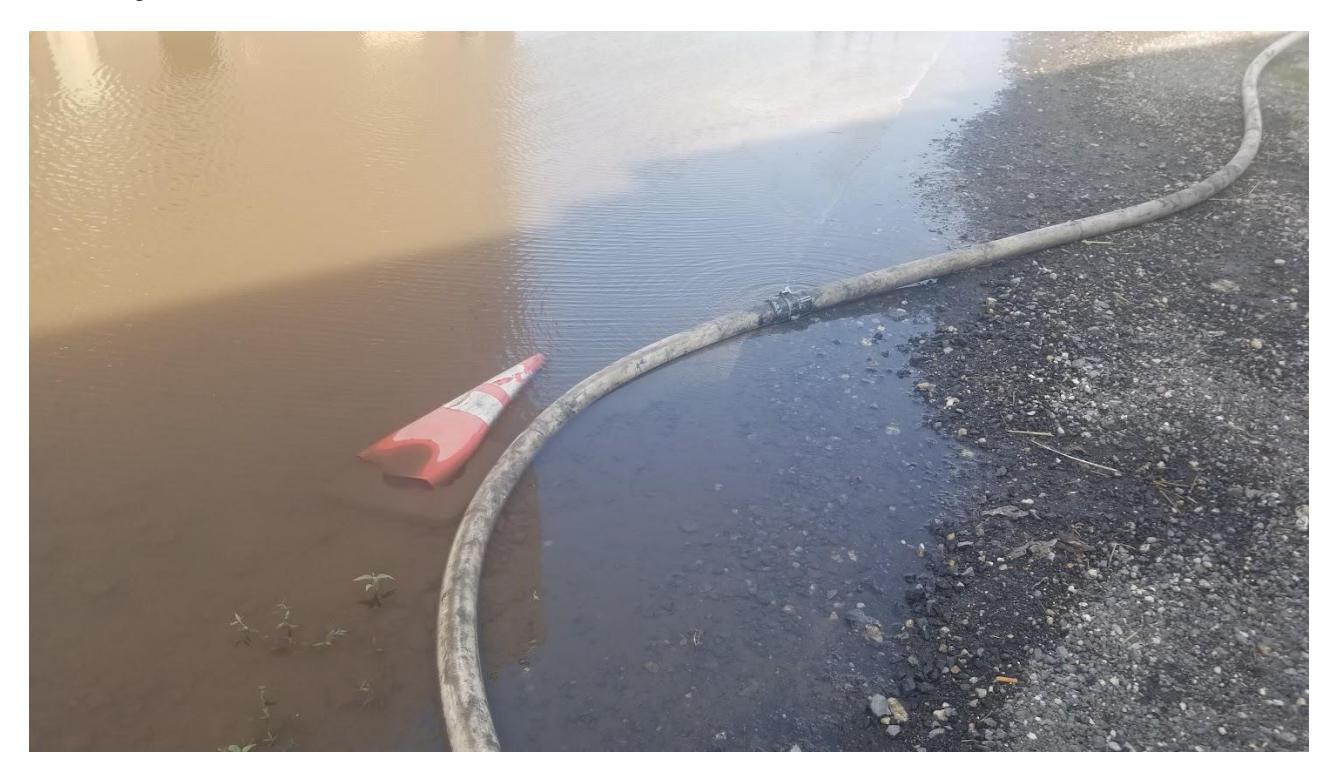
The pump and blower/ IPI building has two bar screens. Bar screen #1 was turned off during the time of this inspection. The bar screens operate on a rotating basis. Industrial influent enters the wastewater treatment plant via this building. This building has approximately 2-3 MGD capacity for industrial influent. A hose that is leaking water is

placed on a puddle of water outdoor, by the west side of the IPI building. Mr. Neal Jackson stated the hose was turned on to remove the accumulated rags on the bar screens in the IPI building. Water from the hose was not observed to be flowing into nearby storm drains. BAF media was observed on both bar screens within the IPI building. A picture of the leaking hose is shown below:

The hose should be fixed to ensure that it is not leaking.

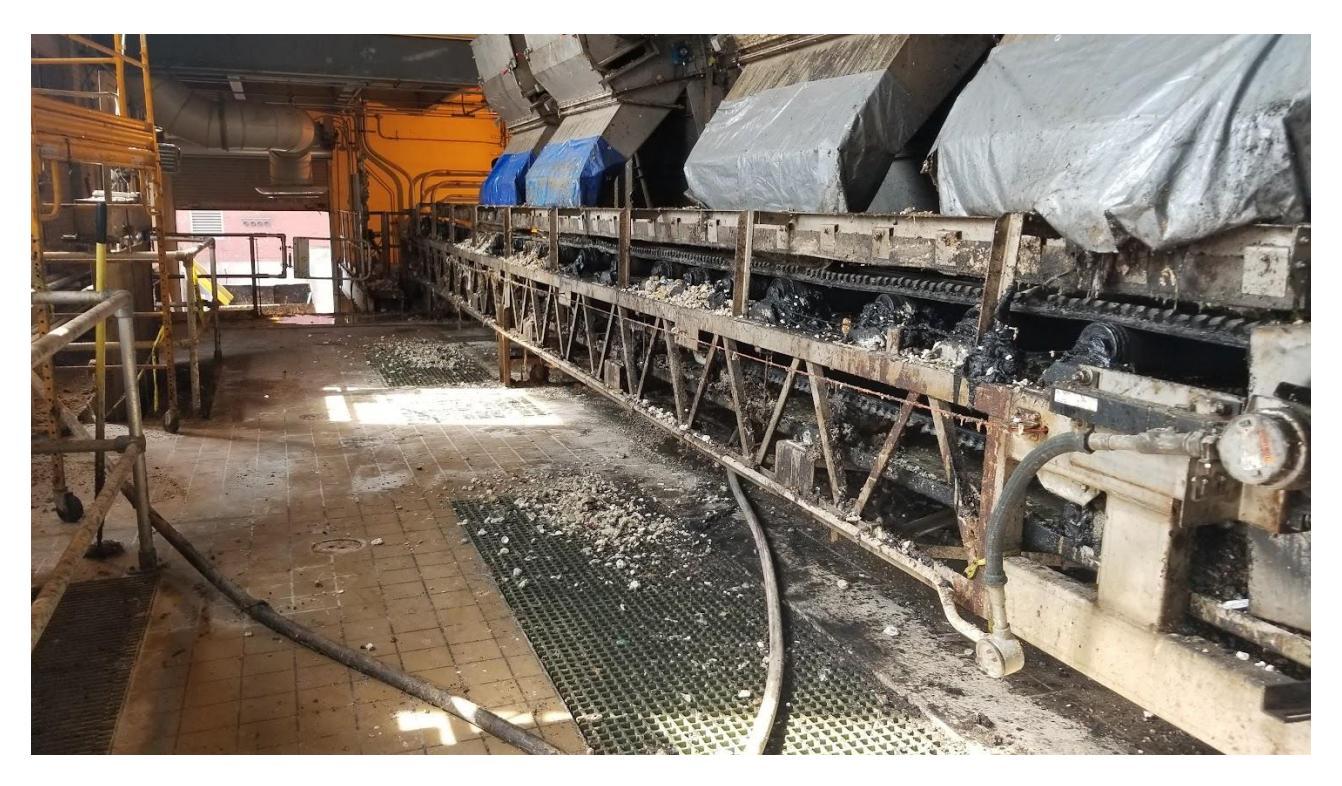
Domestic sewage and industrial influent enter this building. Grease and grit are removed from sewage with fine screens. The solids are then dropped onto the conveyor belts where they will be transported into dumpsters. Grease and grit in the dumpsters are then placed in the transfer station for dewatering. Mr. Chris Saunders stated all eight fine screens are operational. During the time of this inspection, fine screen #3 is turned off and seven other fine screens are currently in running. Grits were observed on the ground by the output side of fine screens # 5-8. A picture of the ground by the output side of fine screen #5-8 is shown next page.

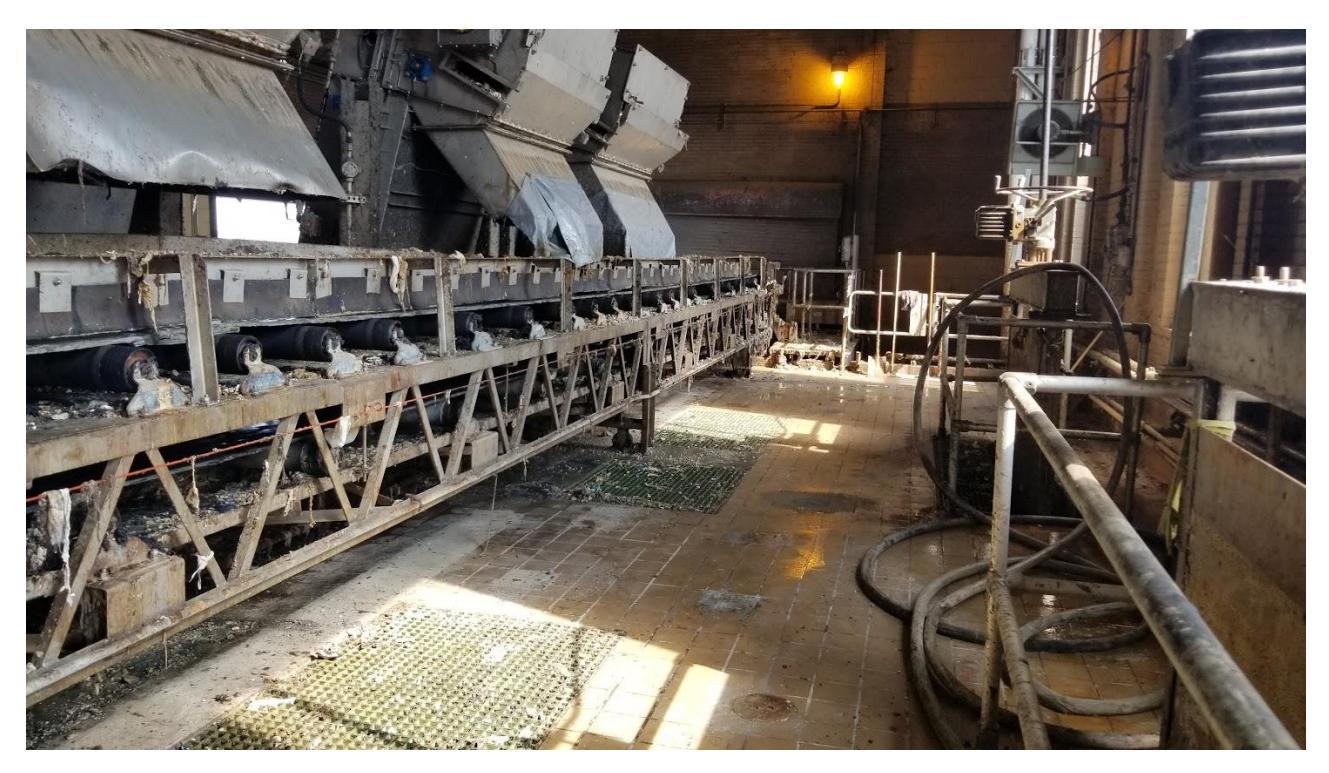
There is less grit on the ground by the output side of fine screens #1-4. A picture of the ground surface by the output side of fine screen #1-4 is shown below:

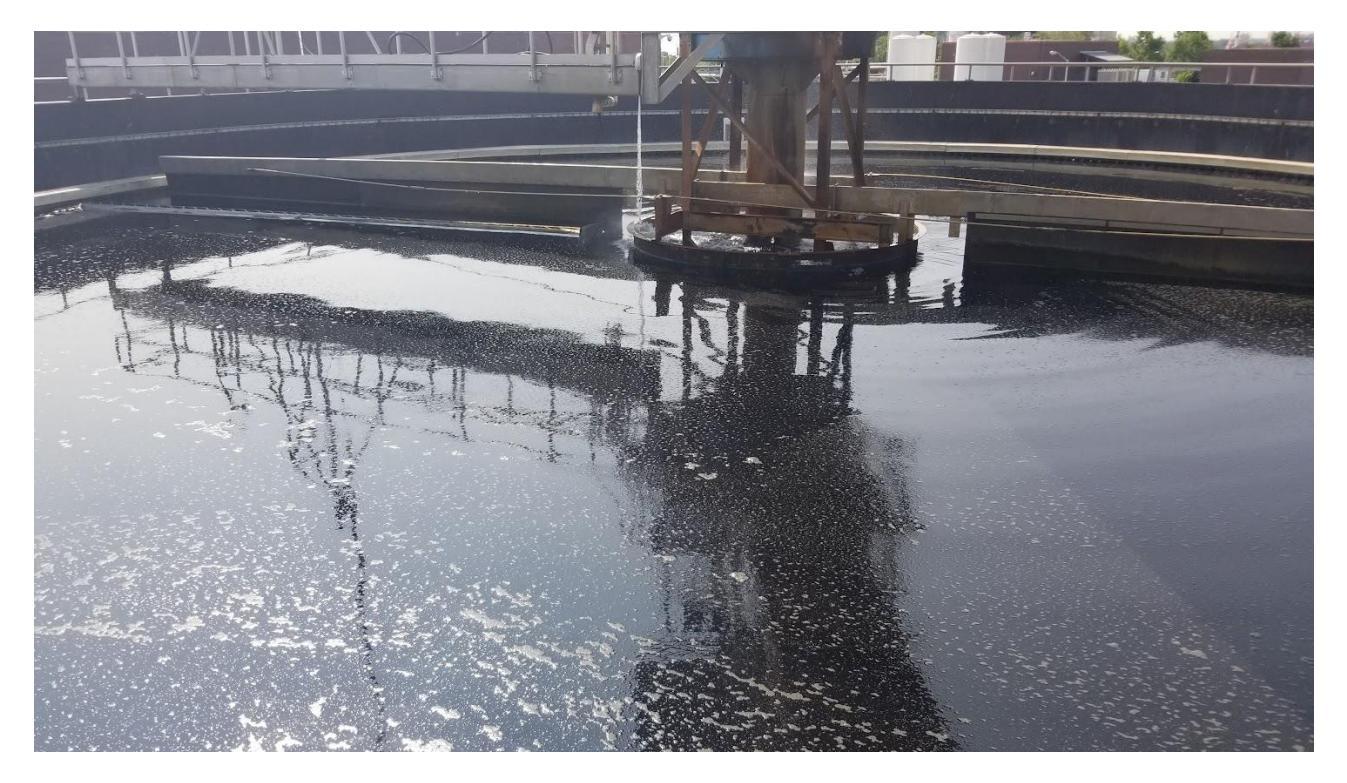
GST #4 is continuously receiving high pressure effluent water and is idle. Grime was observed at the outer weir of the GST. Mr. Chris Saunders does not know the exact date of when GST #4 will run. A picture of GST #4 is shown next page:

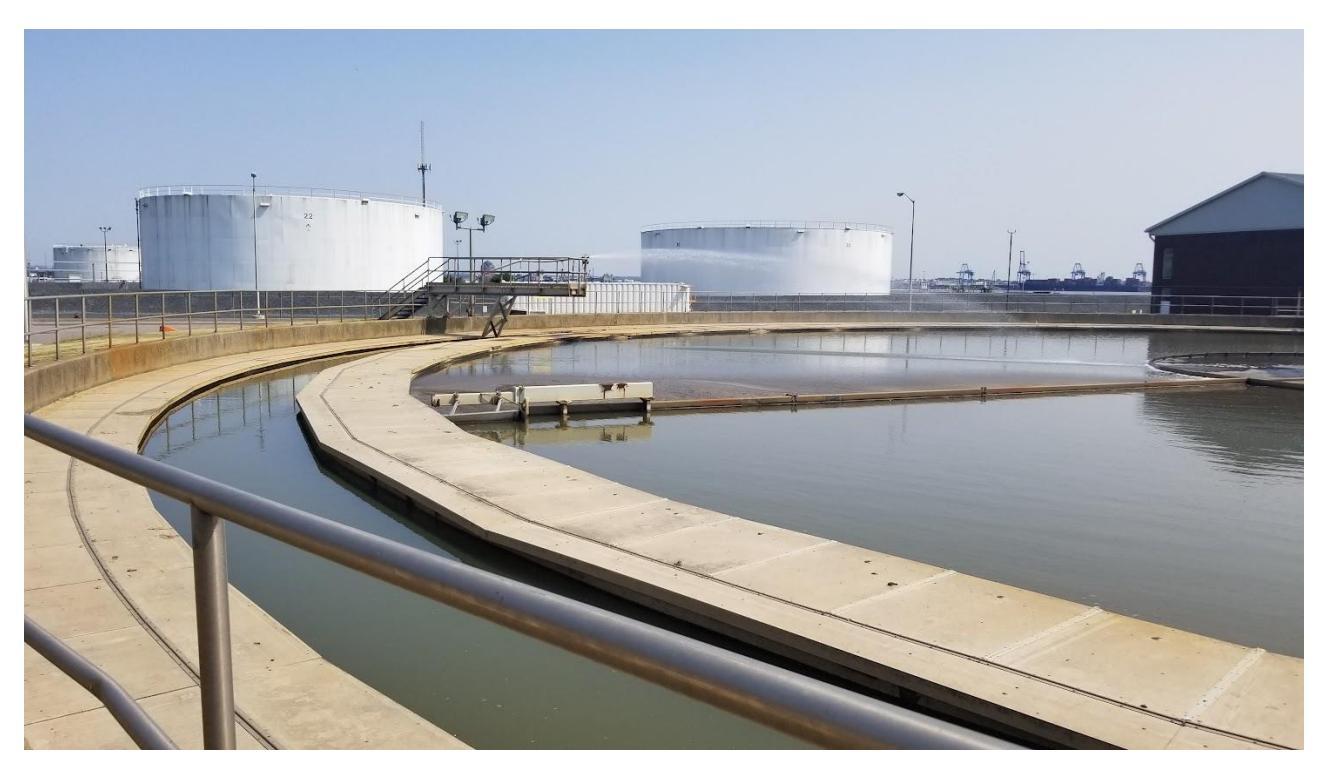
Duckweed was observed on the water surface between two launder covers within Clarifier #1 but did not cause an obstruction in water flowing out of the V- notch weir. All clarifier arms in Clarifier #1 and 6A have been fixed and are functional. A picture of Clarifier #1 is shown below:

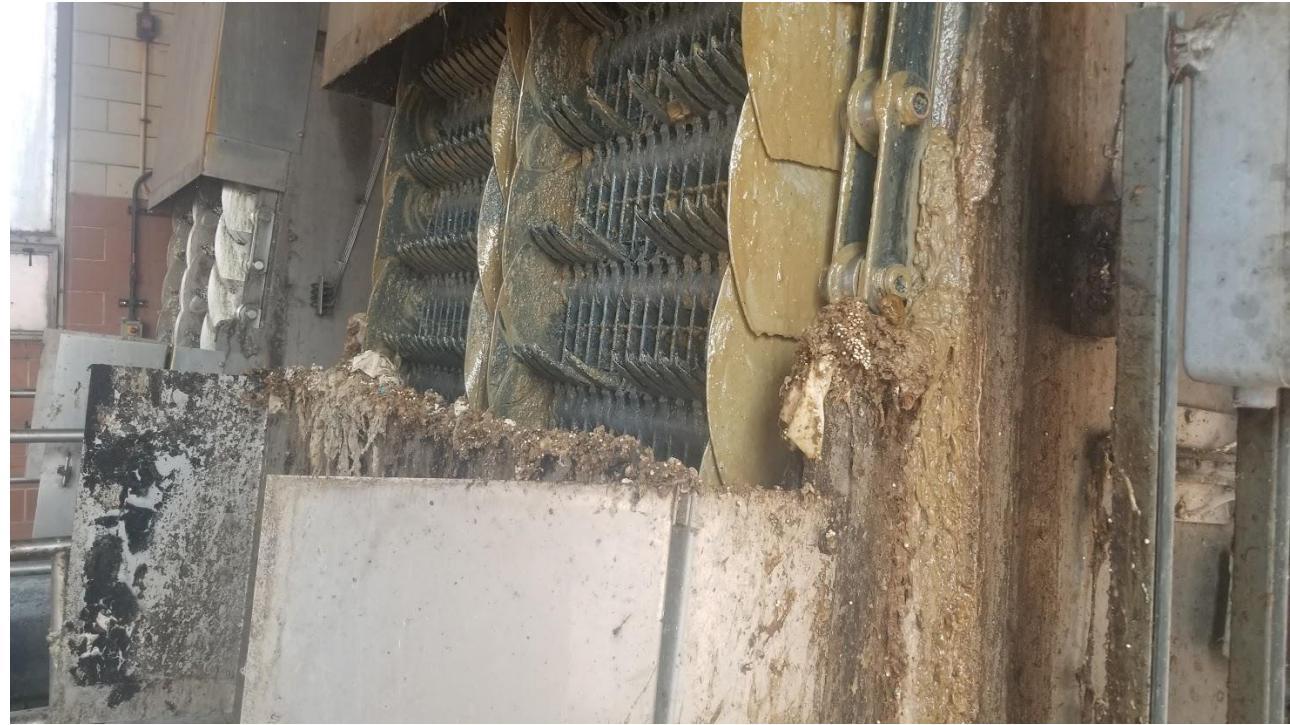
There are BAF media on the ground and on both bar screens inside the IPI building. BAF media was also
observed outdoor on the ground and on the surface of a hopper. A picture of bar screen #2 is shown in Figure
1a. A picture of the BAF media on the ground inside the west side of the IPI building by bar screen #1 is
shown in Figure 1b. A picture of the hoppers outdoor by the west side of the IPI building is shown in Figure
1c.

Figure 1a: BAF media on the side of bar screen #2.

Remove all BAF media from the aforementioned areas and dispose of them accordingly.

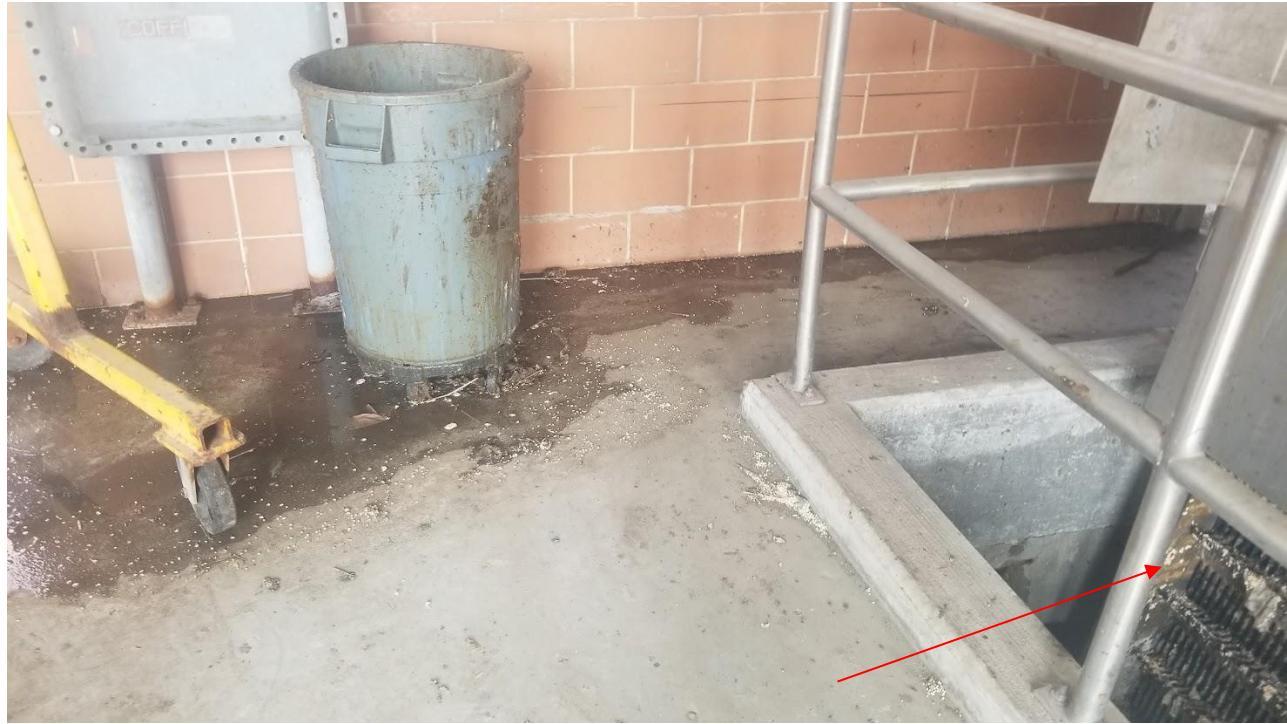
Figure 1b: BAF media on the ground by bar screen #1 inside the west side of the IPI building. There are some BAF media on bar screen #1 (pointed to with a red arrow).

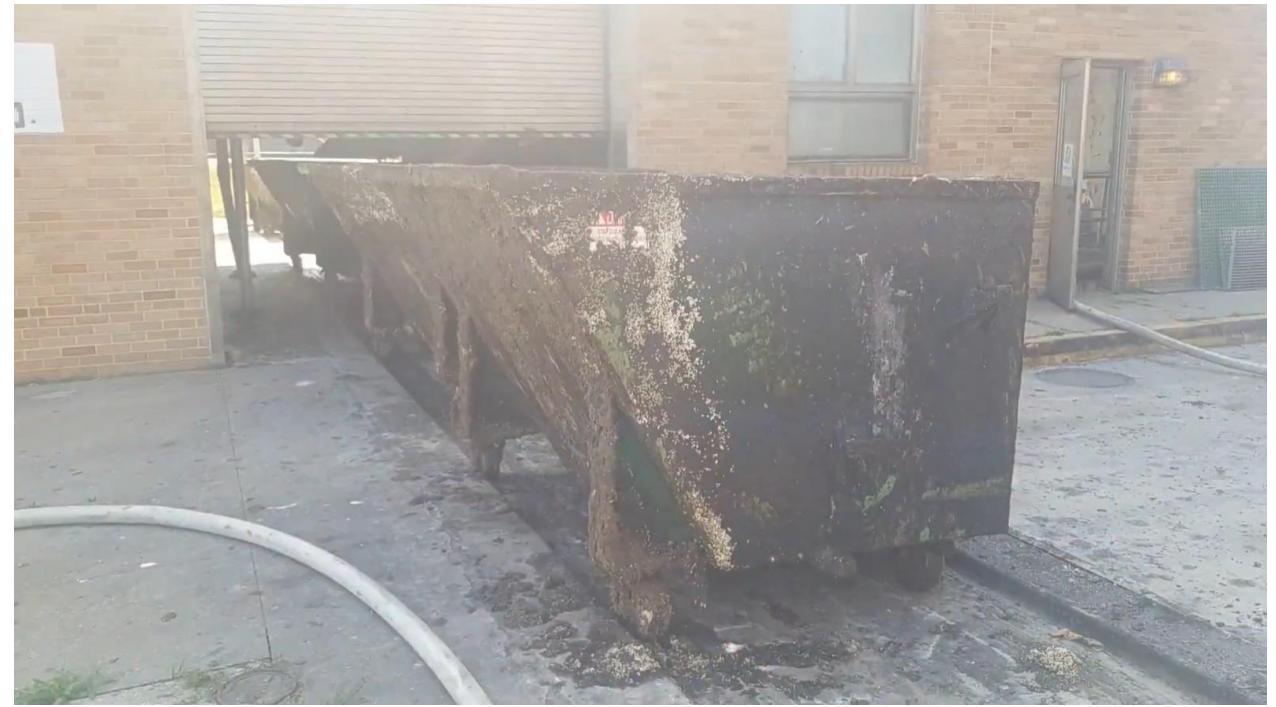
Figure 1c: Hoppers outdoor by the west side of the IPI building. BAF media on the surface of the hopper and on the ground.

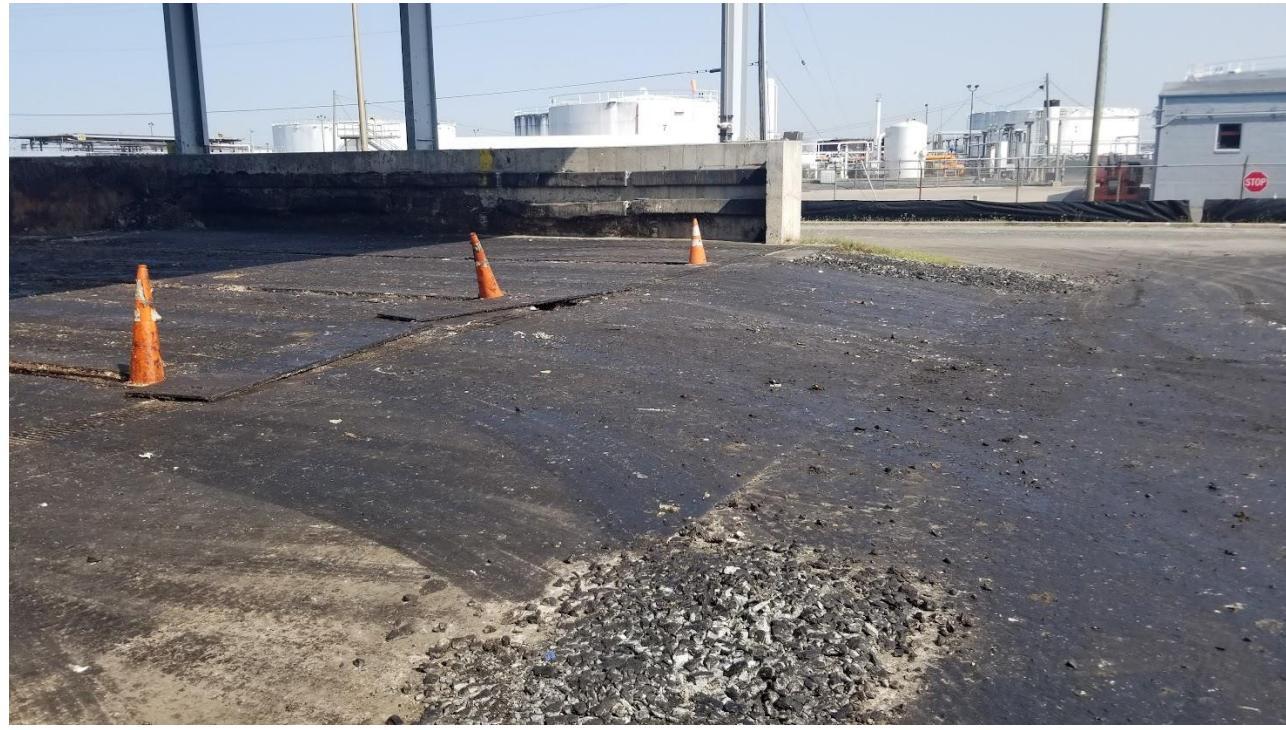
2) Grease track (from the combined influent building) and BAF media were observed on the ground at the road between the transfer station and the combined influent building. A picture of the transfer station is shown in

Figure 2a: Grease track at the transfer station facing northwest.

Remove all BAF media and grit from the ground. Implement better controls to reduce the amount of grease and grit track out from the combined influent building or the transfer station.

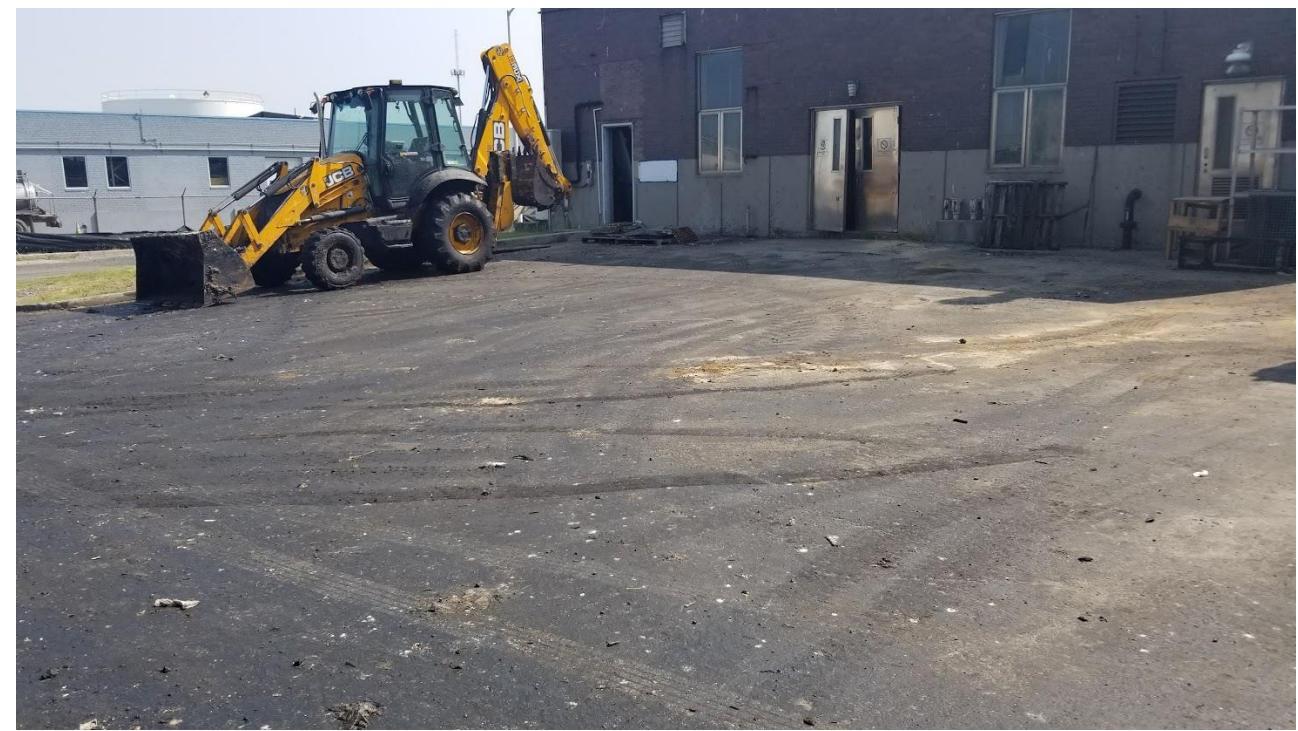
Figure 2b: Grease track and grit on the ground by the transfer station. This location is immediately east of the area shown in Figure 2a, facing northeast.

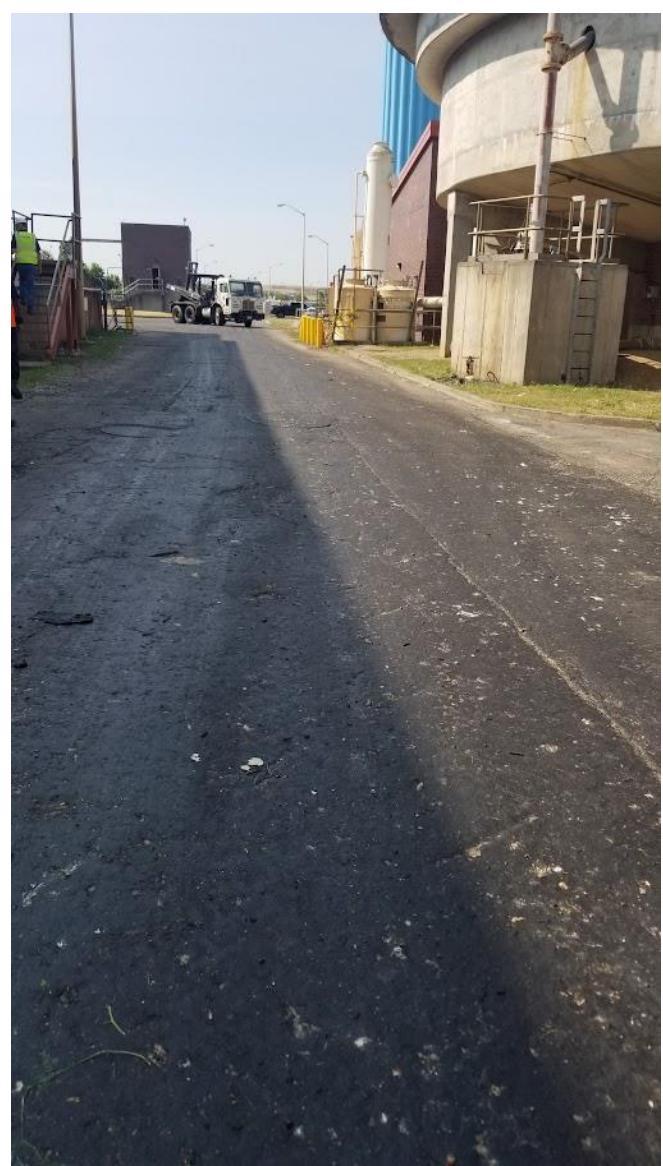
Figure 2c: Grease tracking and grit on the ground at the road west of the combined influent building. This picture was taken facing south.

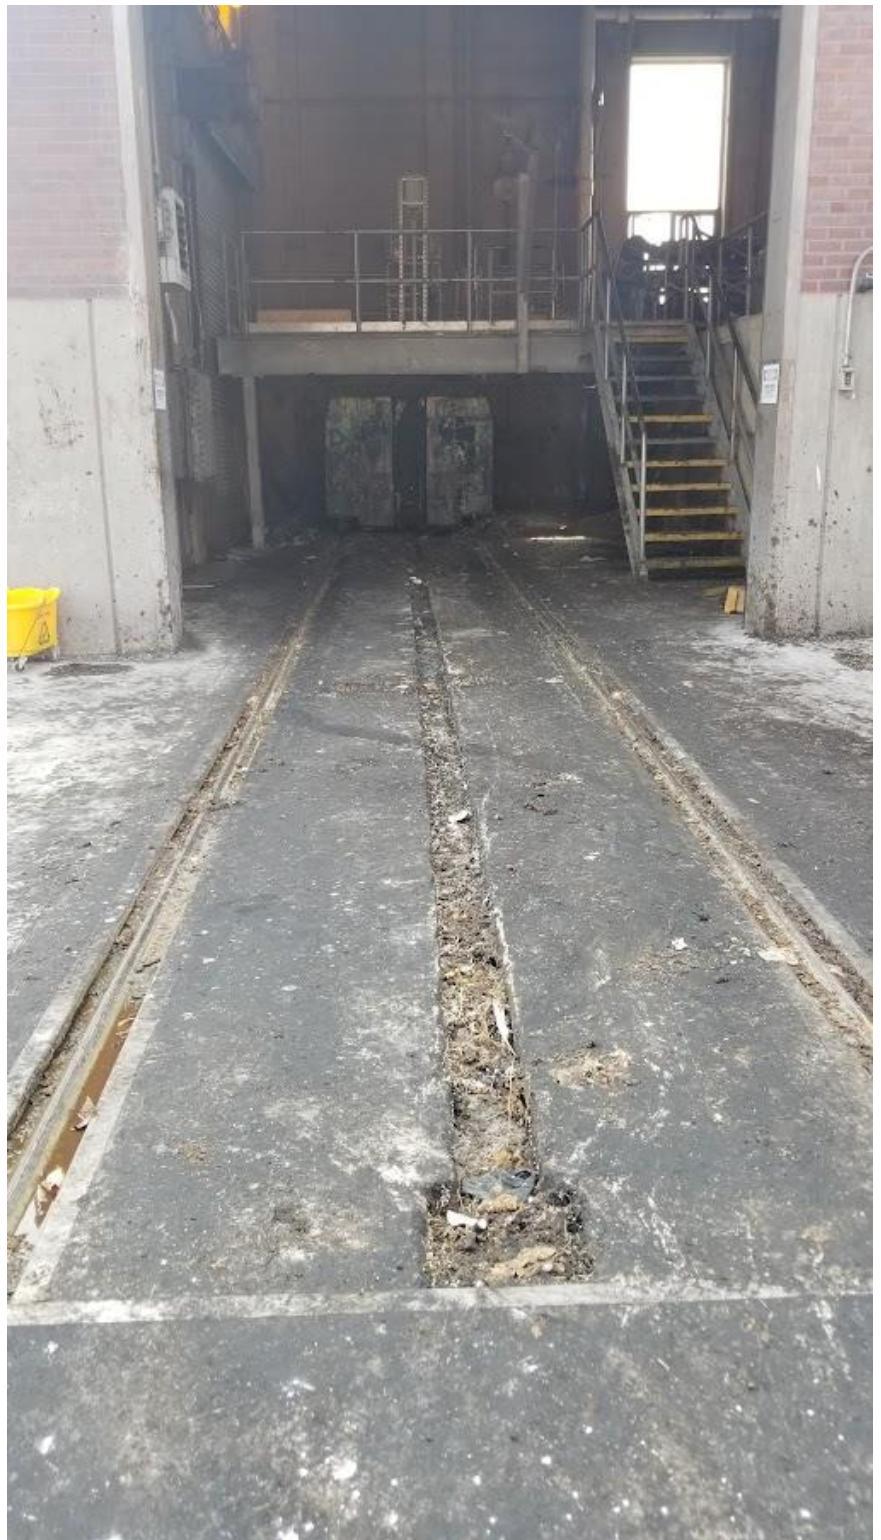
Figure 2d: View of the northwest side of the combined influent building (location of potential grease and grit from fine screens #1- 4 would be dropped into dumpsters at the output side of the conveyor). There are some media imbedded along the depressed area in the middle of the picture.

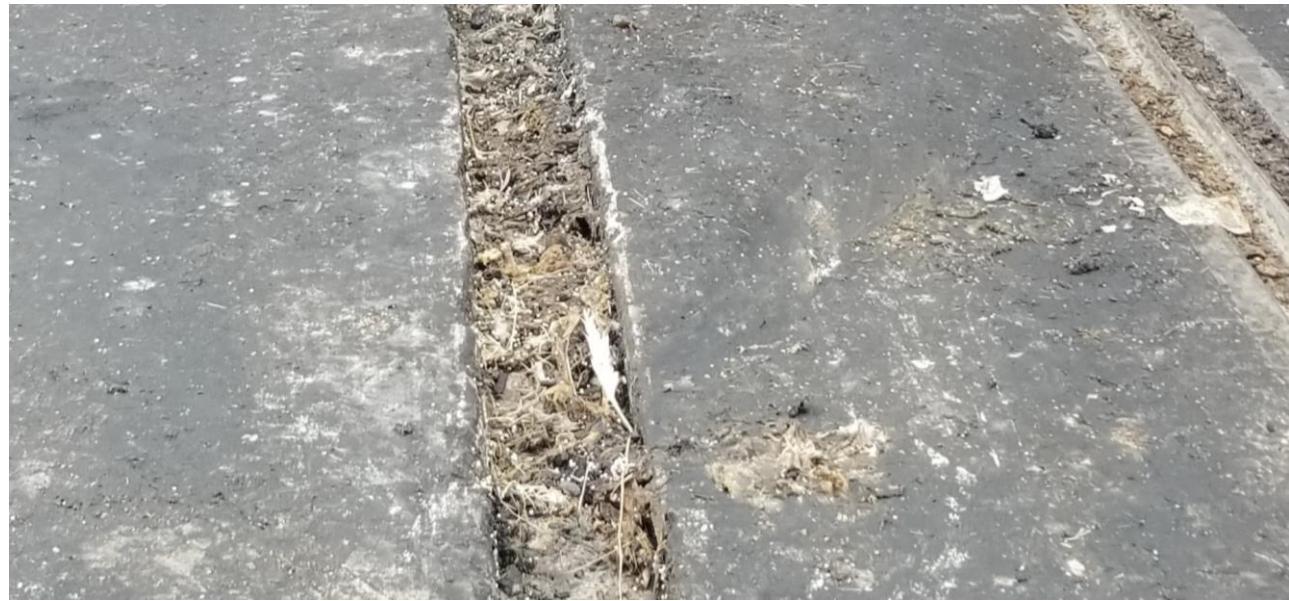
Figure 2e: Close up view of Figure 2d with some BAF media in the depressed area by the northwest side of the combined influent building.

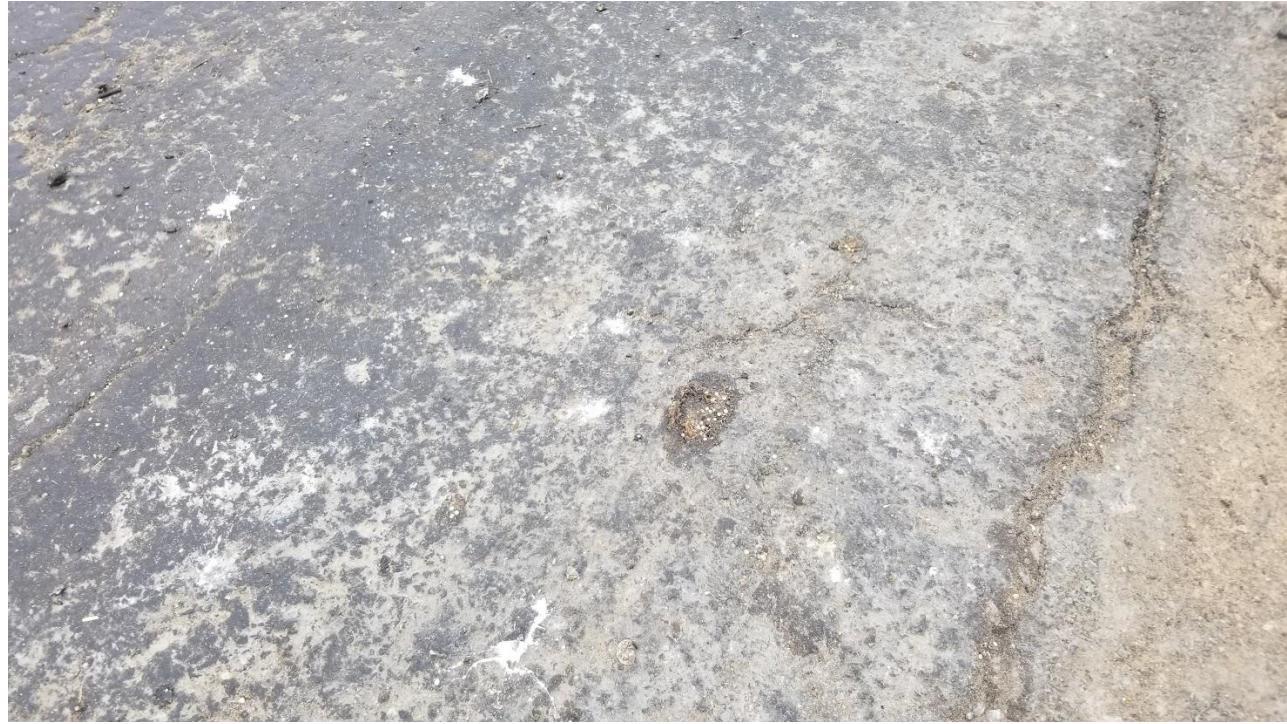
Figure 2f: Close up view of BAF media on the ground by the west side of the combined influent building and south of the area shown in Figure 2d.

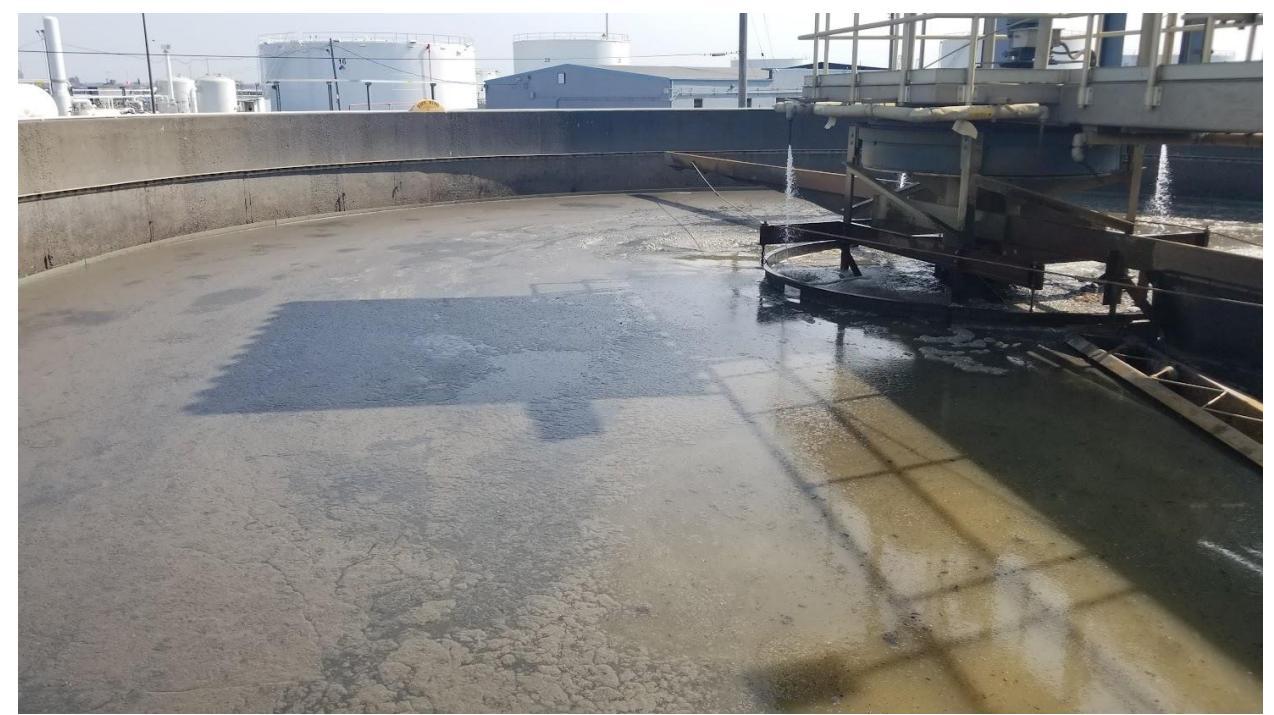
3) The GSTs are overloaded with sludge and solids and are not able to function as designed. The function of the GST is to allow for most of the biosolids to be at the bottom of the GST and for a relatively solids-free supernatant to be at the top. Both skimmer arms in GST #1 are above the water surface. Both skimmer arms in GST #2 are partially on the water surface. The high concentrations of biosolids in GST effluent can negatively impact the pure oxygen reactors' ability to remove BOD and can cause nitrification issues within the plant. Pictures of GST #1 are shown in Figures 3a and 3b. Pictures of GST #2 are shown in Figures 3c and 3d.

Figure 3a: Excessive amount of sludge in GST #1. A skimmer arm in GST #1 is above the water surface.

The Patapsco WWTP should operate and process sludge in the GSTs in a manner consistent with the function and design of the equipment. Solids should be removed from the GSTs regularly.

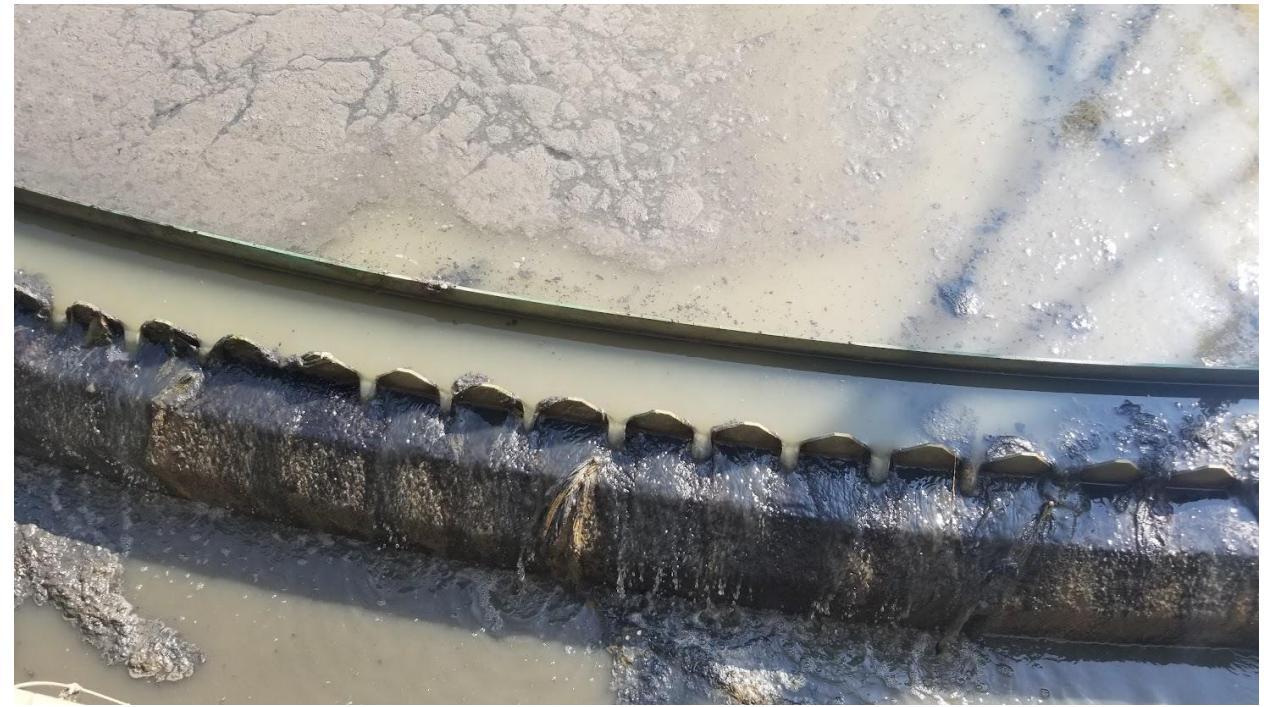
Figure 3b: Sludge outside of the weir in GST # 1.

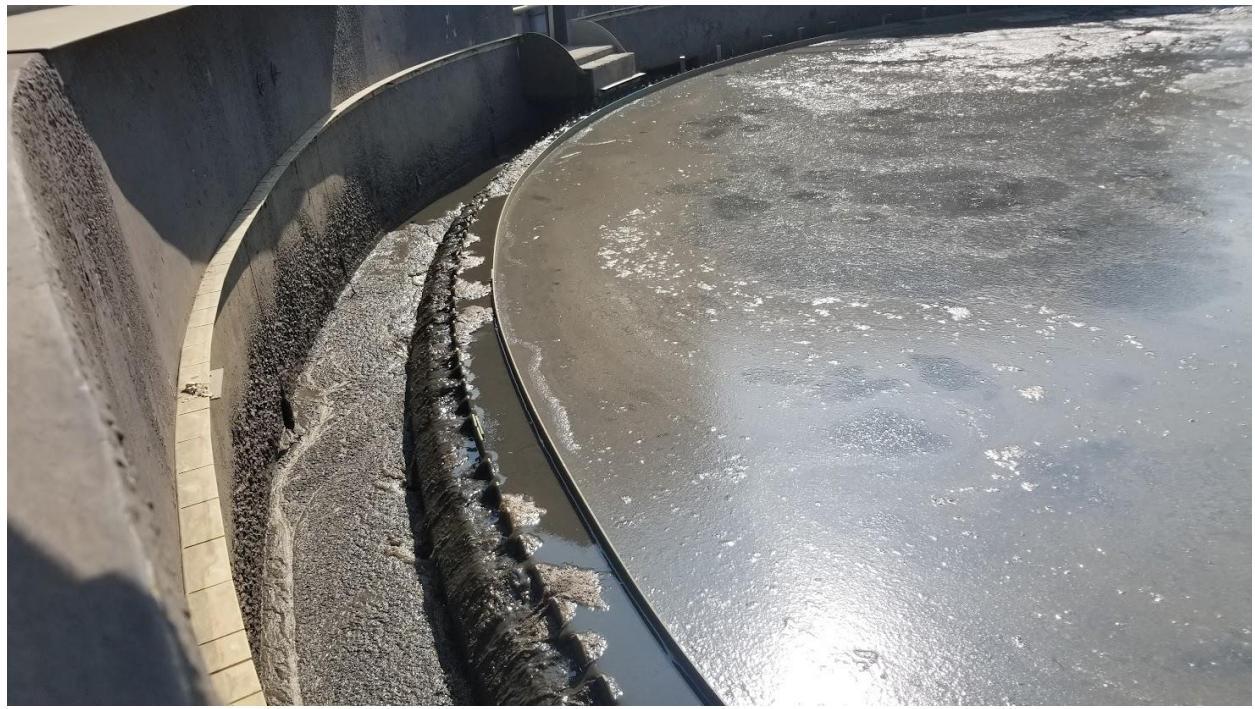
Figure 3c: Sludge outside of the weir in GST # 2.

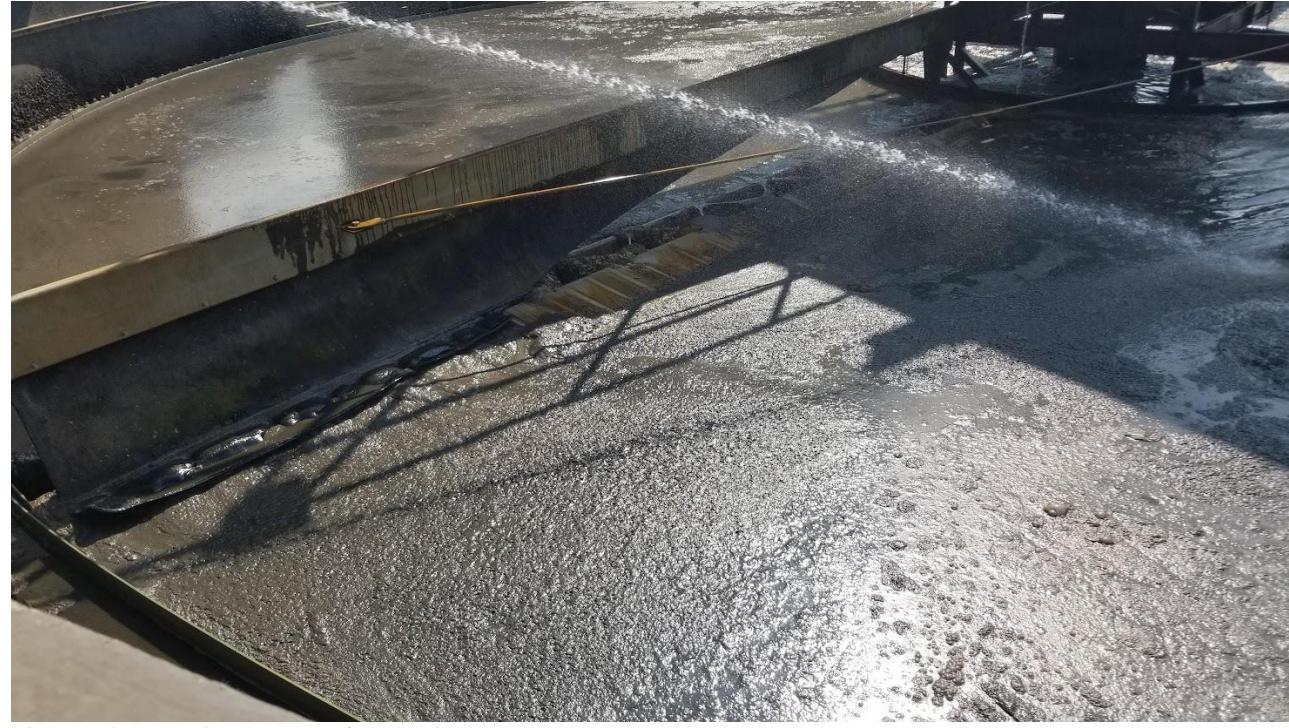
Figure 3d: Excessive amount of sludge in GST # 2.

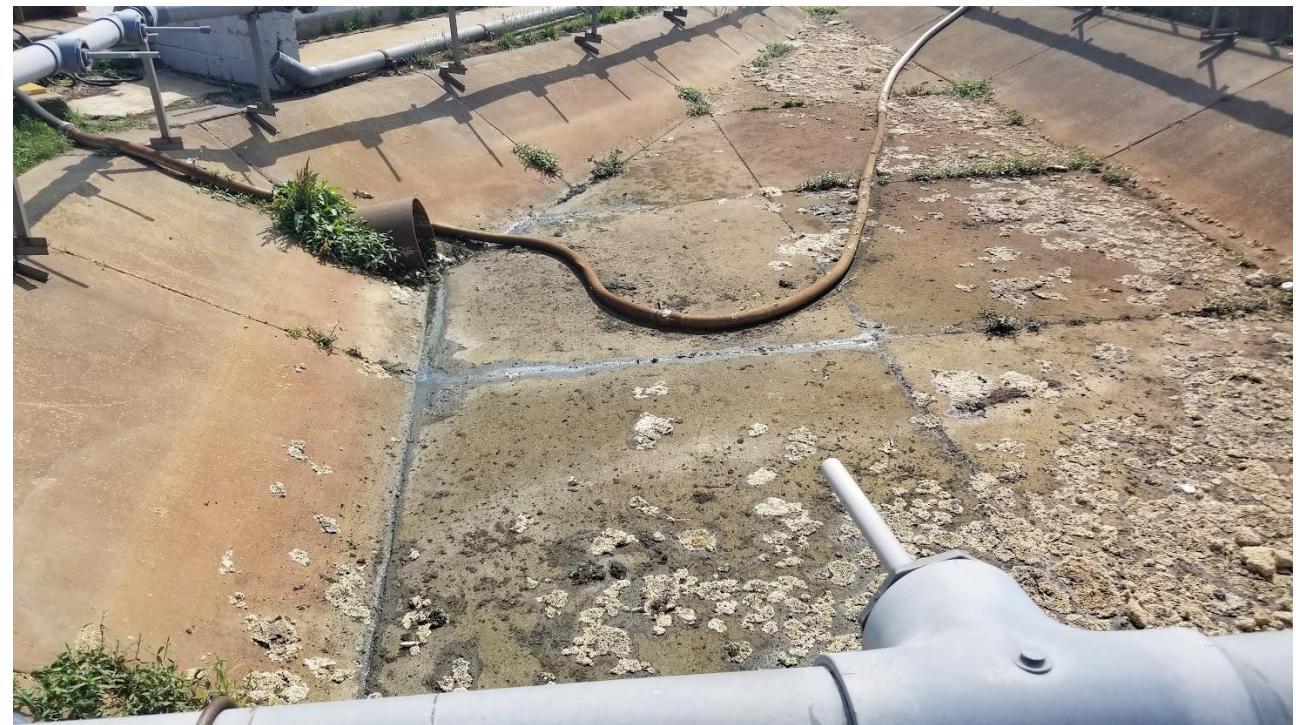
4) BAF media was observed in the concrete outflow pit for Clarifier #1, on the ground by the stairs at Clarifier #1, and on the blue pump by Clarifier #1. A picture of the outflow pit is shown in Figure 4a. A picture of the BAF media by the staircase at Clarifier #1 is shown in Figure 4b. A picture of the pump is shown in Figure 4c.

Figure 4a: BAF media in an outflow pit by the southwest side of Clarifier #1 facing northeast.

Remove all BAF media from the aforementioned areas and disposed of them accordingly.

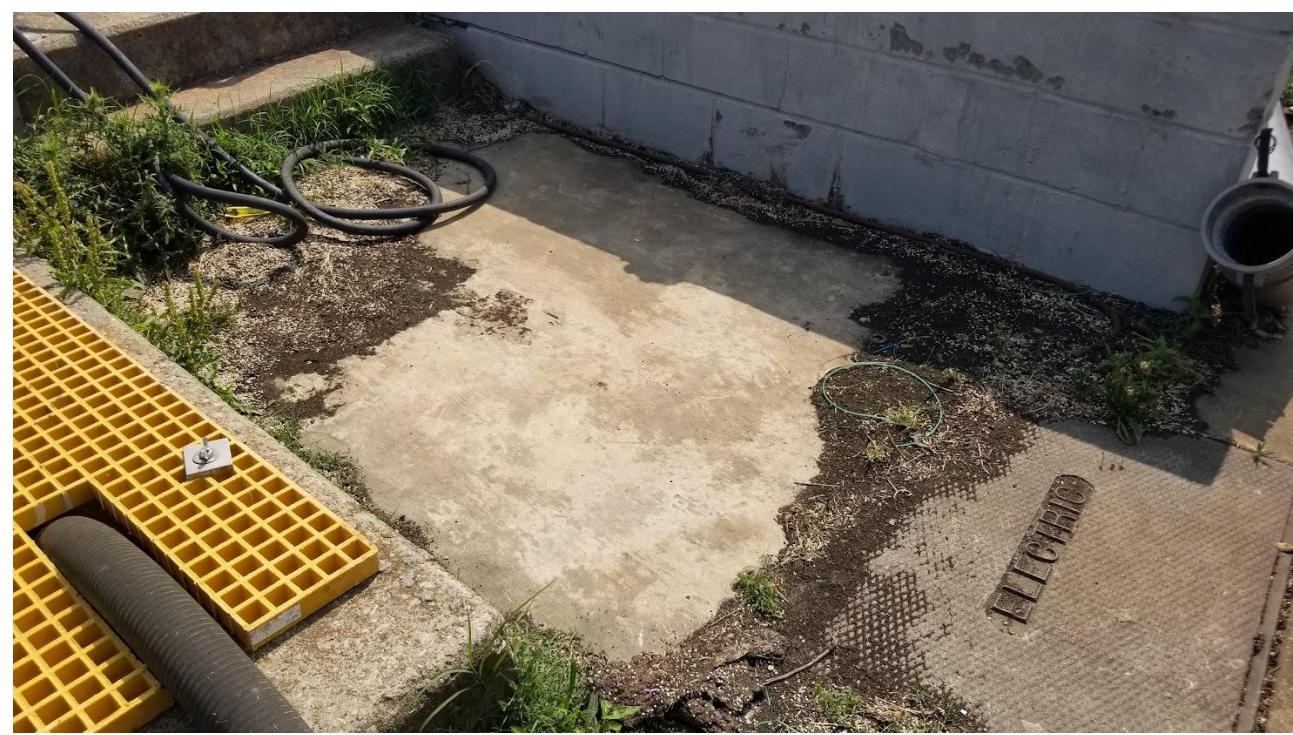
Figure 4b: BAF media on the ground by the stairs leading to the south side of Clarifier #1.

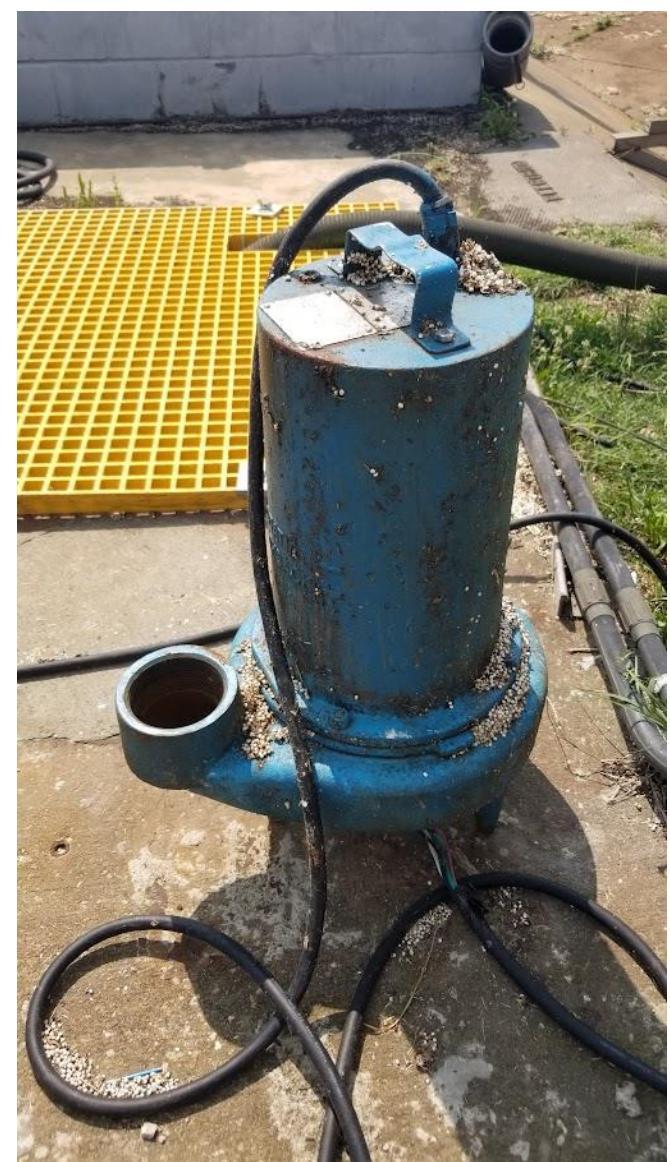
Figure 4c: BAF media on the ground and a pump by the south side of Clarifier #1.
