Maryland Department of Environment

Inspector:	Wendy Huang			
AI ID:	3076			
Site Name:	Patapsco WWTP			
Facility Address:	3501 Asiatic Ave, Curtis Bay, MD 21226			
County:	Baltimore City			
Start Date/Time:	June 15, 2023, 09:00 AM			
End Date /Time:	June 15, 2023, 02:00 PM			
Media Type(s):	NPDES Municipal Major Surface Water, NPDES Industrial Stormwater			
Contact(s):	Neal Jackson- Plant Manager of Patapsco WWTP			
	Andrea Buie- Branam- Environmental Compliance Manager of Baltimore City			
	Eric Johnson- Wastewater Operations Supervisor of Patapsco WWTP			
	Kevin Mc Fadden- Operation Supervisor II of Patapsco WWTP			
	Donald Taylor- ENR Supervisor of Patapsco WWTP			
	Chris Saunders- Senior Associate of Hazen & Sawyers			
	Sajid Roomi- Engineer for Patapsco WWTP			
	Chris Lepadatu- MDE Regulatory Compliance Engineer

NPDES Municipal Major Surface Water/ NPDES Industrial Stormwater

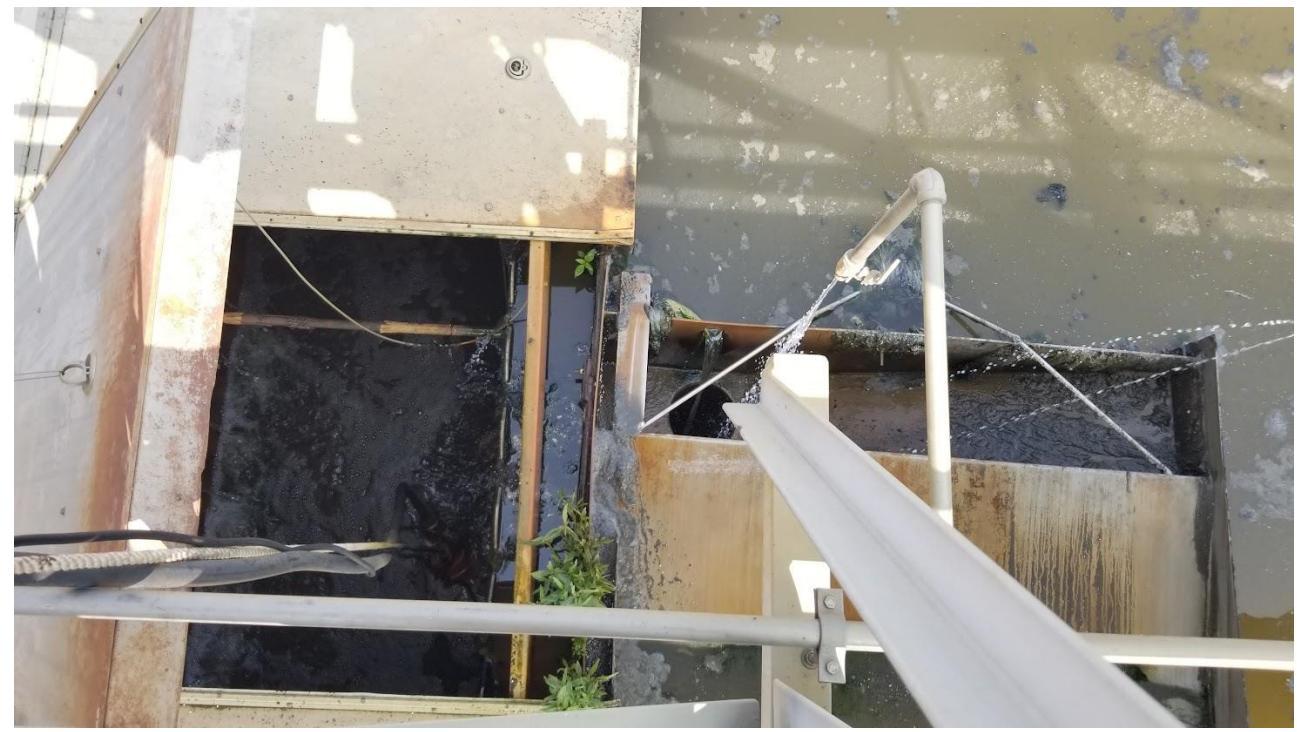
5) The secondary clarifiers are not operating as designed. One of the two skimmer arms in Clarifiers # 4, 5A, 5B, and 6B are not functioning as designed. Grass was observed to be growing in Clarifiers # 1, 5A, 6A, and 6B. BAF media was observed outside of and on the launder cover within Clarifier# 6B. Sludge was observed between the launder covers within Clarifier #4. Debris was observed in Clarifier# 5B and 6A. Trash was observed between two launder covers within Clarifier #5B. Pictures of Clarifier # 1 is shown in Figures 5a. Pictures of Clarifier #4 are shown in Figures 5b and 5c. Pictures of Clarifier #6A are shown in Figures 5d and 5e. Pictures of Clarifier 6B are shown in Figures 5f to 5i. Pictures of Clarifier #5B are shown in Figures 5j to 5l. Figures of Clarifier #5A are shown in Figures 5m and 5n.

Figure 5a: Plants in Clarifier #1, by the V- notch weir

Repair and maintain the clarifiers to ensure that they are functioning per design. The skimmer arms should be fixed to ensure that the entire length of the skimmer arms is on the water surface and extending to the baffles, allowing for solids on the water surface to be skimmed into scum troughs.

Remove all vegetation, trash, and BAF media from the clarifiers. Implement routine maintenance to prevent the excessive buildup of sludge and solids in the clarifiers.

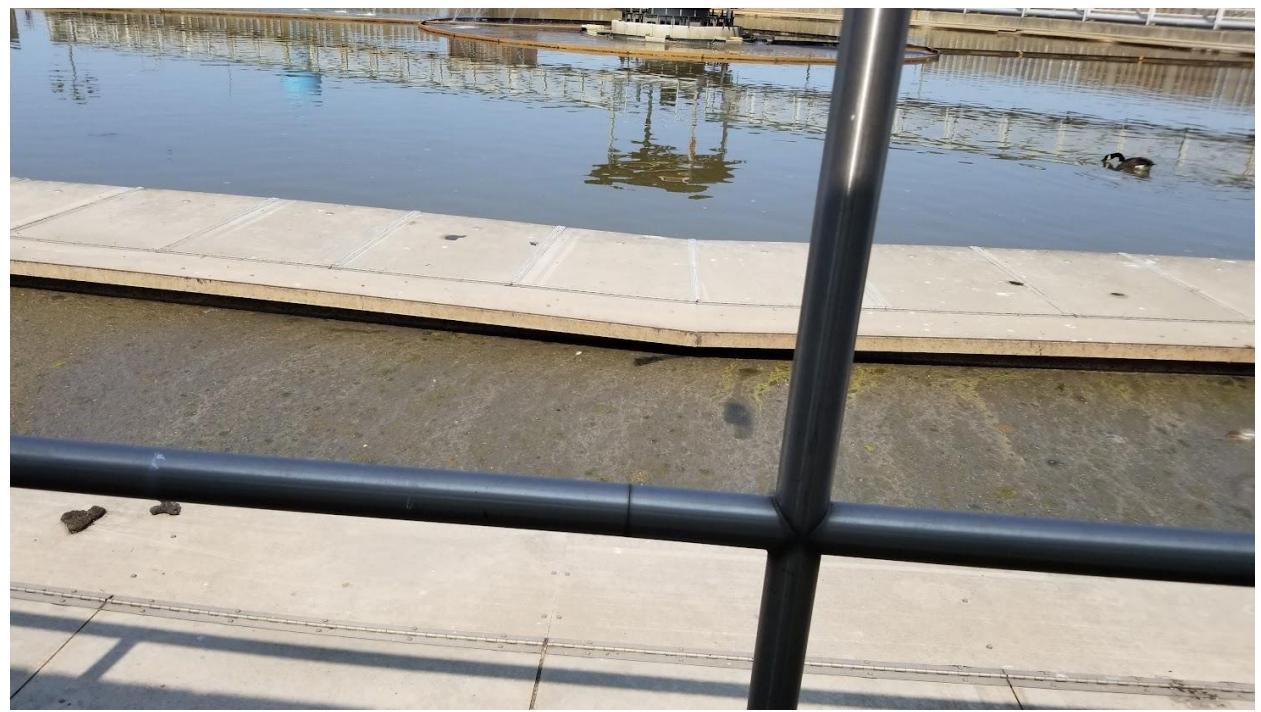
Figure 5c: Sludge between launder covers within Clarifier #4

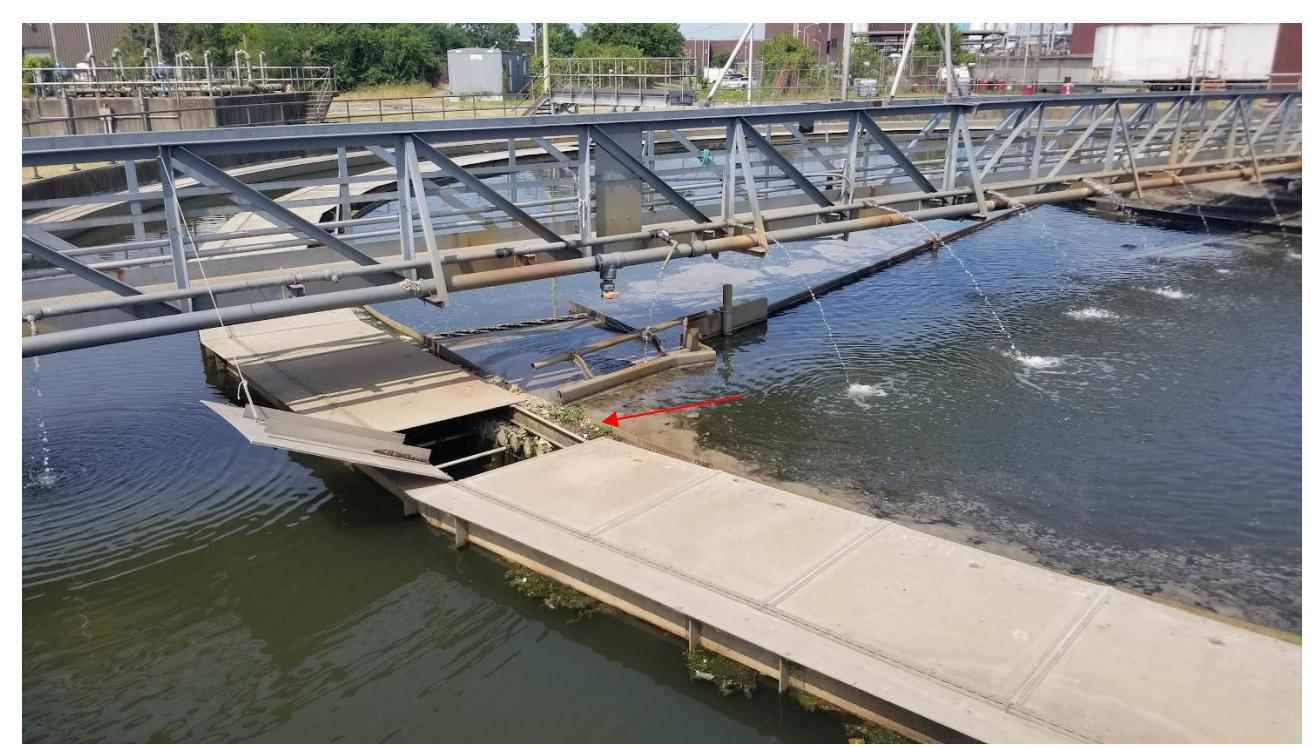
Figure 5d: Plant and debris by the launder cover in Clarifier # 6a (pointed to with a red arrow).

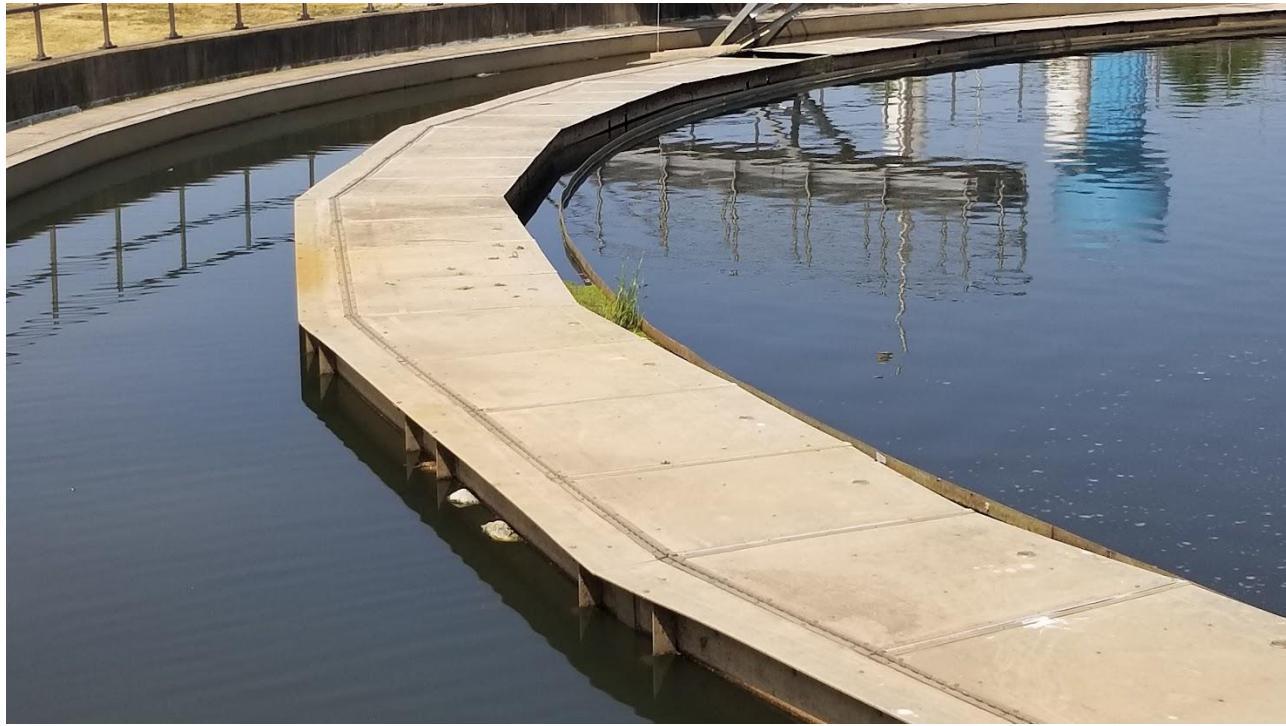
Figure 5e: Grass growing by the launder cover within Clarifier #6A.
