PHASE II INVESTIGATION REPORT

AREA B: PARCEL B14
TRADEPOINT ATLANTIC
SPARROWS POINT, MARYLAND

ARM Project No. 150300M-17

Revision 0 – March 23, 2018

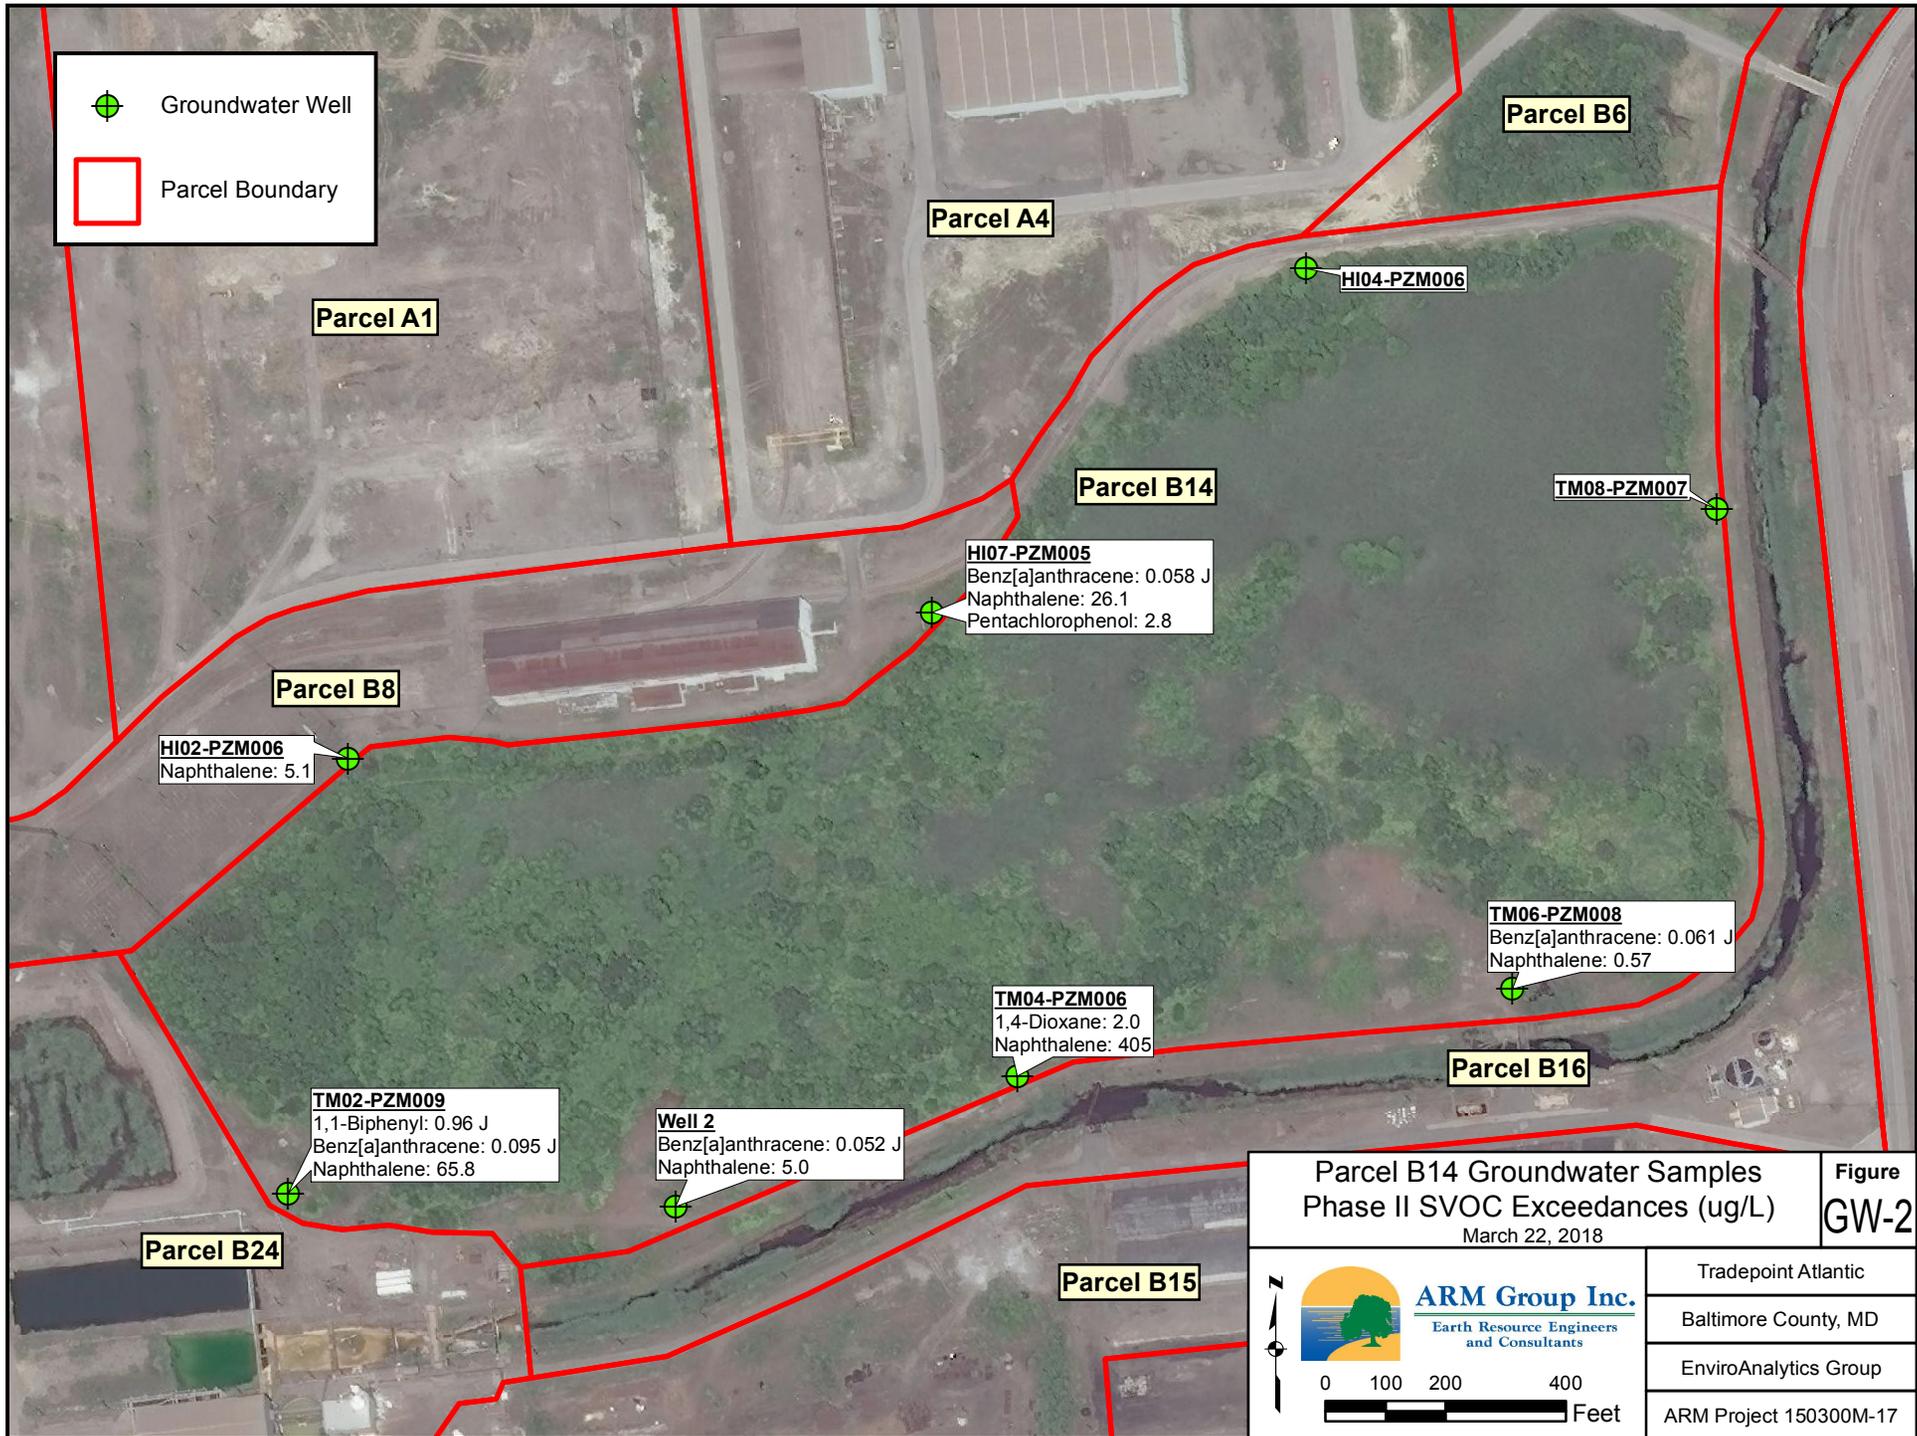
Figure
GW-2

Parcel B14 Groundwater Samples
Phase II SVOC Exceedances (ug/L)
 March 22, 2018

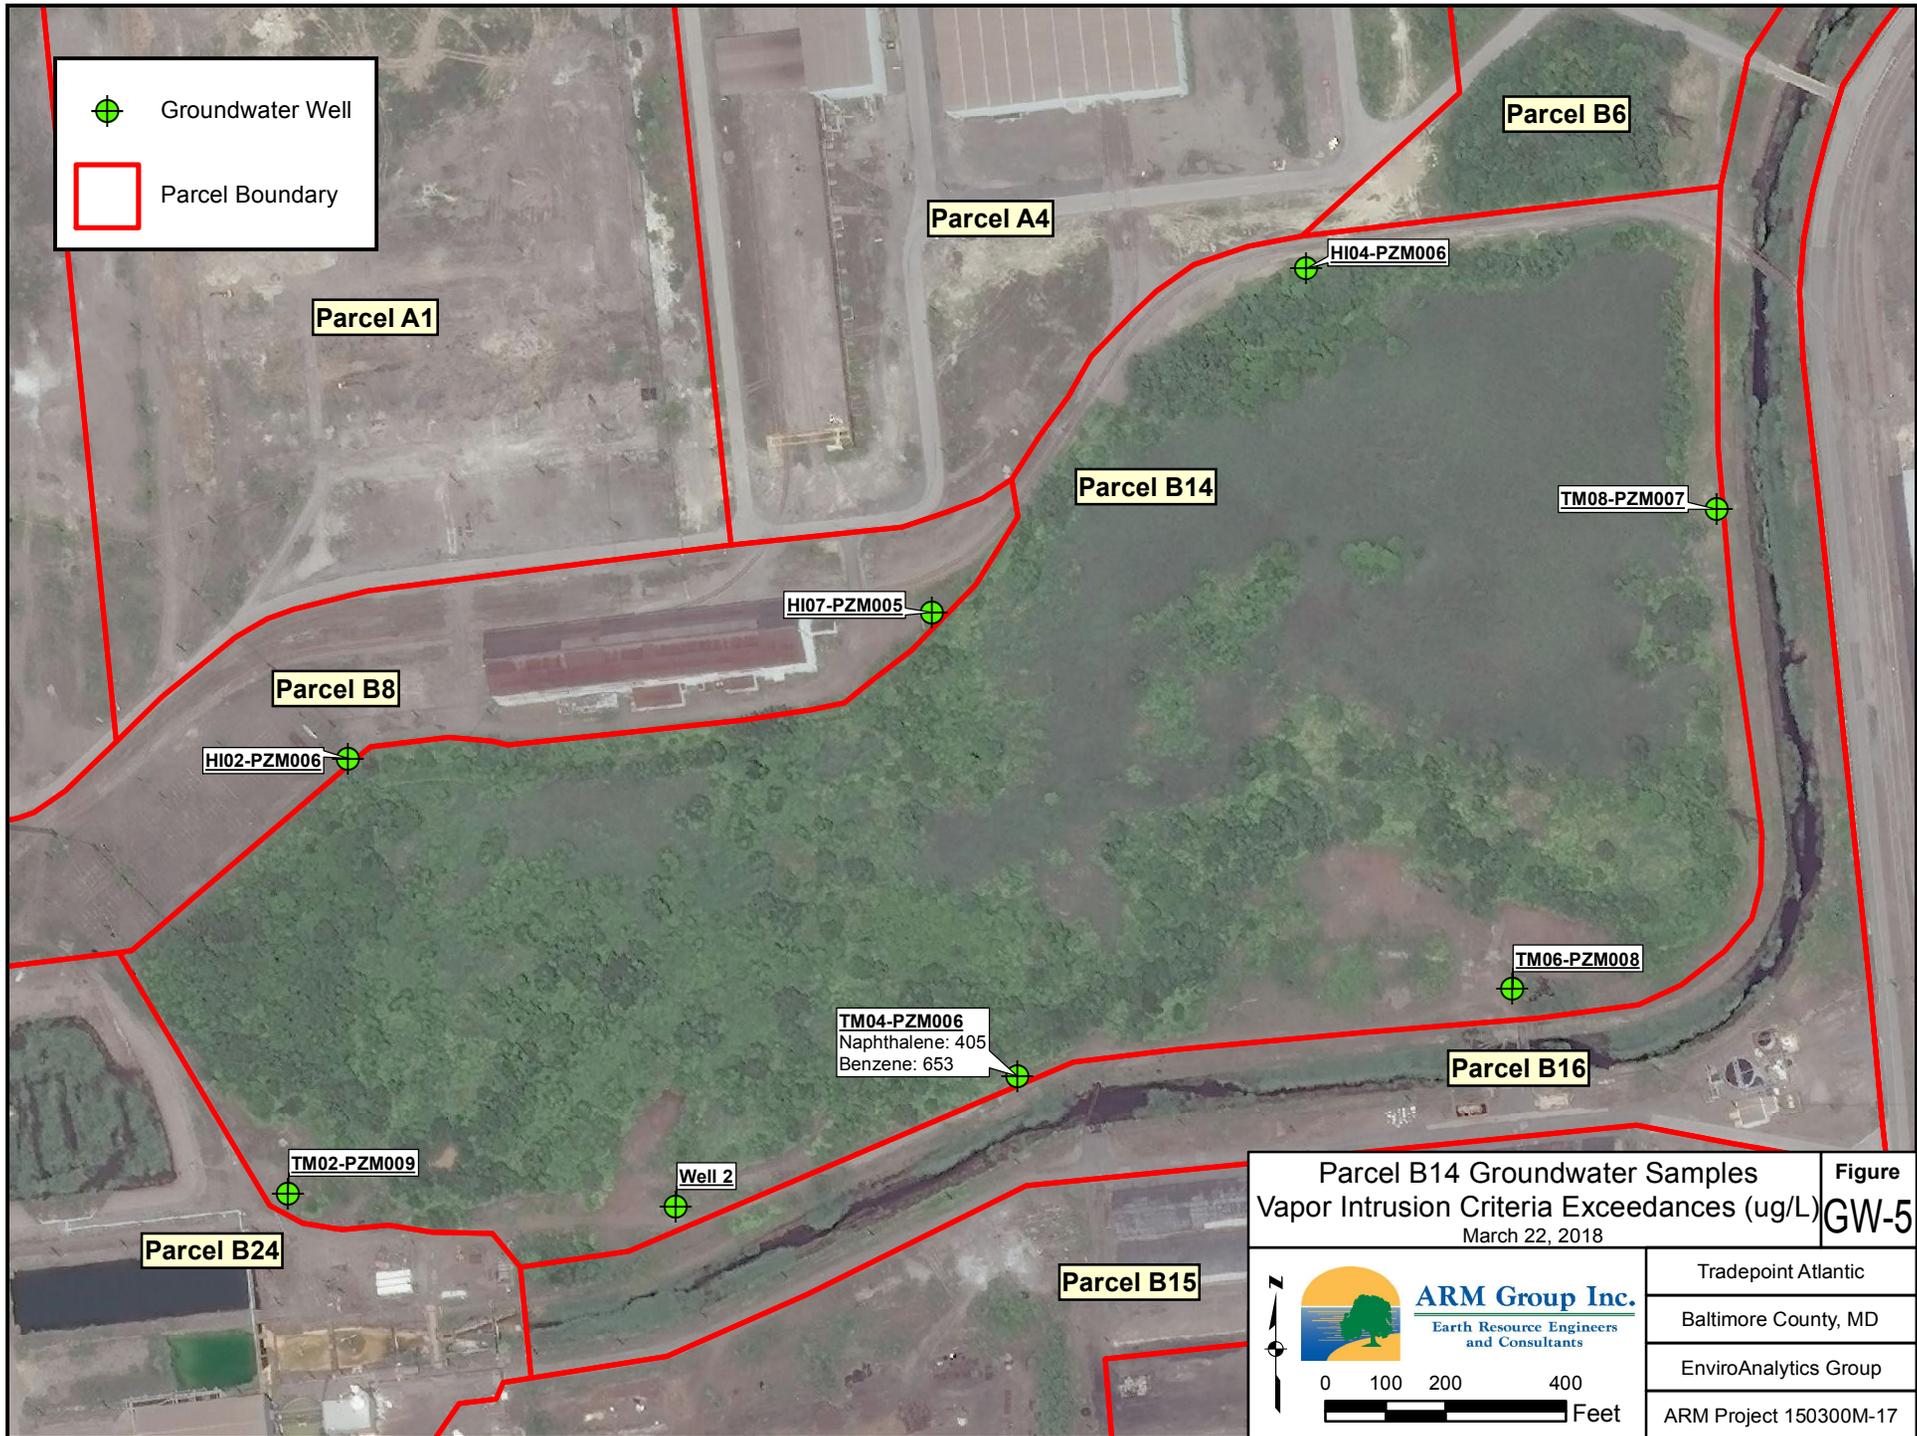
Figure
 GW-5

Two parameters exceeded the individual VI TCR screening levels as specified by the VISL Calculator. These two parameters (benzene at 653 ug/L and naphthalene at 405 ug/L) exceeded the individual VI screening levels at a single location (TM04-PZM006). Sample location TM04-PZM006 was also observed to have elevated TPH/Oil & Grease detections above the aqueous PALs. There were no exceedances of the individual VI THQ criteria. Following the initial screening, a cumulative risk assessment was also performed for each individual sample location, with the results separated by cancer versus non-cancer risk. All compounds with detections were included in the computation of the cumulative cancer risk, and all compounds with detections exceeding 10% of the THQ level were included in the evaluation of non-cancer hazard. Sample location TM04-PZM006 was the only location where the cumulative VI cancer risk was greater

than 1E-5, with a computed value of 1E-4. There were no compounds that were identified above the 10% THQ level to be included in the cumulative VI evaluation for non-cancer hazard. The results of the cumulative VI comparisons are provided in **Table 12**, with the exceedance at location TM04-PZM006 highlighted. The benzene and naphthalene detections at this location which contributed to the VI exceedance are shown on **Figure GW-5**.

Parcel B14 Groundwater Samples
 Vapor Intrusion Criteria Exceedances (ug/L)
 March 22, 2018

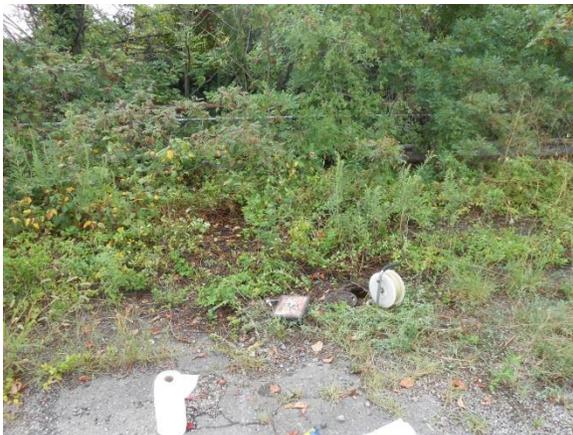
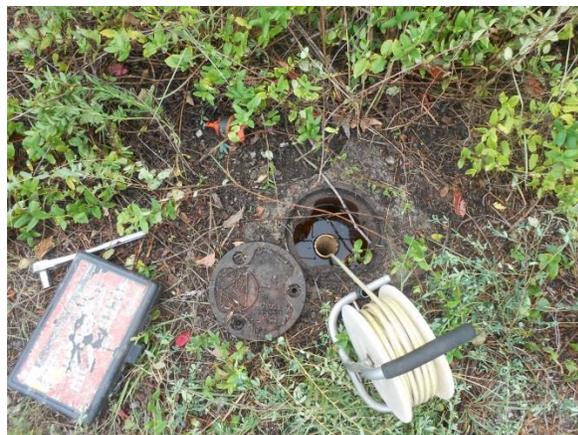
PICTURE OF WELL DURING INSPECTION

Condition of pad and/or cover: Fair (vegetation) Flush Mount or Stick-Up? Flush Mount

Additional Comments: Location of the well was difficult due to the amount of vegetative cover. Housing was filled with water which needed to be bailed out before gauging could be completed.

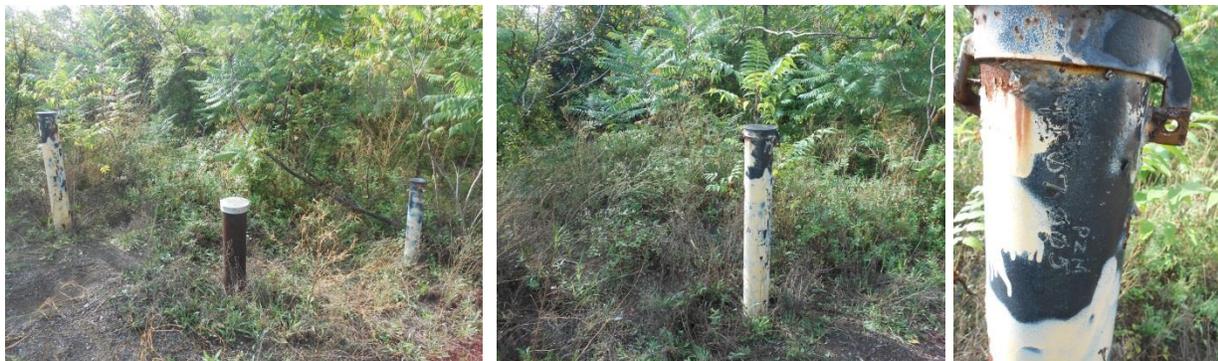
PICTURE OF WELL DURING INSPECTION

Additional Comments: Included in a set of 3 wells located on eastern edge of Parcel B8. Lock was broken to gain access for gauging.

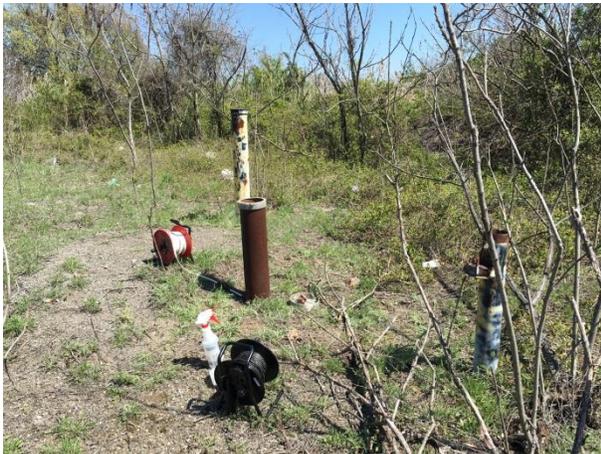
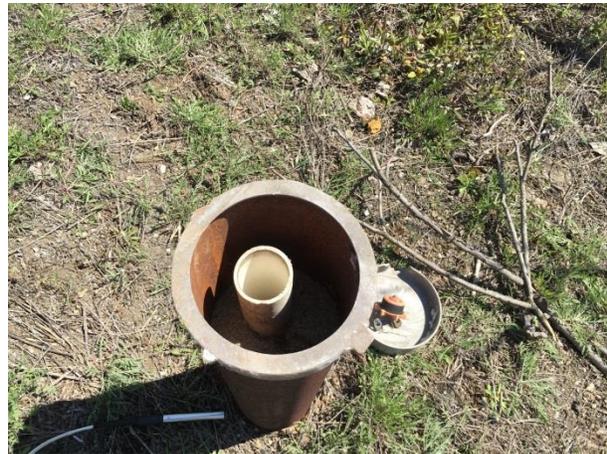
PICTURE OF WELL DURING INSPECTION

Additional Comments: Water probe had only 100 feet of tape, depth to bottom was greater than 100 feet deep.

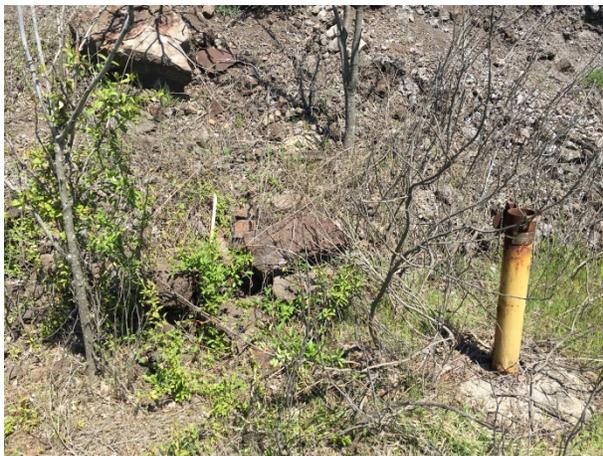
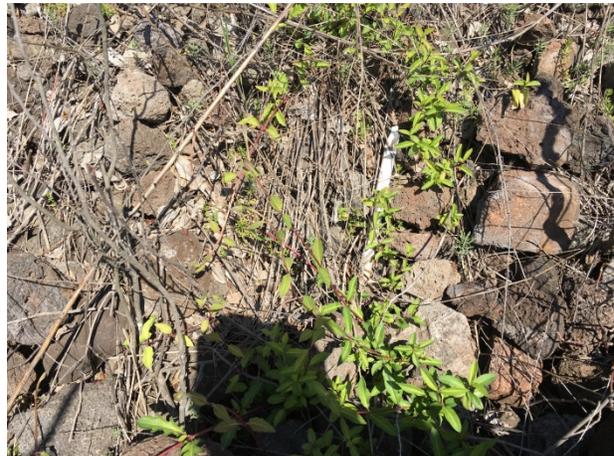
PICTURE OF WELL DURING INSPECTION

Additional Comments: 0.5" well PVC observed during well inspection

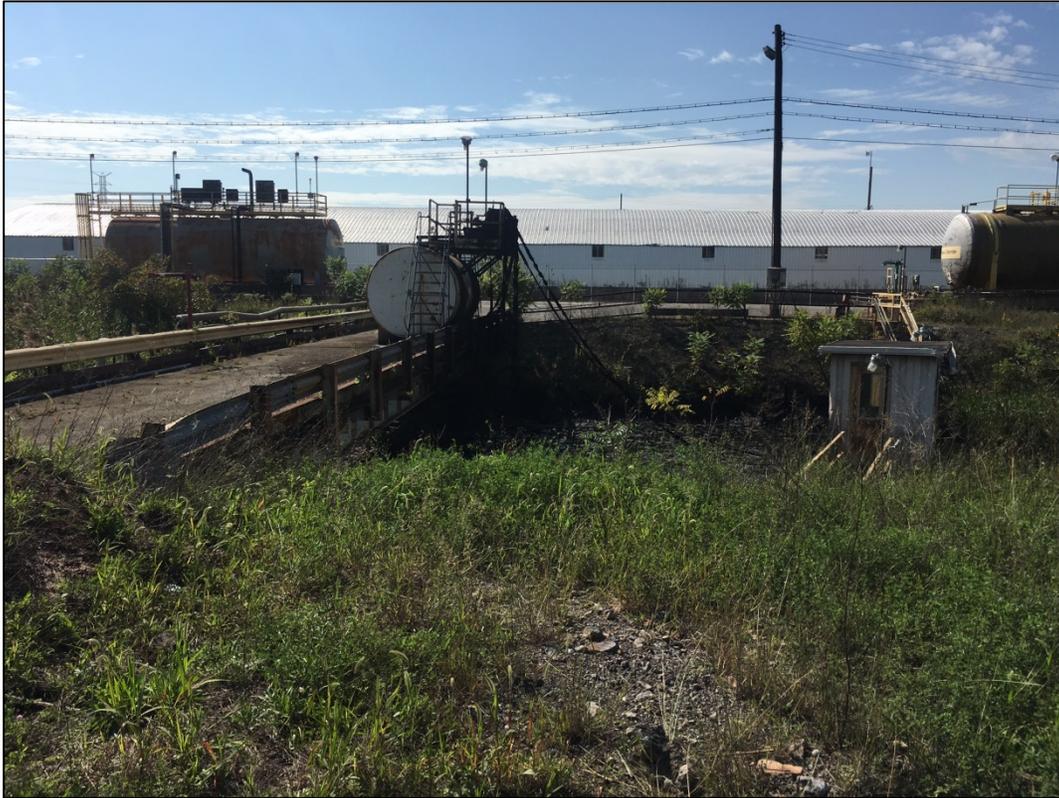
0917-1: Picture from the north facing south. Oil baffle located in the Tin Mill Canal; south of soil boring B14-016-SB.

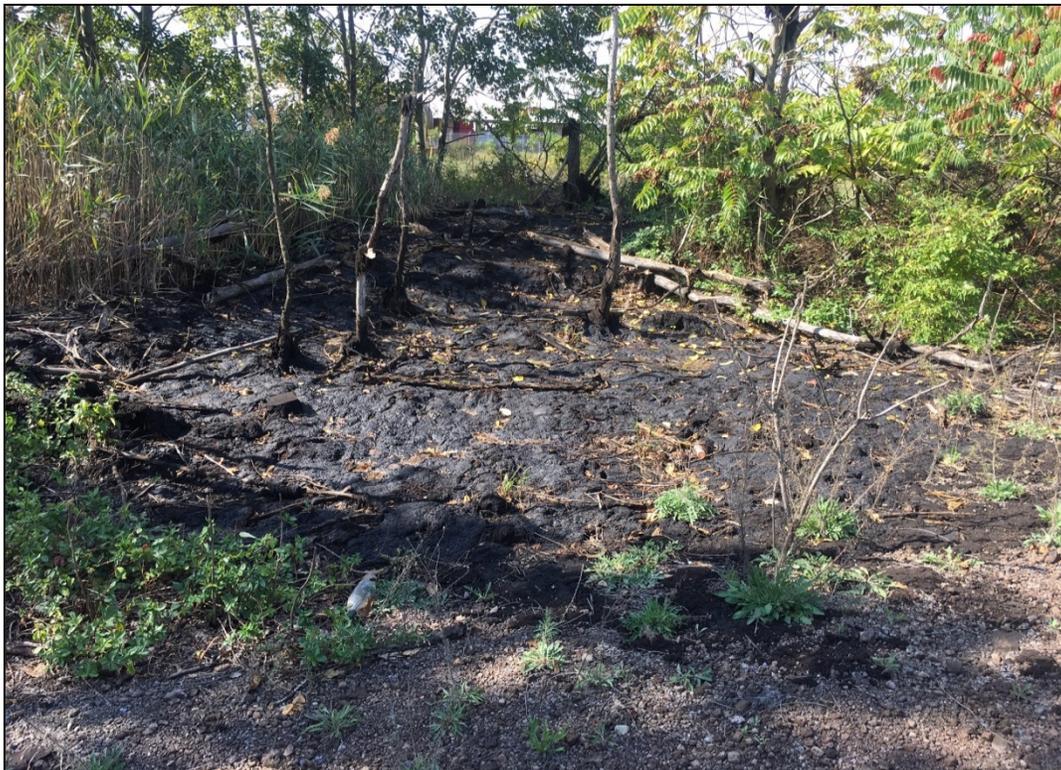
During the field investigation, an area of oil stained ground was observed approximately 100 feet southeast of soil boring B14-016-SB, near an oil baffle installed in the TMC. The approximate location of the stained area is highlighted on **Figure 5** and **Figure 6**. A photographic log of the area surrounding the oil stained ground is provided as **Appendix J**. The oil stained ground was not sampled during this investigation; however, soil analytical results for B14-016-SB are available. GRO was not detected in either soil sample collected at this location. DRO and Oil & Grease were detected at low levels, with a maximum detection of Oil & Grease of 228 mg/kg in sample B14-016-SB-1. A groundwater monitoring well, TM06-PZM008, is located immediately adjacent to the stained area. DRO was detected above its PAL at 1,500 ug/L (flagged with the “J” qualifier) but NAPL was not observed in this monitoring well when it was gauged prior to sampling. Appropriate response actions for this visibly stained area will be coordinated as needed with the MDE.

0917-2: Picture from the north facing south. Observed oil stained ground located approximately 100 feet south east of soil boring B14-016-SB; north of the oil baffle in the Tin Mill Canal (shown above).
