# **PHASE II INVESTIGATION REPORT**

**AREA B: PARCEL B4  
TRADEPOINT ATLANTIC  
SPARROWS POINT, MARYLAND**

ARM Project No. 150300M-7

Revision 0 – March 3, 2017

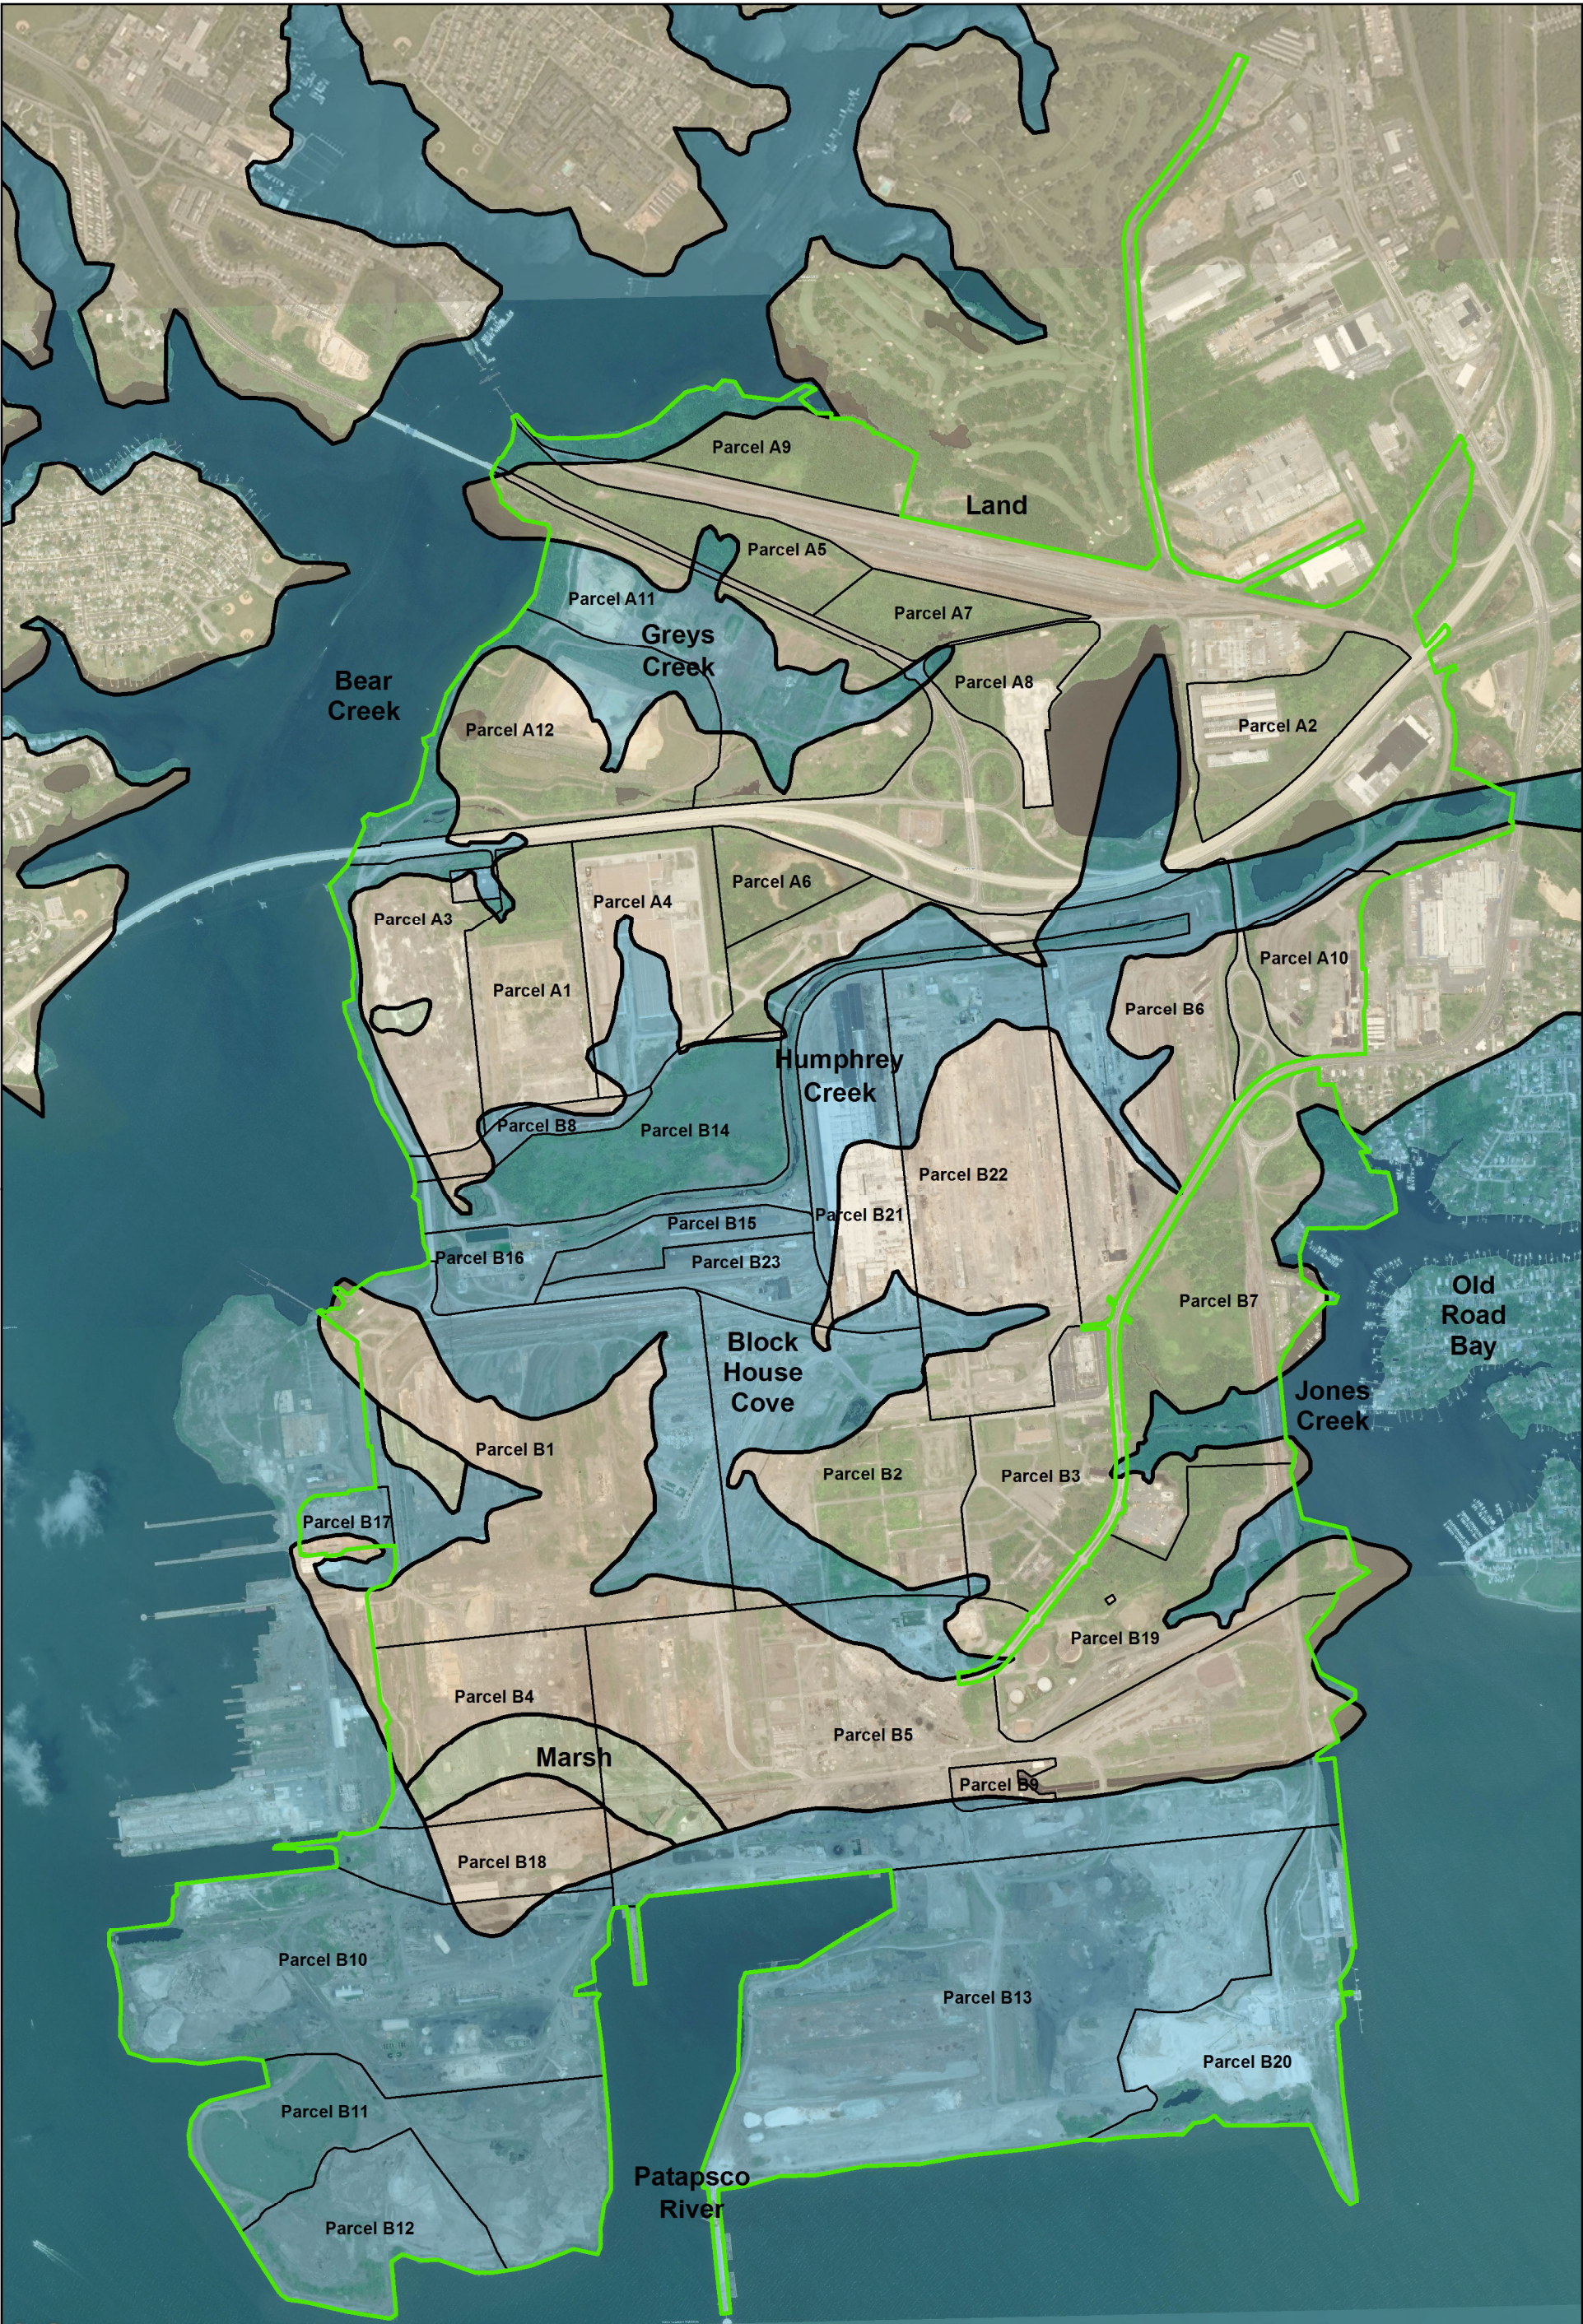
| <br><br><br>ARM Group Inc.<br>Earth Resource Engineers<br>and Consultants | Site Boundary | Land | <b>Approximate Shoreline 1916</b><br>August 1, 2016<br><small>Adapted from Figure 2-5 of the Description of Current Conditions Report prepared by Rust Environmental and Infrastructure, dated January 1998</small> | | EnviroAnalytics Group | Tradepoint Atlantic | <b>Figure</b><br><b>2</b> |

Groundcover at the Site is comprised of approximately 66% natural soils based on the approximate shoreline of the Sparrows Point Peninsula in 1916, as shown on **Figure 2** (adapted from Figure 2-20 in the Description of Current Conditions (DCC) Report prepared by Rust Environmental and Infrastructure, dated January 1998).

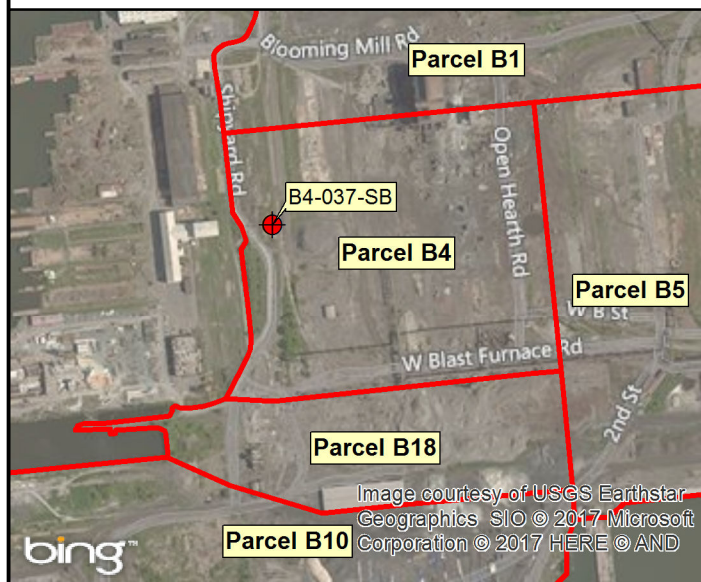
### Parcel B4 PCB Delineation Sample Locations (B4-037-SB)

### Delineation Location
