Soil Sampling and Ecological Risk Assessment Work Plan Axil Belko – 1991-0916-BA4

July 2014

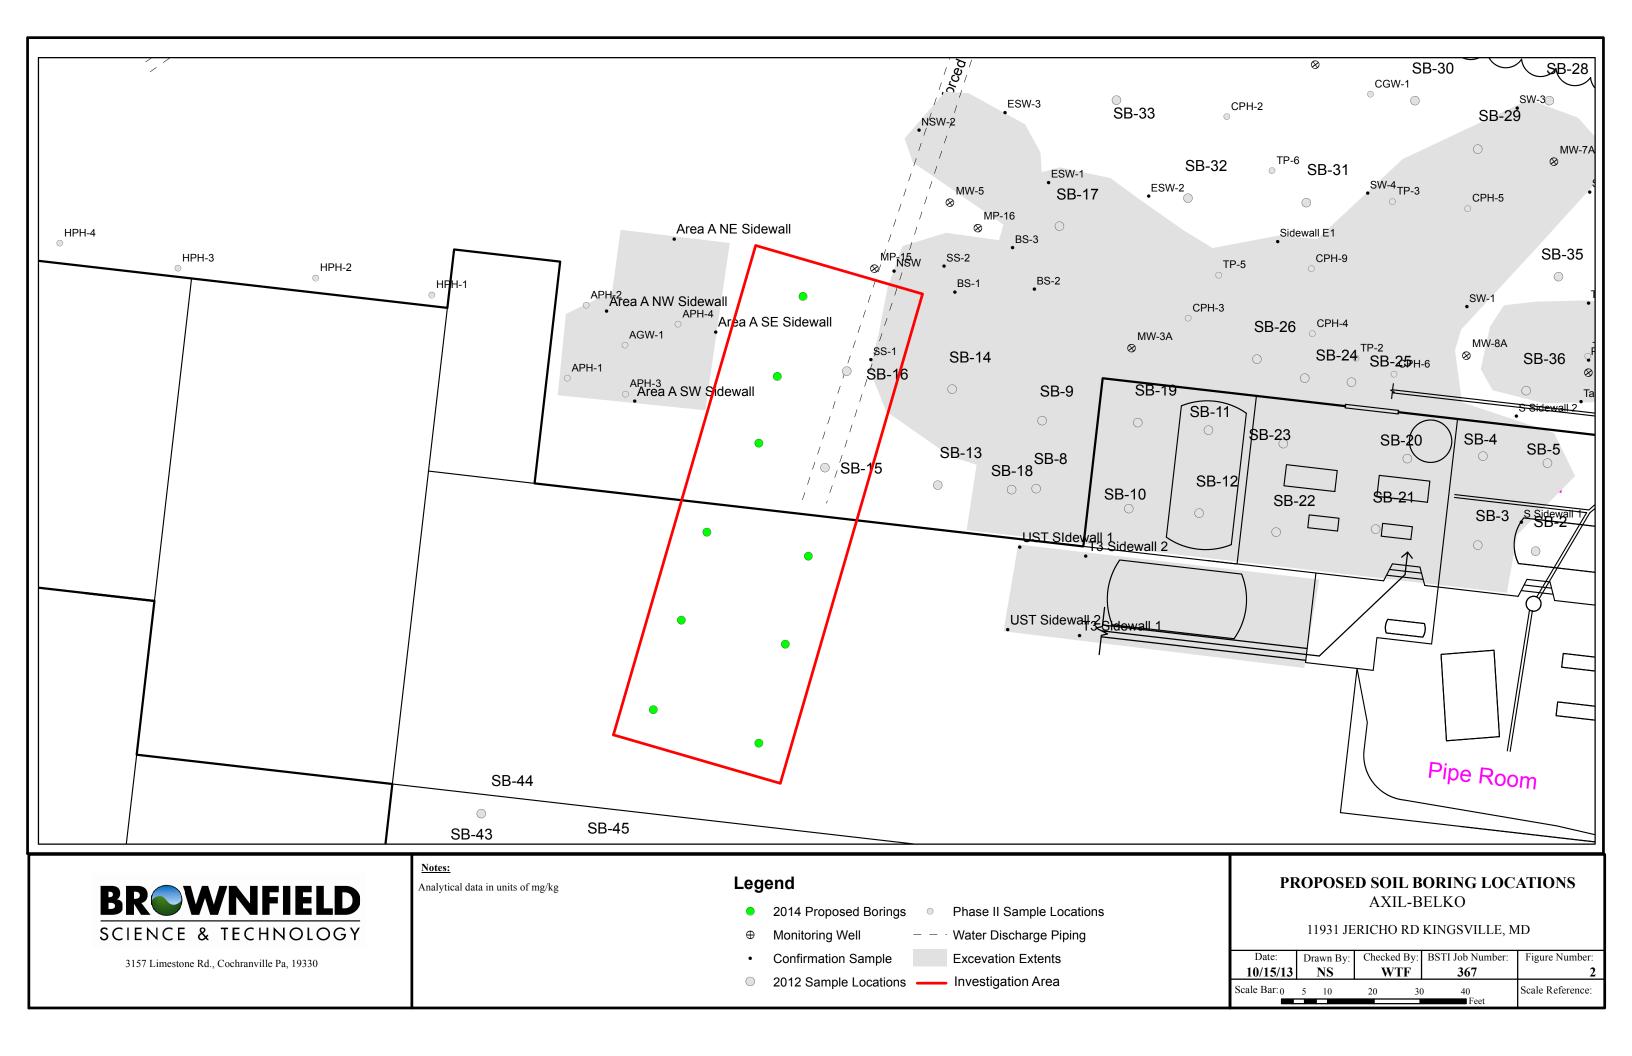
As noted by MDE, prior investigative and remedial activities indicate that TPH-DRO is present in soils between Area A and Area C ranging in concentrations from 4,590 to 12,200 mg/kg. The concrete pipe which formerly connected to Outfall 2 runs through this area (**Figure 2**).

MDE has requested an investigation to delineate the extent of petroleum impacts in between Area A and Area C and to the west within the former building footprint as illustrated in **Figure 2**. MDE has also requested that BSTI determine the origin and path of Outfall 2. BSTI proposes that the horizontal and vertical extent of petroleum impacts in this area be established via a direct push soil boring assessment, proposed boring locations are illustrated in **Figure 2**. If obvious petroleum impacts (sheen or staining) are observed, additional borings will be added as necessary to delineate these impacts.

The direction and orientation of the Outfall 2 pipe within the former building footprint is not precisely known. The origin of Outfall is presumed to be storm water grates located at grade on the uphill (southwest) side of the former building. Based on the observed depth of the Outfall 2 piping at TP-1 it is expected that this piping is located at a depth of over 15 feet below grade as it enterers the building and rises to near grade as it passes through or around the former Building 7. Based on the location and depth of this piping a large excavation requiring extensive removal of concrete would be required to confirm its origin and orientation. This degree of effort is not warranted given that the concern regarding this Outfall is solely related to its potential as a conduit to the LGF River. As described above, the Outfall 2 piping has been removed and backfilled at two locations down gradient of former Building 7 and so up gradient piping no longer serves as a direct conduit to the LGF River.
