Tidal Back River Small Watershed Action Plan

Volume I

This Small Watershed Action Plan (SWAP) is a strategy for the restoration of the Tidal Back River watershed. This report presents recommendations for watershed restoration, describes management strategies for each of the 10 subwatersheds comprising Tidal Back River, and identifies priority projects for implementation. A schedule for implementation over a 10-year time frame is presented in addition to planning level cost estimates where feasible. Financial and technical partners for plan implementation are suggested for the various recommendations. This SWAP is intended to assist the Back River Restoration Committee (BRRC), Baltimore County Department of Environmental Protection and Resource Management (DEPRM) and other partners to keep moving forward with restoration of the Tidal Back River.

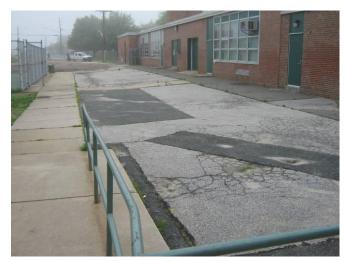
Figure 4-13: Potential Impervious Cover Removal Site at ISI E 700

Impervious cover removal was recommended for both of the public school sites assessed. This is also another opportunity to engage students with tree or vegetation planting while providing education about the importance of filtration for water quality benefits. An impervious surface behind the building at ISI_E_700, for example, is in poor condition with several areas breaking up indicating underutilization and inadequate maintenance. These surfaces are good candidates for removal (in between sidewalks) and grass/vegetation planting to provide more infiltration of runoff from adjacent impervious surfaces.

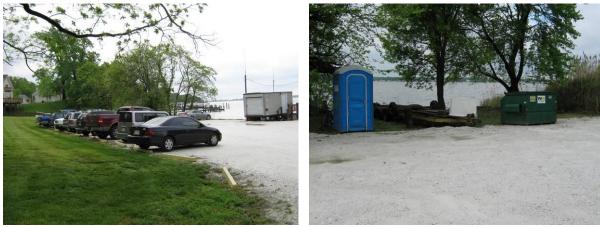
Figure 4-23: Potential Restoration Sites at ISI_E_500

ISI_E_500 is a docking site for Maryland Environmental Services (MES). It includes a gravel parking area for cars and boats. It also includes a docking area and trailer for equipment. There is some opportunity to plant trees in open grass areas on the property and along the shorefront to enhance the shoreline buffer. Another recommendation for this site is to address waste management operations, particularly relocating the dumpster away from the shoreline or creating a diversion to prevent dumpster runoff from entering the Back River.

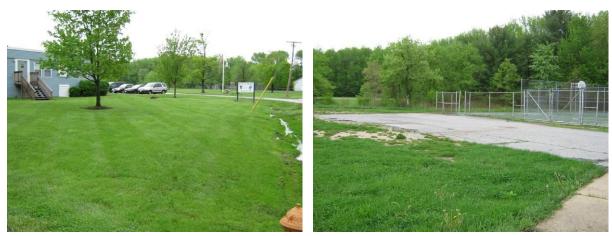
Figure 4-29: Restoration Opportunities at ISI E 301

Several restoration opportunities were noted for ISI_E_301 (Back River Community Center) including storm drain marking, downspout disconnection, stormwater retrofit, impervious cover removal and trash management education. Restoration activities at this site have the potential to engage and educate citizens of all ages since it is a community center and daycare center. A potential stormwater retrofit site was identified for treating runoff from one of the impervious parking lot areas before entering inlets (see figure below). This would help address the bare soil and standing water observed at the time of investigation. An opportunity for impervious cover removal was also noted. A patch of impervious cover next to an athletic court appeared to be in poor condition suggesting that it is underutilized and not maintained.

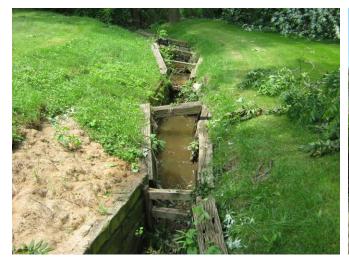
Figure 3-19: Examples of Severe Channel Alteration Sites (rating = 2)

A total of 28 channel alteration sites were documented during the Tidal Back River SCA survey with a total length of 5,254 feet. Less than 10 percent of the total stream miles surveyed (1.0 out of 10.7 miles) were considered to have channel alterations. Severity rating was mainly based on channel alteration length, channel type, and stream functions. The most severe rating of 1 was assigned to concrete channels where water depth was less than \(\frac{1}{2} \) inch with little or no natural sediments present. These channels were generally open to full sunlight over long stretches (> 1,000 feet). Channel alterations were considered moderately severe (rating = 3) if a significant length had been channelized (> 500 ft) but show signs of stabilization and natural stream functions such as sediment bars and vegetation. Minor ratings (rating = 5) were assigned to earthen channels less than 100 feet in length with good water depth, a natural sediment bottom, and with a size and shape similar to unchannelized reaches upstream and downstream of the site. Figure 3-19 shows examples of severe channel alteration sites (severity rating = 2) encountered in the Tidal Back River watershed. The photo on the left is a site along Bread and Cheese Creek where timber retaining walls had been installed and were slightly undermined and rotting with some erosion around the walls. The photo on the right is a site along Deep Creek where a long portion of the stream channel (300 feet) is concrete with no shading and very little water depth.

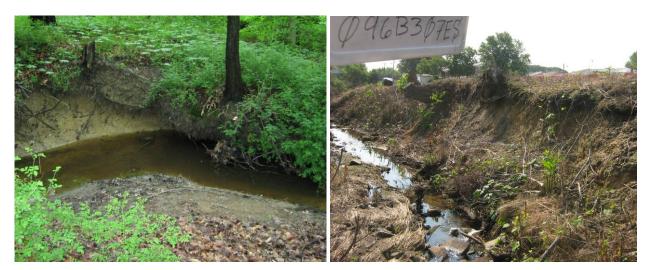
Figure 3-20: Examples of Moderately Severe and Low Severity Erosion Sites

A total of 26 erosion sites were documented during the Tidal Back River SCA survey with a total length of 2,046 feet. Less than 5 percent of the total stream miles surveyed was considered to have erosion problems (0.4 out of 10.7 miles). The severity of erosion was rated based on length and height of the eroding stream bank. The most severe rating (rating = 1) was assigned to sites with long sections of incision (> 1,000 feet), with unstable banks on both sides, and that were eroding at a fast rate. Erosion was considered minor (rating = 5) if it was a short stream section (< 300 feet) where the affected area was fairly limited. Figure 3-20 shows examples of moderately severe (rating = 3) and low severity (rating = 4) erosion sites identified during the SCA survey. The photo on the left is an erosion site along Muddy Gut which was approximately 400 feet long with banks approximately 2.5 feet high. The photo on the right is erosion occurring along a 50-foot stretch in Bread and Cheese and appears to be a result of land use change upstream (construction activity).

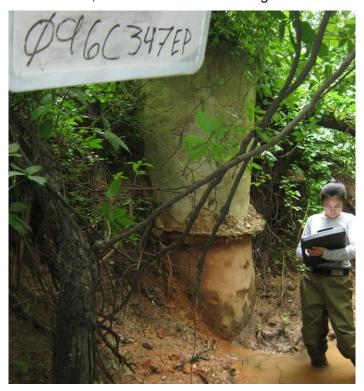
Figure 3-21: Examples of a Potentially Severe Exposed Pipe Problem (rating = 2)

Similar to pipe outfalls, none of the exposed pipes identified were rated as a very severe environmental problem. Of the 7 documented during the SCA survey, 1 was considered as a potentially severe problem (severity rating = 2) and 2 were considered moderately severe. The remaining 4 exposed pipes were considered low severity or minor issues. Figure 3-21 shows a photo of the exposed pipe considered as a potentially severe problem. This was an exposed manhole in Bread and Cheese Creek and was rated as severe because of the large exposed section, its proximity to the stream, and since it carries sewage.

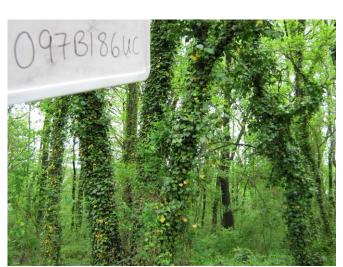
Figure 3-25: Potentially Severe Unusual Conditions (rating = 2)

A total of 40 unusual condition forms were completed; 8 of these were used to provide additional comments for specific problems. For all 40 sites, the most common unusual conditions encountered were presence of ferric oxide (10 sites), stream bank destruction as a result of all terrain vehicle (ATV)/mountain bike trails (7 sites), invasive species such as English Ivy and Japanese Knot Weed (6 sites), and excessive algae (3 sites). Most unusual conditions encountered were rated as moderately severe environmental problems. The two very severe conditions were used as additional comments. One site was located in Duck creek and used to document a large area of English Ivy killing trees and invading a wetland (see Figure 3-25, left photo). The second site was used to document disturbance to the streambed, banks, and forested wetlands as a result of ATV use in Muddy Gut (see Figure 3-25, right photo). Unusual conditions documenting stream impacts related to ATV use and excessive algae may be addressed via public outreach/education type projects. For example, fertilizer reduction/education may help address algae growth resulting from nutrient or chemical use by adjacent properties.

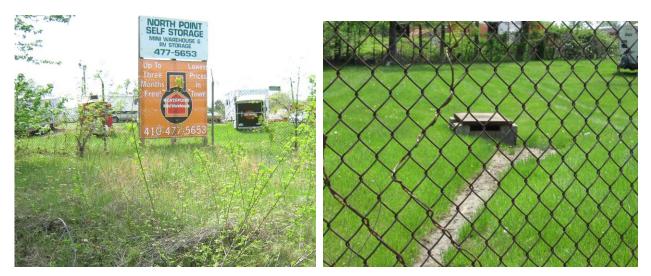
Figure 3-27: Detention Pond SWM-04 (North Point Rd, Back River-A)

property was a secured gate. The existing vegetation is low consisting mainly of patchy grass. The outfall was in poor condition with debris, trash, and sediment noted. Downstream channel continues through a culvert under 695 S which was determined to be in good condition. The adjacent land use conditions make lateral expansion of this detention unlikely. However, since the pond is mainly open pervious/grassed area, there is potential for deepening the pond and incorporating vegetation to improve water quality treatment potential.

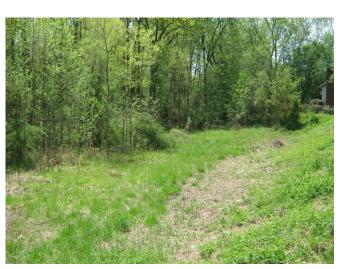
Figure 3-28: Detention Pond SWM-06 (Urbanwood Ct, Duck Creek)

Detention pond, SWM-06, is located at the end of the cul-de-sac on Urbanwood Court. It is bordered by two private residential properties on either side and by a forested stream buffer area and Duck Creek at the outfall both of which restrict physical expansion potential. The orifice and riser conditions were considered as in fair condition since some sediment was observed at the inlet and few cracks/minor weathering was noted for the riser. The overall condition of the existing detention pond is good with little to no debris and medium vegetation (thick grass and shrubs/trees). The outfall and downstream conditions were inaccessible due to fence conditions. The main recommendation for this facility is to monitor the condition of the inlet and riser and make sure maintenance of the pond continues to ensure proper function. This pond could be considered for planting of native vegetation that requires low maintenance while providing some water quality benefit. However, it may not be a priority since vegetation other than grass is well established and there is no room for physical expansion.

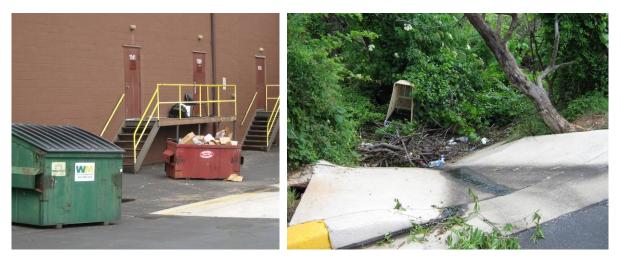
Figure 4-14: Examples of Overflowing Dumpsters and Curb Cuts Leading to Stream

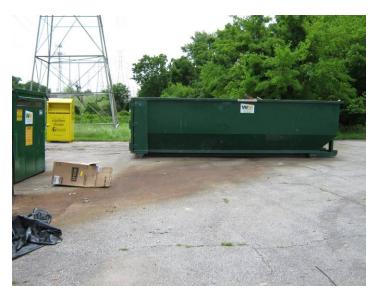
Figure 4-15: Potential Pollution Source from Stained Parking Lot/Leaking Dumpster

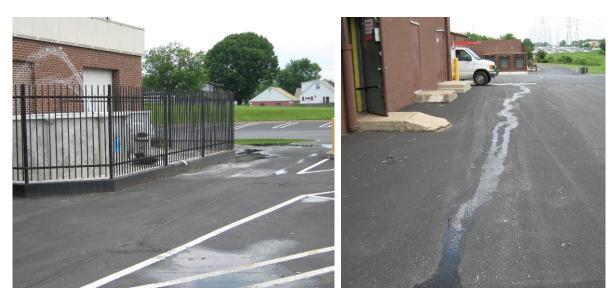
Figure 4-16: Runoff from Outdoor Material Areas at Commercial Hotspots

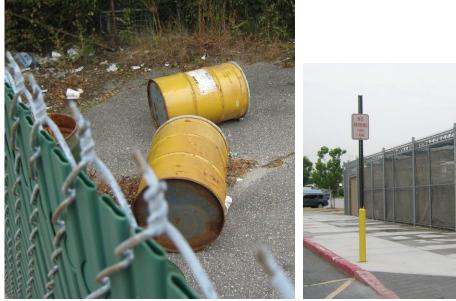
Figure 4-17: Potential Pollution Sources at Commercial Hotspots

Commercial areas sometimes have outdoor shopping areas where materials are stored outside. Similar to the discussion above, if materials are uncovered and on impervious surfaces, runoff from these areas can go directly into the storm drain system along with certain pollutants depending on the type of materials. For example, Figure 4-16 shows an outdoor pool display leaking/spraying water onto an adjacent impervious surfaces. This discharge may contain chemicals such as chlorine which can end up in the storm drains or streams. The left photo in Figure 4-17 shows a commercial shopping area where improperly labeled drums were stored

outdoors on pavement and sideways. This has potential for potentially hazardous pollutants to leak into the adjacent stream. The photo on the right in Figure 4-17 shows an outdoor garden center. While the outdoor garden center was covered, runoff from non-target irrigation practices was observed on the adjacent sidewalk indicating lack of diversion methods for storm drain inlets.

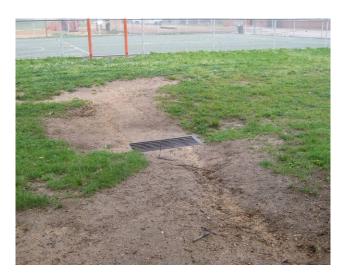
Figure 4-20: Stormwater Retrofit Opportunities at ISI_E_700

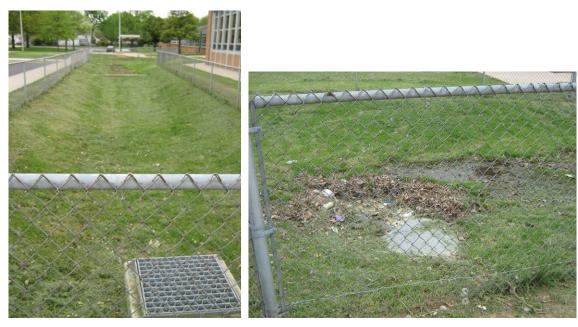
Figure 4-21: Stormwater Retrofit Opportunity for an Existing Detention Pond at ISI E 101

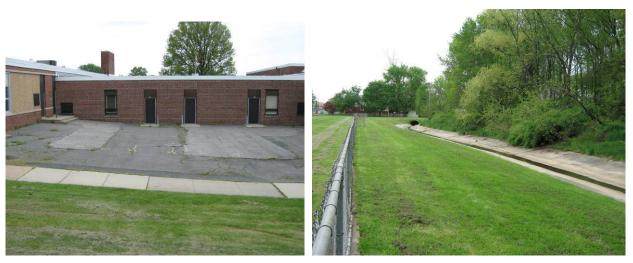
Figure 4-22: Potential Impervious Cover Removal at ISI_E_100

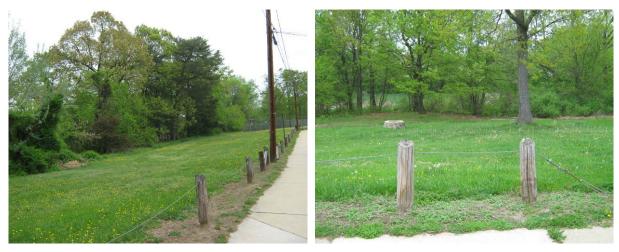
Figure 4-25: Photos of PAA_E_101

Fox Ridge Park is located between Deep Creek and the alley behind Foxwood Lane. It is also maintained by Baltimore County Parks and Recreation and easily accessible by foot, vehicle, or heavy equipment. It is mostly covered by turf (75%) with some trees and a paved athletic court. This site was recommended for reforestation with minimal site preparation based on initial field observations. Since the site is only 1.5 acres, reforestation was recommended mostly to improve the forested buffer area along Deep Creek. The current use of the park will need to be evaluated during a follow-up visit if the site is selected for potential restoration to balance buffer improvement with pervious area available for recreation. This could also be a community tree planting project.

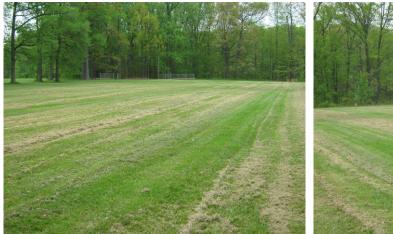
Figure 4-26: Photos of PAA E 200

A PAA was conducted for an isolated pervious area between Deep Creek Middle School main building and Back River. It was considered to be a good candidate for natural regeneration and for reforestation within minimal site preparation. The site is approximately 2.6 acres with full sun exposure and 100 percent turf cover. This site was recommended because the open pervious area appeared to be an unused baseball field and was isolated from the rest of the school property by existing trees. Because the open pervious area is located so close to the Back River, it was also noted as having potential for wetland creation. This would connect the surrounding forested buffer area while providing increased wildlife habitat and water quality benefits as well as an education opportunity for the school. Reforestation and wetland planting using native plants would require less maintenance than current mowing operations. A follow-up site inspection would involve verifying that the field is no longer used by the school for recreational purposes and a closer look at invasive species noted at the edge of the adjacent forested buffer area.

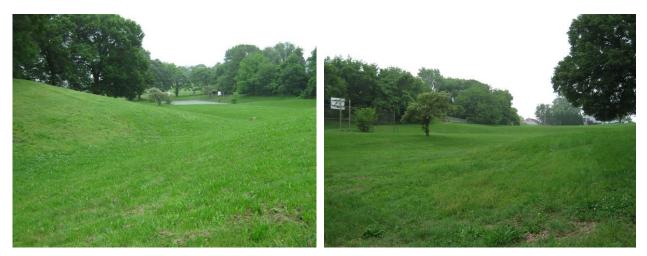
Figure 4-30: Potential Reforestation Areas at PAA_E_700

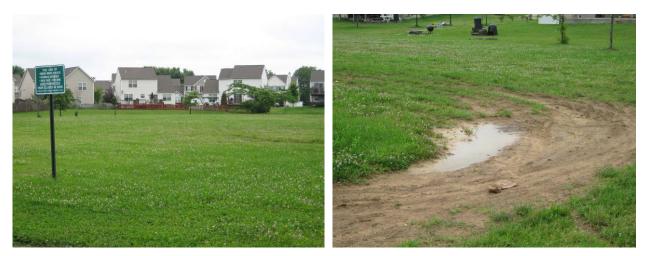
Figure 4-32: Photos of PAA_E_800

Beachwood Estates Park is located off of Greencove Circle in Back River-A and is easily accessible by foot, vehicle, or heavy equipment. It is maintained by Baltimore County Parks and Recreation and is approximately 2.6 acres. The site consists mostly of turf cover (70%) with some trees (15%) and a considerable amount of bare soil (15%) and receives full sun exposure. The site was recommended for reforestation with minimal site preparation. Erosion and backyards of private residences were noted as potential reforestation constraints. Some trees have been planted between private residences and the park; this buffer could be enhanced by planting additional trees while also stabilizing areas that appear to be prone to erosion.
