**Columbia Gas Transmission, LLC., a TransCanada
Company**

**JOINT FEDERAL/STATE APPLICATION
FOR THE ALTERATION OF ANY
FLOODPLAIN, WATERWAY, TIDAL
OR NONTIDAL WETLAND IN
MARYLAND**

**Eastern Panhandle Expansion
Project**

March 2017

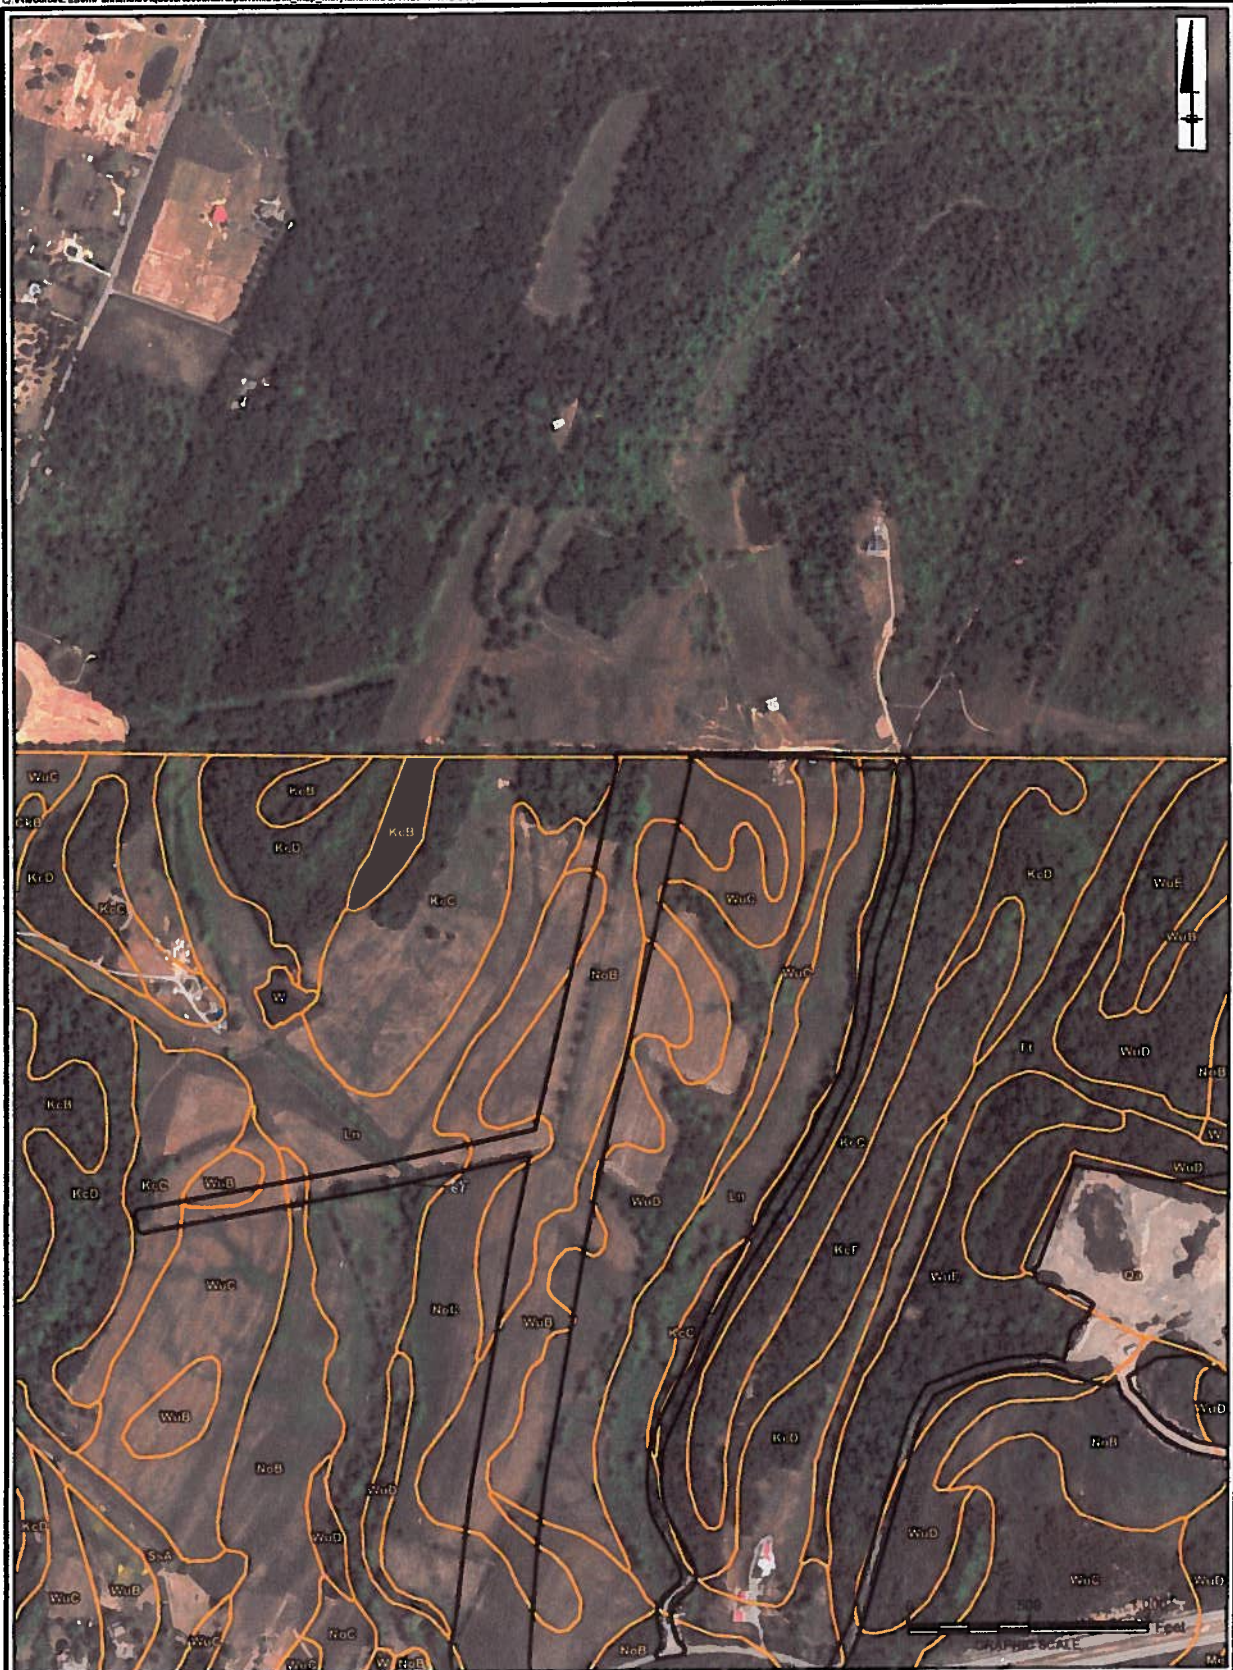
ARCADIS Energy & Construction
 Environmental
 Infrastructure | **FIGURE 2-1**

LEGEND:
 SOIL CLASS BOUNDARY
 ENVIRONMENTAL SURVEY CORRIDOR

The NRCS has mapped the Project's study area with twenty-five (25) soil mapping units (Appendix A, Figure 2). Two (2) of the soils are listed as hydric soils. Hydric soils are defined as soils formed under conditions of saturation, flooding, or ponding long enough during the growing season to develop anaerobic conditions in the upper part (Federal Register, July 13, 1994). Hydric soil indicators are formed predominantly by the accumulation or loss of iron, manganese, sulfur, or carbon compounds. The presence of hydrogen sulfide gas is a strong indicator of hydric soil in certain wetland habitats. In areas where soils are formed from parent material with low iron and manganese concentrations, features related to accumulations of organic carbon are typically used to determine hydric soils. The mapping units identified within the study area are listed in Table 3.1, below.
