**WELLHEAD AREA SURVEY
HELMICK'S GROCERY STORE
ACHD SITE NO. 67
Flintstone, Allegany County, Maryland**

ALWI Project No. AL7N001

NONCOMMUNITY WATER SUPPLY SANITARY SURVEY

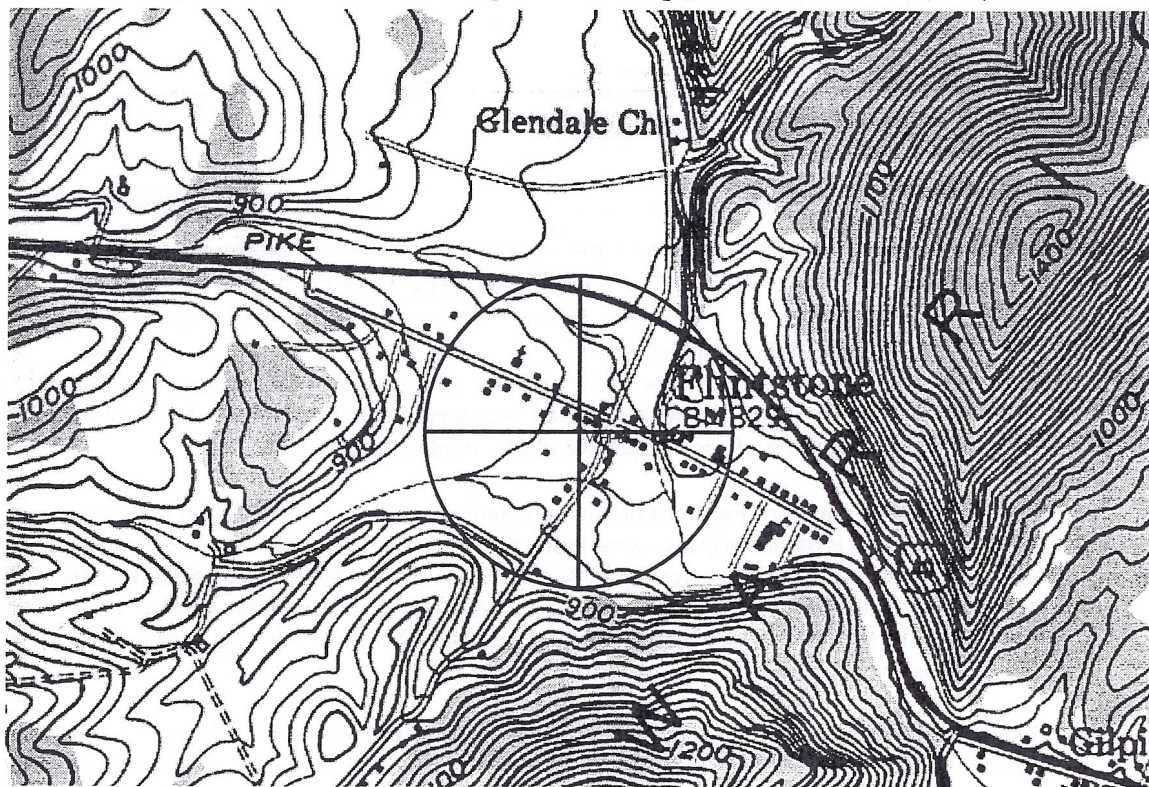
24. Well Location Diagram (1 in. = 1250 ft.) with Approximate Distances from Potential Contaminant Sources (i.e. septic, sewer lines, structures, petroleum storage, surface water bodies, etc.):

ALWI delineated a surveyed area surrounding this site's well using generalized criteria developed by MDE for non-community supplies, as modified by ALWI (with ACHD consent) based on the specific topographic setting of the site. The resultant delineation is shown on the "Water Plant Information" survey form (Appendix B). ALWI used a fixed radius of 1,000 feet around the well, which creates an area of approximately 72 acres. Within an assumed 600 gallons per day per acre (gpd/ac) of annualized groundwater recharge (Slaughter and Darling, 1962, Table 37), slightly more than 43,000 gallons per day exists within the aquifer beneath this surveyed area. In actuality, the modest demand of this well (doubtlessly less than 100 gpd) is more than two orders of magnitude smaller than the total available in the surveyed area, lending a high degree of conservatism to this analysis.

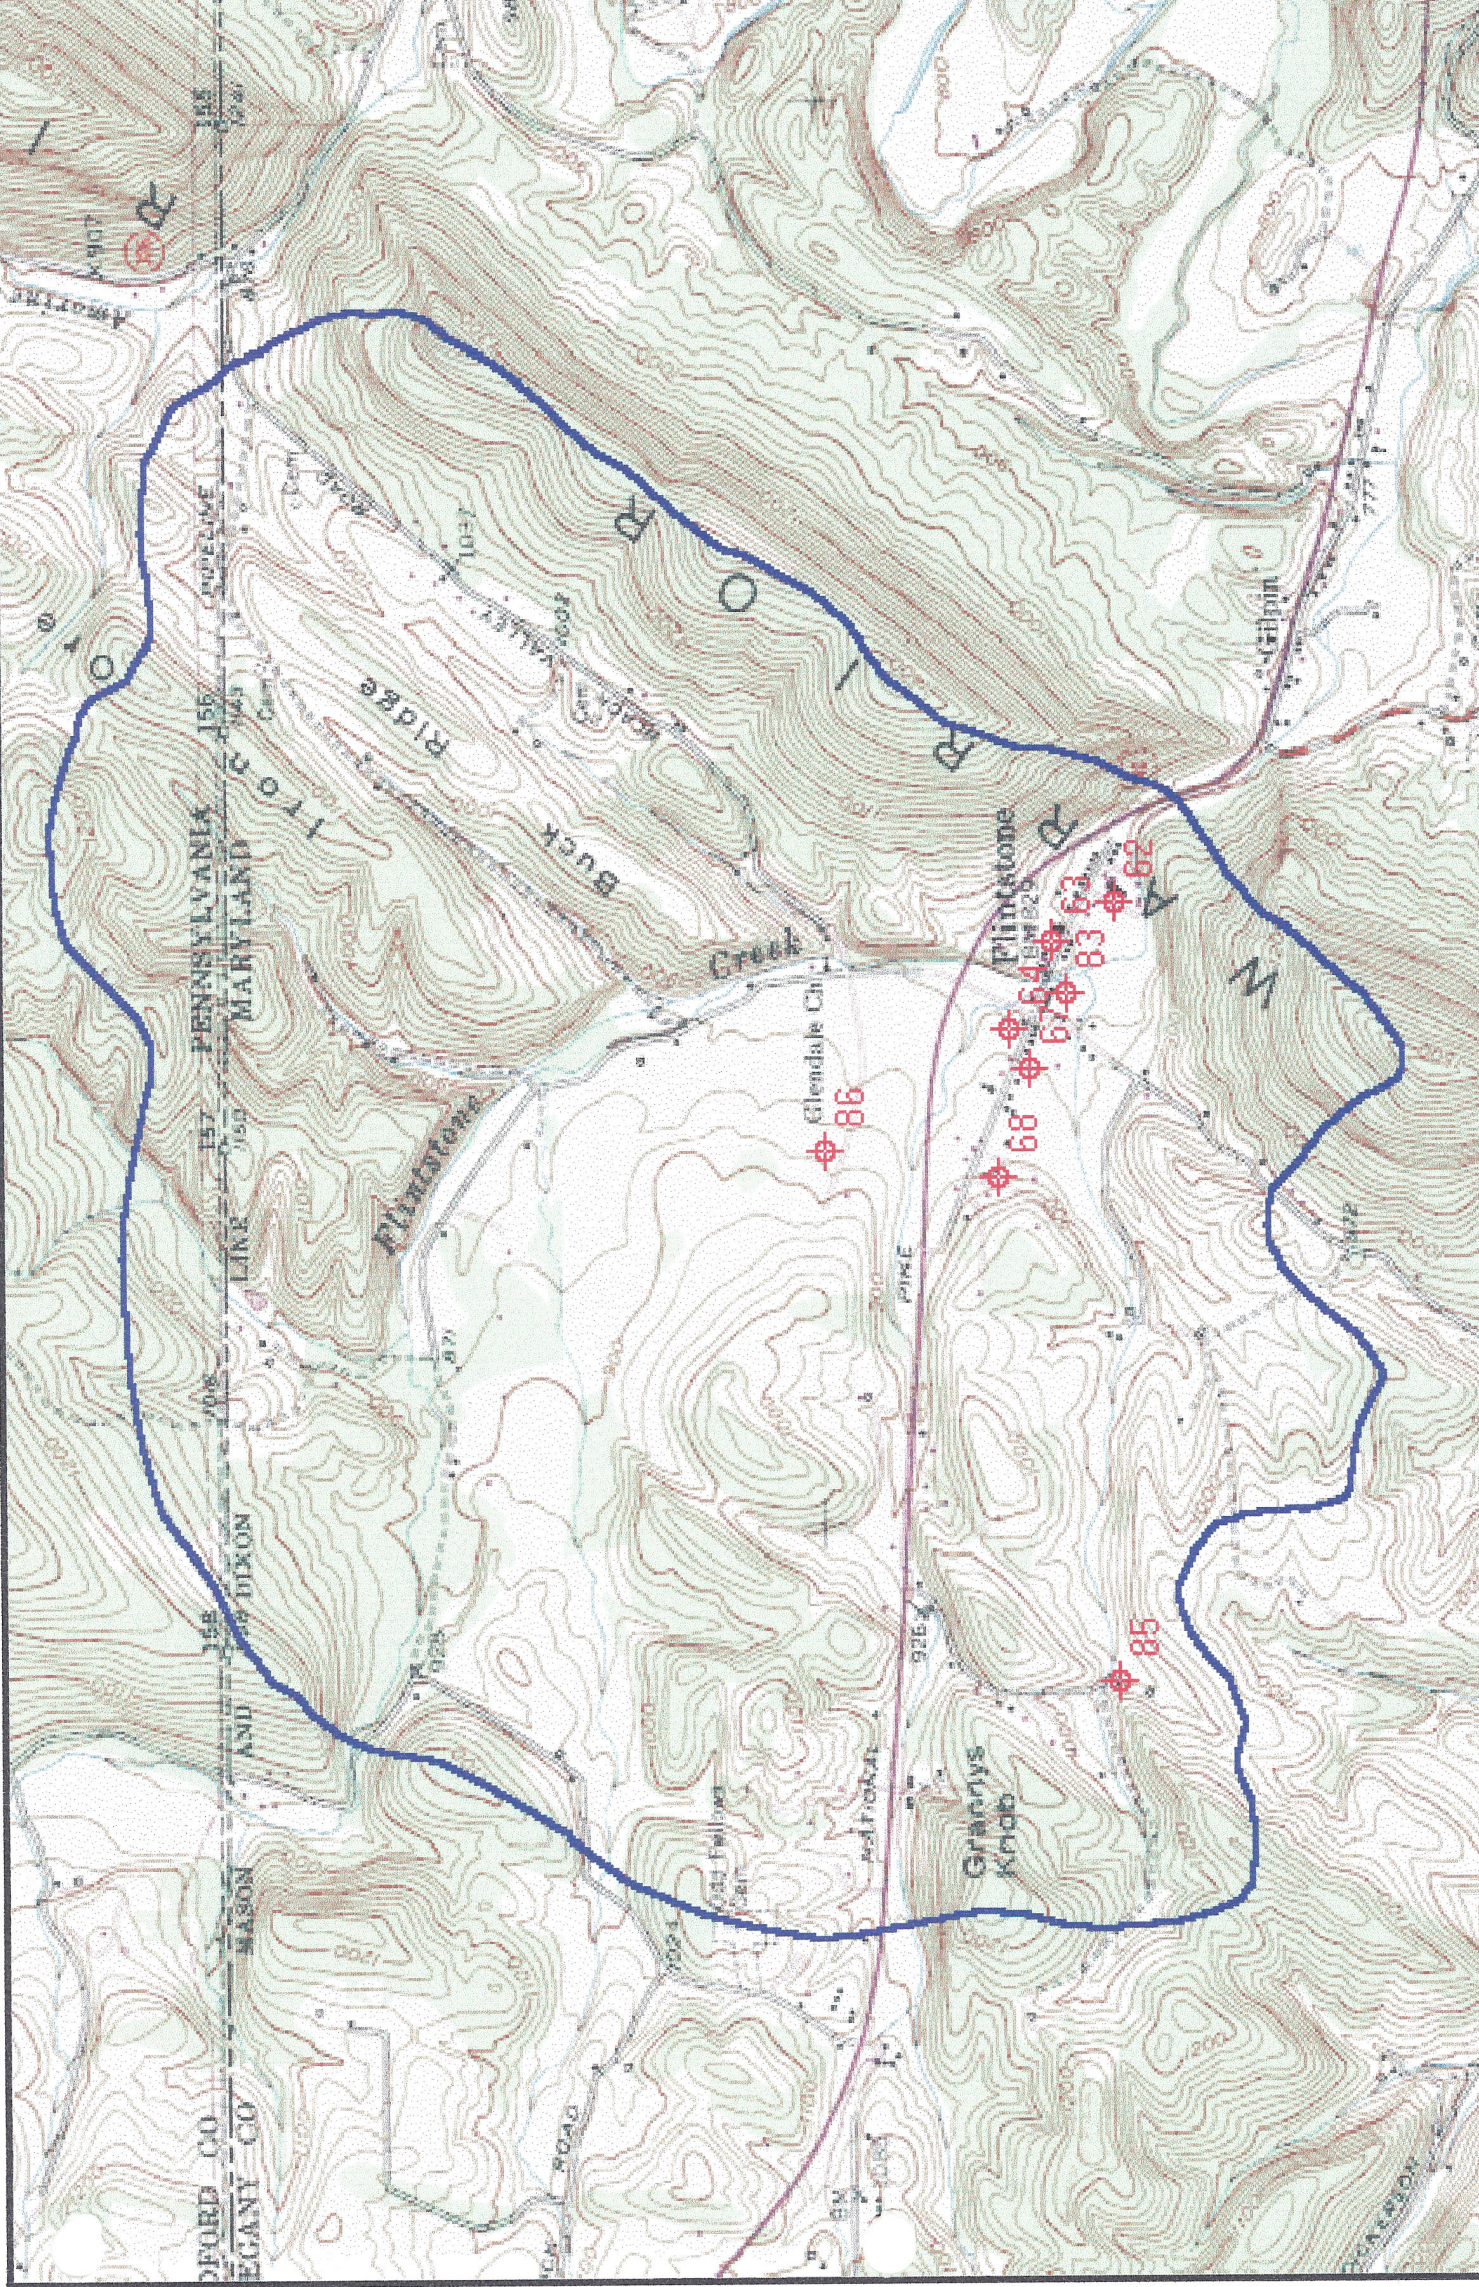
**Figure 3.
Composite
Source Water
Protection Area
for Flintstone**

- ⊕ **TNC or NTNC well**
- 62 → Flintstone High School
- 63 Flintstone VFD
- 64 Dawn's
- 67 Helmick's Grocery
- 68 National Pike Sunoco
- 83 Vanmeter's Gas & Grocery
- 85 Mt. Valley Farm Bed & Breakfast
- 86 Alpine Pantry

topographically-constrained sourced water protection area [includes areas within 1,000 feet of each surveyed well unless clear hydrogeologic evidence suggested a need for a site-specific modification of this MDE criterion.
