**Source Water Assessment  
for the Saint James School Water System  
Washington County, Maryland**

**Prepared By  
Maryland Department of the Environment  
Water Management Administration  
Water Supply Program  
February 2004**

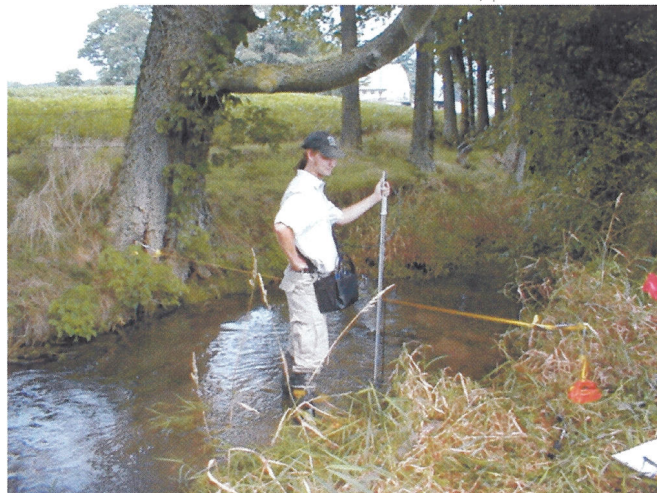
*Measuring discharge on the tributary to St James Run at stream gaging site 1.*

Discharge at the tributary to St. James Run was measured prior to the dye trace. Three sites were gaged (Fig. 1). Stream discharge data was collected after no measurable precipitation was recorded for five consecutive days. This was required to ensure base flow conditions. Results of discharge measurements are listed in Table 3. Site 1, which was also gaged by Duigon, is located approximately 1.3 miles north of the spring, just downstream of the Rench Road crossing. Sites 2 and 3 are upstream of the College Road crossing. Site 3 was chosen to determine if the section between sites 1 and 3 was gaining or losing. Site 2 was chosen after field investigation revealed an outcrop of bedrock in the streambed, which represented a possible location for stream water to enter the ground water system. Site 2 is approximately 200 feet upstream from the outcrop.

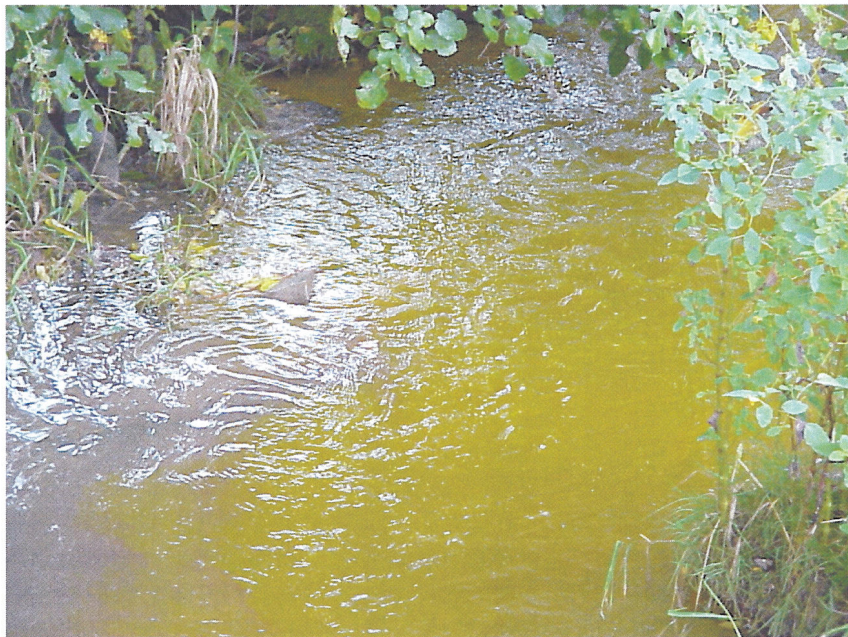
*Eosine dye in the tributary to St James Run immediately following injection (Photo taken 9/11/00).*

Fluorescent dyes were injected into the sewer system at the St. James School and the tributary of St. James Run. Approximately 1 pound of Rhodamine WT was introduced into the sewer system on September 1, 2000 in two locations in the campus restroom facilities. Approximately 1.5 pounds of Eosine was introduced to the stream at the upstream stream gaging location (site 1) on September 11, 2000. Rhodamine WT (C.I. Acid Red #388) is a deep red fluorescent dye and Eosine (Color Index 45380) is a dark red dye at very high concentrations, but becomes a yellow-green fluorescent dye as it is diluted. Both dyes are common to ground water and potable water supply tracing.
