## **Response Action Plan**

**Ox Fibre Apartments  
400 East Church Street  
Frederick, Maryland 21701**

AEC Project No. 20-021

March 6, 2020

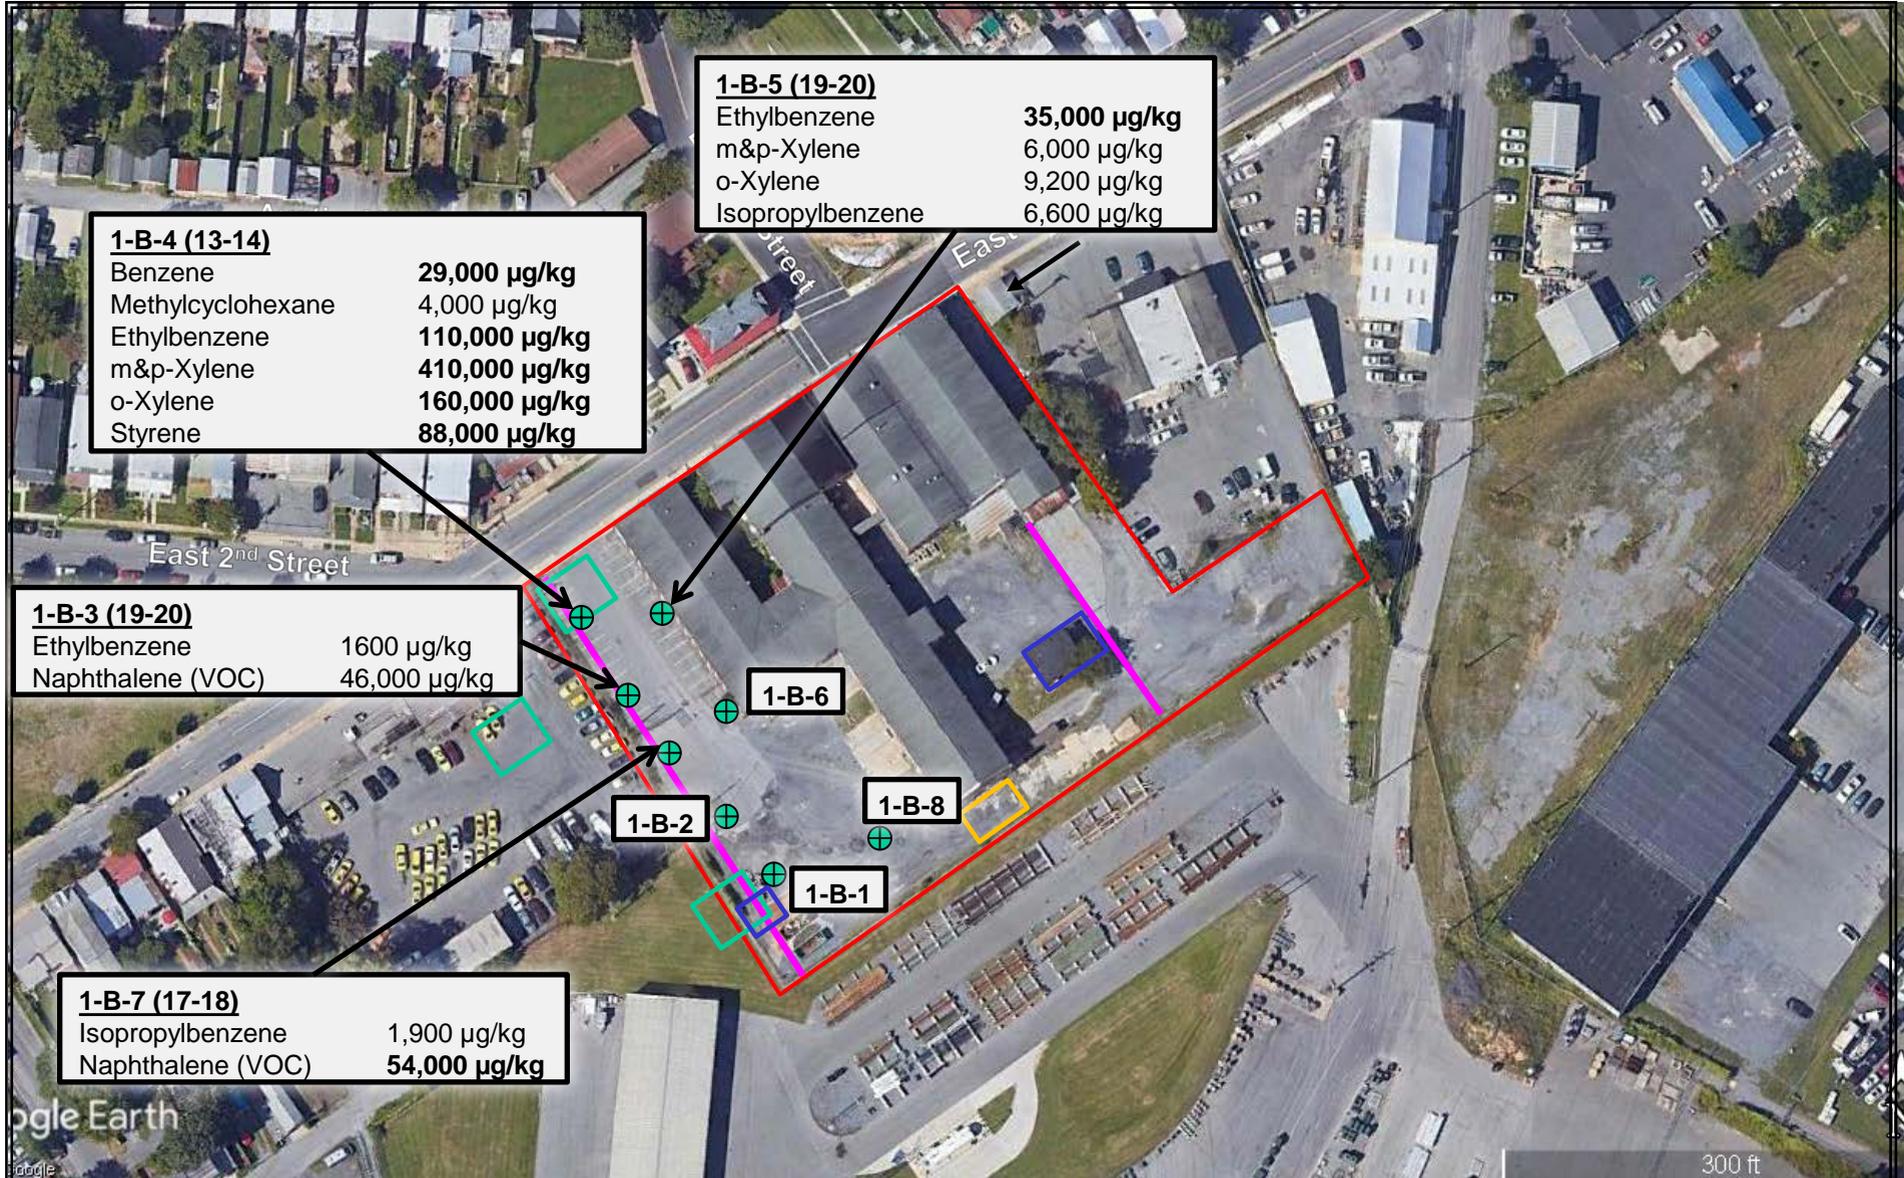
**1-B-4 (13-14)**  
 Benzene 29,000 µg/kg  
 Methylcyclohexane 4,000 µg/kg  
 Ethylbenzene 110,000 µg/kg  
 m&p-Xylene 410,000 µg/kg  
 o-Xylene 160,000 µg/kg  
 Styrene 88,000 µg/kg

**1-B-5 (19-20)**  
 Ethylbenzene 35,000 µg/kg  
 m&p-Xylene 6,000 µg/kg  
 o-Xylene 9,200 µg/kg  
 Isopropylbenzene 6,600 µg/kg

Petroleum odors were noted in B-3 at depths of 14 to 20 feet bgs, in B-4 at four to 15 feet bgs, in B-5 at 18 to 25 feet bgs, and in B-7 at 12 to 20 feet bgs. Various VOCs, PAHs, TPH diesel range organics (DRO), and TPH gasoline range organics (GRO) were found above and below MDE Residential Cleanup Standards in soil samples. The VOCs benzene, ethylbenzene, xylenes, and naphthalene, TPH DRO, and TPH GRO were found above the MDE Groundwater Standards in one groundwater sample.

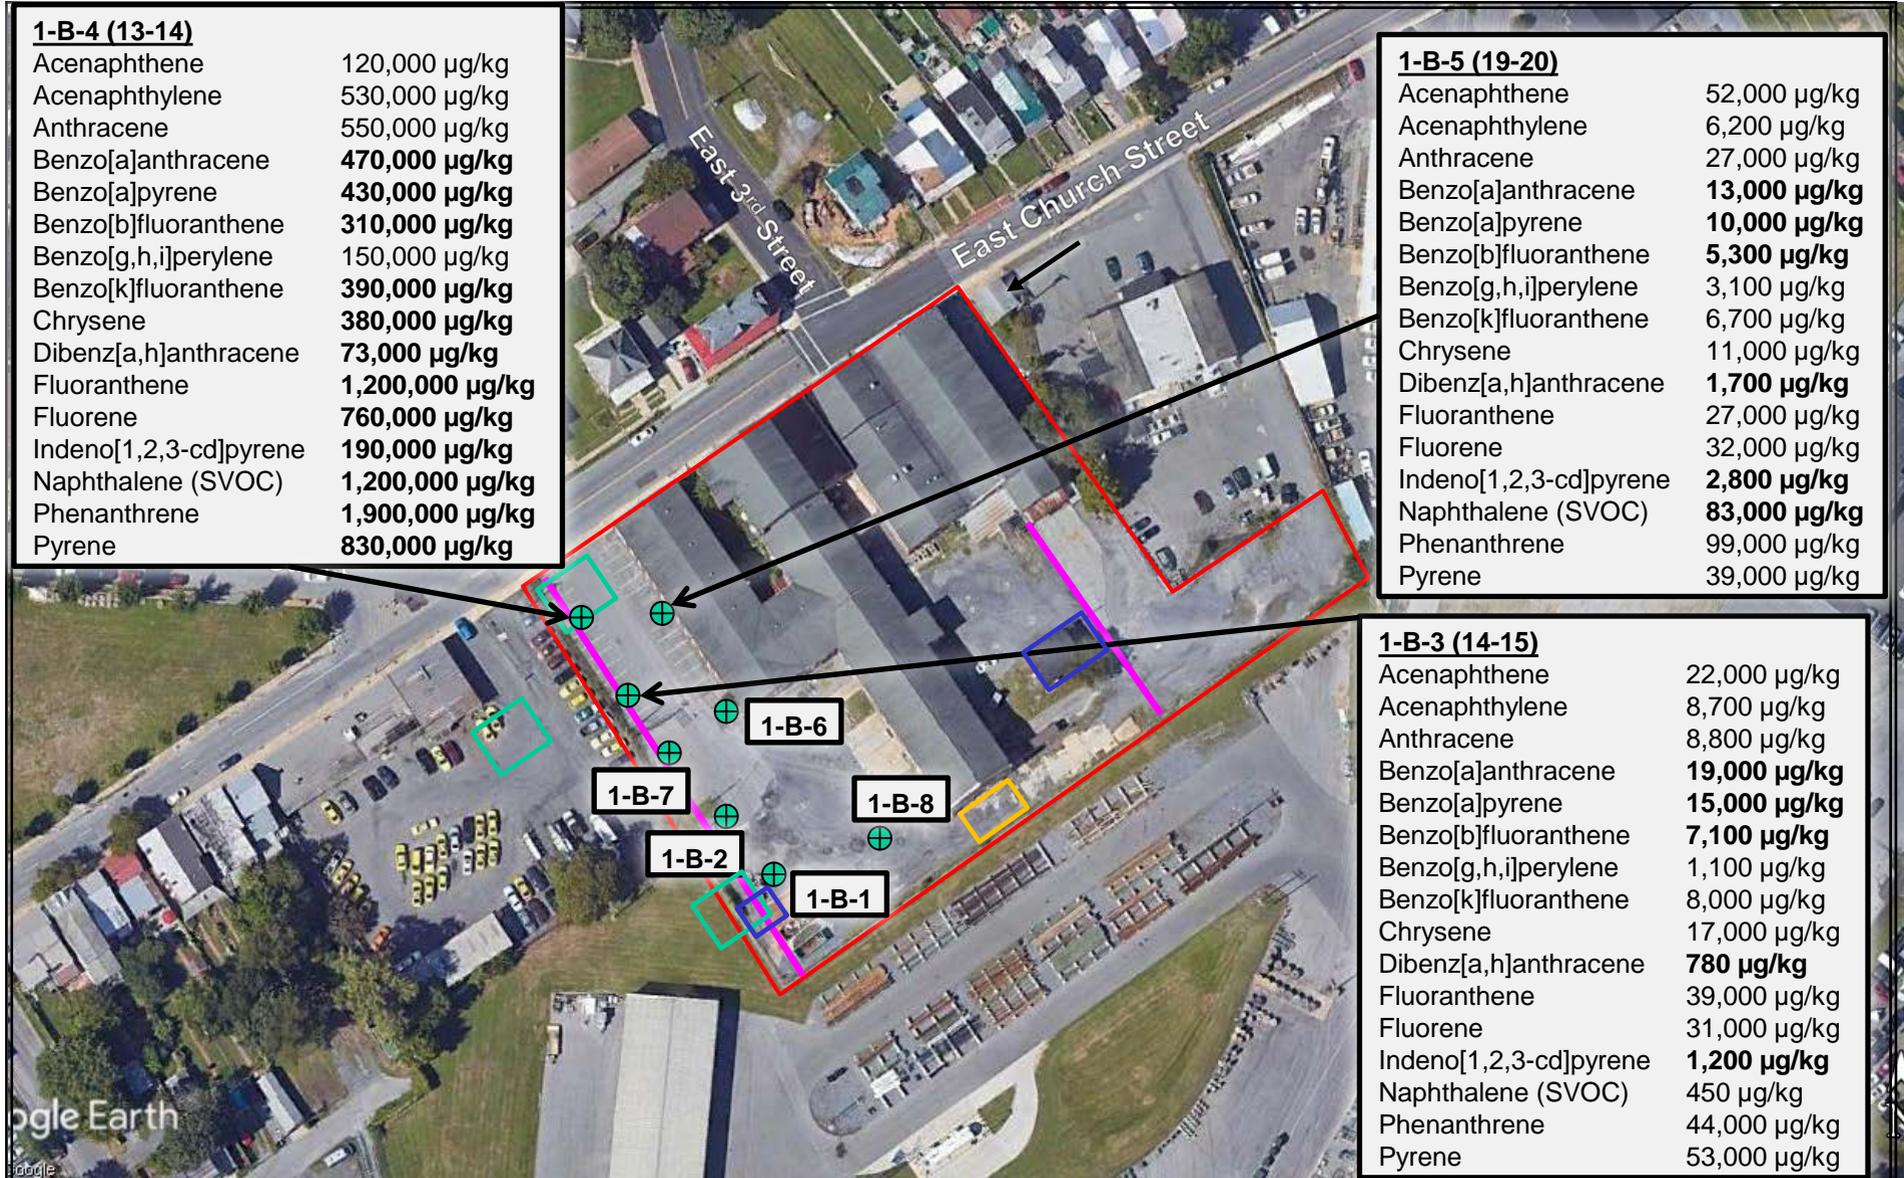
Figure 4 – PAH Soil Sample Results (August 17, 2017)  
 Ox Fibre Apartments  
 400 East Church Street  
 Frederick, Maryland 21701

Acenaphthene	22,000 µg/kg
Acenaphthylene	8,700 µg/kg
Anthracene	8,800 µg/kg
Benzo[a]anthracene	<b>19,000 µg/kg</b>
Benzo[a]pyrene	<b>15,000 µg/kg</b>
Benzo[b]fluoranthene	<b>7,100 µg/kg</b>
Benzo[g,h,i]perylene	1,100 µg/kg
Benzo[k]fluoranthene	8,000 µg/kg
Chrysene	17,000 µg/kg
Dibenz[a,h]anthracene	<b>780 µg/kg</b>
Fluoranthene	39,000 µg/kg
Fluorene	31,000 µg/kg
Indeno[1,2,3-cd]pyrene	<b>1,200 µg/kg</b>
Naphthalene (SVOC)	450 µg/kg
Phenanthrene	44,000 µg/kg
Pyrene	53,000 µg/kg

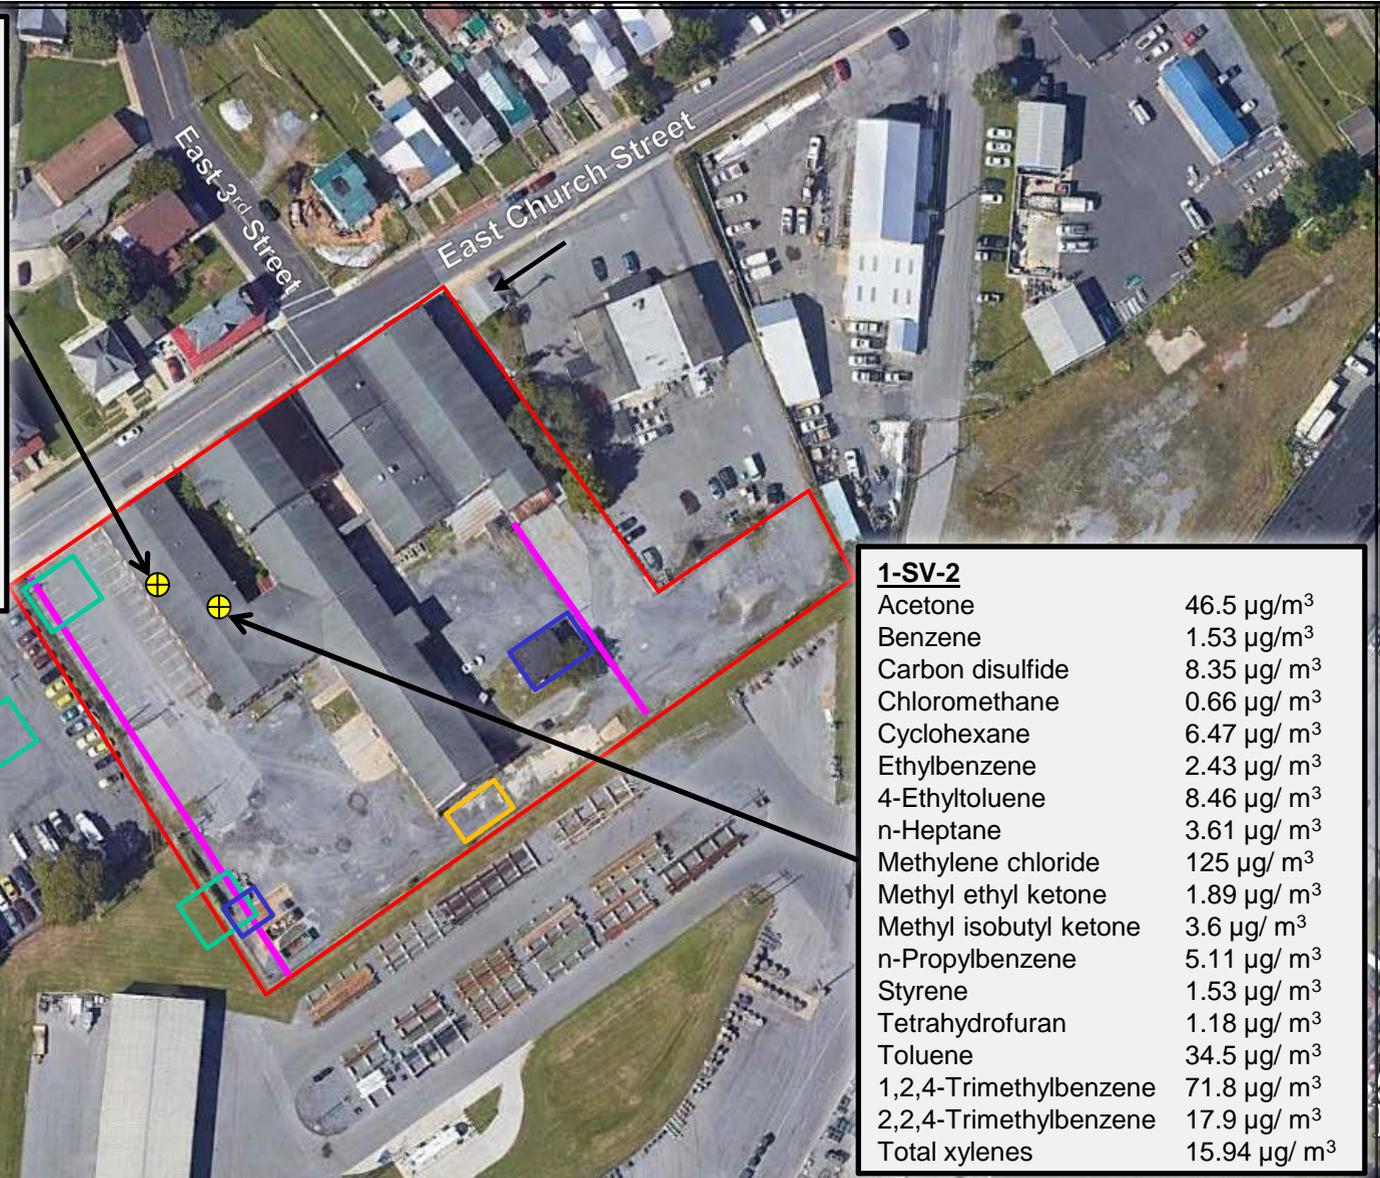
↑ N  
 Figure 7 – Soil Vapor Results (August 17, 2017)  
 Ox Fibre Apartments  
 400 East Church Street  
 Frederick, Maryland 21701

Acetone	51 µg/m <sup>3</sup>
Benzene	1.41 µg/m <sup>3</sup>
Carbon disulfide	16.4 µg/m <sup>3</sup>
Chloromethane	0.66 µg/m <sup>3</sup>
Cyclohexane	4.82 µg/m <sup>3</sup>
Ethylbenzene	2.78 µg/m <sup>3</sup>
4-Ethyltoluene	9.44 µg/m <sup>3</sup>
n-Heptane	2.95 µg/m <sup>3</sup>
Methyl ethyl ketone	3.07 µg/m <sup>3</sup>
Methyl isobutyl ketone	3.93 µg/m <sup>3</sup>
n-Propylbenzene	5.9 µg/m <sup>3</sup>
Styrene	1.7 µg/m <sup>3</sup>
Tetrahydrofuran	1.18 µg/m <sup>3</sup>
Toluene	29.2 µg/m <sup>3</sup>
1,2,4-Trimethylbenzene	92.6 µg/m <sup>3</sup>
2,2,4-Trimethylbenzene	20.1 µg/m <sup>3</sup>
Total xylenes	17.45 µg/m <sup>3</sup>

Acetone	46.5 µg/m <sup>3</sup>
Benzene	1.53 µg/m <sup>3</sup>
Carbon disulfide	8.35 µg/m <sup>3</sup>
Chloromethane	0.66 µg/m <sup>3</sup>
Cyclohexane	6.47 µg/m <sup>3</sup>
Ethylbenzene	2.43 µg/m <sup>3</sup>
4-Ethyltoluene	8.46 µg/m <sup>3</sup>
n-Heptane	3.61 µg/m <sup>3</sup>
Methylene chloride	125 µg/m <sup>3</sup>
Methyl ethyl ketone	1.89 µg/m <sup>3</sup>
Methyl isobutyl ketone	3.6 µg/m <sup>3</sup>
n-Propylbenzene	5.11 µg/m <sup>3</sup>
Styrene	1.53 µg/m <sup>3</sup>
Tetrahydrofuran	1.18 µg/m <sup>3</sup>
Toluene	34.5 µg/m <sup>3</sup>
1,2,4-Trimethylbenzene	71.8 µg/m <sup>3</sup>
2,2,4-Trimethylbenzene	17.9 µg/m <sup>3</sup>
Total xylenes	15.94 µg/m <sup>3</sup>

ICOR collected two sub-slab soil vapor samples from two locations within the western portion of the Site building. Neither of the two samples were found to contain constituents above the MDE Tier 1 Residential Cleanup Standards. Table 5 summarizes the sub-slab soil vapor results. Figure 7 illustrates the sub-slab soil vapor sample locations and soil gas quality.

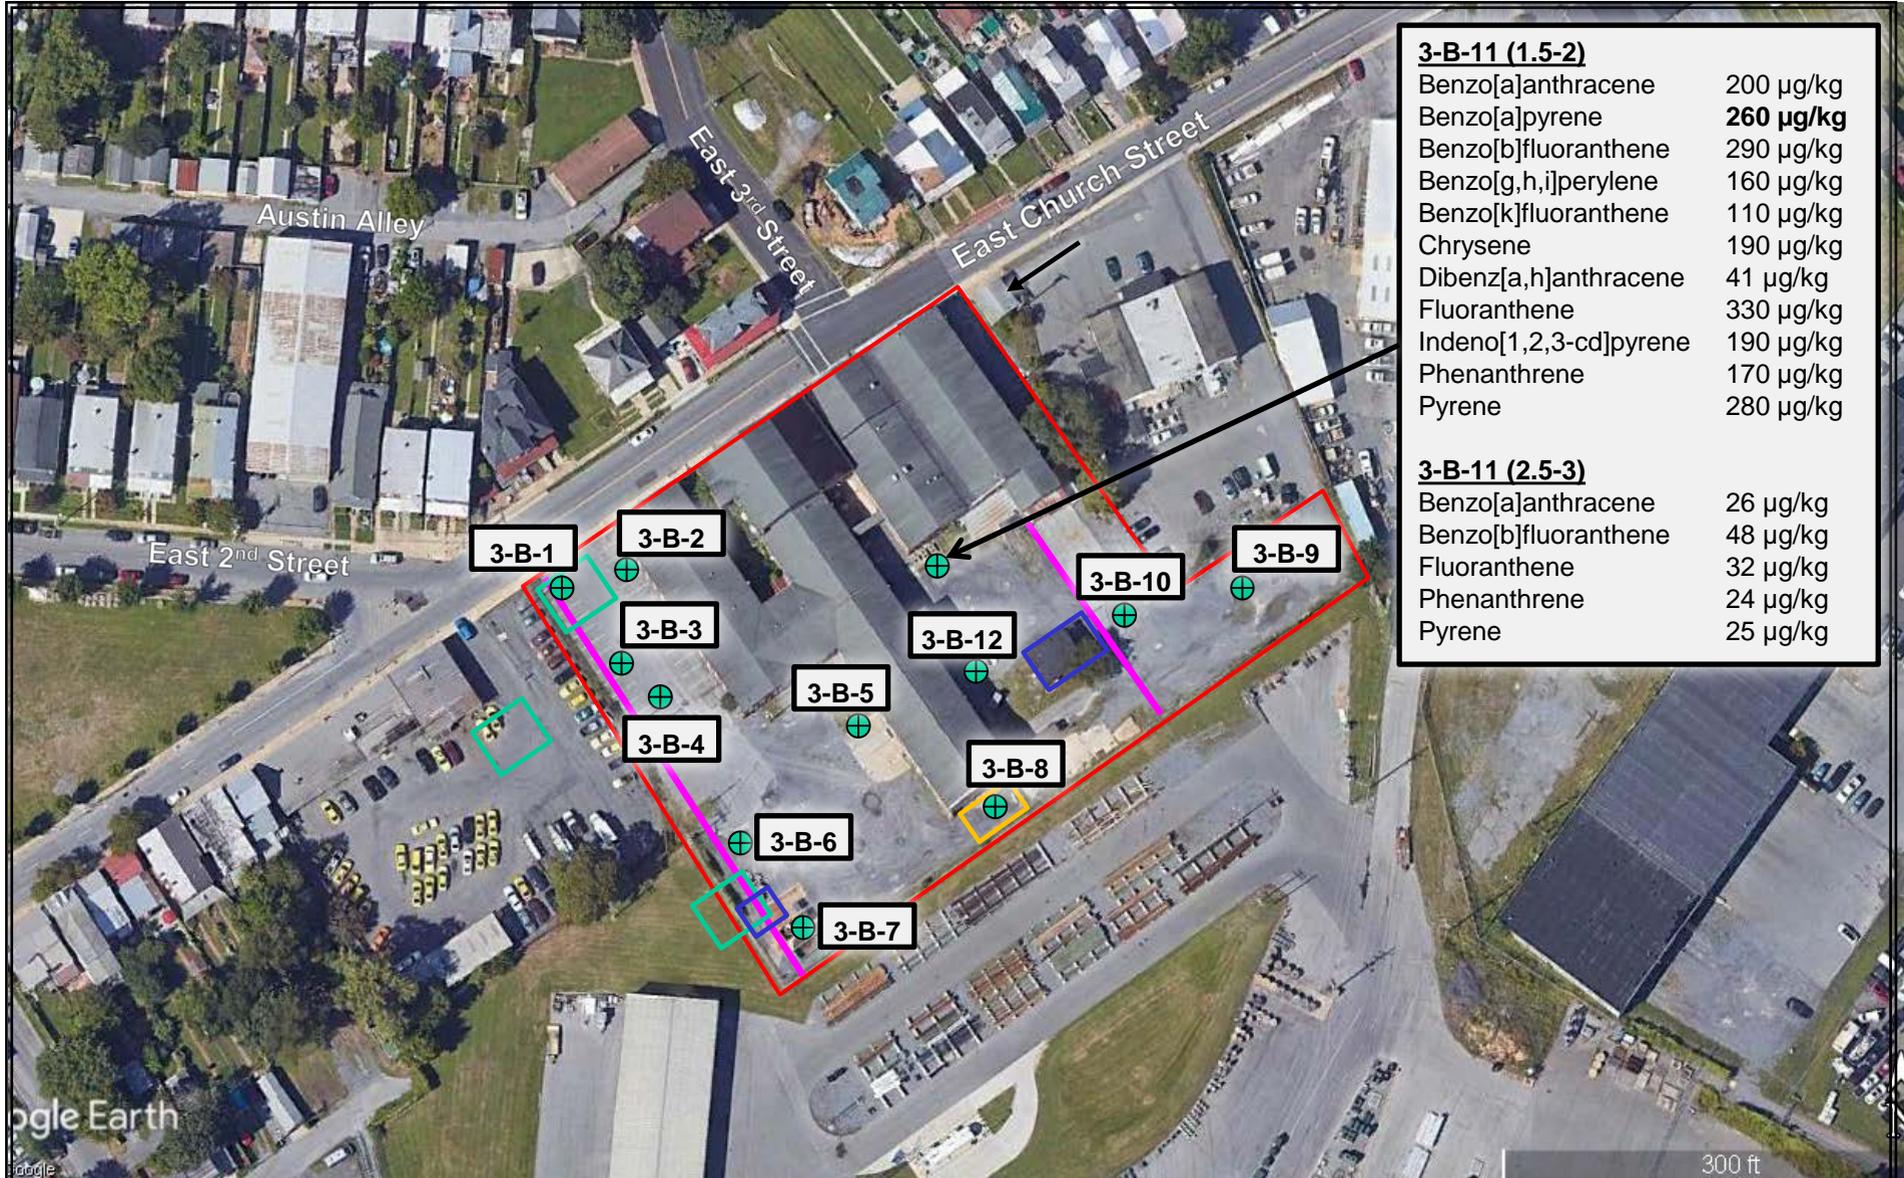
↑ **Figure 12d – PAH Soil Sample Results (July 23, 2019)**  
 Ox Fibre Apartments  
 400 East Church Street  
 Frederick, Maryland 21701

Benzo[a]anthracene	200 µg/kg
Benzo[a]pyrene	<b>260 µg/kg</b>
Benzo[b]fluoranthene	290 µg/kg
Benzo[g,h,i]perylene	160 µg/kg
Benzo[k]fluoranthene	110 µg/kg
Chrysene	190 µg/kg
Dibenz[a,h]anthracene	41 µg/kg
Fluoranthene	330 µg/kg
Indeno[1,2,3-cd]pyrene	190 µg/kg
Phenanthrene	170 µg/kg
Pyrene	280 µg/kg

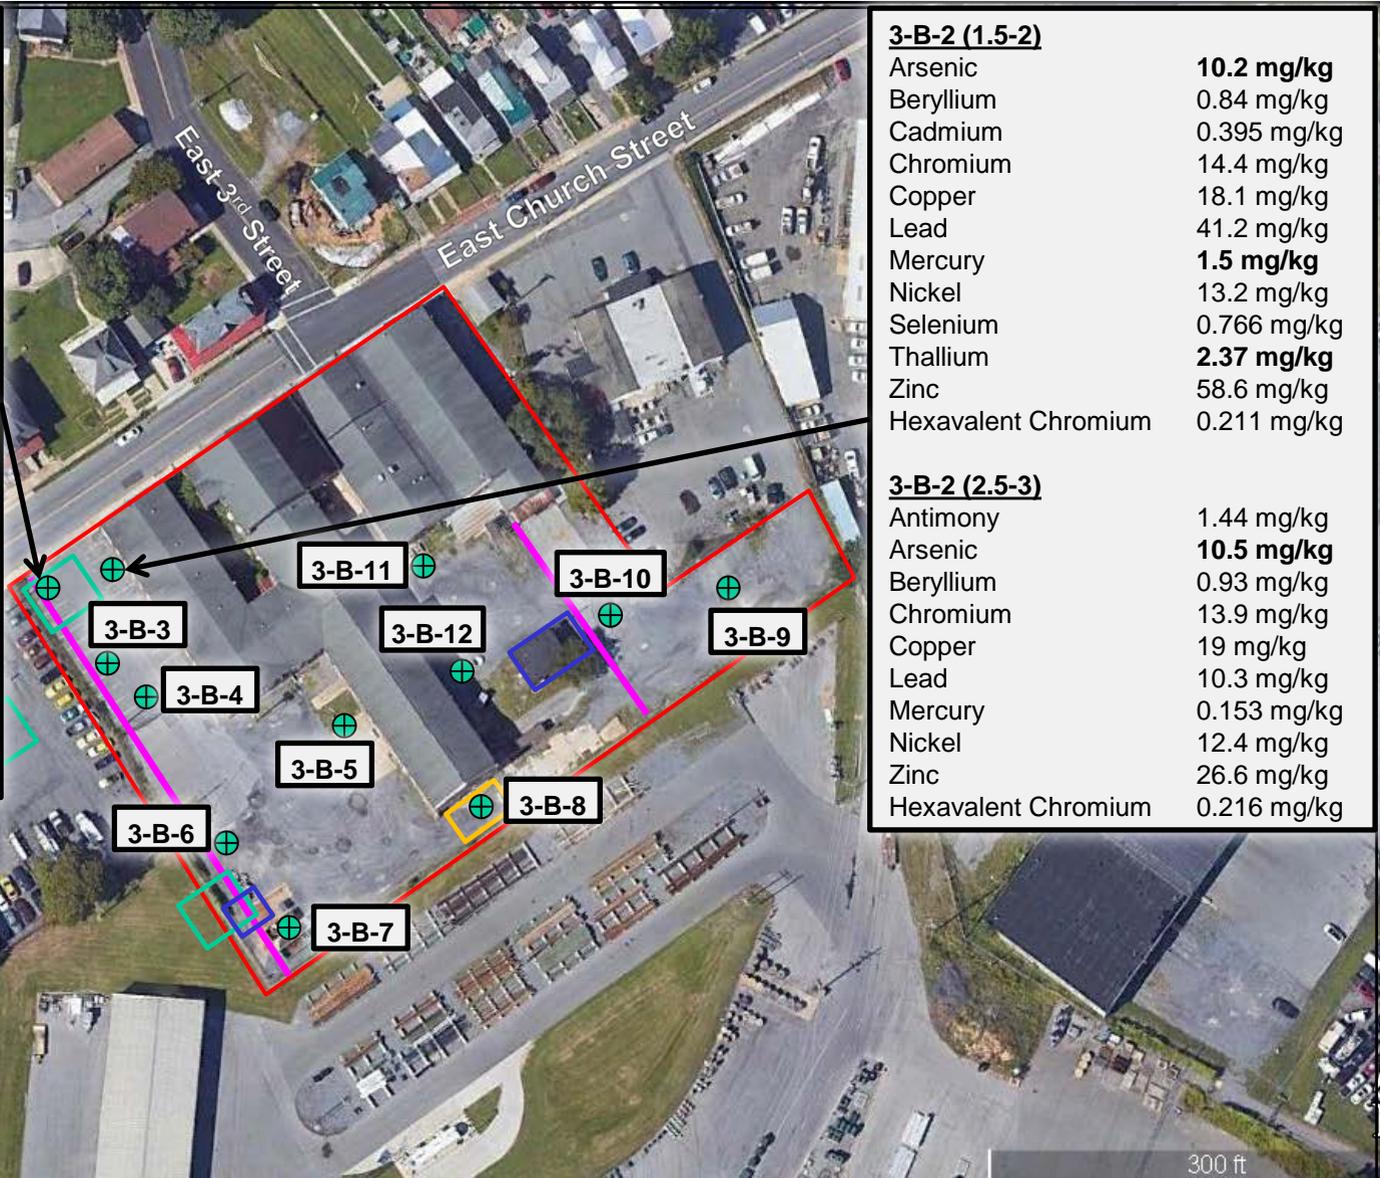
Figure 14a – Metals Soil Sample Results (July 23, 2019)  
 Ox Fibre Apartments  
 400 East Church Street  
 Frederick, Maryland 21701

Antimony	1.44 mg/kg
Arsenic	<b>10.5 mg/kg</b>
Beryllium	0.93 mg/kg
Chromium	13.9 mg/kg
Copper	19 mg/kg
Lead	10.3 mg/kg
Mercury	0.153 mg/kg
Nickel	12.4 mg/kg
Zinc	26.6 mg/kg
Hexavalent Chromium	0.216 mg/kg

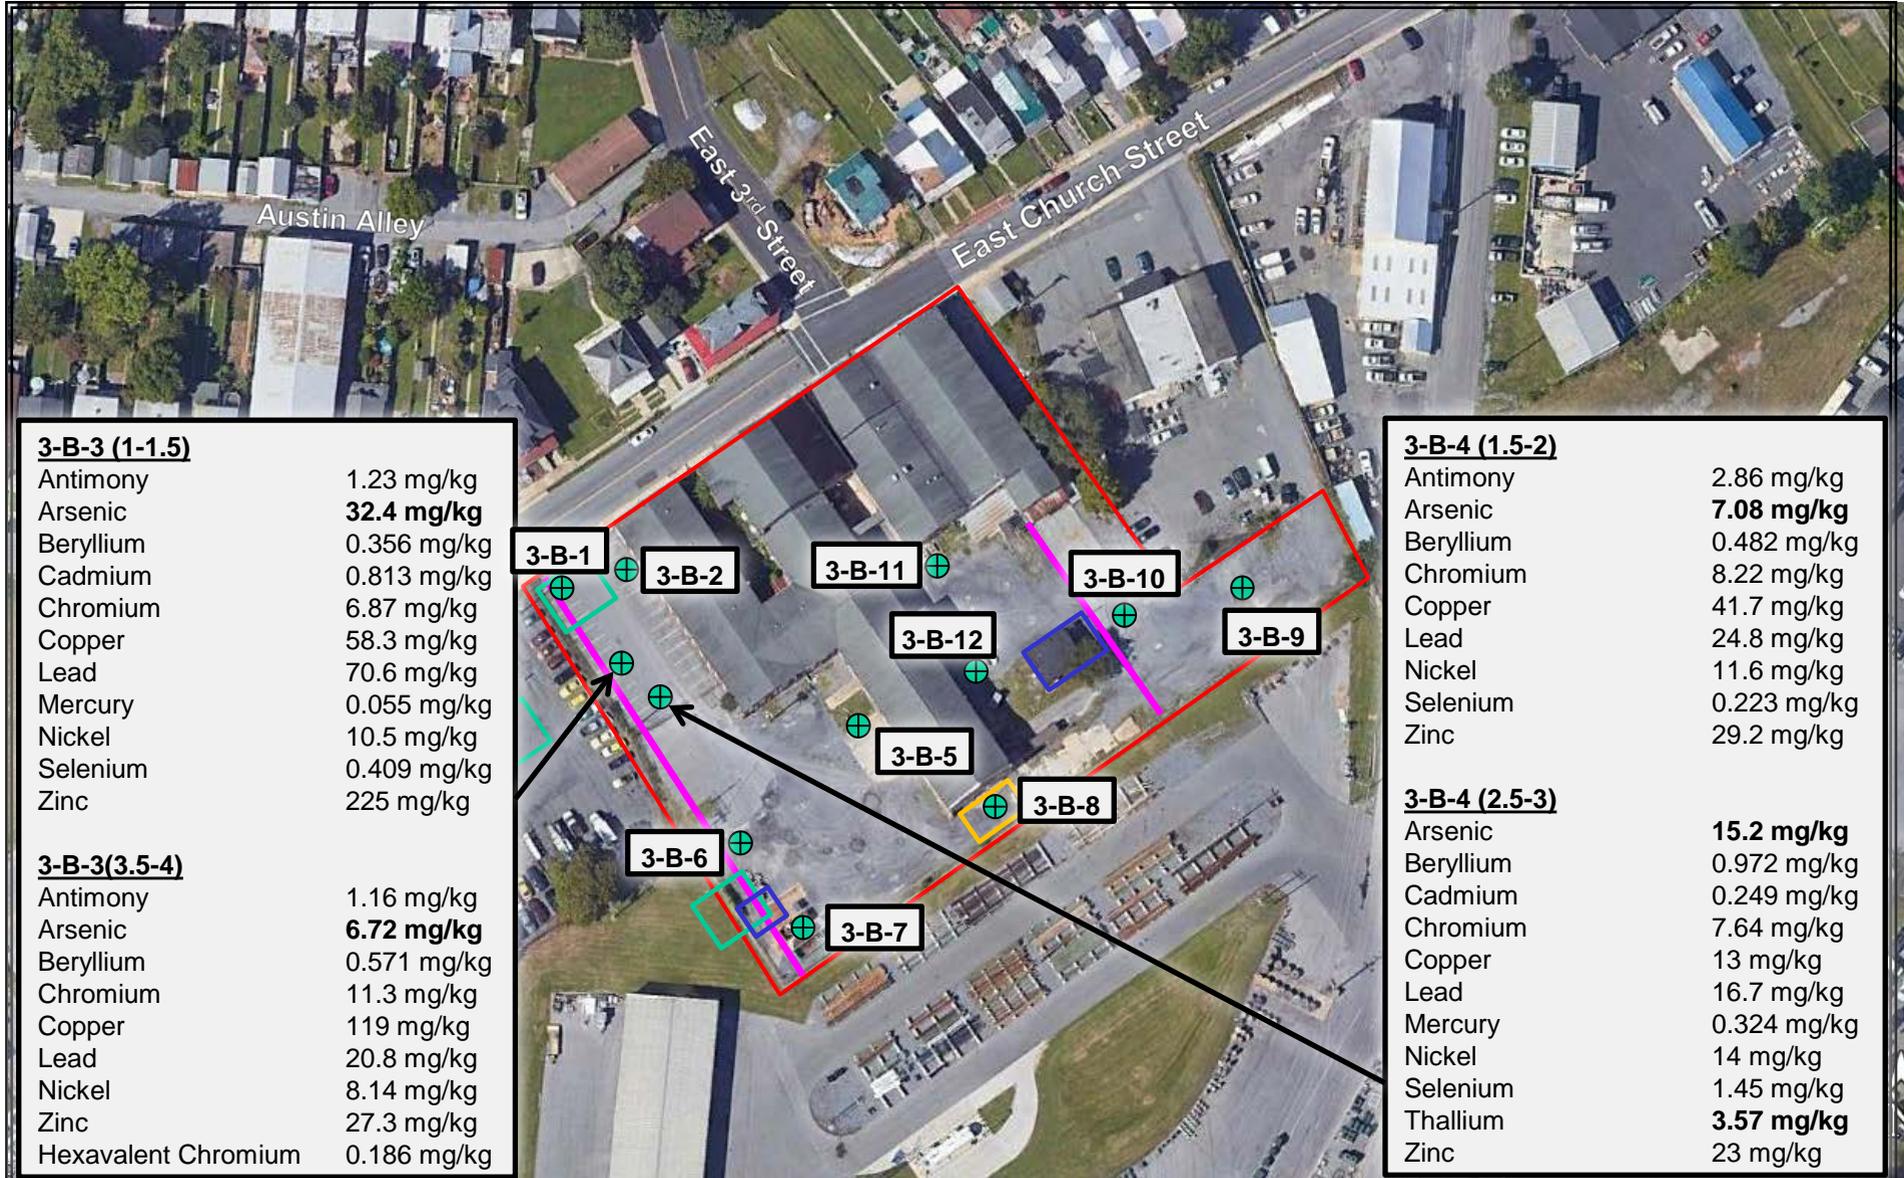
Figure 14b – Metals Soil Sample Results (July 23, 2019)  
 Ox Fibre Apartments  
 400 East Church Street  
 Frederick, Maryland 21701

<b>3-B-3 (1-1.5)</b>	
Antimony	1.23 mg/kg
Arsenic	<b>32.4 mg/kg</b>
Beryllium	0.356 mg/kg
Cadmium	0.813 mg/kg
Chromium	6.87 mg/kg
Copper	58.3 mg/kg
Lead	70.6 mg/kg
Mercury	0.055 mg/kg
Nickel	10.5 mg/kg
Selenium	0.409 mg/kg
Zinc	225 mg/kg
<b>3-B-3(3.5-4)</b>	
Antimony	1.16 mg/kg
Arsenic	<b>6.72 mg/kg</b>
Beryllium	0.571 mg/kg
Chromium	11.3 mg/kg
Copper	119 mg/kg
Lead	20.8 mg/kg
Nickel	8.14 mg/kg
Zinc	27.3 mg/kg
Hexavalent Chromium	0.186 mg/kg

<b>3-B-4 (1.5-2)</b>	
Antimony	2.86 mg/kg
Arsenic	<b>7.08 mg/kg</b>
Beryllium	0.482 mg/kg
Chromium	8.22 mg/kg
Copper	41.7 mg/kg
Lead	24.8 mg/kg
Nickel	11.6 mg/kg
Selenium	0.223 mg/kg
Zinc	29.2 mg/kg
<b>3-B-4 (2.5-3)</b>	
Arsenic	<b>15.2 mg/kg</b>
Beryllium	0.972 mg/kg
Cadmium	0.249 mg/kg
Chromium	7.64 mg/kg
Copper	13 mg/kg
Lead	16.7 mg/kg
Mercury	0.324 mg/kg
Nickel	14 mg/kg
Selenium	1.45 mg/kg
Thallium	<b>3.57 mg/kg</b>
Zinc	23 mg/kg

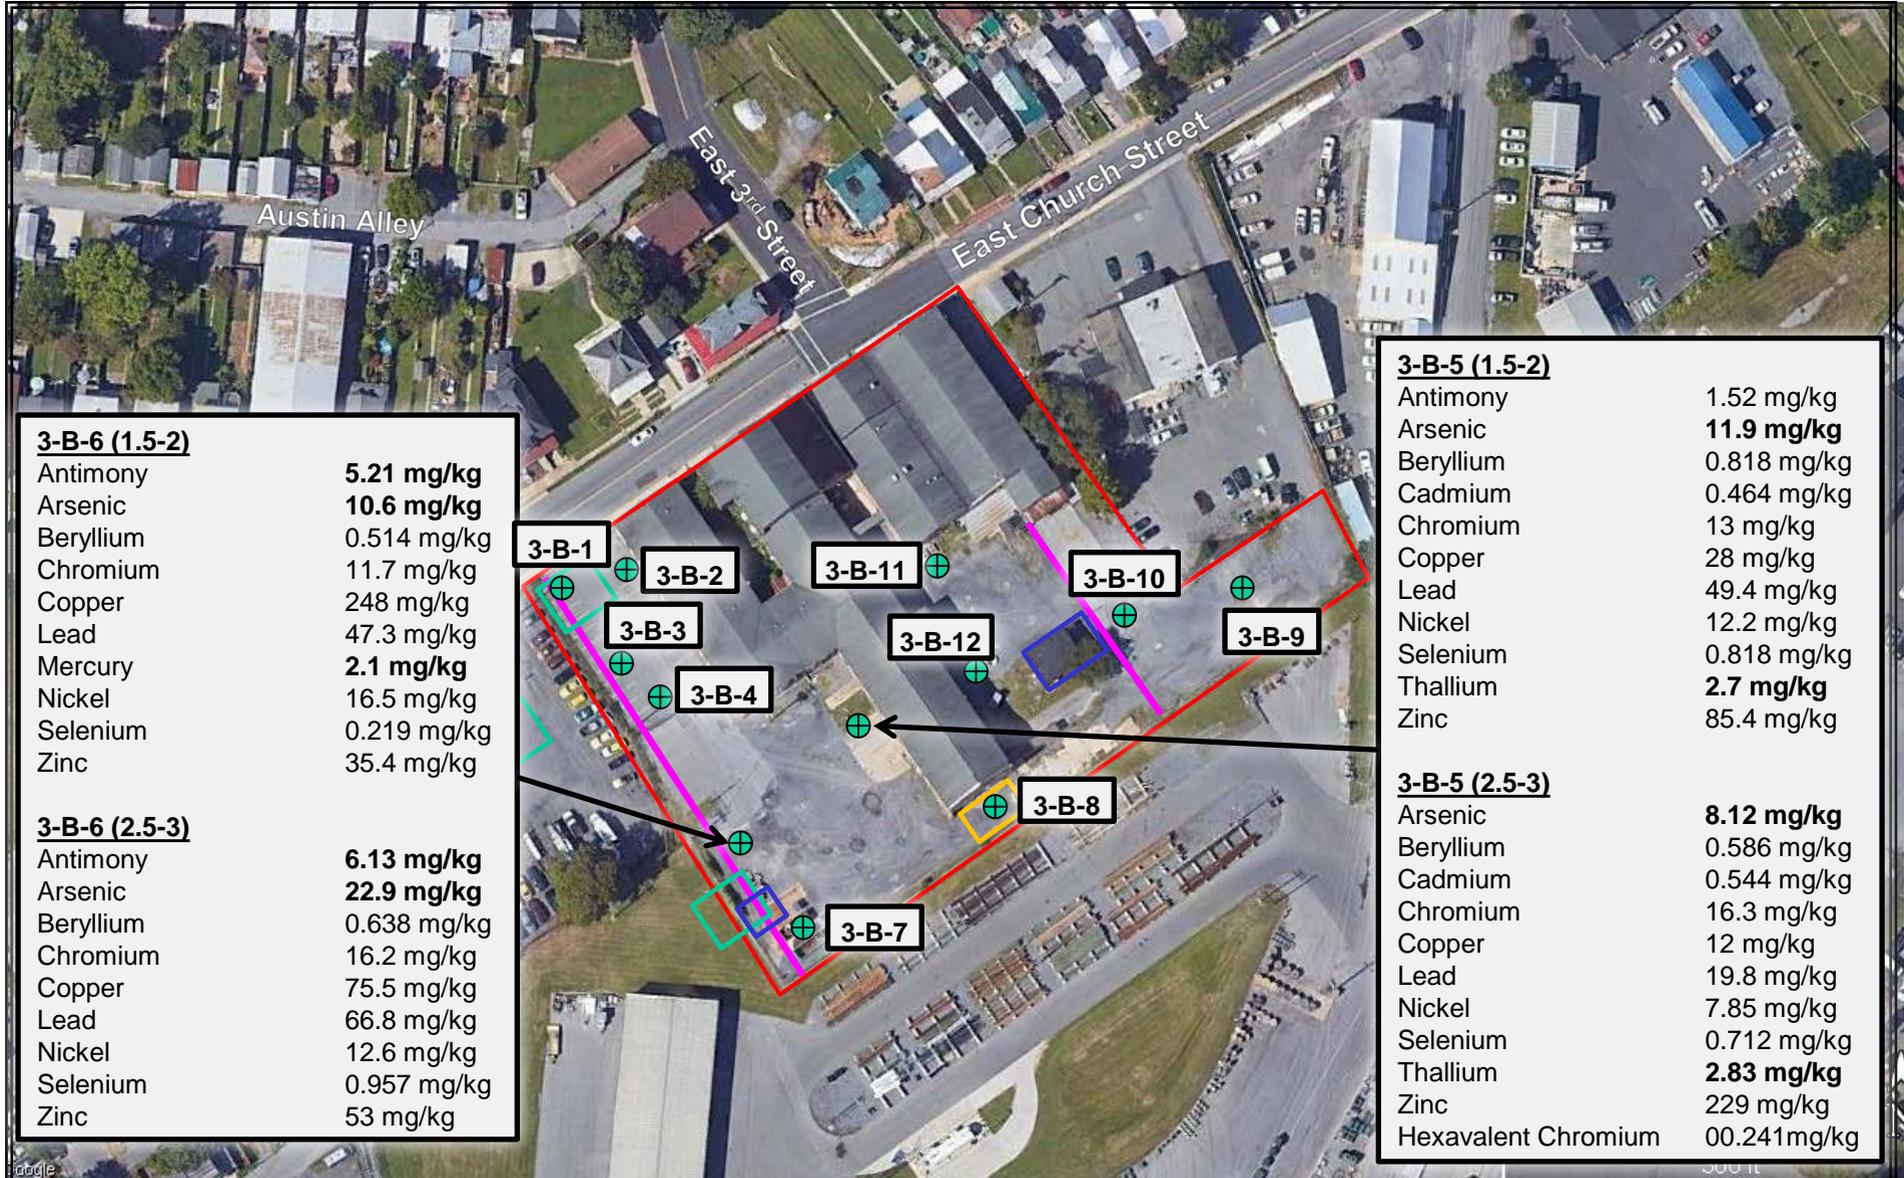
Figure 14c – Metals Soil Sample Results (July 23, 2019)  
 Ox Fibre Apartments  
 400 East Church Street  
 Frederick, Maryland 21701

Antimony	5.21 mg/kg
Arsenic	<b>10.6 mg/kg</b>
Beryllium	0.514 mg/kg
Chromium	11.7 mg/kg
Copper	248 mg/kg
Lead	47.3 mg/kg
Mercury	<b>2.1 mg/kg</b>
Nickel	16.5 mg/kg
Selenium	0.219 mg/kg
Zinc	35.4 mg/kg

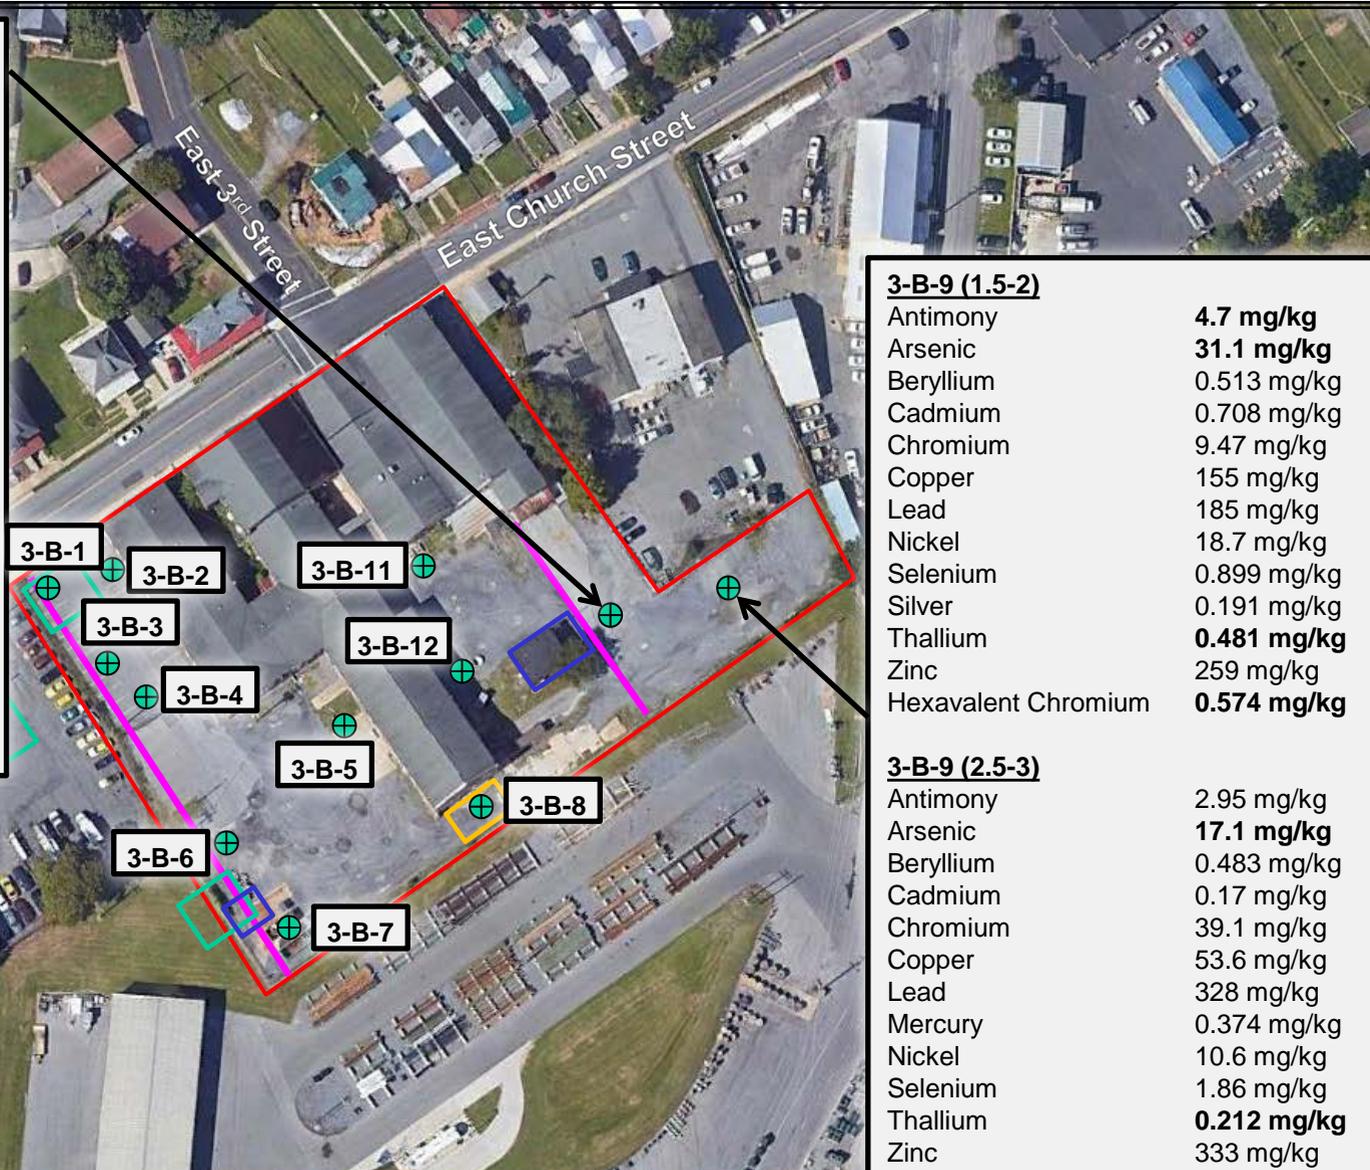
Figure 14e – Metals Soil Sample Results (July 23, 2019)  
 Ox Fibre Apartments  
 400 East Church Street  
 Frederick, Maryland 21701

Antimony	2.95 mg/kg
Arsenic	<b>17.1 mg/kg</b>
Beryllium	0.483 mg/kg
Cadmium	0.17 mg/kg
Chromium	39.1 mg/kg
Copper	53.6 mg/kg
Lead	328 mg/kg
Mercury	0.374 mg/kg
Nickel	10.6 mg/kg
Selenium	1.86 mg/kg
Thallium	<b>0.212 mg/kg</b>
Zinc	333 mg/kg

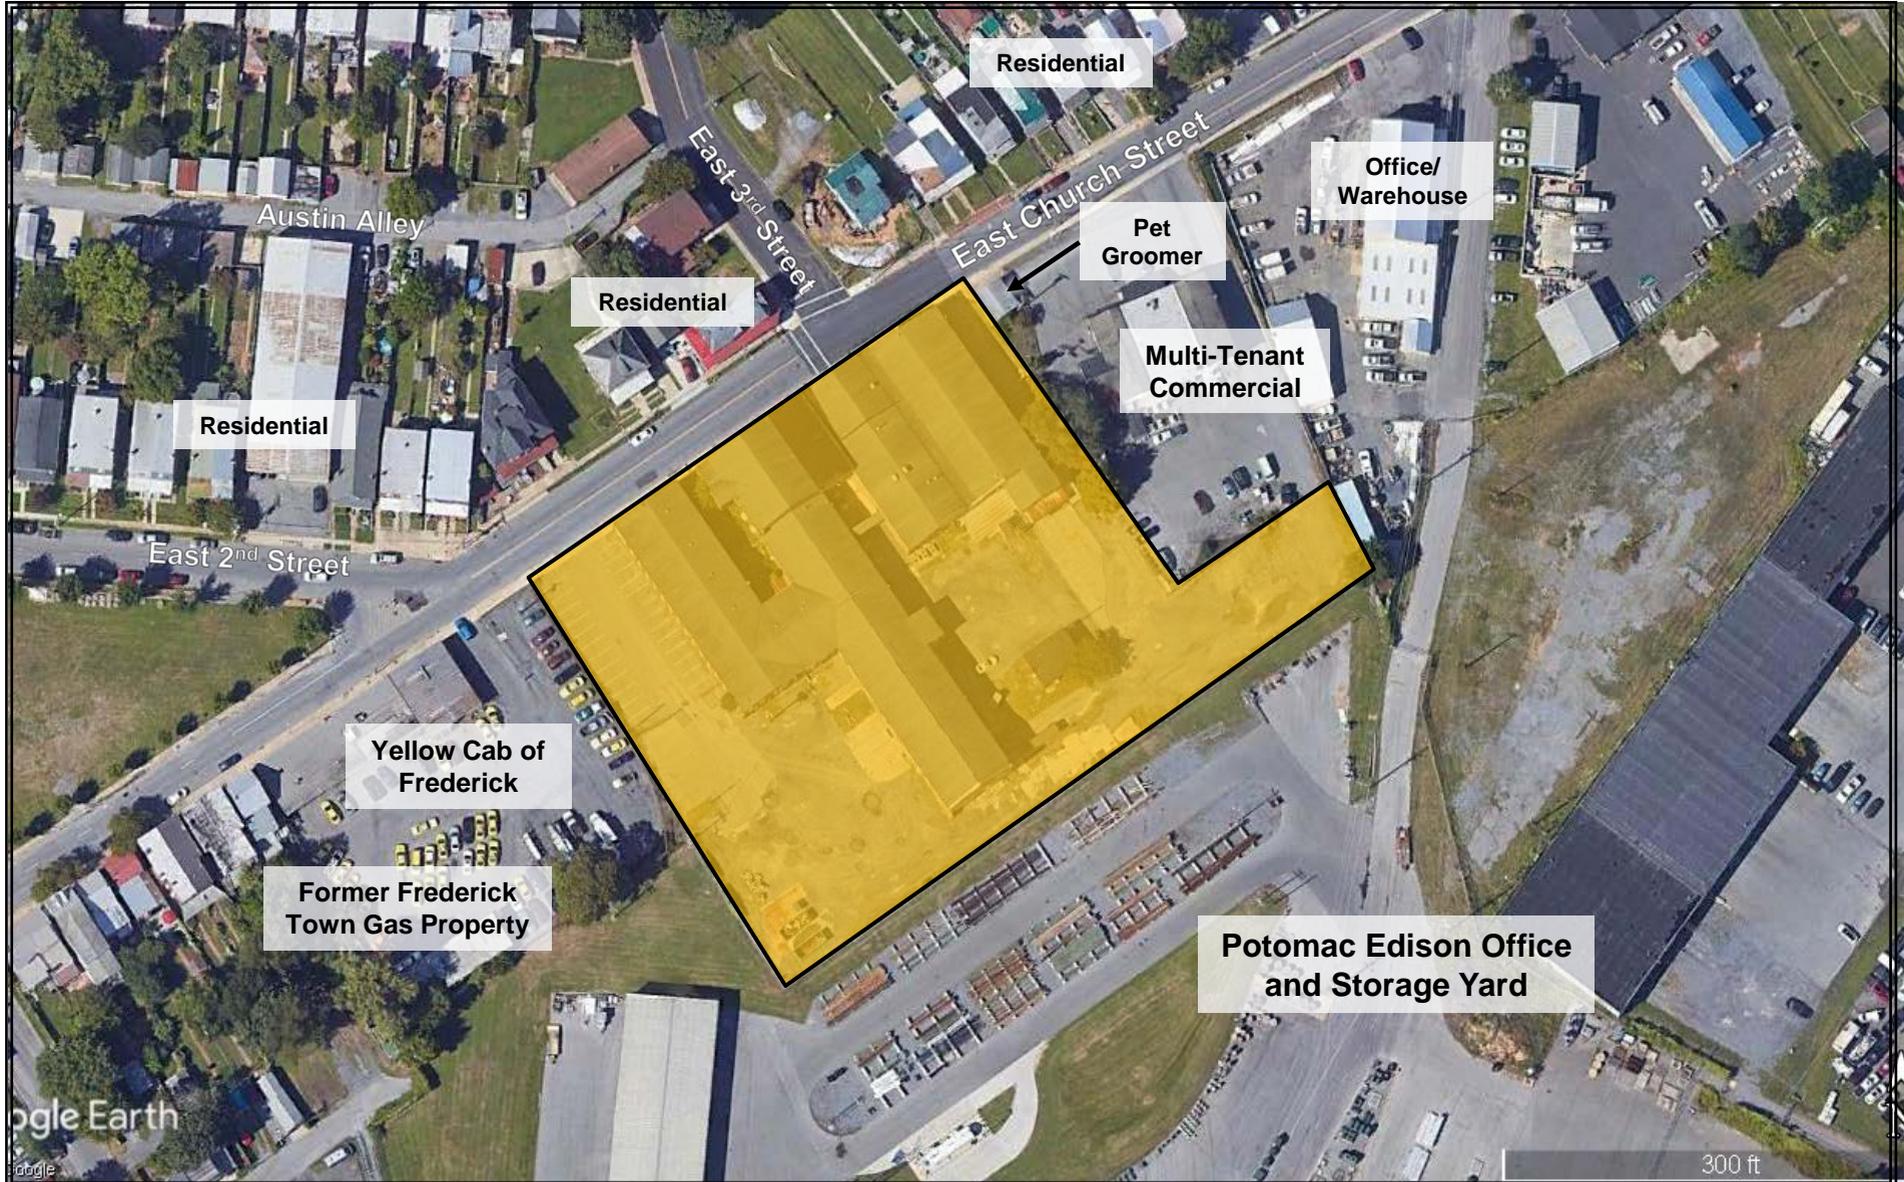
**Legend**  
 — = Site Boundary  
 [Yellow Box] = Excavation Restriction Area

Surface and subsurface soils are not anticipated to be encountered by residents due to the presence of the existing Site building foundation slab, paved exterior surfaces, and clean topsoil. In order to further ensure that surface and subsurface soils will not present an exposure risk a Containment Remedy Operations and Maintenance Plan (CROMP) will be developed and implemented in order to ensure that the existing slab beneath the building, pavement surfaces, and condition of topsoil will be maintained with yearly inspections. Written records documenting building slab, pavement, and topsoil maintenance will be maintained at the Site and available upon request. In addition, the CROMP will include excavation restrictions for the Site.
