Re: Excavation Completion Report
PORI Lagoon
Area B: Parcel B22
Tradepoint Atlantic
Sparrows Point, MD 21219

ARM Group LLC (ARM), on behalf of Tradepoint Atlantic, has prepared this Excavation Completion Report for response activities completed inside the former Palm Oil Recovery, Inc. (PORI) Lagoon, located on Parcel B22 on the Tradepoint Atlantic (TPA) property. The location of the PORI Lagoon is presented on **Figure 1**. The response actions were required to remove sediment accumulated in the PORI Lagoon that contained petroleum hydrocarbons and oil & grease that may serve as an ongoing source of contamination to groundwater downgradient of the lagoon.

**Excavation Photograph Log
Area B: Parcel B22 PORI Lagoon
Sparrows Point, Maryland**

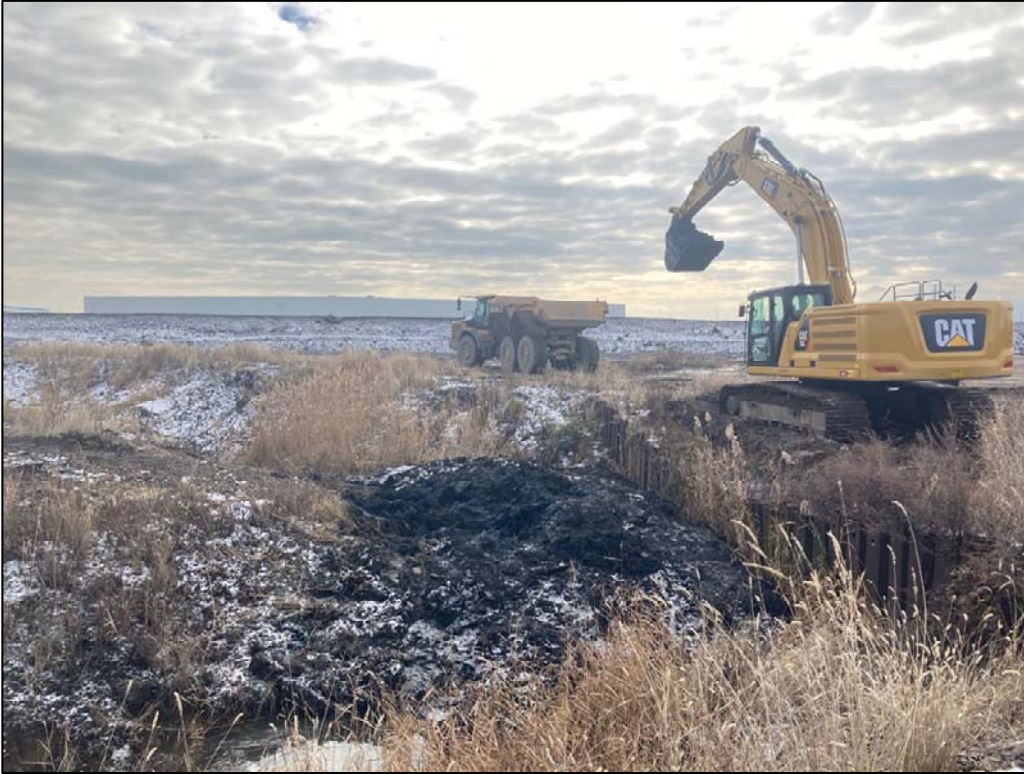
121820-1: Excavated material piled for drying within the lagoon.

Excavation of the PORI Lagoon occurred between December 17 and December 23, 2020. Wet sediment from within the lagoon was stockpiled on the lagoon's sidewalls to allow the material to dry prior to transport to the on-site Greys Landfill. To allow for more efficient drying of the material, sediment with higher moisture content was stockpiled above the lagoon's bank. A bermed drying pad was constructed for this material and covered with polyethylene sheeting. Liquids drained from the wet material flowed into the lagoon.

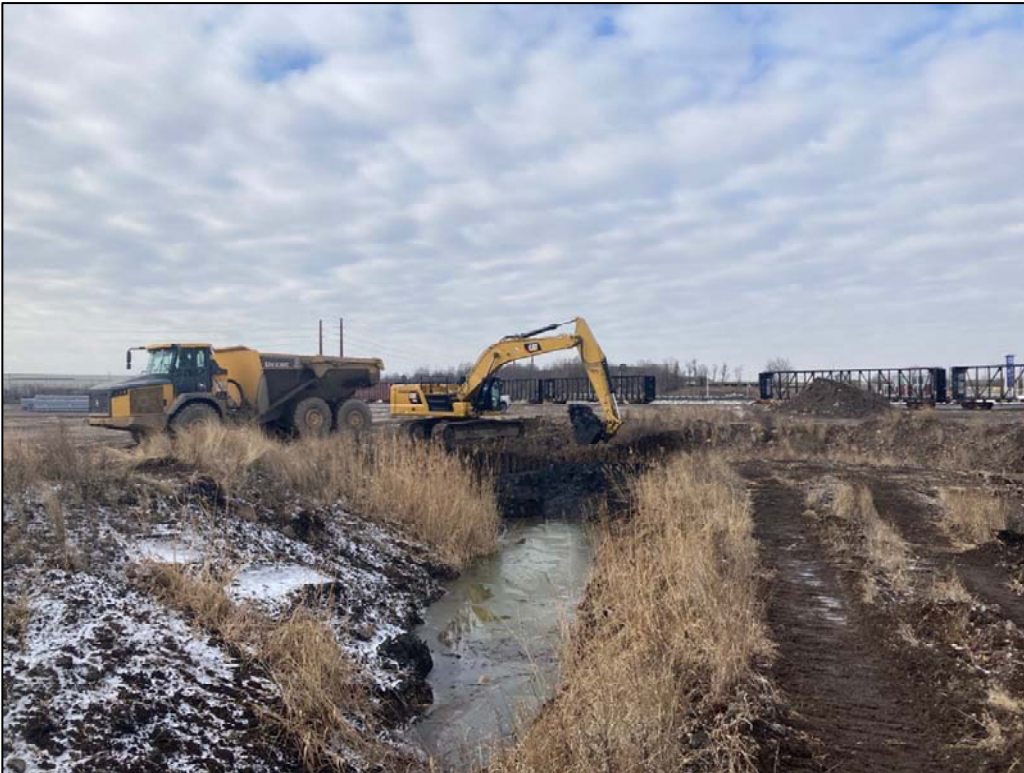
121820-2: Dried material being loaded for transport to Greys Landfill.

Prior to transporting the material to Greys Landfill, two composite sediment samples were collected from within the lagoon and submitted to Caliber Analytical Services for laboratory testing for TCLP parameters (VOCs, SVOCs, and metals) and PCBs. Each composite sample from the sediment consisted of 10 randomly selected grab aliquots. The analytical laboratory reports are provided as an electronic attachment. The analytical data is presented on **Table 1**. All results indicated that the PORI Lagoon materials were non-hazardous, and thus appropriate for disposal at Greys Landfill.

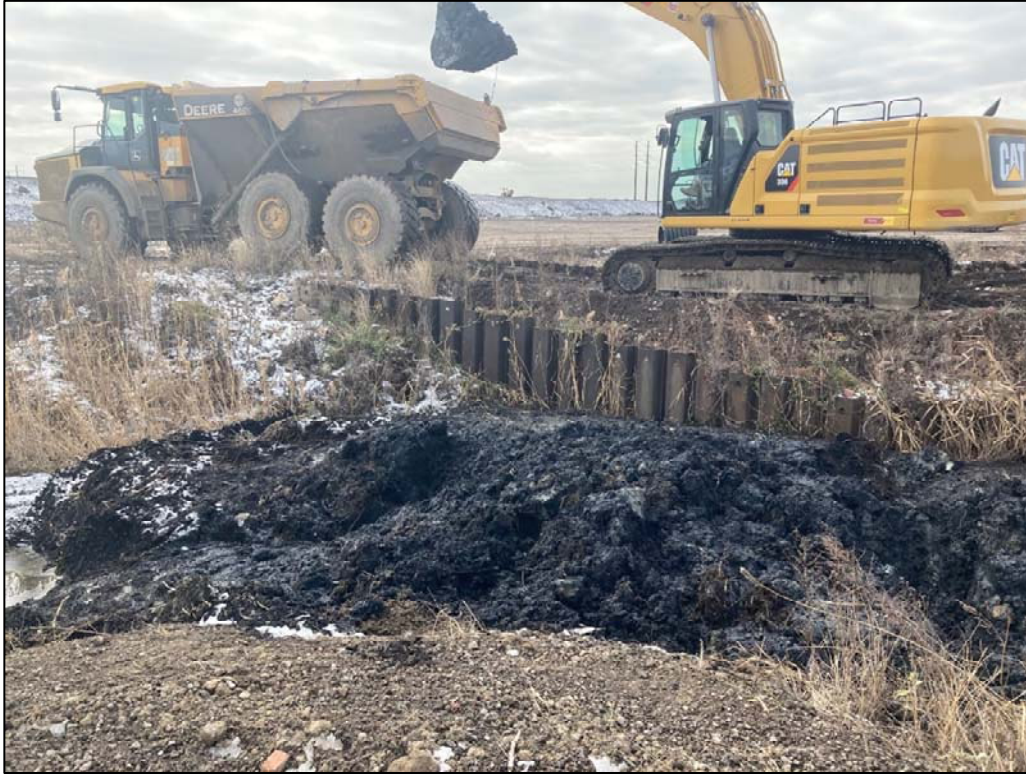
121820-3: Material placed within the lagoon for drying. Historic sheet piling observed in some sections of the PORI Lagoon's sidewalls was left in place.

Test pitting was completed to understand the approximate area and volume of the dark, oily sediment within the lagoon. During the test pitting activities, TPA was able to confirm the sidewalls (including sheet piling in certain areas) and the bottom of the lagoon. Test pitting reached either concrete or hard pack bottom and located the invert of the lagoon's inactive outfall. The "lagoon" actually consists of a fairly narrow conveyance channel and is not in fact a "lagoon." The sediment was found to be located within the channel with a bottom width of approximately 12 to 15 feet that is laid out in a U-shape. Soil forming the banks of this channel did not show visual contamination. The depth of the sediment within the lagoon was also investigated through test pitting. A structural hard bottom or a hard compacted soil bottom was observed between 4 and 6 feet below the surface of the contaminated sediment, which coincided with the approximate water table elevation.

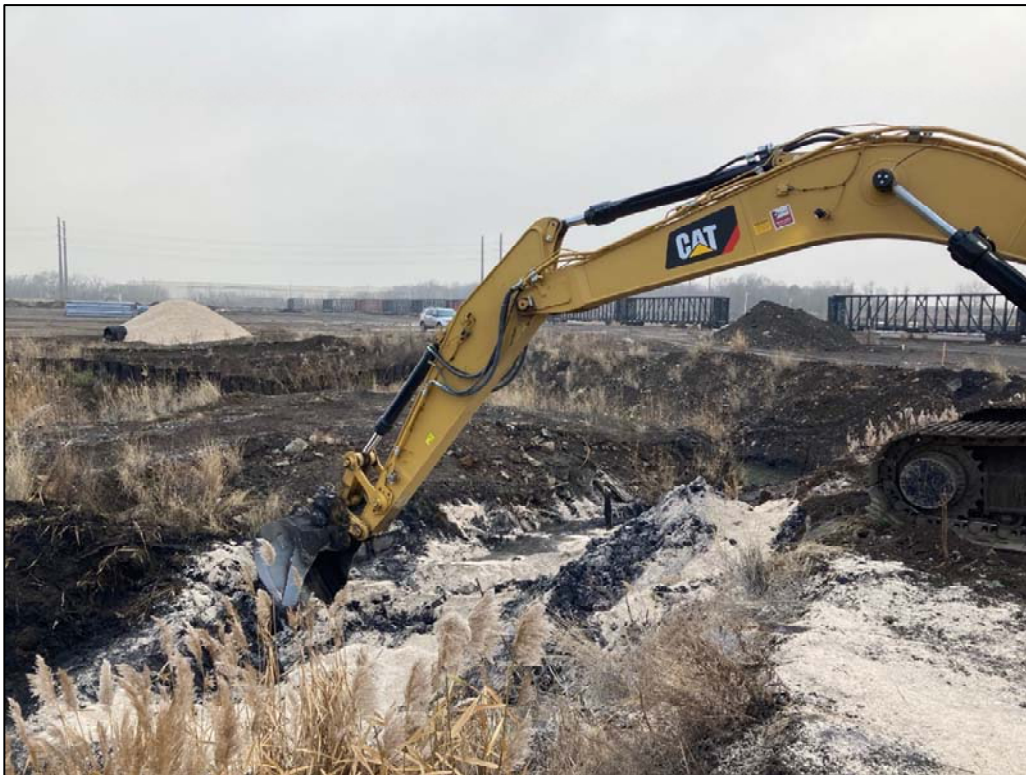
122120-1: Excavated material combined with calcite to accelerate the drying process.

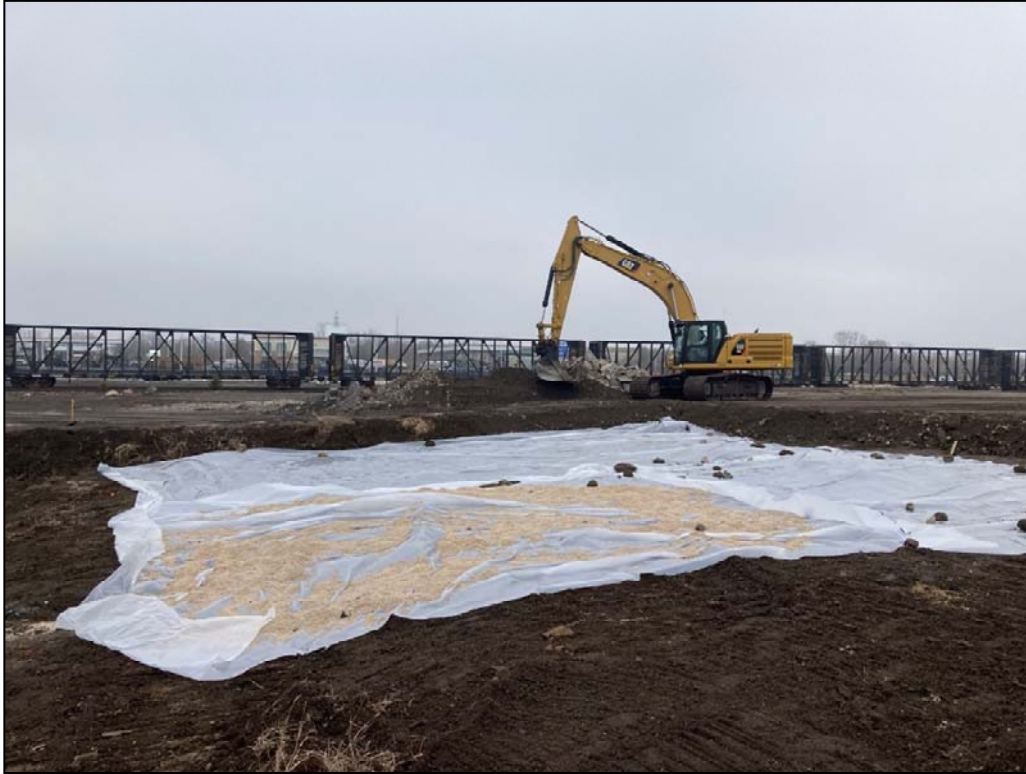
122120-2: Material dry-out pad constructed with polyethylene sheeting and a berm. The dry-out pad allowed liquids drained out of the excavated material to drain into the lagoon.

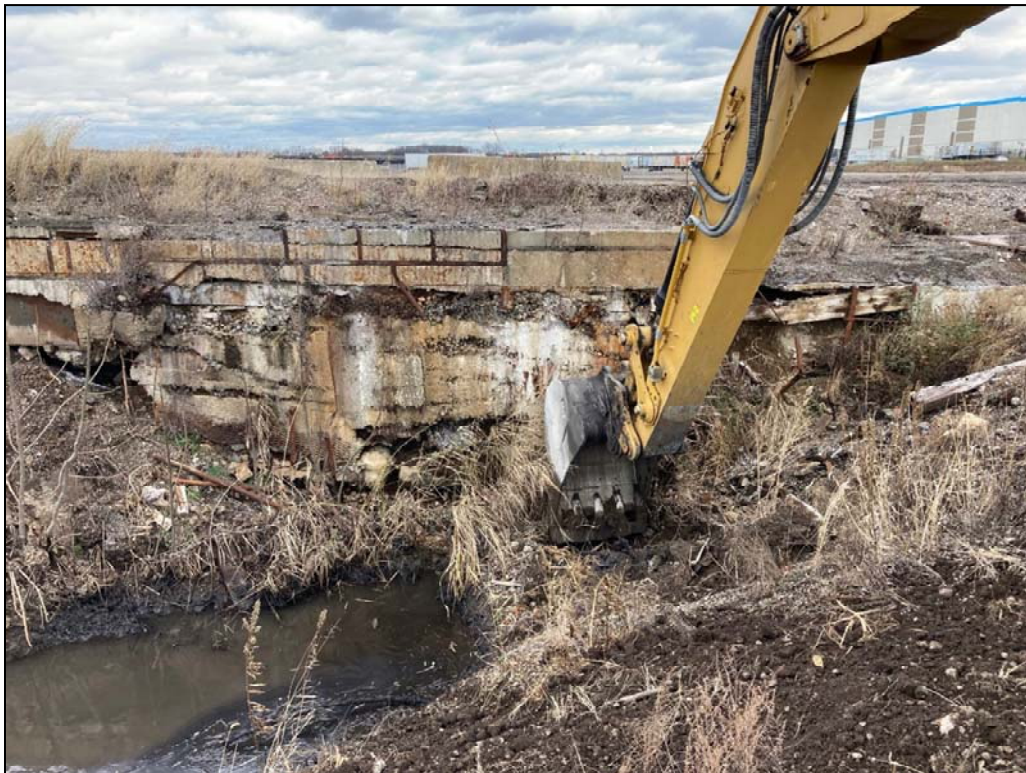
122220-1: Material excavation in the southeastern end of the lagoon.

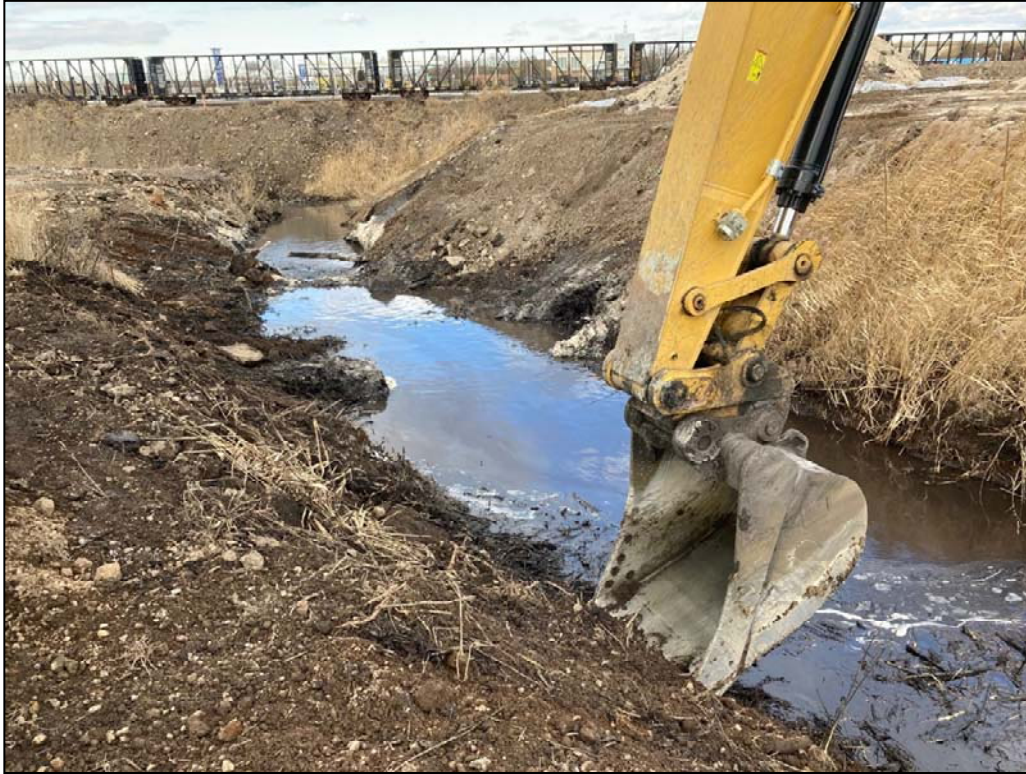
122220-2: Excavator bucket completing confirmation sampling at the approximate water table elevation.

Near the completion of the excavation, confirmation soil samples were collected at nine perimeter locations within the channel that had formerly contained the excavated sediment. Samples were collected from the material in the bank of the lagoon at the approximate water table elevation. The locations of the samples are presented on **Figure 2** and the results of the sampling are presented on **Table 2**. The maximum concentrations of TPH-DRO and Oil & Grease in the confirmation samples are generally an order of magnitude lower than the average levels observed in the samples of accumulated sediments from the pre-excavation test pits. The results for the PAHs were also compared against the health-based criteria established by MDE for the screening of sediments in the Tin Mill Canal. These criteria were the respective USEPA industrial soil Regional Screening Levels (RSLs) set to a hazard index of 10 and a cancer risk of 1×10^{-4} (i.e., Adjusted RSLs). None of the PAH concentrations in the confirmation samples exceeded these adjusted RSL values. The laboratory report for the confirmation samples is also included as an electronic attachment.

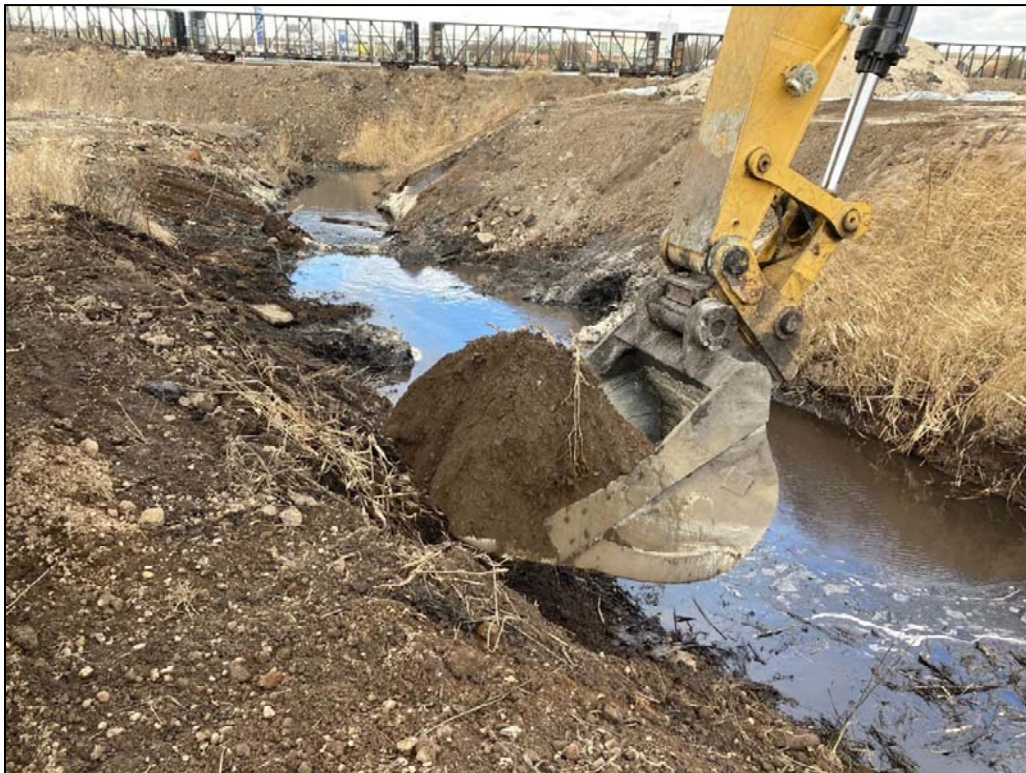
122220-3: Material collected from the lagoon sidewall for confirmation sampling. Material from the lagoon sidewalls did not have the oily appearance of the material from within the lagoon's channel bottom.

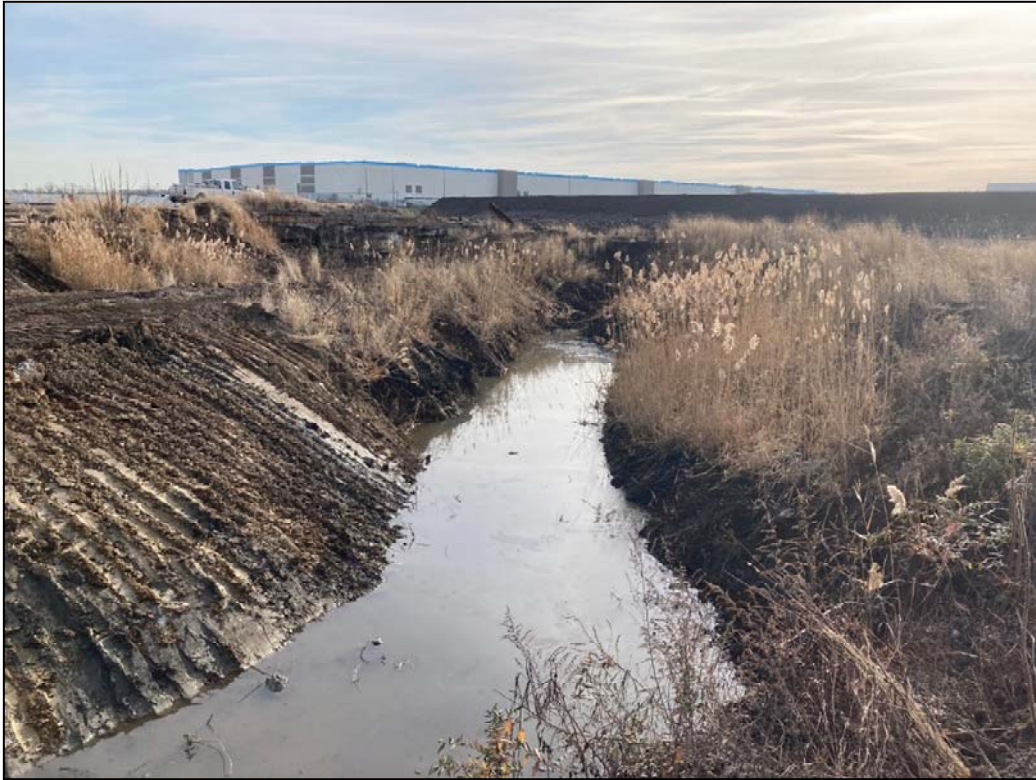
122320-1: The western portion of the PORI Lagoon near the completion of material removal.

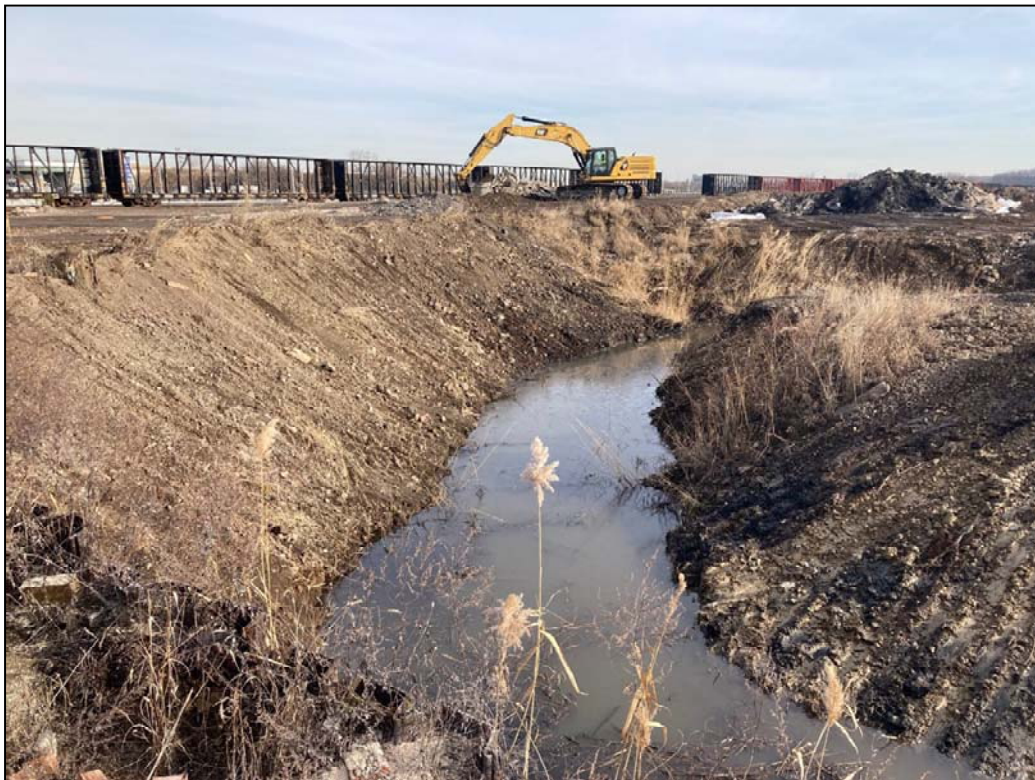
122320-2: The northern portion of the PORI Lagoon near the completion of material removal.

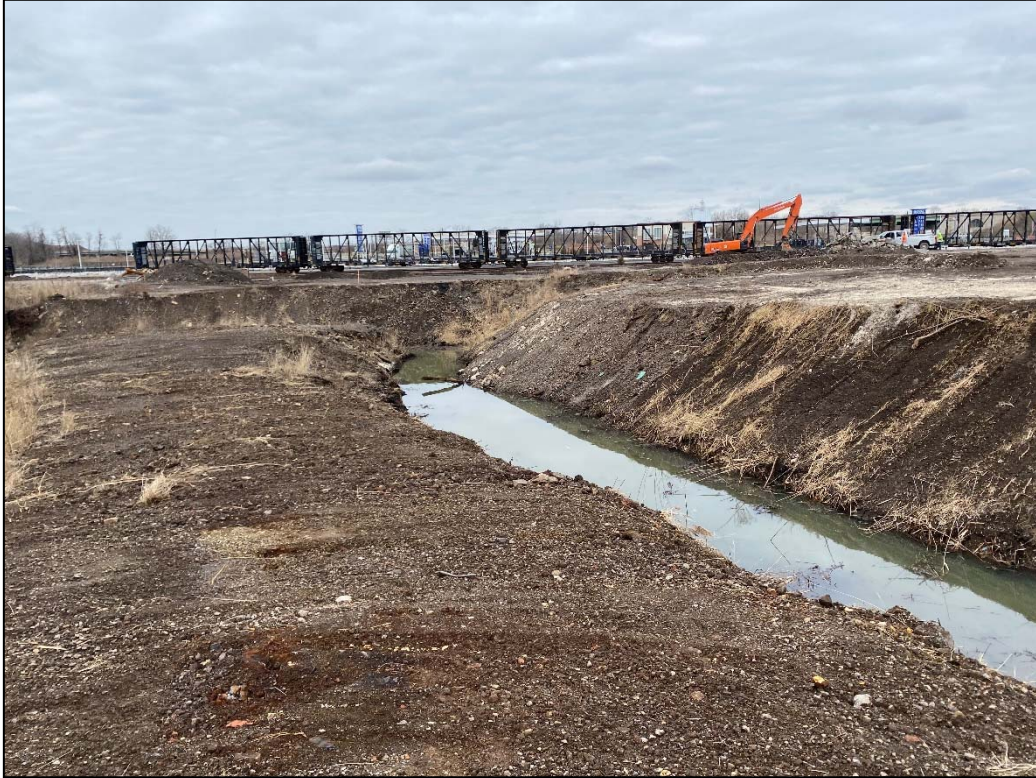
010521-1: The eastern portion of the PORI Lagoon following the completion of material removal.

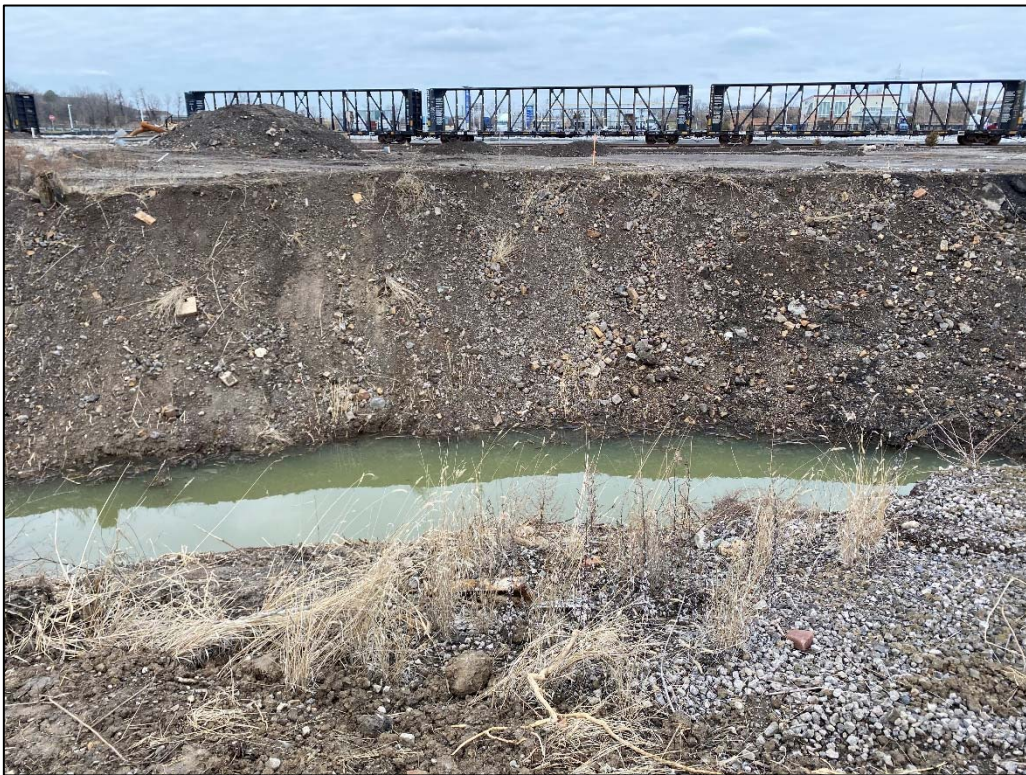
010521-2: The northern portion of the PORI Lagoon following the completion of material removal.

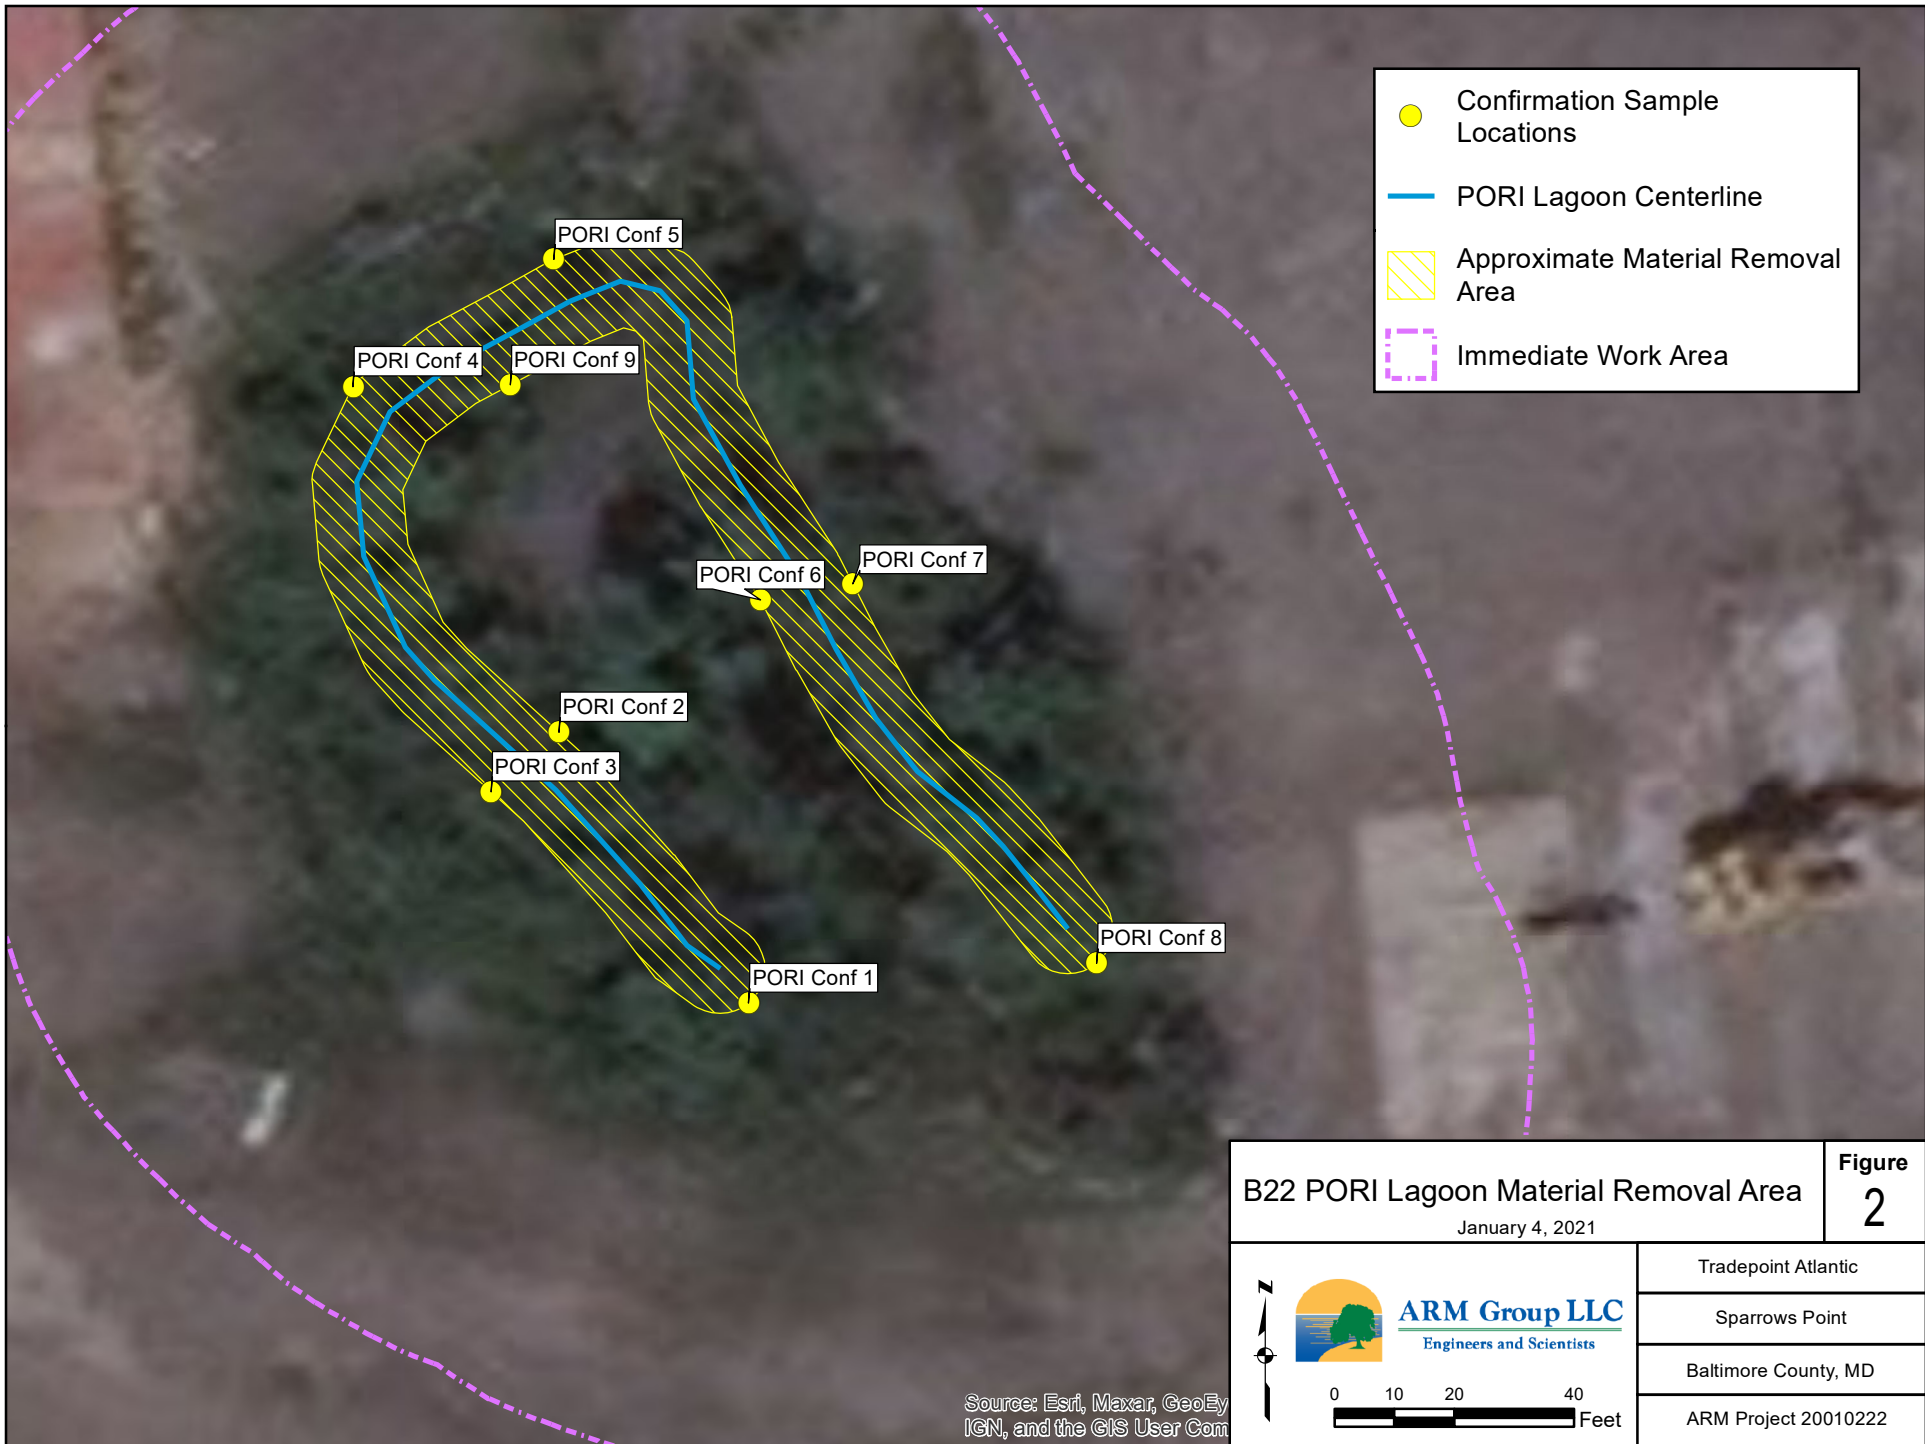
B22 PORI Lagoon Material Removal Area January 4, 2021		Figure 2

The horizontal and vertical extent of the lagoon channel were confirmed and the test pitting illustrated that sediment removal was feasible and the most effective means of source control. Therefore, TPA proceeded with the process of source control through direct removal. Where feasible, excavation extended at least three feet past the original bottom. The area of sediment removal is presented on **Figure 2**.

- Confirmation Sample Locations
- PORI Lagoon Centerline
- Approximate Material Removal Area
- Immediate Work Area
