ARM Group LLC

Re: PORI Lagoon Characterization Report
Area B: Parcel B22
Tradepoint Atlantic
Sparrows Point, MD 21219

ARM Group LLC (ARM), on behalf of EnviroAnalytics Group, LLC (EAG), has prepared this Palm Oil Recovery, Inc. (PORI) Lagoon Characterization Report for soil and groundwater investigation activities completed within the PORI Lagoon area in Parcel B22 (the Site) on the Tradepoint Atlantic (TPA) property located in Sparrows Point, Maryland. The location of the PORI Lagoon within the larger TPA property is indicated on **Figure 1**.

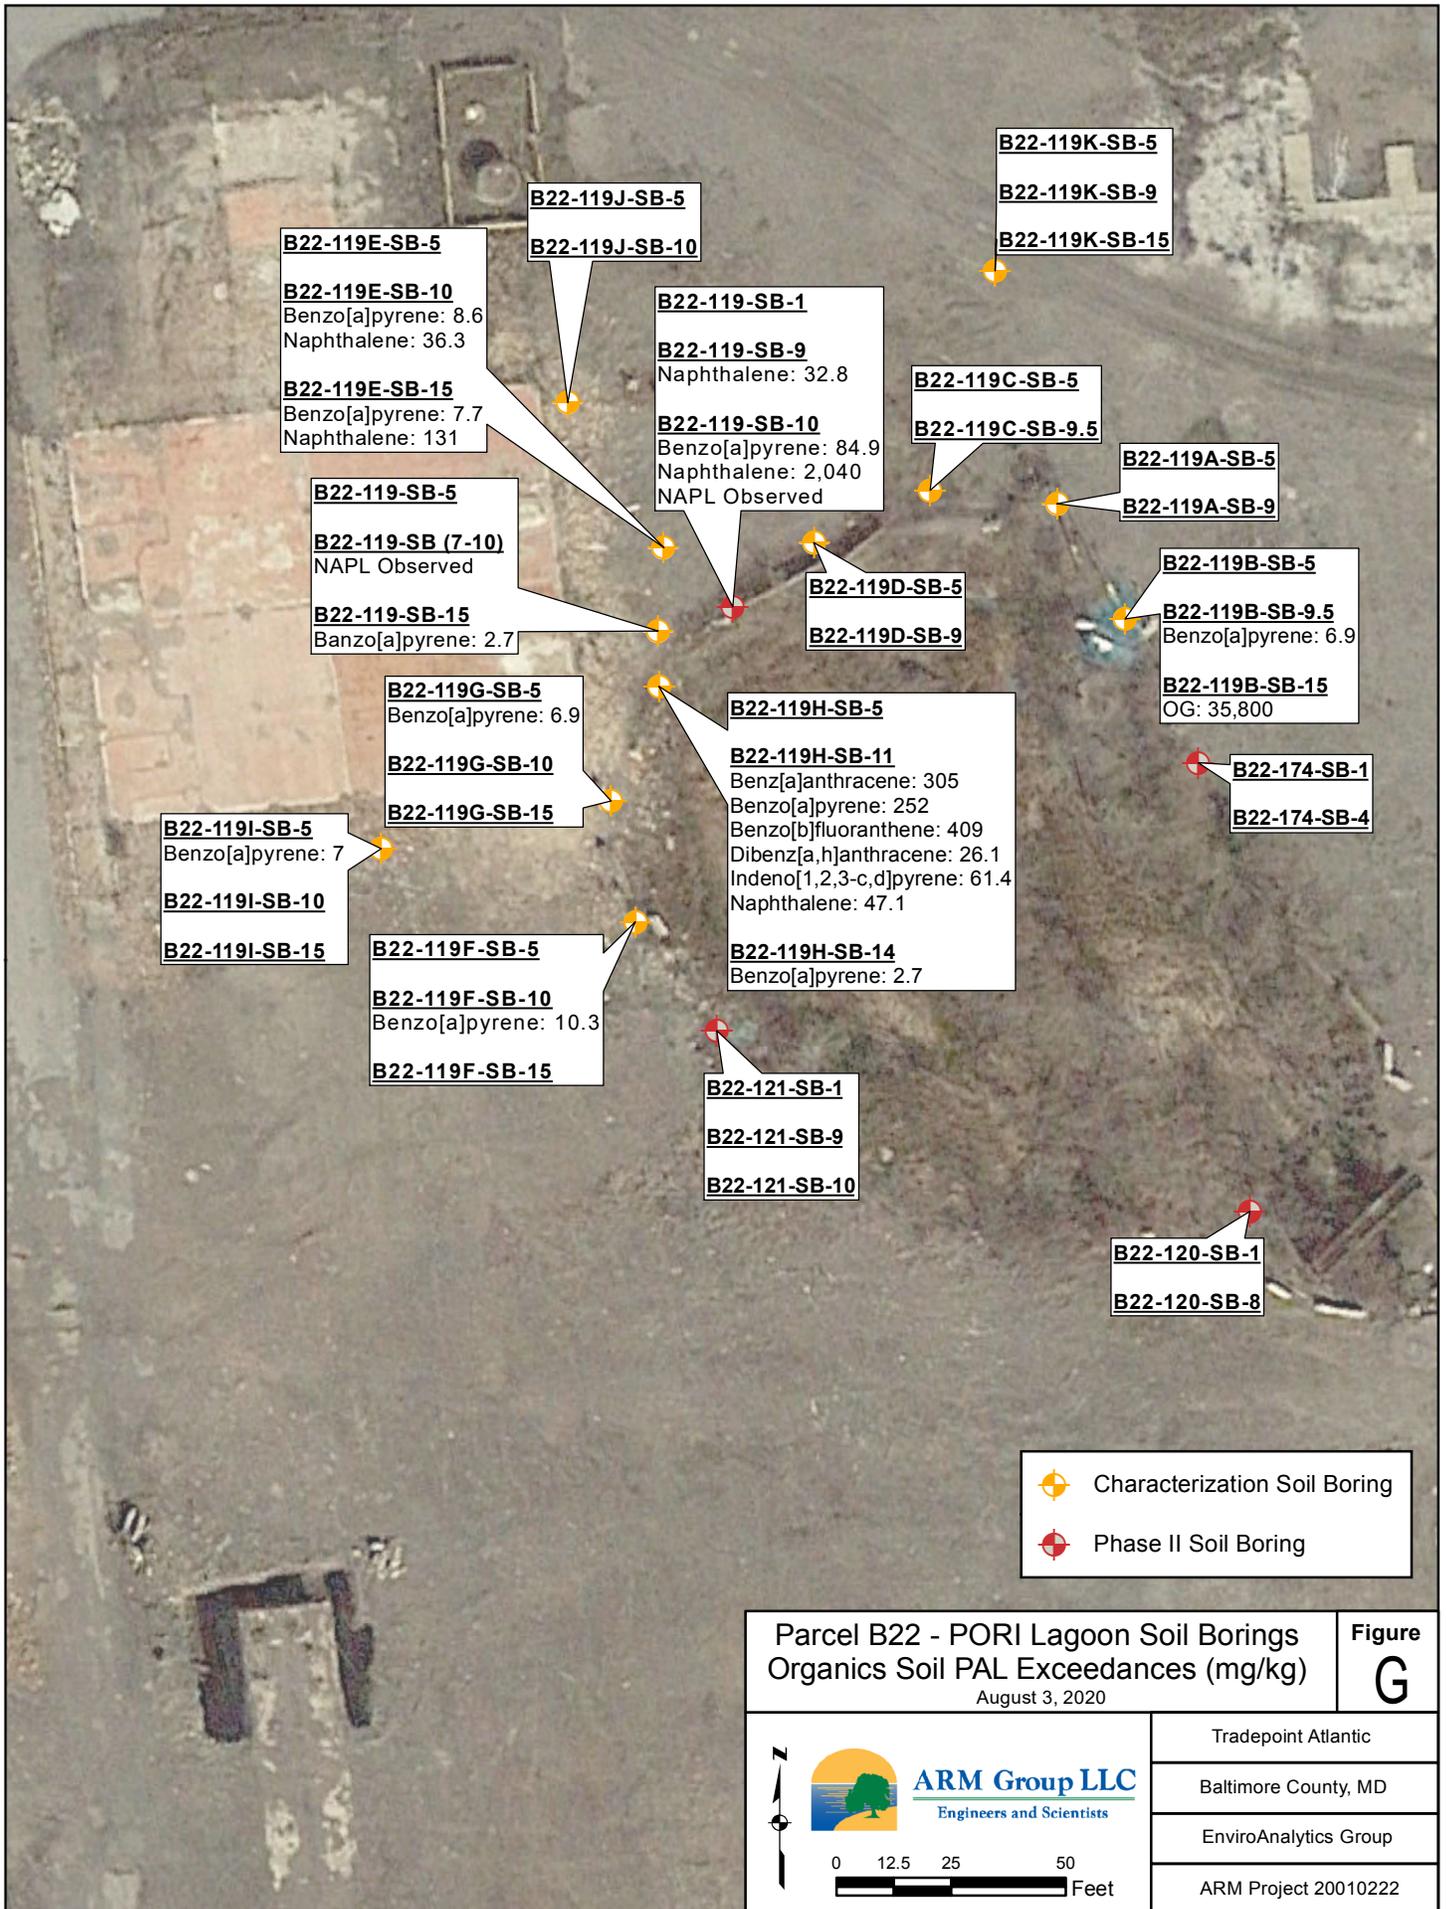
Parcel B22 - PORI Lagoon Soil Borings Organics Soil PAL Exceedances (mg/kg) August 3, 2020		Figure G
ARM Group LLC Engineers and Scientists		
		Tradepoint Atlantic Baltimore County, MD EnviroAnalytics Group ARM Project 20010222

Table 1 shows that seven out of 12 soil borings (B22-119-SB, B22-119B-SB, B22-119E-SB, B22-119F-SB, B22-119G-SB, B22-119H-SB, B22-119I-SB) had concentrations of naphthalene and/or benzo[a]pyrene detected in one or more soil samples above their respective Project Action Limits (PALs). Several other PAHs were identified above their respective PALs in sample B22-119H-SB-11 only. Oil & Grease exceeded its PAL of 6,200 mg/kg in sample B22-119B-SB-15 with a detected concentration of 35,800 mg/kg. The soil boring PAL exceedance locations and results are shown on **Figure 2**. During the original Phase II Investigation in 2016, there were elevated concentrations of naphthalene and benzo[a]pyrene in sample B22-119-SB-10 (corresponding with observations of NAPL). B22-119-SB was re-installed during this supplemental investigation, and NAPL was again observed in the soil core (7 to 10 feet bgs). NAPL was not observed in any other borings although odors were noted at several locations. The soil borings with the highest naphthalene and benzo[a]pyrene concentrations identified during this supplemental phase of investigation (B22-119E-SB and B22-119H-SB) were the two borings completed closest to the original boring B22-119-SB.

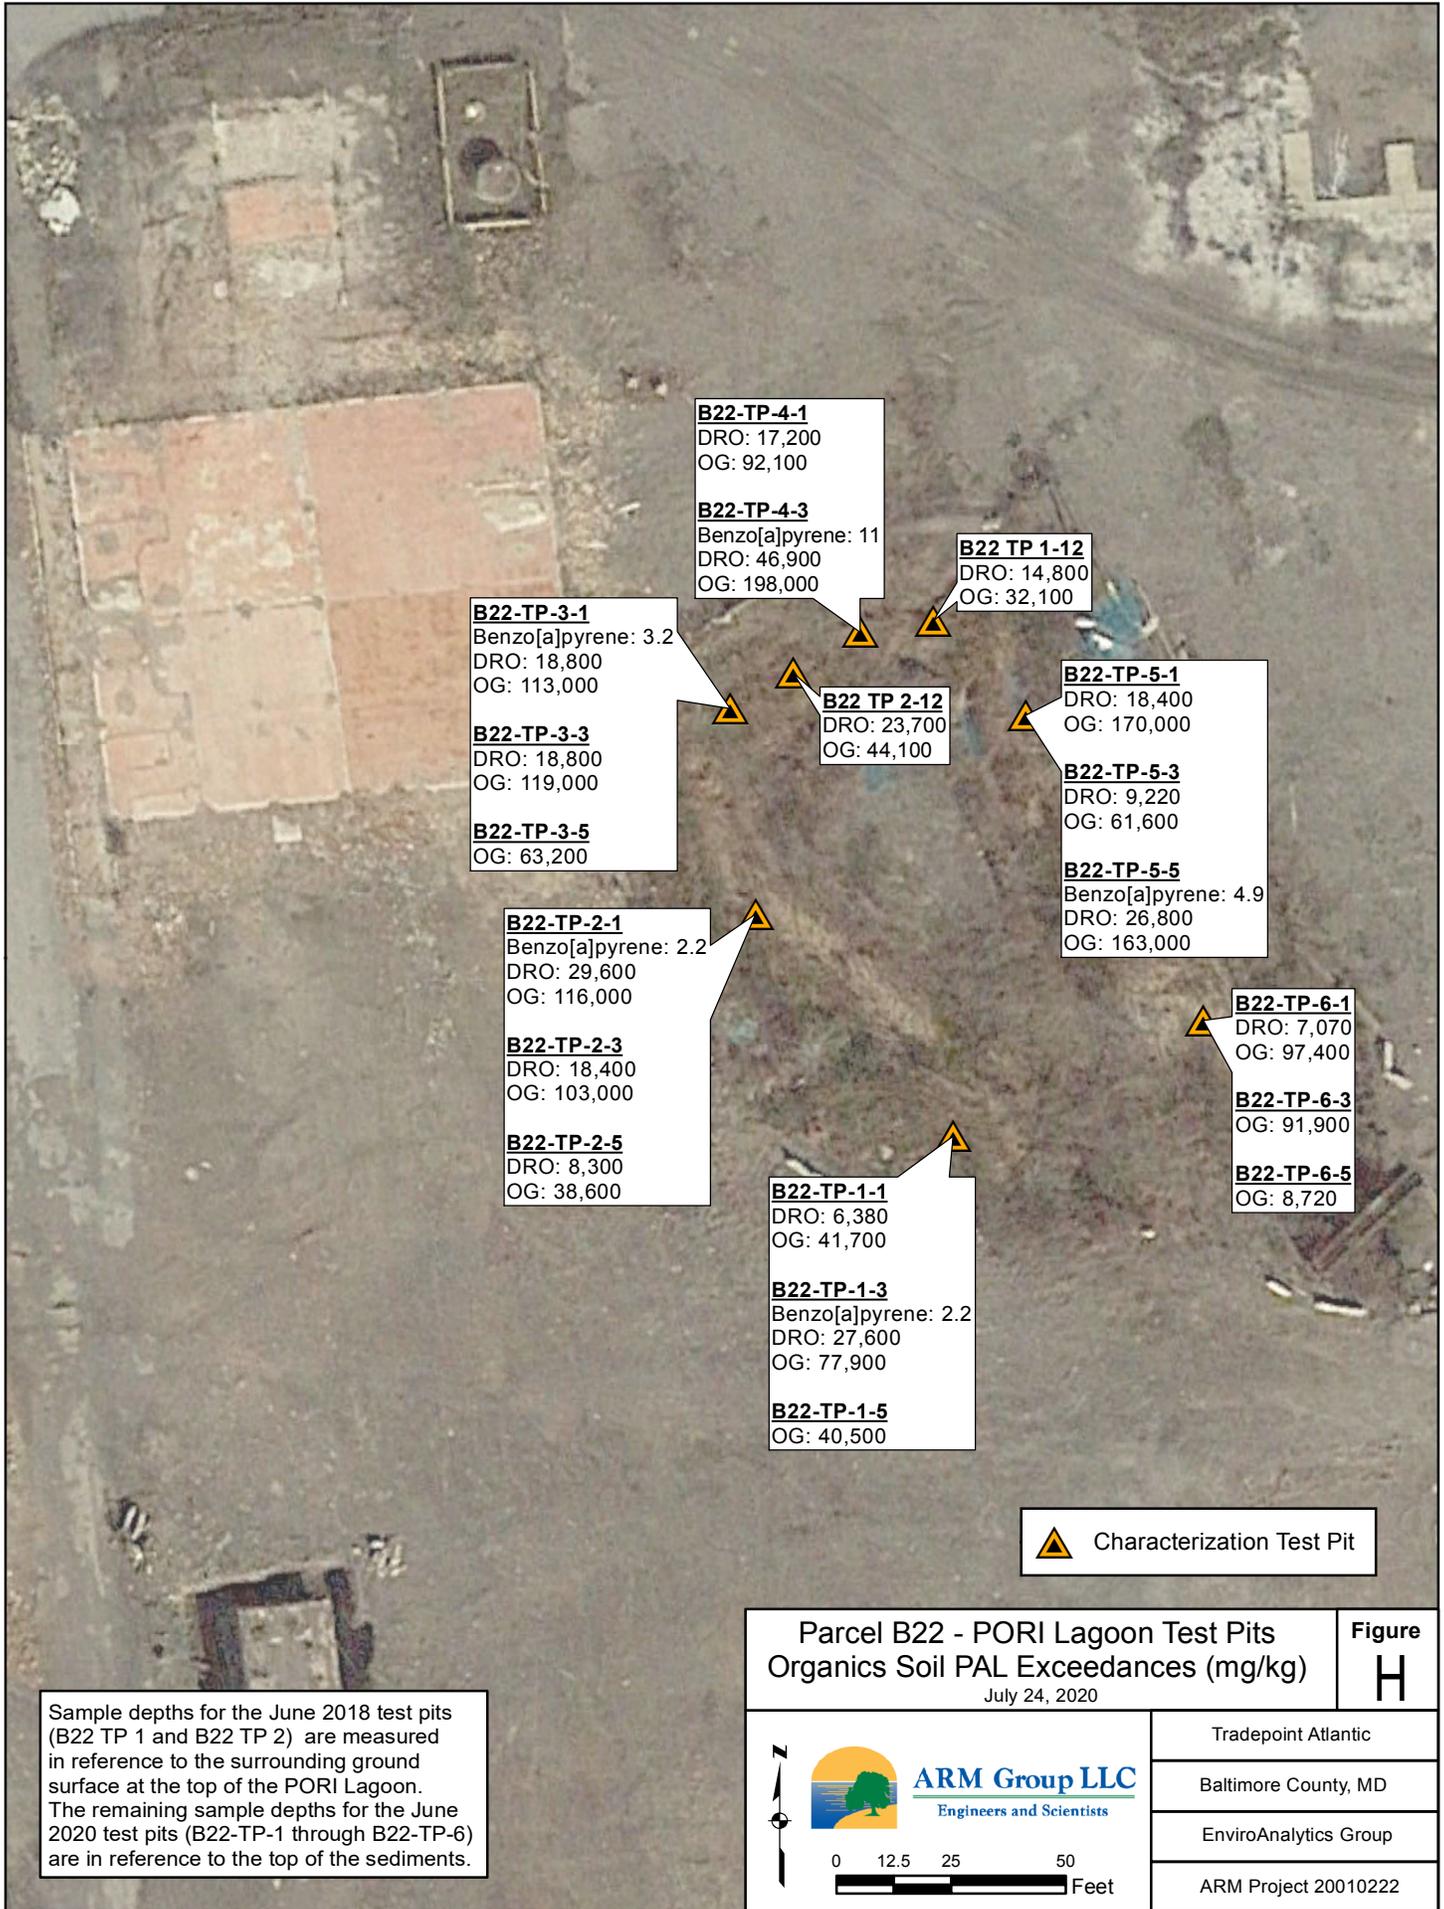
Sample depths for the June 2018 test pits (B22 TP 1 and B22 TP 2) are measured in reference to the surrounding ground surface at the top of the PORI Lagoon. The remaining sample depths for the June 2020 test pits (B22-TP-1 through B22-TP-6) are in reference to the top of the sediments.

Parcel B22 - PORI Lagoon Test Pits Organics Soil PAL Exceedances (mg/kg) July 24, 2020		Figure H
		Tradepoint Atlantic
		Baltimore County, MD
		EnviroAnalytics Group
		ARM Project 20010222

Two additional soil samples were collected from a depth of approximately 12 feet bgs (measured relative to the surrounding ground surface at the top of the PORI Lagoon) from the two test pit locations (B22 TP 1 and B22 TP 2). The results from these test pit soil samples are provided on **Table 2**. These test pit samples had naphthalene detections of 0.31 mg/kg and 0.26 mg/kg and benzo[a]pyrene detections of 0.62 mg/kg and 0.71 mg/kg, respectively. These detections were below the PALs for naphthalene and benzo[a]pyrene; however, TPH-DRO and Oil & Grease were both detected above the PAL of 6,200 mg/kg. The test pit PAL exceedance locations and results are shown on **Figure 3**.

The analytical soil results from the supplemental test pit samples are provided on **Table 2** (along with the results from the test pits completed in 2018). Each test pit sample collected on June 17, 2020 had an exceedance of TPH-DRO and/or Oil & Grease. Several elevated concentrations were identified among the test pit samples above the PAL of 6,200 mg/kg. The highest detected concentrations of TPH-DRO and Oil & Grease among all the test pit samples were 46,900 mg/kg and 198,000 mg/kg, respectively, both detected at B22-TP-4-3. A visible sheen was also observed in the excavator bucket (on the water) by the ARM field personnel providing oversight during the completion of B22-TP-4. Despite the elevated concentrations of TPH-DRO and Oil & Grease, the concentrations of VOCs and PAHs detected in the test pit soil samples were comparatively low. There were five PAL exceedances of benzo[a]pyrene among the test pits samples, with a maximum detected concentration of only 11 mg/kg in B22-TP-4-3. The test pit PAL exceedance locations and results from both investigation phases (2018 and 2020) are shown on **Figure 3**.

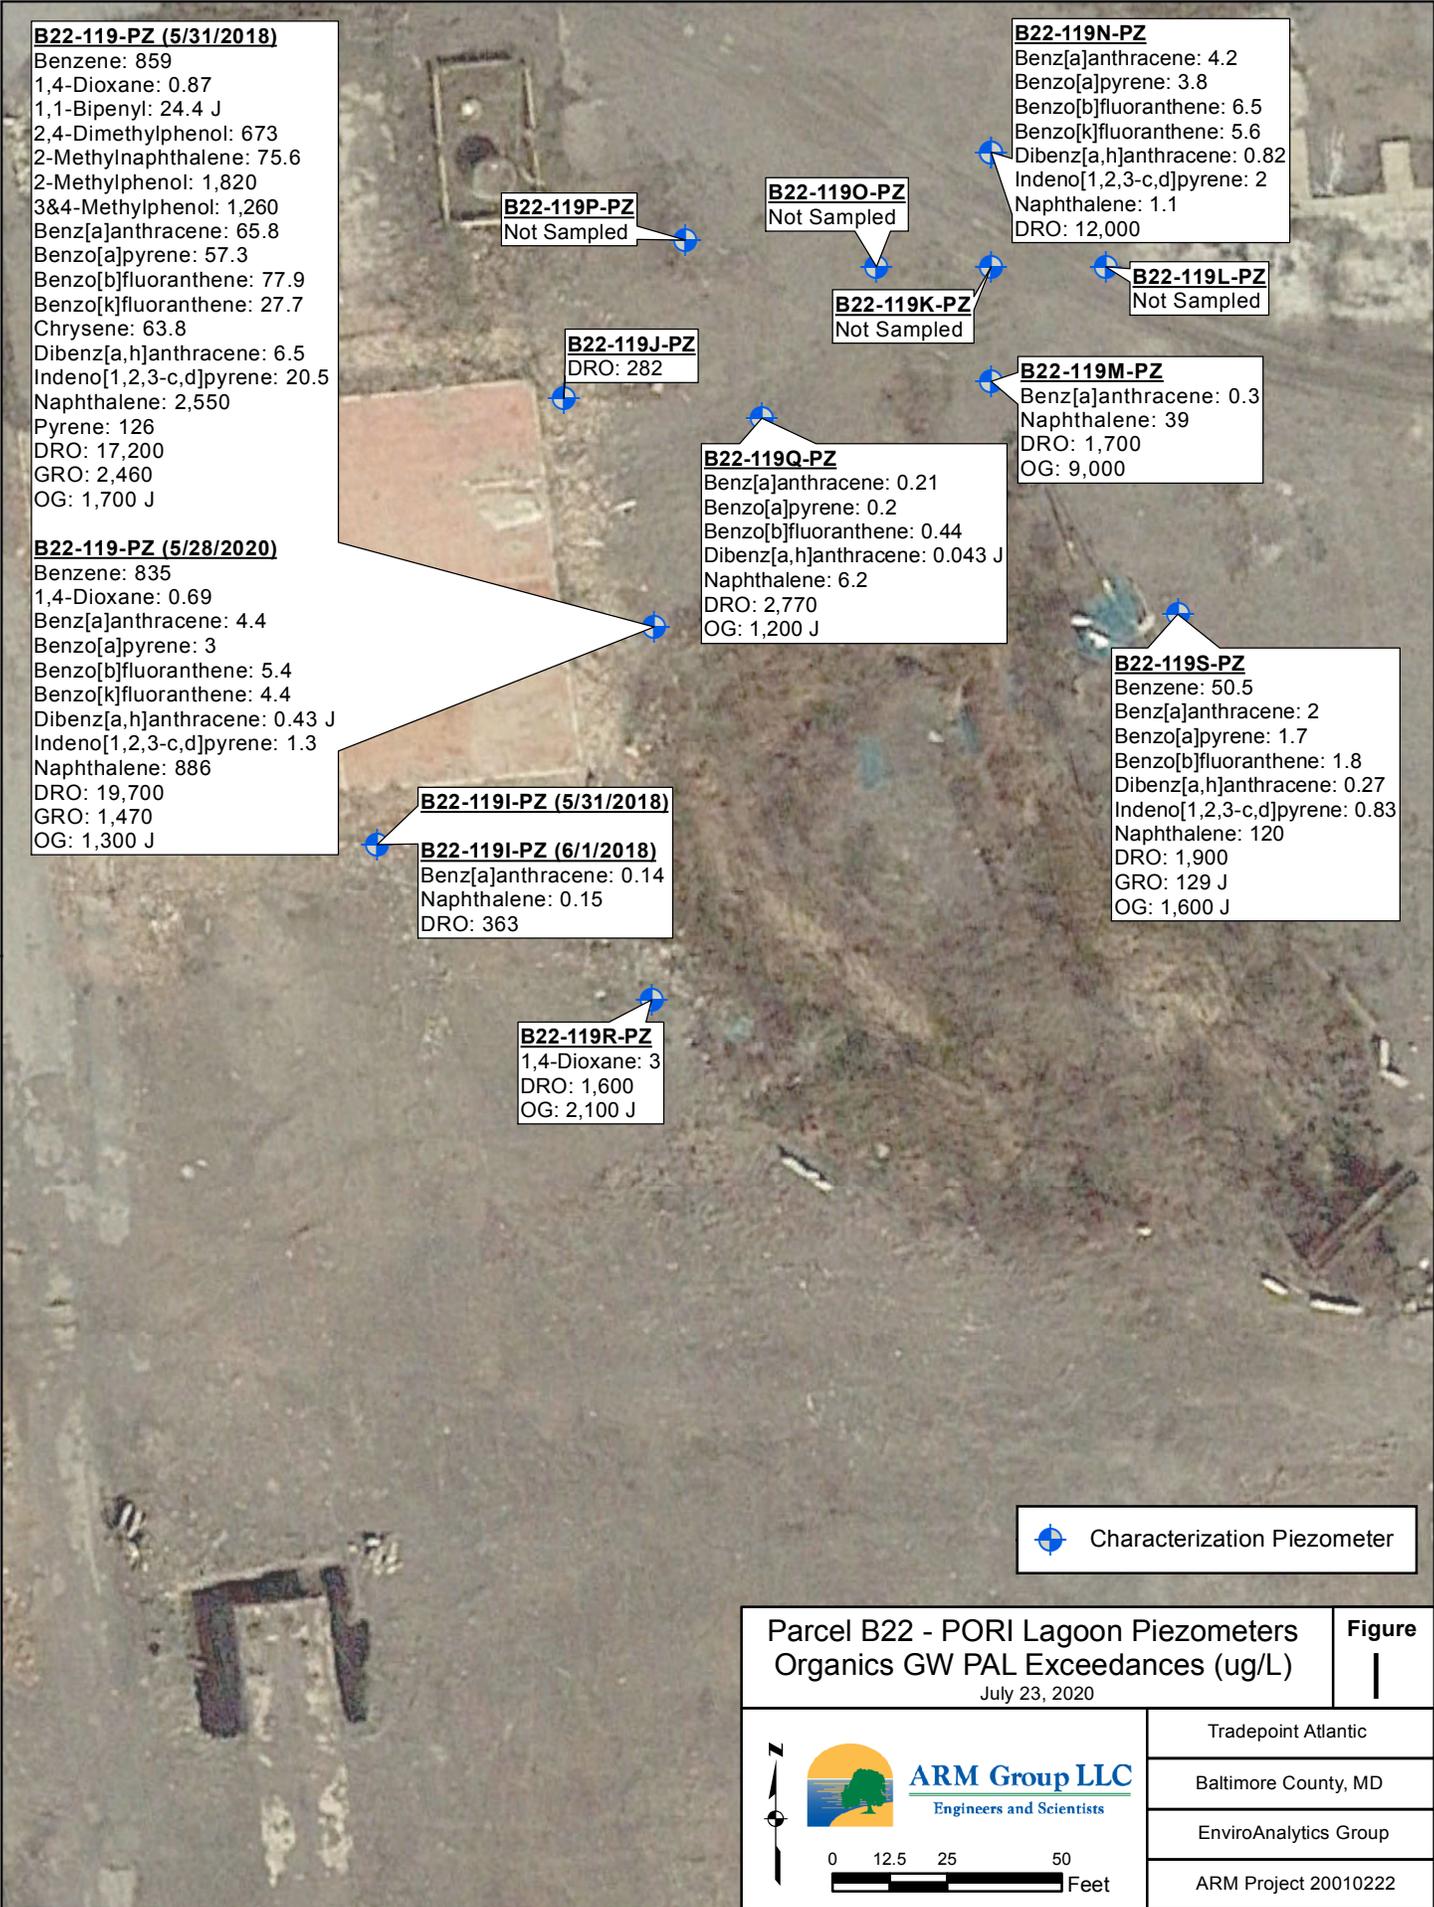
Parcel B22 - PORI Lagoon Piezometers
 Organics GW PAL Exceedances (ug/L)

observations of NAPL and heavy silt within the piezometer (as indicated on the purge log). The groundwater sample collected from B22-119-PZ, corresponding to the soil boring with observed NAPL and the highest concentrations of naphthalene and benzo[a]pyrene during the original Phase II Investigation, had aqueous PAL exceedances including TPH/Oil & Grease, various PAHs including naphthalene (2,550 µg/L) and benzo[a]pyrene (57.3 µg/L), and benzene (859 µg/L). The groundwater PAL exceedance locations and results are shown on **Figure 4**.

respectively. The groundwater PAL exceedance locations and results from both investigation phases (2018 and 2020) are shown on **Figure 4**.

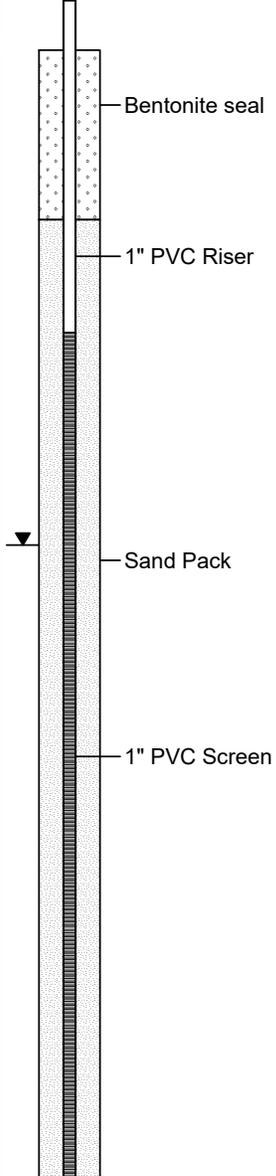
Depth (ft.)	% Recovery	PID Reading (PPM)	Sample No/Interval	DESCRIPTION	USCS	REMARKS
0	-	-		(0-5') SAND with GRAVEL, medium to dense, dark brown to black, no plasticity, no cohesion	SW	
60	0.7					Trace SLAG COBBLES throughout
	0.5					
5	1.3		B22-119-SB-5			Wood at 5.5' bgs
	-			(5-20') CLAY with SAND and GRAVEL, pale brown to bluish gray, firm, medium plasticity, cohesive, slightly moist to wet at 15' bgs		Oil throughout from 7-10' bgs, with prominent oil at 8' bgs and 9' bgs
90	180.9					SLAG GRAVEL lens at 7.5' bgs
	237.6					
10	18.5					
	-					
	10.2					
100	27.8				CL	
	1.4					
15	1.5		B22-119-SB-15			Wet at 15' bgs
	-					
	-					
90	-					Trace NAPL at 19' bgs
	-					
20	-			End of boring

Boring terminated at 20' bgs due to water and piezometer installation
 TOC: Top of PVC casing
 DTW: Depth to water
 bgs: Below ground surface
 AMSL: Above mean sea level

Riser Stickup: 2.86'
 Riser: 0 - 5' bgs
 Screen: 5 - 20' bgs [Slot Size: 0.010"]
 Sand Pack: 3 - 20' bgs [Grain Size: WG #2]
 Bentonite Seal: 0 - 3' bgs [Grain Size: 3/8" chips]

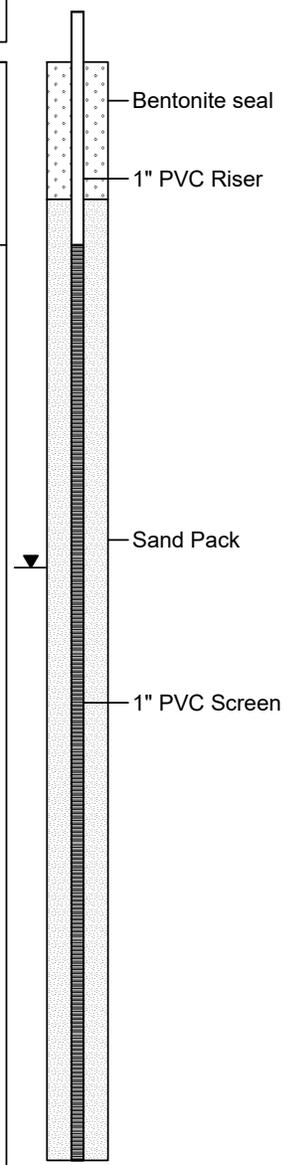
Depth (ft.)	% Recovery	PID Reading (PPM)	Sample No/Interval	DESCRIPTION	USCS	REMARKS
0	-	-		(0-4') SAND with GRAVEL, medium to fine, slightly moist, loose, light brown to pale yellow, no plasticity, no cohesion	SW	BRICK fragments from 1-4' bgs
0.5	80	4.4				
5	5.6	7.9	B22-119I-SB-5	(4-25') CLAY with SAND and GRAVEL, dark greenish gray to black, very firm, moist, medium plasticity, cohesive		Odor at 5' bgs
3.7		2.4				
10	100	0.2				
		0.4	B22-119I-SB-10			
15	70	-			CL	
		-	B22-119I-SB-15			
20	100	-				
		-				
25	100	-		End of boring

Boring terminated at 25' bgs due to water and piezometer installation
 TOC: Top of PVC casing
 DTW: Depth to water
 bgs: Below ground surface
 AMSL: Above mean sea level

Riser Stickup: 3.13'
 Riser: 0 - 4' bgs
 Screen: 4 - 24' bgs [Slot Size: 0.010"]
 Sand Pack: 3 - 24' bgs [Grain Size: WG #2]
 Bentonite Seal: 0 - 3' bgs [Grain Size: 3/8" chips]

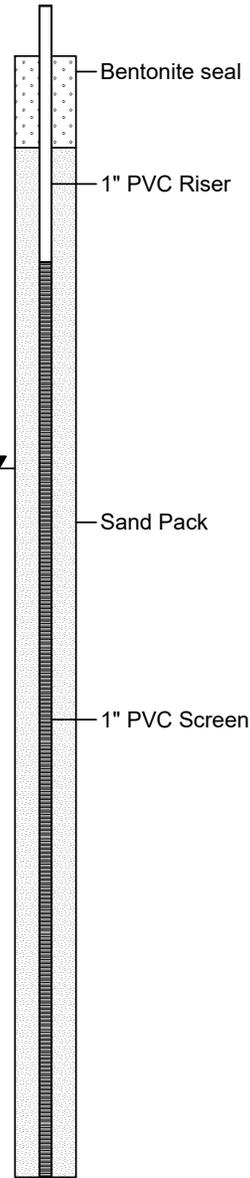
Depth (ft.)	% Recovery	PID Reading (PPM)	Sample No/Interval	DESCRIPTION	USCS	REMARKS
0	-	-		(0-7') SLAG SAND and GRAVEL, loose, black, dry, no plasticity, no cohesion		
0.8						
80	1.4					
0.4						
5	0.6		B22-119K-SB-5		SW/GW	
0.1						
100	0.6					
0.7						
10	1.1		B22-119K-SB-9	(8-9') SLAG GRAVEL and SILT, hard, tan, dry, no plasticity, cohesive	GW/ML	
-				(9-12') SLAG SAND and GRAVEL, black, wet, no plasticity, no cohesion	SW/GW	
70	1.7			(12-25') CLAY with GRAVEL from 20-21' bgs, firm, dry to wet at 20' bgs, gray, high plasticity, cohesive		
0.6						
15	0.1		B22-119K-SB-15			
-						
60	-					
-						
20	-				CL	
100	-					
25	-			End of Boring

Boring terminated at 24.5' bgs due to water and piezometer installation
 TOC: Top of PVC casing
 DTW: Depth to water
 bgs: Below ground surface
 AMSL: Above mean sea level

Riser Stickup: 5.45'
 Riser: 0 - 4.5' bgs
 Screen: 4.5 - 24.5' bgs [Slot Size: 0.010"]
 Sand Pack: 2 - 24.5' bgs [Grain Size: WG #2]
 Bentonite Seal: 0 - 2' bgs [Grain Size: 3/8" chips]

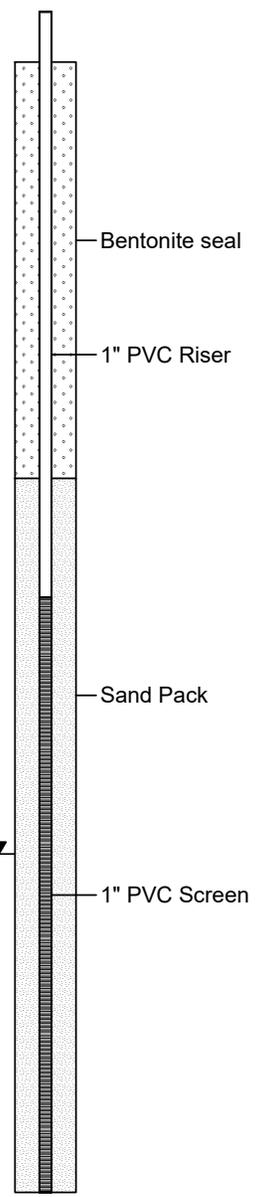
Depth (ft.)	% Recovery	PID Reading (PPM)	Sample No/Interval	DESCRIPTION	USCS	REMARKS
0		-	No Samples Collected	(0-15') SAND with GRAVEL, fine to coarse, loose, dark brown to pale gray, dry, no plasticity, no cohesion		
2.3						
80	2.0					
59.8						
5	2.7					
	-					
80	7.7					
	0.5				SW	
	0.6					
10	2.6					
	-					
80	8.5					
	6.6					
	6.1					
15	6.9					
	0.2			(15-19') SLAG GRAVEL with SAND, medium to coarse, dense, black to reddish brown, no plasticity, no cohesion		
	0.3					
100	5.5				SW/GW	
	8.0					
				End of boring

Wet at 16' bgs
 BRICK at 17' bgs

Boring terminated at 19' bgs due to water and refusal
 TOC: Top of PVC casing
 DTW: Depth to water
 bgs: Below ground surface
 AMSL: Above mean sea level

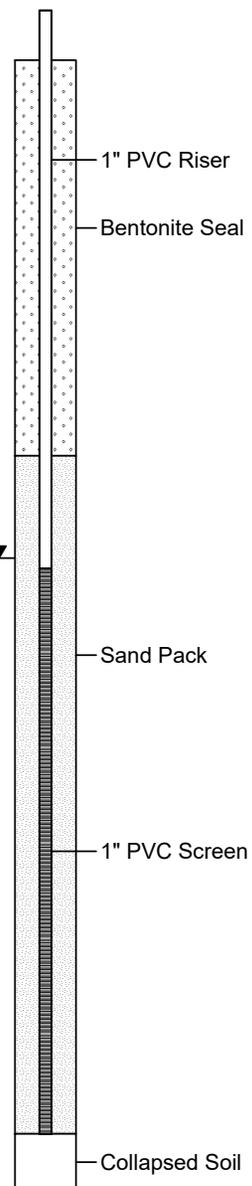
17.2				(15.2-17.2') FILL GRAVEL with some SAND and SILT, medium dense, red yellow and brown, wet, no plasticity, no cohesion	GW	
20	86	0.5		(17.2-20') CLAY with trace SAND, very firm, pale green and black, moist, low plasticity, cohesive	CL	
				End of Boring

Wet at 12' bgs

Boring terminated at 20' bgs due to water and piezometer installation
 Piezometer installed to 19' bgs
 TOC: Top of PVC casing
 DTW: Depth to water
 bgs: Below ground surface

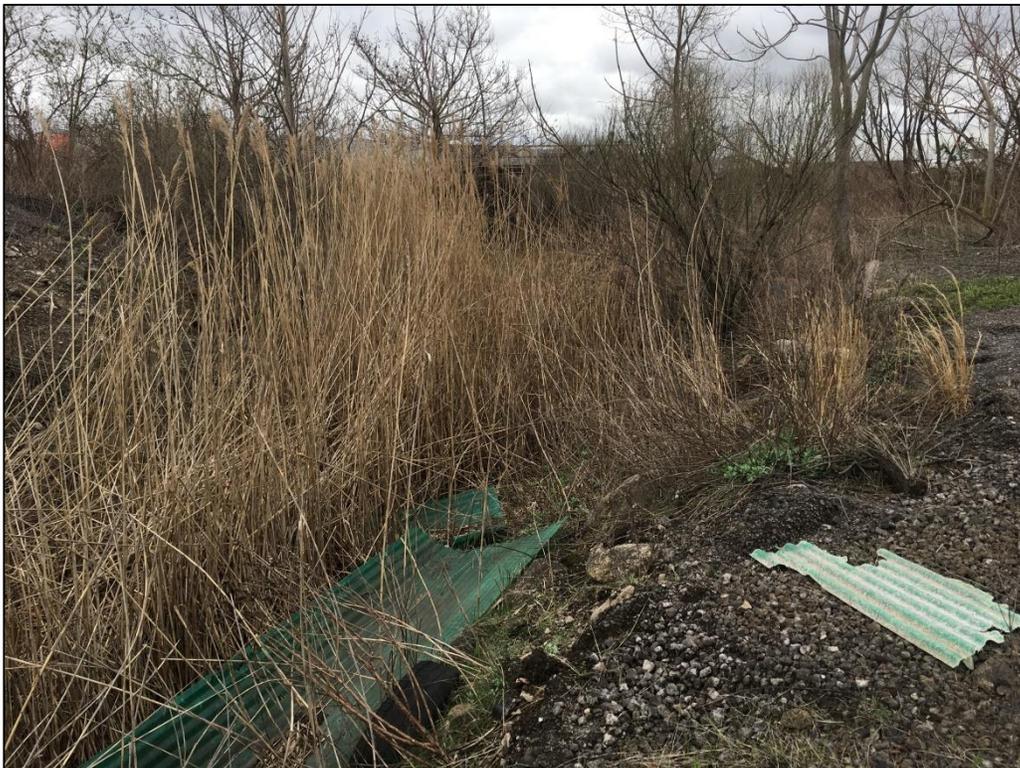
060518-2: View of the ground surface at the PORI Lagoon.

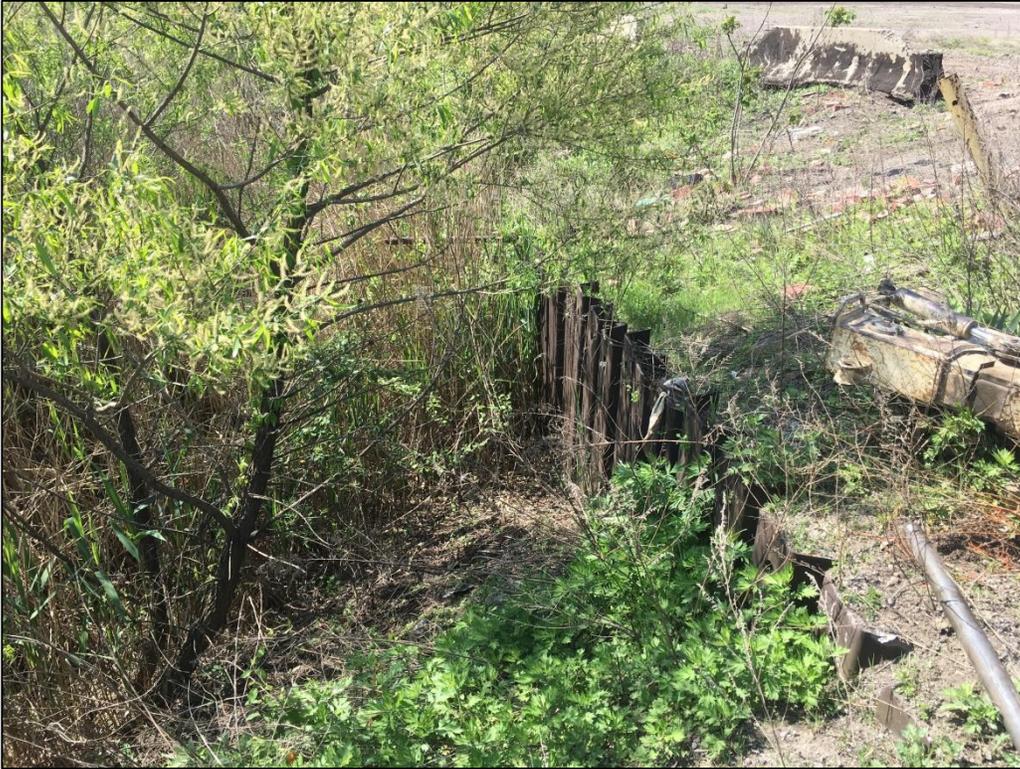
060518-3: View of the sheet piling at the northern end of the PORI Lagoon.

Mill Canal. A soil sample was collected from each test pit along the sidewall above the water table, at approximately 12 feet bgs relative to the surrounding ground surface at the top of the PORI Lagoon. A photograph log with representative photos from the test pitting is provided in **Attachment 3**. As shown in the photograph log, a length of sheet piling was observed at the northwestern edge of the PORI Lagoon.

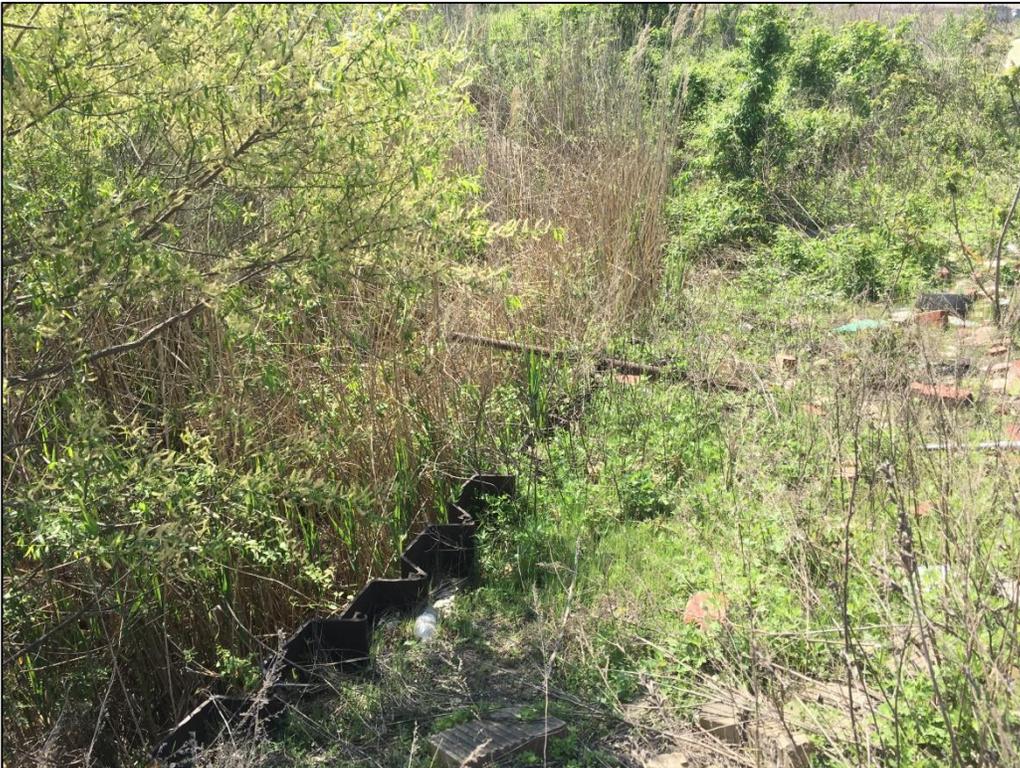
060518-4: View of the sheet piling at the northern end of the PORI Lagoon.

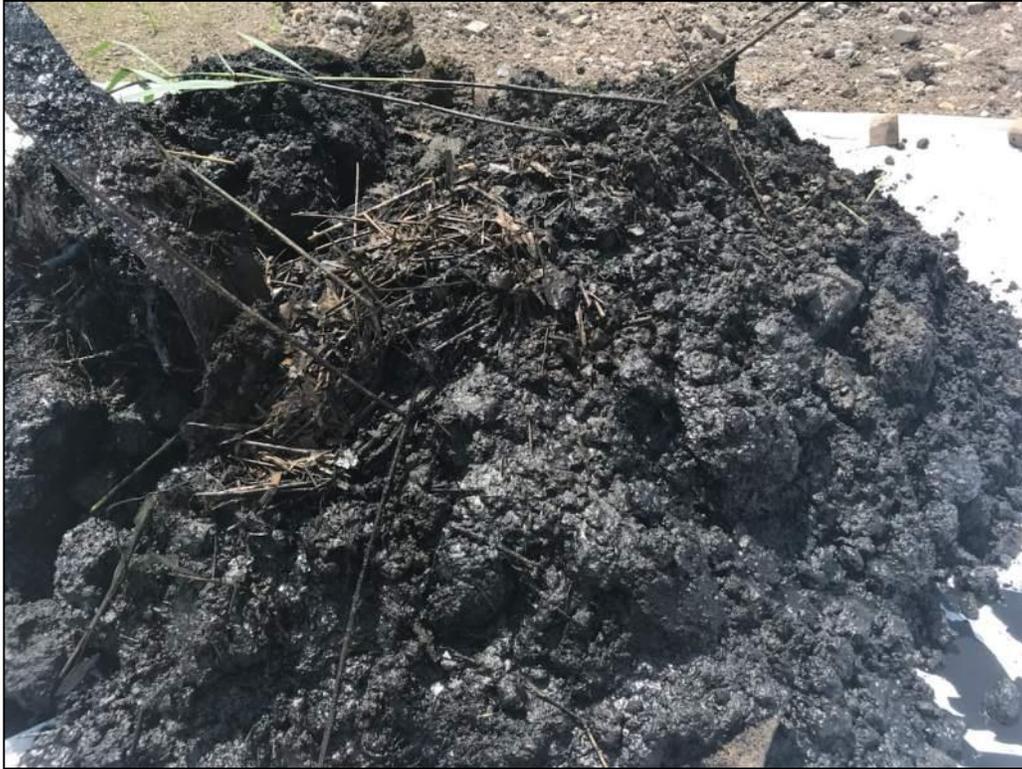
060518-5: View of excavated material from test pitting activities at the PORI Lagoon.

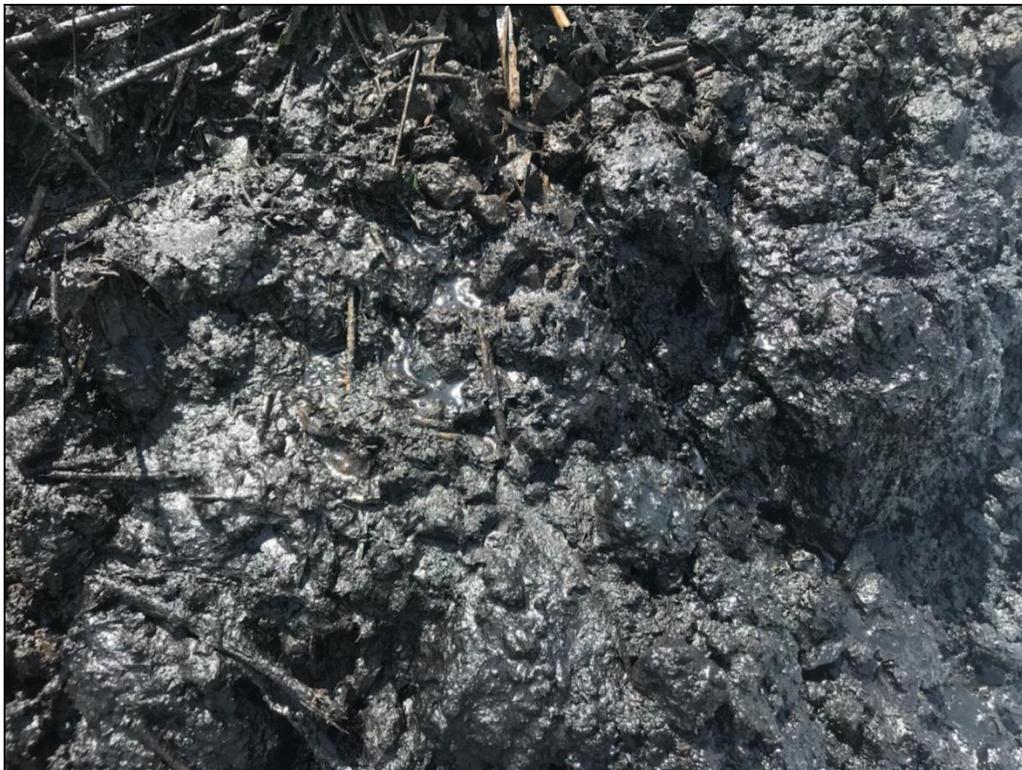
060518-6: View of excavated material from test pitting activities at the PORI Lagoon.

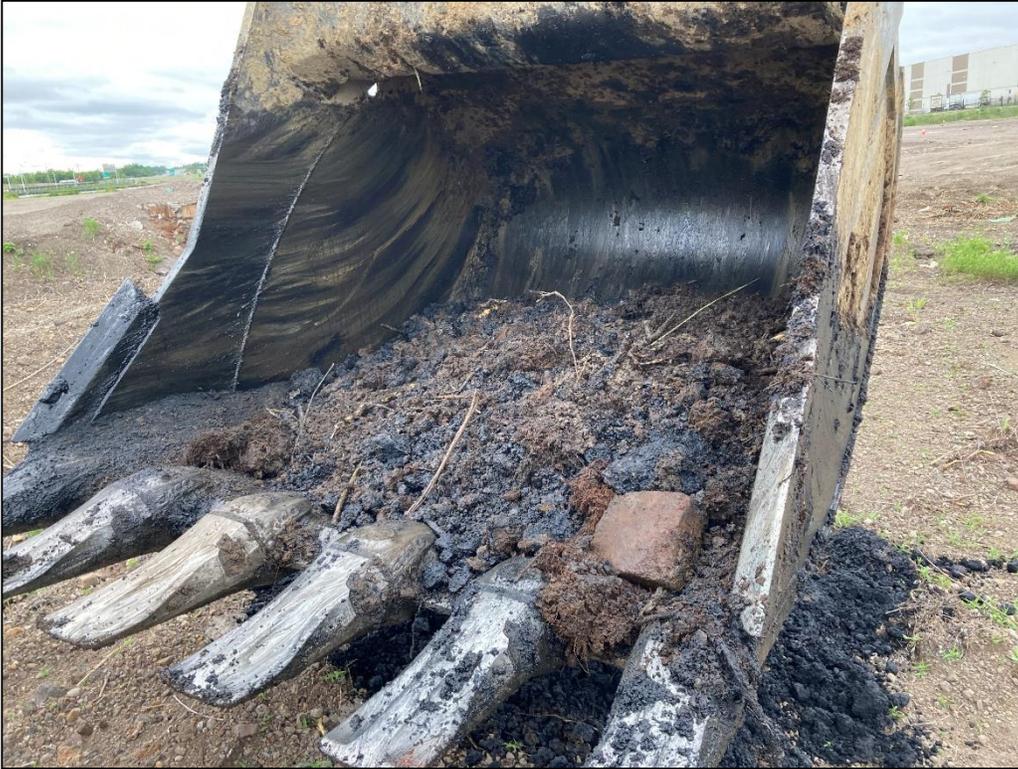
061720-1: View of excavated material from test pitting activities at the PORI Lagoon.

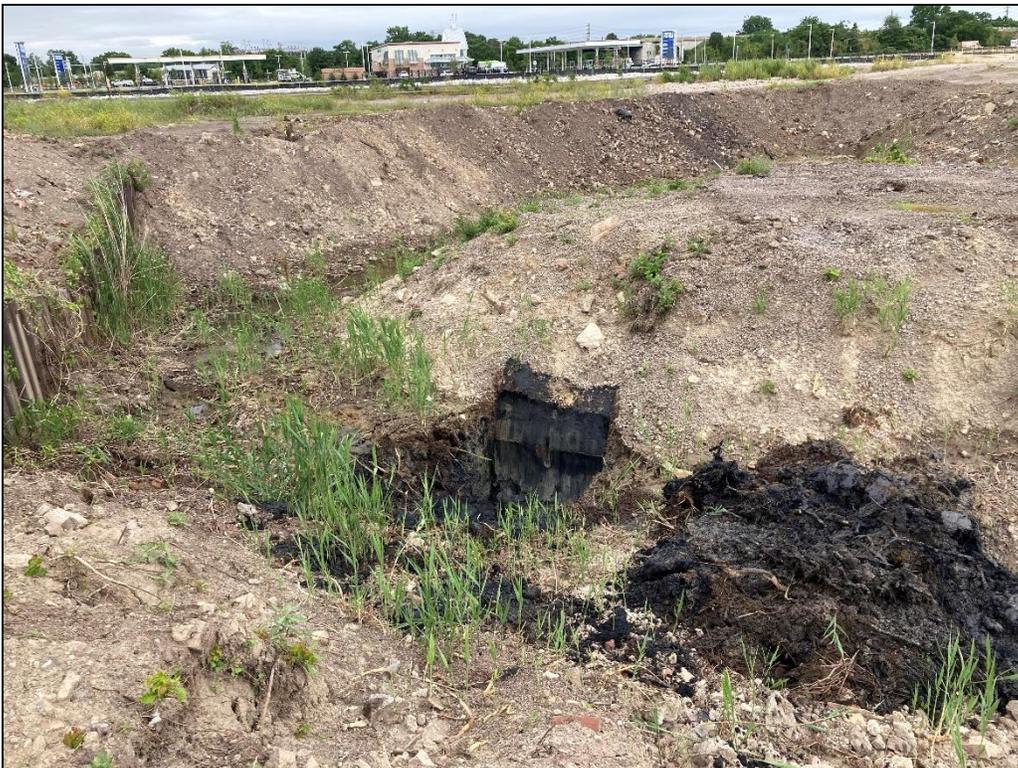
061720-2: View of excavated material from test pitting activities at the PORI Lagoon.
Sheet piling is visible to the left side of the image.

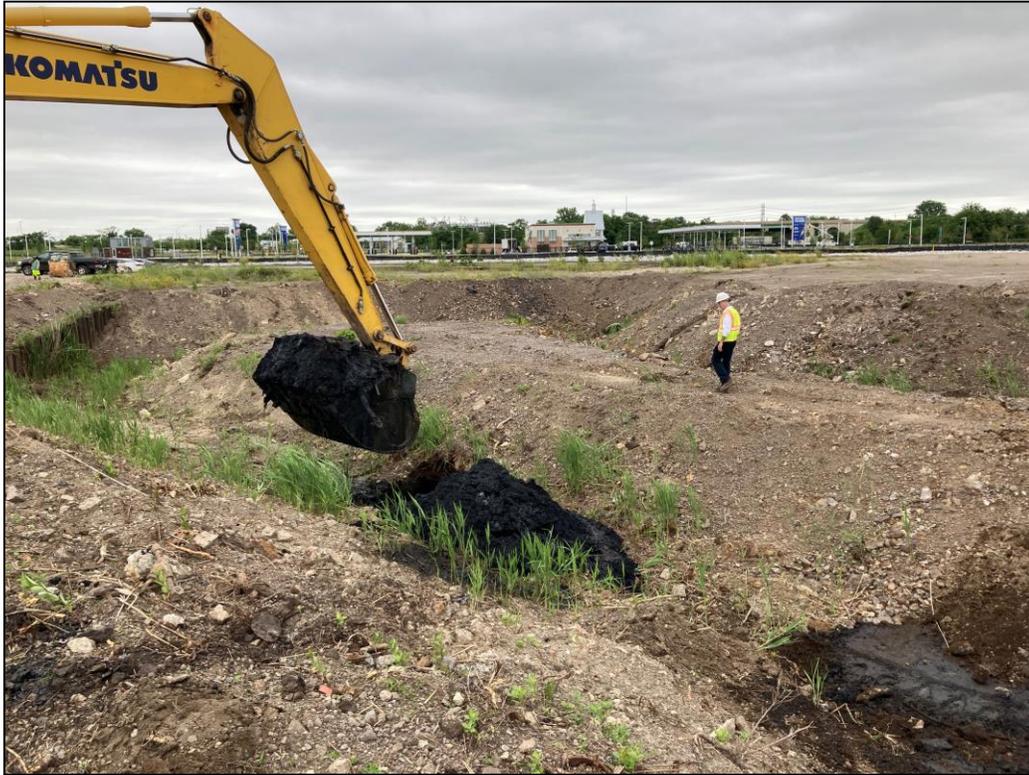
061720-3: View of excavated material from test pitting activities at the PORI Lagoon. Sheet piling is visible in the background.

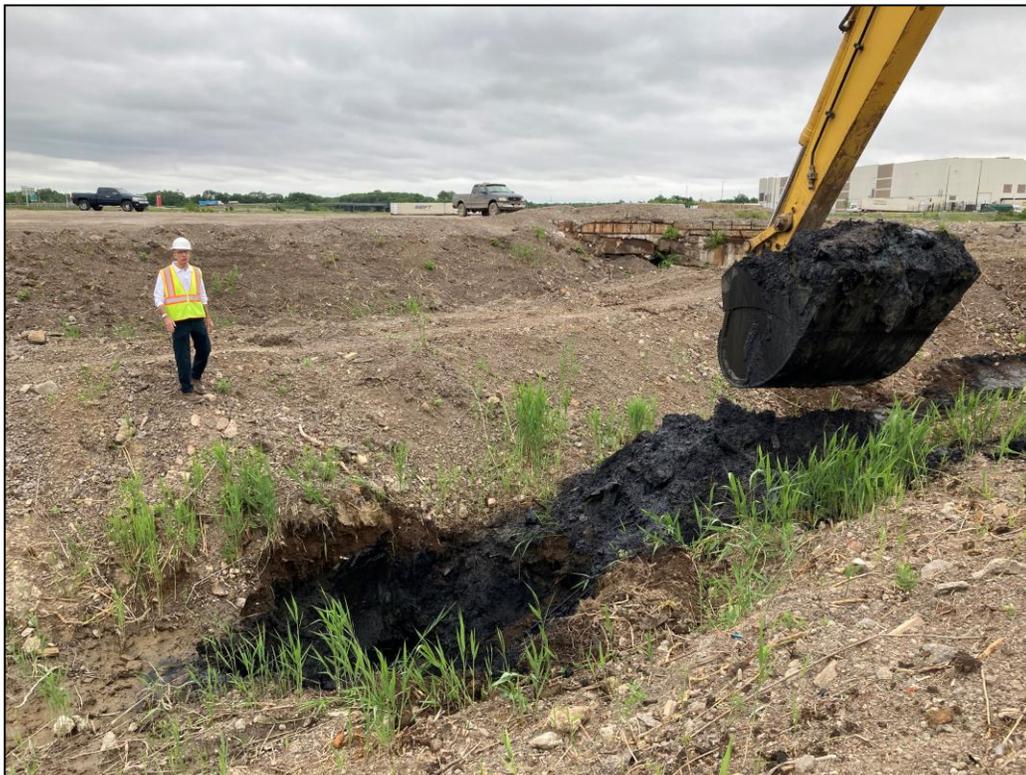
061720-4: View of excavated material from test pitting activities at the PORI Lagoon.

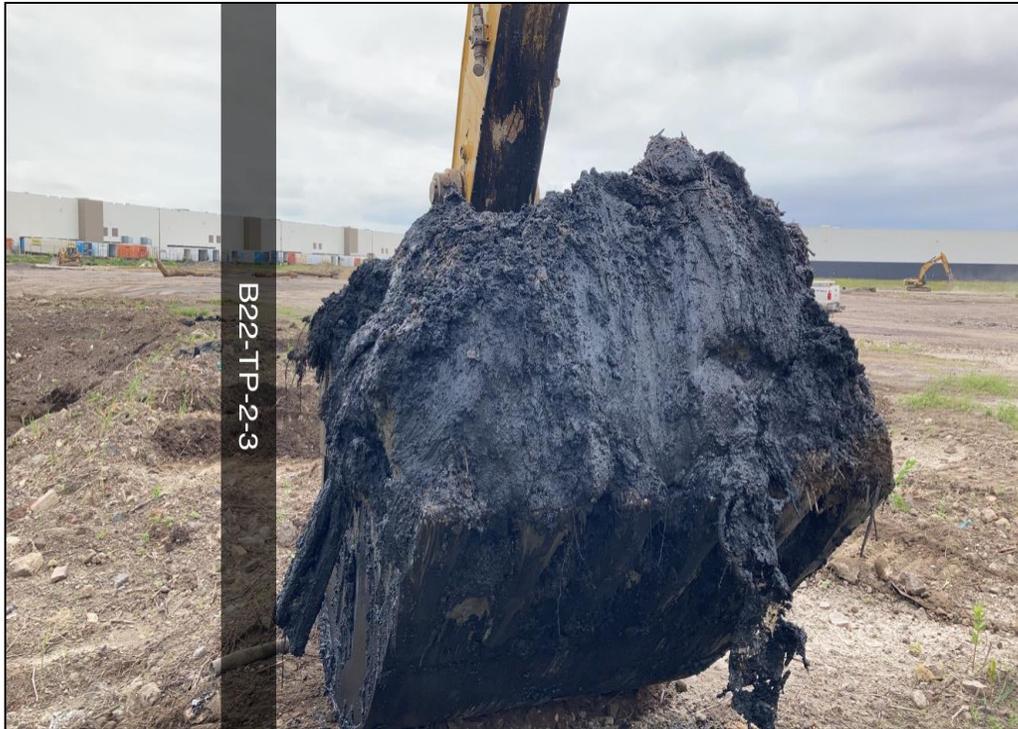
061720-5: View of excavated material from test pitting activities at B22-TP-2.

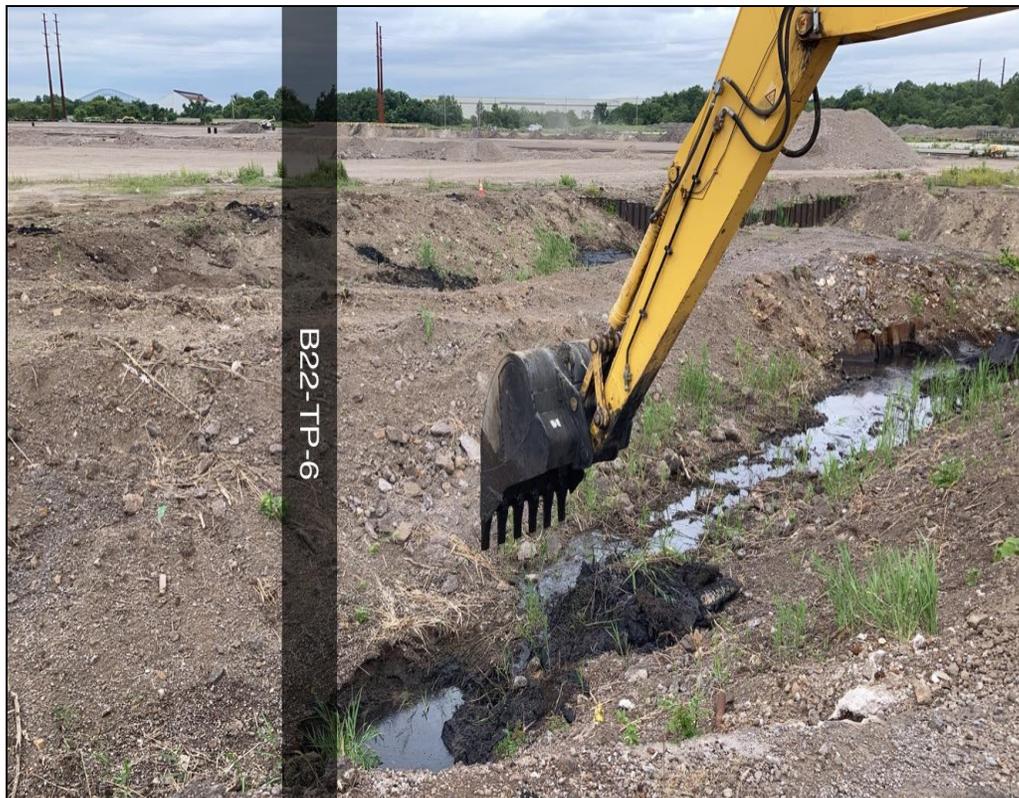
061720-6: View of excavated material from test pitting activities at B22-TP-6.
Sheet piling is visible in the background.
