PHASE II INVESTIGATION REPORT

AREA A: PARCEL A10
TRADEPOINT ATLANTIC
SPARROWS POINT, MARYLAND

ARM Project No. 150298M-5

Revision 1 – July 8, 2019

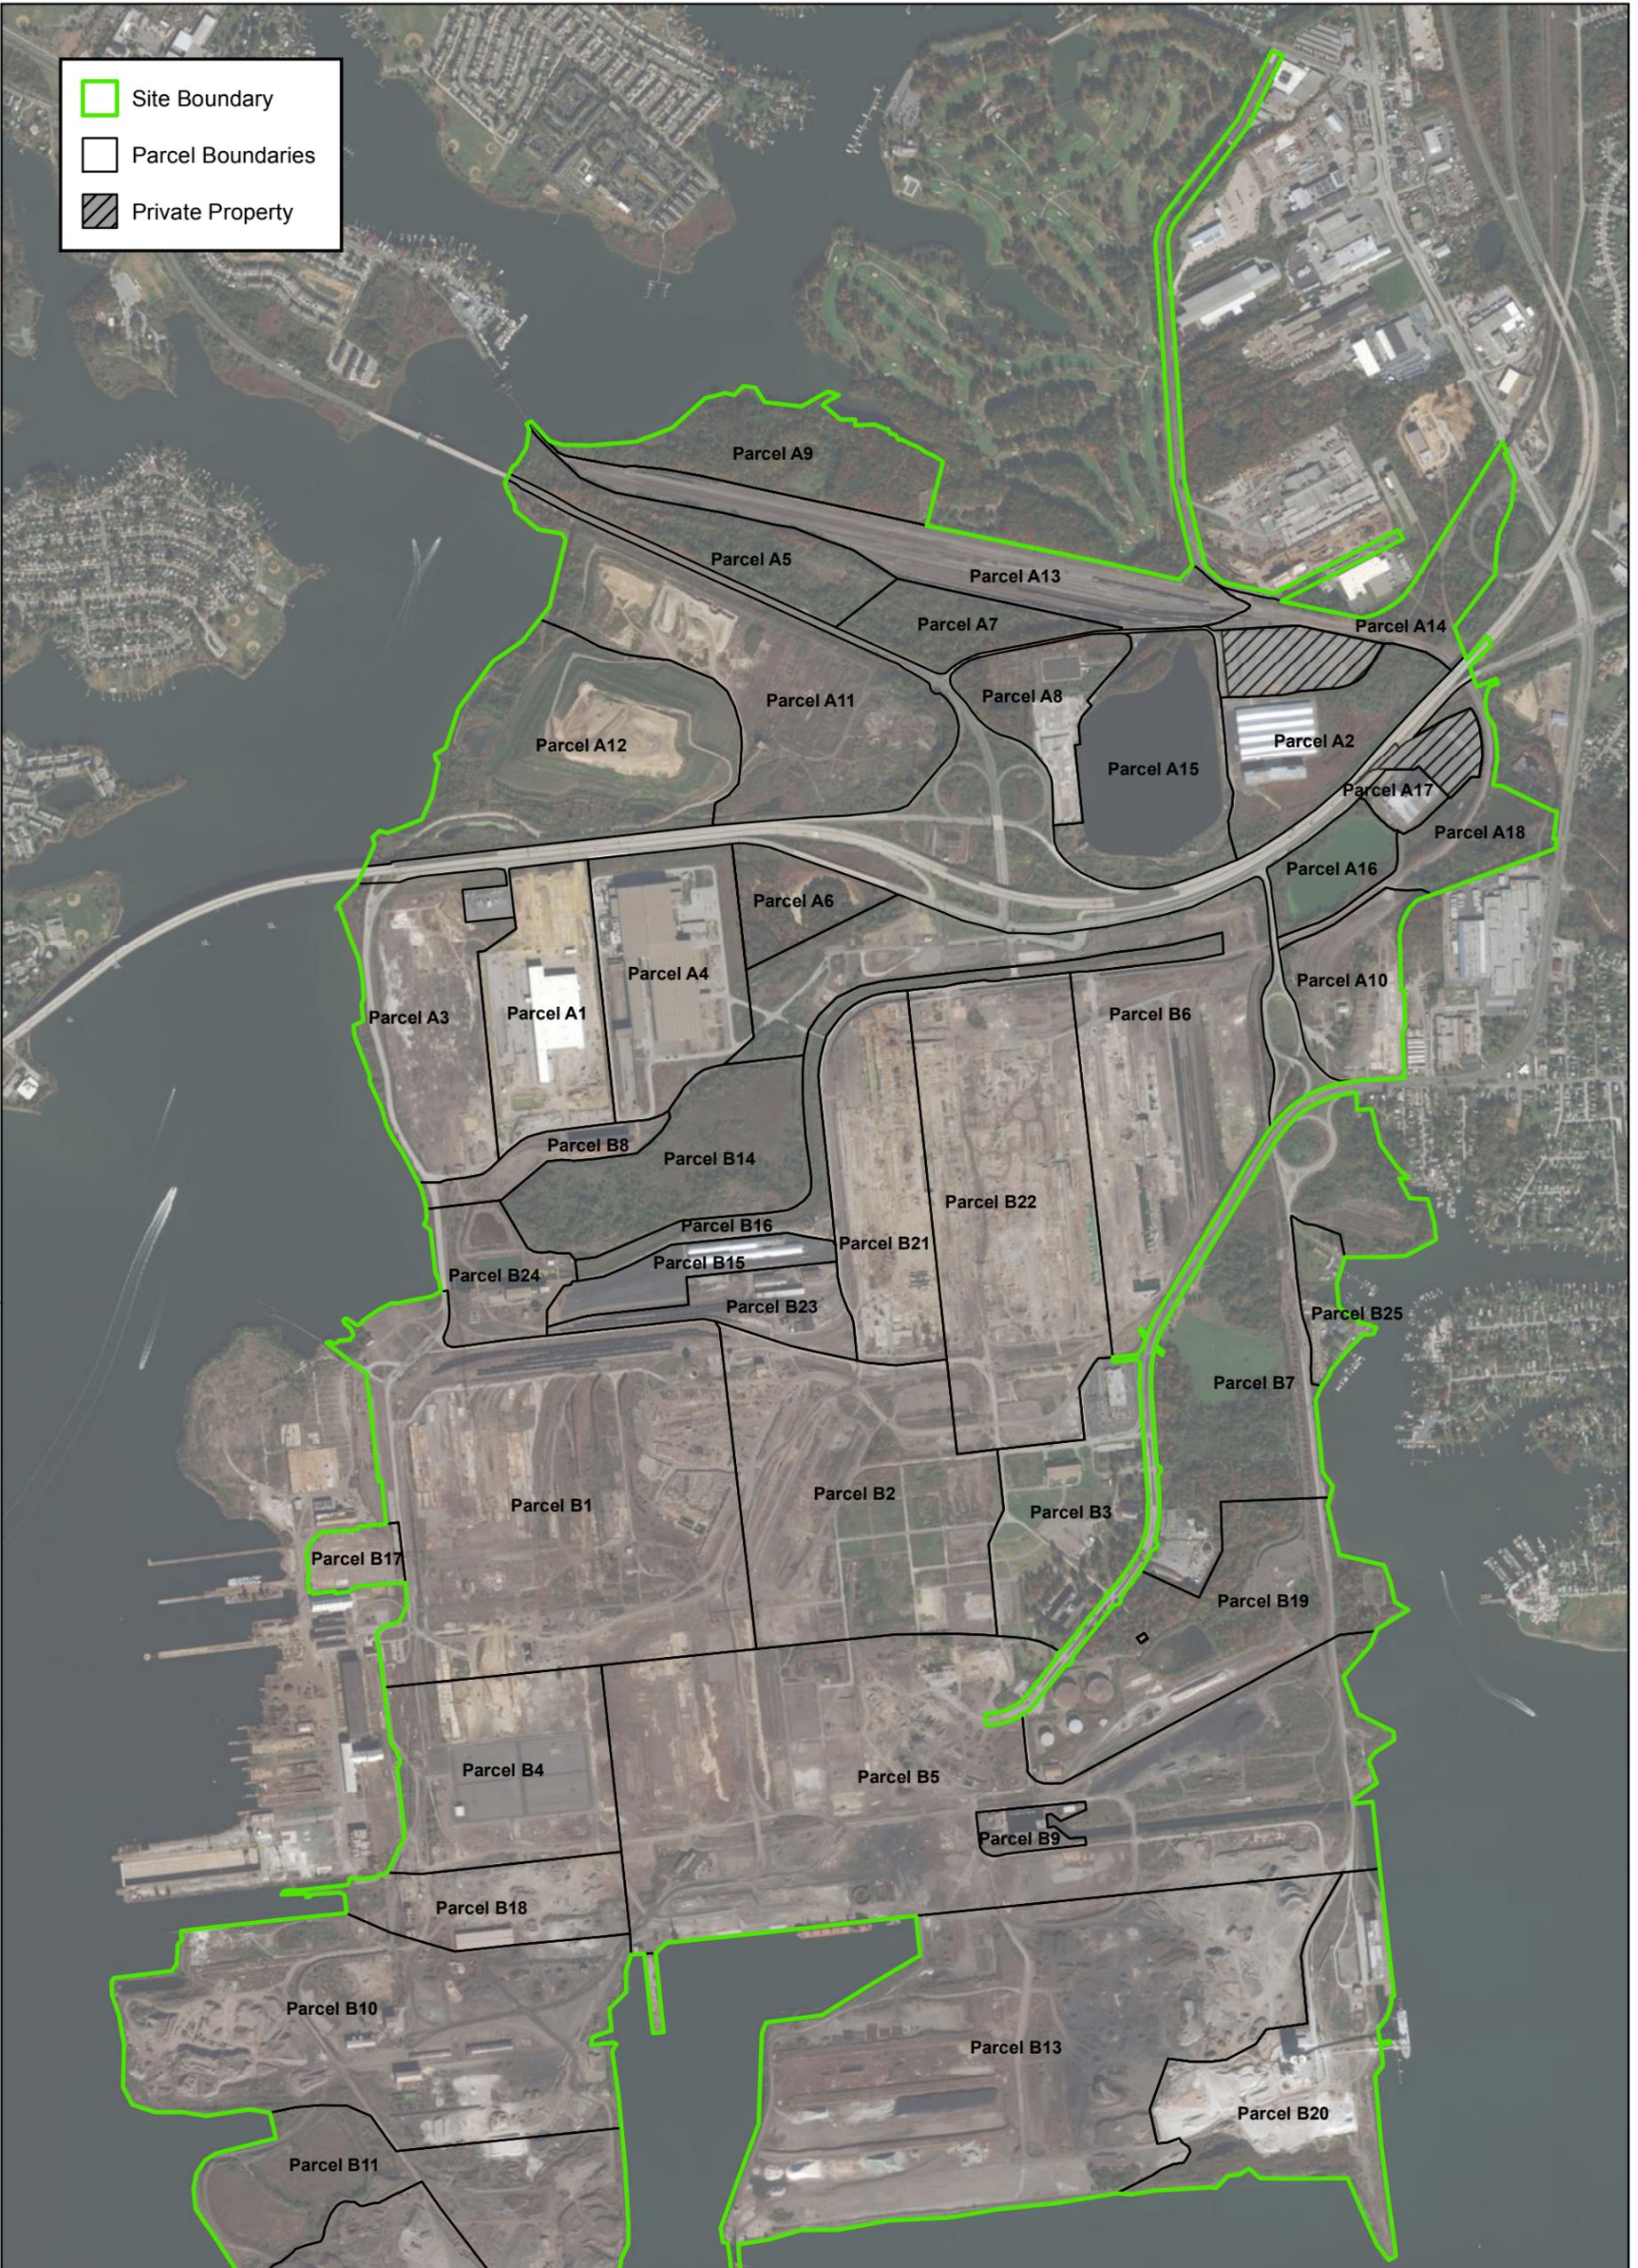
Tradepoint Atlantic Area A and Area B Parcels March 1, 2018		Figure 1
 ARM Group Inc. Earth Resource Engineers and Consultants	Tradepoint Atlantic Baltimore County, MD EnviroAnalytics Group	
	Area A: Project 150298M Area B: Project 150300M Development: Project 160443M

Site Boundary
 Parcel Boundaries
 Private Property

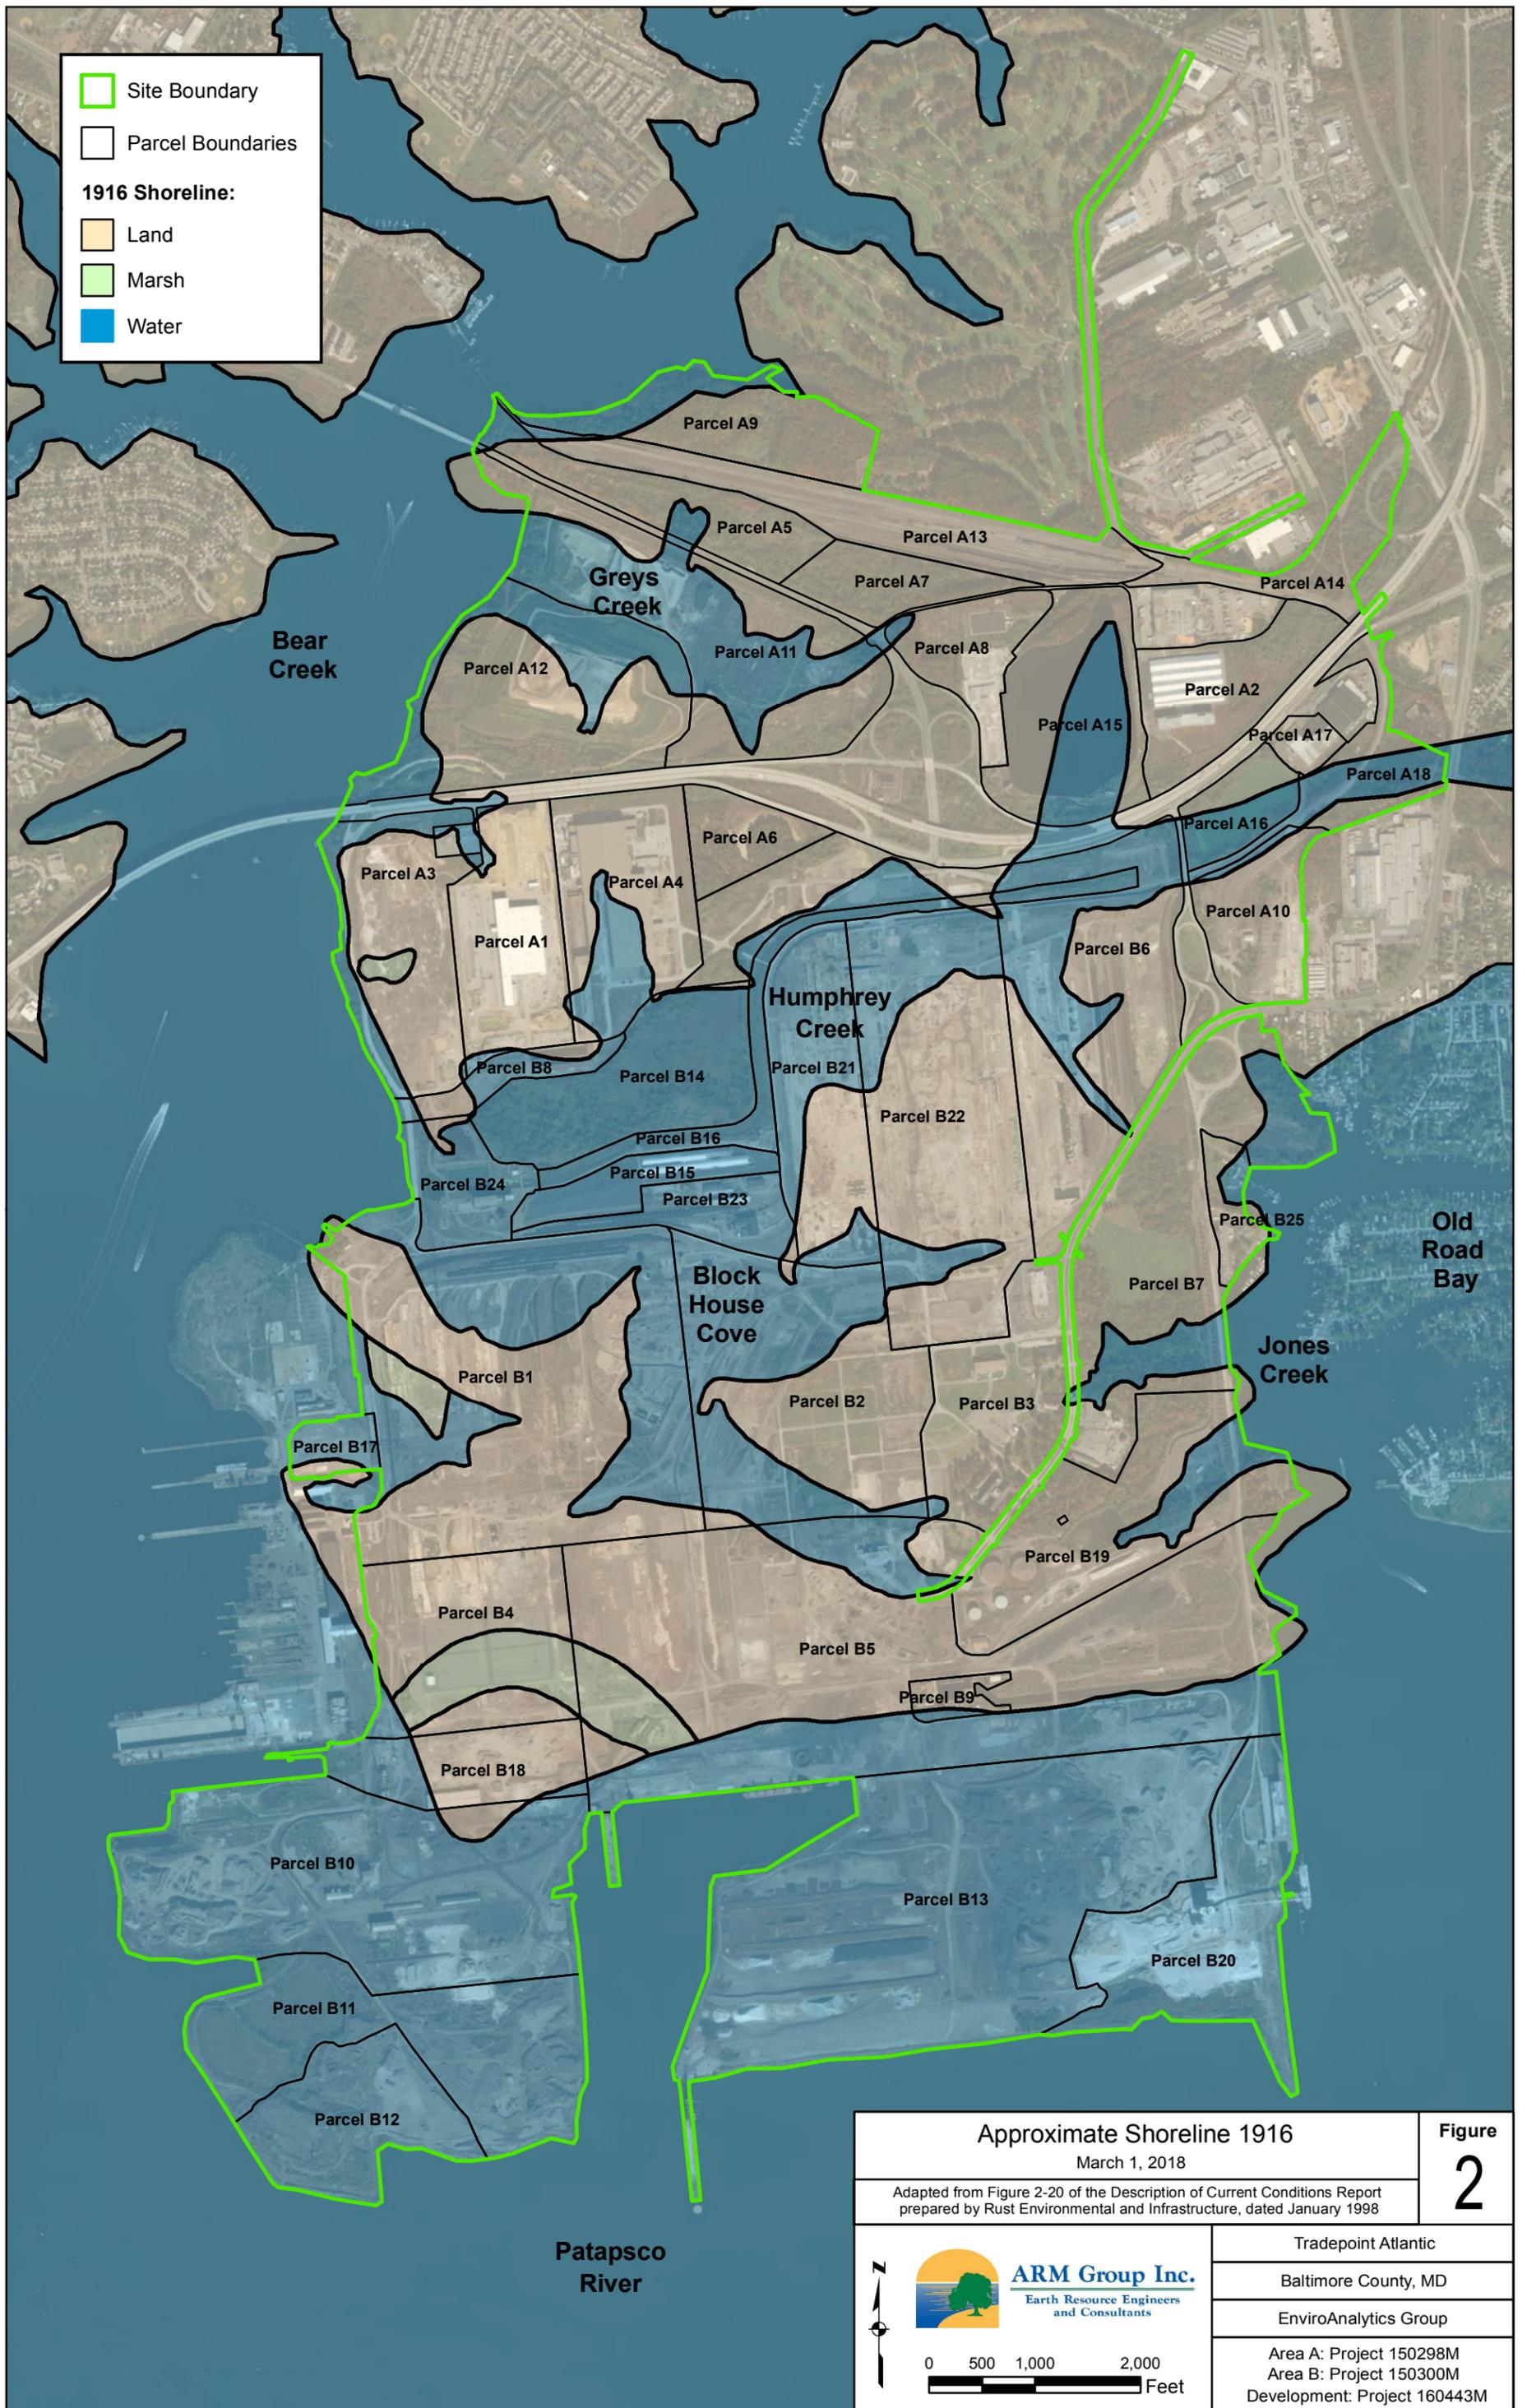
2

Groundcover at the Site is comprised of approximately 95% natural soils and 5% fill materials based on the approximate shoreline of the Sparrows Point Peninsula in 1916, as shown on **Figure 2** (adapted from Figure 2-20 in the Description of Current Conditions (DCC) Report prepared by Rust Environment and Infrastructure dated January 1998).

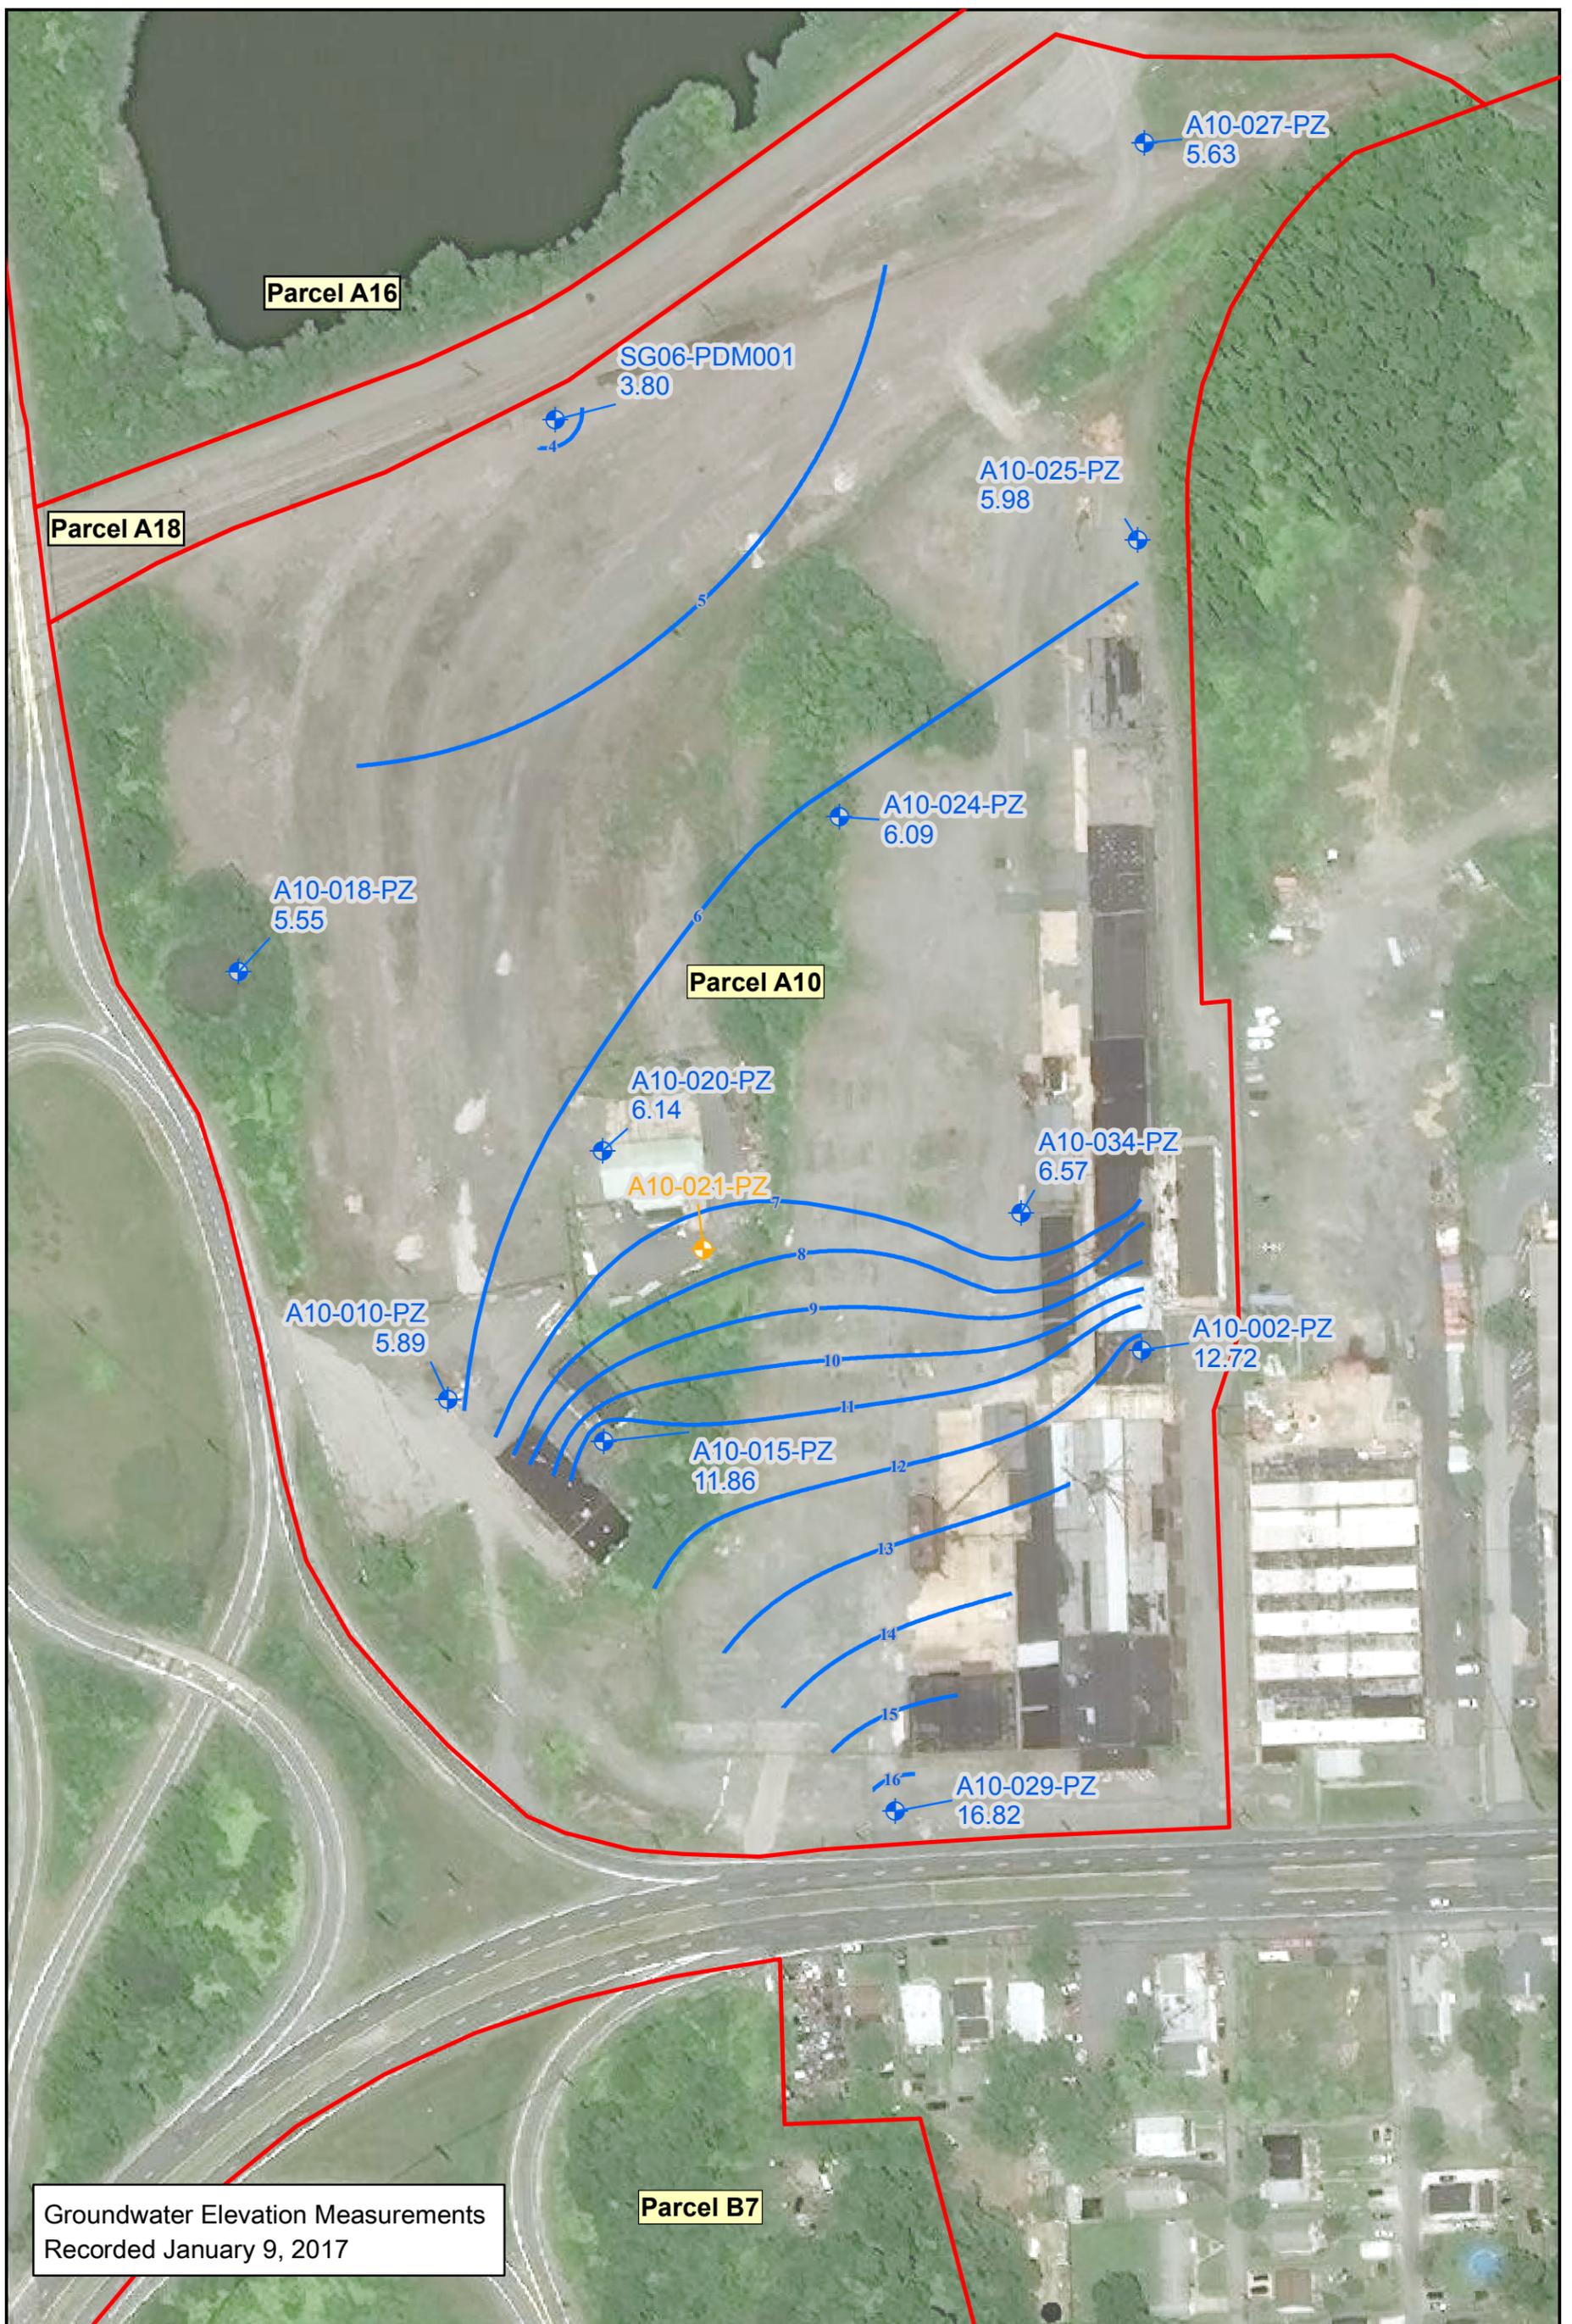
Figure
3

Temporary groundwater sample collection points were installed at 11 locations across the Site to investigate shallow groundwater conditions. One existing historical well (SG06-PDM001) was also sampled during this investigation. The locations of the groundwater sampling points are indicated on **Figure 3**. The temporary groundwater sample collection points and the existing permanent well were surveyed by a Maryland-licensed surveyor. Supporting documentation from the surveys is included in **Appendix C**. A synoptic round of groundwater level measurements was collected on January 9, 2017 from each of the groundwater points included in the parcel-specific sampling plan, with the exception of A10-021-PZ. Sample location A10-021-PZ was observed to be bent at the surface, and a water level measurement could not be obtained due to the damage. Surveyed top of casing (TOC) and ground surface elevations for all applicable locations can be found in **Table 1**, along with the depth to water (DTW) measurements from this date.

Piezometer/Permanent Well
 Piezometer (damaged)
 Potentiometric Surface Contour (ft amsl)
 Parcel Boundary

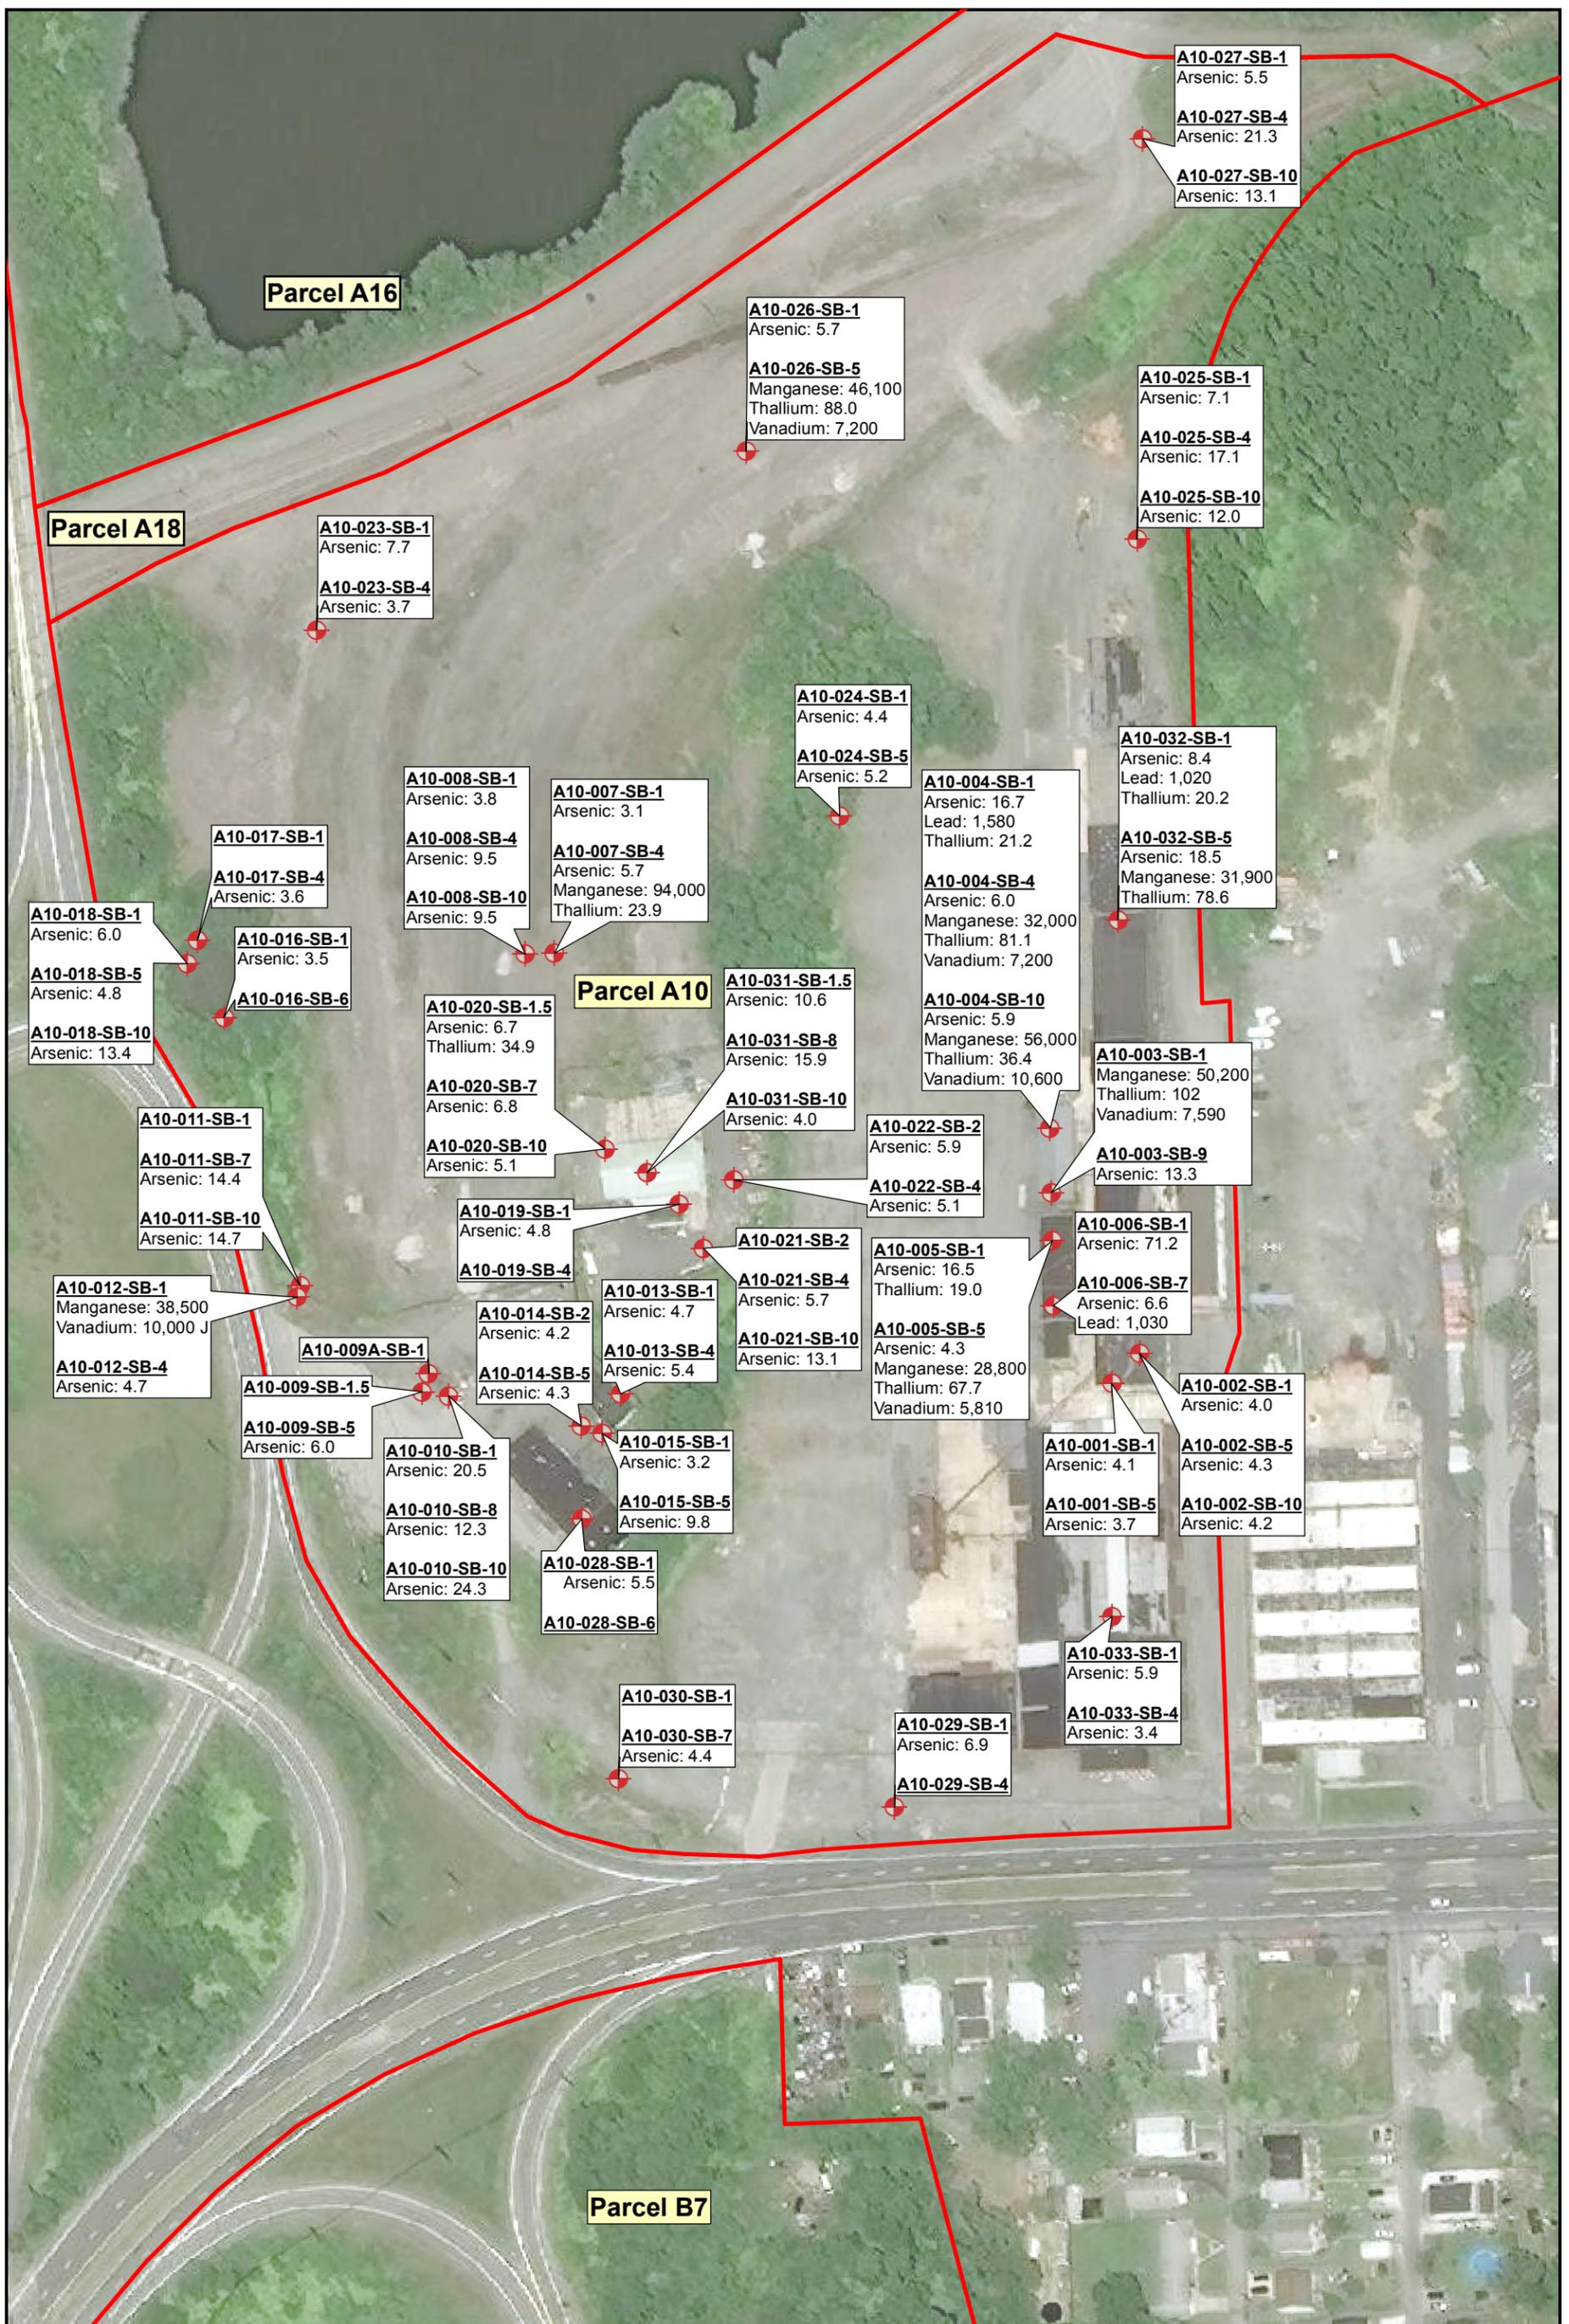
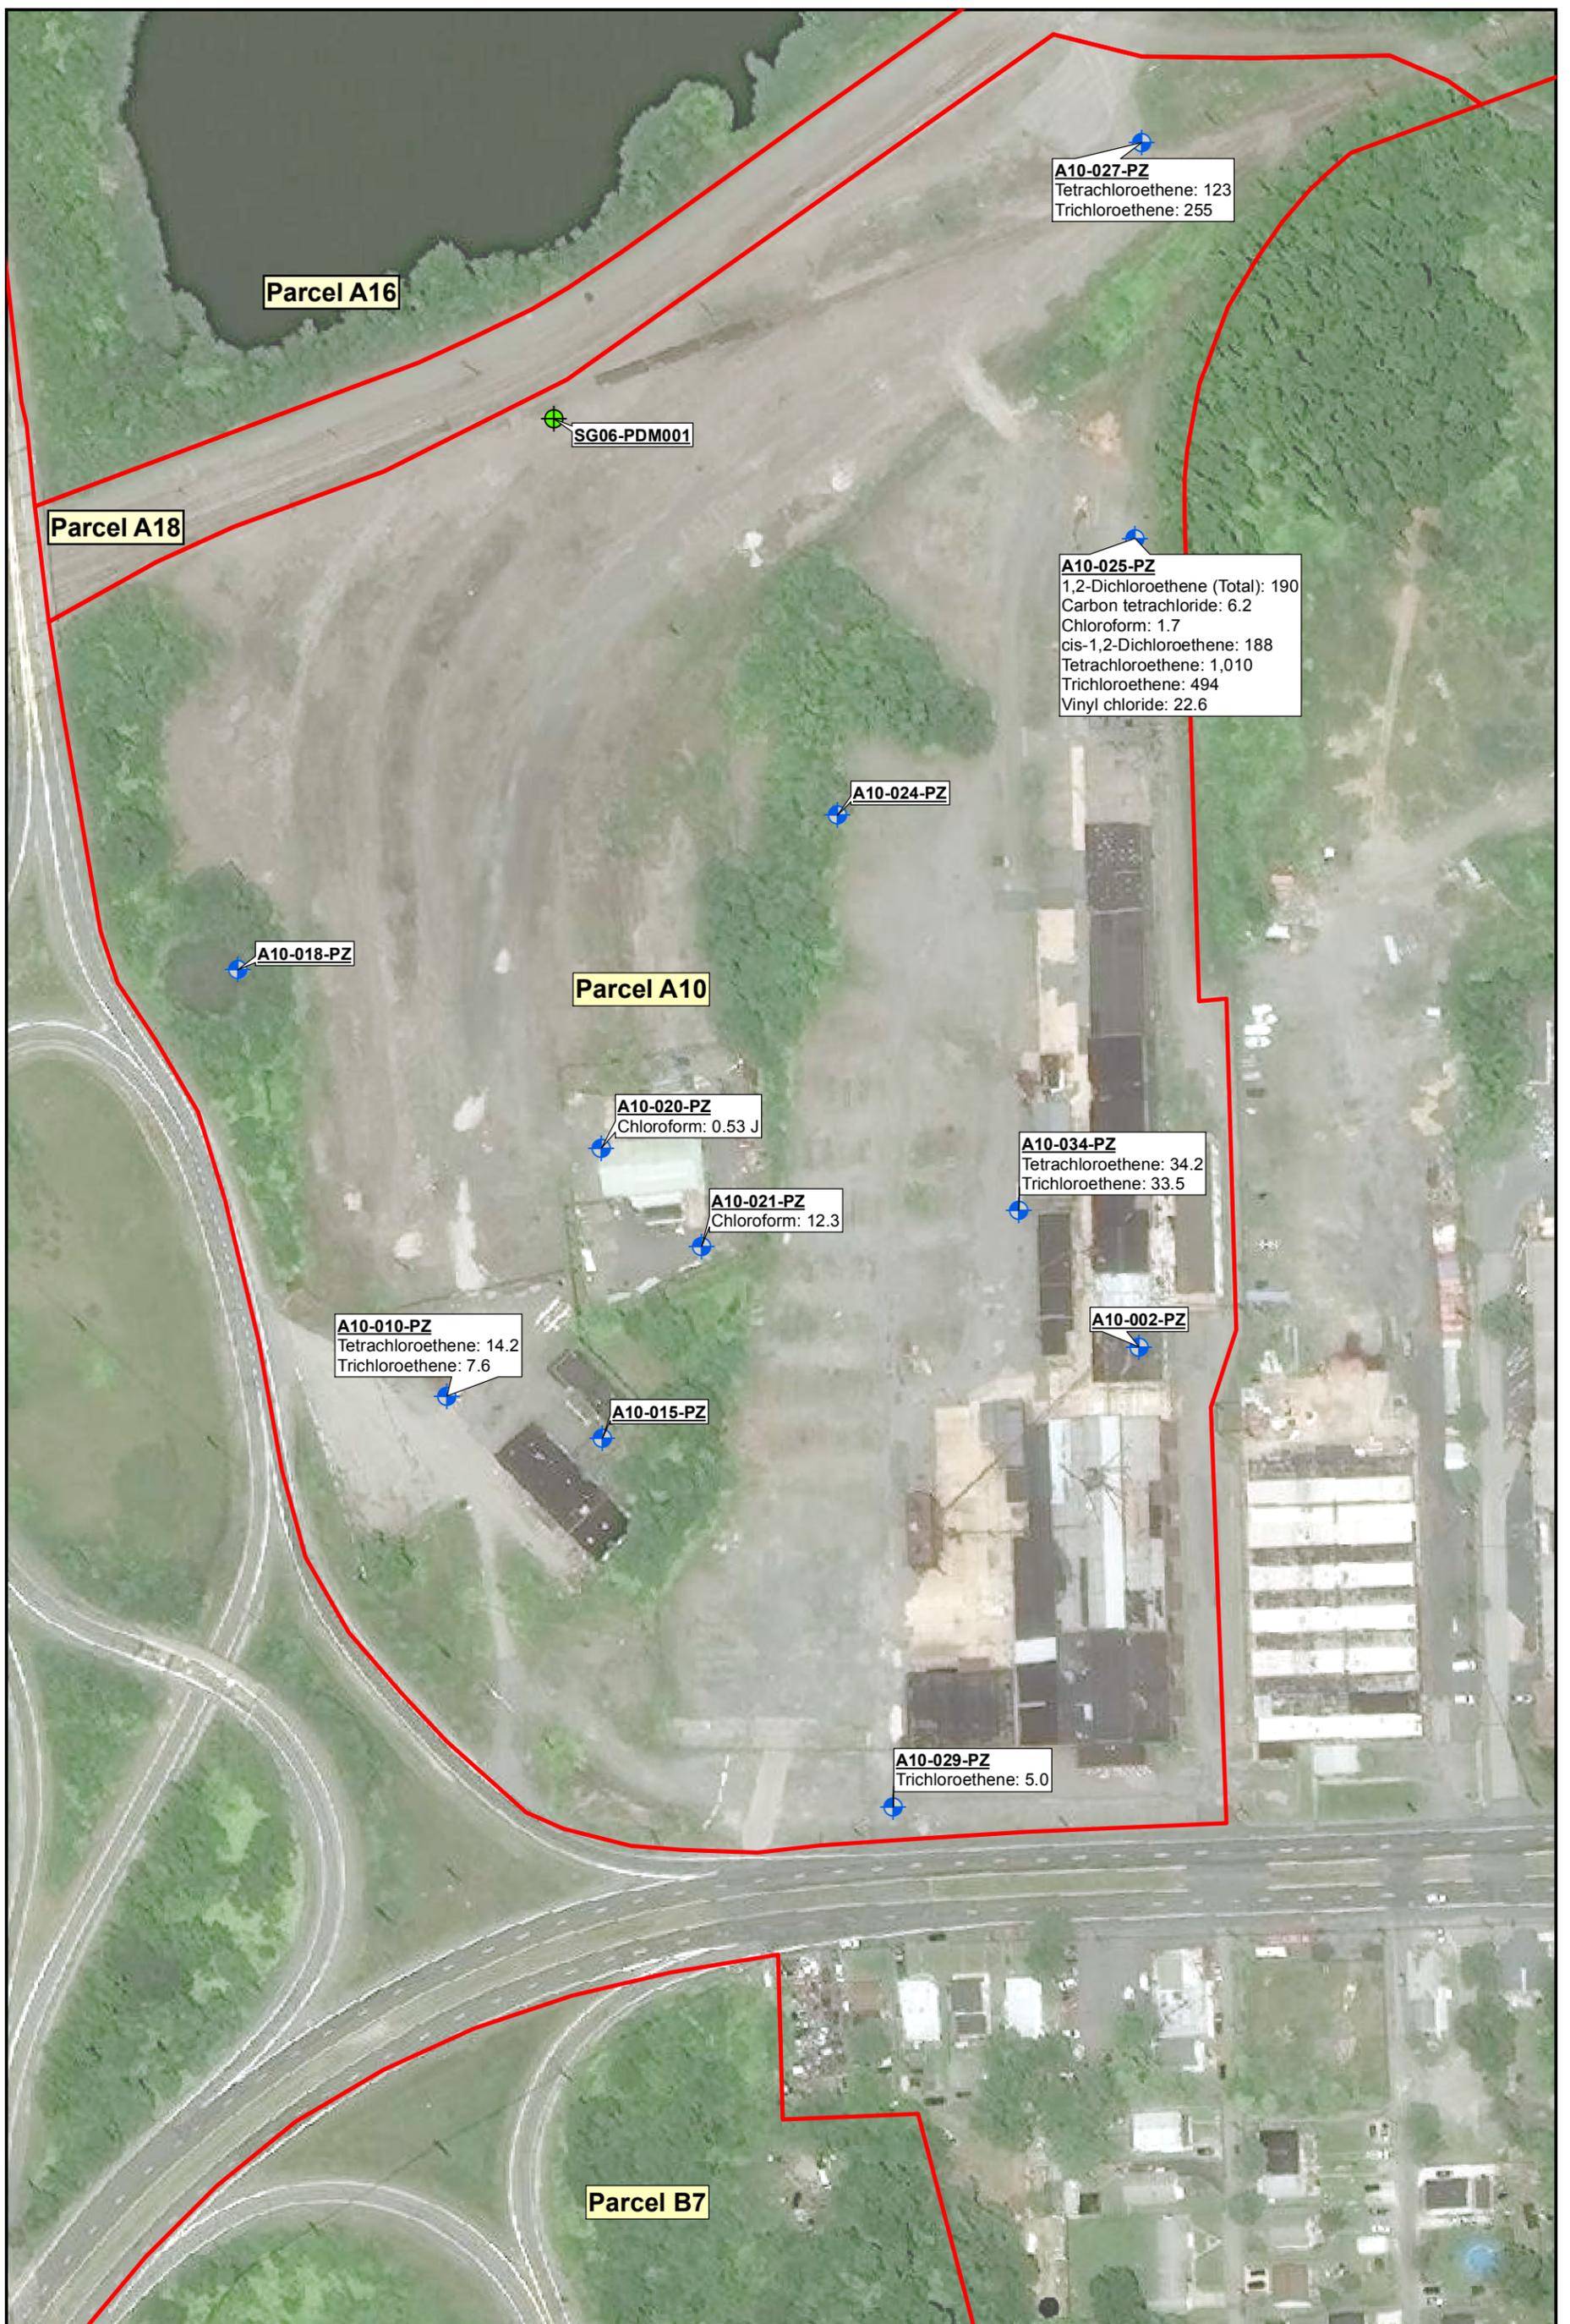
Figure
GW-1

As provided on **Table 10**, several VOCs were identified above the laboratory's MDLs in groundwater samples collected from across the Site. A total of seven VOCs (cis-1,2-dichloroethene and 1,2-dichloroethene (total), carbon tetrachloride, chloroform, tetrachloroethene, trichloroethene, and vinyl chloride) were detected above their respective PALs. Most notably, tetrachloroethene and its degradation products (trichloroethene, 1,2-dichloroethene, and vinyl chloride) were observed to be present in the eastern and southern areas of the Site. Each VOC parameter exceeded its respective PAL at groundwater sample location A10-025-PZ which is located toward the eastern boundary of the Site and provided parcel coverage. Based on the magnitude of the PAL exceedances, location A10-025-PZ appears to be the most heavily impacted by VOCs including chlorinated ethenes. A summary of the VOC PAL exceedance locations and results has been provided as **Figure GW-1**.

Seven VOCs exceeded their respective PALs at the Site (cis-1,2-dichloroethene and 1,2-dichloroethene (total), carbon tetrachloride, chloroform, tetrachloroethene, trichloroethene, and vinyl chloride), all of which were detected above their PALs in sample location A10-025-PZ. Chloroform, tetrachloroethene, and trichloroethene each exceeded their respective PALs in two, three, and four additional groundwater samples, respectively. Most notably, tetrachloroethene and its degradation products (trichloroethene, 1,2-dichloroethene, and vinyl chloride) were observed to be present in the eastern and southern areas of the Site. Four SVOCs (1,1-biphenyl, 1,4-dioxane, benz[a]anthracene, and naphthalene) were detected at concentrations above the aqueous PALs at one groundwater sample location each, excluding naphthalene which exceeded its PAL in two groundwater samples. Nine out of the 12 groundwater samples exceeded the PAL for DRO, with a maximum detection of 1,130 µg/L (flagged with the “J” qualifier indicating that it is an estimated value) at location A10-018-PZ. GRO exceeded its PAL in two groundwater samples (A10-025-PZ and A10-027-PZ) with a maximum detection of 565 µg/L.

- Tetrachloroethene and its degradation products were observed to be present in groundwater at elevated levels in the eastern and southern areas of the Site. The nature and extent of the groundwater impacts should be further defined to determine whether response actions are warranted to reduce the detected concentrations of these VOCs to acceptable levels. A separate Work Plan to provide additional delineation of associated groundwater conditions will be coordinated with the MDE and submitted in the future.
